REPAINTING THE PAINT- NEGLECTED HOUSE

UNITED STATES DEPARTMENT OF AGRICULTURE
FOREST SERVICE
FOREST PRODUCTS LABORATORY
Madison 5, Wisconsin
In Cooperation with the University of Wisconsin

F. L. BROWNE,
Senior Chemist

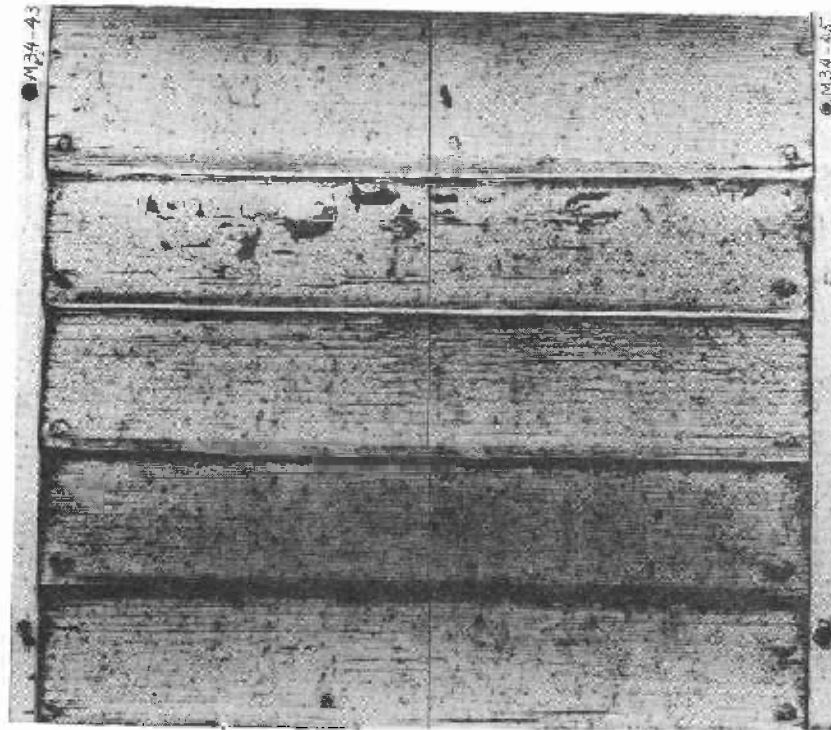
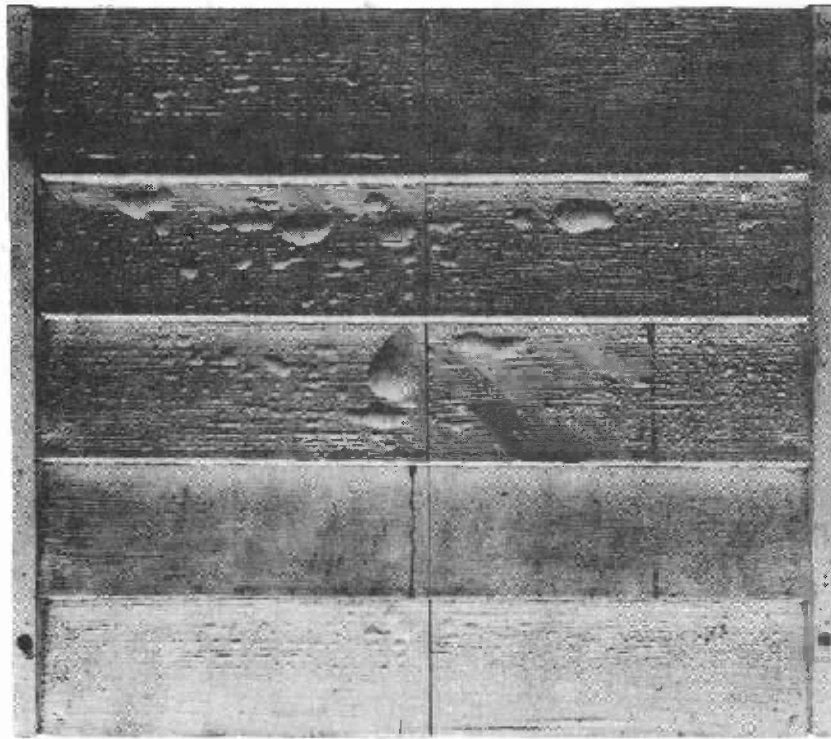
Blistering Reproduced in the Laboratory

The Forest Products Laboratory has equipment for reproducing typical moisture failures of paint for the purpose of studying the effects of different woods and paints. The panel shown in the illustration was made of 4-inch red cedar siding of the kind used on houses. It was painted in October 1934 with three coats of a representative house paint of the titanox, lead and zinc type. On the left-hand half of the panel the paint liquid contained pure linseed oil but on the right-hand half a mixture of linseed oil and heat-treated tung oil was used. The panel was exposed to the weather facing south at 45° for 2-1/2 months, after which it was tested on the blistering apparatus. The apparatus consists in a wooden framework to which panels are attached as though they were the side walls of a house. The miniature "house" has a roof and a floor and inside there is a large pan of water that is heated electrically to provide heat and humidification. The "house" is placed in a large cold-room kept at 40° F. The temperature within the house was approximately 80° F. Under such conditions moisture condensed on the backs of the boards of siding, making them thoroughly wet.

Blisters began to appear on the top board of the panel shown after the "house" was in operation for 1 day. After 2 days blisters appeared on the second and third boards also and after 3 days they appeared on the fifth board. One photograph was taken after 11 days, when the panel was removed from the "house" and replaced on the test fence out of doors. The other photograph was taken 8 months later when the coating was beginning to fail by scaling.

z M 31269 r Blistering reproduced in tests in Forest Products Laboratory.

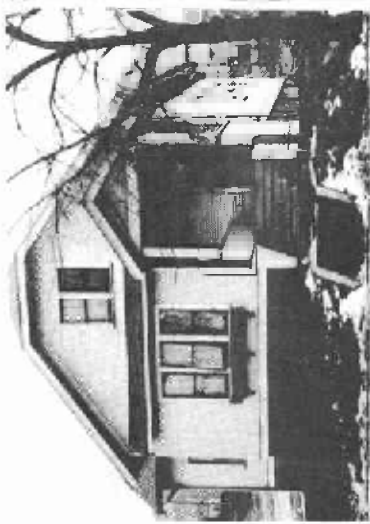
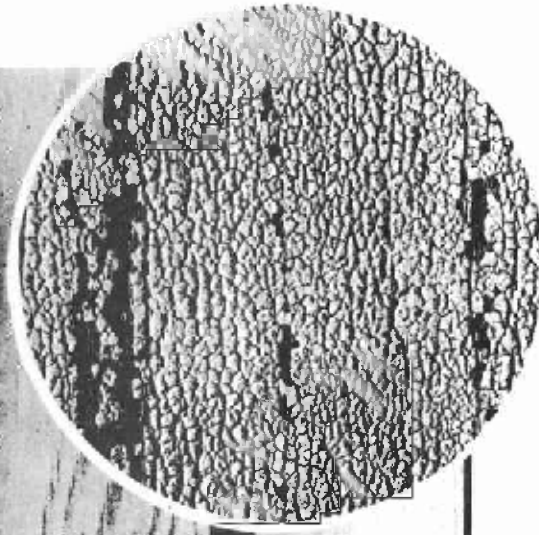
House No. 1 has always been painted with the old-fashioned soft type of paint but no new paint has been applied for 7 or 8 years and the surface has become badly neglected. The coating has thoroughly disintegrated. From a distance it merely looks shabby but close inspection proves that it has crumbled badly and has left considerable areas of wood entirely bare. Still closer observation with a magnifying glass demonstrates that disintegration of the coating developed from checking, which is characteristic of the soft type of paint. When the paint "checks" finally penetrated through the coating to the wood some of the little "islands" of coating thus cut off became dislodged one by one, leaving the wood bare underneath. Many painters call this kind of disintegration "chalking" but, although the paint has been chalking for a long time, the failure really develops from checking and crumbling.

House No. 1.--From across the street the paint merely looks rather shabby. A close view shows that the coating is worn down to bare wood in many places. Through a magnifying glass it is seen that the coating is disintegrating by checking and crumbling.

The painter who gets the job of repainting House No. 1 is lucky because he has very little to worry about. After any necessary carpenter's repairs have been attended to the painter need merely dust off loose chalk and dirt, perhaps clean a few places where soot or grease from oil-burning furnaces has collected on shaded parts of the building, and he is ready to brush on new paint. Two coats of new paint are necessary, of course, because part of the wood surface has been left bare and what is left of the old coating is little more than a mass of porous pigment that will absorb much oil from the first coat of new paint.

As a rule the new paint should be of the same soft type previously used on House No. 1 because the chances are that the job will again pass through a long period of neglect before it is repainted. If, however, the owner feels that in future he will repaint before the coating disintegrates badly and wishes to enjoy the advantages of harder types of paint it is practicable to apply them over this surface. The first coat of new paint should be thinned with linseed oil and relatively little turpentine or other volatile thinner, using not more than 1-1/4 gallons of total liquid to 1 gallon of soft paste paint. At least a gallon of the mixture should be

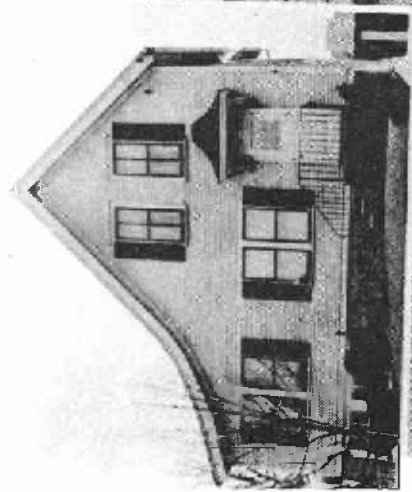
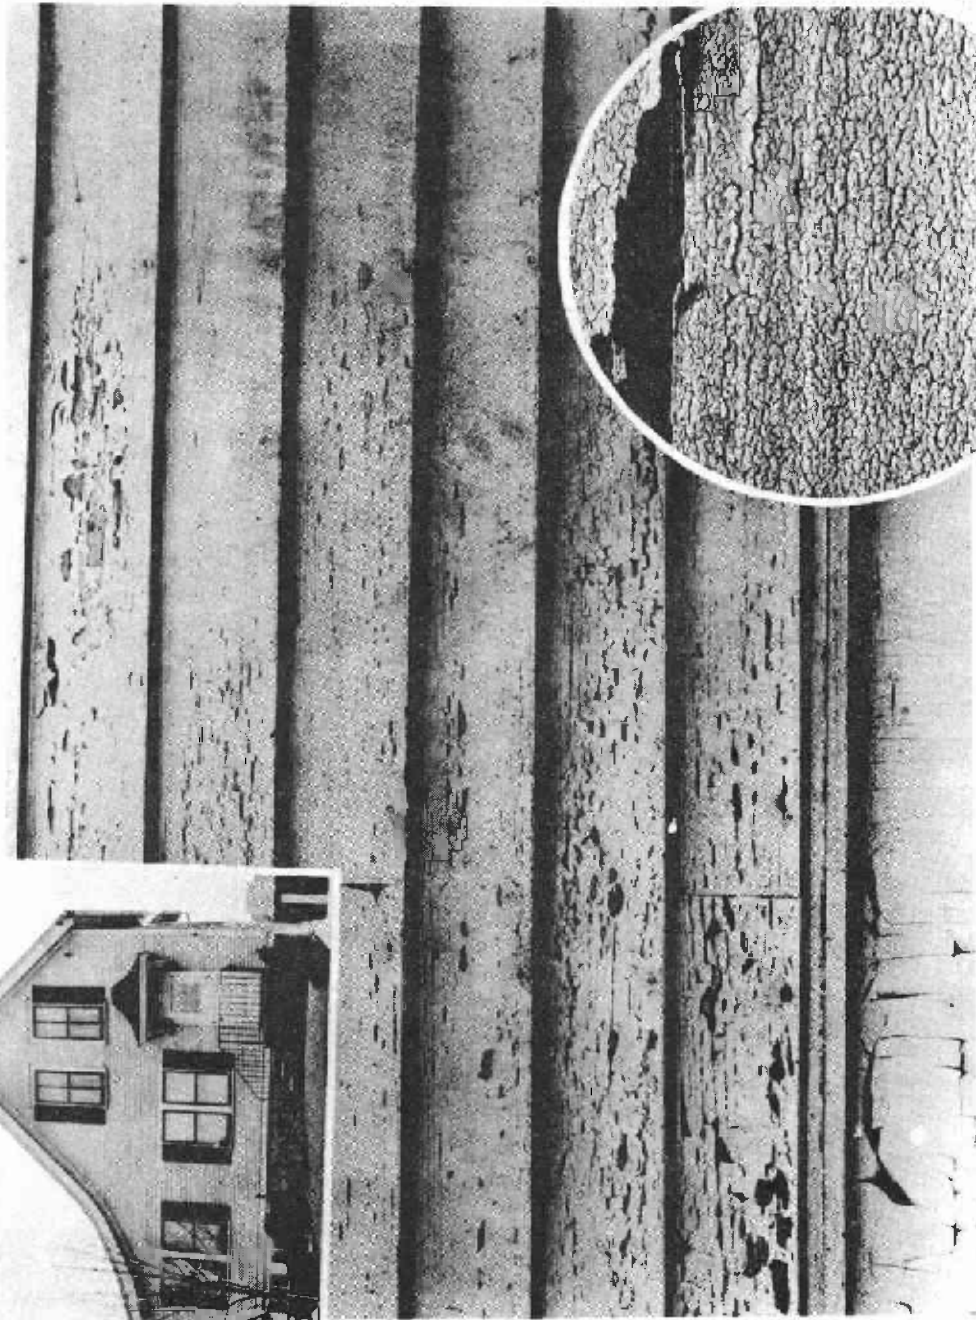
House No. 2 has been painted and two or three times repainted with paints of a fairly hard type but the owner waits just a little too long each time before he calls in the painter. As a result the painter each time has a difficult surface to deal with and as time passes successive repaintings are proving less durable. The paint is in a more advanced stage of disintegration than that on House No. 1, yet the last painting of House No. 2 was 2 or 3 years more recent than that on No. 1. The break-up of the coating on House No. 2 is easily observable from the opposite side of the street. Closer inspection shows that it is disintegrating by flaking and scaling rather than by crumbling. The view through a magnifying glass shows how such behavior differs from the crumbling on House No. 1. Note that flaking does not develop from checking but from an entirely different kind of fissure in the coating, cracking, which is a much larger and more conspicuous sort of break-up. At the edges of the cracks the coating curls upward and eventually falls off, leaving a patch of bare wood, and the coating still clinging to the wood has jagged and insecurely adhering edges.

House No. 2.--Even from across the street it can be seen that the coating is disintegrating. A close view shows how the coating comes loose from the wood in rather large and conspicuous flakes. Through a magnifying glass it can be seen that the coating disintegrates by cracking, curling, and flaking.

For a really first-class job the old paint on House No. 2 should be burned off completely but it is highly improbable that the owner will pay for it this year. If all loosened edges of old paint are carefully removed with putty knife, wire brush, and sandpaper a fairly good job of repainting can be done with reasonable assurance that it will stand up for about 3 years but probably no longer. The owner should be warned, however, that the new paint will not form a perfectly smooth coating because the places where the old coating has flaked off will show as hollows in the new one. He should also be warned that continuance of his practice of allowing the coating to get into this condition before repainting will eventually make a complete burn-off necessary before repainting can be done at all satisfactorily.

In repainting over this old coating the painter should use a hard type of paint, preferably the same paint that was used previously. If a soft type of paint is applied there is danger of conspicuous alligatoring developing within a year or two. The paint should be a real oil paint; it should contain no heat-treated oils or varnishes that tend to give enamel-like consistency to paint. A real oil paint properly mixed will show brush marks but it will fill the flaked patches better and more nearly conceal them than a paint containing oils treated to give quick drying or freedom from brush marks.

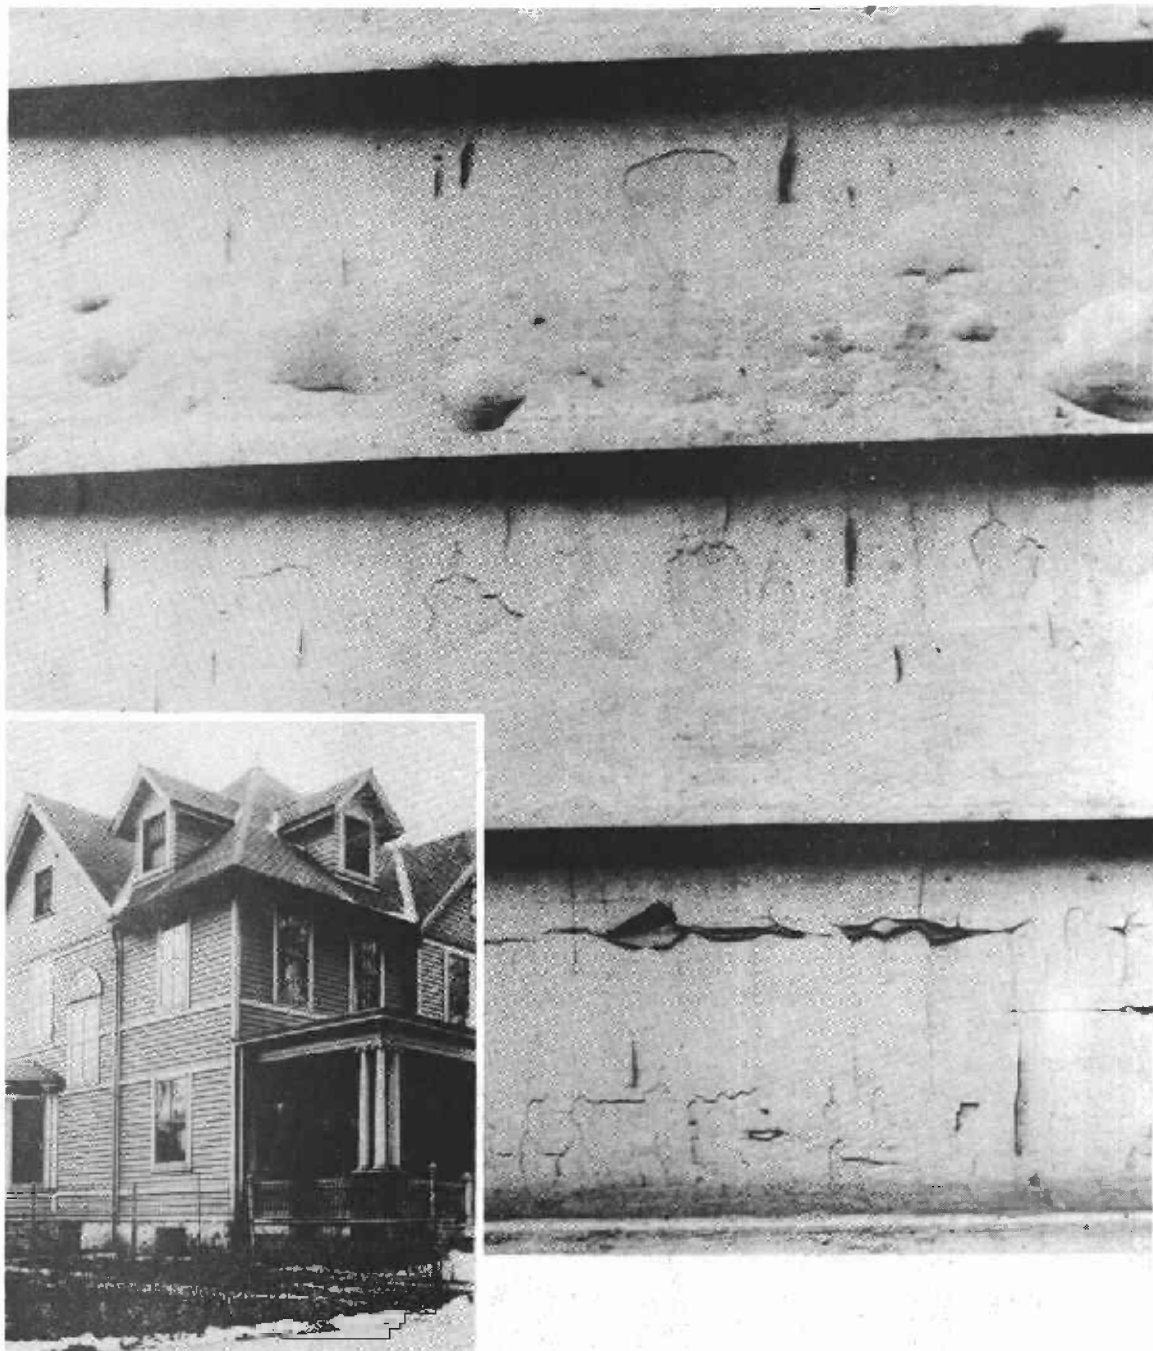
The condition of blistering observable on House No. 3 is an unmistakable sign of moisture in the side walls. If a board of siding is removed while such blisters are swollen the back of the board will be found thoroughly wet. A carpenter can easily remove a board of siding for such examination and replace it without damage if it is necessary to convince the owner that there is moisture behind the boards. As a rule that condition is

Blisters may break and peel soon after they are formed but very often they merely dry out and shrink back until the coating becomes more brittle as a result of weathering for a few months longer, after which the blistered areas crack open and scale off. House No. 3 shows places where the previous paint job had blistered and subsequently scaled. The present coating was put on only a year or so ago and is still soft and flexible, yet it is already cracking and coming loose. The painter should recognize this house at once as a "chronic peeler" and should not undertake to repaint it even if he burns off the old coating entirely unless the owner understands that the paint cannot be expected to give good service until proper steps have been taken to keep moisture from getting behind the painted boards.

A CHRONIC CASE OF MOISTURE BLISTERING

Not only has the last paint applied developed blisters, but places where the previous paint job blistered and peeled are clearly evident.

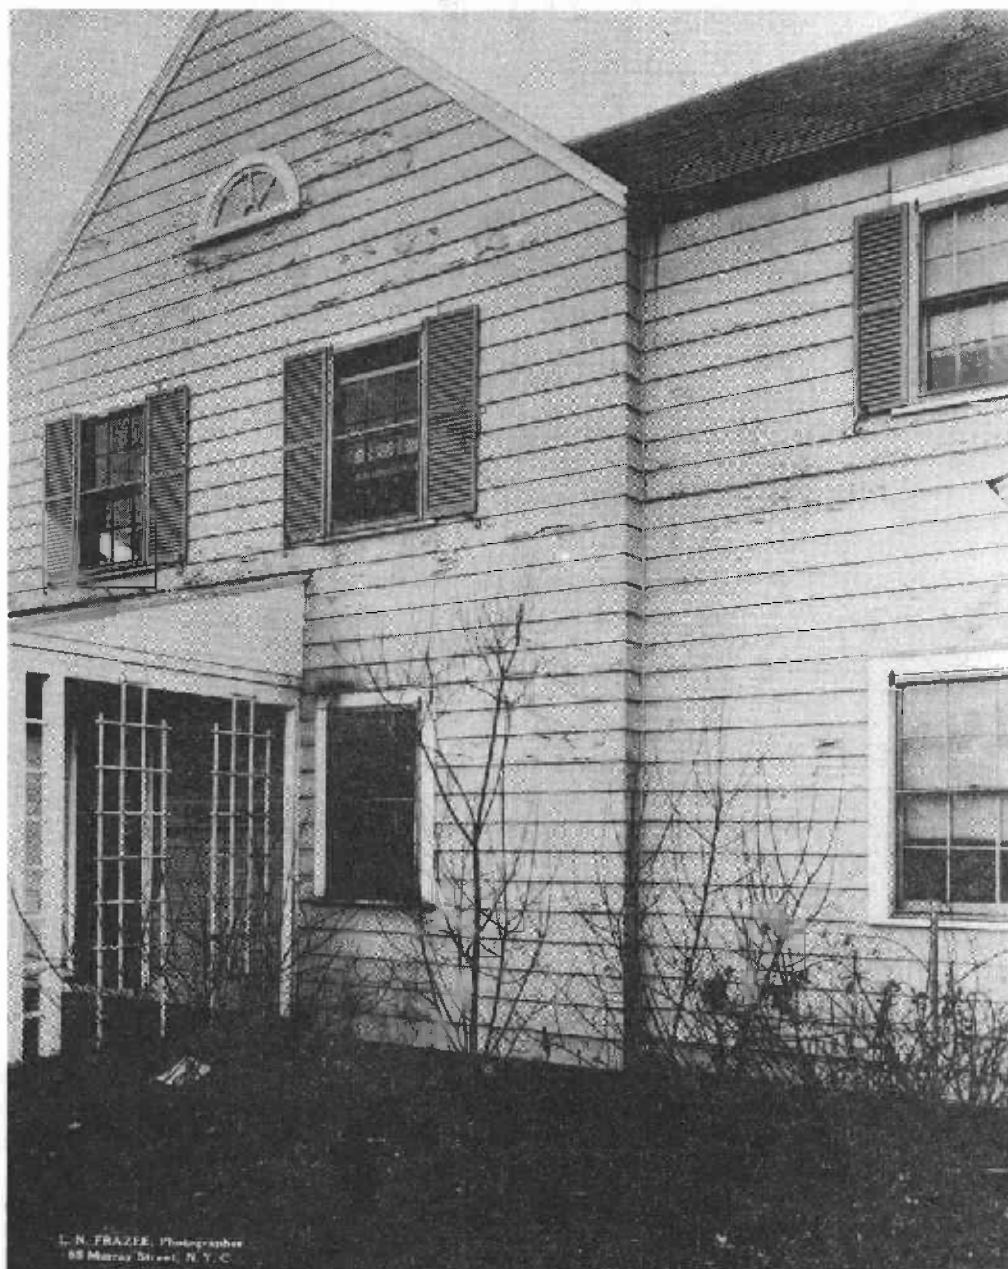
The sort of scaling of the old coating to be seen on House No. 4 is commonly the result of wet side walls but it must not be confused with some of the results of painting with incompatible paints that will be discussed subsequently. House No. 4 is one of nearly 200 houses in a single community that have been "chronic peelers" ever since development of the plat began some 7 years ago. This house had been painted three times within 2 years when the photograph was taken, each job failing in much the same way. Some houses were burned off and repainted and still failed promptly in the same way. Examination of the houses showed that the backs of the boards of siding and the building paper behind them become thoroughly wet every winter. The writer knows of no way in which these houses can be kept properly painted at reasonable cost until construction practices in the community are altered in such a way as to keep the side walls dry at all times.

House No. 4.--The side walls of this house become wet every winter and by spring the boards of siding are thoroughly wet and scaling of paint results. The house was painted in March of one year, repainted in July the next year, and photographed the following year.

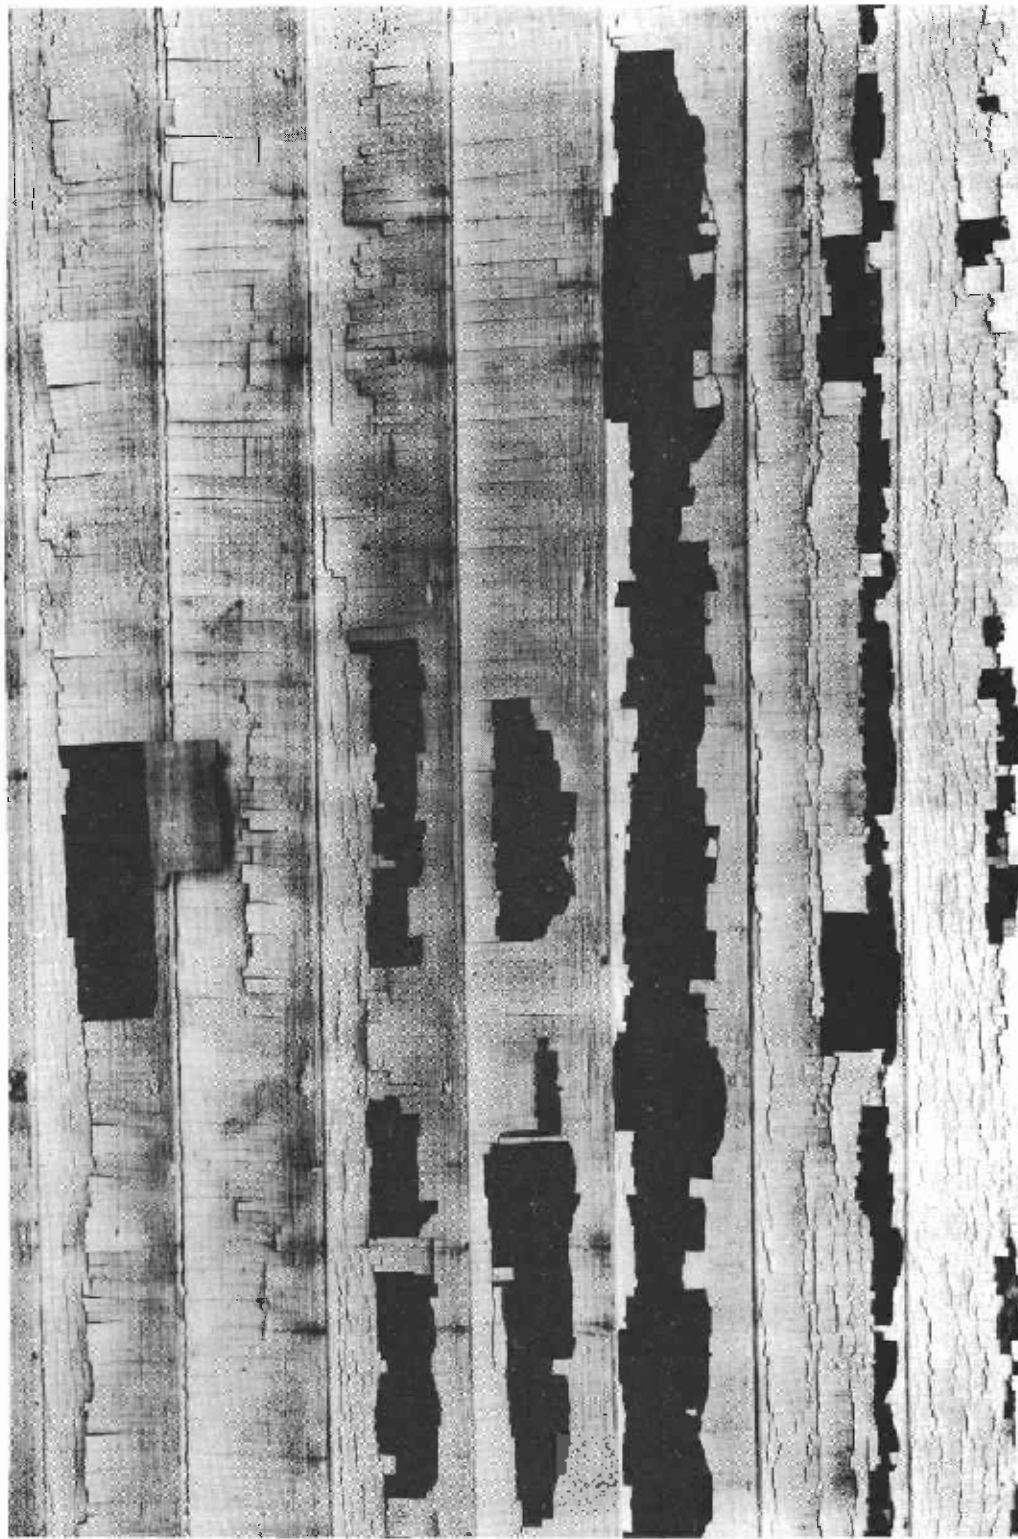
House No. 5 is an old house to which additions have been made from time to time. There apparently had been no great trouble with the paint until the last alteration was made some 8 or 9 years ago. Since then it has been necessary to repaint at yearly or biyearly intervals and a very thick coating has been built up except on patches here and there where scaling took place before the last repainting. In 1934 the side walls were filled with insulation, which in this case seems to have increased the condensation of moisture behind the siding. All over the house the thick paint is cracking badly as shown in the photograph, and under the porch on the south side the coating is now scaling very badly. At the time the photograph was taken the moisture content of the boards was 30 to 40 percent, that is, they were thoroughly wet.

House No. 5.--The paint on all parts of the house was cracked as shown in the upper right-hand corner of the photograph. The boards shown contained 30 to 40 percent moisture when the photograph was taken.

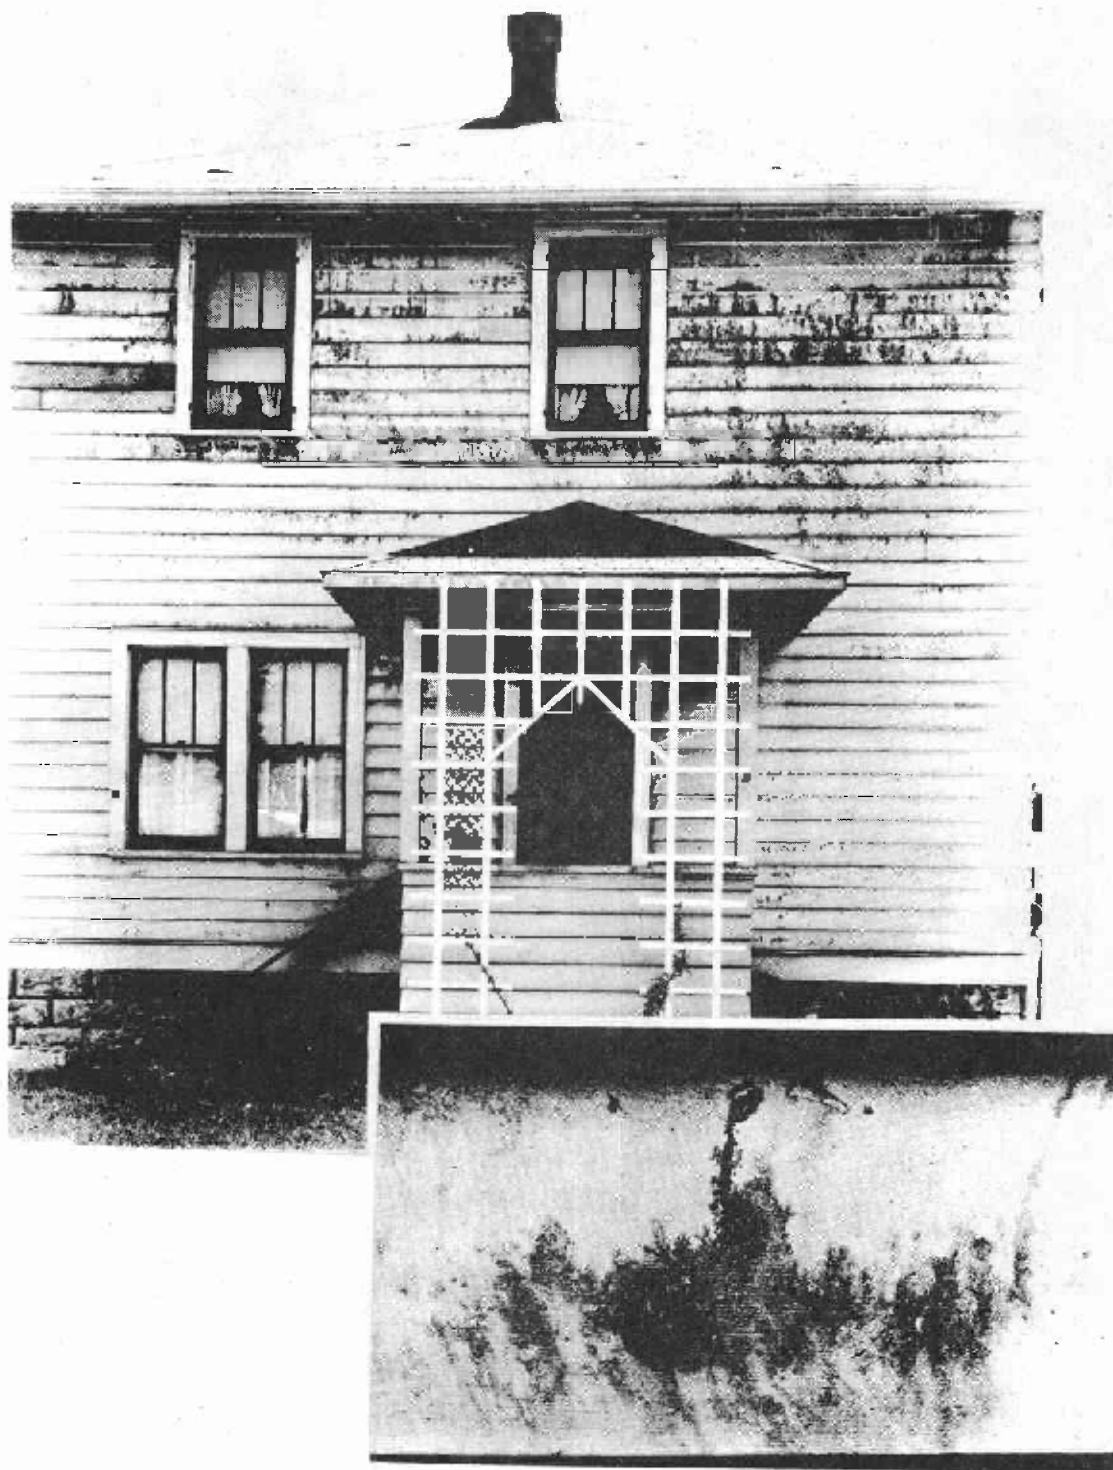
House No. 6 was erected in 1919 and painted with pure white lead paint, which gave entirely satisfactory service. In 1926 it was repainted with white lead paint. During the following winter the outlet to the sewer became clogged and caused water to run back through the cellar floor drain, partly flooding the cellar floor. The difficulty was not properly repaired until the ground thawed in the spring, when it was less difficult to uncover the connection to the sewer. The photograph was taken in May 1927, nine months after painting.

In this case there was comparatively little blistering because pure white lead paint is distinctly more resistant to blistering than most other kinds of paint. The siding, however, was redwood, a wood that holds paint excellently but one that contains colored substances soluble in water that turn dark reddish-brown in color when exposed to air. When the boards became wet the water carrying the soluble matter exuded through the paint, smeared over the surface, and developed the dark stains as shown. Under similar circumstances somewhat similar stains may appear over western red cedar and on at least one house the writer has seen them on white pine. Such discoloration of paint with water soluble material from the wood is unmistakable proof that the wood became thoroughly wet after the house was built. The fact that some woods discolor paint under such conditions should be no objection to their use in exterior construction because no wood will hold paint properly unless the faulty moisture conditions are removed. The discoloration gives warning of the need of corrective measures.

House No. 6.--Discoloration of white lead paint with water soluble substances in redwood siding caused by moisture in the side walls during the winter months.

House No. 6 was washed and repainted in 1927 after the plumbing had been repaired. No subsequent difficulty with the paint has been reported.

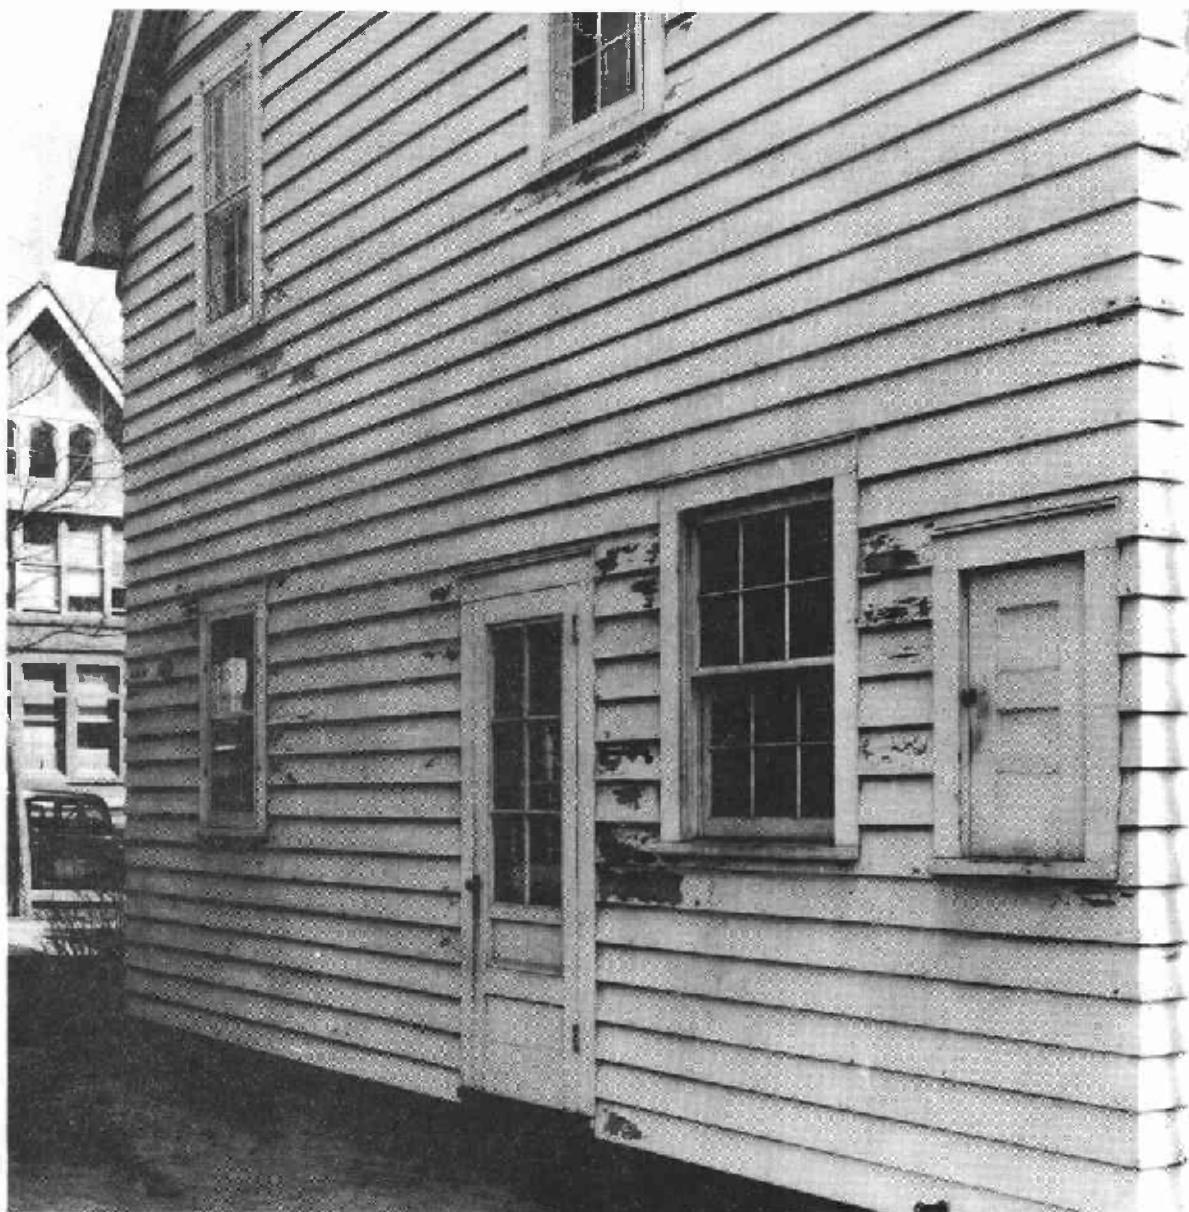
House No. 7 was painted when erected in 1928 with two coats of a dark gray paint, probably of a lead and zinc type, and a finish coat of a dark brown paint. The house was sold to a purchaser who disliked the dark color. In 1932 there was some scaling of paint on parts of the house and a few typical moisture blisters, such as those on House No. 3, were observed. The scaling was therefore attributed to moisture in the side walls but the source of moisture and means of excluding it were not discovered. The house was repainted with white paint of the titanox, lead and zinc type. The photograph was taken in March 1935. The moisture content of the boards from which the paint is scaling was found to be 11 percent, which is perfectly normal and indicates that the boards were not wet during the past winter. On the opposite side of the house where blisters were observed before and after the application of the white paint a few boards were found with 20 percent of moisture but there was very little scaling of paint on any of the moist boards. On those patches where the brown paint had scaled before the white paint was applied the coating is now in excellent condition. Where the scaling occurs the white and brown paints come off together but the gray paint of the initial paint job remains intact.

Although some doubt may be admitted as to a possible part played by moisture in the paint failure on House No. 7, the sandwiching of a dark brown paint between a tinted white paint and a white paint makes an incompatible combination that is certainly the primary cause of difficulty in this case. To repaint without burning off all of the old paint is to invite further disappointment.

House No. 7.--In spite of the close resemblance to scaling caused by wet side walls moisture seems to play only a minor role, if any, in this paint failure. A coat of dark brown paint sandwiched between a preceding job of tinted white paint and a succeeding job of white paint made an incompatible coating. The white and brown paints are scaling from the tinted white paint.

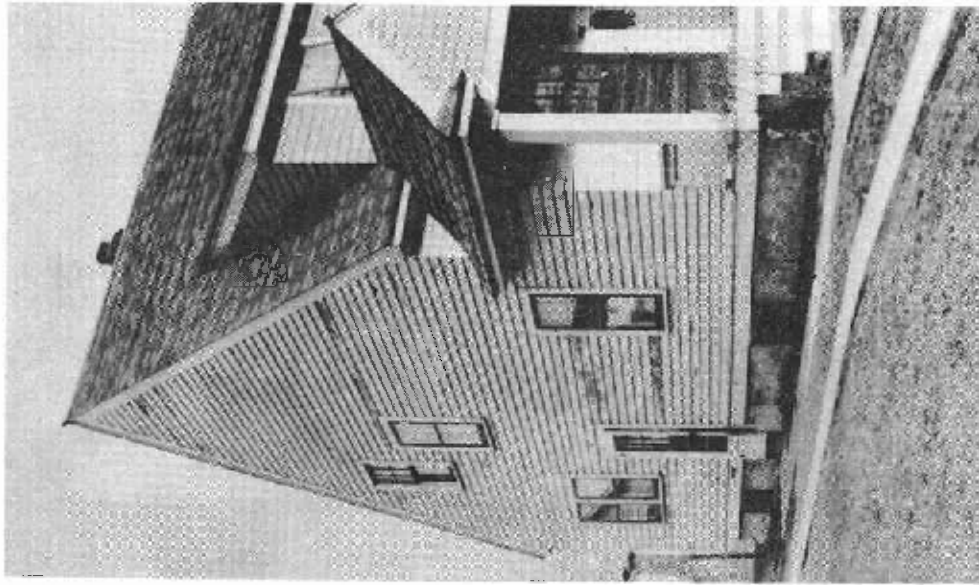
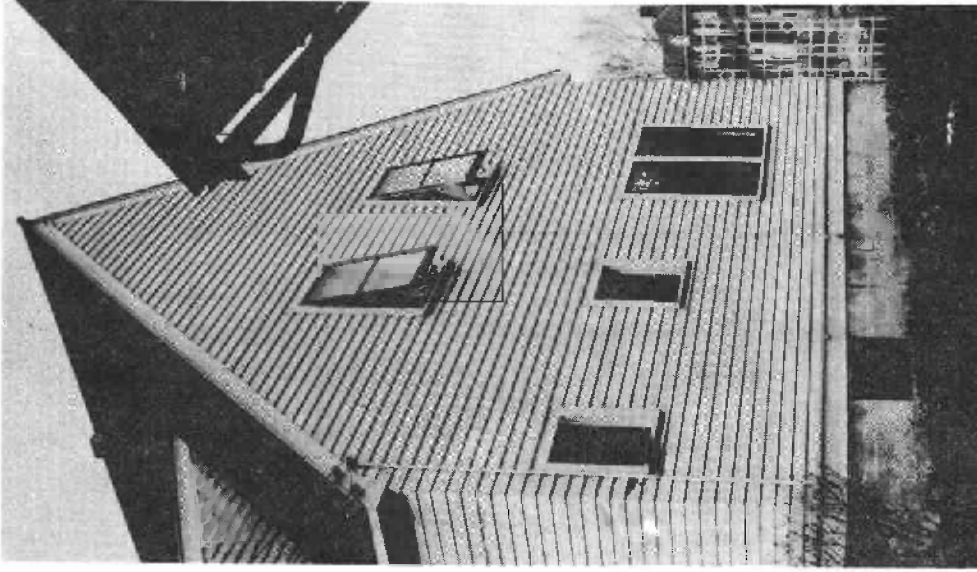
The failure on House No. 8 bears a striking resemblance to moisture failure like that on House No. 3, but the house was examined carefully for moisture in March and the boards found to contain slightly less than 11 percent. Four boards were removed and observed to detect signs of water on the backs of the boards, rust at the nail holes, or rumpling of the building paper behind them. Apparently the side walls have never been wet.

House No. 8 was completed late in 1929 and a primer coat of paint applied. In June 1930 the painting was completed with what the owner understood to be lead and oil but on examination proved to be a mixed pigment paint, probably of the lead and zinc type. In July 1933 the owner contracted to have the house repainted with one coat of lead and oil but the painter purchased a so-called quick drying house paint in which the liquid contains a mixture of linseed oil and heat-treated tung oil and the pigment contains titanox, white lead, and zinc oxide. The painter began on the north side of the house but had so much trouble picking up his laps with the quick drying paint that he reduced 100 pounds of soft paste white lead and mixed it with 5 gallons of the quick drying paint to complete the job.

Paint scaling began within a year. The photograph was taken in March 1935. There is scaling on all sides of the house but it is distinctly worse on the north side than elsewhere. The quick drying paint is a well-made product put out by a responsible manufacturer and will give excellent service over a proper foundation but it differs so markedly from the paint used previously that the combination failed very early. The failure should not be considered a fault of either the old or the new paint but a mistake in using the one over the other. The painter, however, is badly compromised in any case because he used a paint other than the one specified in the contract.

House No. 8.--Careful examination, including removal of boards of siding, shows that the side walls have always been dry. A quick drying type of paint was used over ordinary linseed oil paint on the north side (left), but the painter had so much trouble picking up laps that he added white lead paint to the quick drying paint for the other three sides. The south side (right) shows little scaling.

House No. 8 must be burned off before it can be repainted with reasonable assurance of a durable coating.

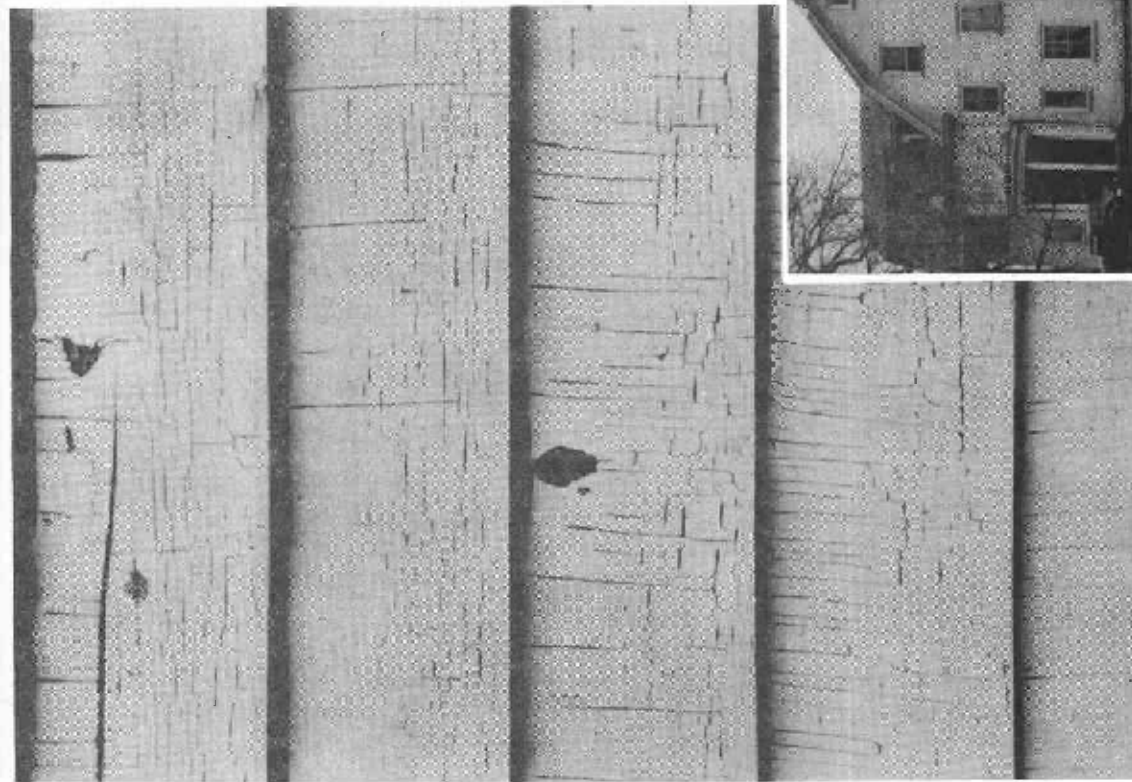
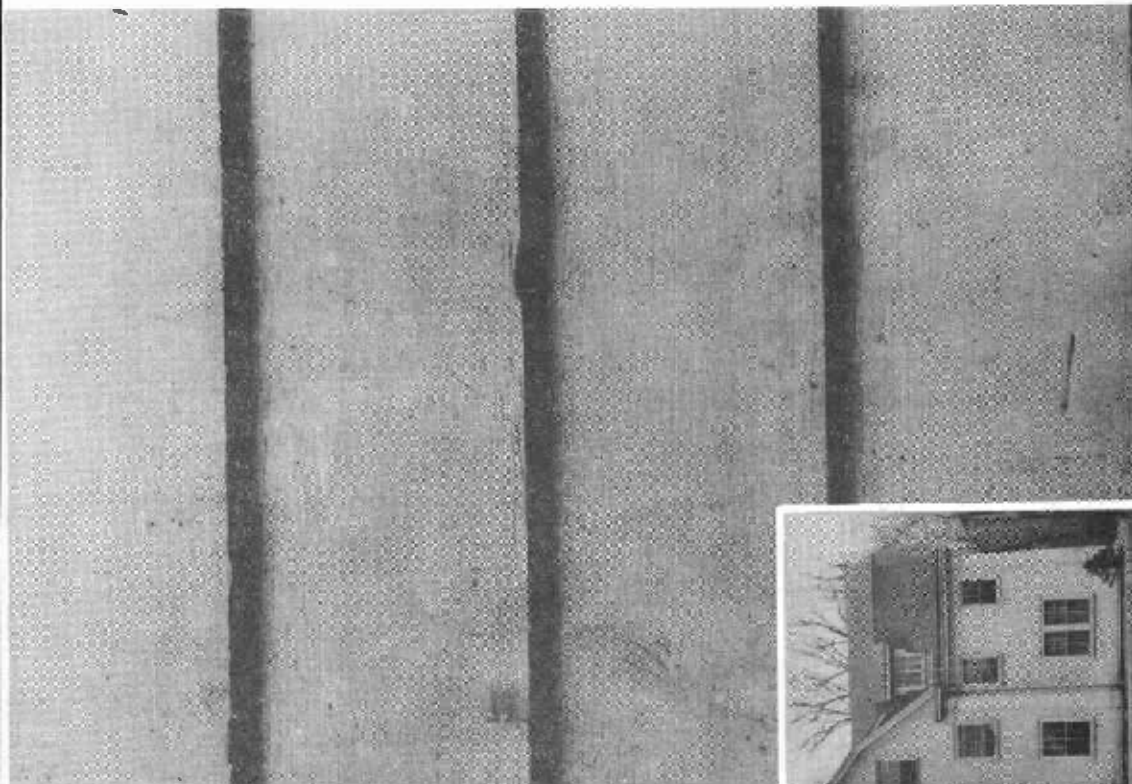
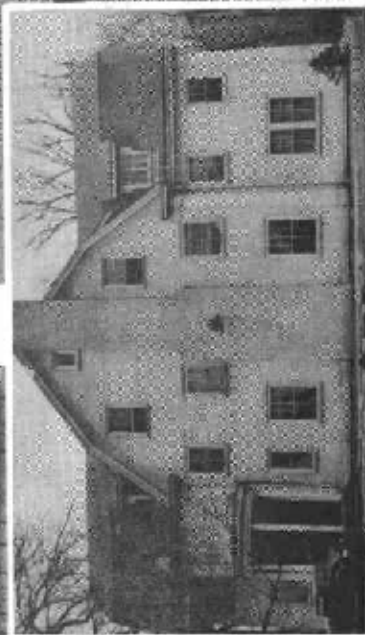
House No. 9 is an old one that has been painted at least six times. On three sides the paint is failing very badly but on the east side, which is as fully exposed to the weather as any of the others, the paint is in such excellent condition that one repaint coat should prove sufficient. About 10 years ago a fire in the house made it necessary to rebuild the east wall but left the other three walls undamaged.

Examination of the old coating shows that the house was painted initially with a dark reddish-brown paint, then successively with a paint of the color of yellow ochre, a dark gray paint, and at least three times with white paint. The east side has only the three jobs of white paint. The yellow paint may have been compatible with the brown paint but the gray paint and the white paints were not. Painters have repeatedly struggled to repaint these three sides of the house smoothly with less success and less durable jobs each time. The east side, however, has never presented any difficulty. Now the three sides with incompatible coatings must be burned off before they can be painted at all smoothly.

AN EXAMPLE OF INCOMPATIBLE PAINTS

On three sides of this house the paint has cracked and scaled badly as shown at the left. On the fourth side, which is more fully exposed to the weather than the others, the paint gives good service as shown at the right. On the bad sides the wood carries successive coatings of dark brown paint, deep yellow paint, dark gray paint, and at least three jobs of white paint. The good side was rebuilt after a fire some years ago and has only the last three jobs of white paint.

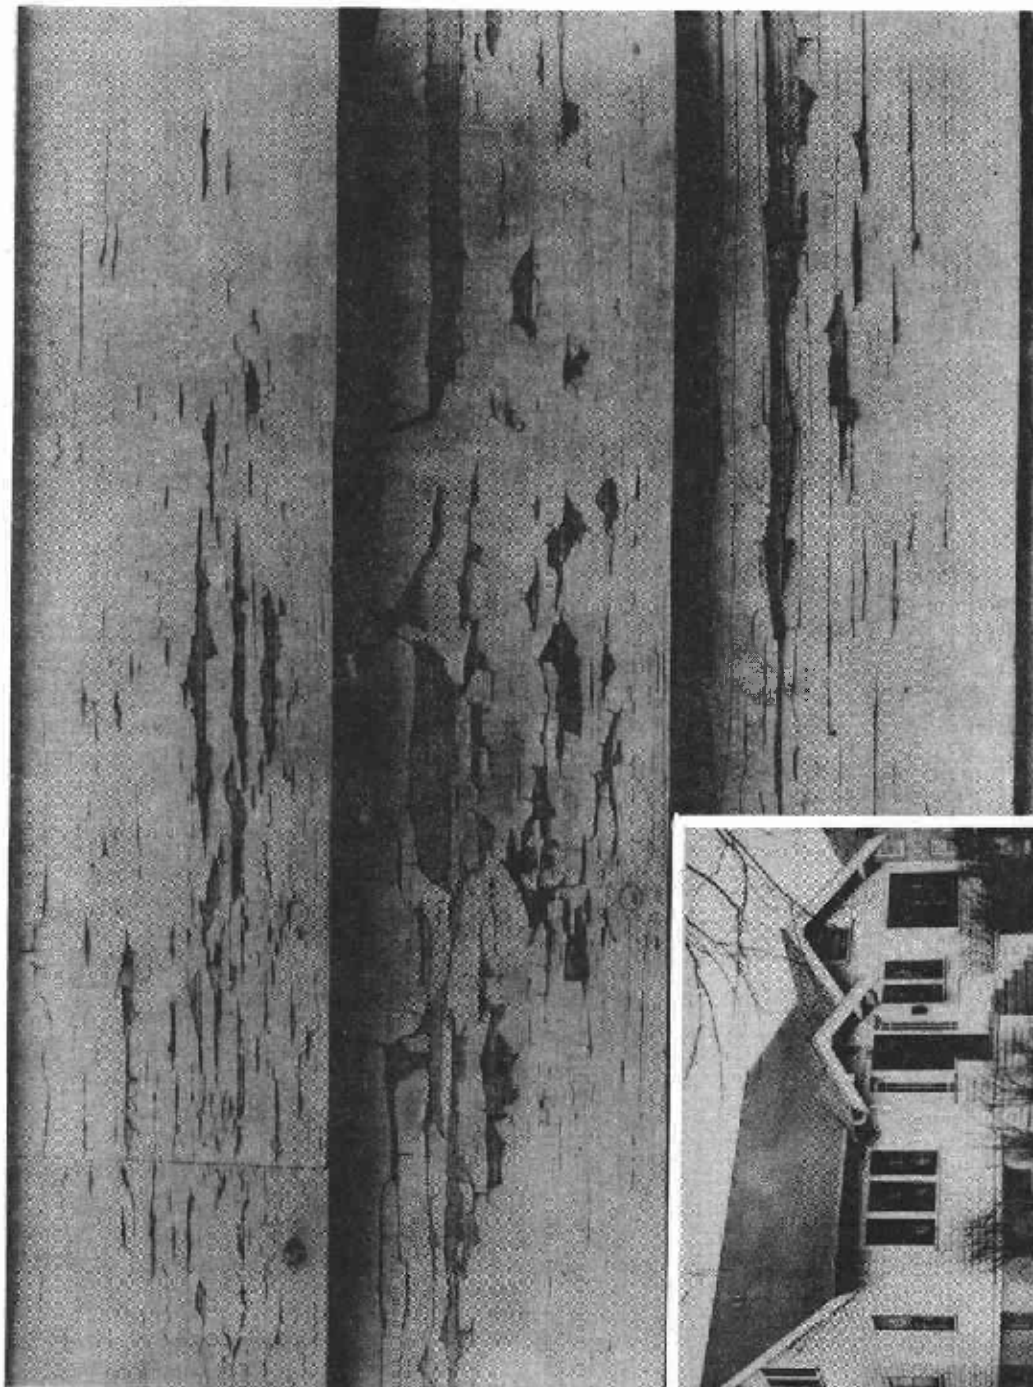
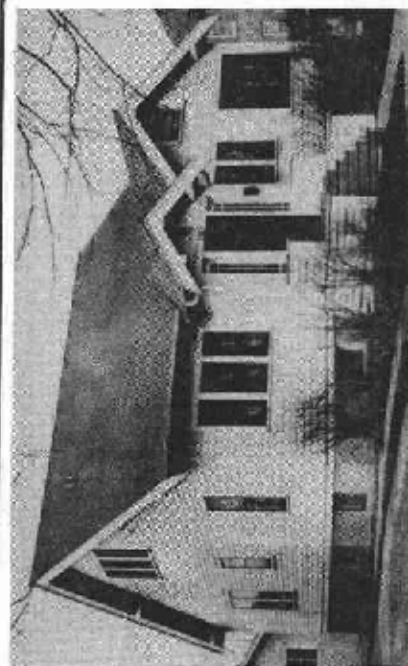
House No. 10 was painted initially with a white paint of the lead and zinc type and then repainted some years later with white paint of the titanox, lead and zinc type. The second paint probably was mixed with a materially higher proportion of pigment than the first, as is commonly the case in manufacturing paints of these two types. The failure takes place by scaling of the second paint, leaving the first paint still firmly adhering to the wood. Successive coats of paint should, as a rule, contain decreasing proportions of pigment. Violation of this principle probably accounts for the unsatisfactory form of failure on House No. 10.

INCOMPATIBILITY OF SOME WHITE PAINTS

This house was originally painted with a lead and zinc paint and subsequently re-painted with a titanox, lead, and zinc type of paint. The last paint was a very good one, but it is falling in an unsatisfactory manner.

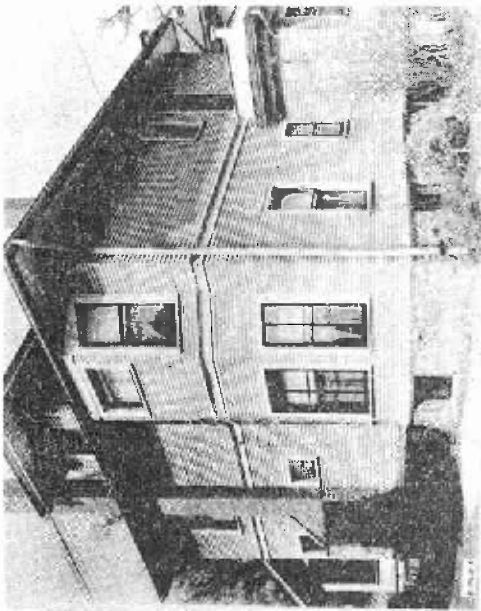
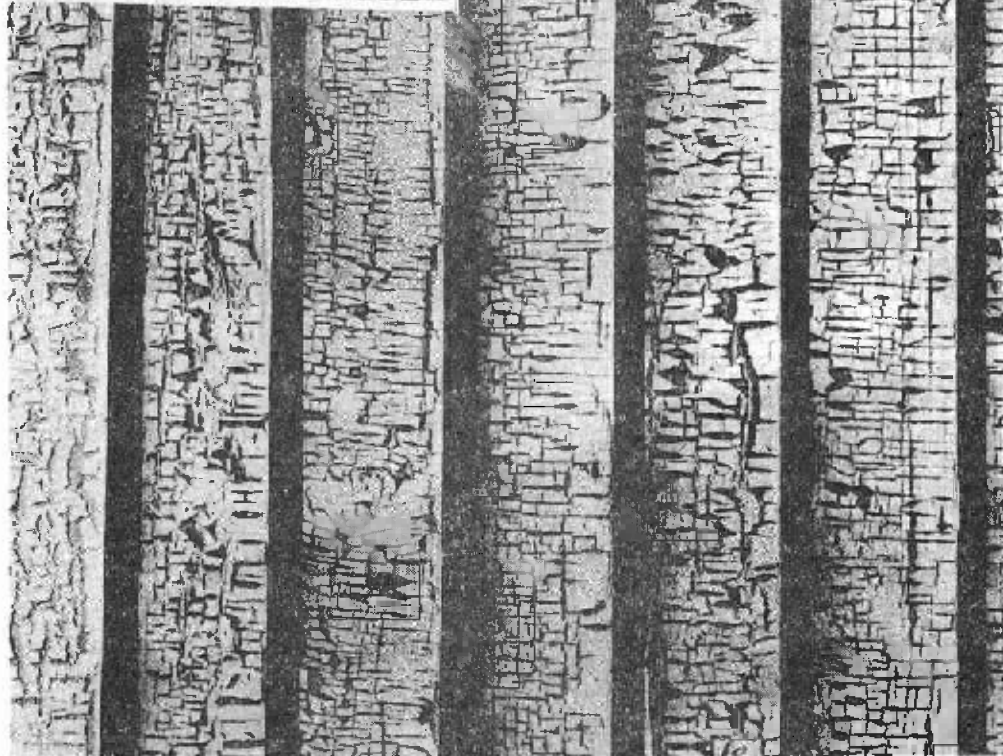
House No. 11 is another example of white paint applied over paint of dark color with which it is incompatible. The incompatibility, however, is more pronounced, appeared after fewer repaintings, and presents a more characteristic form of failure than House No. 9, where the yellow and gray paints perhaps effected a more gradual transition from the dark brown to the white paints. Paint failures of the kind seen on House No. 11 have been common in recent years on the freight stations and other wooden buildings of many railroads. They were formerly painted with red "freight-car" paint for economy in maintenance but were repainted with a more cheerful color chosen to represent the railroad for advertising purposes. The brighter paint often proved incompatible with the red.

House No. 11.--A very typical form of failure of white paint applied over
paint of dark color.
