REPAINTING THE PAINT- NEGLECTED HOUSE

UNITED STATES DEPARTMENT OF AGRICULTURE
FOREST SERVICE
FOREST PRODUCTS LABORATORY
Madison 5, Wisconsin
In Cooperation with the University of Wisconsin

F. L. BROWNE,
Senior Chemist

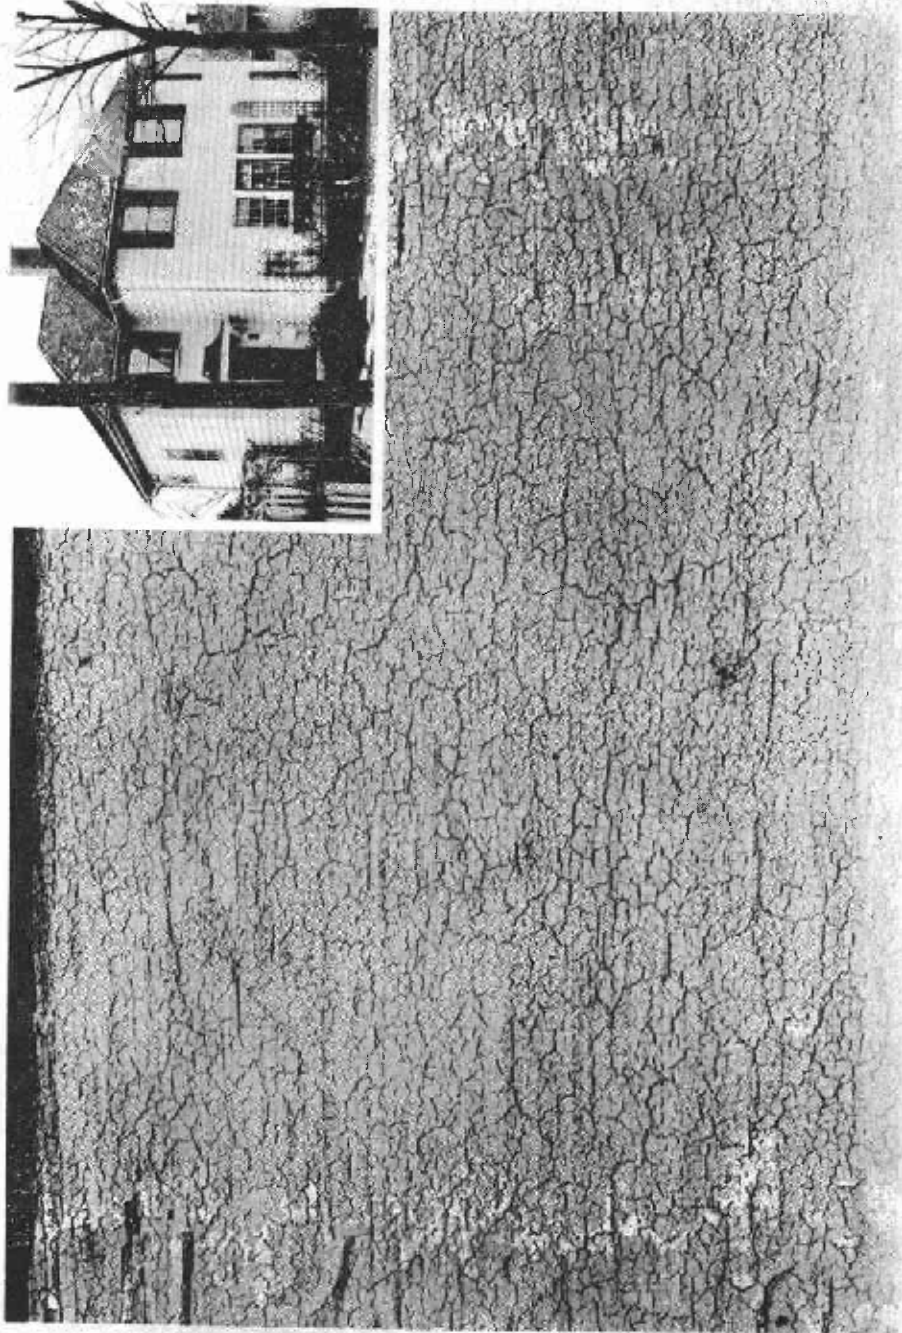
House No. 12 was painted about 7 years ago with a white paint of the lead and zinc type and again 3 years ago with pure white lead paint. The conspicuous alligatoring that has now developed is very objectionable to the owner. The writer has repeatedly observed it on houses where white lead has been applied over other kinds of white paint and has reproduced it by painting panels in that way on test fences. Mixed pigment paints can usually be applied with safety over white lead paint but many cases of coarse alligatoring occur when white lead paint is applied over paints that contain zinc oxide.

House No. 12.---Coarse alligatoring of pure white lead paint applied over old
paint of the lead and zinc type.

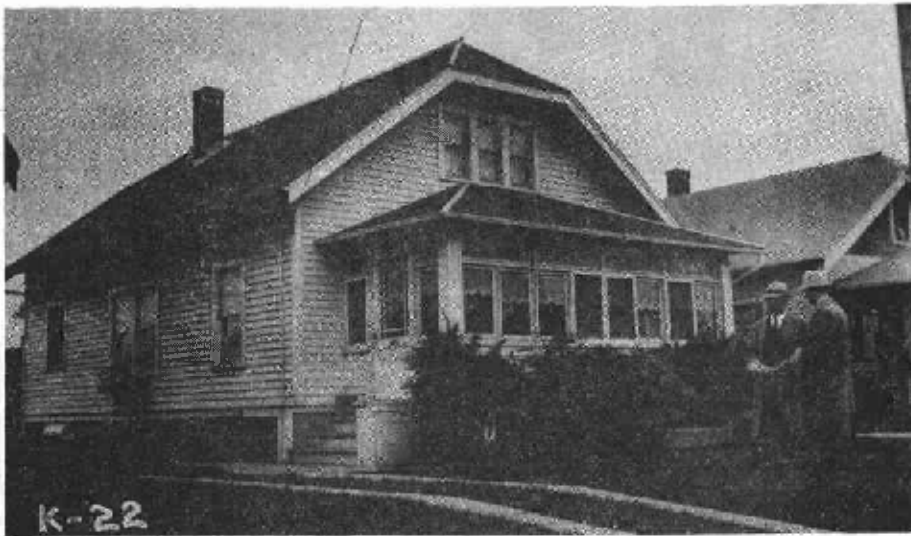
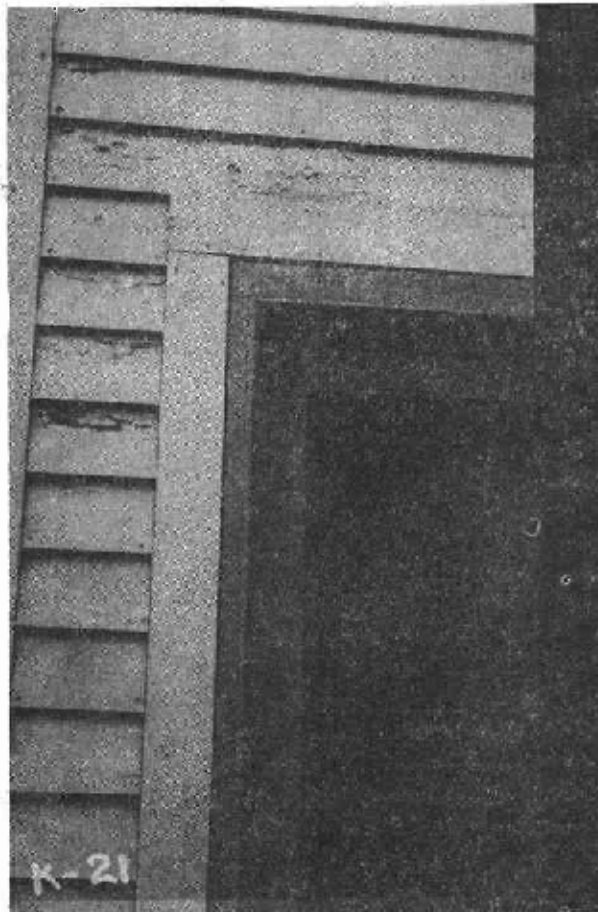
A MOISTURE FAILURE AFTER CHANGING FROM A SOFT TO A HARD TYPE OF PAINT

This house was built in 1931 and painted with pure white lead paint, which proved satisfactory to the owner. In 1934 it was repainted with a hard type of paint made with a quick-drying vehicle. The photographs were taken in June 1935. Besides the scaling paint shown typical moisture blisters were found and some of the boards of siding were wet.

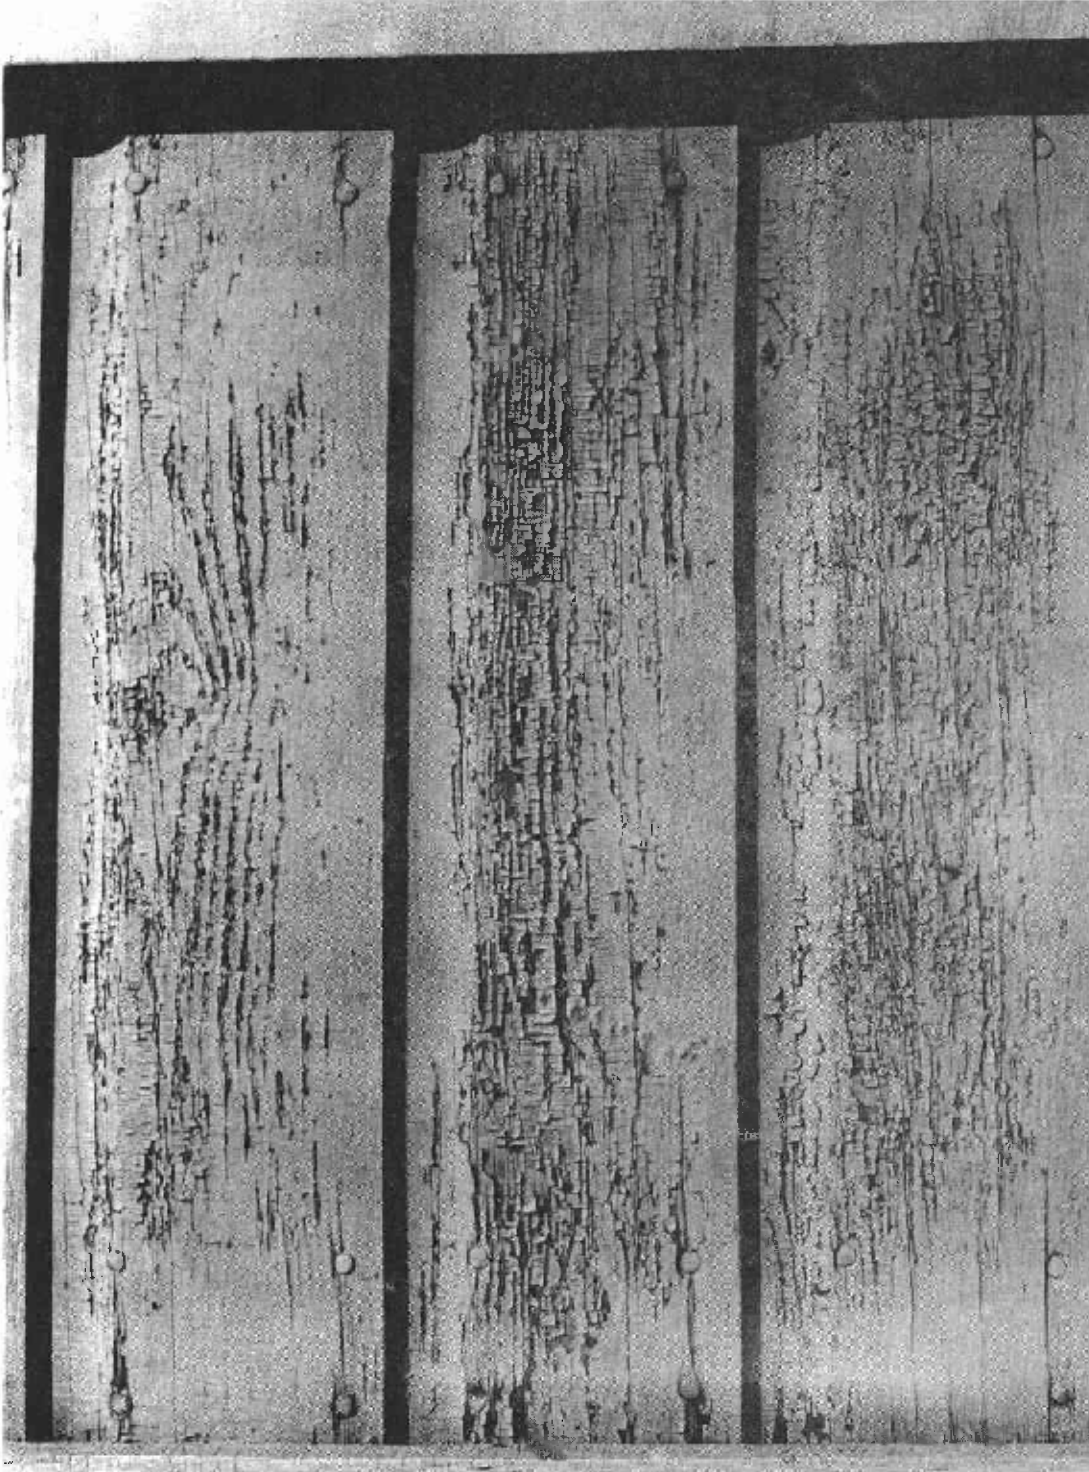
RESULT OF REPEATED NEGLECT OF PAINTS OF HARD TYPE

This building has been painted repeatedly with hard types of paint over a long period of years, but each time the owner waited until the old coating was disintegrating badly before putting on new paint. The surface can no longer be painted smoothly or durably unless the old coating is removed completely.

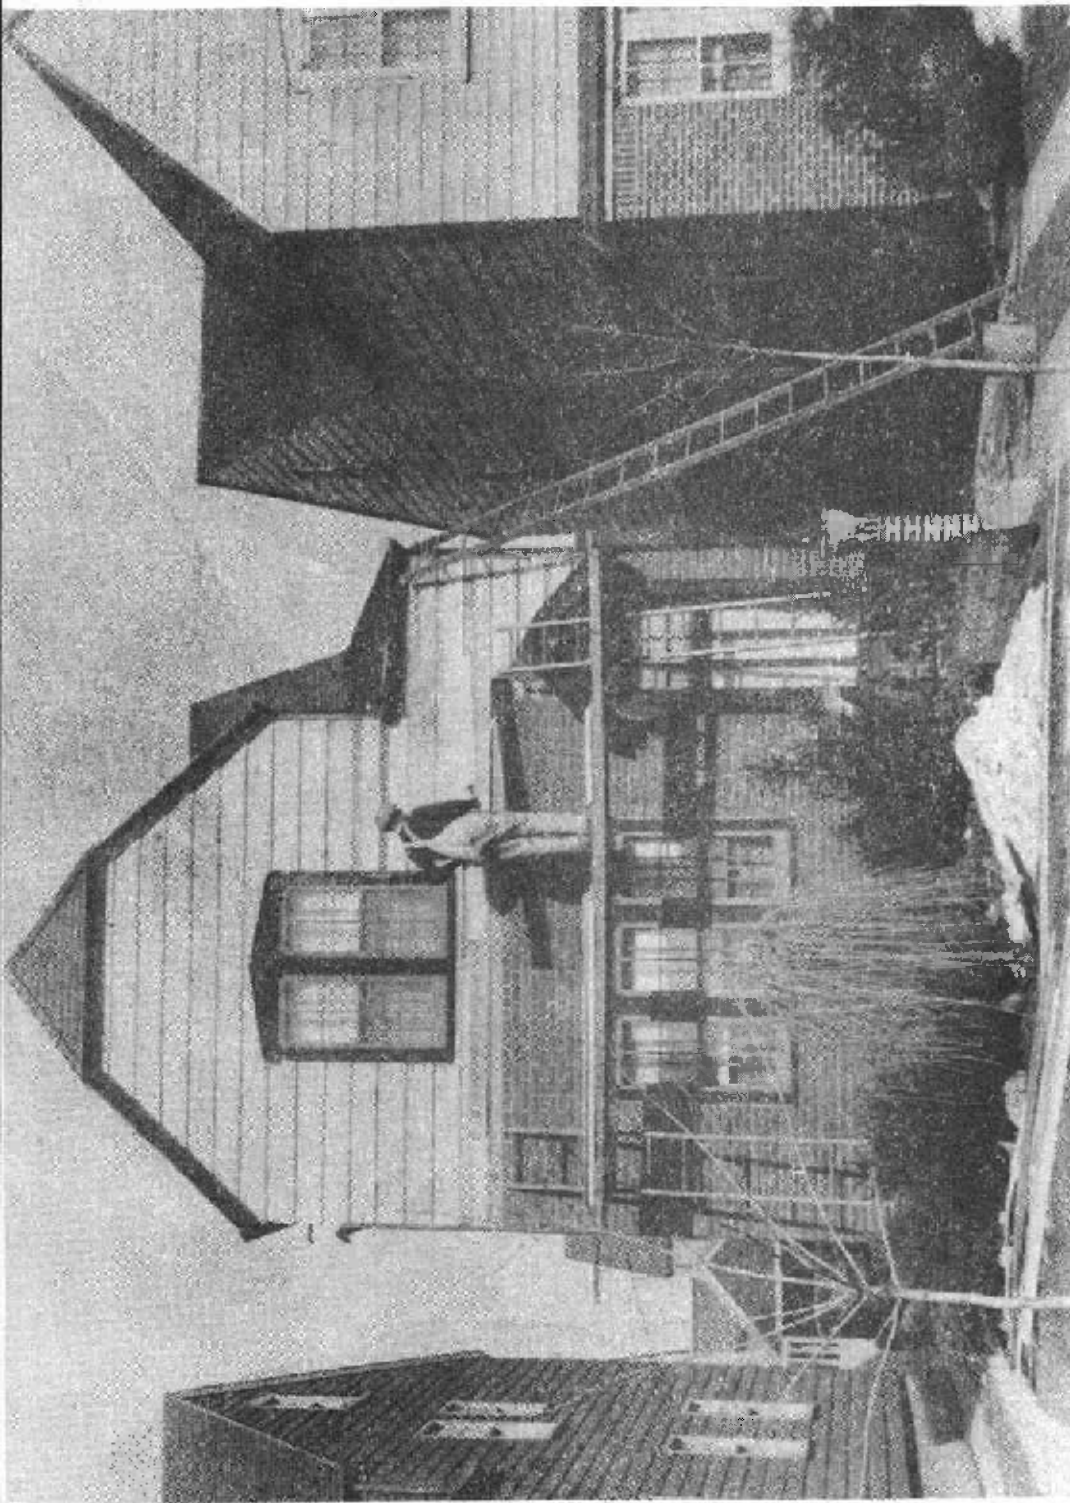
Paint troubles lead to loss of market for paint

This house is being covered with composition material imitating brick because several paint jobs on wood siding each failed within a year or two. The neighboring houses were likewise covered over with composition material or with stained shingles for the same reason.

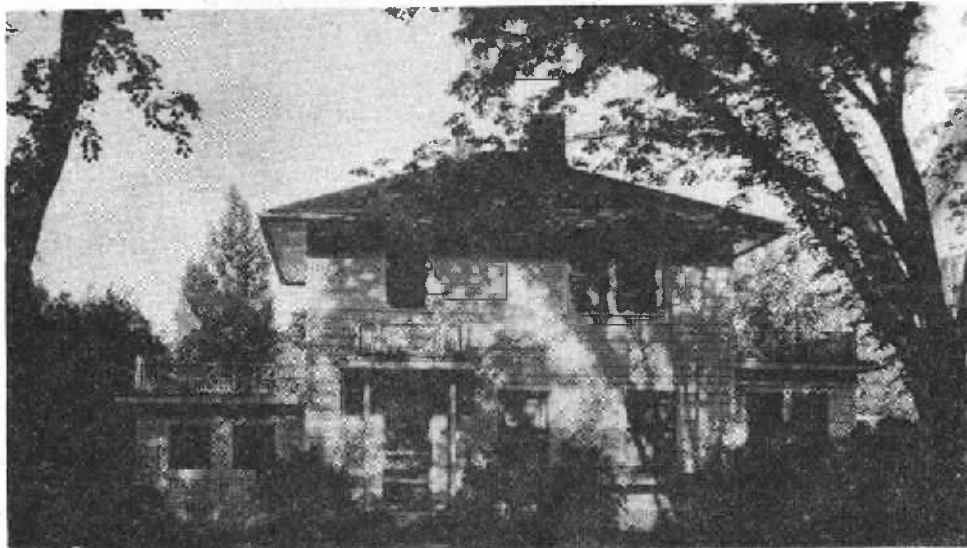
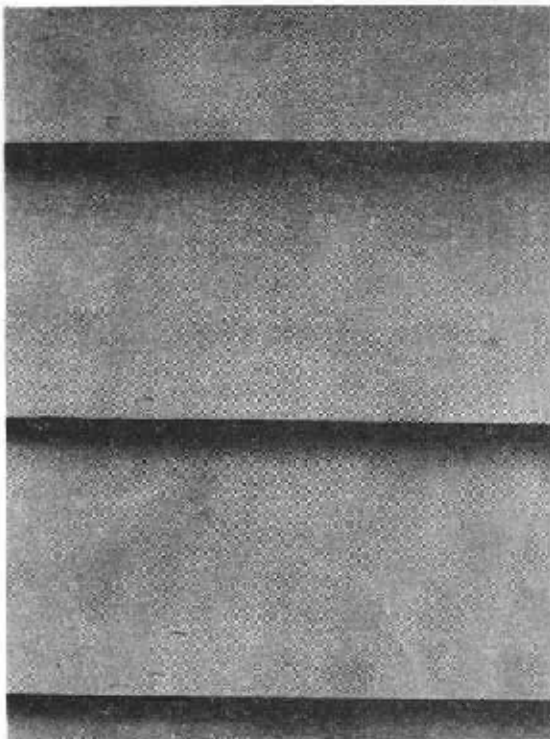
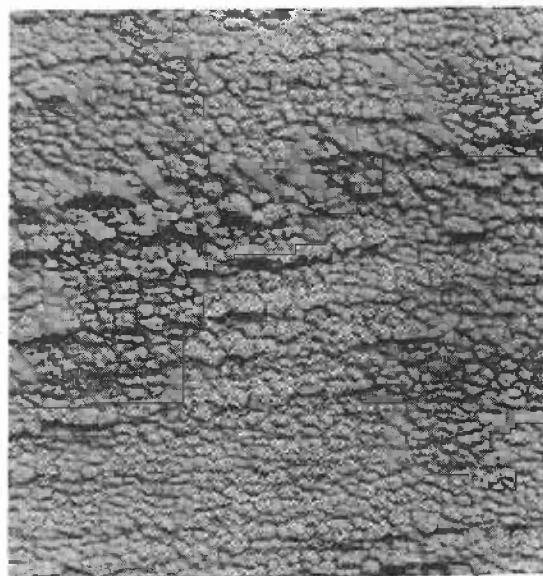
A successful maintenance program in which paint of soft type is used with long intervals between paintings. This house, which is next door to the one shown in the previous illustration, was erected in 1923, repainted in 1931, and has not been painted subsequently. The photograph was taken in 1936.

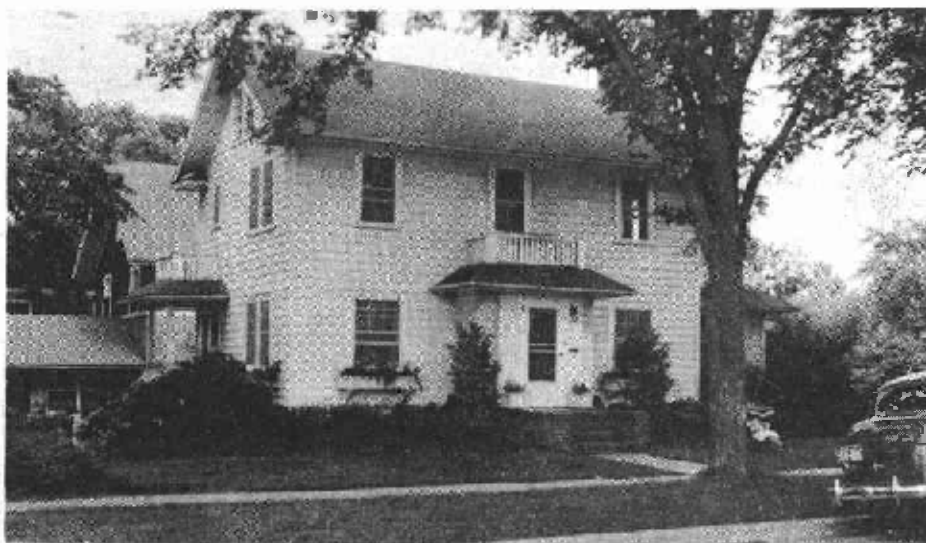
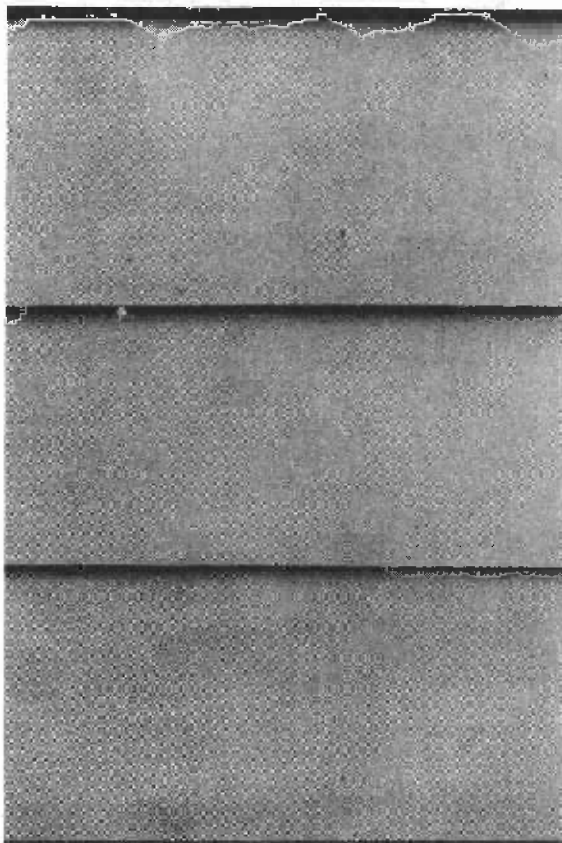
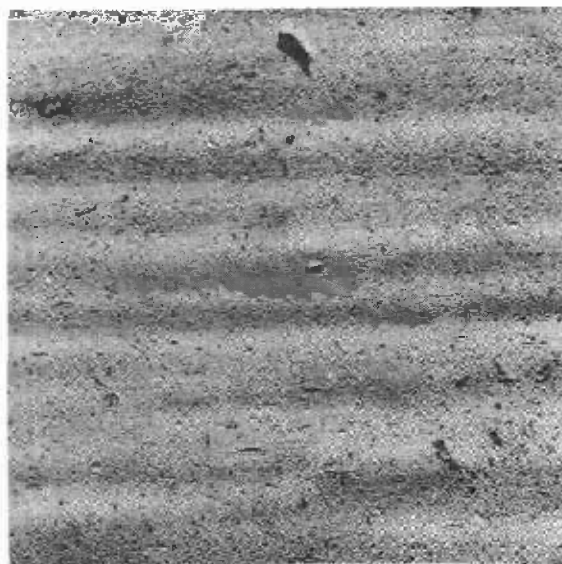
A successful maintenance program based on applying one coat of paint of fairly hard type every four years. This house was erected in 1923, repainted in 1927, 1931, and 1935. The photographs were taken in 1935 just before the last repainting.
