INSPECTION OF WOOD AIRCRAFT AT SALINAS, ECUADOR, APRIL 4, 1943

No. 1361

INSPECTION OF WOOD AIRCRAFT AT SALINAS, ECUADOR, APRIL 4, 1943¹

By
L. V. TEESDALE, Principal Industrial Specialist²
and
J. E. MYER, Senior Industrial Specialist,
Forest Service
United States Department of Agriculture

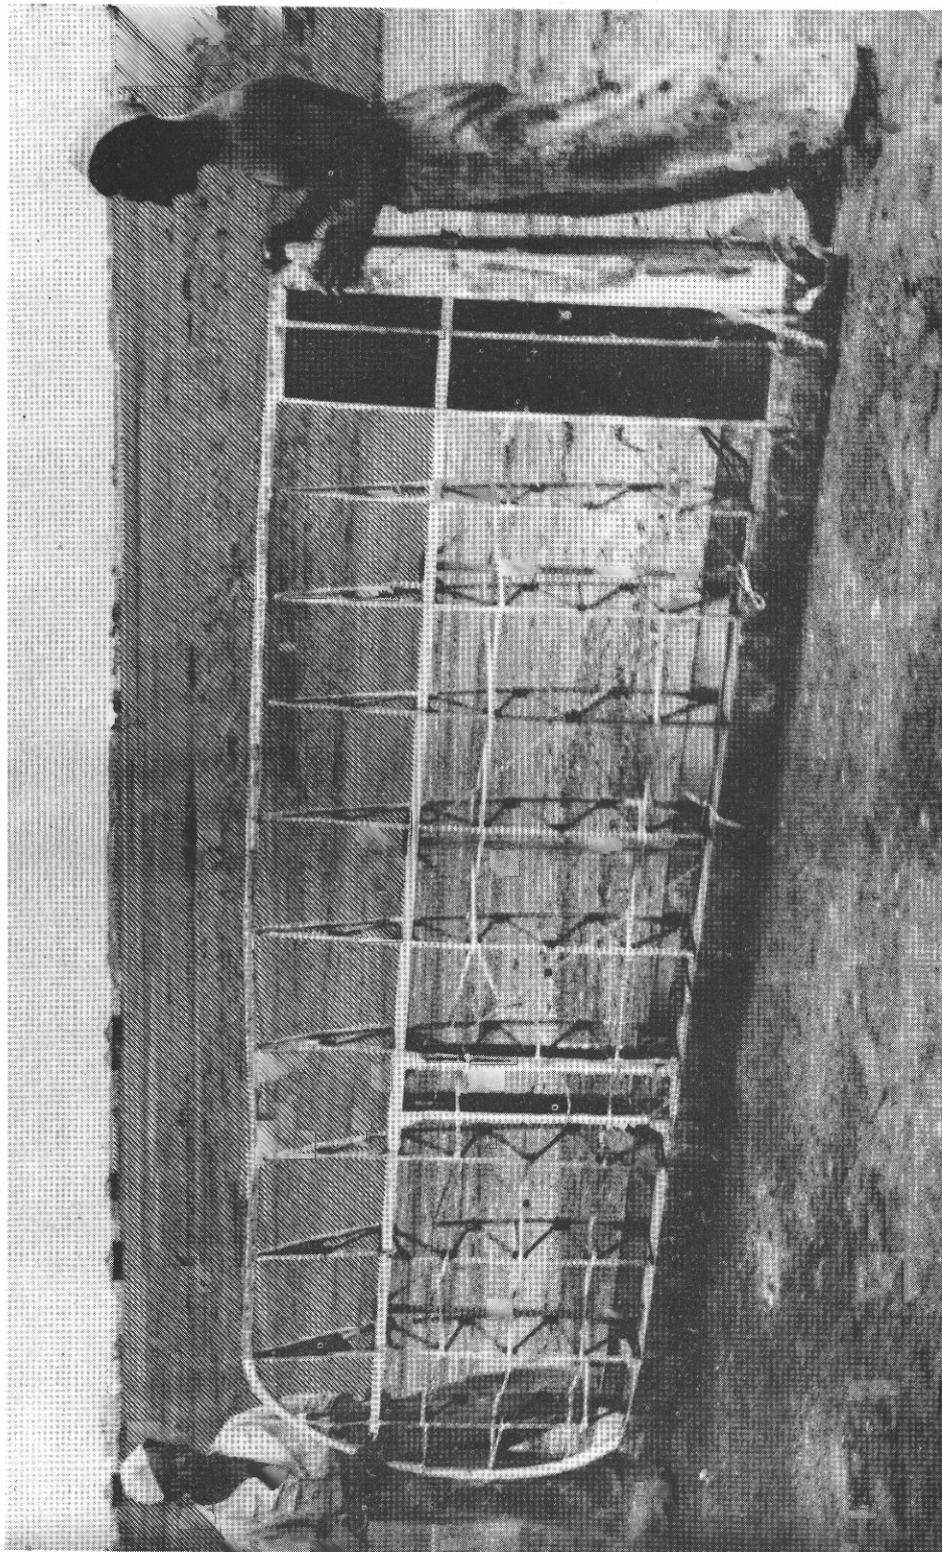
These were biplanes, wings covered with fabric, and had been in Ecuador for eight years and belong to the local government. One wing had been stripped of the covering and the entire skeleton could be examined. There was no evidence of blue stain or decay in any part, no loose glue joints and no delamination in the plywood of the step piece. Some of the wing ribs had been broken in service, and it was the intention to repair these parts and put the wing back in use. Moisture content tests made with a Kaydel moisture meter gave readings of 14 percent in the spars. The spars and ribs were of

Sitka spruce, the spars being solid. The type of glue used in the ribs could not be determined definitely, although it was the same color as resin glue. Another wing was examined through the end where it joined on to the fuselage and also at an inspection hole cut in the top of the wing, about midway of the wing length near the trailing edge. There was some evidence that there had been water in the wing, but this wing looked as good in all respects as the wing with the covering removed. The wing drain holes, about 1/8 inch in diameter, were clean and open.

Figure 1.--Wing of Curtis trainer biplane which has been in service in Ecuador for 8 years. Wing covering removed to repair wing ribs damaged in landing crash. No evidence of stain, decay, or glue failure.
