Title: Serviceability of Douglas-fir Marine Piles and Control of
Their Deterioration

Serviceability of Douglas-fir Marine Piles
and Control of Their Deterioration

A THESIS

Oregon State University

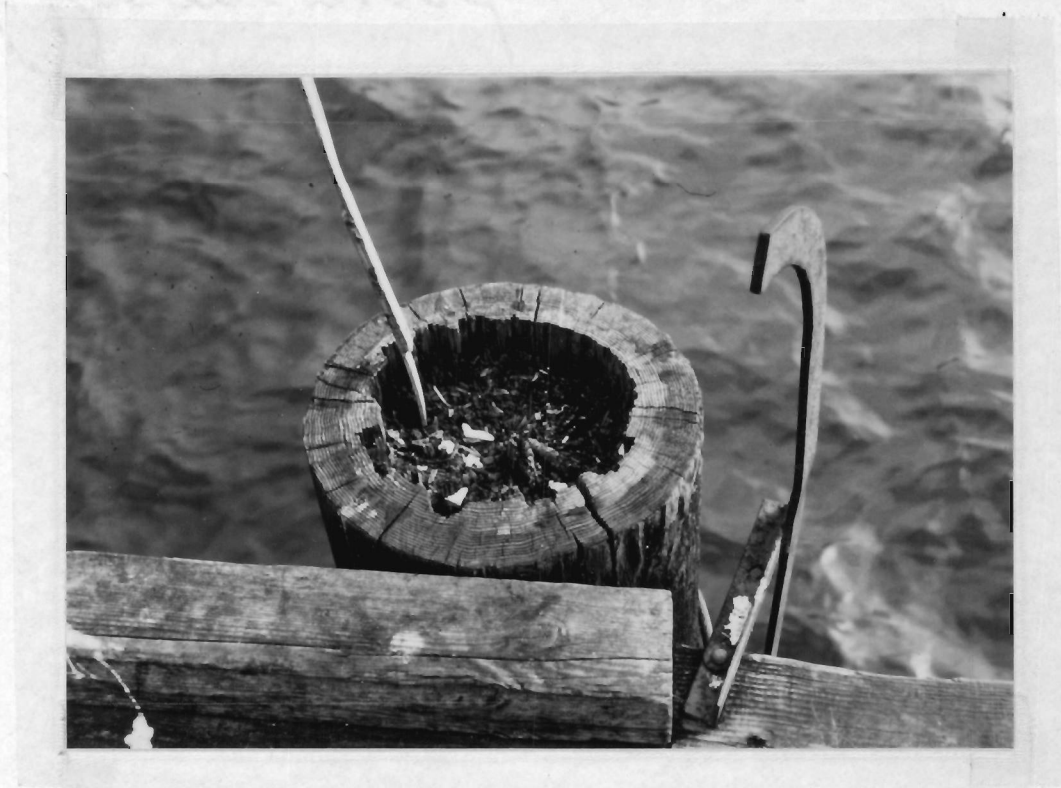
Figure 1. Top decay of piles is frequently found.

Piles with tops exposed to rain wetting tended to have lower years of service life than piles with tops protected because of top decay. Pile tops usually are cut off, most of them brush-flooded with creosote and they may or may not be covered with asphalt or metal cone-shaped caps. Decay fungi were present within the tops of 56% of 245 pressure-creosoted piles in service for 0.3 to 15 years (Table 3). All 36 four-year old bulkhead support piles at Florence, OR, that had been cut off at a slant to drain water contained advanced decay beginning 5 to 15 cm below the sound-appearing tops.

Collars driven into tops that are then filled with hot creosote is an accepted practice (1) but has not been evaluated. Other methods include nailing creosote-soaked felt or resin-lade burlap over the pile tops; coating the tops with epoxy resin, asphalt, coal-tar, and application of metal caps.

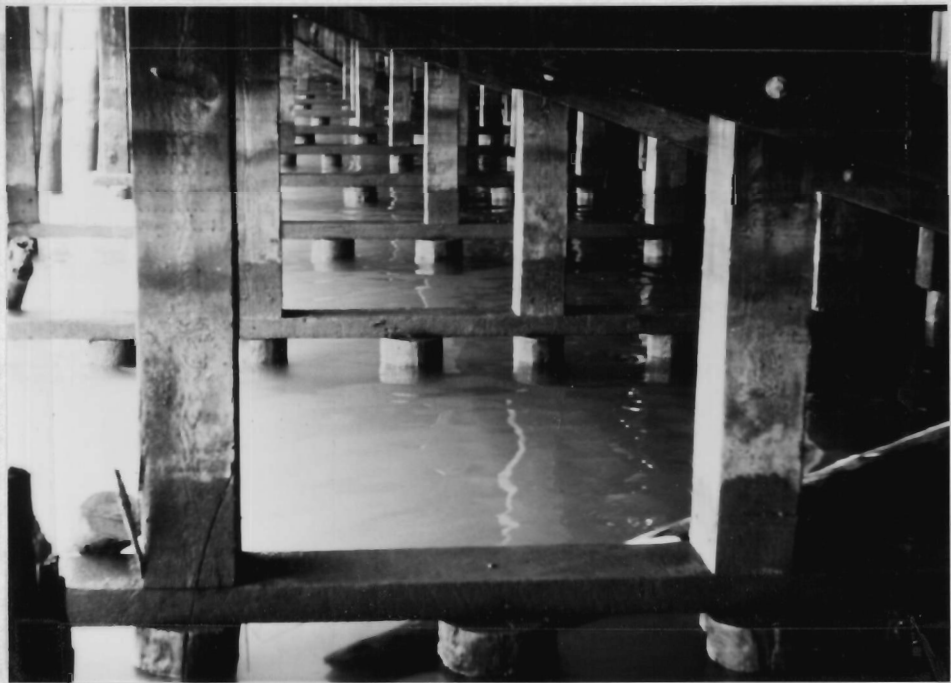
Nearly all piers at this fresh water port are supported on untreated piles that were cut off in the intertidal zone and built up from there with pressure-treated framework to support the superstructure (Figure 3). Port authorities estimate that full length untreated piles fail in about 15 years due to top decay. Marine borers are not a problem in Astoria so the submerged portion of untreated piles lasts indefinitely.

Figure 3. In Astoria untreated piles are cutoff below the fresh waterline and built up from there with a pressure-treated framework to support the superstructure.

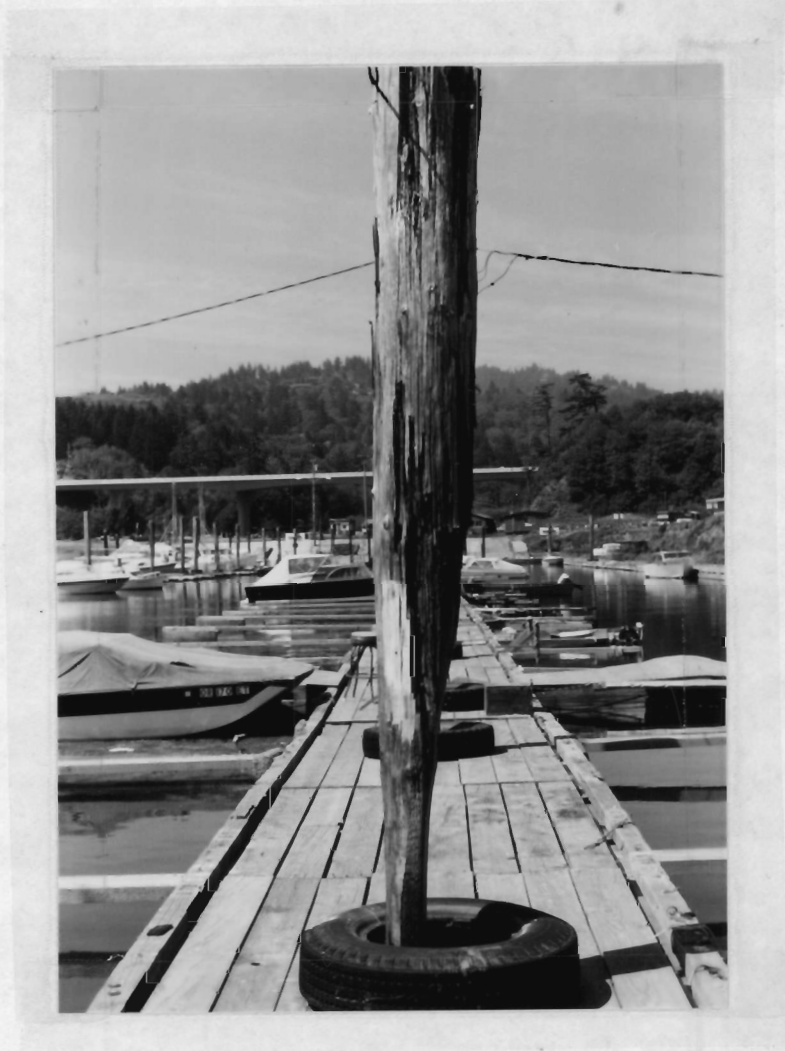
Figure 4. Floating docks at Brookings, Oregon, during tidal changes abraded some piles to one-fourth of their original diameter.

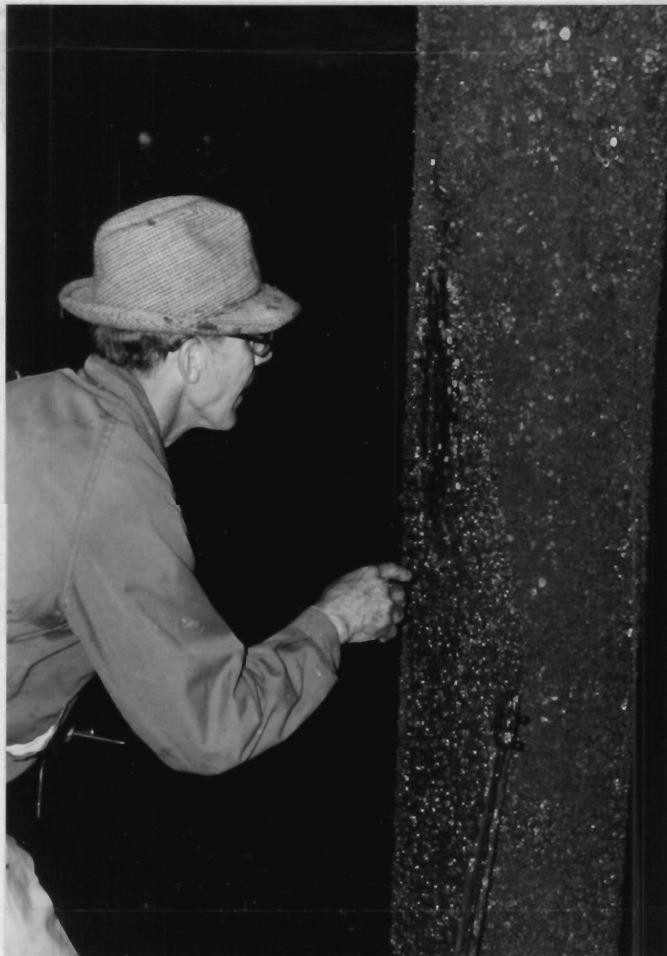
destroyers with little sign of shipworm damage. Untreated fender piles are commonly used because it is thought that large cargo ships crush these piling or break them off at the mudline before biological degradation occurs. The rapid Limnoria attack is estimated by Dr. J. J. Gonor, Marine Biologist, OSU, to reduce the diameter of untreated piles about 1 inch a year making this marine wood borer a major contributor to pile breakage (Figure 5).

The finding of high populations of Limnoria tripunctata (which attacks creosoted piles in southern waters) within upper Coos Bay (approximately 10 to 16 miles from the river mouth) by Gonor, prompted an inspection to determine if pressure-creosoted Douglas-fir piles in this zone are being attacked. Four hundred and fifty-two piles within the L. tripunctata zone in the upper bay and 468 piles within the Limnoria lignorum zone in the lower bay (river mouth to river mile 10) were inspected for Limnoria attack within the intertidal portion of each pile (Table 5).

The 153 piles with surface attack within the L. tripunctata zone as compared to 5 piles with surface attack within the L. lignorum zone indicate that L. tripunctata are more destructive of pressure-creosoted piles in Coos Bay than L. lignorum. It should be noted, however, that in the upper bay surface-attacked piles had been in service for 50 to 55 years whereas no surface attack was present on the piles in service 3 to 17 years. Also, 75% of the 55-year old piles had patches or vertical strips of inner bark remaining on the pile surface above water suggesting that the surface attack may have occurred in

Figure 5. Surface attack on pile by Limnoria tripunctata in the upper Coos Bay, Oregon.

areas of low creosote retention where strips of bark had not been removed prior to pressure-treatment. Analysis by Timber Products Inspection Company of 17 increment cores removed from within the inter-tidal zone of these piles showed an average creosote retention of 16.9 pcf. Although less than the 20 pcf required in AWP Standard C3 (1), this amount of residual creosote suggests that the original retentions probably exceeded 20 pcf. Further studies are needed to resolve whether L. tripunctata attack pressure-creosoted wood in Oregon estuaries.

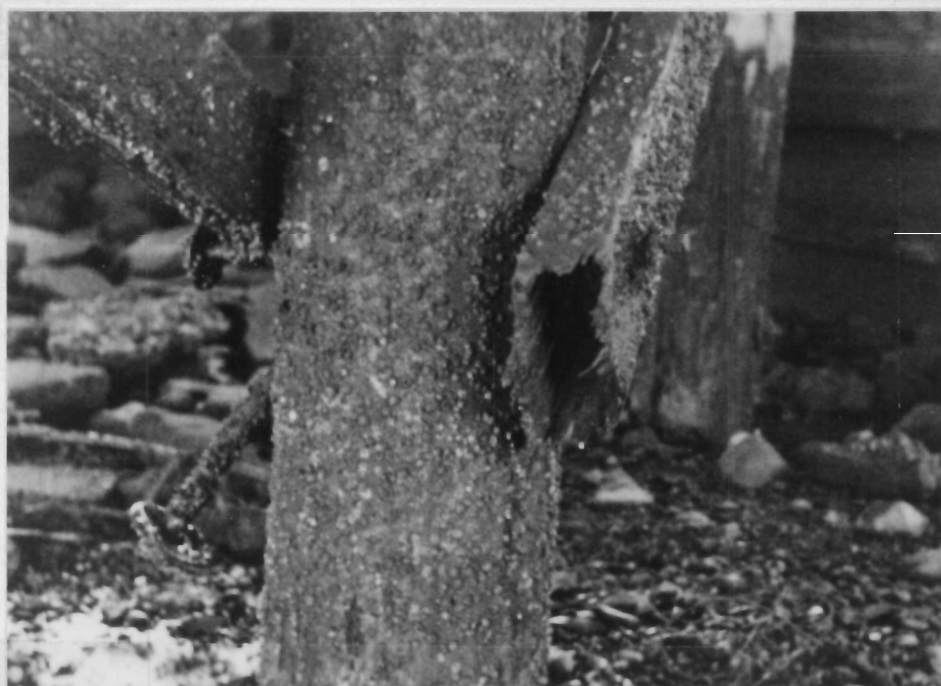
Figure 6. Cutoff pressure-treated cross bracing hollowed out by Limnoria.

The untreated support piles beneath had been severely damaged by Limnoria.

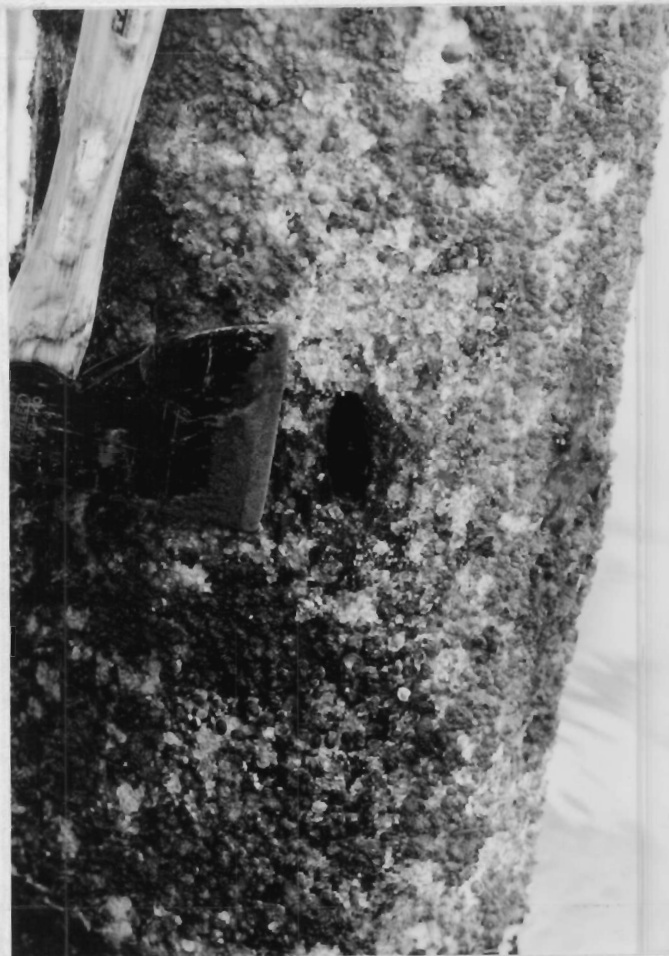
Pressure-creosoted piles with oval holes about 2 inches long within the intertidal area were hollowed by marine borers (Figure 7). Similar holes were found in piles being installed in a new dock. On the shore, a crane was lifting the creosoted piles into place by grasping each pile with pointed tongs near the balance site. American Wood Preservers' Association Standard M4 states "treated piling may be handled with pointed tools provided that side surfaces are not penetrated over one-half inch". Because of the variable preservative penetration depth, the use of pointed tools should be prohibited or limited to a fixed distance from the top or bottom of piling.

Figure 7. Oval holes with hollowing of the pile by Limnoria was a result of using sharp pointed tongs to lift piles. The port manager filled the hollowed piles with concrete to strengthen them.

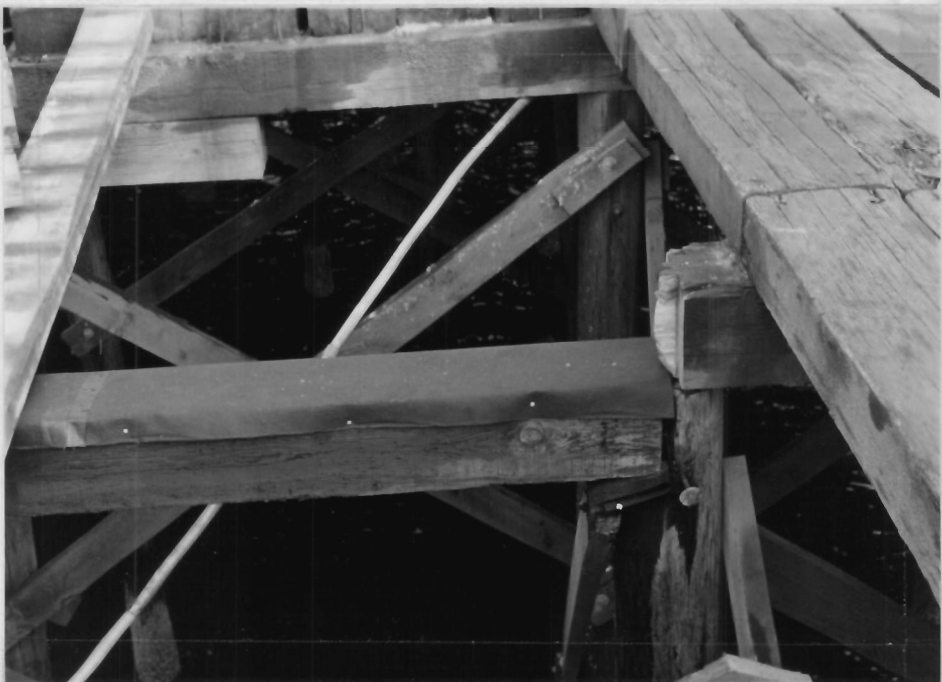
Figure 8. Preservative brushed over untreated wood members and covered with roofing felt.

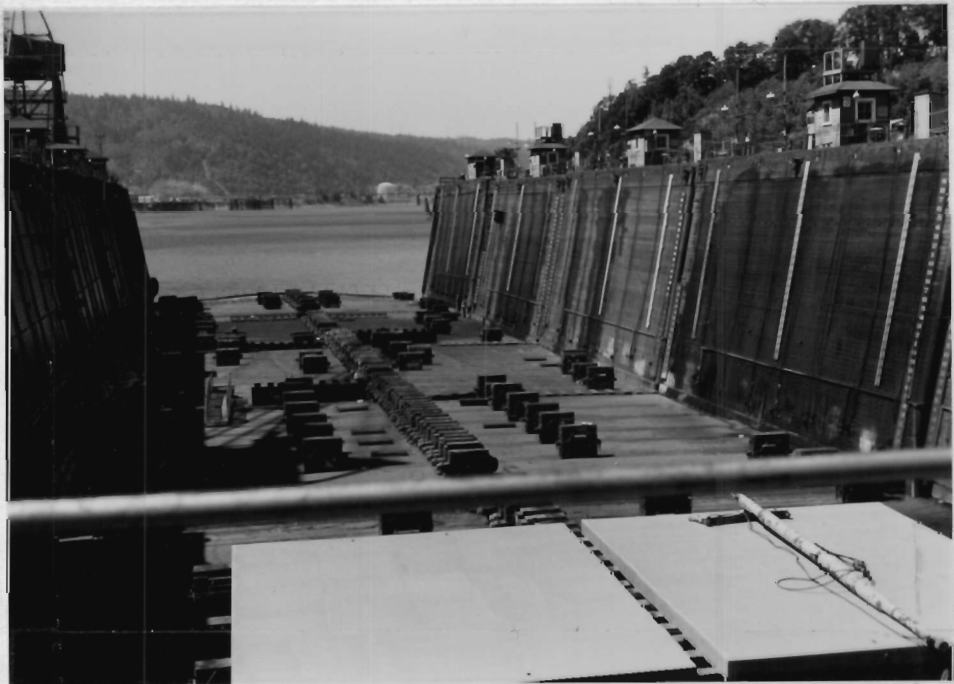
Figure 9. Fifty-five year old wooden dry dock in excellent condition except for soft rot found on the surface of continuously wetted wood surfaces.

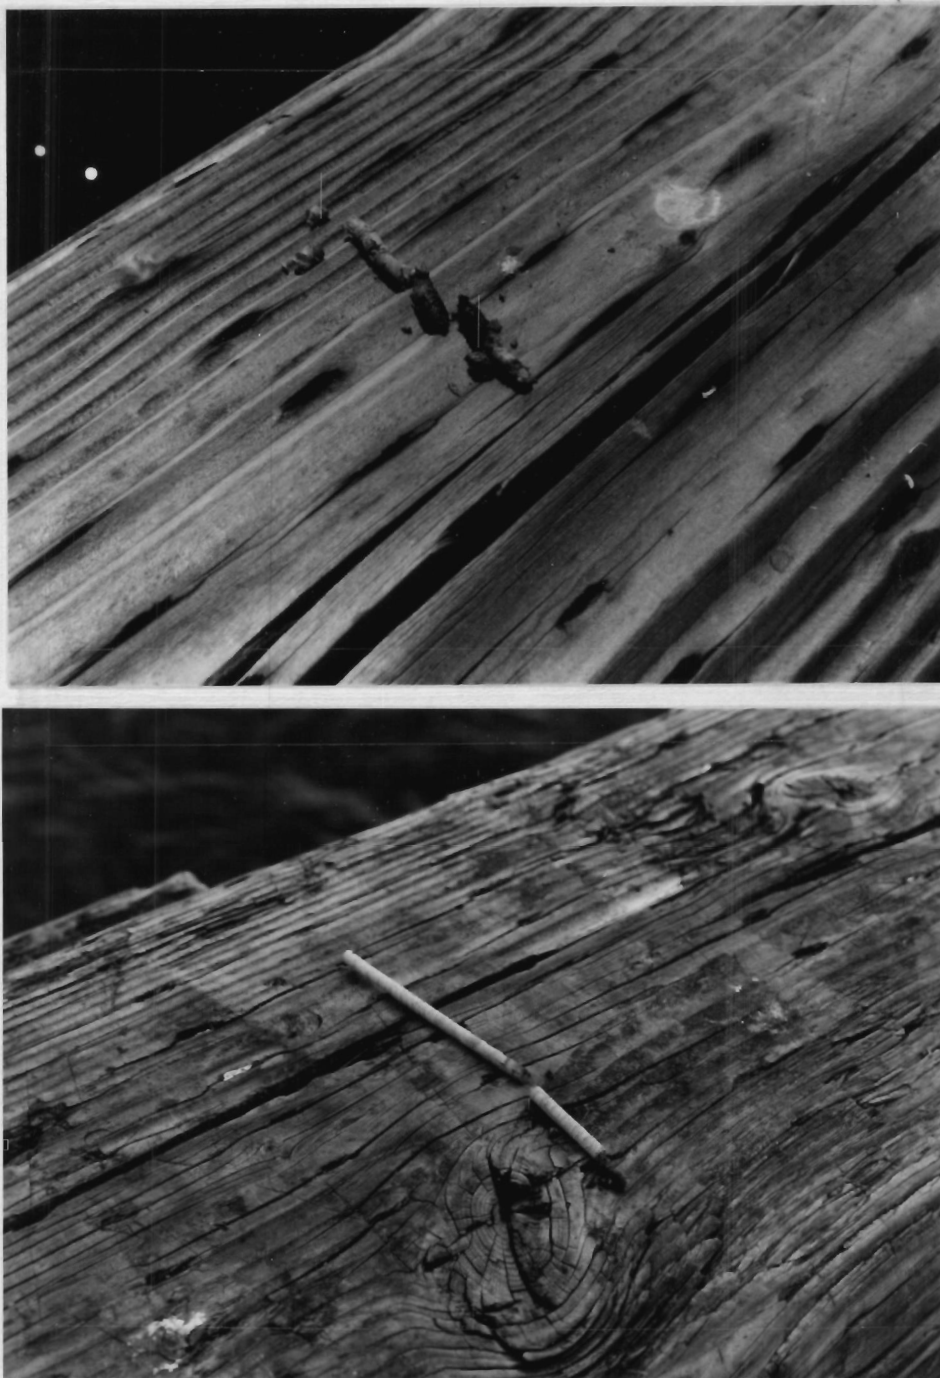
Figure 10. After 20 years this Douglas-fir timber pressure-treated with FCAP had sound wood in the seasoning check compared to the 3-year-old penta pressure-treated timber above with advanced decay at the base of the seasoning check.

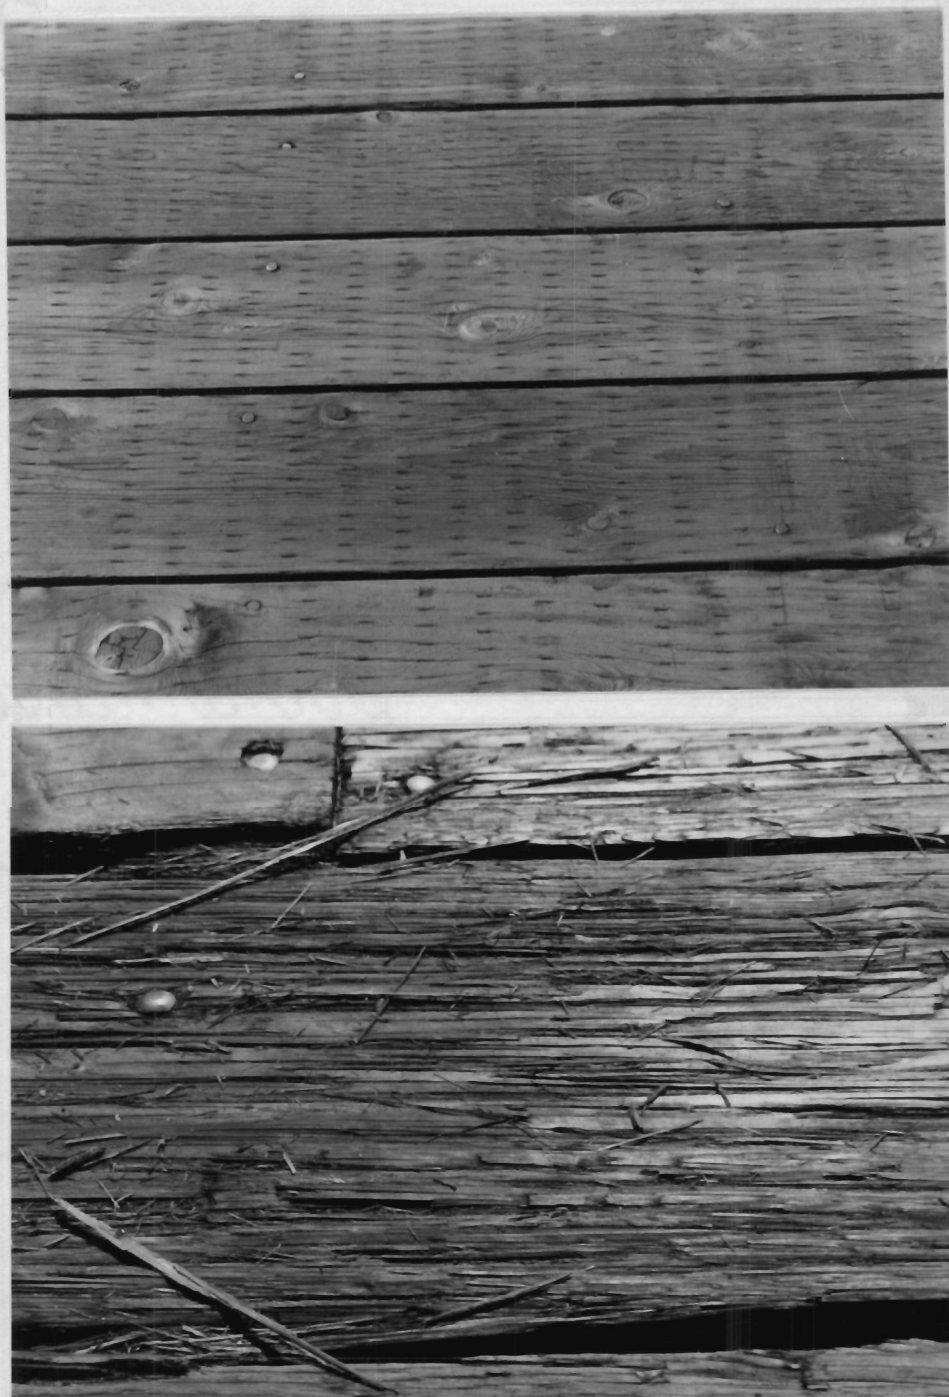
Figure 11. Decking planks treated with creosote (above) showing no surface splintering after 10 years as opposed to the surface splintering in 20-year old decking planks treated with FCAP (below).
