STUDIES OF COMPRESSION FAILURES AND THEIR DETECTION IN LADDER RAILS

February 1949

No. D1733

By MAXON Y. PILLOW, Wood Technologist

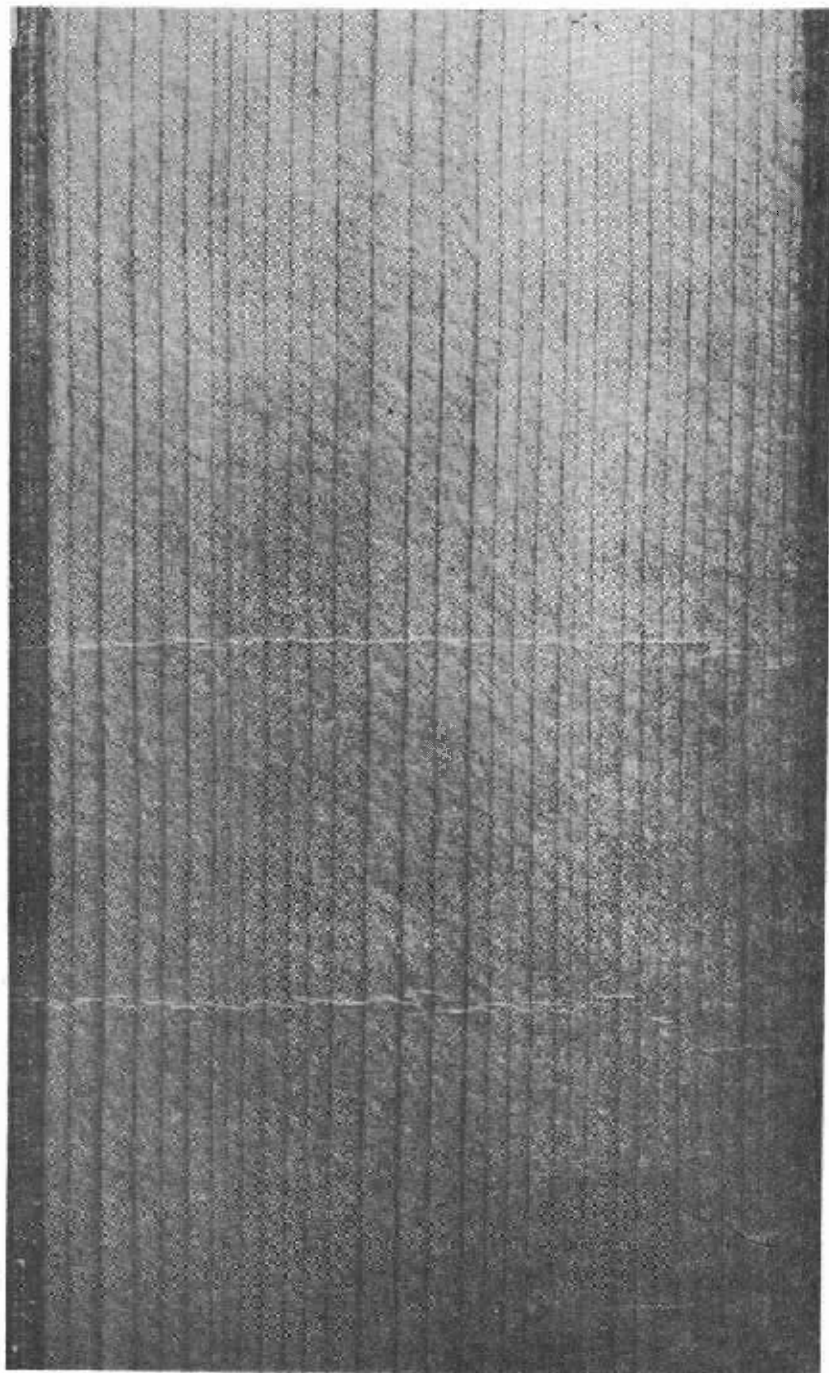
Figure 1.--Compression failures in spruce lumber that are visible as lines across the grain. Slightly magnified.

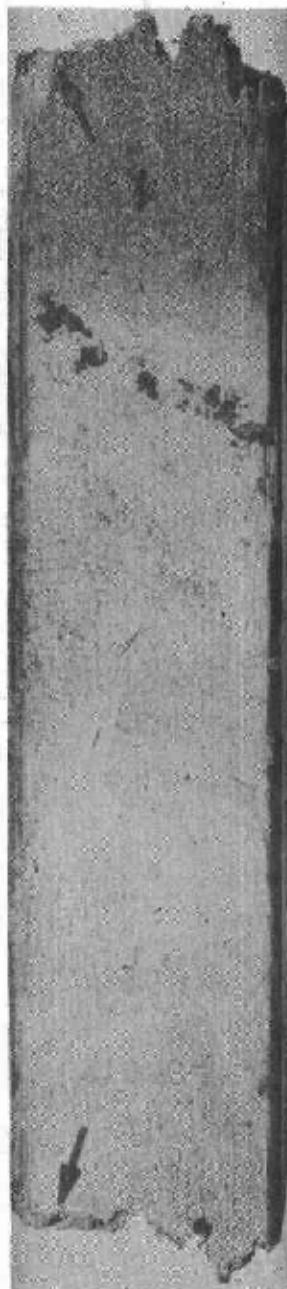
Two breaks due to compression failures occurred about 1 foot apart in one ladder rail (fig. 2), while in another ladder both rails had broken simultaneously at the same rung insertion because of compression failures in both rails. In the rails of both of these ladders, the compression failures were too small to be detected by ordinary visual inspection of the sides and

Figure 2.--Side view of a ladder rail that failed in two places at approximately the same time because compression failures were present prior to the ultimate breaks in tension, which are indicated by arrows.

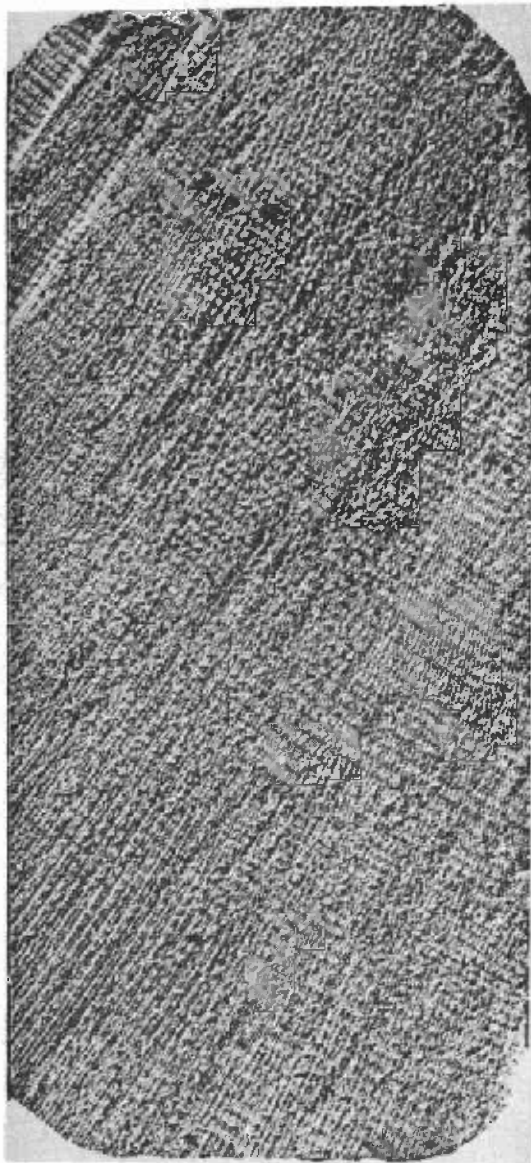
edges of the rails. Their presence, nevertheless, was indicated by areas of broken fibers that extended across several annual rings on end-grain surfaces (fig. 3) that were cut from near the failures of each of the rails.² Thus, the abrupt fractures across the grain of the rails were found to occur at compression failures already present in the wood, and the presence of these defects was indicated in nearby parts of the rail by fiber breakage in end-grain surfaces, although they were not detected by ordinary visual inspection of other surfaces.

Figure 3.--Cross section of a ladder rail showing fiber breakage
that indicates the presence of compression failures.
Z M 80314 F

The known information on occurrence and effects of compression failures demonstrates that a ladder rail having fiber breakage on one or both ends is likely to be hazardous to safety of life and property. Therefore, ladder rails having fiber breakage at either end, such as is shown in figures 3, 6, and 7, are not considered safe.

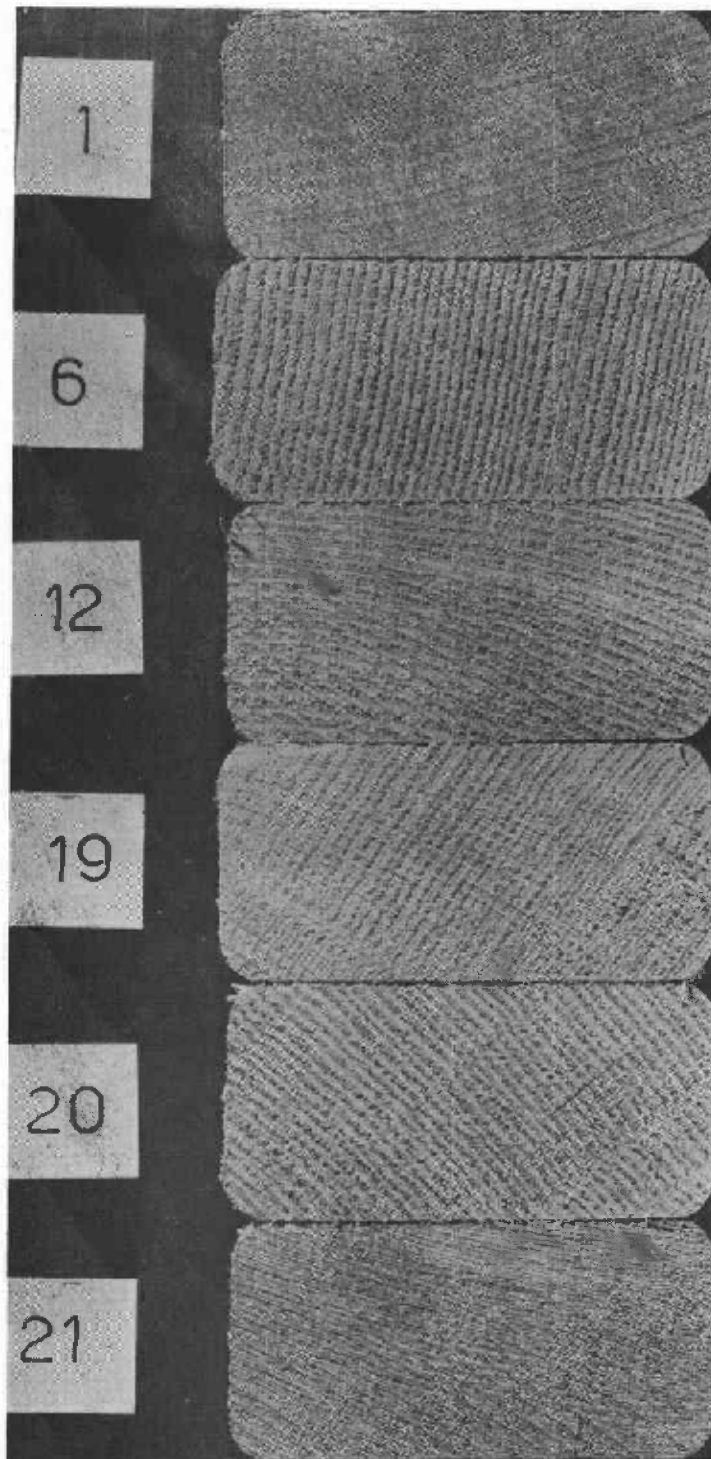
The samples were classified with respect to the presence or absence of fiber breakage after examination under uniform conditions (table 1). This classification, in general, conformed to the previous observation in which fiber breakage had been suspected on one or both ends of the ladder rails originally examined. Samples from other rails showed no indications of fiber breakage either in the original examination at the manufacturing plant or in that at the Laboratory under more favorable conditions (fig. 4).

Figure 4.--Cross sections of ladder-rail samples that showed no fiber breakage.

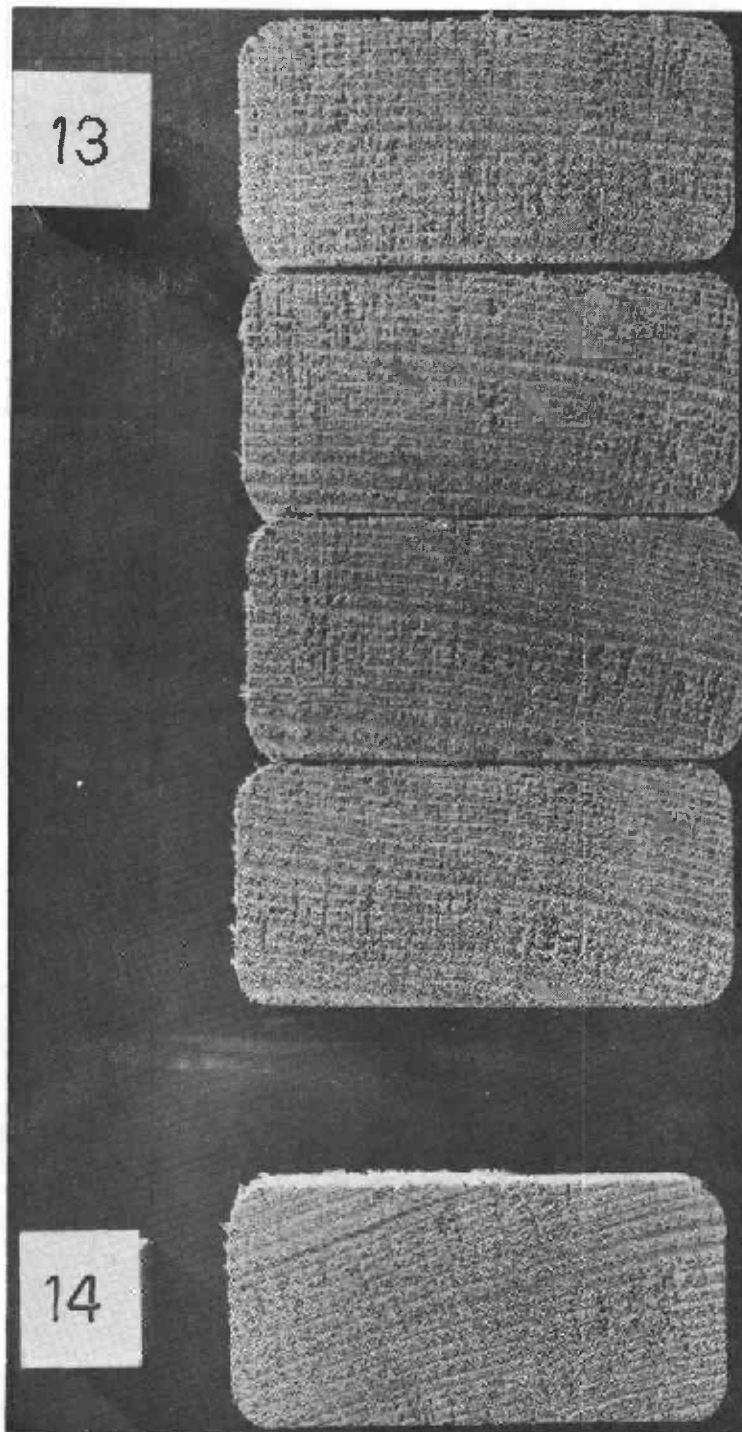
Examinations at low magnification (20X) of end-grain surfaces with fiber breakage showed that cells of the wood had been broken off cleanly rather than having been cut and pushed to one side by the saw teeth (fig. 5). This breakage occurred in radially oriented areas that frequently extended across both springwood and summerwood of two or more annual rings. The saw cut obviously must be made close to compression failures to cause such fiber breakage. The occurrence of fiber breakage at both ends of the ladder rails and at frequent distances along their lengths indicated that compression failures were closely spaced and uniformly distributed throughout some of the ladder rails being studied (fig. 6).

Figure 6.--Four cross sections cut at about 2-foot intervals from one end (13) and one from the opposite end (14) of a 16-foot ladder rail, all showing fiber breakage caused by the presence of compression failures.

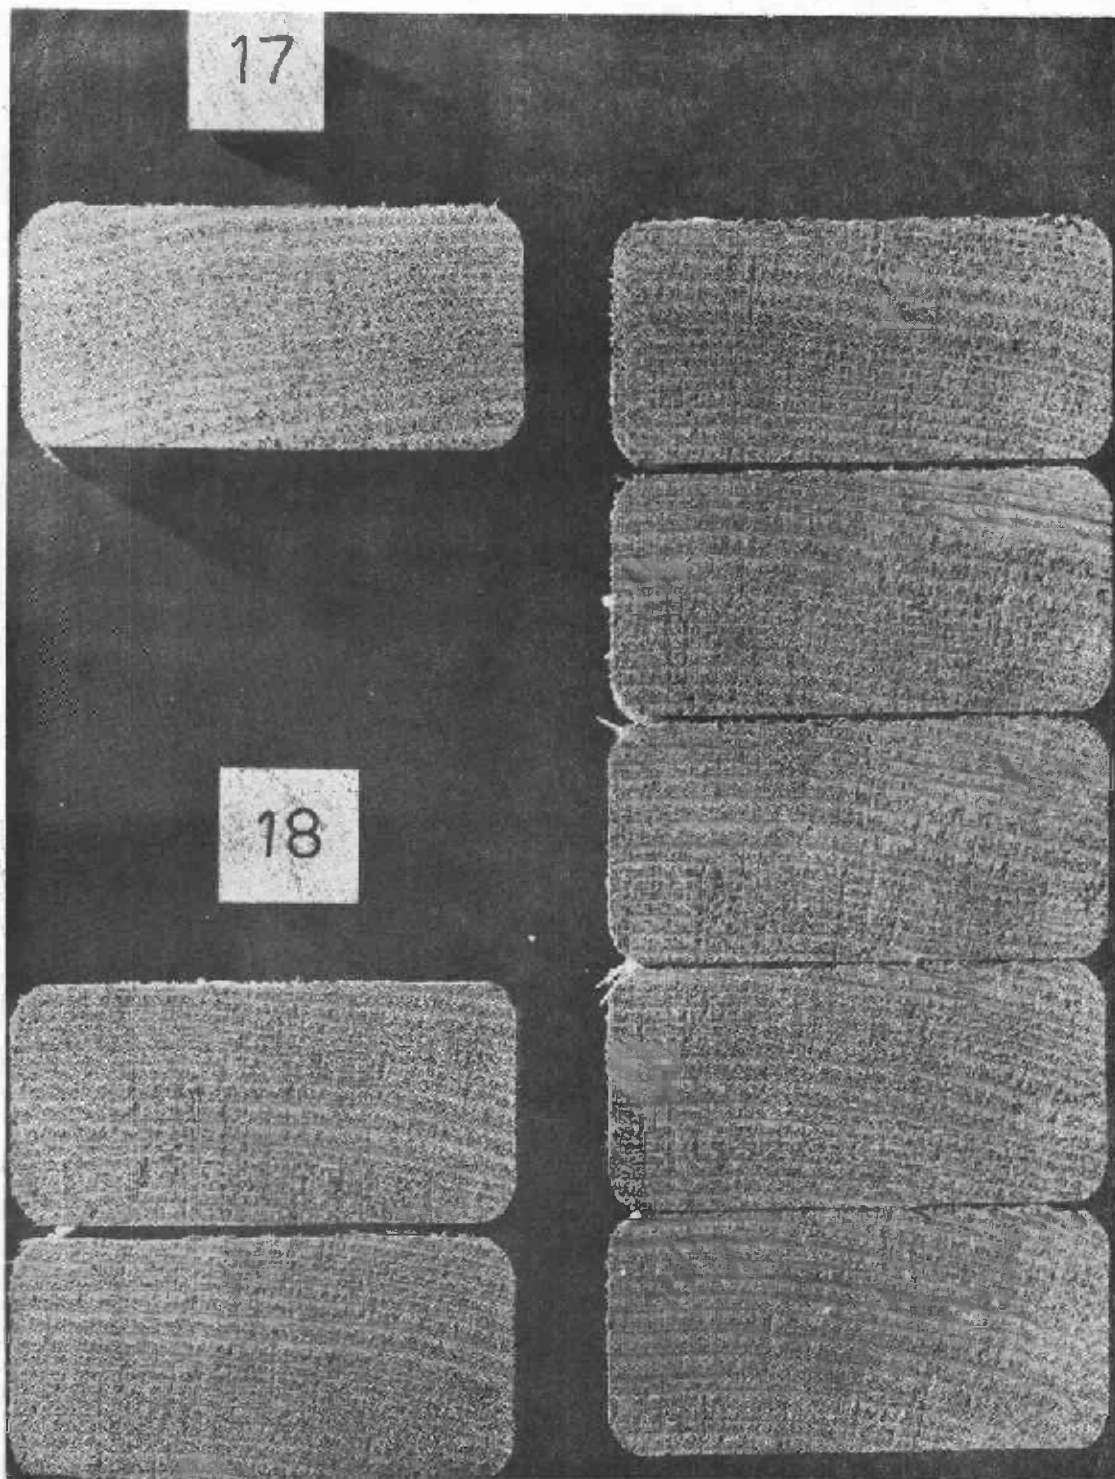
The fiber breakage showed considerable variation with respect to the size of the areas in which the cells had been broken rather than having been normally cut by the saw teeth, and also to the frequency of occurrence of broken-fiber areas on the end-grain surface (fig. 7). The occurrence of any fiber breakage is considered evidence of the presence of compression failures. Examinations of broken ladder rails under a high-power microscope and polarized light, both in this study and in previous ones, showed that numerous compression failures of microscopic size were present in the vicinity of fiber breakage on end-grain surfaces of the wood.

Figure 7.--Cross sections from a ladder rail cut at about 2-foot intervals, all of which show fiber breakage to lesser or greater extents, indicating the presence of uniformly distributed compression failures along the length.

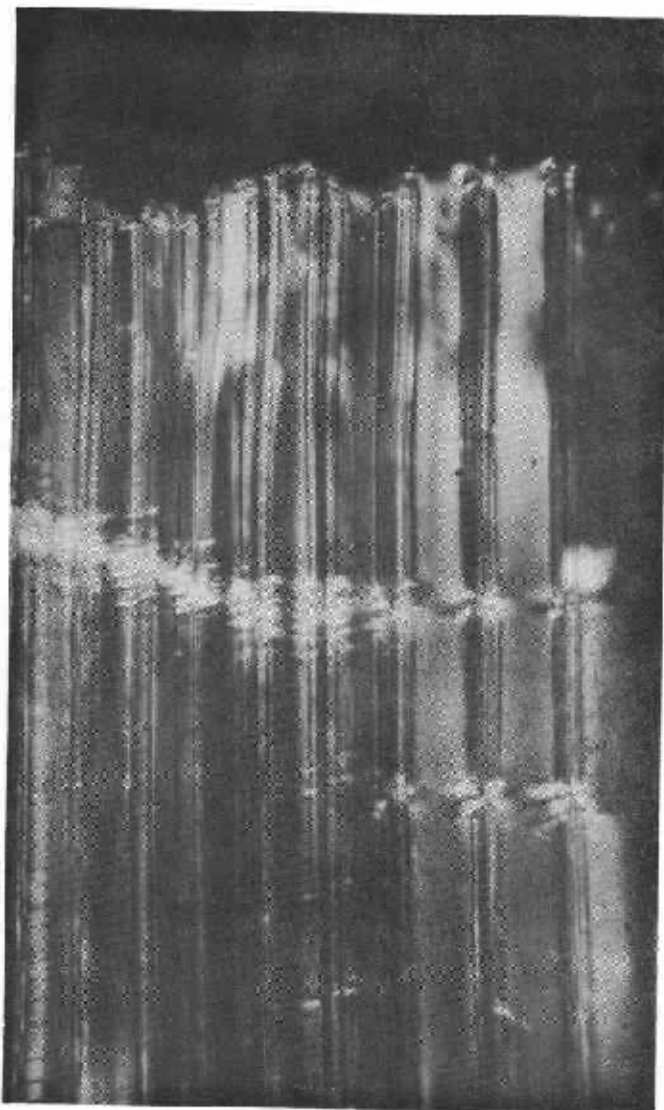
Types of failure.--Toughness specimens of this study, and also of previous studies of causes of brashness,² have shown that abrupt or brittle breaks across the grain are very frequently caused by compression failures present before the ultimate fractures occurred. Examination of such brittle fractures by high-power magnification has shown that many occurred at compression failures (fig. 11). The specimens from samples having fiber breakage on end-grain surfaces had characteristically brittle failures in contrast to the splintering failures of specimens from samples without fiber breakage (figs. 12, 13, and table 1).

Figure 11.--Photomicrograph of a brittle break in tension that occurred at a compression failure already present before the piece ultimately broke. X450 by polarized light.

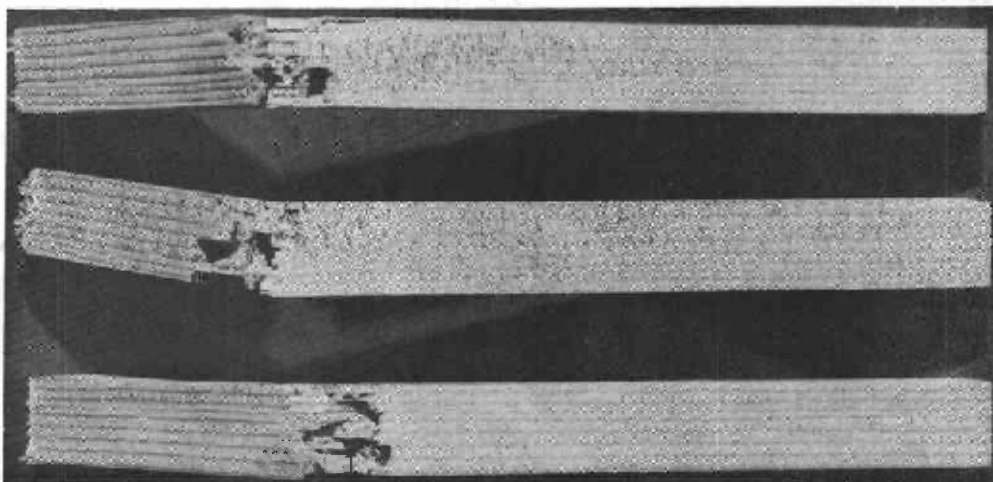
Figure 12.--Brittle breaks across the grain of toughness-test specimens from a ladder-rail sample that showed fiber breakage on end-grain surfaces.

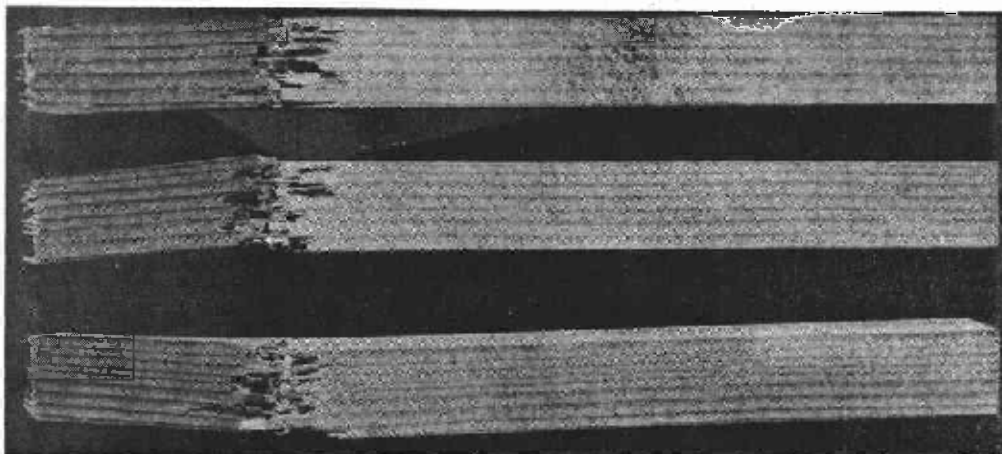
Figure 13.--Splintering toughness-test failures of specimens from sample without fiber breakage on end-grain surface.

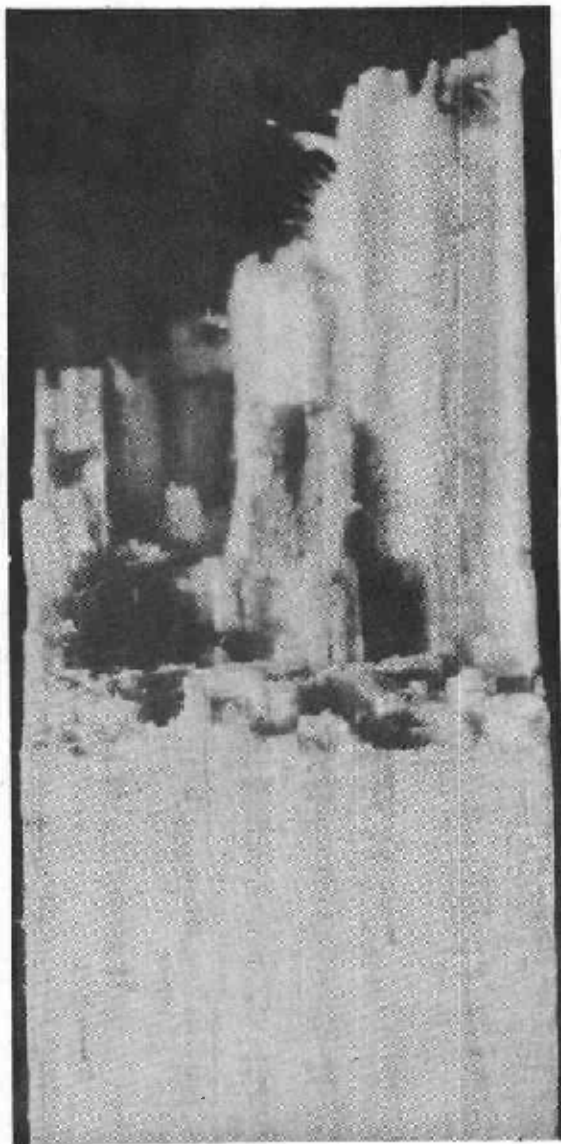
Abrupt breaks due to compression failures in the specimens occurred almost directly across many fibers and sometimes across parts of several annual rings. Examinations by low magnification of specimens with brittle fractures due to compression failures showed that they had characteristically steplike contours (fig. 14). This type of failure in wood bent as a beam results when the ultimate fracture occurs along several closely adjacent compression failures. Such steplike breaks serve as a means of identification of ultimate failures through previously existing compression failures. They were found to be present, wholly or in part, in all of the specimens from samples showing fiber breakage on the end grain, but not in those from samples that did not show this characteristic (table 1).

Figure 14.--Steplike break in a toughness-test specimen that is characteristic of a fracture through several compression failures already present before the ultimate break occurred. X5 photographed by reflected light.

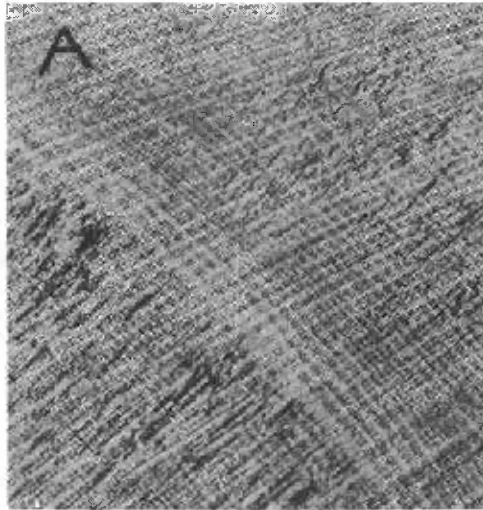
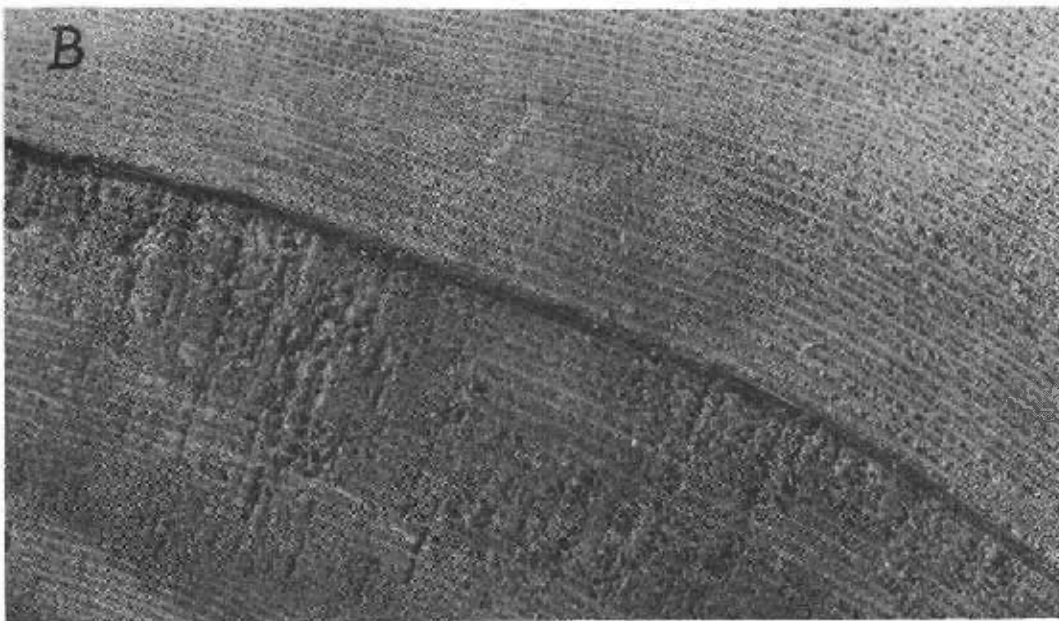
Figure 15.--End-grain surfaces of Sitka spruce lumber showing fiber breakage: A, distributed across most of the surface; and B, in the part below the black line in comparison to wood free from this characteristic above the line.

Observations at plants manufacturing ladder rails showed that careful inspection of end-grain surfaces for fiber breakage is a practical means of detecting compression failures. Such inspections can be made on sawed lumber in large sizes intended for resawing to ladder-rail dimensions, provided that the ends are sawed with reasonable smoothness. Exclusion of pieces showing fiber breakage in rough-lumber sizes will result in some saving in manufacturing costs (fig. 15, A). Lumber having that characteristic confined to only part of the cross section sometimes can be resawed so as to salvage the remainder that is suitable for ladder-rail material (fig. 15, B).
