WITHIN-RING CHECKING: CAUSES AND CURES

Michael R. Milota
Oregon State University
Corvallis, Oregon

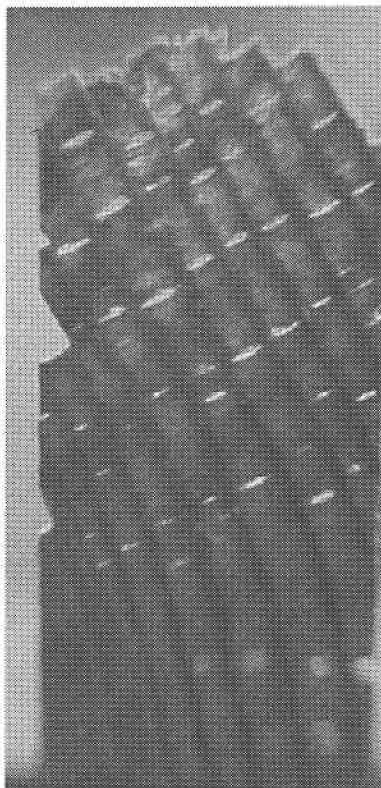
A problem that often rears its head for ponderosa pine producers is inter-ring checking. The problem is illustrated in Figure 1. Small cracks form within the earlywood portion of the ring. These do not extend through the latewood, or dense portion of the ring. This problem mostly occurs in abrupt transition species which are those in which the density (and other cell characteristics) rapidly change with position in the ring and we see very distinct dark and light bands. Other properties that promote this defect are high initial moisture contents, thin early wood cells walls, and rapid initial drying. In New Zealand, they note that this defect occurs in wood from certain stands more than others and more frequently in the butt log of the tree. They also suspect that a boron deficiency in the soil may contribute.

Figure 1. Ponderosa pine and within-ring checking.

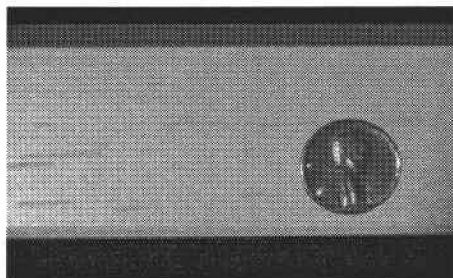
In the past year, several samples like this have come to the Forest Research Lab at OSU. Of course, it's not the sawmills who are finding the problem. When the wood is sawn into a part and painted, the checks are highly visible (Figure 2). On the surface, it is not evident that these are drying checks. In fact, one mill insisted that it was the resin canals that were causing the problem and it was a natural feature of the wood. Microscopic investigation demonstrates the causes.

Figure 2. Checks are highly visible.

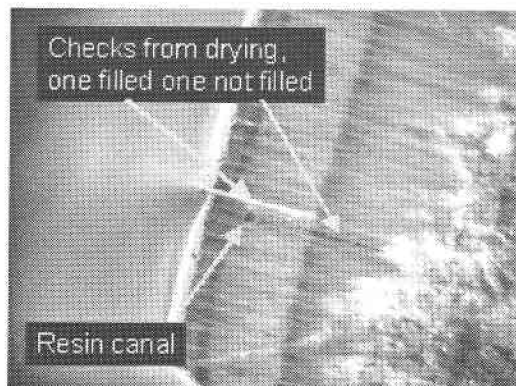
Figure 3. Coating moves into check and leaves surface layer thin.

In Figure 3 a check is clearly visible. This is what many of the streaks looked like when cut in cross section. The paint has struck into the check, filled it and left the coating on the surface very thin. Figure 4 shows the effect of a resin canal at the surface. The coating is thin and this is visible on the surface. However, this was a rare observation. This resin canal was cut so that the entire canal could fill. Note the one just above it which is cut half way through. It barely affects the surface coating. Resin canals were a minor factor in the samples and the vast majority of the imperfections in the coating were due to checks.

So what's the problem? As water evaporates from the surface of the wood, it tries to pull water from the center of the wood. This wood can be crushed by these capillary forces and we see this as collapse in species such as cedar and redwood. The cure for this is to reduce the drying rate early in the schedule.

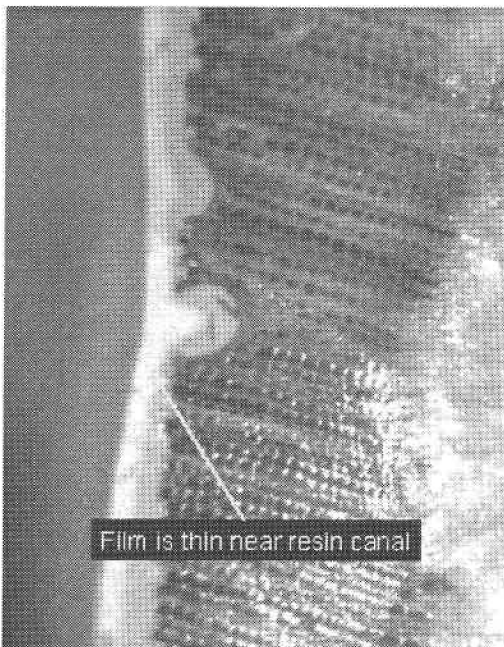
Figure 4. Problem can occur due to a resin canal, but this is rare.
