SEISMIC EVALUATION

HMSC OFFICE BUILDING NEWPORT, OREGON

OREGON DEPARTMENT OF FISH & WILDLIFE

TO	State of Oregon, Department of Fish and Wildlife				
FROM	John Evans, P.E, S.E., Pillar Consulting Group, Inc.				
PROJECT	ODFW HMSC Office Building Seismic Study – Newport, Oregon				
SUBJECT	ASCE 31-03 Seismic Evaluation & Schematic Upgrade Design - FINAL				
DATE	6/22/2013	PROJECT #	2013007	MEMO #	EM-01

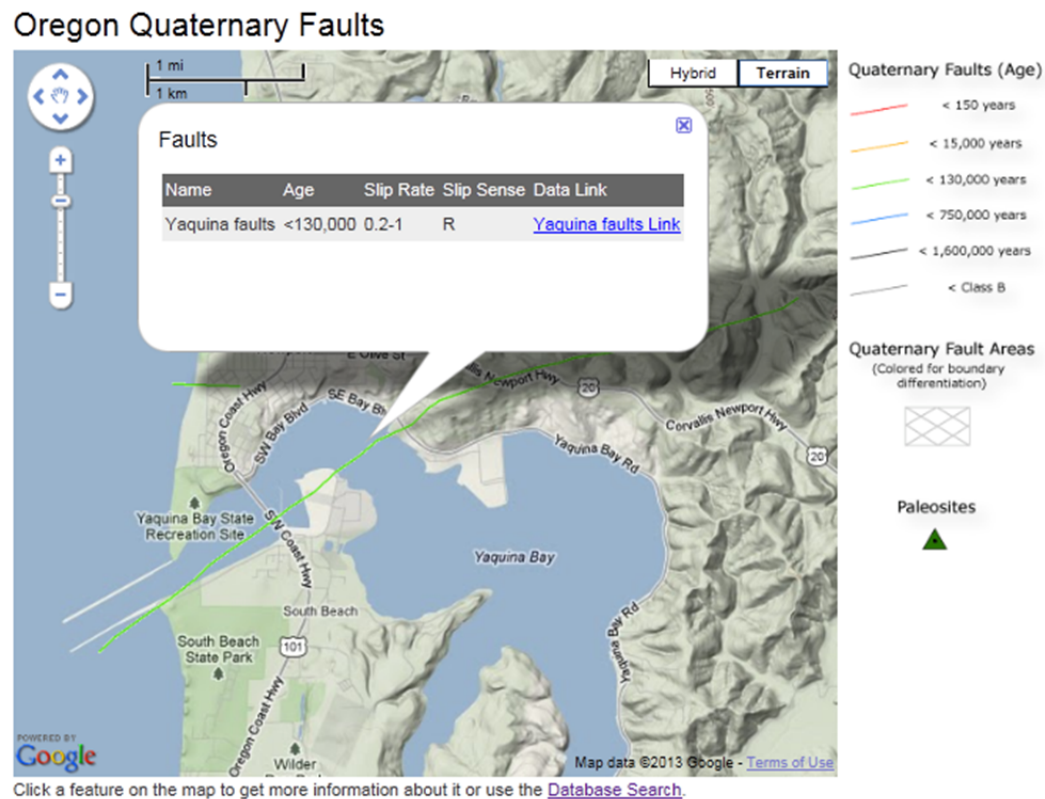
- 5-3 C **NC** NA SURFACE FAULT RUPTURE: Surface fault rupture and surface displacement at the building site is not anticipated.

The building is in close proximity to the mapped Yaquina fault. This fault is anticipated to have been active within the last 130,000 years but has not been active within recorded history. It is unknown whether this fault would act on its own or if its displacement would coincide with a larger megathrust earthquake on the subduction zone.

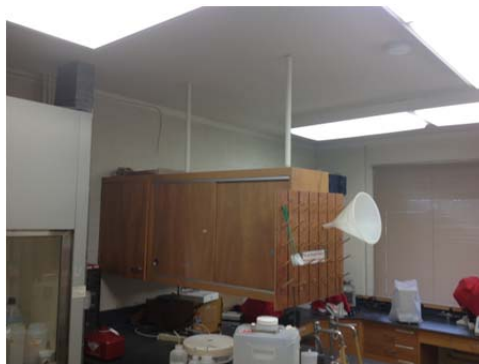
Photo 6-2: Hung cabinet

- 6-24 C **NC** NA ATTACHED EQUIPMENT: Equipment weighing over 20 lb. that is attached to ceilings, walls, or other supports 4 feet above the floor level shall be braced.

Large cabinets as well as a large ceiling hung fan were observed. These present a fall hazard in a seismic event.

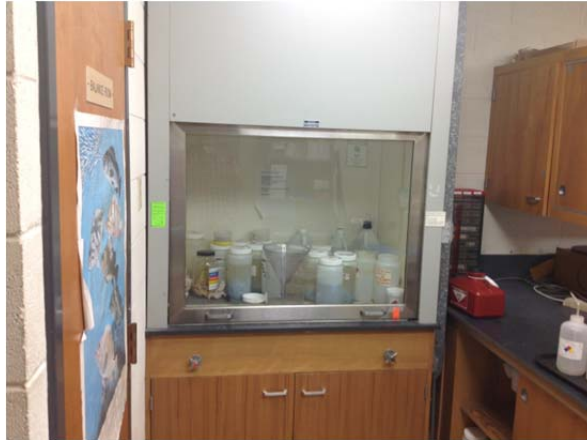
Photo 6-4: Hazardous substance storage

6-27 **C** NC NA TOXIC SUBSTANCES: Toxic and hazardous substances stored in breakable containers shall be restrained from falling by latched doors, shelf lips, wires, or other methods.

Toxic substances appear to be stored in a way that would prevent them from falling.
