Damage Assessment of a Full-Scale Six-Story Wood-Frame Building Following Triaxial Shake Table Tests

Abstract: In the summer of 2009, a full-scale midrise wood-frame building was tested under a series of simulated earthquakes on the world's largest shake table in Miki City, Japan. The objective of this series of tests was to validate a performance-based seismic design approach by qualitatively and quantitatively examining the building's seismic performance in terms of response kinematics and observed damage. This paper presents the results of detailed damage inspections following each test in a series of five shake table tests, and explains their qualitative synthesis to provide design method validation. The seismic test program had two phases. Phase I was the testing of a seven-story mixed-use building with the first story consisting of a steel special moment frame (SMF) and stories 2–7 made of light-frame wood. In Phase II, the SMF was heavily braced such that it effectively became an extension of the shake table and testing was conducted on only stories 2–7, making the building a six-story light-frame multifamily residential building instead of a mixed-use building. All earthqu

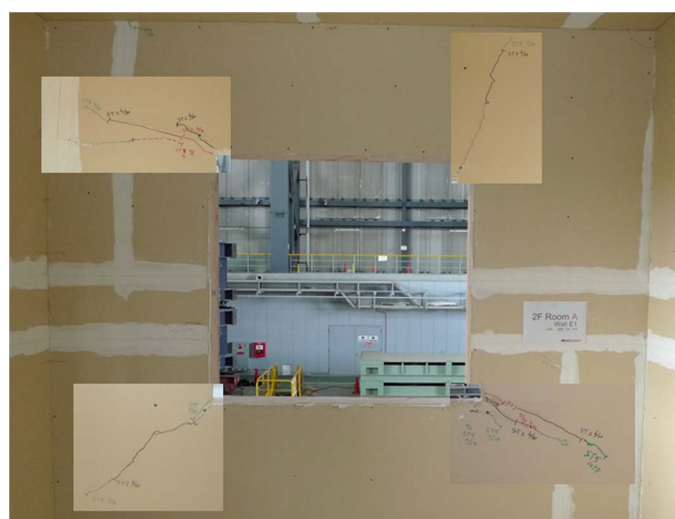
**Fig. 6.** Example of cracking propagation from the corners of a window opening after five simulated earthquake tests

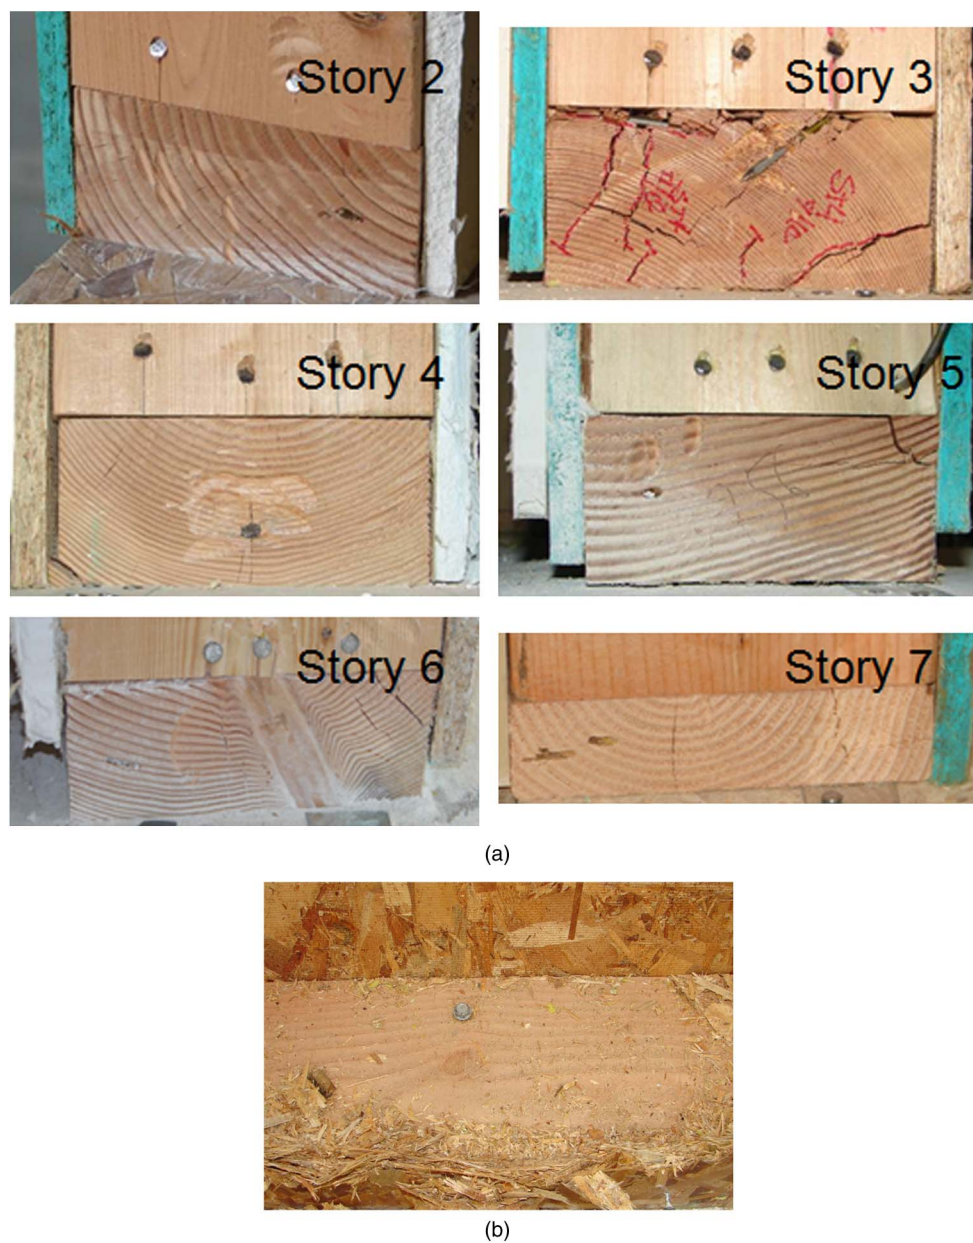
result of toe-nailing during construction and was marked as pretest damage. Fig. 7(b) shows the top of the wood screws after removing OSB on one side of the shear wall following the final seismic test. Other than the damage to GWB, no additional damage was observed, i.e., no nail withdrawal, no nail pull-through in the sheathing, and no visible stud splitting around tie-down rods. In a typical shear wall, testing without GWB failures like these are seen. But the full-scale, six-story Capstone building did not see any of these failures. This is because in shear wall testing, shear deformation is dominant, whereas in a full-scale and especially a six-story building, other deformations (such as bending and axial) are also present. Also, tie-down rods that extended the whole height of the building resisted most of the overturning forces.

Fig. 7. (a) Sill plates remaining intact (i.e., no splitting) following all five shakes; (b) close-up of sill plate after removing wall sheathing

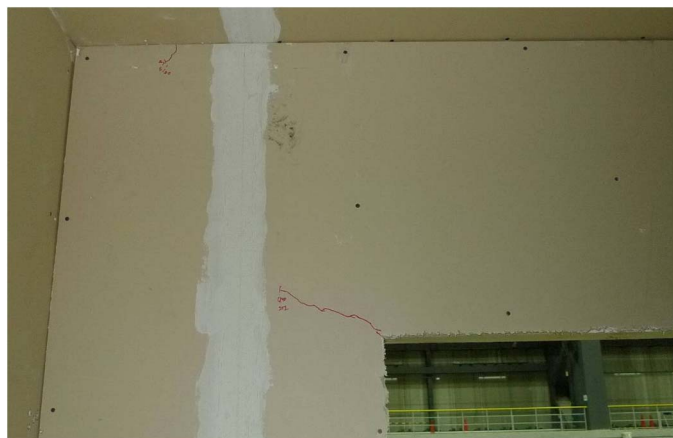
Although damage was limited to dry wall cracks only, correlation of damage to the seismic intensity test level can be identified during all five tests. In the test at Seismic Intensity Level 1, only very minor cracking was observed around the openings, as shown in Fig. 8. In many of these cases, the cracks were small enough to have been covered/filled with paint. As was anticipated, Seismic Intensity Level 2+, which slightly exceeded the design-basis earthquake (DBE), caused more damage. The cracking was definitely detectable at many locations, but was still limited to the GWB. At this

Fig. 8. Minor crack on Wall E4, Story 2 (over window opening) after Level 1 shaking

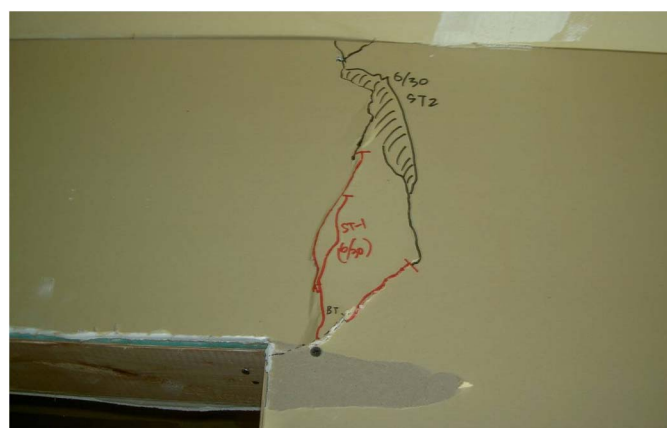
seismic intensity level, it became apparent that the stories with the larger interstory drift levels had longer, wider, and at times more numerous GWB cracks. Fig. 9 shows one of the more noticeable crack patterns that occurred above several doorways after Seismic Test 2. The diagonal pen marking indicates a section of the GWB that may have slightly pulled away, or in which the paper was loosened. Seismic Test 3 was a smaller shake, but with the steel SMF locked down, i.e., testing only the six-story wood building. During this small shake, many locations had no propagation of crack damage. For example, Fig. 10 shows a vertical crack above the doorway that occurred during Seismic Test 2 but did not widen or spall during Seismic Test 3. Because of the way the tests were performed, it is difficult to tell if the 50%/50-year earthquake used in Seismic Test 3 would have caused any appreciable damage even to the GWB. It is likely there would have been only hairline cracking such as that shown in Fig. 11.

Fig. 9. Crack on Wall D1, Story 4 (over door opening) after Seismic Test 2

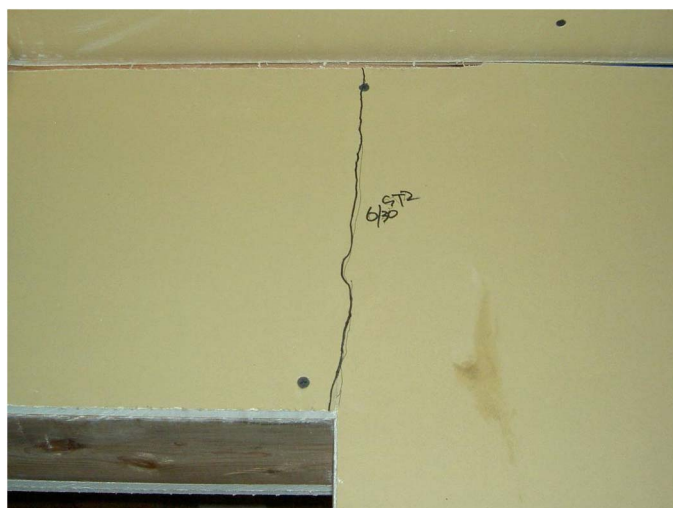
Fig. 10. No new crack on Wall 2A, Story 7 (over door opening) after Seismic Test 3; the crack shown was developed during Seismic Test 2

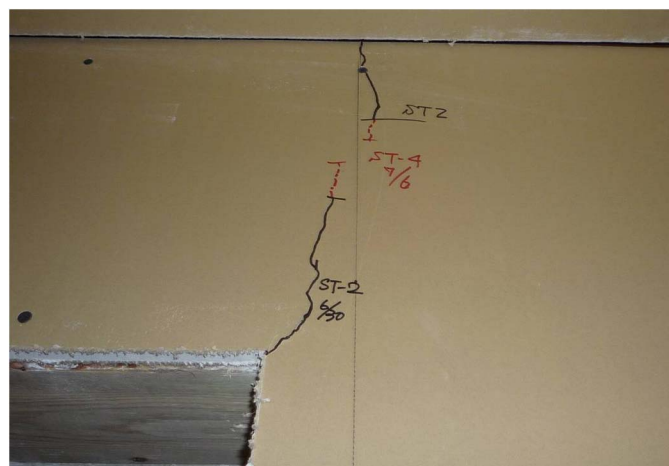
Fig. 13. Crack on Wall 2A, Story 5 (over door opening) after Seismic Test 4

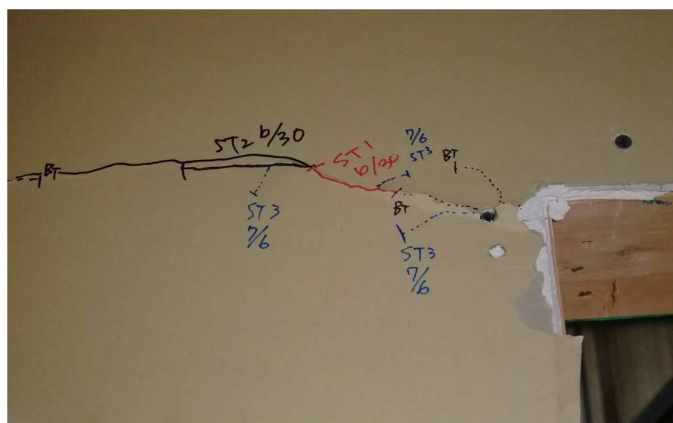
Fig. 11. Crack on Wall A3, Story 2 (over window opening)

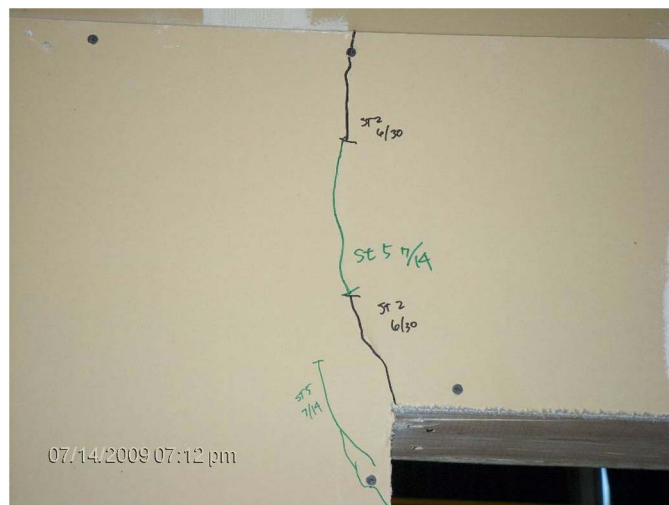
Fig. 14. Crack on Wall A3, Story 4 (over window opening) after Seismic Test 5

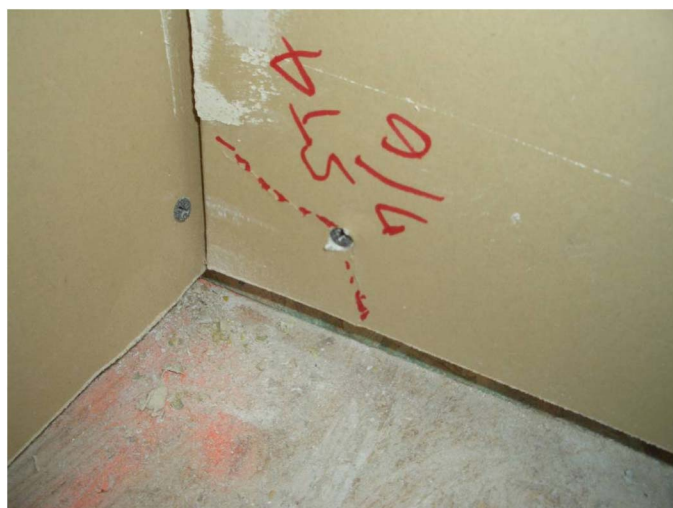
Seismic Test 4 (ST4) was a DBE level earthquake and resulted in more GWB damage. The start of some GWB spalling can be seen in the photograph. In general, Seismic Test 4 propagated existing cracks and caused some smaller cracks to branch off from the main cracks. Fig. 12 shows some new cracking near one of the corner GWB screws, indicating significant racking in the panel after ST4. The propagation discussed previously was observed routinely, as shown in Fig. 13. The “ST4” marking is for both the upward and downward propagating cracks. Repairs (structural or to the GWB) between tests were not made; thus, conclusions and correlations discussed in this paper only seek to better understand the trends.

Fig. 12. New crack on Wall D1, Story 3 (corner crushing) after Seismic Test 4

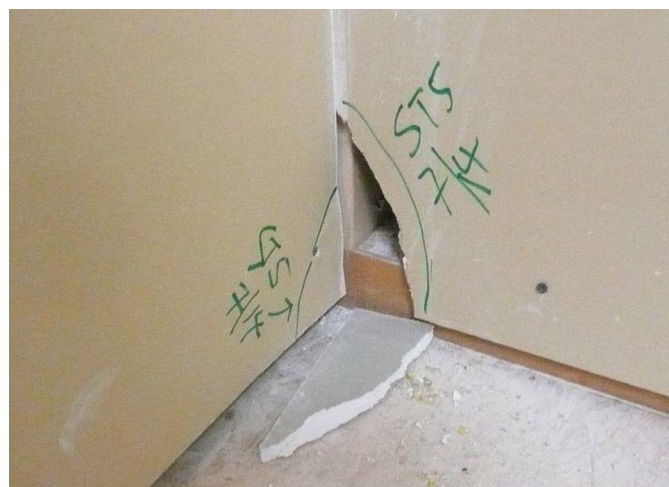
Fig. 15. Crack on Wall D2, Story 6 (corner crushing) after Seismic Test 5

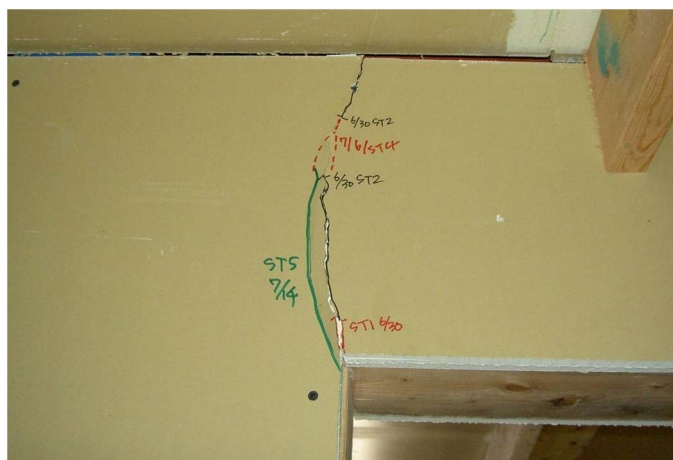
The final test [Seismic Test 5 (ST5)] in the Capstone test program was a maximum credible earthquake (MCE) level corresponding to a 2%/50-year event, statistically giving a return period of approximately 2,500 years. In ST5, crack propagation from the top corner of an opening connected to another crack propagation from a GWB screw. This was observed for walls that experienced the largest interstory drifts, i.e., near 3%, but not all. An example of this type of damage is shown in Fig. 14. In some places a crushed corner was observed, as shown in Fig. 15. A more interesting occurrence was the substantial cracks that were observed to be new and not propagating from existing cracks from the previous tests. This only occurred as a result of ST5 and an example is shown in Fig. 16.

Fig. 16. New crack on Wall 2A, Story 7 (over door opening) after Seismic Test 5

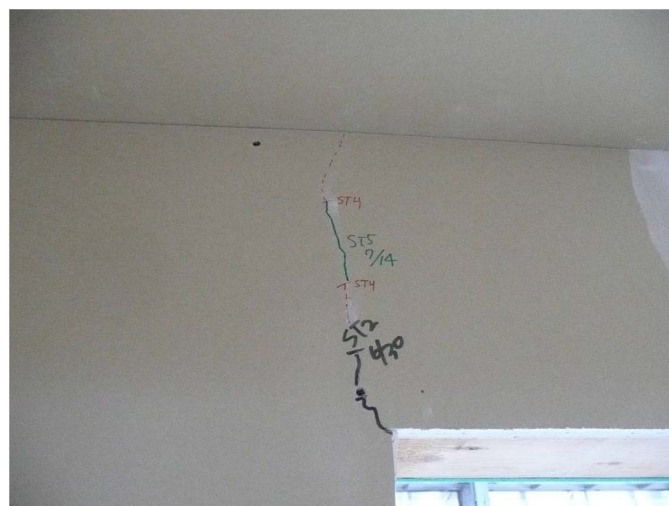
Fig. 19. Story 6, Wall E1; cracks develop all the way through panel after Seismic Test 5

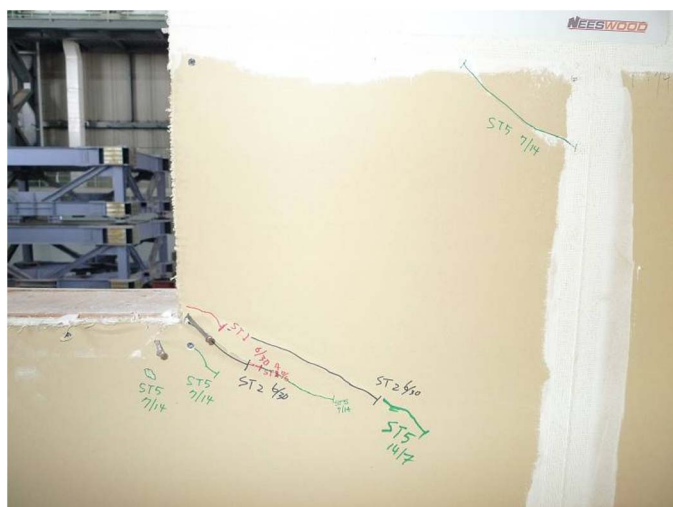
An effort is made here to qualitatively correlate damage with drift. Initially, Story 2 had a smaller interstory drift during each of the tests than Story 6 (Tables 2 and 3), yet the amount of damage was about the same at both stories. Figs. 17 and 18 show very typical damage for Story 2 after ST5. Fig. 17 shows some light spalling, but in general the cracks did not extend all the way to the panel seam or nearby wall corners. Fig. 18 shows two cracks failing to

Fig. 17. Wall E1; cracks did not extend all the way to the panel edge after Seismic Test 5

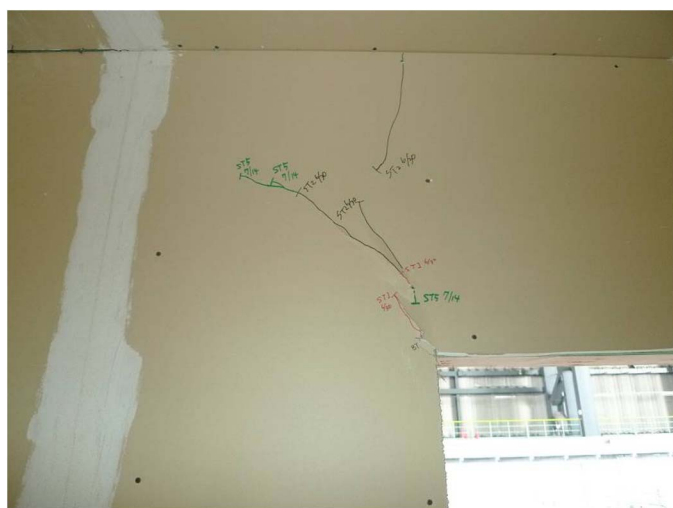
Fig. 18. Story 2, Wall E2; cracks failing to connect together after Seismic Test 5

connect following ST5 at Story 2. For some of the damaged GWB in this study, cracks tended to propagate until they connected to another crack, particularly when there was significant interstory drift caused by a combination of shear and bending. This was typical on lower stories of the building because the overall interstory drifts were lower. Comparatively, consider Story 6 following the series of five shakes. The cracks tended to propagate all the way through the panel as shown in Fig. 19. Fig. 20 shows this from a full-panel vantage point. Further, in Story 6, crushing of the panel corners was more routinely observed, as shown in Fig. 21. Most of the damage in lower stories was attributed to shear deformation,

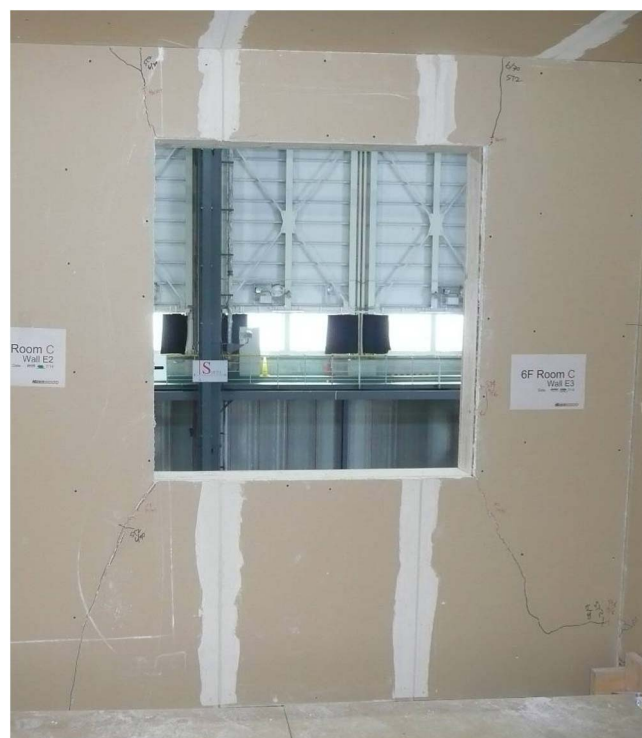
Fig. 20. Story 6, Wall E2; cracks develop all the way through panel for all corners after Seismic Test 5

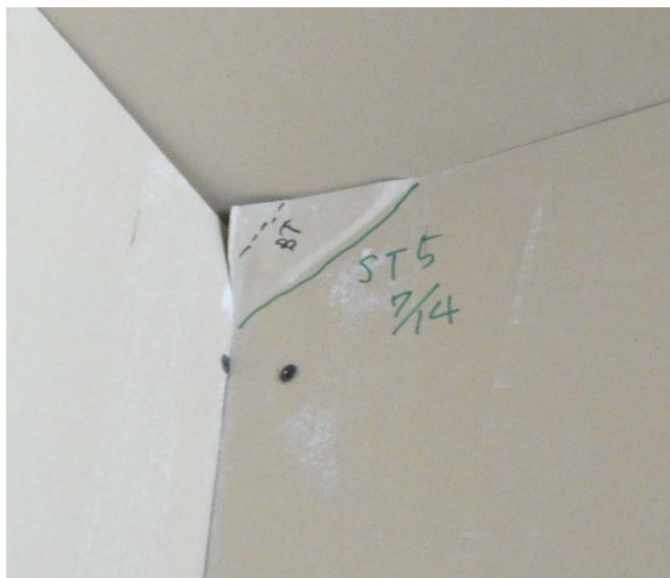
Fig. 21. Crushing of corners also seen at Story 6, Wall E5 after seismic test

whereas in upper stories the damage was attributed to a combination of shear and bending.
