Subject: ^TPreservation of the Exterior Surfaces of Wooden
Shipping Containers to Retain Identification Symbols
In Long-Term Outdoor Storage--
Final Report After 4 Years of Exposure

Report No. 59-2

Authors: V.P. Miniutti and E.A. Mraz

Date: January 29, 1960

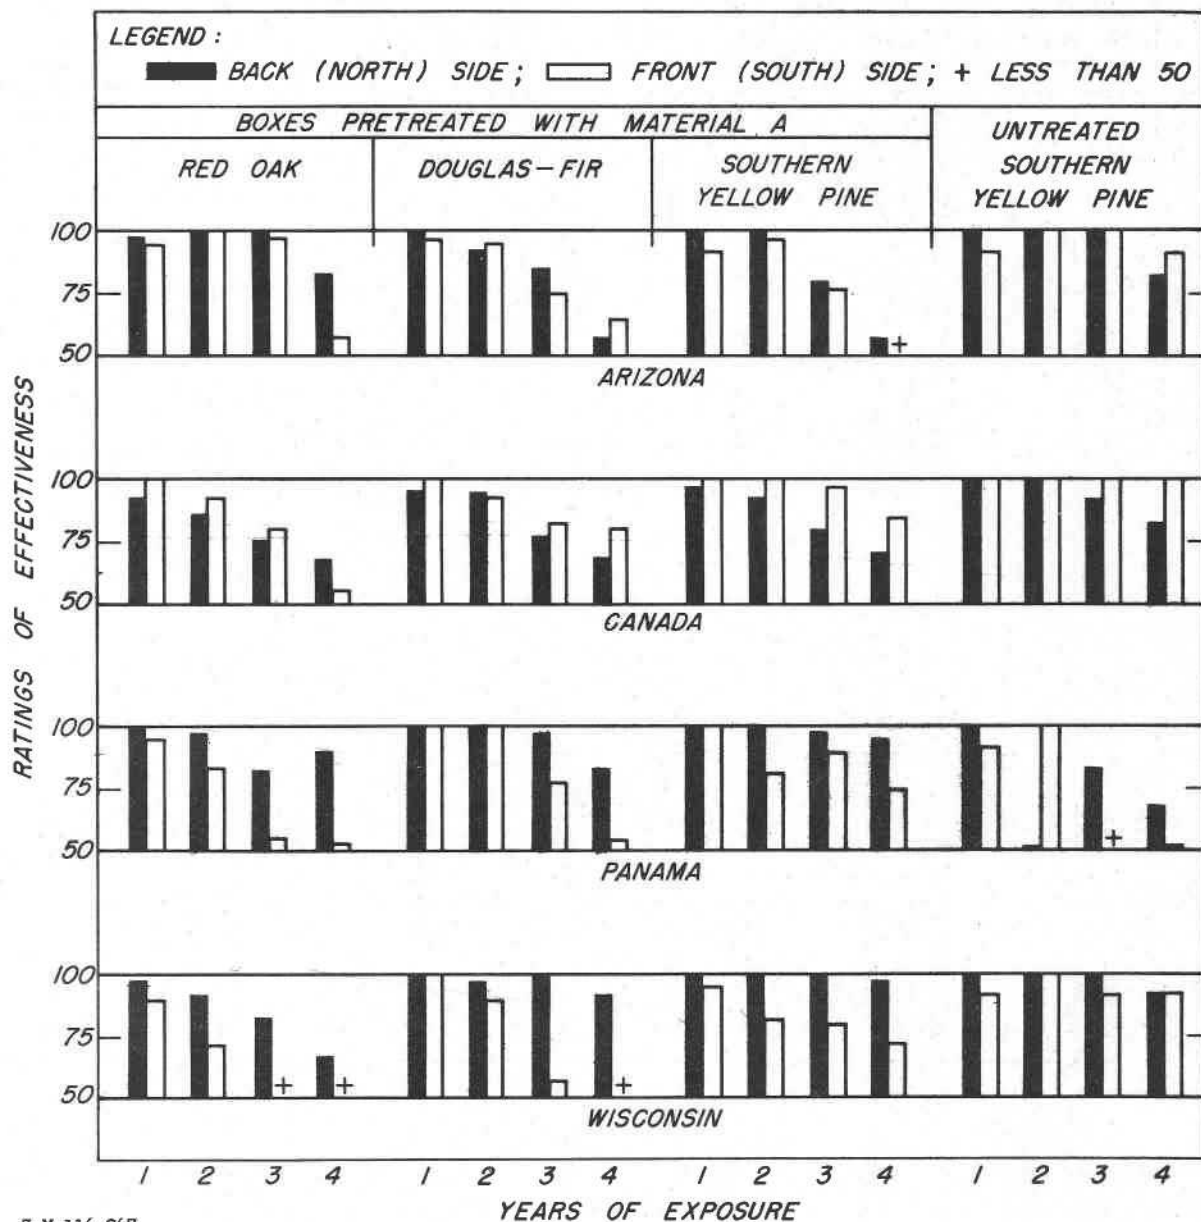
Figure 6. --Ratings of effectiveness (percentage of the number of test areas that were legible) for stencils by species, side of box, and site during 4 years of exposure. Each rating is for 36 areas on treated boxes or for 12 areas on untreated boxes. All materials and treatments are included in each rating.

The ratings of effectiveness in figure 6 indicate that the performance of the stencils was affected by the direction in which they faced, species of wood, test site, and pretreatment of the box with material A.

On the pretreated boxes, all stencils were legible (effectiveness rating of 100) on the north sides for 3 of 12 combinations of species and site after 3 years of exposure. The three combinations were red oak boxes in Arizona and Douglas-fir and southern yellow pine boxes in Wisconsin. After 4 years of exposure, the highest rating of effectiveness for all stencils on any combination of side, species, and site was 97 for the north sides of the southern yellow pine boxes in Wisconsin. For the southern yellow pine boxes not pretreated, there were three sites (Panama excluded) at which all stencils were legible on at least one side of the box after 3 years, but after 4 years, all stencils were legible only on the south side of the box in Canada.

pretreated with material A, the highest stencil effectiveness was on the north sides for 9 of 12 combinations of species and site. The highest stencil effectiveness for the south sides of boxes was on the combinations of Douglas-fir in Arizona and Canada, and southern yellow pine in Canada. For the southern yellow pine boxes not pretreated, the stencil effectiveness was highest on the south sides of the boxes in Arizona and Canada, and on the north side of the box in Panama. It was equal on the north and south sides of the box in Wisconsin.

For the pretreated boxes, the decreasing order of stencil effectiveness by site, judged from the best side of the boxes after 4 years of weathering, was Wisconsin, Panama, Canada, and Arizona for stencils on Douglas-fir and southern yellow pine, but the order was Panama and Arizona, with Canada and Wisconsin equal, for stencils on red oak boxes. For the southern yellow pine boxes not pretreated, the decreasing order of stencil effectiveness by site, judged from the best side of the boxes after 4 years of weathering was Canada, Wisconsin, Arizona, and Panama.

On the same basis, the decreasing order of stencil effectiveness by species for pretreated boxes was southern yellow pine, Douglas-fir, and red oak in Canada and Wisconsin, but it was southern yellow pine, red oak, and Douglas-fir in Panama, and red oak, Douglas-fir, and southern yellow pine in Arizona.

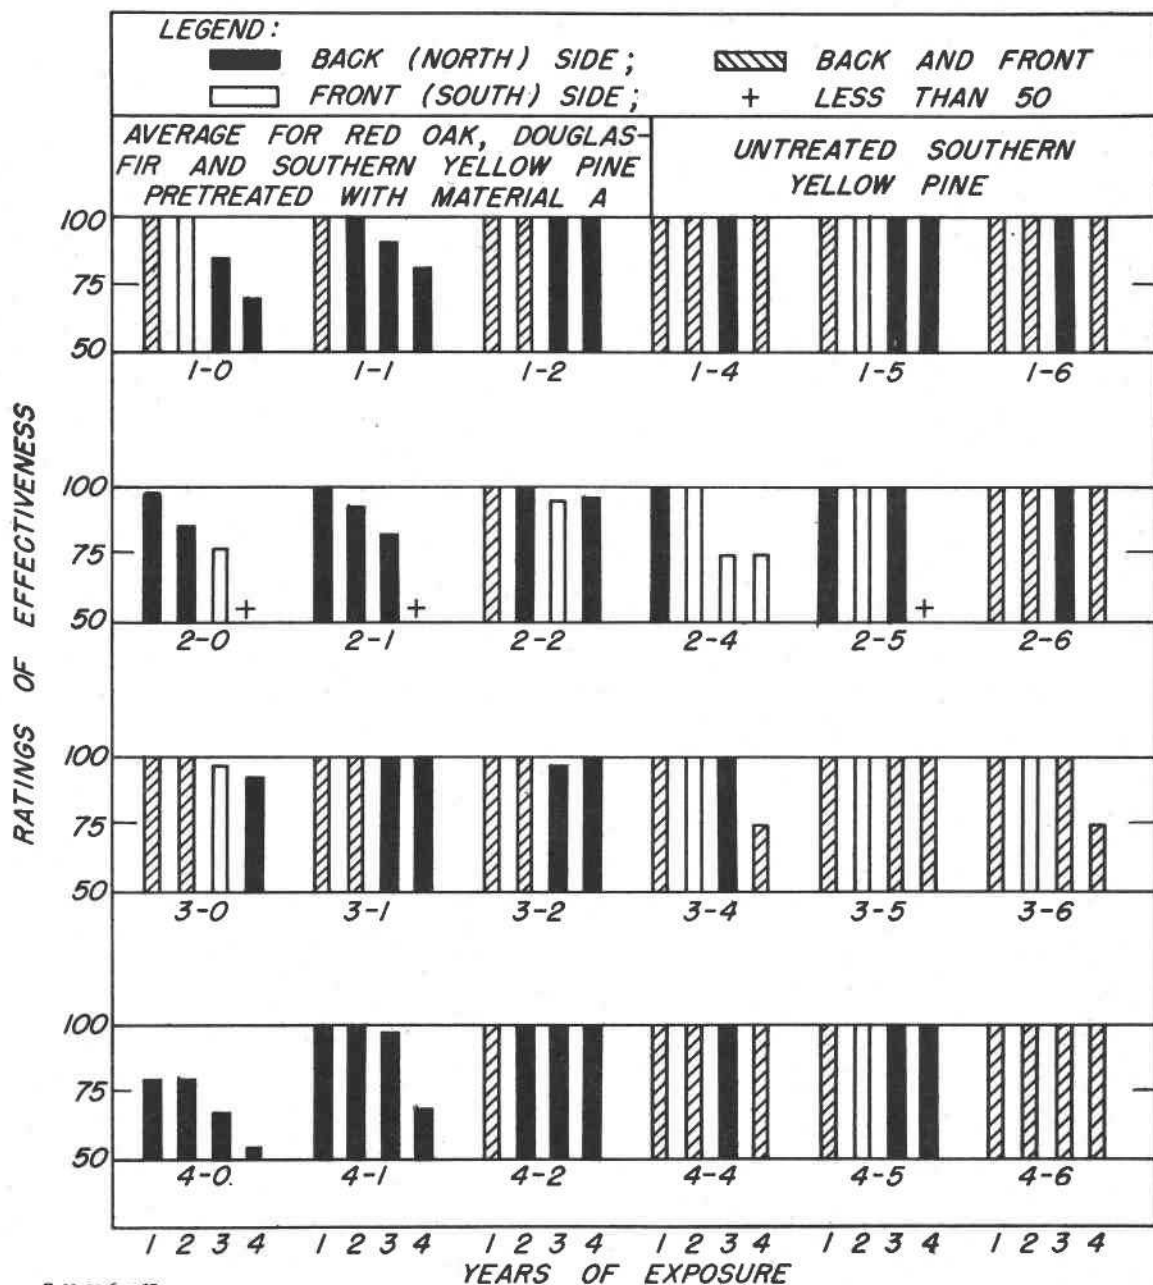
Figure 7. --Ratings of effectiveness (percentage of the number of test areas that were legible) during 4 years of exposure for the indicated combinations of marking material and undercoat-topcoat treatments, such as 1-0, where the marking material is designated by 1 and the undercoat-topcoat treatment by 0. Each rating applies to the best side of each group of boxes and is for 36 areas on 3 species of treated boxes from 4 test sites, or for 4 areas on untreated southern yellow pine boxes from 4 test sites.

In figure 7, the stencils are rated for each combination of marking material and undercoat-topcoat treatment by side of box, with all species and sites included in each rating. After 4 years of weathering of the pretreated boxes, stencils made of 4 (1-2, 3-1, 3-2, 4-2) of 12 combinations of marking material and undercoat-topcoat treatment were legible on all north areas, but none was legible on all south areas to which they were applied. After 4 years of weathering of the southern yellow pine boxes not pretreated, stencils made of 8 of the 12 combinations of marking material and undercoat-topcoat treatment were legible on all north areas and those made of 6 combinations were legible on all south areas.

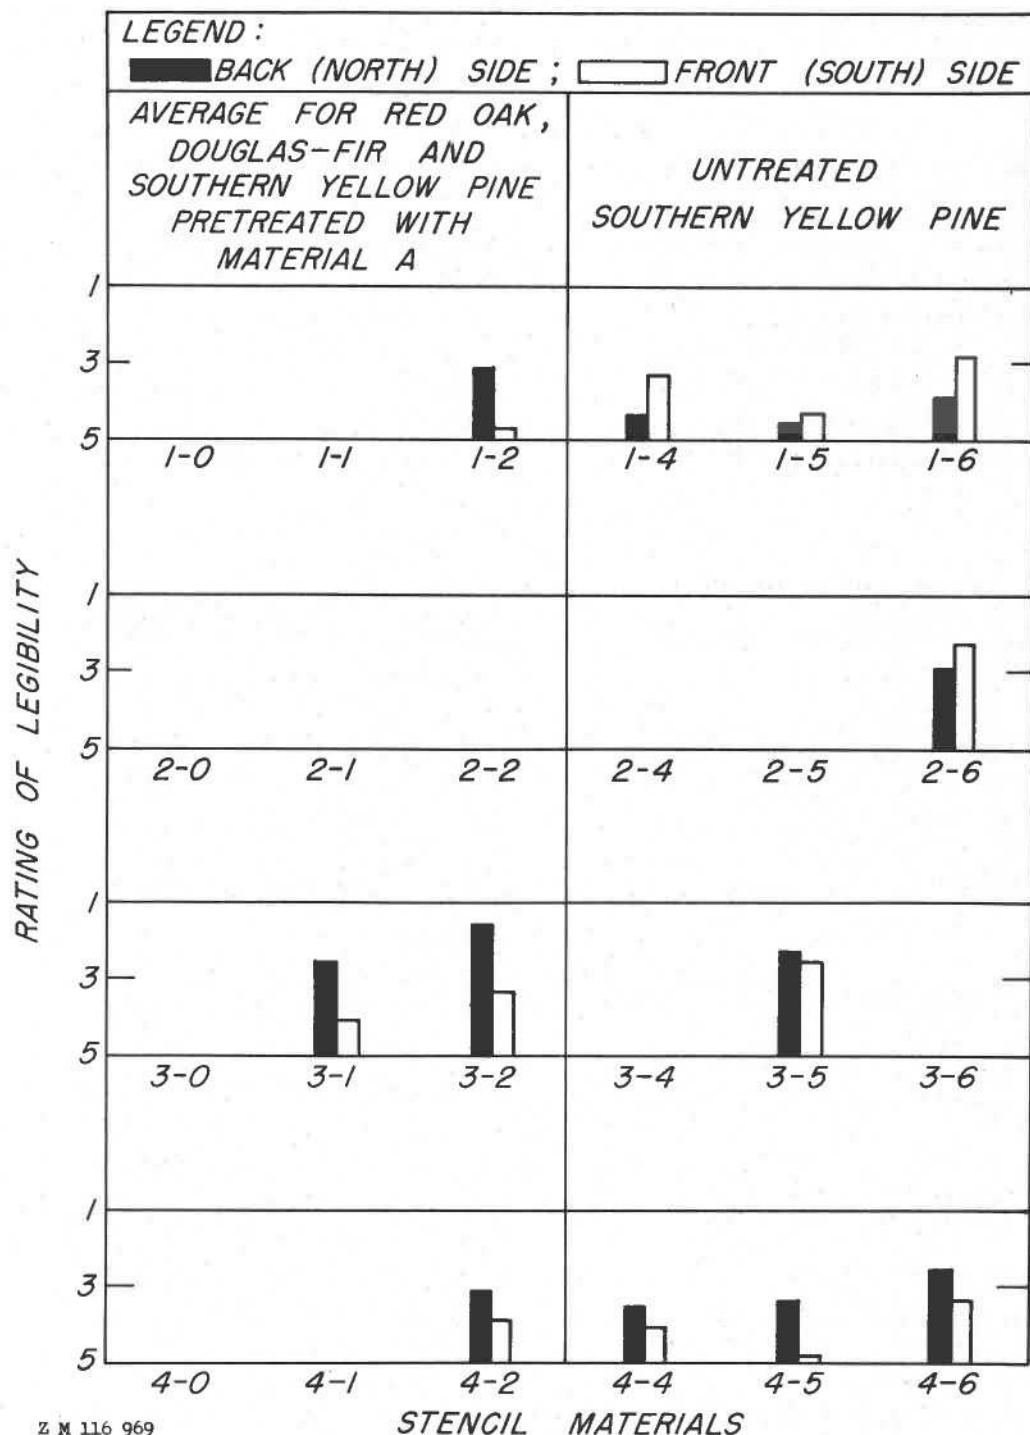
Figure 8. --Ratings of legibility, on a scale of from 1 (good) to 10 (bad) after 4 years of exposure for the combinations of marking material and undercoat-topcoat treatment, such as 1-2, that had ratings of effectiveness of 100 (all markings legible) after 4 years of exposure, according to figure 7. Spaces are provided, but no ratings are given for the combinations that were not legible on all test areas.

The combinations of marking material and undercoat-topcoat treatment that have a rating in figure 7 of 100 in effectiveness after 4 years of weathering are rated in figure 8 for legibility on a scale of from 1 (good) to 10 (bad) after the same period of weathering. To have a rating of 100 in effectiveness, the stencils in all test areas for which the rating applies must each have a legibility rating no worse than 5. The ratings of legibility in figure 8 measure how much better the average legibility is than the minimum requirement.

According to figure 8, the marking material that performed best on the pretreated boxes was marking material 3. On the untreated southern yellow pine boxes, the best performance was given by marking material 4, which was only slightly superior to marking material 1. A topcoat treatment was necessary for maximum durability of the stencils. Topcoat material C was most helpful on both treated and untreated boxes. If, however, one combination of marking and topcoat materials is to be used on both pretreated and untreated boxes, the data indicate that marking material 3 with topcoat material B is the combination to apply.

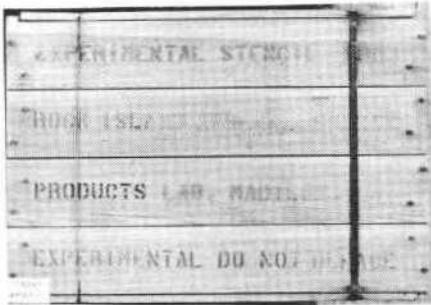
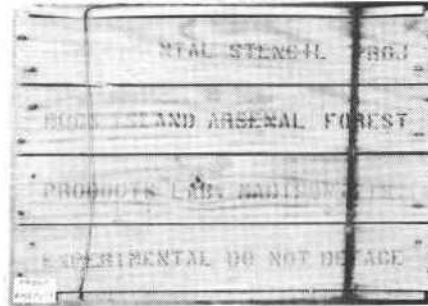
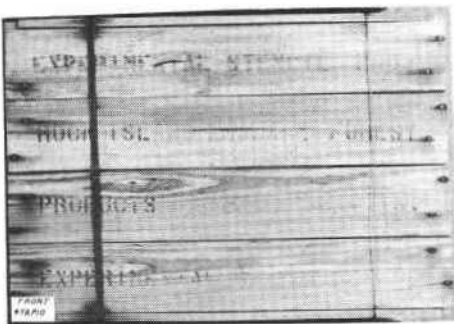
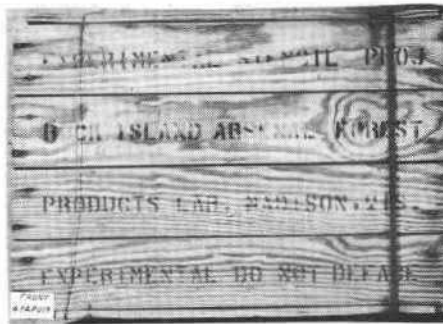
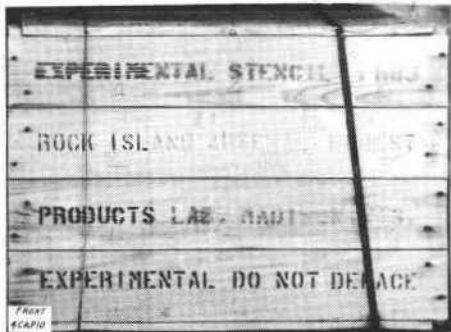
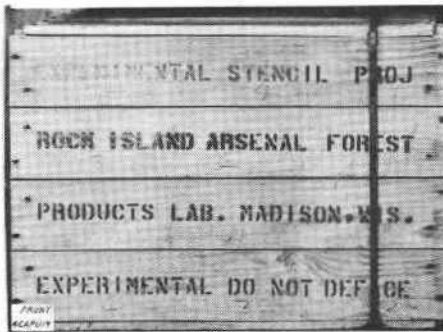
The appearance of treated and untreated boxes of southern yellow pine after 4 years of weathering at the four test sites are illustrated in figures 9 and 10.³

Figure 9. --Appearance of stencils on fronts (south sides) of boxes made of treated (left) and untreated (right) southern yellow pine after 4 years of outdoor exposure.

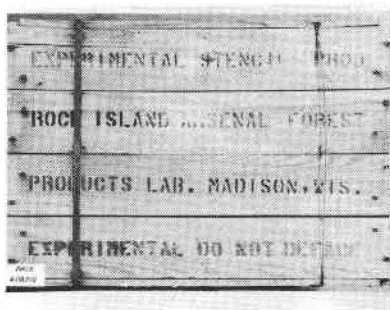
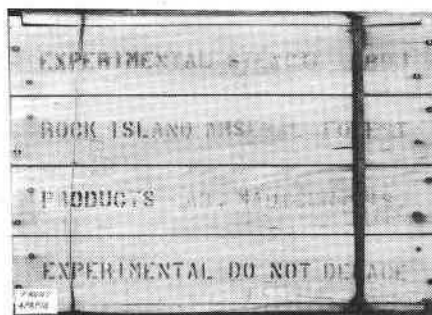
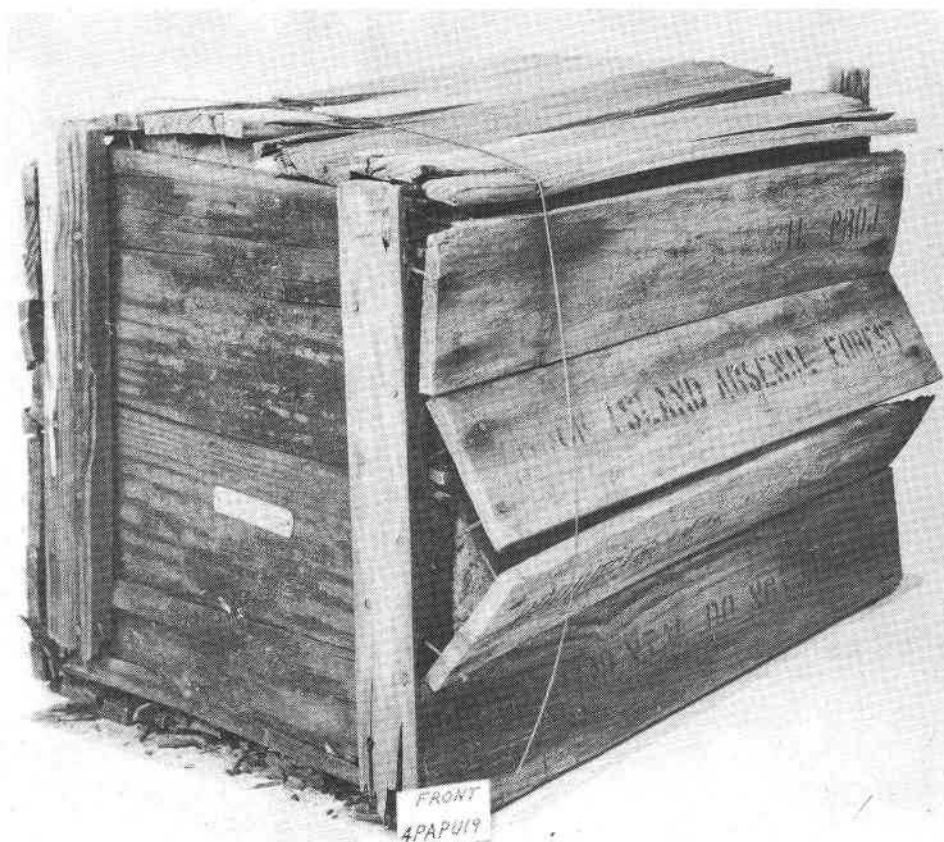
Figure 10. --Treated and untreated southern yellow pine boxes after 4 years of outdoor storage in Panama.

The results for the southern yellow pine boxes show that pretreatment with material A preserved the legibility of the stencils in Panama, but not of those at the other three test sites. Material A, a water-repellent preservative, gives protection against stain and decay fungi that is needed at Panama, but not at the other three test sites (see figs. 9 and 10). Other factors, however, should be considered. The test boxes in this study were not stacked but were spaced several feet apart, simulating conditions of weathering and decay on one or more surfaces of boxes at the top or sides of a pile of boxes. The test exposure did not simulate conditions around other boxes in a pile where, under certain conditions, the occurrence of stain and decay fungi may more than offset the advantage gained by shading. Therefore, unless previous experience indicates that decay and stain are not likely to occur, it is advisable to treat all wood boxes with a water-repellent preservative if they are to be stacked in outside storage.

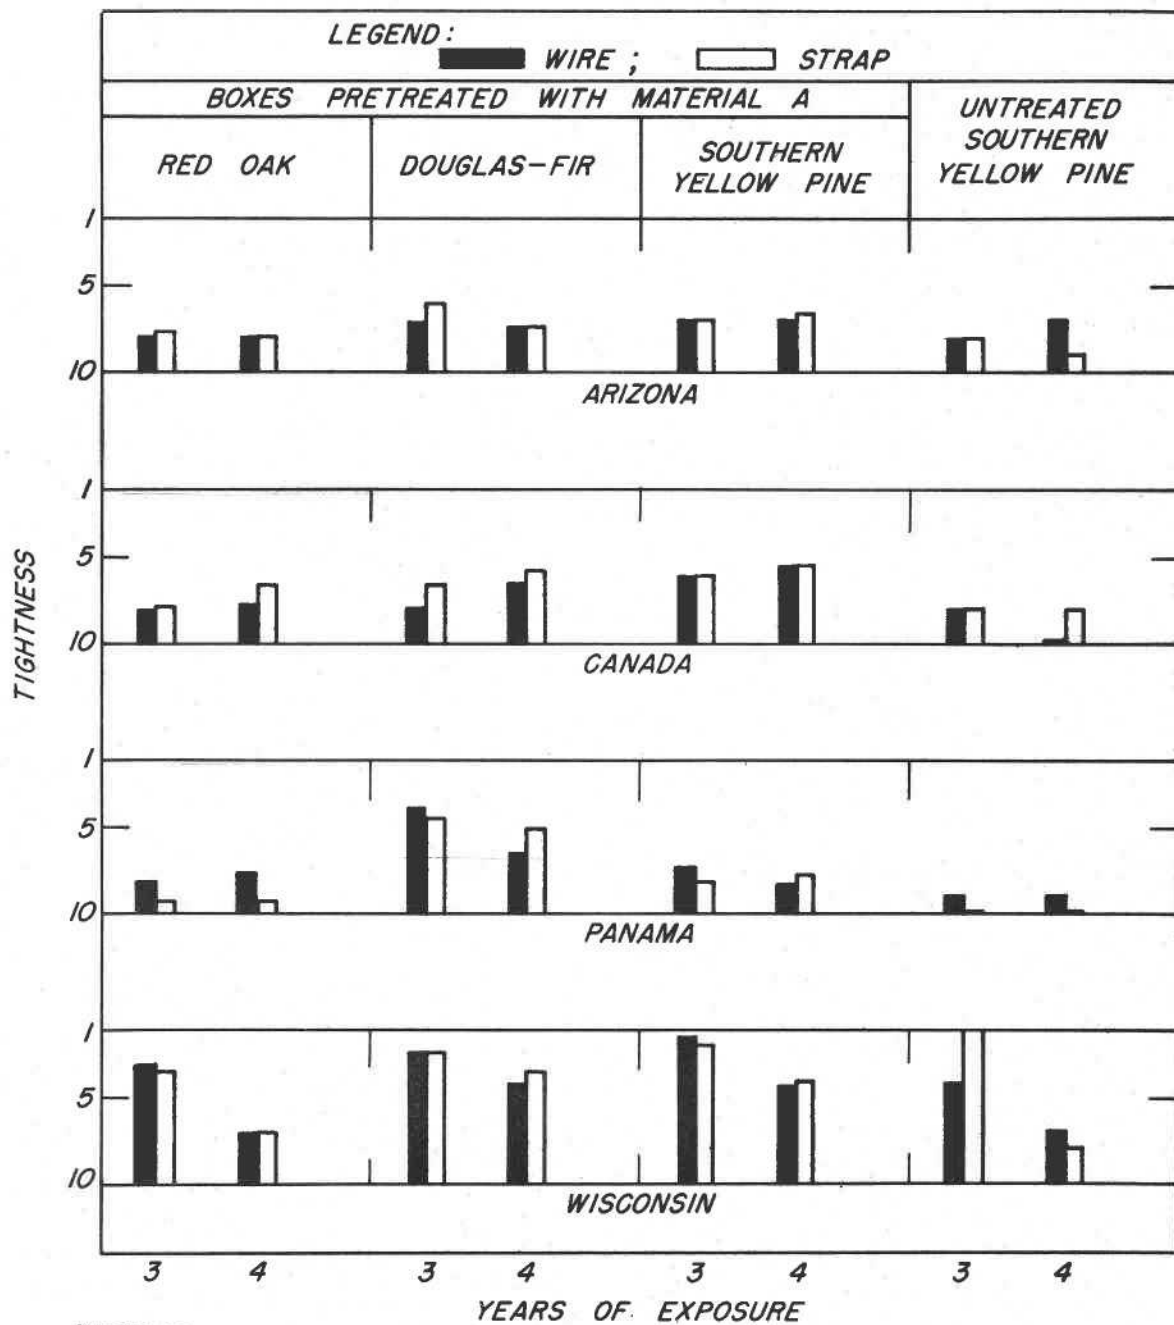
Figure 11. --Ratings of tightness on a scale of from 1 (tight) to 10 (broken), for steel bindings on wood boxes after 3 and 4 years of outdoor exposure. Each rating is for one binding on untreated boxes and for three bindings on pretreated boxes.

Ratings of tightness for the metal bindings after 3 and 4 years of weathering are given in figure 11. After 4 years of weathering, the decreasing order of tightness by species was Douglas-fir, southern yellow pine, and red oak in Wisconsin and Panama, but southern yellow pine, Douglas-fir, and red oak in Arizona and Canada. For all species, the tightest bindings were on the boxes exposed in Wisconsin. These boxes received less handling and were moved much shorter distances than the boxes from the other sites, which may account for the relative

tightness of their bindings. Pretreating the southern yellow pine boxes with material A generally improved the tightness of the bindings at all sites.

The bindings that rated 10 for tightness broke during weathering, probably by rusting. After 4 years of weathering, four wires were broken, two in Canada and two in Panama, and four straps were broken, one in Canada and three in Panama. The number of broken bindings and the tightness of the bindings do not indicate a definite preference for either type.
