WATER-REPELLENT PRESERVATIVES

REDUCE RAIN-CAUSED PAINT BLISTERING ON WOOD SIDING

No. 1990

FOREST PRODUCTS LABORATORY

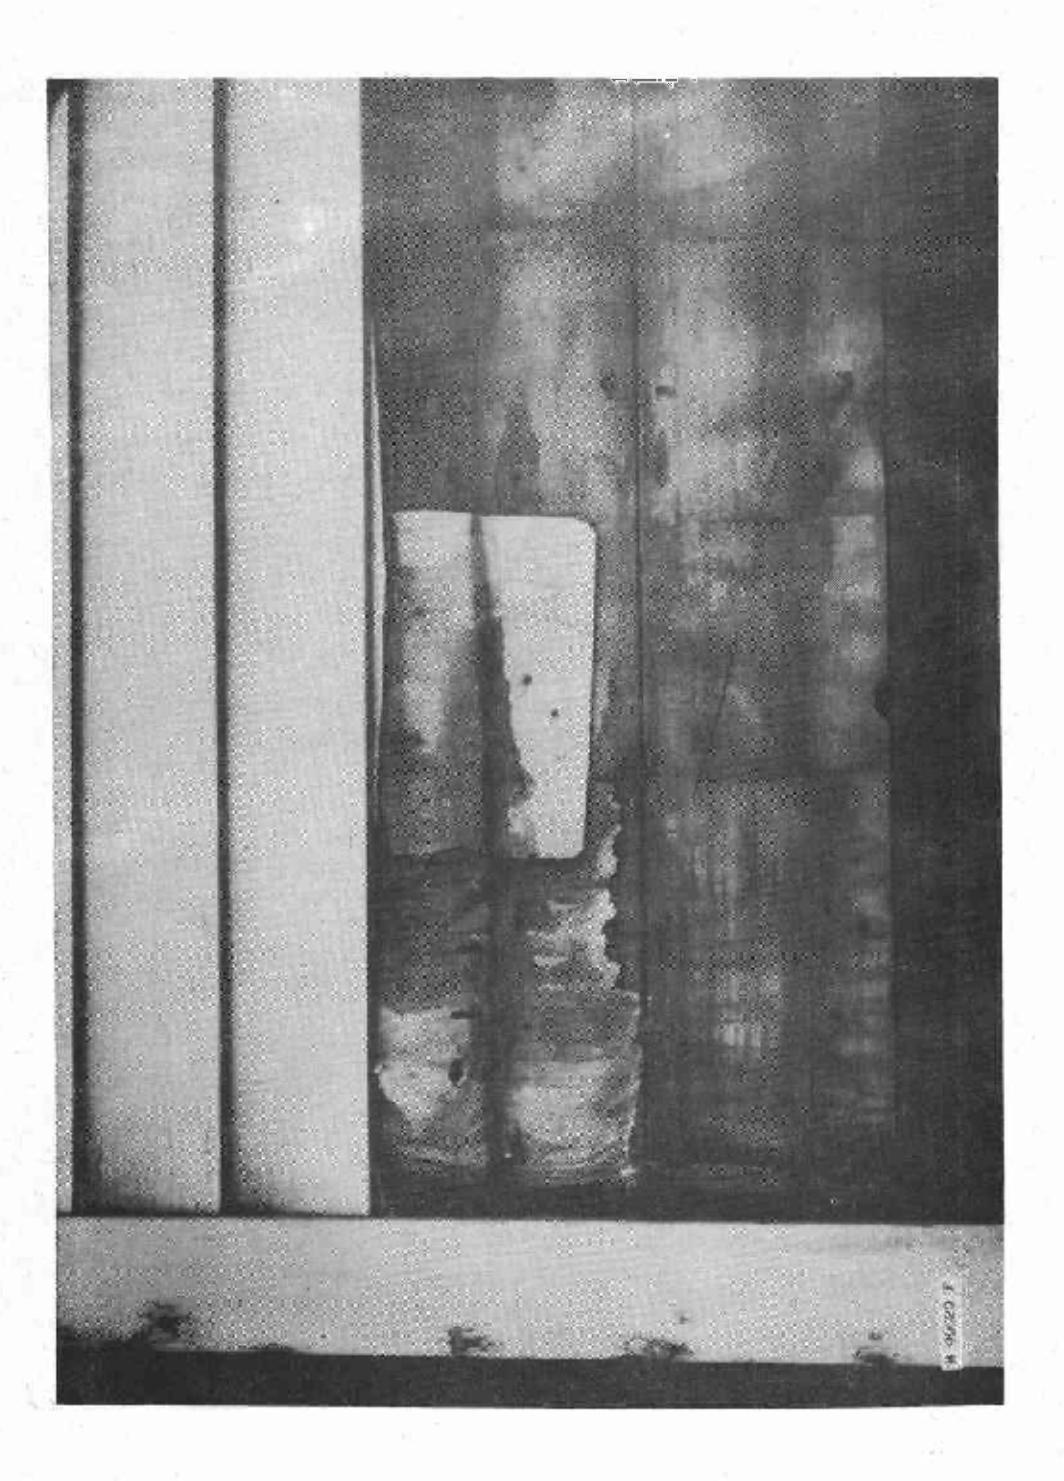
ZM 96020 F

Rainwater, however, is not generally recognized as a source of paintblistering moisture, even though it may be as important a source as condensation. Some rain has always gotten behind siding, even in old houses that were protected with good overhang and narrow-pattern siding, but the paint on these old houses was much less sensitive to moisture than are our modern paints, and there was little or no trouble with paint blistering (fig. 1).

Figure 1.--Although water got in back of the siding of this 61-year old house, as shown by the paper and wood sheathing, the paint was still in good condition when the house was torn down.

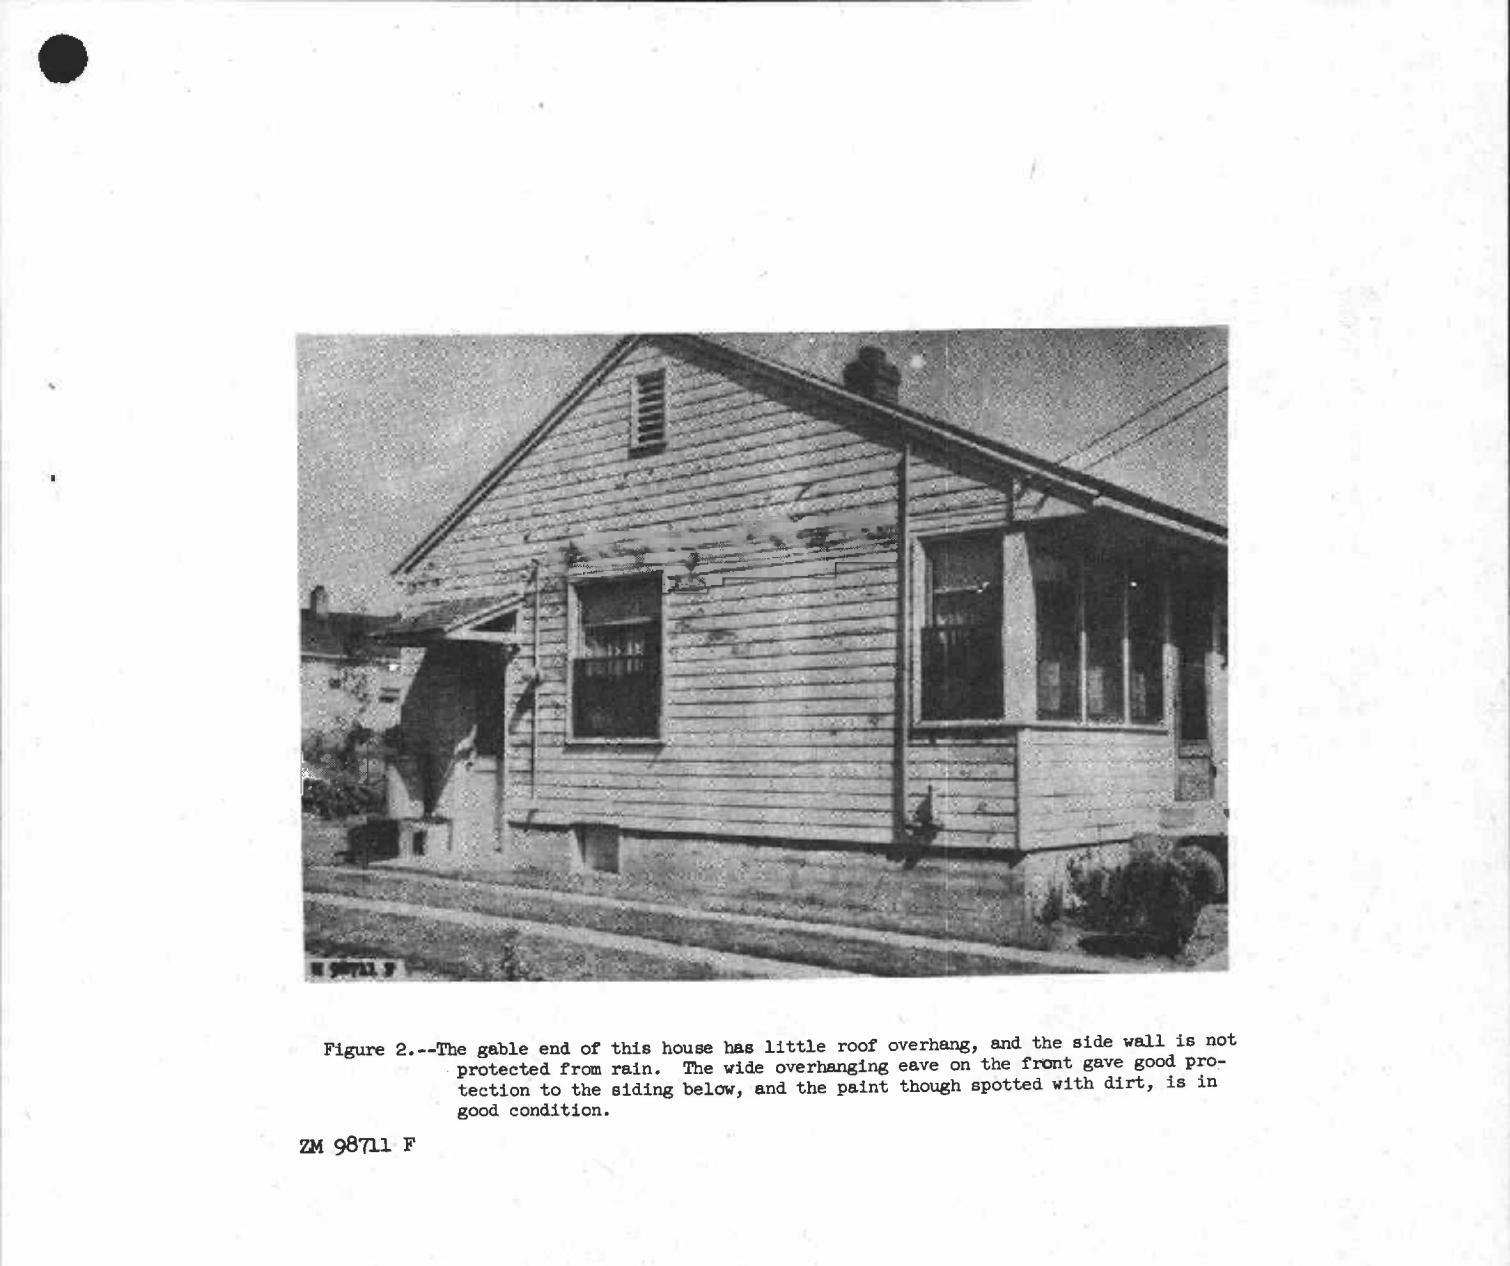
Many of our modern houses are designed with no overhang at the gables and very little at the eaves, so that the siding is given little protection from rain. This lack of protection plus the moisture sensitivity of modern paints often results in paint failure (figs. 2 and 3).

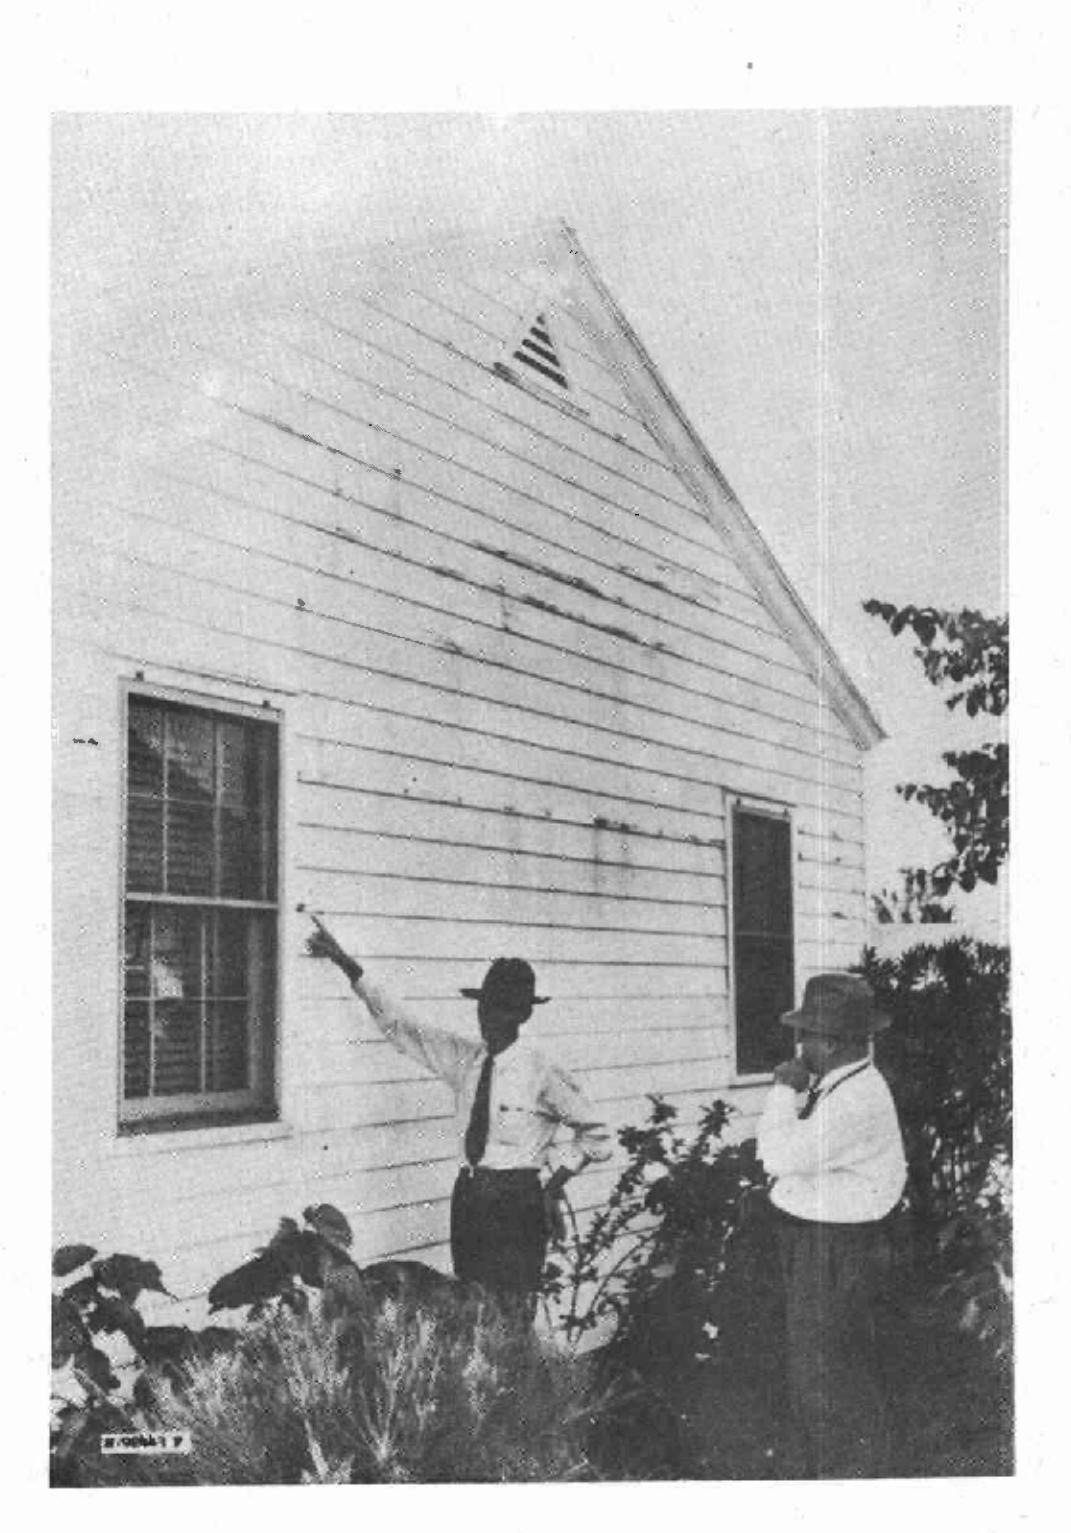
ZM 92443 F

Figure 3.--The limited overhang on this Florida house did not protect the siding and paint from frequent wetting by rain. Siding and paint on nearby houses with wide overhangs were in good condition.

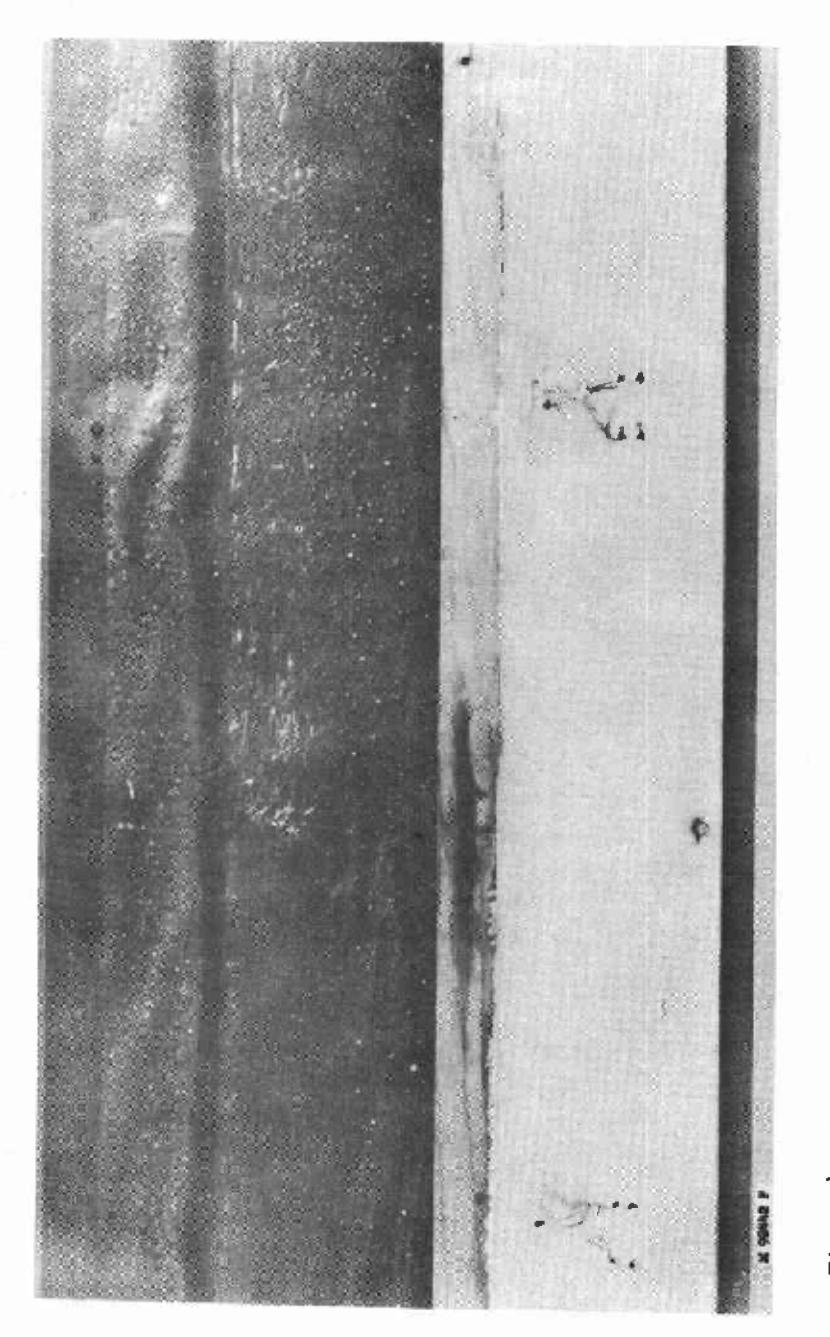
ZM 92442 F

An exploratory study was started at the Laboratory to find ways and means of improving the performance of beveled wood siding under service conditions and, particularly, to reduce or eliminate moisture entrance from the outside. The first objective was to determine how water got back of siding, the second to determine the effectiveness of modified siding patterns and treatments in preventing or reducing water ingress (fig. 4).

Figure 4.--Water found on sheathing paper when siding was removed in late September. The back of the siding was wet. The water had worked under the laps by capillary action.

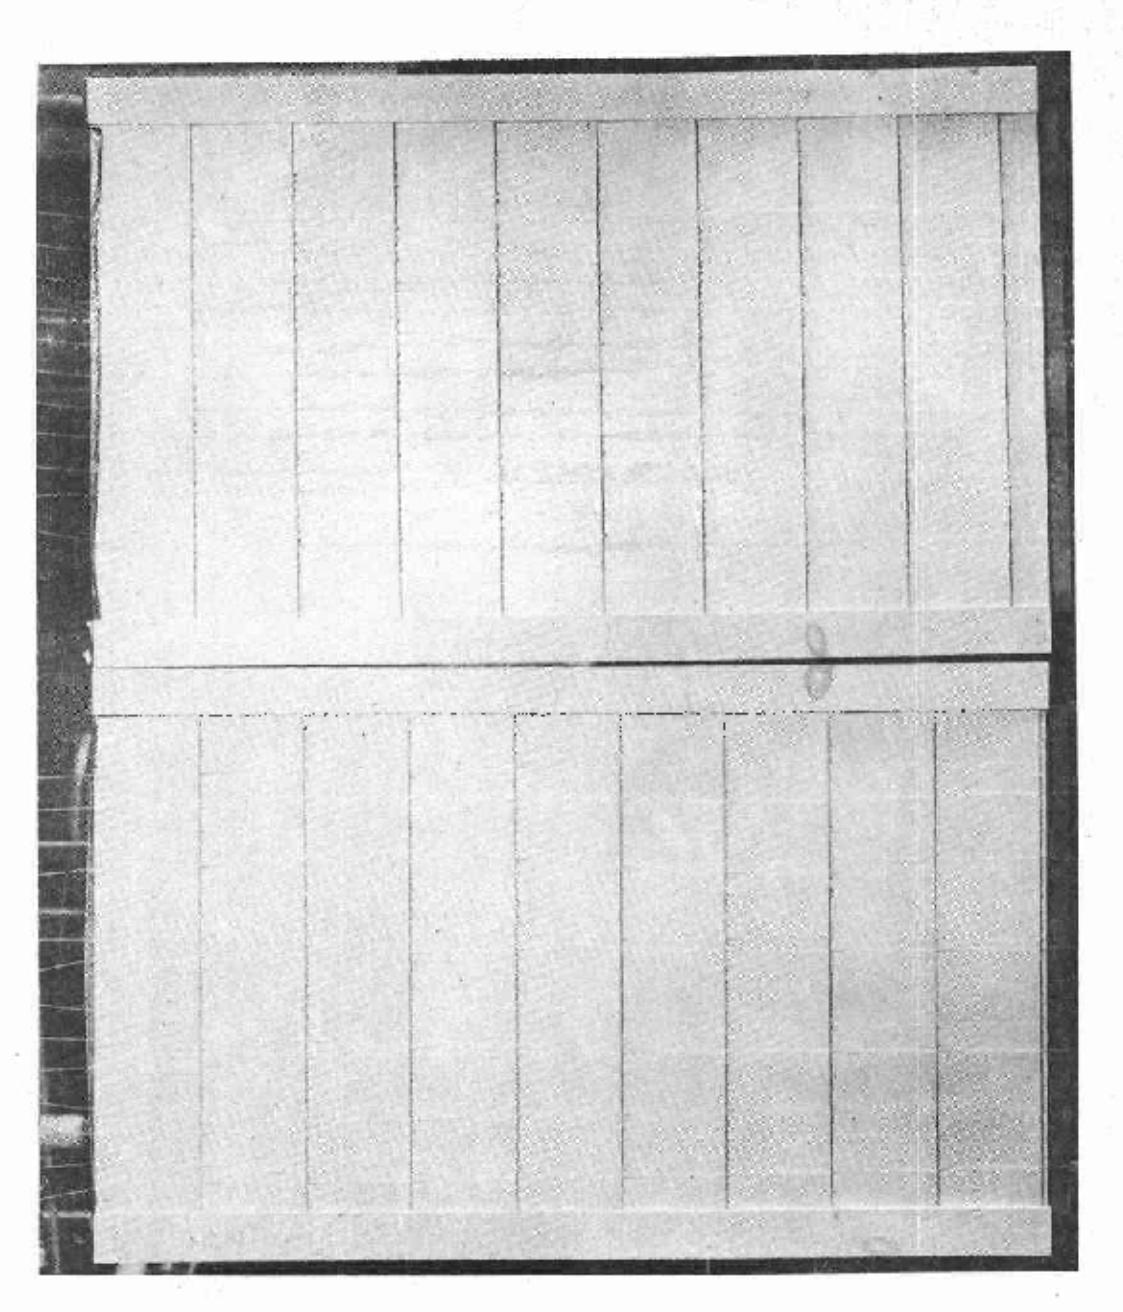
ZM 90572 F

Another series of panels was made with standard and modified patterns of siding that had been dipped for 3 minutes in a water-repellent preservative. These panels were painted, exposed in the dry kiln to cause swelling and shrinking, and then wetted in the same manner as the untreated siding (fig. 7). Regardless of pattern, the treated material was consistently free from wetting on the back. There was no evidence of capillary action nor of the wetting caused by splits on the thin edge. When the panels were exposed to wind in the revolving frame, there was evidence of some minor, relatively unimportant wetting on some of the panels.

Figure 7.--The panel on the left was made up of treated material, that on the right of untreated material. Note the difference in the water pattern.

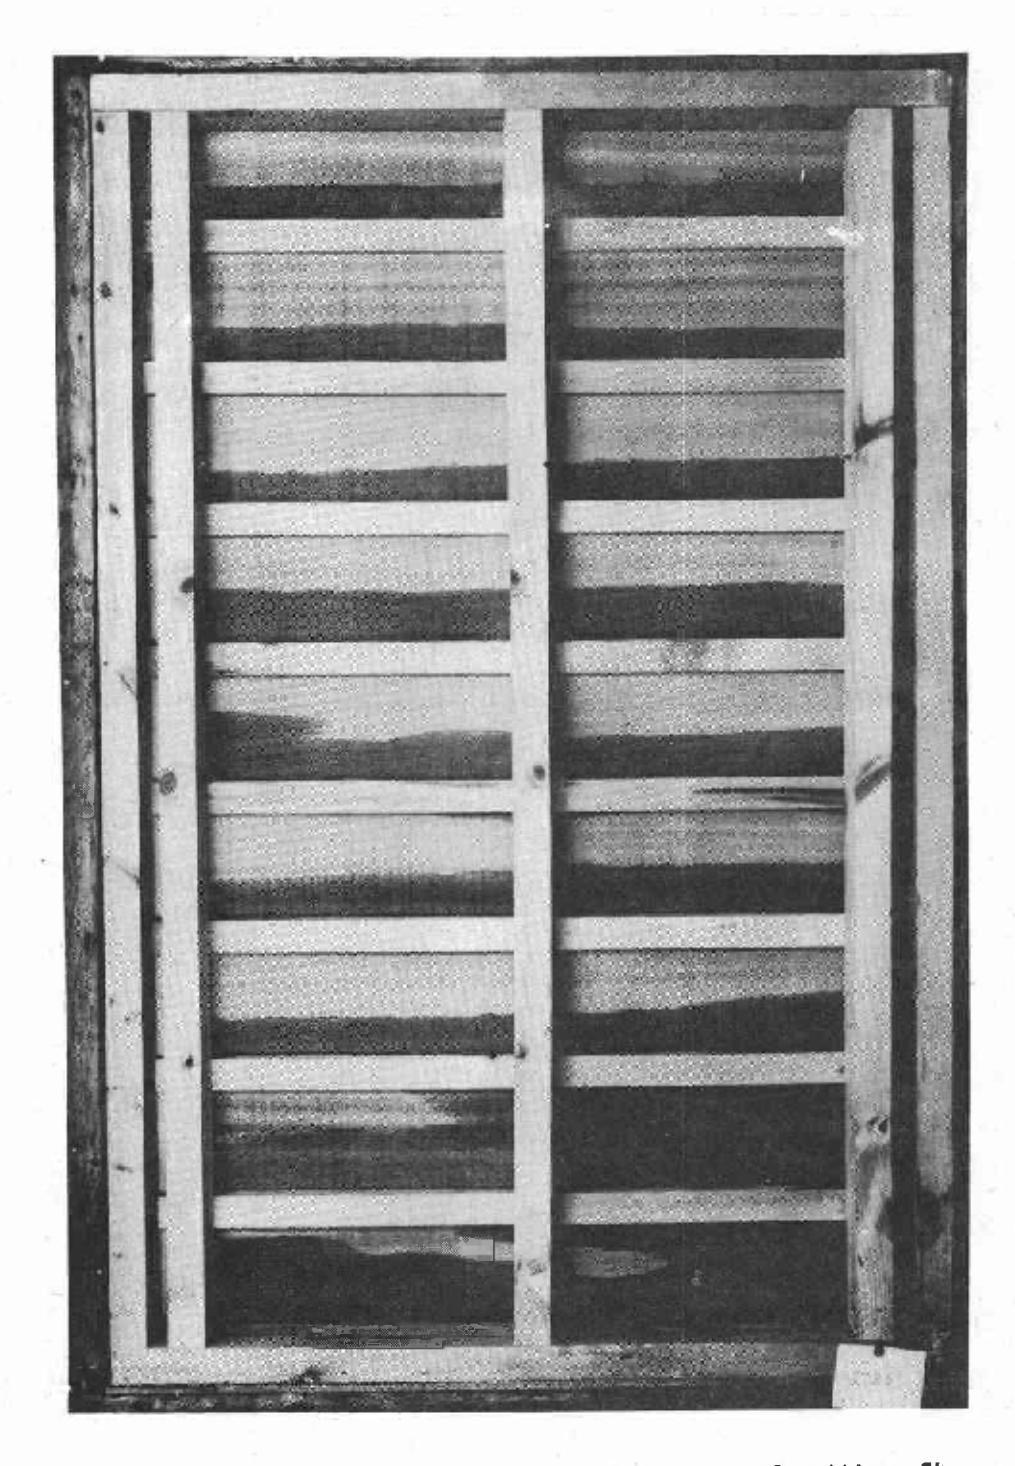
ZM 90909 F

Panels were also made up of treated and untreated standard-pattern stock and tested without being painted. Here again there was no evidence of capillary wetting on the back of the treated material, but there was general wetting on the untreated material (figs. 8 and 9). Perhaps this means that, where treated siding is used, priming need not follow immediately after the siding is applied but could be deferred to a time more convenient to the builder.

Figure 8.--Untreated, unpainted siding showed general wetting after a 4-hour water spray on the panel face. Marked wetting of the bottom boards was due to a nail split. Paint would reduce but not eliminate water ingress.

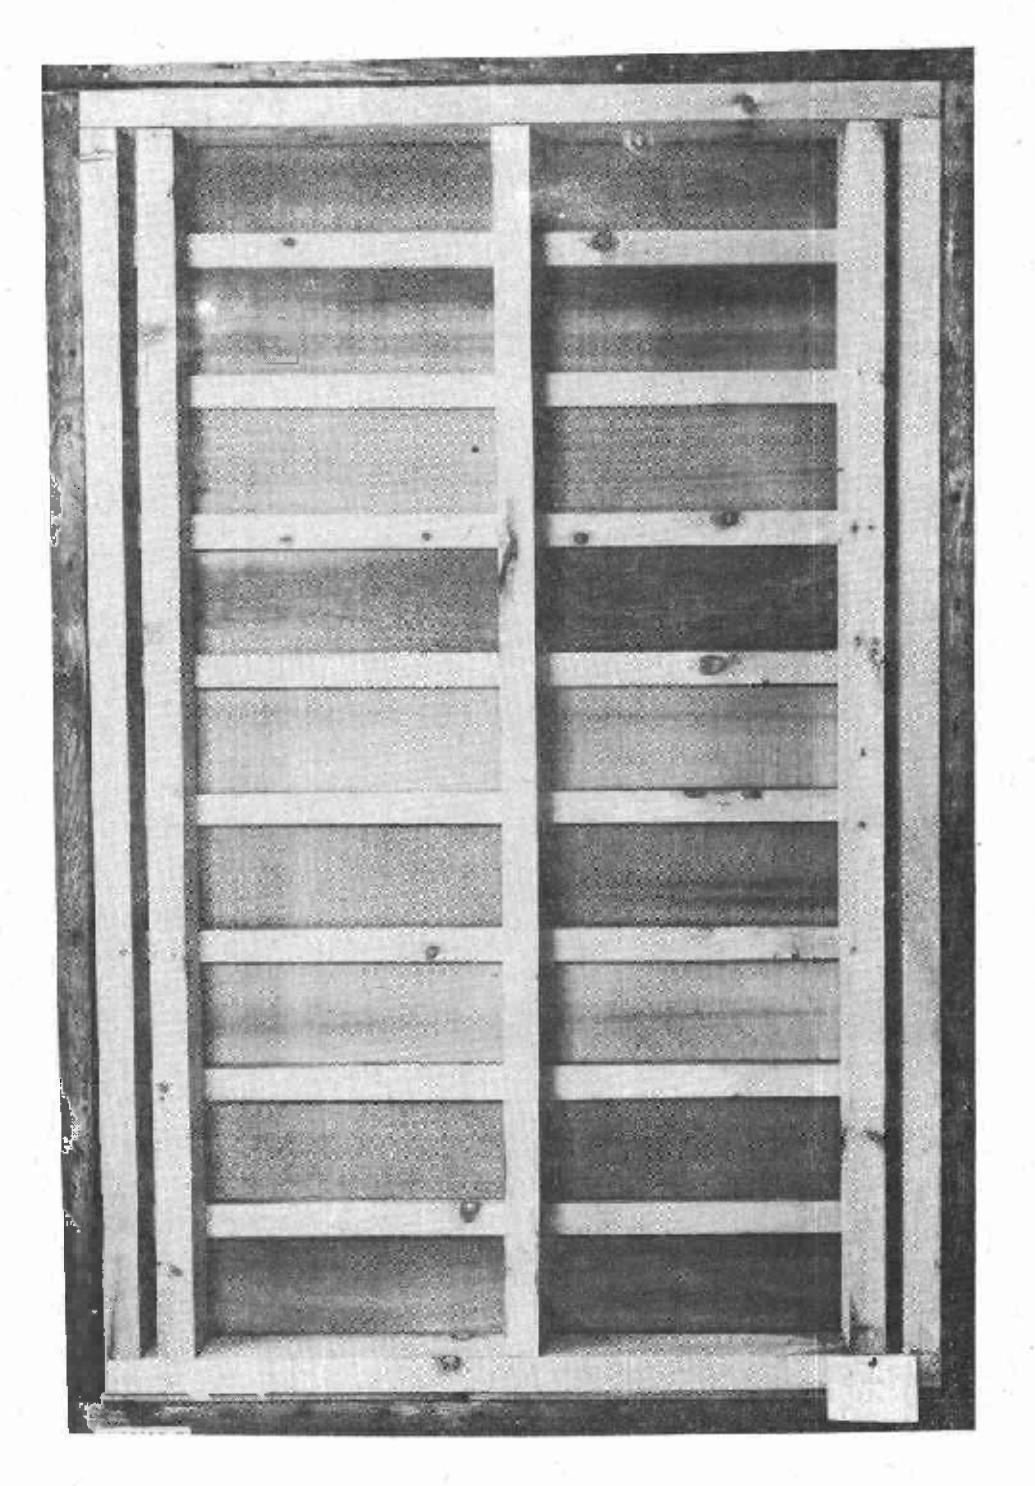
ZM 90910 F

Figure 9.--The back of this panel of treated but unpainted siding showed no wetting after a 4-hour exposure to water sprayed on the face of the panel.
