Christine G. Rasmussen for the degree of Master in Science in Rangeland Resources presented on January 29, 1996. Title: Results and Review of a Riparian Survey Method Used in Eastern Oregon.

**Results and Review of a Riparian Survey Method Used in Eastern Oregon**

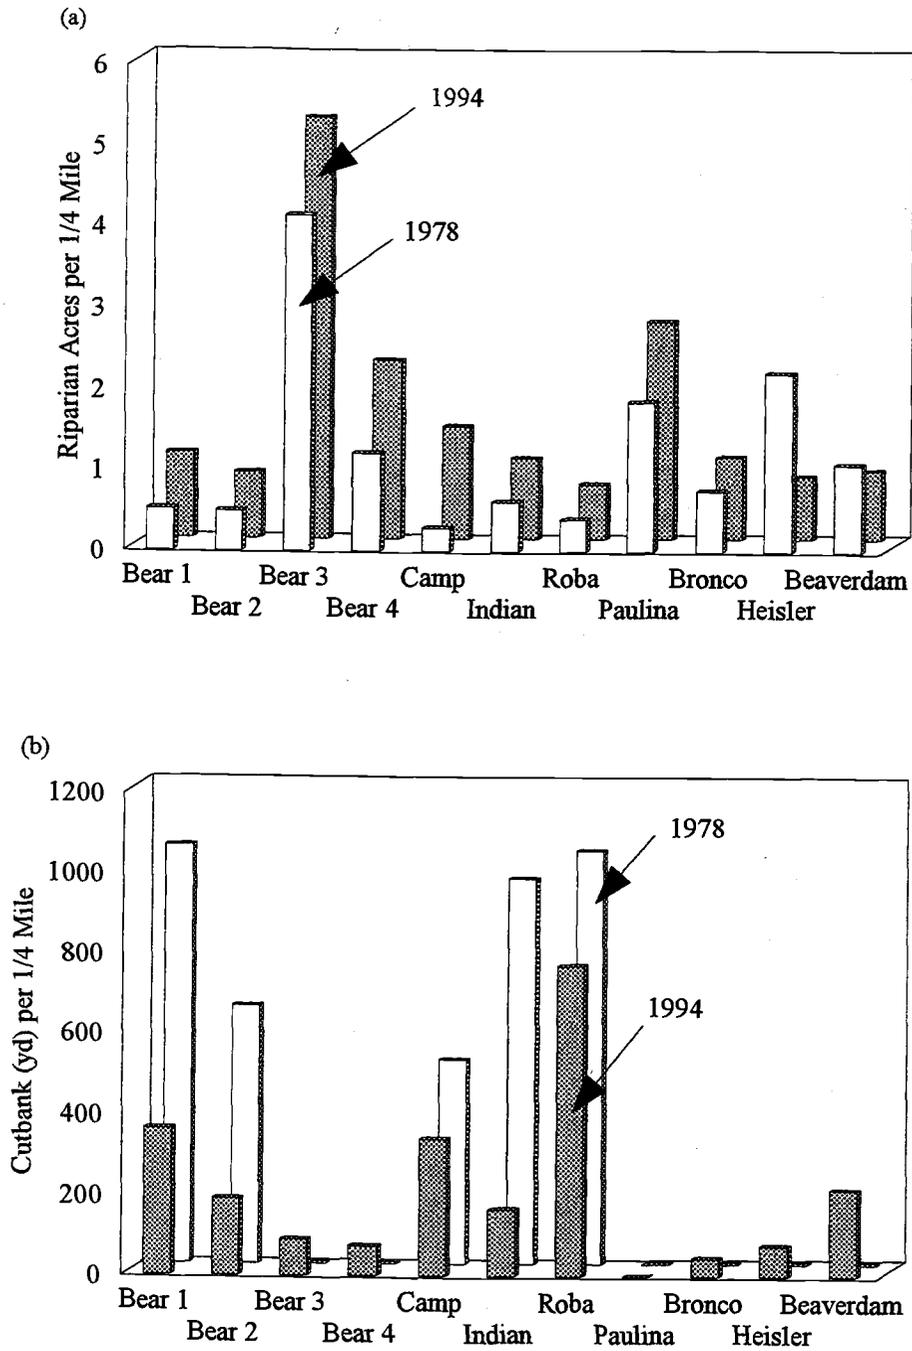
Even with the wide array of grazing strategies, topography and communities, most of these streams appear to be in better condition now than they were in the late 1970s. The lengths of cutbanks, the composition of riparian vegetation, and the total riparian areas show mixed responses (Figure 1).

Figure 1. Summaries of (a) total riparian acres per 1/4 mile and (b) total cutbank lengths per 1/4 mile in the 1978 and 1994 surveys.

In Heisler and Beaverdam, suspected non-compliance to the grazing plan may have worked in conjunction with logging activity and loss of beaver to cause a decline in total riparian area and increase cutbank lengths (Figure 1a and Figure 1b). Upstream and upland land use histories are not known.

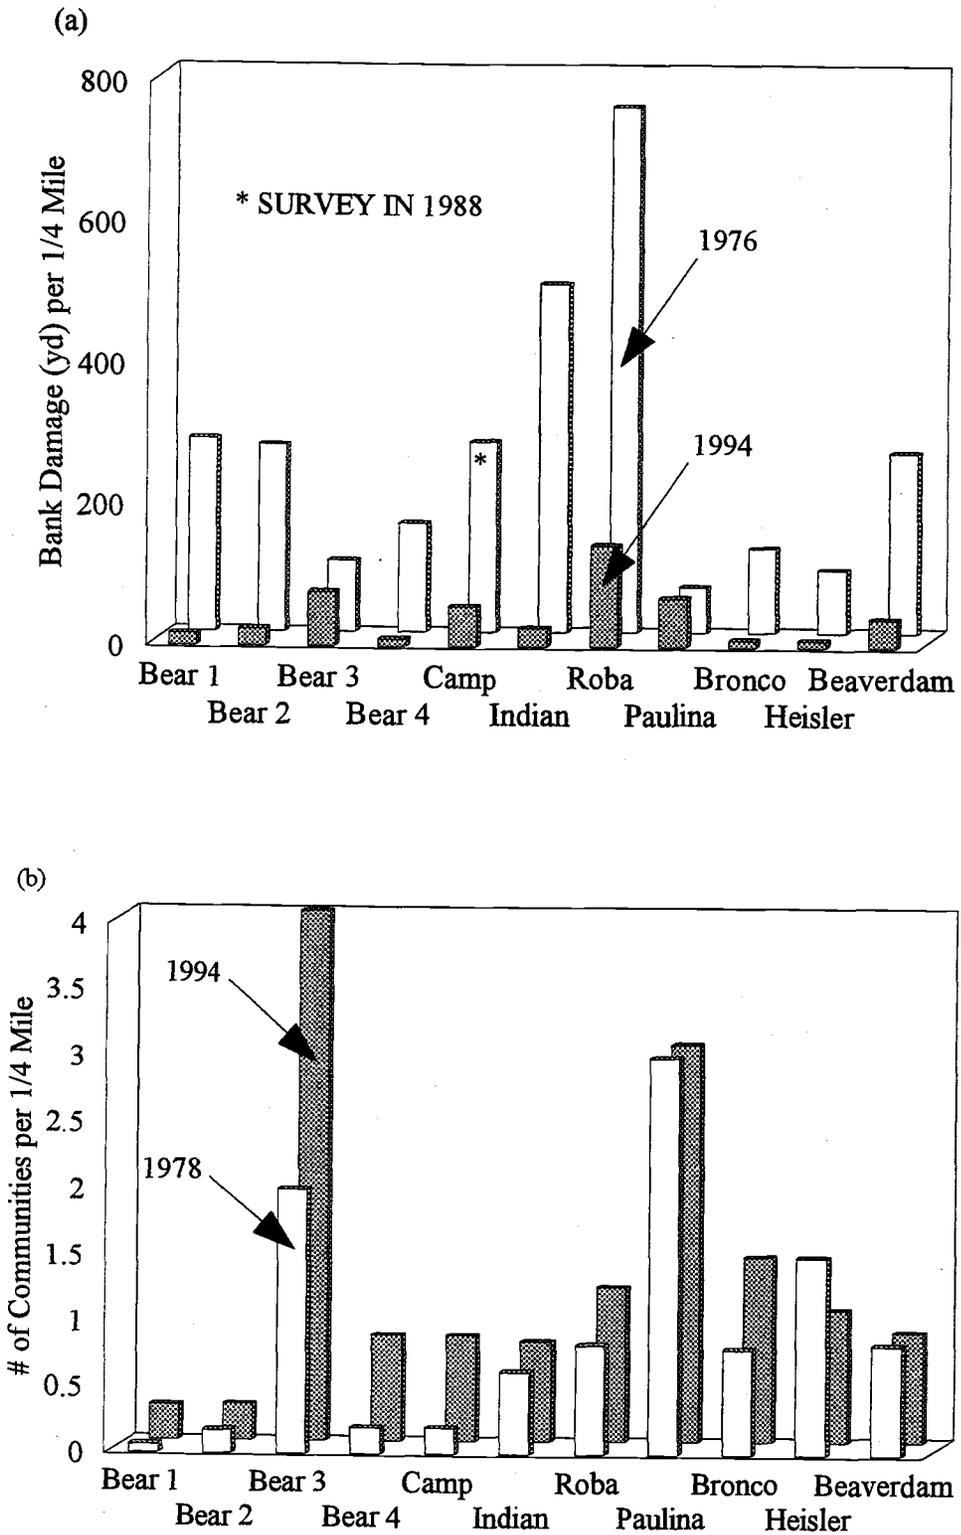
The number of vegetative communities surveyed in each section is interpreted as positive though not all increased (Figure 2b). Increases from very few communities to several (Bear 1, Bear 4, and Camp) suggest that diversification is occurring with the establishment of more stable community types (i.e. sedge-rush and beaver communities where only grass-forb was originally surveyed). The decline of community types in moderate gradient, shrub dominated sections (Heisler Creek) may be due to increasing willow populations homogenizing otherwise small and discrete stands of other shrubs.

Figure 2. Summaries of (a) the total length of bank damage and (b) the number of vegetative communities identified in the 1976-78 and 1994 surveys.
