SPECIAL REPORT No. 1

EFFECT OF UNUSUALLY LOW DISCHARGE FROM PELTON
REGULATING RESERVOIR, DESCHUTES RIVER, ON
FISH AND OTHER AQUATIC ORGANISMS

By
Robert W. Phillips
Fishery Biologist

Portland, Oregon
May 1969

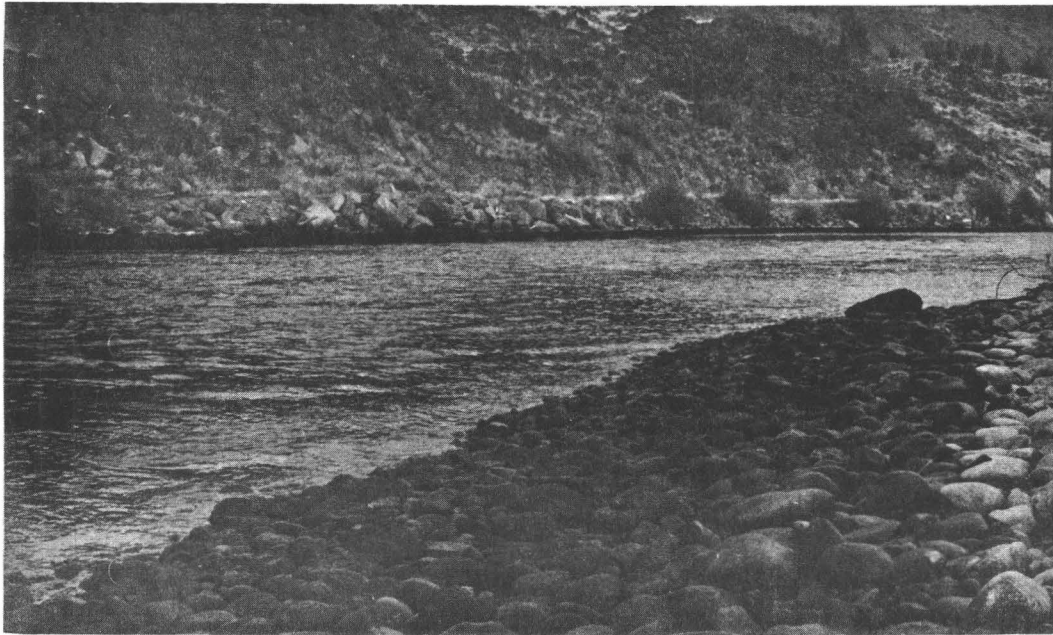
After closure of the gates, water level below the dam dropped 1.55 feet almost immediately, as measured at the USGS cable crossing some 0.3 mile below the dam. (Fig. 2a) Brief examination of a few feet of exposed shoreline revealed that several sculpins and stonefly nymphs were stranded among the rubble (Fig. 5). No salmonids were seen. Loss of salmon and trout from stranding in the area was probably negligible because the exposed stream banks were relatively steep and there were no gravel bars.

Fig. 5. East shoreline just below Pelton regulating dam that was exposed during flow reduction. (Photo by Rohweder)

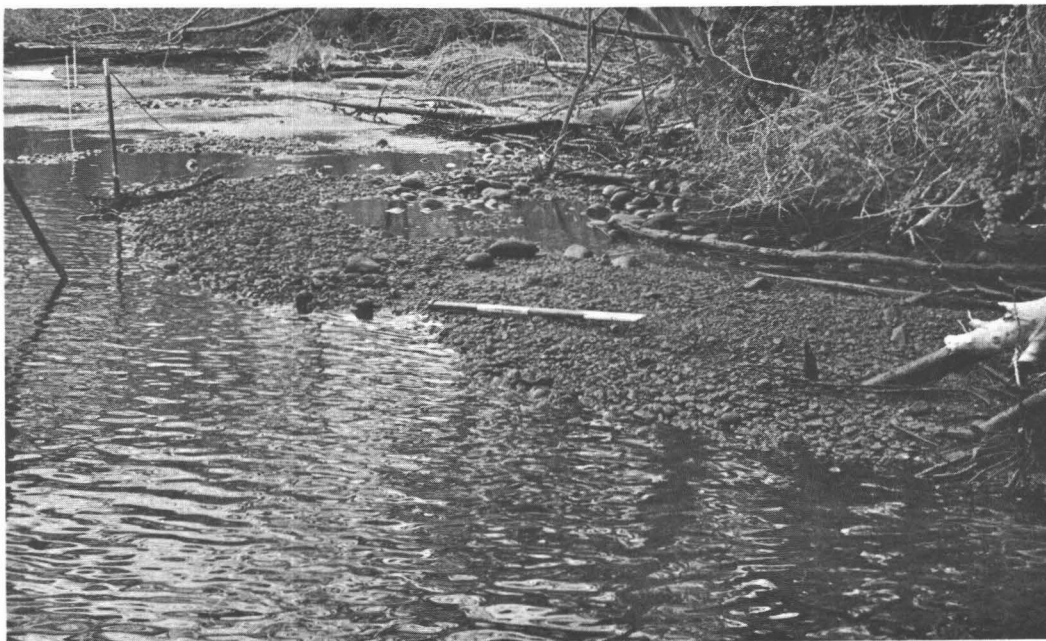
One area along the island drained (Fig. 7), stranding two rainbow trout 6 to 8 inches long, and about 30 chinook fry 2 inches long. The fish would have died had they not been removed and placed in deeper water. Numerous sculpins and aquatic insects were also stranded (Fig. 8). Loss of these organisms was minimal because of the short duration of the flow reduction and the cool weather.

Fig. 7. Zane Jackson study area: exposed bar near island where fish were stranded. (Photo by Herrig)

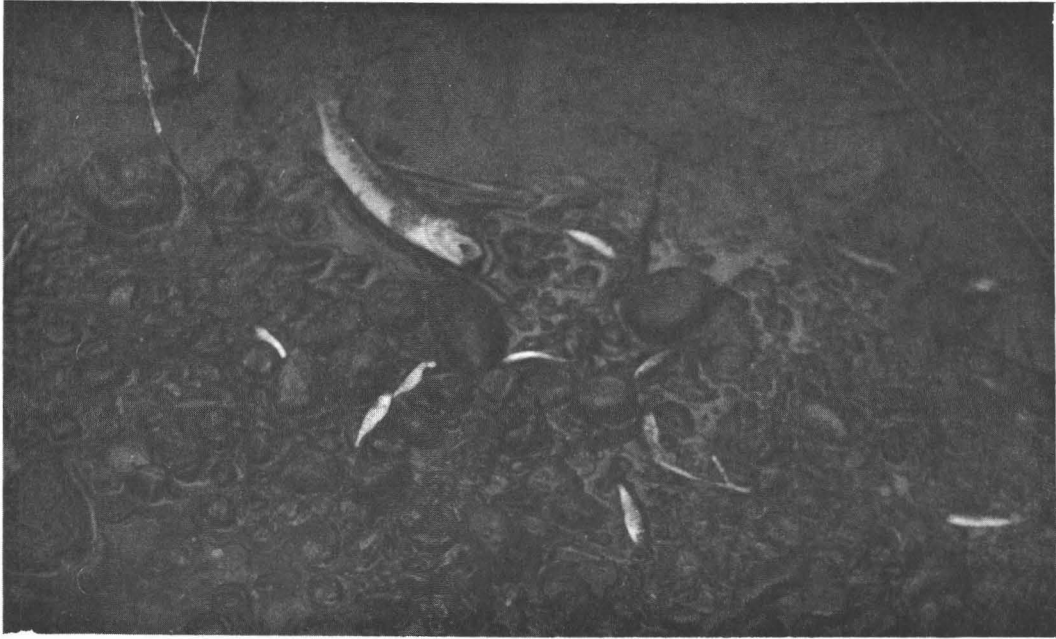
Most of the time was spent making observations of stranded fish. There were large numbers of 1-3 inch chinook and some trout to 7 inches. The West Disney area was also surveyed for stranded fish; many 1-3 inch chinook and a few small trout were observed, as well as three exposed steelhead redds. We estimated the loss of fish in the East Disney and West Disney areas to number several thousand.

Fig. 12. East Disney study area: dead and dying fish stranded by flow reduction. (Photo by Ebert)

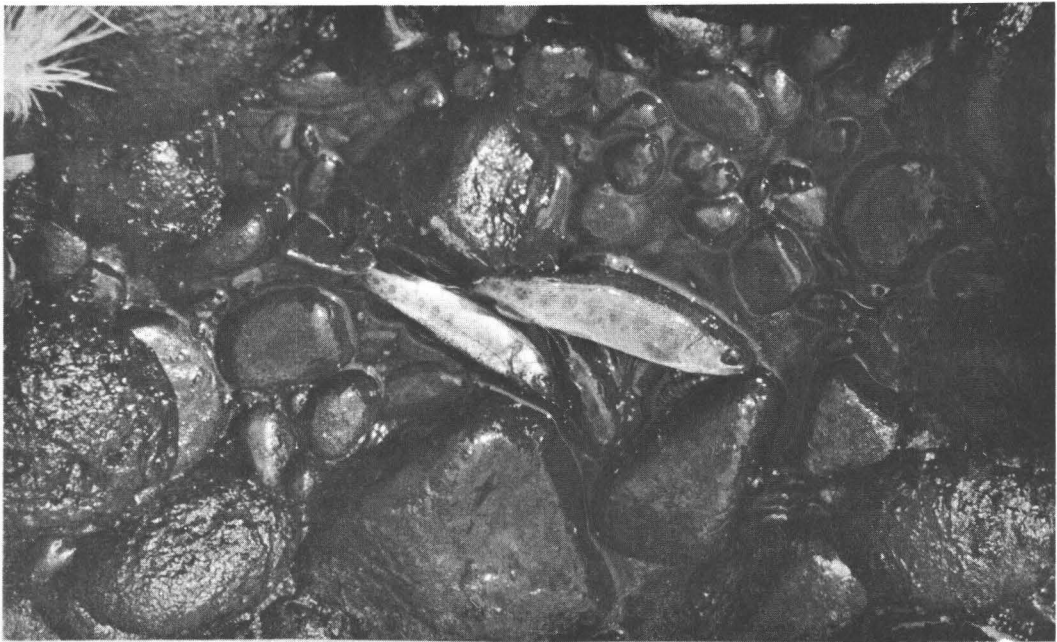
Heavy mortality was noted on salmon about 2 inches long (Fig. 14 and 15). On one bar on the east side of the river 40 dead fish were observed. On the west side of the river in the channel on the west side of the island another 47 dead fish were seen. In several instances mortality was noted on trout in the 4 to 5-inch class. Six fish were counted in dried up pools on the south

Fig. 14. Rainbow fingerlings stranded on gravel bar in Dry Creek area. (Photo by Scherzinger)

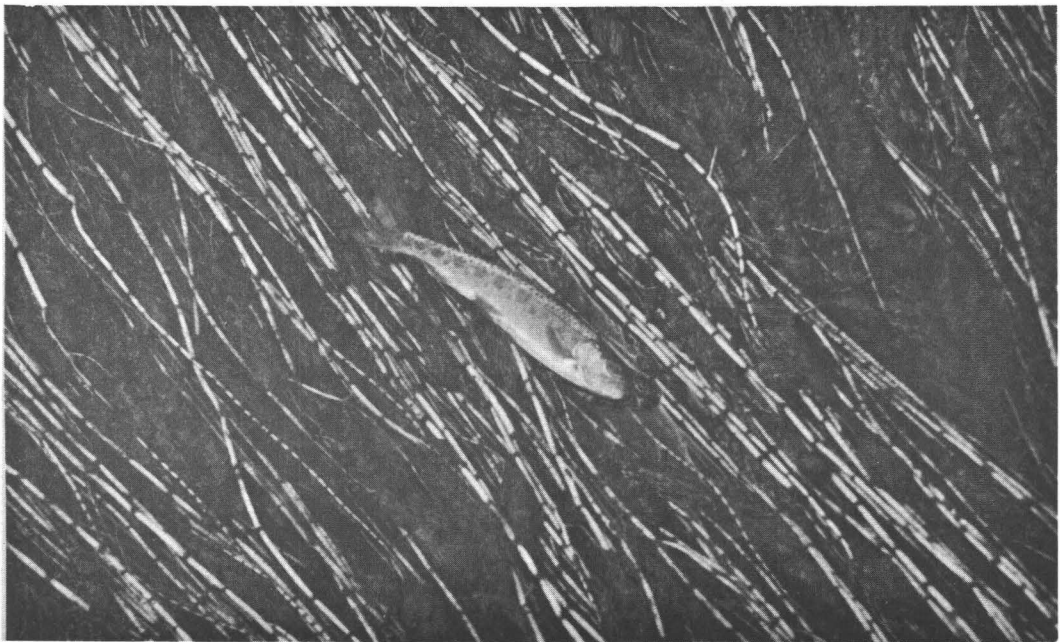
end of the island. Most of the smaller fish were stranded on bars where they were caught in the aquatic weeds or among the rocks where the water seeped out of the pools.

Fig. 15. Rainbow fingerling stranded in aquatic vegetation at Dry Creek area as river flow was reduced. (Photo by Scherzinger)

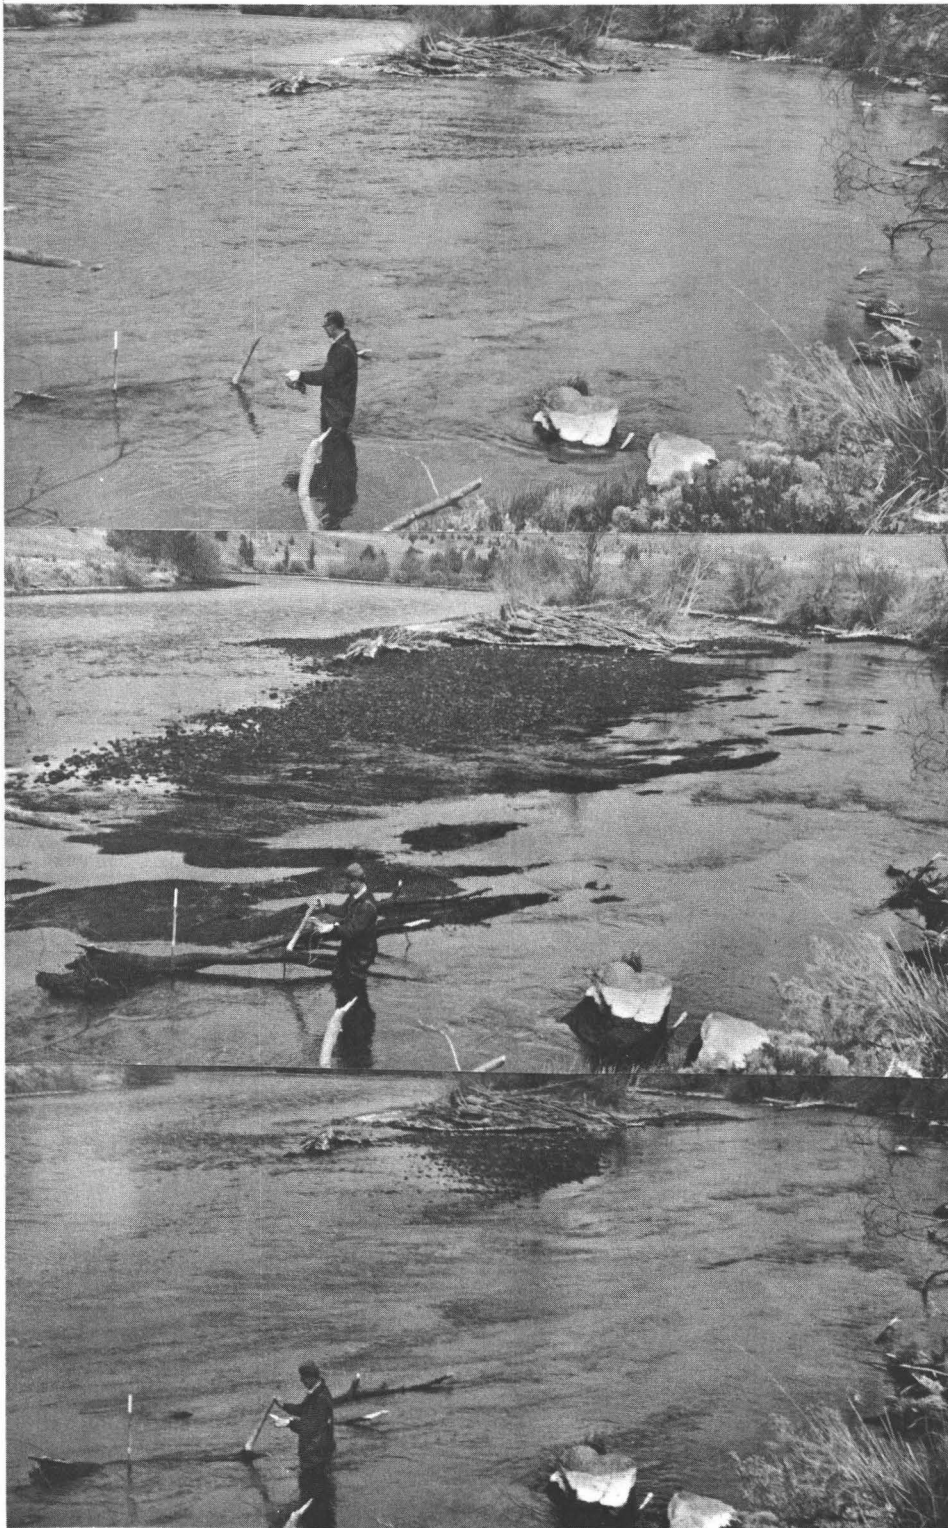
Much of the stream bottom was exposed at the study area and adjacent stream sections by the reduction in flow (Fig. 16 and 17). Several small chinook and rainbow, and one summer steelhead (marked LV-An) (Fig. 18), were entangled in the weed beds. Four sections of exposed bank 100 feet long and 3 feet wide were surveyed. The number of fish found stranded totaled 3 salmon fry and 6 rainbow fingerlings. However, the count of dead fish is believed to be only a fraction of the total mortality in the sections as fish slipped into crevices between rocks and were difficult to observe.

Fig. 16. Trout Creek study area depicting area exposed by flow reduction. (Photos by Cummings)

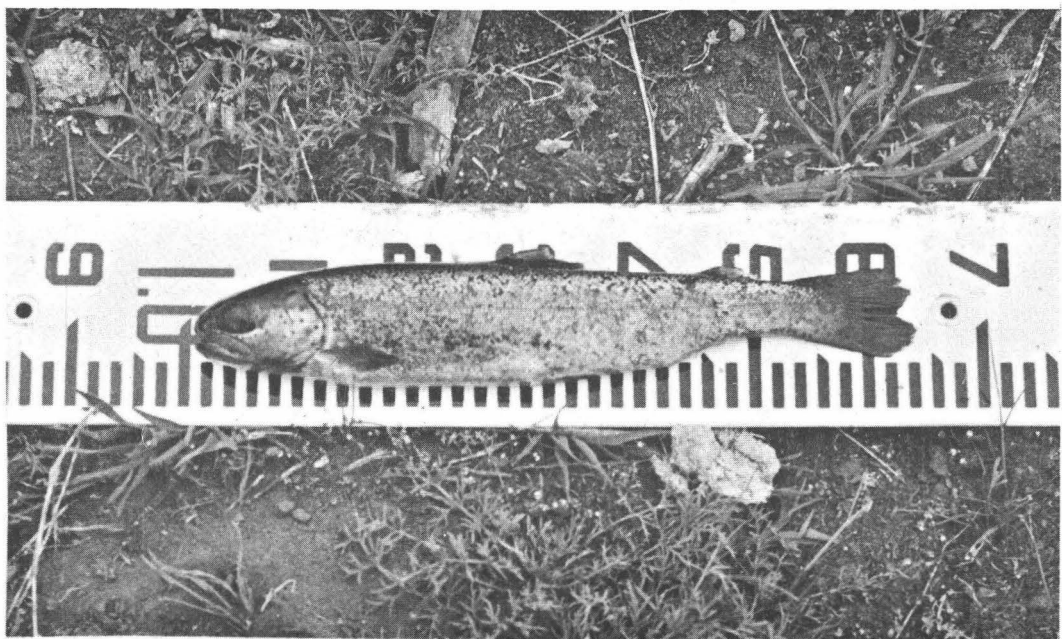
Fig. 18. Hatchery-reared summer steelhead, which had been marked prior to release by excising the left ventral and anal fins, that became entangled in weed beds at Trout Creek study area when water level receded. (Photo by Cummings)

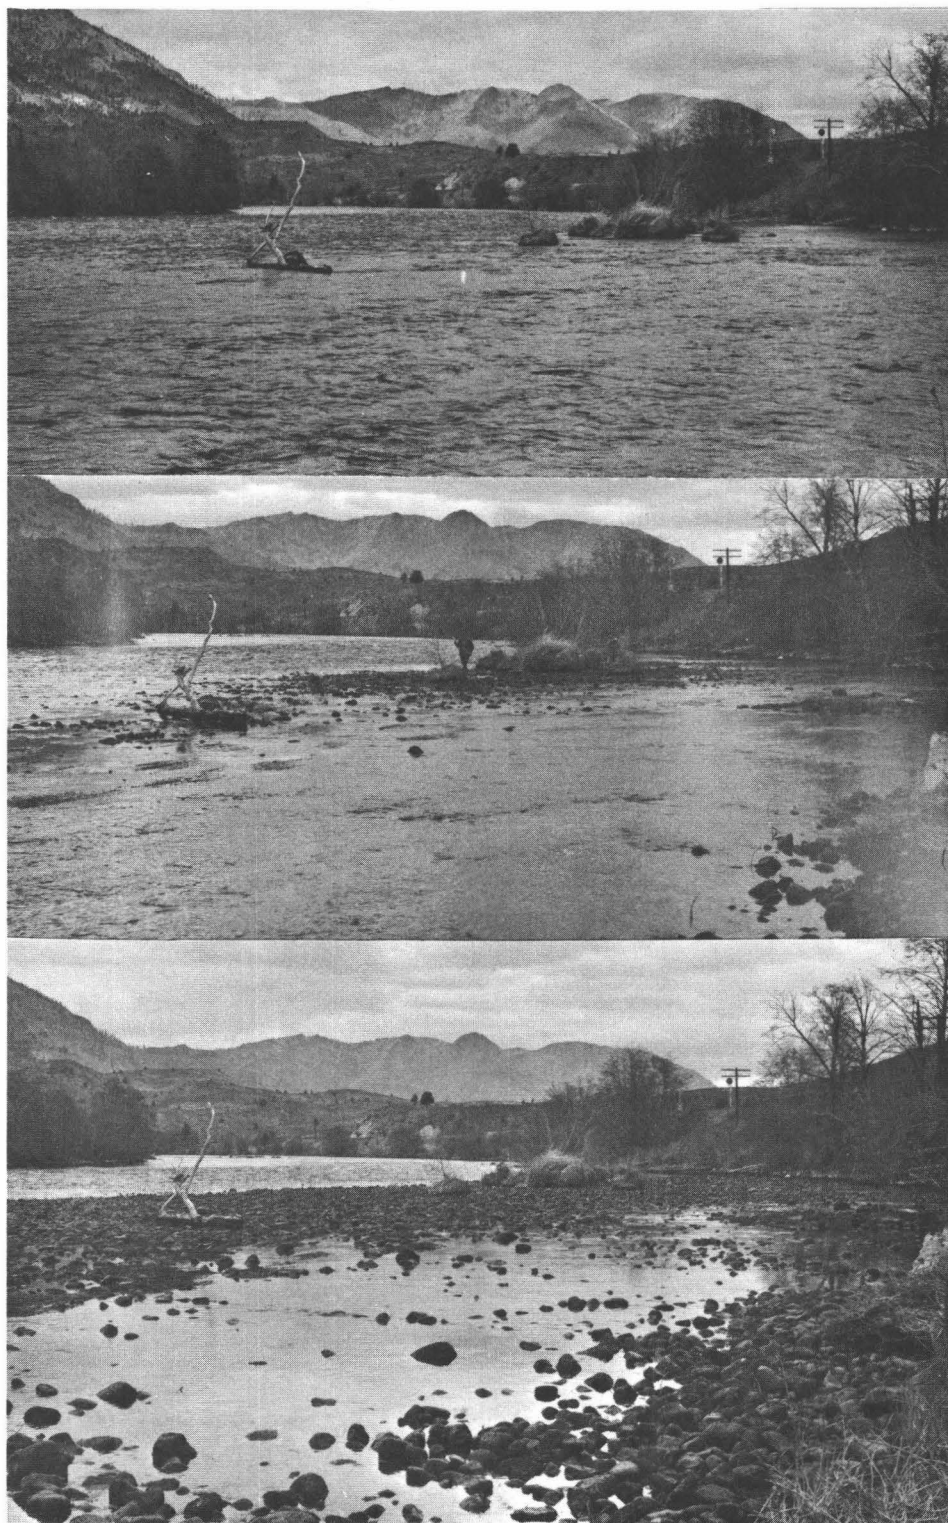
The water level dropped almost 0.9 foot (Fig. 2f), leaving a large area dewatered (Fig. 19). Losses of young chinook were observed but in much smaller numbers than at East and West Disney, due in part to the type of bottom and shoreline. Most of the loss at this station was in the vegetation where the small fish were trying to use it for cover as the water receded.

Fig. 19. Kaskela area showing gravel bar exposed at low (bottom), intermediate (middle), and pre-reduction (top) flows.

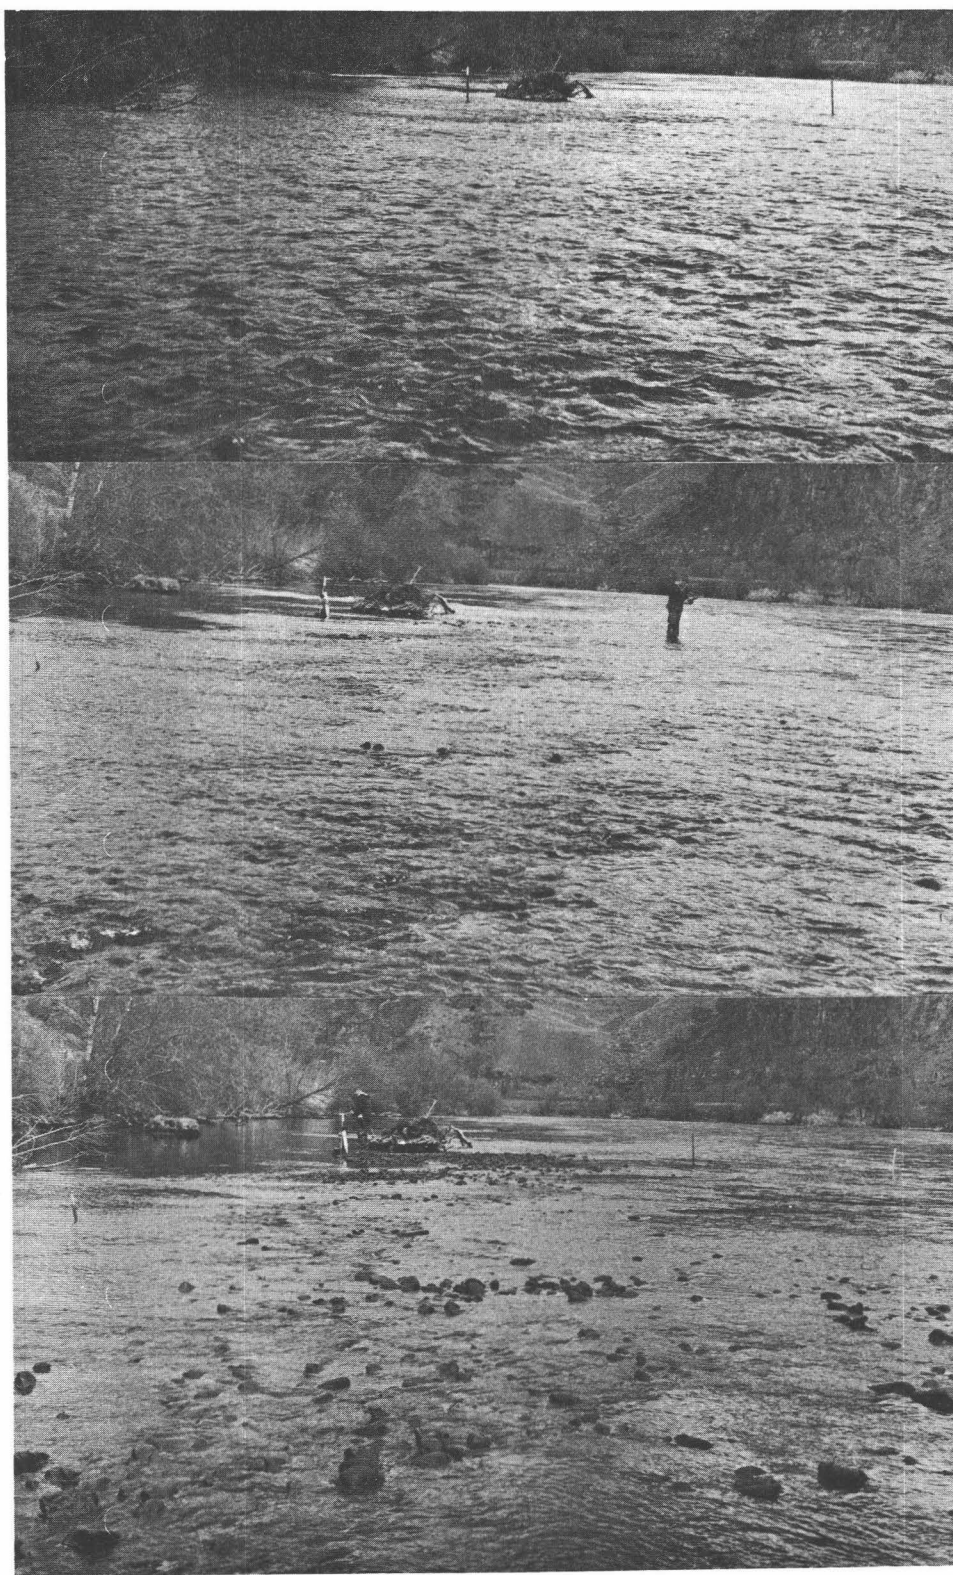
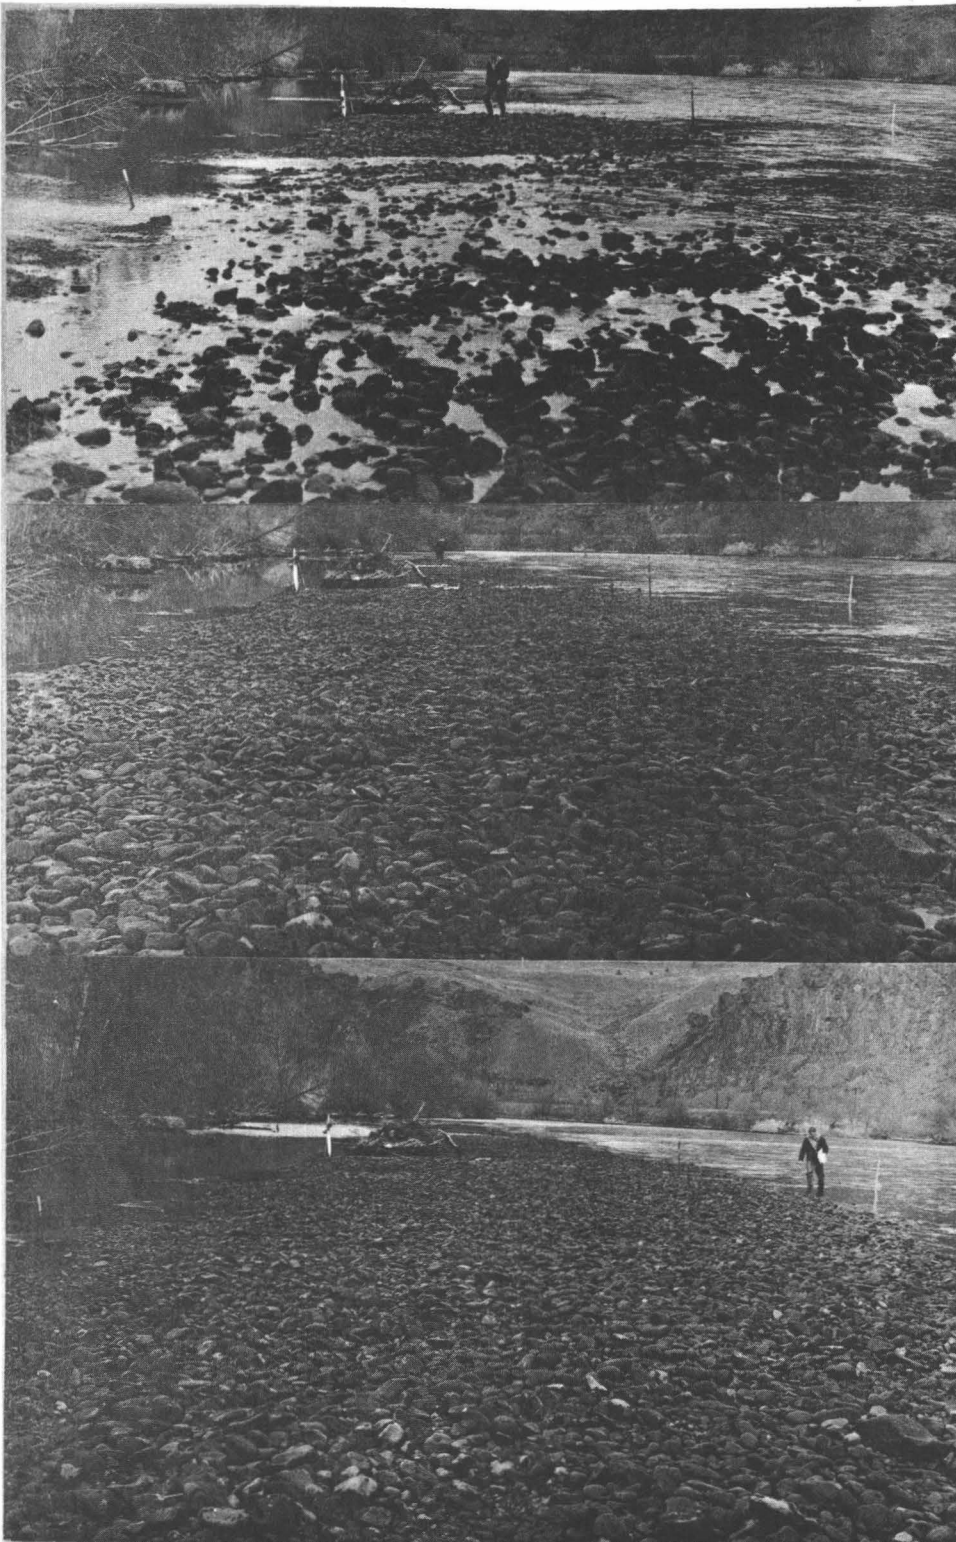
By the time the water level had fallen half way, or about 0.5 foot, the majority of the most desirable spawning area was exposed or too shallow for use (Fig. 20). For practical purposes all the stations on the west side of the base post could be ignored because water velocity and gravel were inadequate to support spawning on that side. Gravel composition was good as far to the east as we could reach. However, the configuration of the bar did not present an ideal spawning situation as it fell off toward mid-channel at a fair slope and velocities were about 2.5 feet per second.

Fig. 20. Whiskey Dick study area showing water receding from normal level (top) to intermediate level (bottom).
(Photos by Fortune)

Fig. 20. (continued) Whiskey Dick study area showing water receding from intermediate level (top) to low level (bottom). (Photos by Fortune)

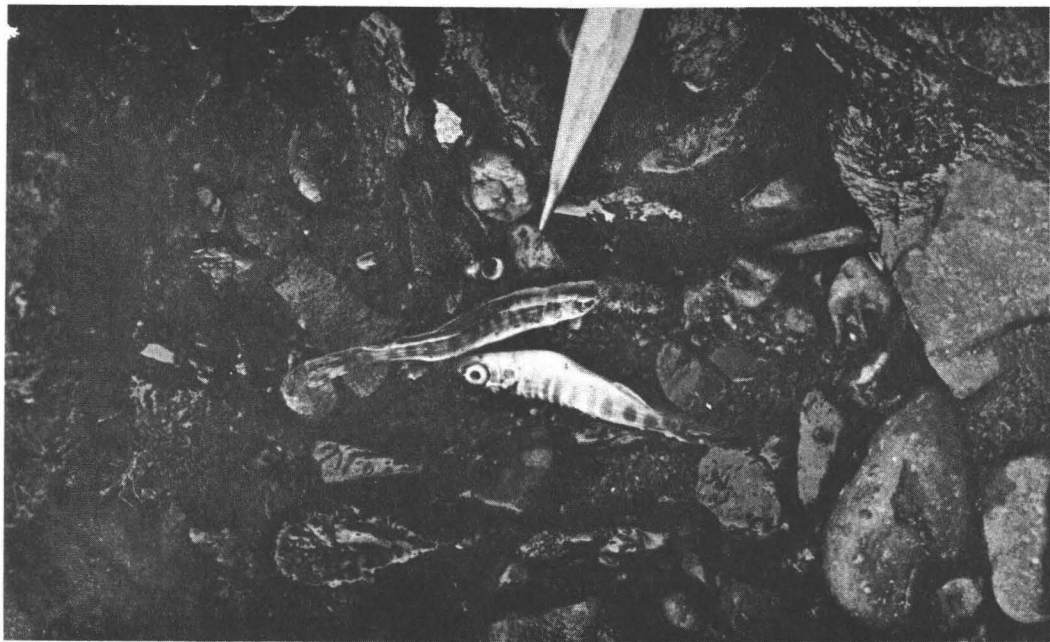
Sample sections were surveyed along the east bank of the Deschutes River from Maupin to a point 15 miles south of Maupin (Table 3). All salmon and trout mortality was recorded in a given length of river bank (Fig. 21).

Fig. 21. Dead chinook salmon fry stranded by reduction in flow, Maupin area. (Photo by Aney)

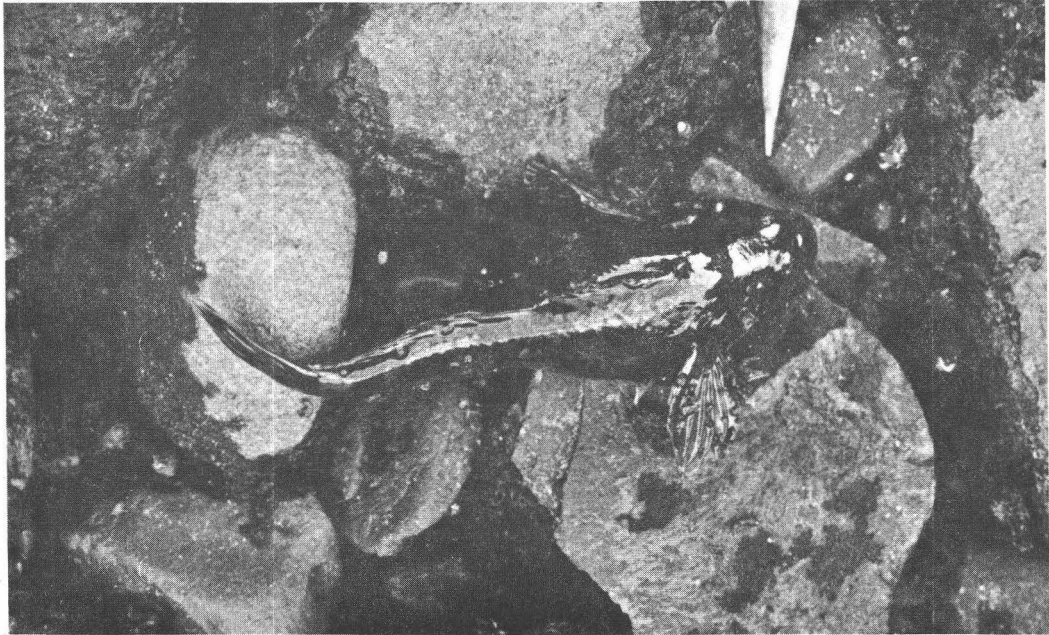
For the section of river that was covered this would be a loss of 18 fish per 1,000 feet of river bank. No attempt was made to record other species such as sculpins (Fig. 22). It was noted, however, that the lamprey ammocoetes were heavily affected by the flow reduction. On one small mud bank it was estimated that 300 ammocoetes were stranded. Many aquatic insects were also stranded (Fig. 23).

Fig. 22. Live sculpin stranded on gravel bar in area above Maupin.
(Photo by Aney)

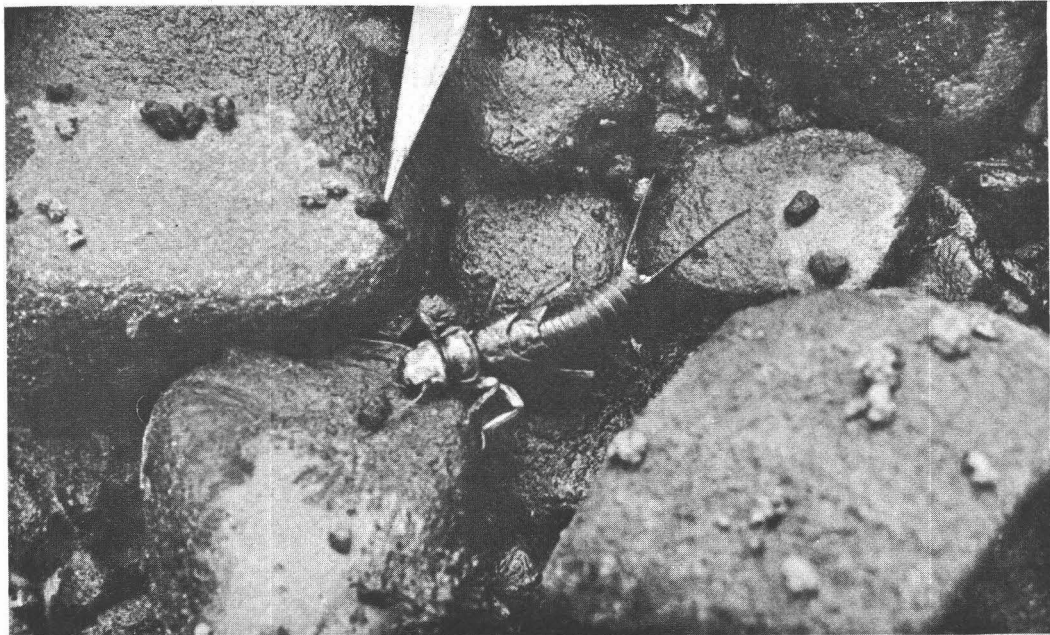
Fig. 23. Live stonefly nymph stranded by reduced flow in area
above Maupin. (Photo by Aney)

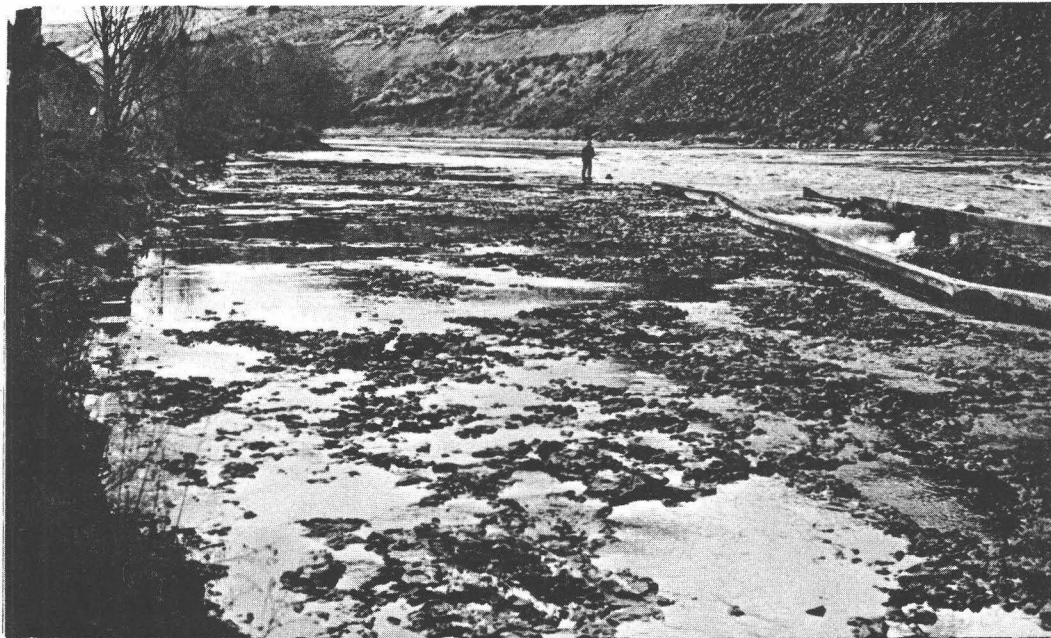
Hundreds of chinook salmon fry and rainbow or steelhead trout up to 4 inches long were stranded as water fell from bedrock areas in the vicinity of the falls. Many small dace were also caught. Primary area of stranding was adjacent to the west fishway (Fig. 24). Water was retained in the pools; thus mortality was low although 10 dead chinook were found on a rocky bar. If the reduction had occurred in daylight in the absence of humans, predators such as birds probably would have taken nearly all of those stranded. Large numbers of aquatic insects were exposed, but no estimate of mortality was made.

Fig. 24. Area on west side of Sherars Falls fishway where fish were stranded.
