SURVEY OF ALSEA RIVER, OREGON.

*With letter of the Chief of Engineers, report of a survey of Alsea River, Oregon.*

**Map of  
ALSEA RIVER,  
OREGON.**

FROM THE FORKS TO ITS MOUTH  
SHOWING OBSTRUCTIONS TO BOAT NAVIGATION

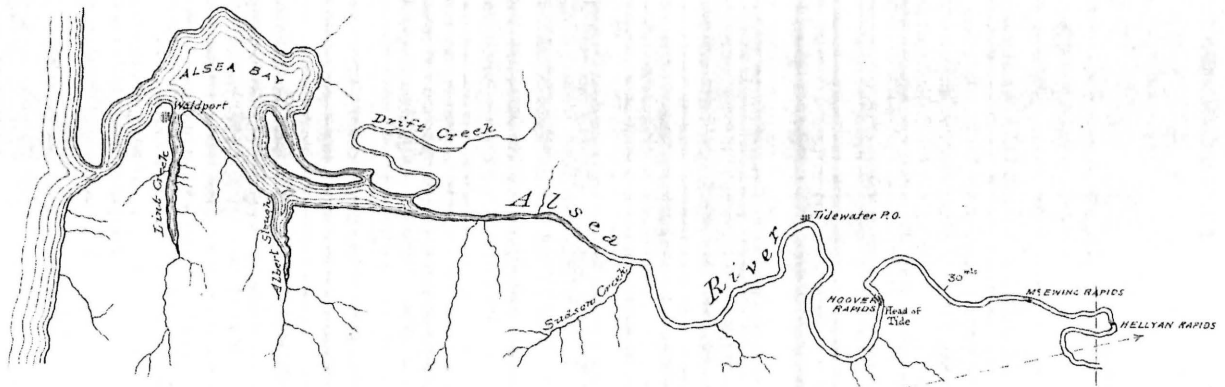
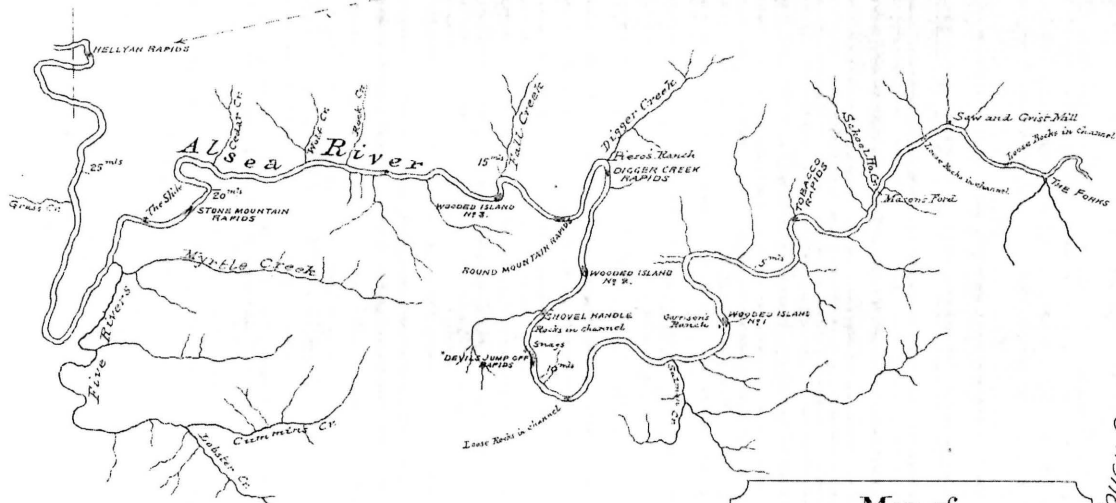
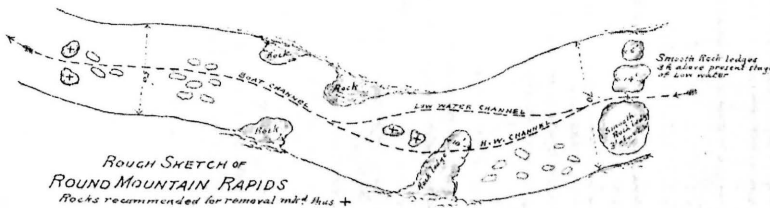
This forms a very bad reach of river. To effectually help matters will require (referring to accompanying sketch) the removal of the loose rocks along the left bank, a half dozen of those at the lower end upon the right bank, and about 20 feet of the outer end of the reef marked A, which stands about 3 feet out of low water.

The strong current in the approach to the rapids and the sharp turn required around reef B will almost inevitably throw a boat upon reef C, but with the removal of the obstructions mentioned, reefs B and C will cease to be a menace and will doubtless prove beneficial rather than otherwise, as they will tend to confine the flow to the newly-straightened channel along the left bank.

section narrows and a comparatively small rise covers them well. The rock in place is smooth-surfaced, and boats slide over them without serious difficulty. Formidable as it looks at low-water, it is not as dangerous in the boating season as some other sections, and with the removal of the few rocks indicated upon the sketch will be rendered comparatively safe.
