# TESTS OF CARGO FLOORING R AND S FOR AIRCRAFT

No. 1550-E

FOREST PRODUCTS LABORATORY  
MADISON 5, WISCONSIN

J. A. LISKA, Engineer

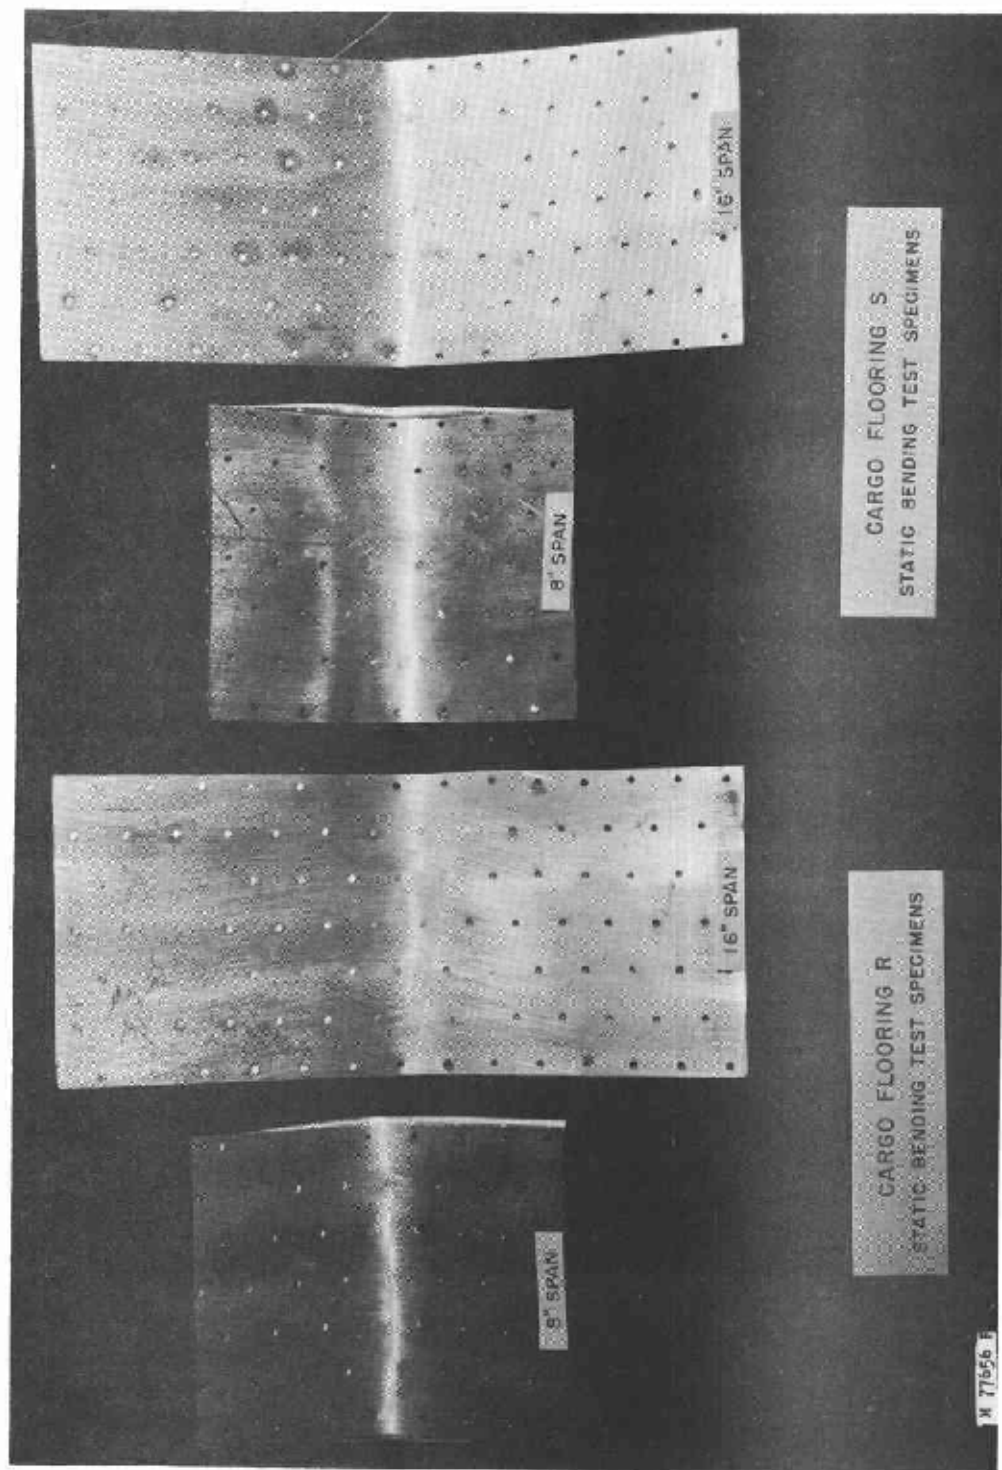
Three static-bending specimens of each flooring material and span length were tested over 8- and 16-inch spans. Typical load-deflection curves for each span length and material are presented in figures 2 and 3. Top and edge views of typical failures for each material and span length show in figures 4 and 5 the shearing of rivets that was encountered in every test.

The primary cause of failure in static-bending tests of specimens from flooring materials R and S was due to the failure of the rivets in shear over one-half of the span. This permitted the top wearing surface to slide over the corrugations as the specimen was deflected during test. The appearance of the specimens at failure can be seen in figures 4 and 5. In general, the load and deflection continued to increase up to the point where the first rivet failed, after which time the deflection increased, but the load decreased as more of the rivets failed in shear. The specimens continued to carry a large percentage of the ultimate load after most of the rivets in half of the span had failed; and when the test was continued, the load would tend to increase somewhat after the specimen had been deflected to the point where the load block was acting as a wedge. The specimen at this time, however, was not acting as an integrated unit of wearing surface and corrugations. Possibly because of the greater stiffness of the corrugations, floor S specimens tested over an 8-inch span behaved somewhat differently in test. As may be noted in figure 2, the load continued to increase, although somewhat erratically after the first rivet failure at a load of about 750 pounds until ultimate, where a greater portion of the rivets had failed.

Figure 5.--Top view of static-bending test specimens of cargo flooring R and S.  
Note that on one-half of each specimen the rivets have failed in shear, which is typical of all tests on these flooring materials.

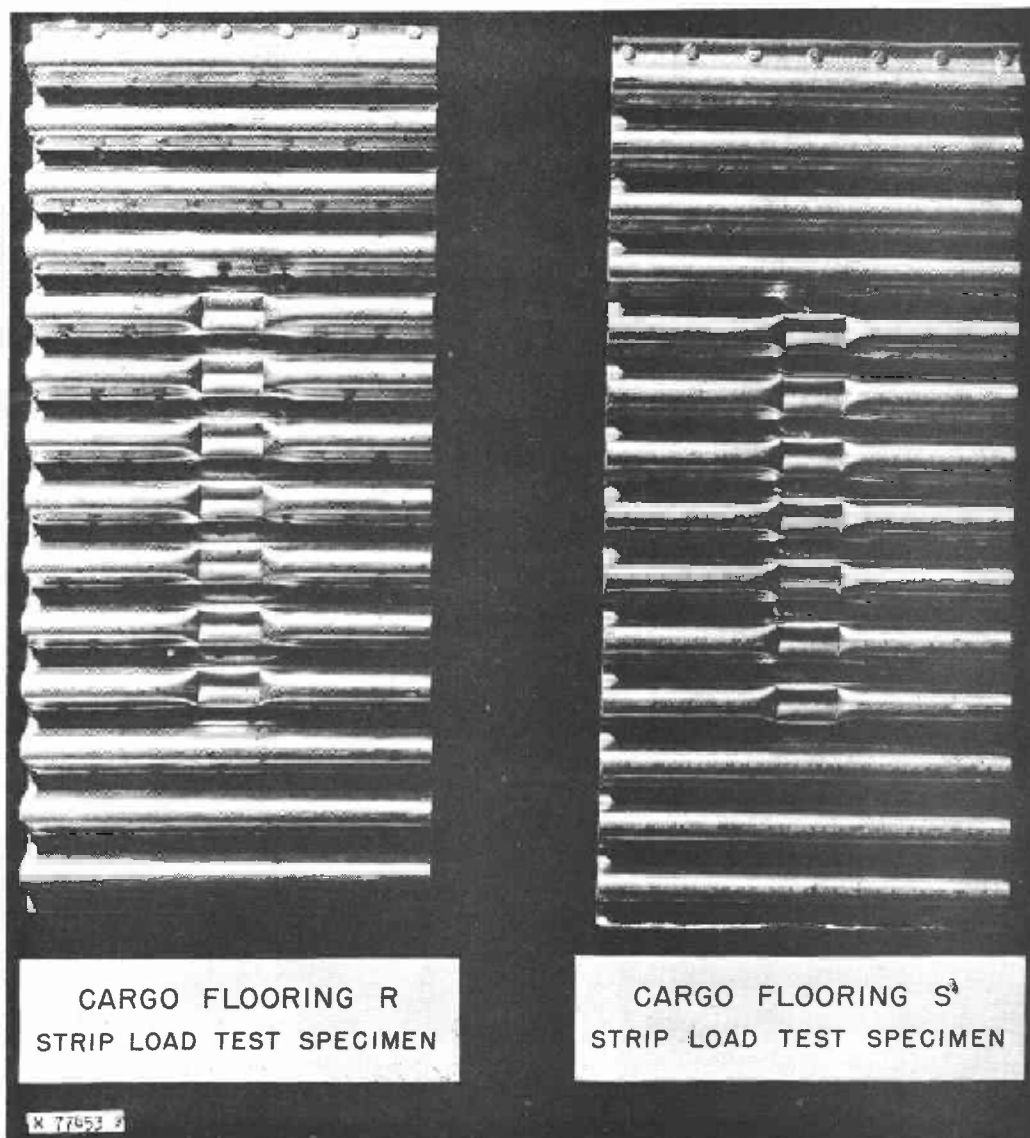
The small, closely spaced corrugations of floors R and S make them much more resistant to crushing, as measured by results of strip-loading tests, than the floors of similar construction but with larger corrugations H and I.<sup>2</sup> Floor S was shown, figure 7, to be about 40 percent stronger than floor R in this property and gave comparable results to those obtained on the strong sandwich honeycomb-type floors, N and P.<sup>2</sup> In all cases the corrugations under the loading bar fractured, as shown in figure 7, at the maximum recorded load. At this point the support offered by the corrugations to floor areas adjacent to the fracture would be reduced, but the corrugations would still carry a considerable load as they are crushed further.

Figure 7.--Appearance of tested surface of cargo flooring R and S strip-loading specimens. Note the failures in each corrugation that occurred as the maximum test load was reached.

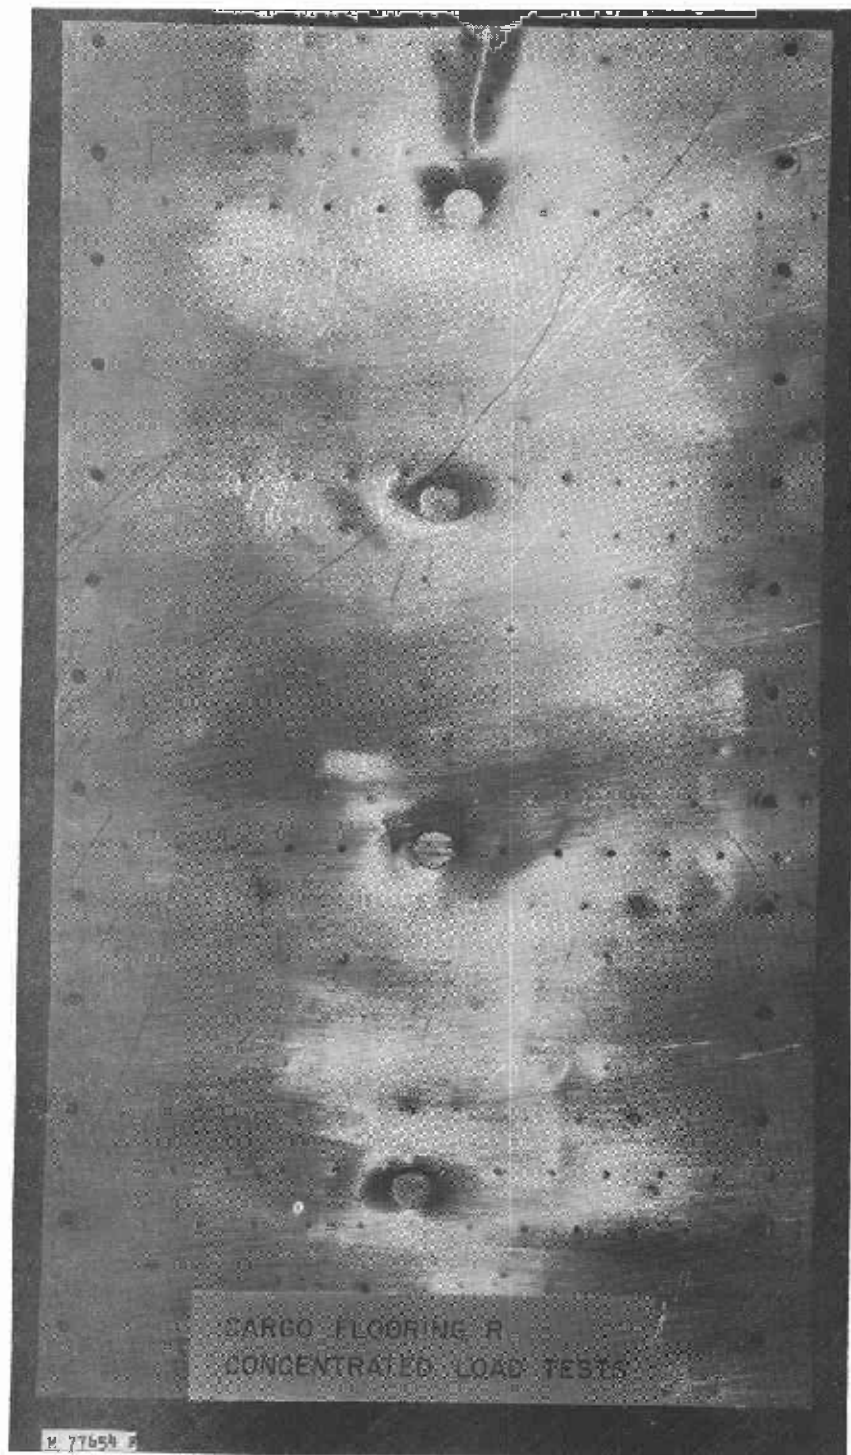
Concentrated-load tests using a 1-inch-diameter steel bar to apply loads at exterior and interior positions (4 and 12 inches from an unsupported edge) and above and between crests of corrugations were made on each flooring material. Positioning of loads and evidence of damage may be seen in figures 8 and 9. The limited data obtained did not indicate any definite trend of load relative to position with respect to the edge of the panel, but did show a 20 to 35 percent increase when the load was applied above rather than between corrugation crests. When the load was applied over a corrugation, floor S was the stronger, but the floors were about equal in strength, as would be anticipated when the top surface alone carried the majority of the load. Floors R and S rate well in comparison with other floors, although they are somewhat less strong than floors H, I, and N.<sup>3,5</sup>

Figure 8.--Concentrated-load test panel of cargo flooring R showing load positions on and between crests of corrugations as indicated by rows of rivets. Type of failure is much the same in each case.

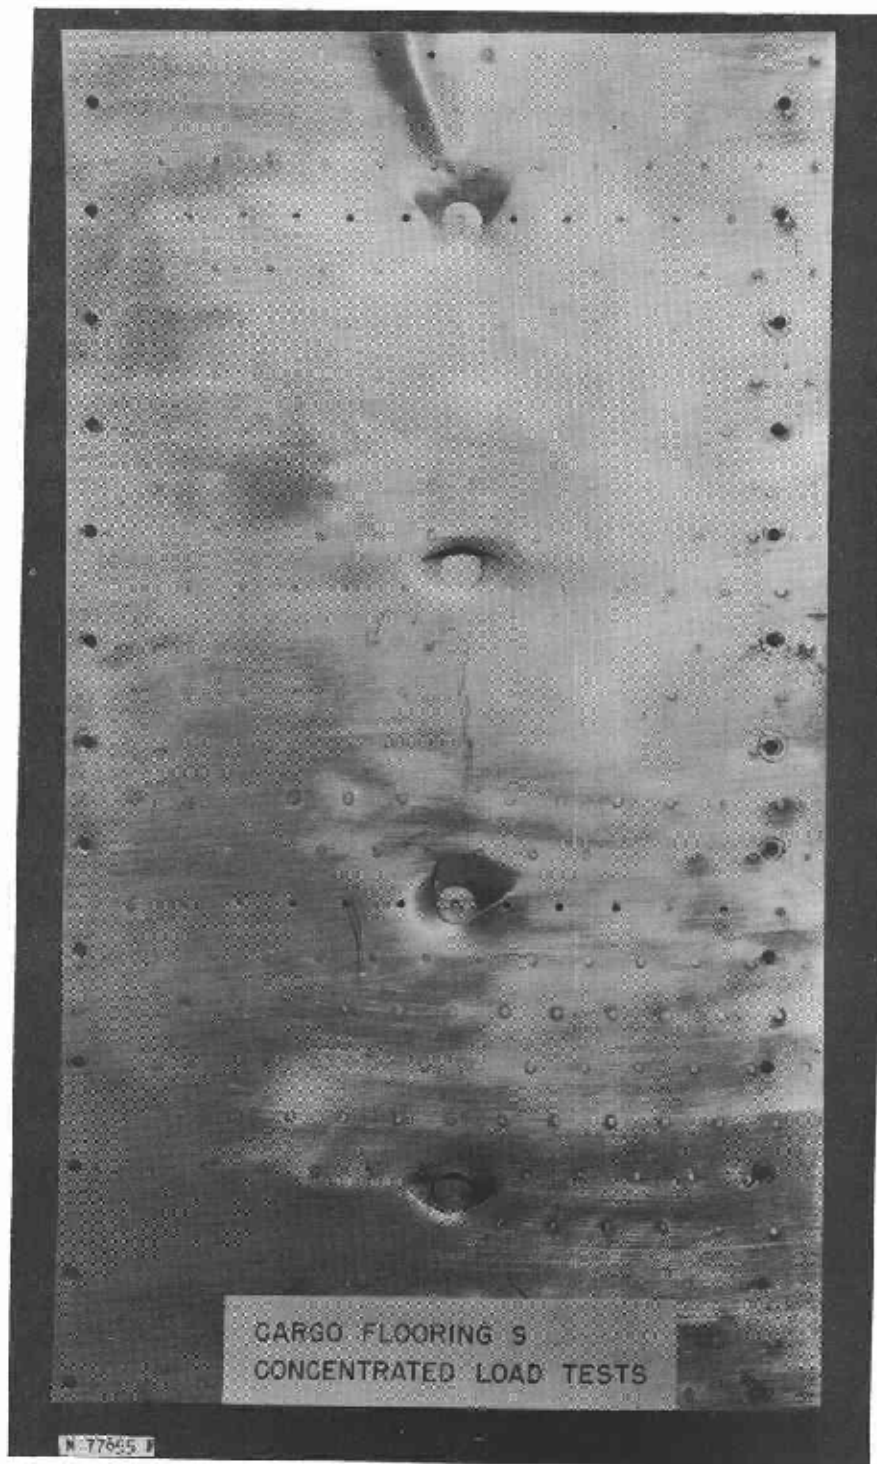
Figure 9.--Concentrated-load test panel of cargo flooring S showing load position on and between crests of corrugations as indicated by rows of rivets. Failures in each case were similar.

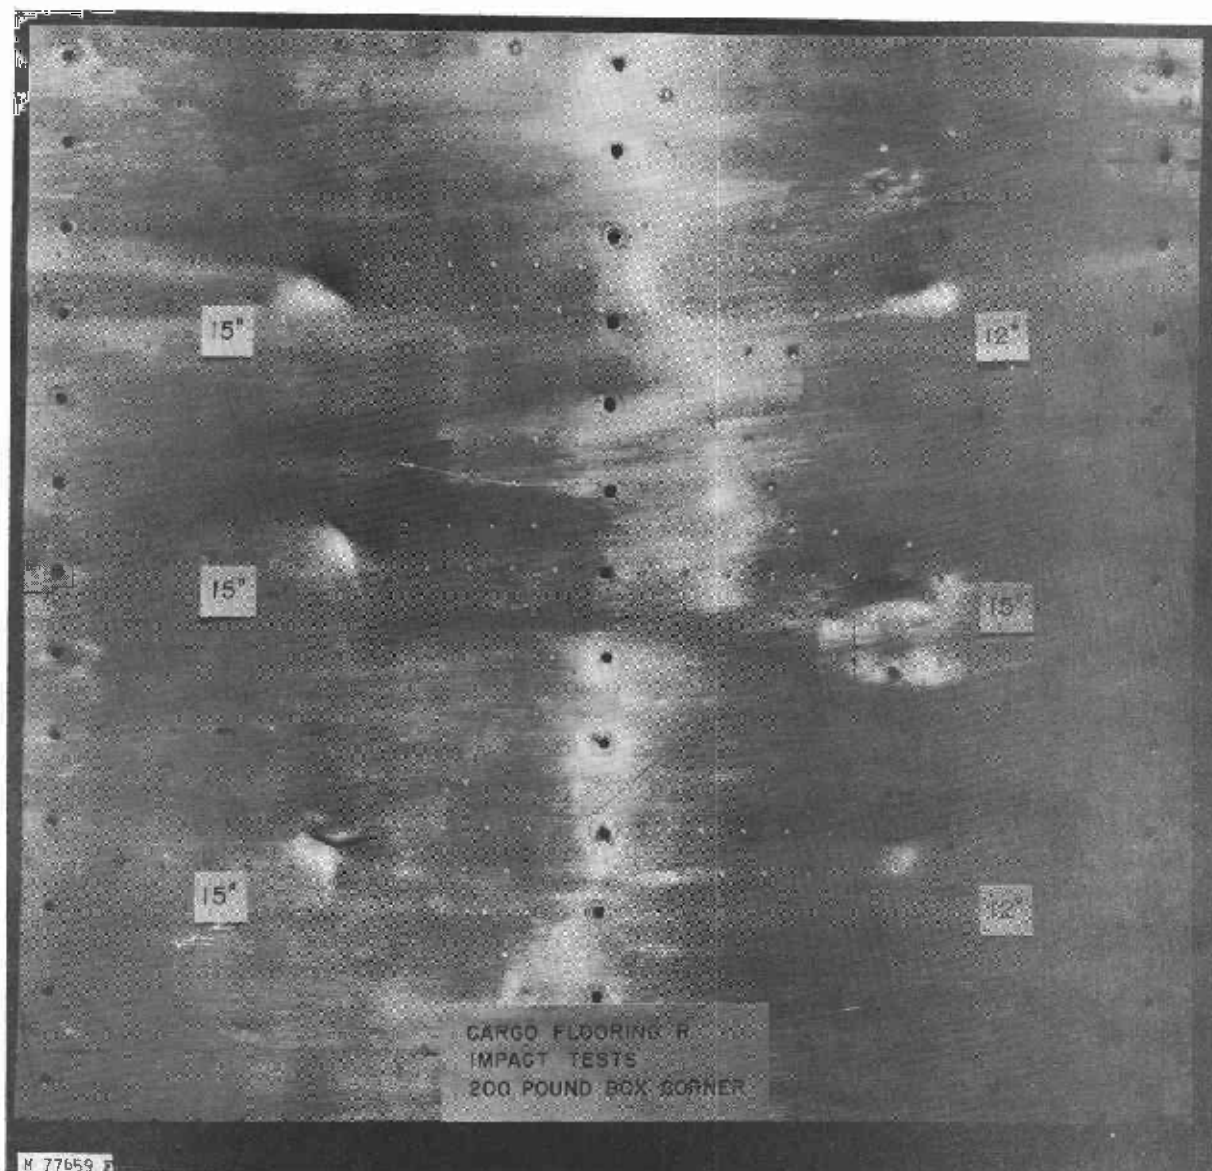
Preliminary tests indicated that there was little difference in measured deflection or set of the panels under impact loading when the load was applied above or between crests of corrugations. Since fracture of the top surface was more likely when the blow fell on an unsupported surface, all panels were loaded between crests of corrugations. Impact tests with a 200-pound softwood box corner dropped from heights of 12 and 15 inches revealed that floors R and S are high in impact resistance. No damage that would make the floors unserviceable was noted after these tests, figures 10 and 11. Floor S deflected less under impact than did floor R and had less permanent deformation, but based on these tests the floors gave as good a performance as any tested previously. The deflection caused by the impact loading was sufficient to pull the wearing surface away from the rivets adjacent to the indented area, with the result that some of the rivets protrude slightly above the panel surface.

Figure 10.--Loaded surface of cargo flooring R impact-test panel that shows the position of blow, height of drop, and extent of damage due to test with a 200-pound softwood box corner.

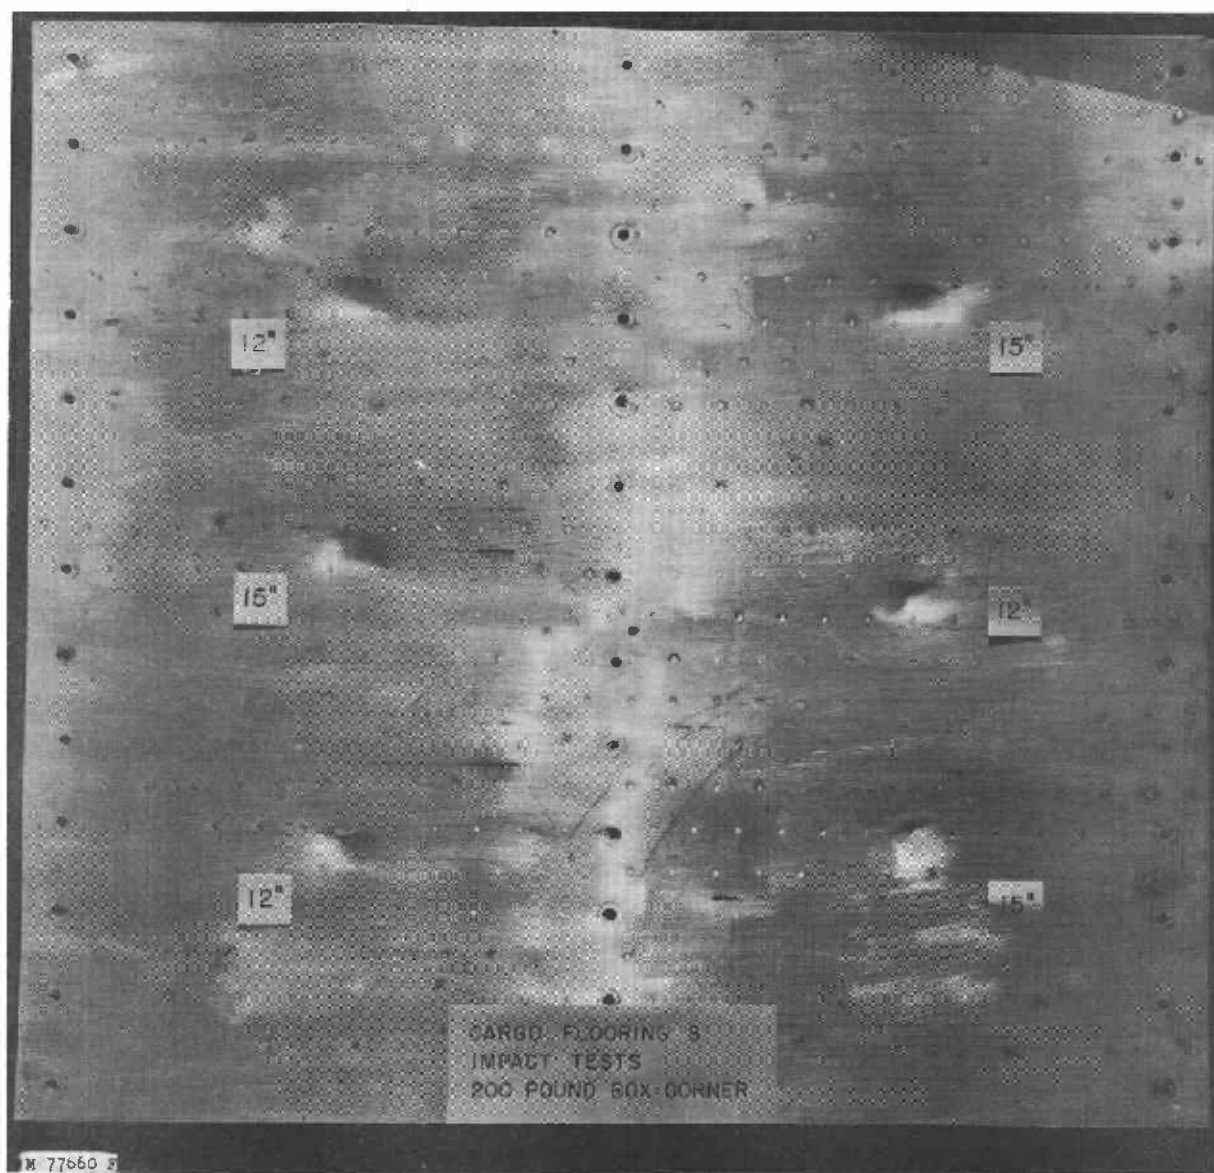
Figure 11.--Loaded surface of cargo flooring S impact-test panel that shows position of blow, height of drop, and extent of damage due to test with a 200-pound softwood box corner.

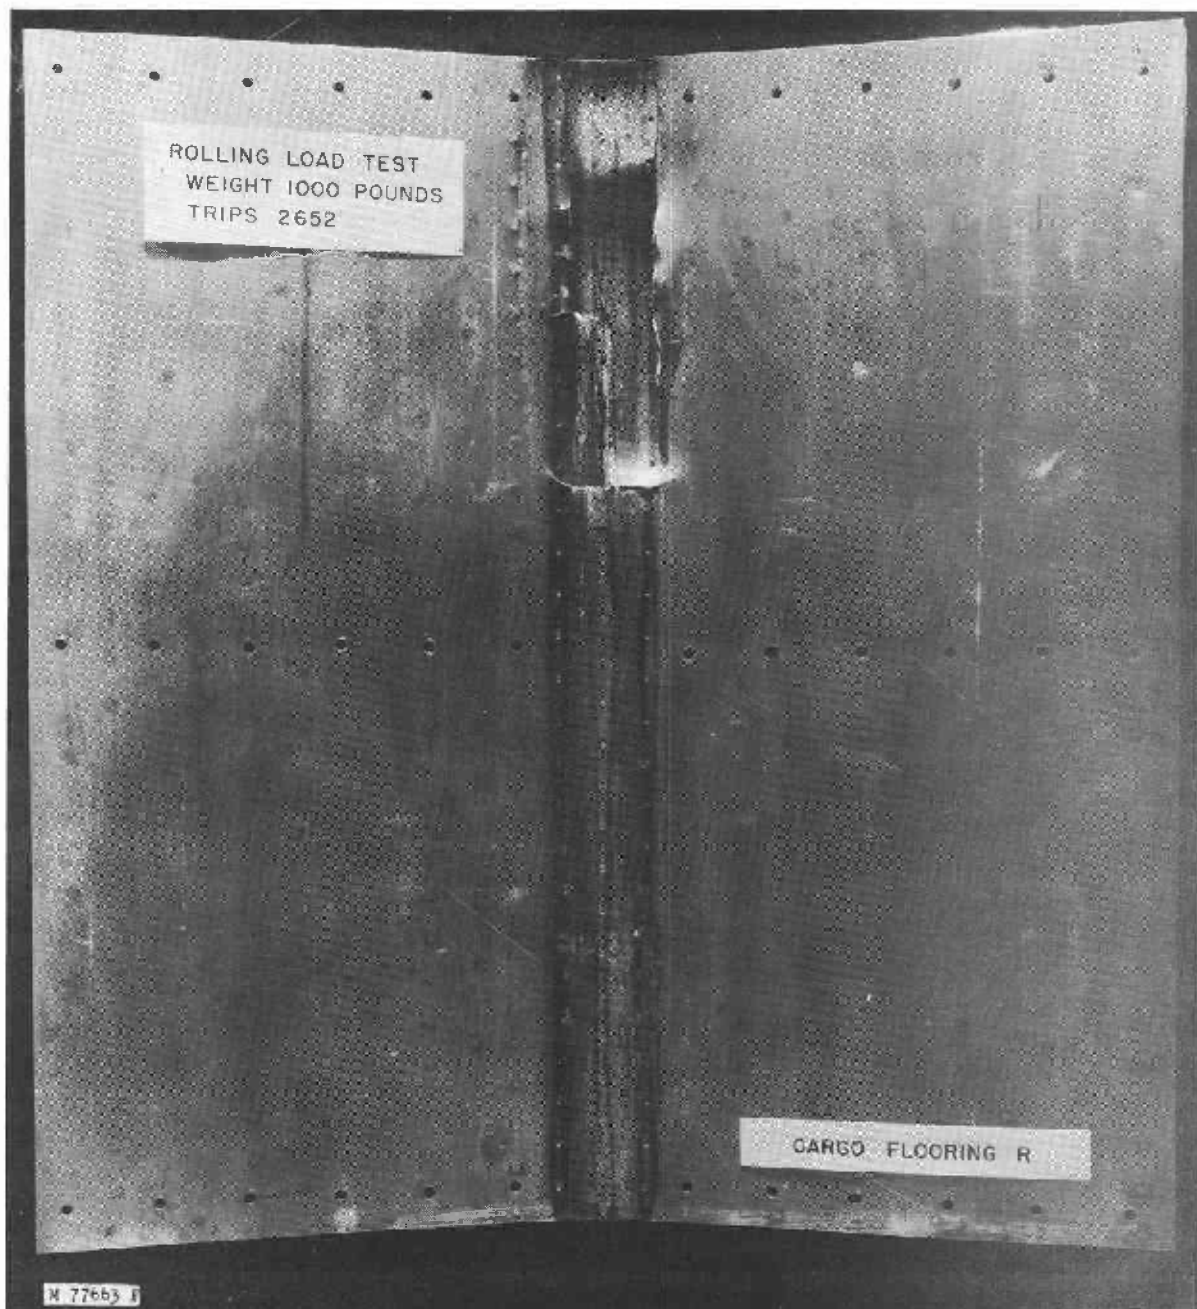
Early in each test the deflection of the panel due to the passage of the rolling load caused the top surface to pull away from the rivets with the result that the rivets adjacent to the wheel path projected slightly above the panel surface. Directly in the wheel path the rivets were flattened out, but after a relatively small number of load repetitions, a number of loose rivets were noted in this area. The next evidence of damage was a crushing of the corrugations directly over the supports. While the failures that subsequently occurred in all panels were due to a combination of failure in the wearing surface through or adjacent to a line of rivet holes and of tensile fractures in the corrugations, normally near the supports, the order of failure was not always the same. Under the 1,450-pound wheel load the failure began in the wearing surface, while under the lesser loads first evidence of damage was apparent in the corrugations.

Figure 12.--Loaded surface of cargo flooring R rolling-load test specimen showing damage caused by 2,652 repetitions of a 1,000-pound engine-cradle-wheel load. Fracture of upper surface is generally along line of rivet holes. The corrugations have also failed in tension at the midpoint of the damaged span and have been crushed over all supports

z M 78625 F under the wheel path.

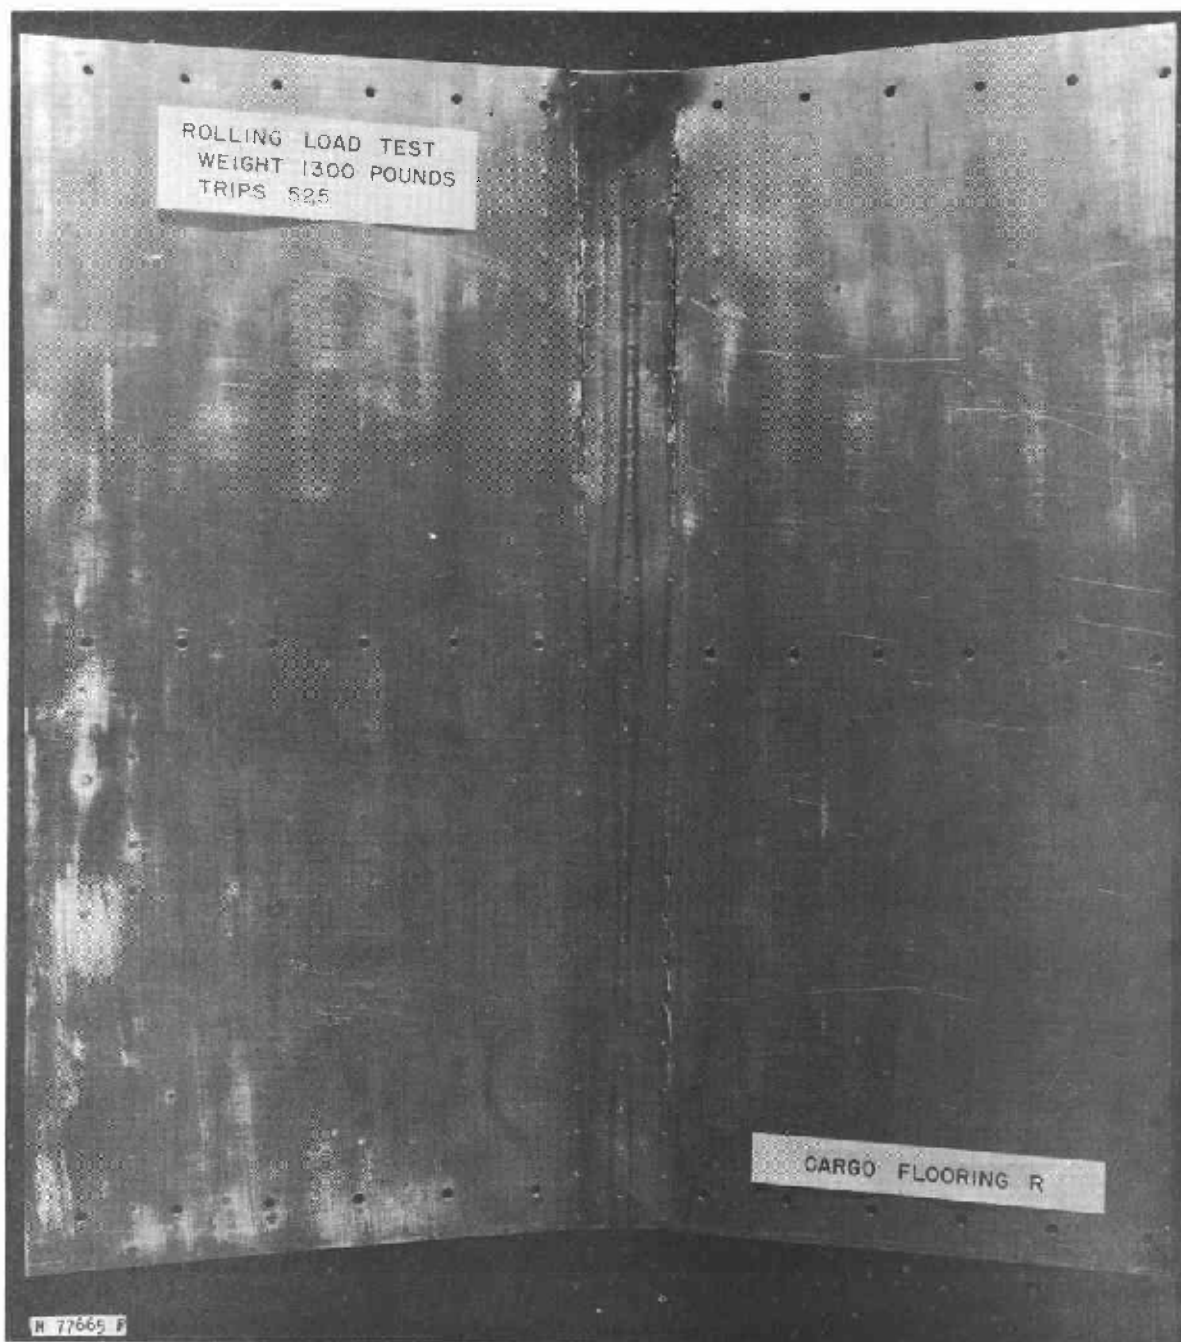
Figure 13.--Loaded surface of cargo flooring R rolling-load test specimen showing damage caused by 525 repetitions of a 1,300-pound engine-cradle-wheel load. The top surface has failed along the line of rivet holes and the corrugations have been crushed and split over all supports under the wheel path.

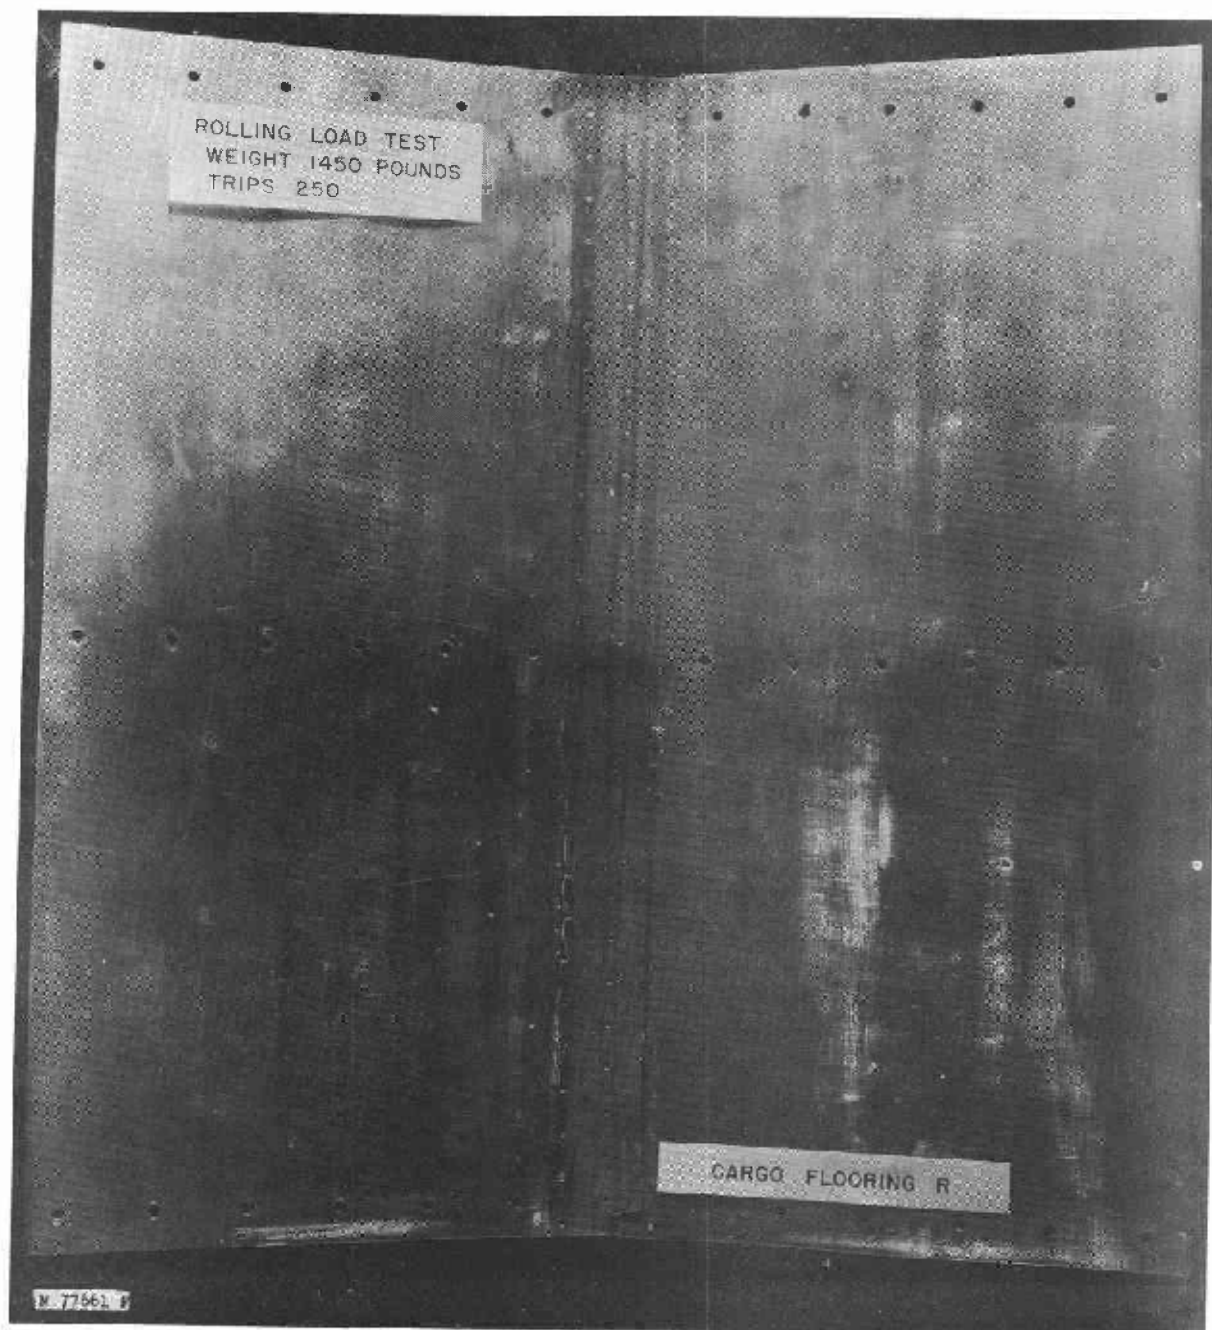
Figure 14.--Loaded surface of cargo-flooring R rolling-load test specimen showing damage caused by 250 repetitions of a 1,450-pound engine-cradle-wheel load. One edge of wearing surface fracture is along line of rivet holes. The corrugations under the wheel path have been crushed over all supports and have failed in tension adjacent to center support.

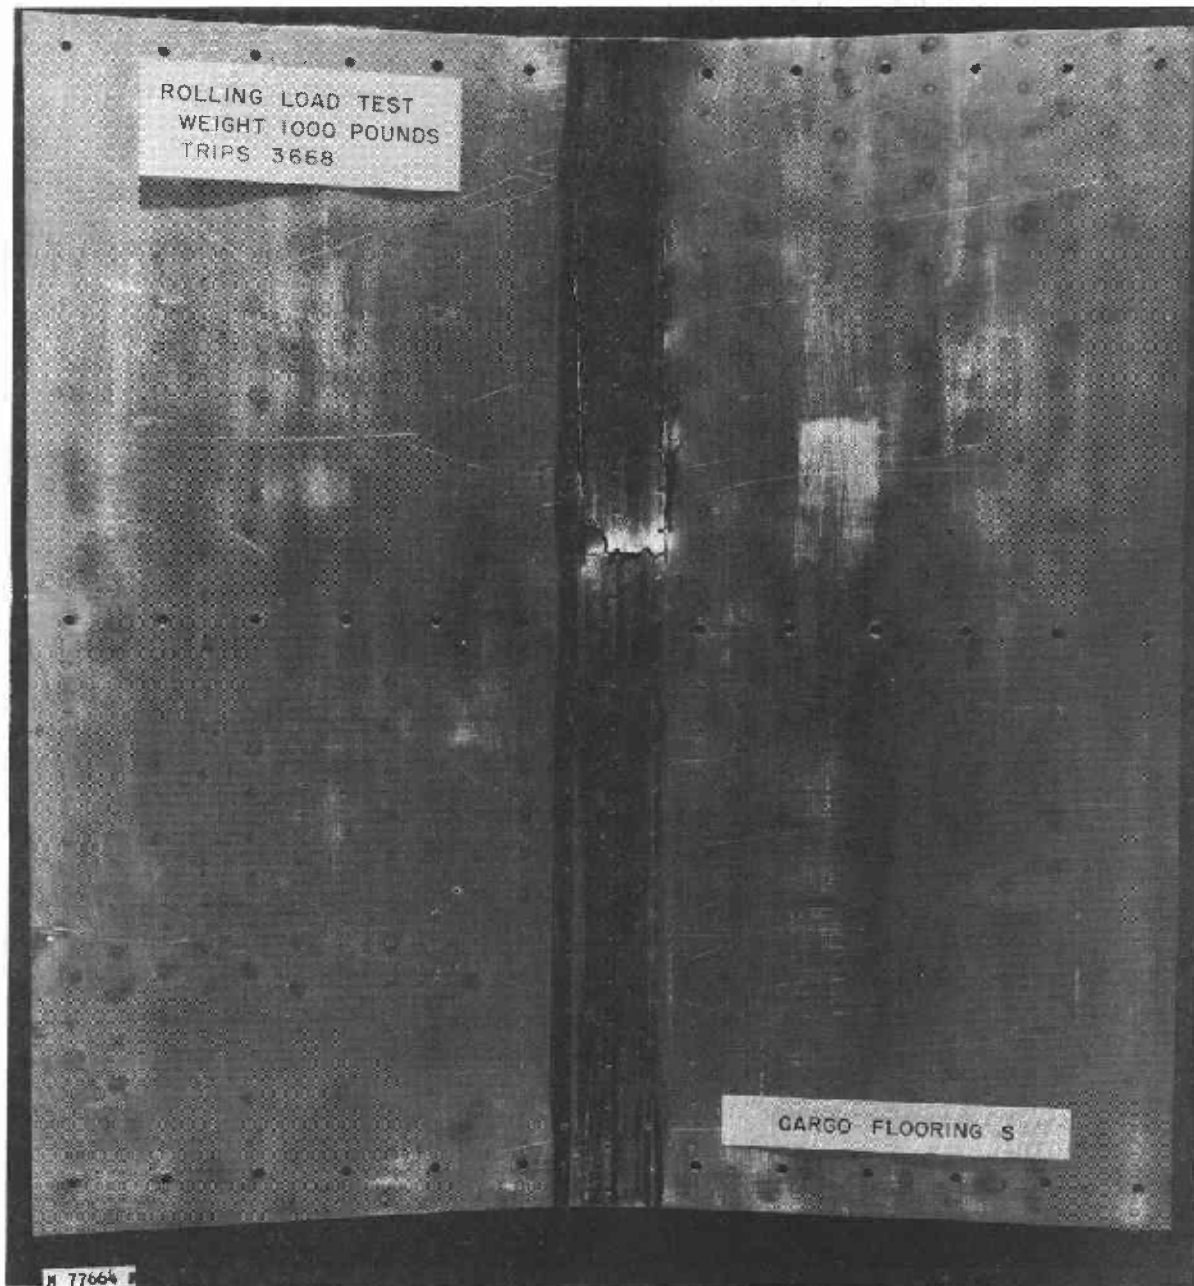
Cargo flooring S gave the more satisfactory demonstration of resistance to the action of the rolling load, and in this respect equaled the performance of the better of the panels tested similarly. The flooring, as given in table 1, withstood 614 trips of a 1,450-pound rolling load and 3,668 trips of a 1,000-pound load. Flooring R was able to carry the same loads for 250 and 2,652 repetitions, respectively, and required 525 trips of a 1,300-pound load to cause failure. This is evidence of a good flooring material, although one that is less satisfactory than type S. The number of trips or repetitions of load to cause sufficient damage to render the flooring unfit for service may be taken as 5 to 10 percent less than the trips to give the failures shown in figures 12 to 16 inclusive.

Figure 15.--Loaded surface of cargo-flooring S rolling-load test panel showing damage caused by 3,668 repetitions of a 1,000-pound engine-cradle-wheel load. The wearing surface has been fractured along the lines of rivet holes. The corrugations under the wheel path have been crushed over the supports and failures in tension occurred adjacent to the center and one end support.

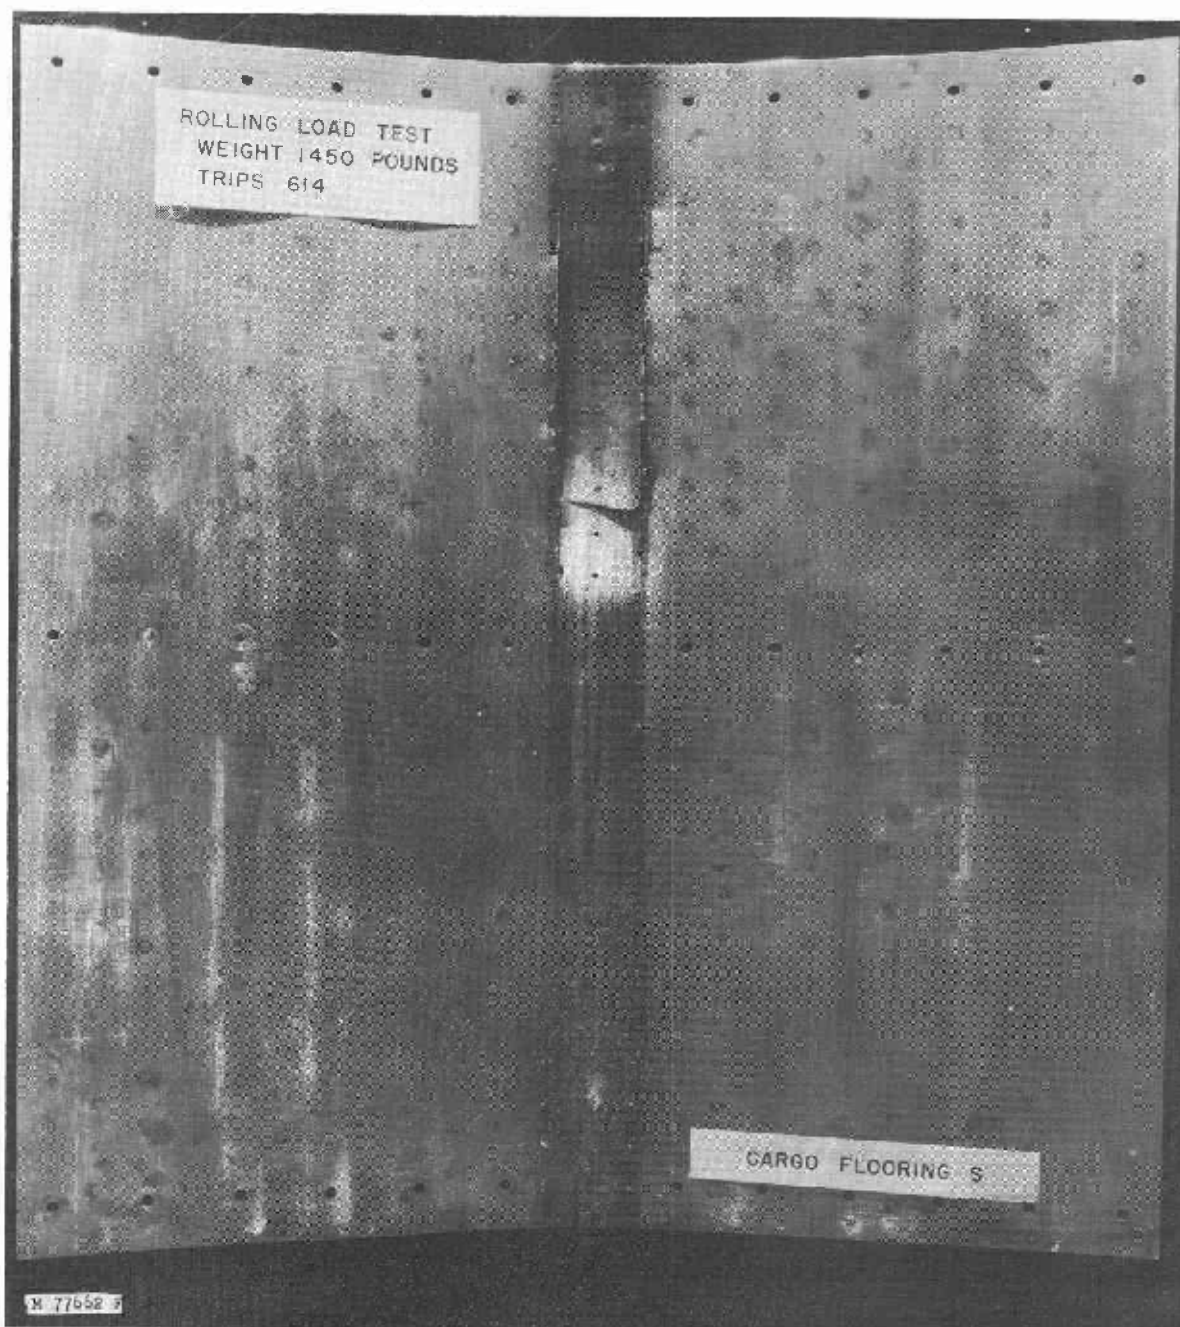
Figure 16.--Loaded surface of cargo-flooring S rolling-load test panel showing damage caused by 614 repetitions of a 1,450-pound engine-cradle-wheel load. The wearing surface has been fractured through the line of rivet holes at the edge of the wheel path. Corrugations under the wheel path have been crushed over all supports and failed in tension adjacent to center support.
