Monitoring Terrace Control of Water Pollution from Soil Erosion and Sediment in the Columbia Basin Counties of Oregon: October 1978 to April 1979

Special Report 595, July 1980
Agricultural Experiment Station
Oregon State University, Corvallis

Gerald O. George

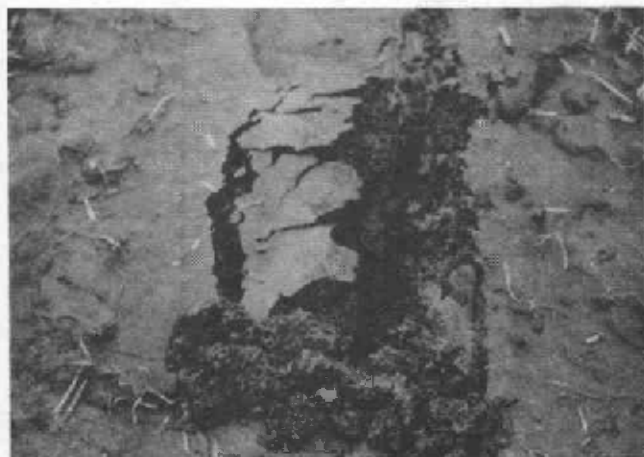
Figure 3. Surface soil flows back into footprint on February 8, 1979.

When the snow melt and rainfall occurred in November, there was no observable runoff, erosion, or sediment from the monitored sites. All the fields were quagmires about 3 inches deep (Figure 3). Subsequently, rainfall and snowfall periods did not produce any runoff until the general thaw occurred between February 5 and 14. During the first two days of the thaw, February 5 and 6, there was little or no erosion because the ground was still frozen to the surface and covered with snow. As the snow cover disappeared, the soil surface warmed and became a slurry quagmire over the frozen, deeper layers of soil. This slurry of soil and water became fluid enough to move; it accumulated in low areas, then ran over the top of snow that had not melted. This action continued for two to three days with rilling becoming more pronounced each day.

Measurements at the flow meters and computations of storage in the level terraces indicated that 95 percent of the total snowfall and rainfall from December 27 to February 14 ran off the intraterrace areas (Figures 3 and 4). There was no outflow from the level terraces, so their traps had no silt (Figure 5).
