Title: Behavior and Analysis of Pile Caps with Poor Anchorage Details.

BEHAVIOR and ANALYSIS of PILE CAPS with POOR ANCHORAGE DETAILS

A THESIS

Oregon State University

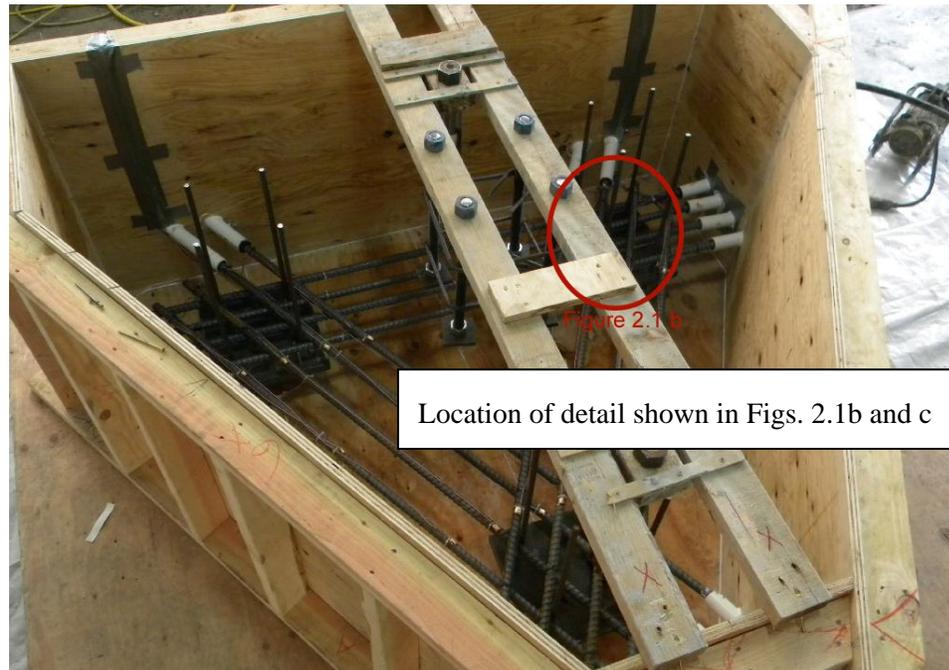
Figure 3.1.1a: Reference location for pipe bearing plates in Figure 2.1b

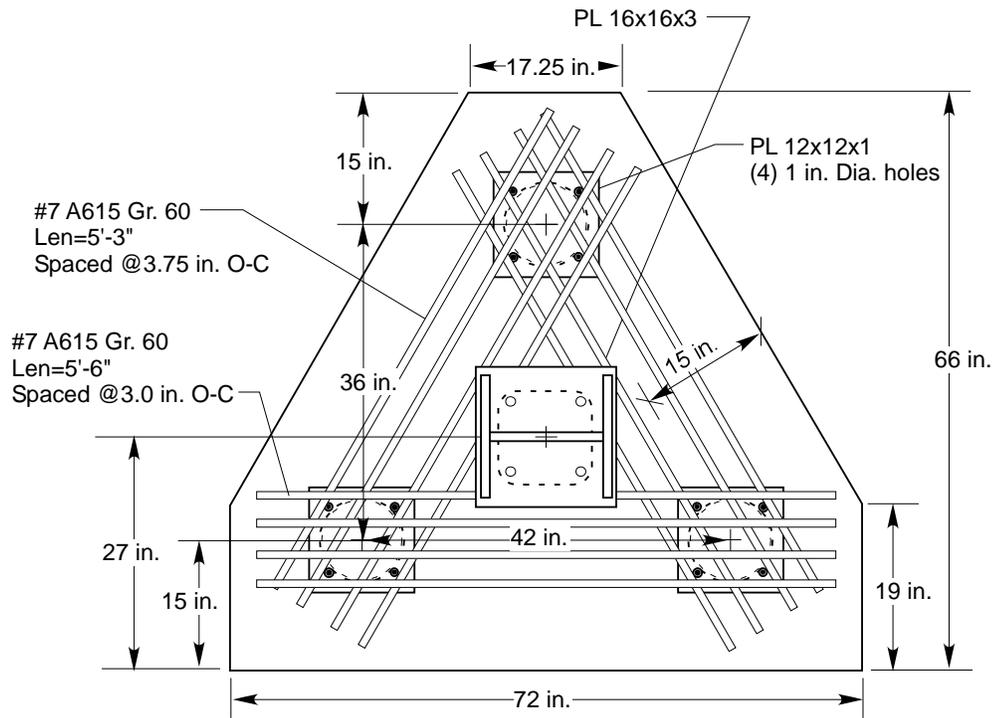
Figure 3.1.2a: Plan View – Pile Cap #3

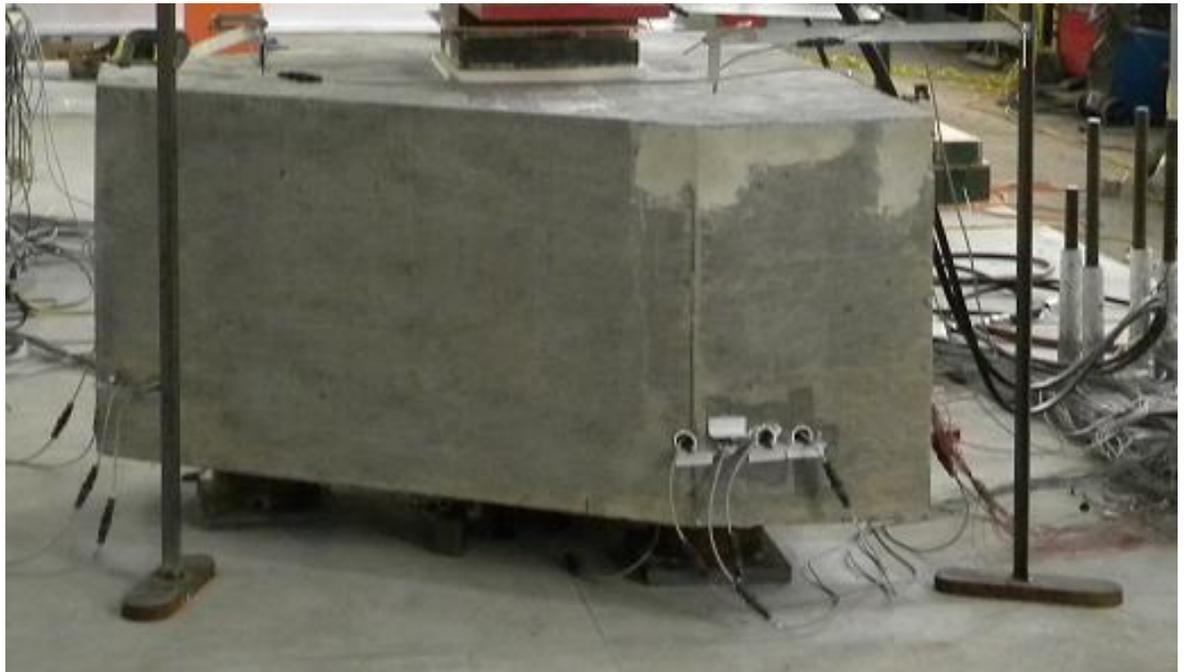
Figure 3.1.2d: Elevation view of completed specimen on strong floor – Pile Cap #3

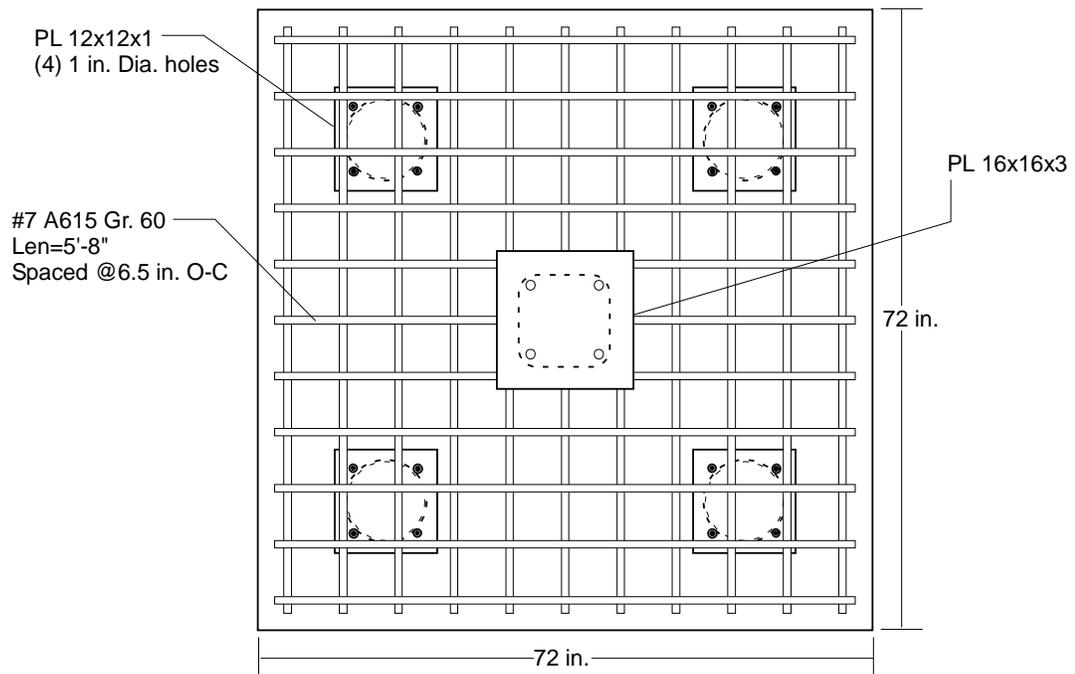
Figure 3.1.3a: Plan view for Pile Cap #4

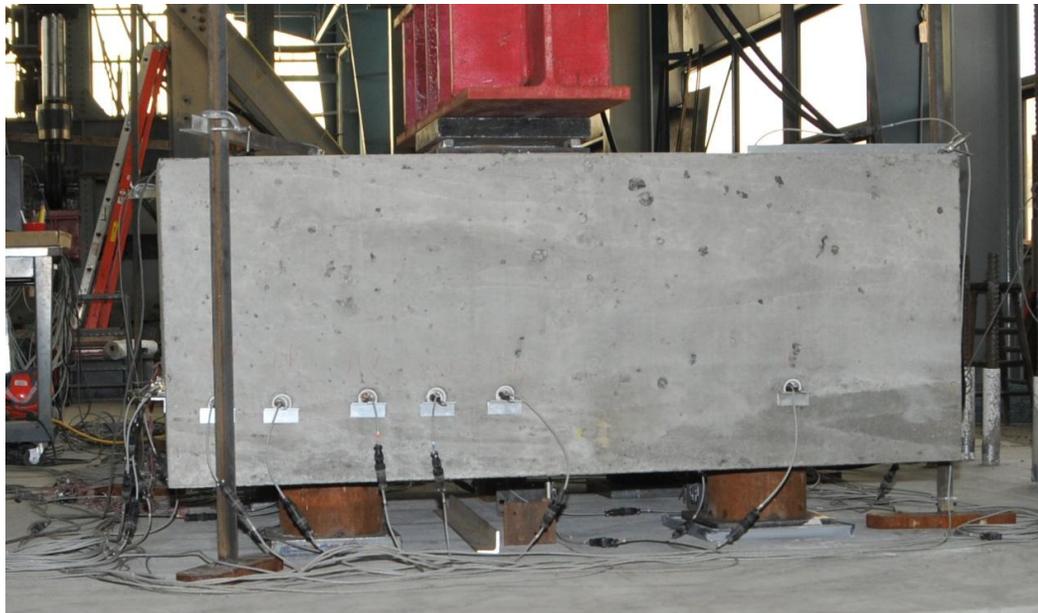
Figure 3.1.3d: Elevation view of completed specimen on strong floor – Pile Cap #4

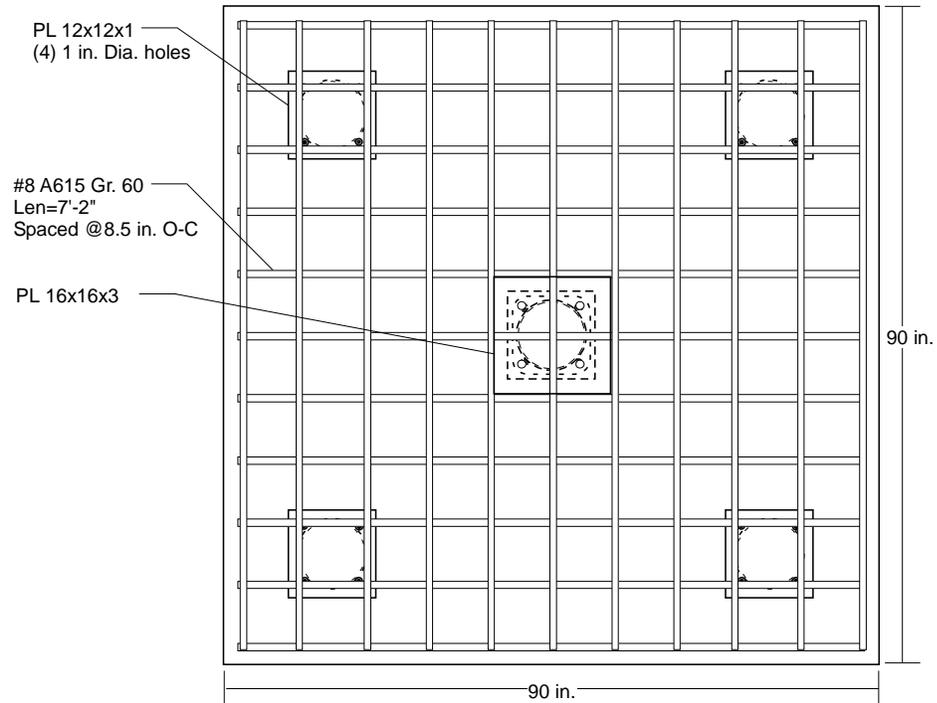
Figure 3.1.4a: Plan View – Pile Cap #5

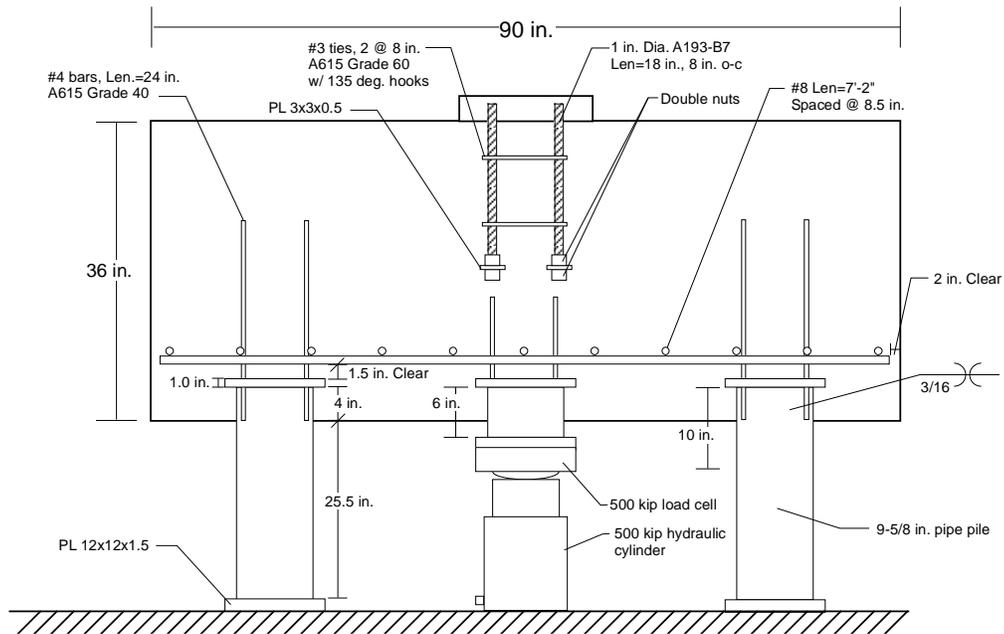
Figure 3.1.4c: Elevation View – Pile Cap #5

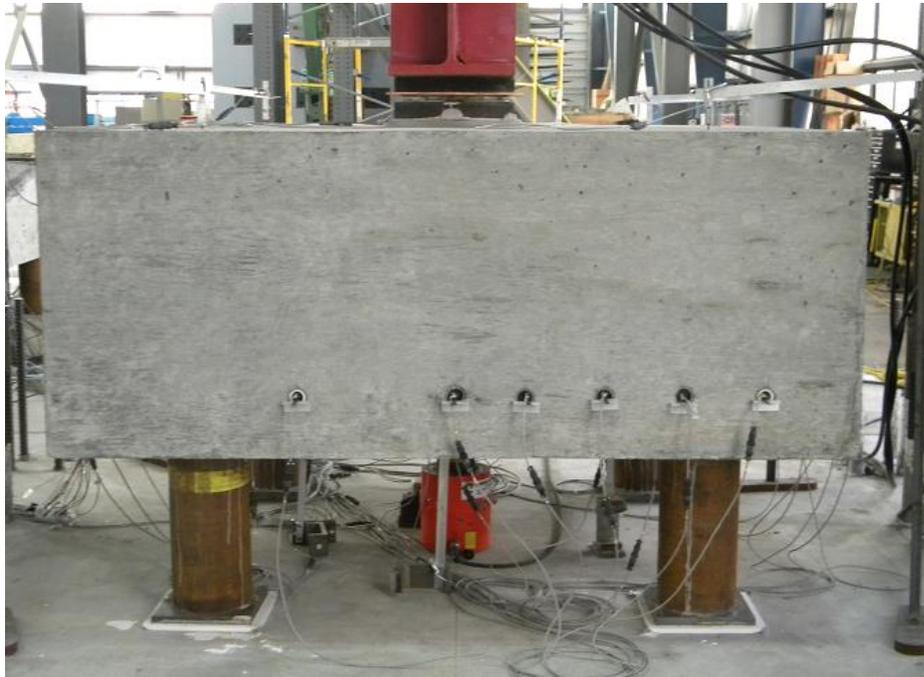
Figure 3.1.4d: Elevation view of completed specimen on strong floor – Pile Cap #5

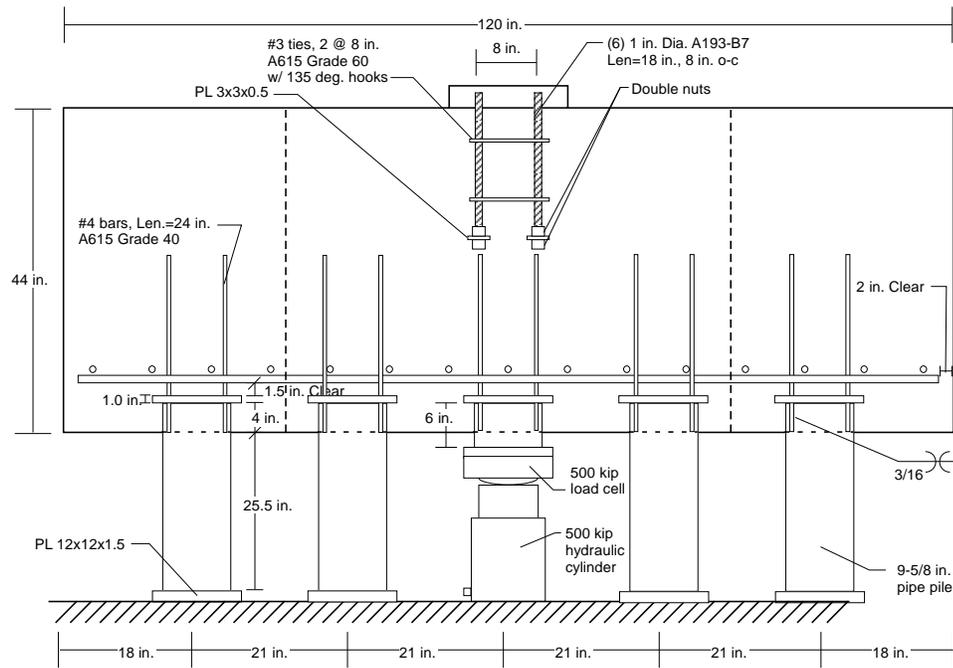
Figure 3.1.5c: Elevation View – Pile Cap #7

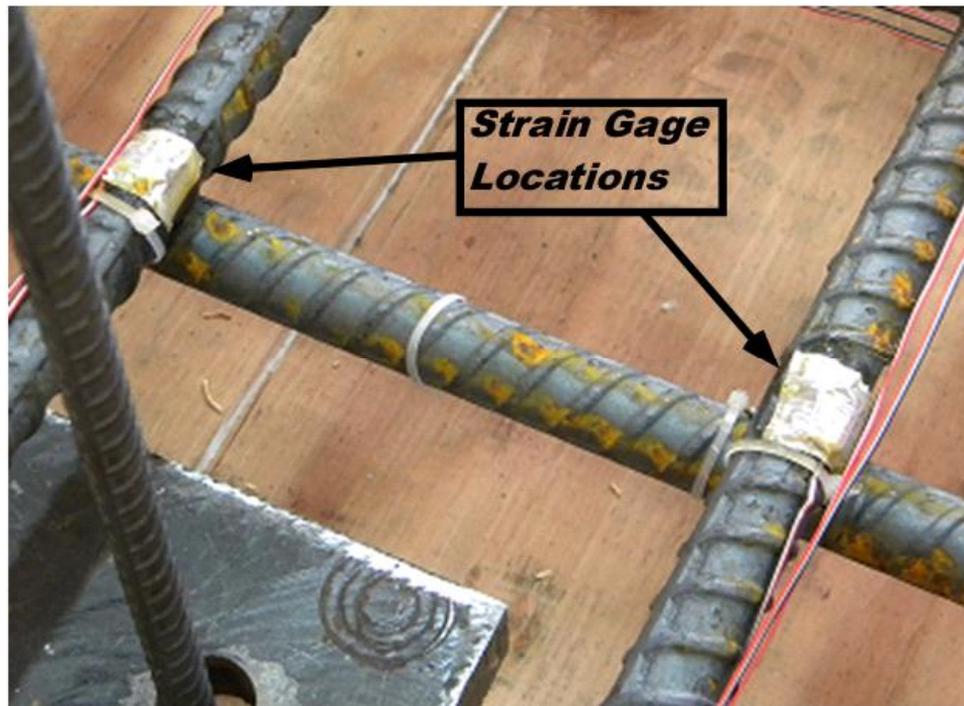
Figure 3.2.1: Example strain gage location on reinforcing bar near bearing plate of pipe pile

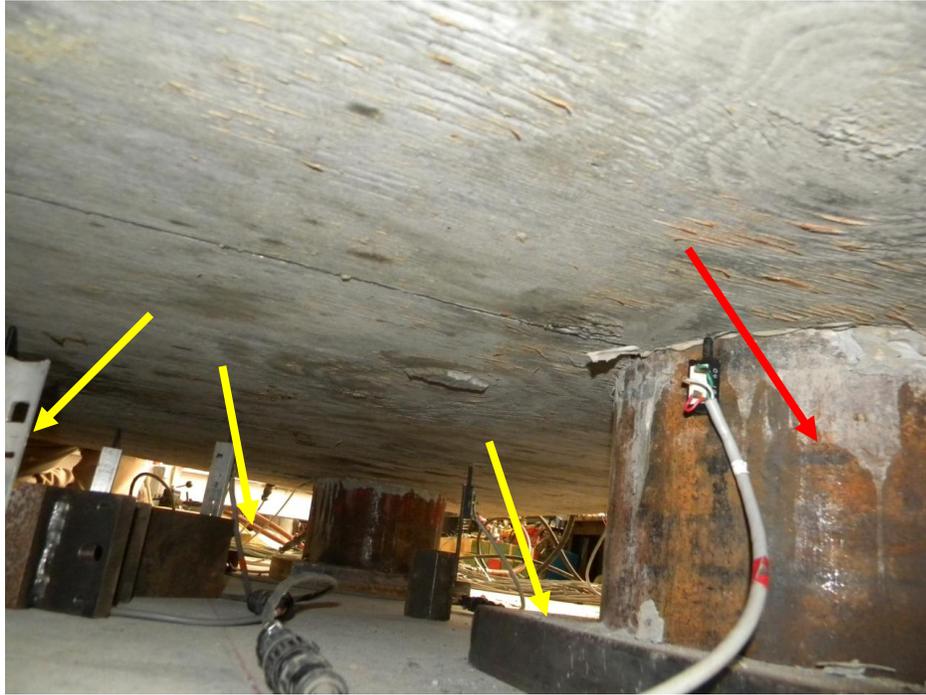
Figure 3.2.3 Example vertical displacement measurements of specimen relative to strong floor (yellow arrows) and pipe motion relative to concrete (red arrow)

In addition to reinforcement slip, displacement sensors were placed on the specimens to measure vertical displacement relative to the strong floor at selected locations as illustrated in Fig. 3.2.3. Instrumentation plans for all 4 pile caps can be found in Figs. 3.2.4 to 3.2.7.

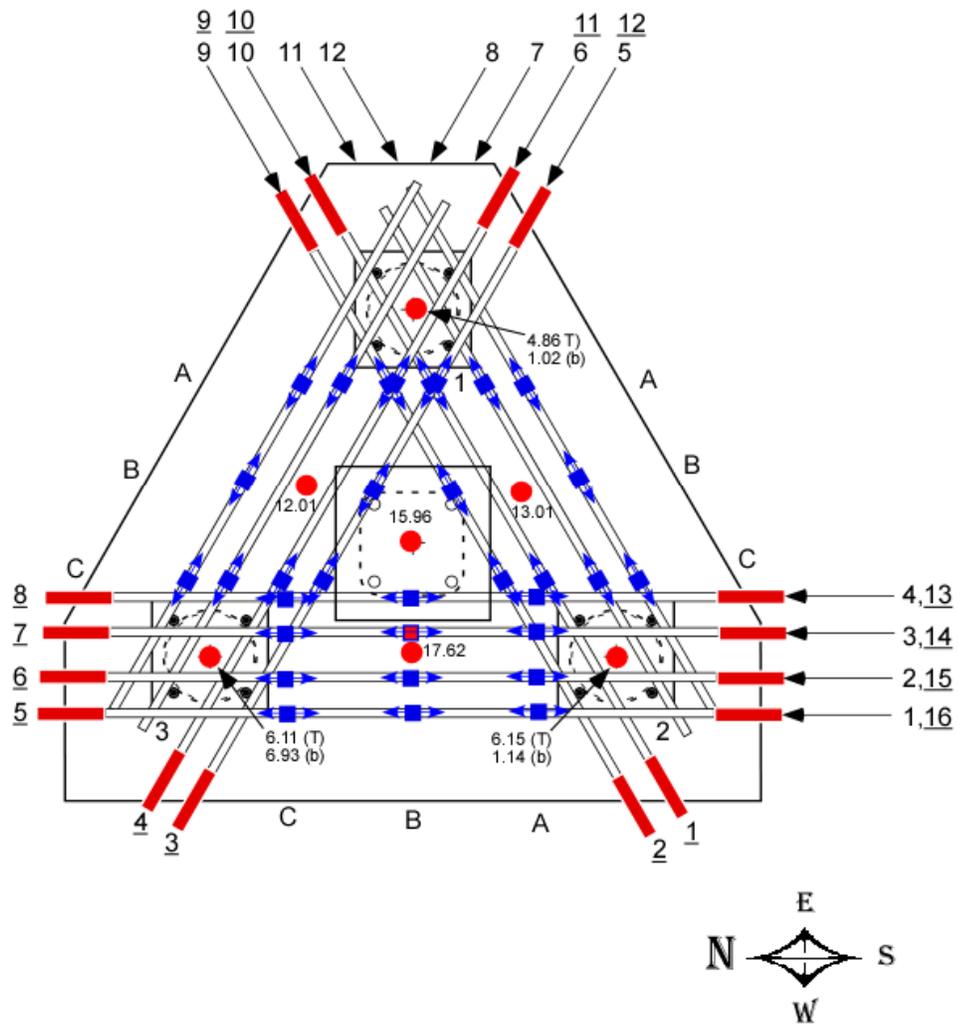
*Bars designated by plain numbering, underlined numbers represent instrumentation locations

- Displacements (10 total, 7 relative to strong floor, 3 on piles)
- Reinforcing bar end slip (16 relative to concrete surface)
Designation - Underlined number
- Uniaxial strain gages on reinforcing bars (28 totals, arrow shows orientation)
Designation- Bar then location relative to A,B,C (when only two, A and B only)
- Damaged during Construction

Figure 3.2.4: Instrumentation plan for specimen #3

instrumentation for each test is as follows: Pile Cap #3 received 32 strain gages, 10 displacement sensors and 16 slip sensors. The gages or gage wires are sometimes damaged as a resultant of concrete placement. When this occurs, the sensor can no longer be used to collect data. For the specimens in this study, the number of gages damaged was relatively small. Only 1 strain gage was damaged during construction of Pile cap #3. Pile Cap #4 received 34 strain gages, 13 displacement sensors and 16 slip displacement sensors. Three of the 34 strain gages in Pile Cap #4 were damaged during construction. Pile Cap #5 received 38 strain gages, 13 displacement sensors and 18 slip displacement sensors. Three strain gages were damaged during construction. Pile Cap #7 was instrumented with 34 strain gages, 13 displacement sensors and 21 slip sensors. Three strain gages were damaged during construction of Pile Cap #7.

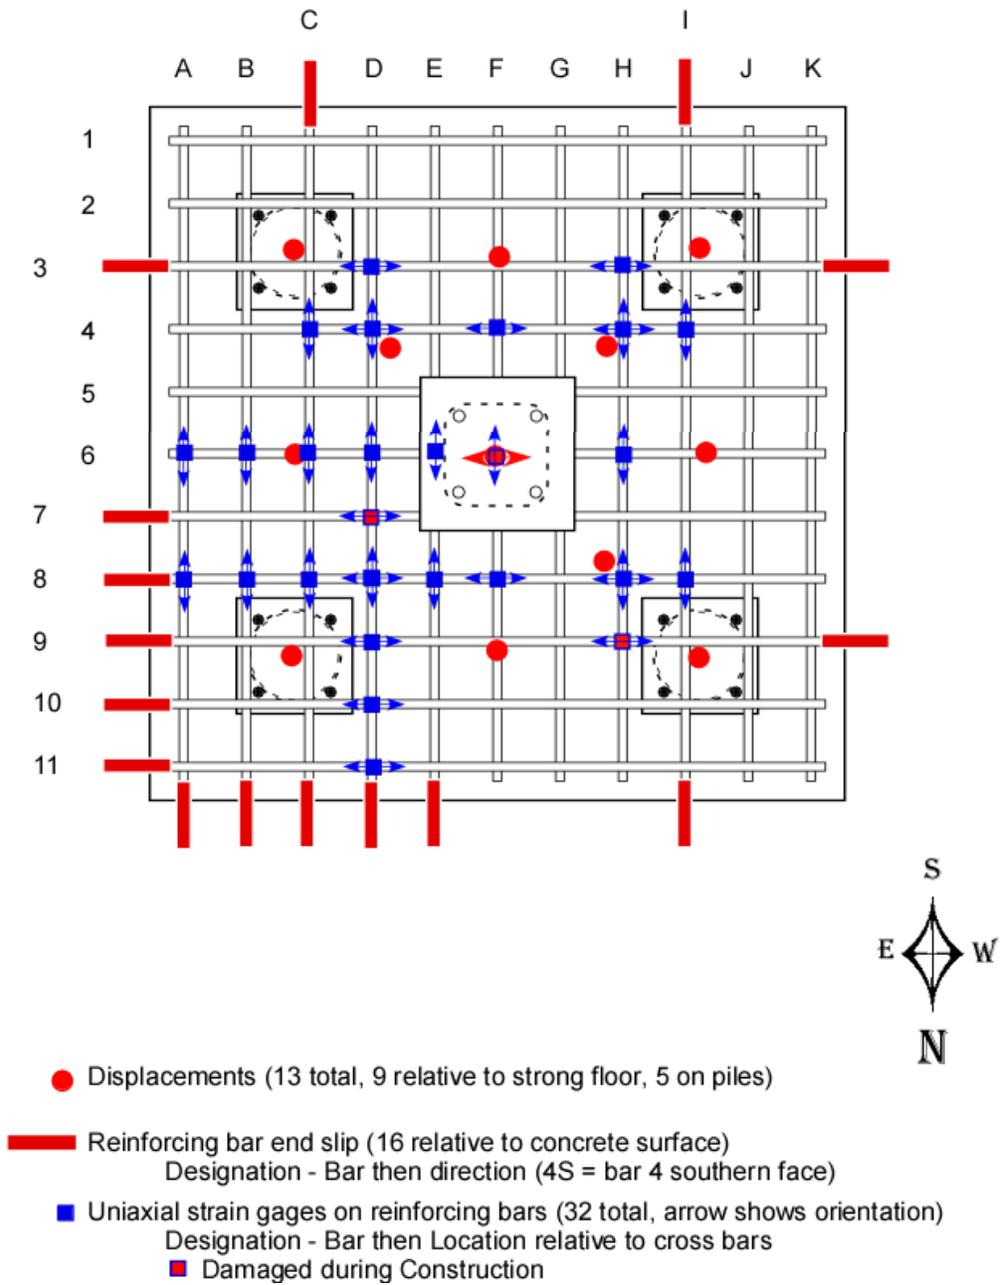
Figure 3.2.5: Instrumentation plan for specimen #4

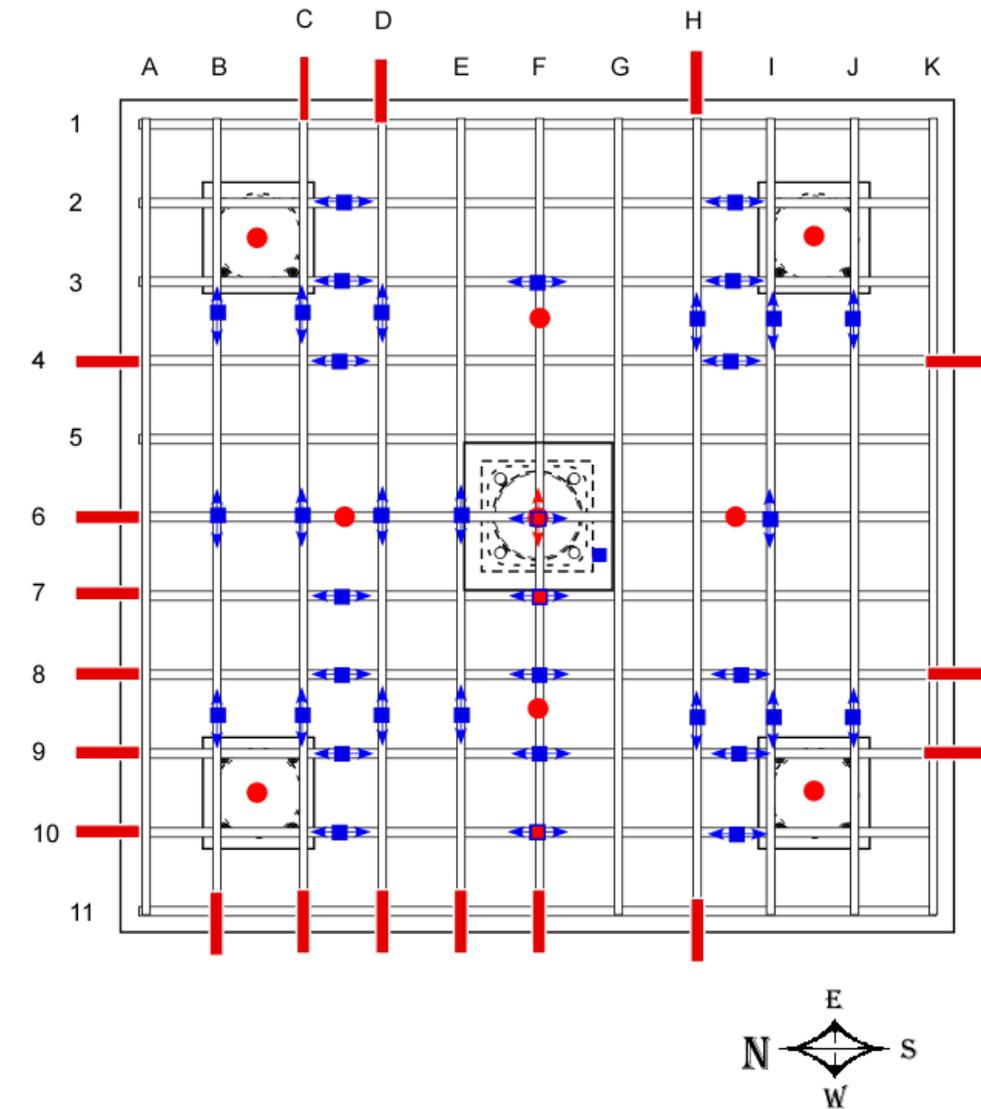
● Displacements (13 total, 9 relative to strong floor, 4 on piles)

■ Reinforcing bar end slip (18 relative to concrete surface)
Designation - Bar then direction (4S = bar 4 southern face)

■ Uniaxial strain gages on reinforcing bars (38 total, arrow shows orientation)
Designation - Bar then Location relative to cross bars
■ Damaged During Construction

Figure 3.2.6: Instrumentation plan for specimen #5

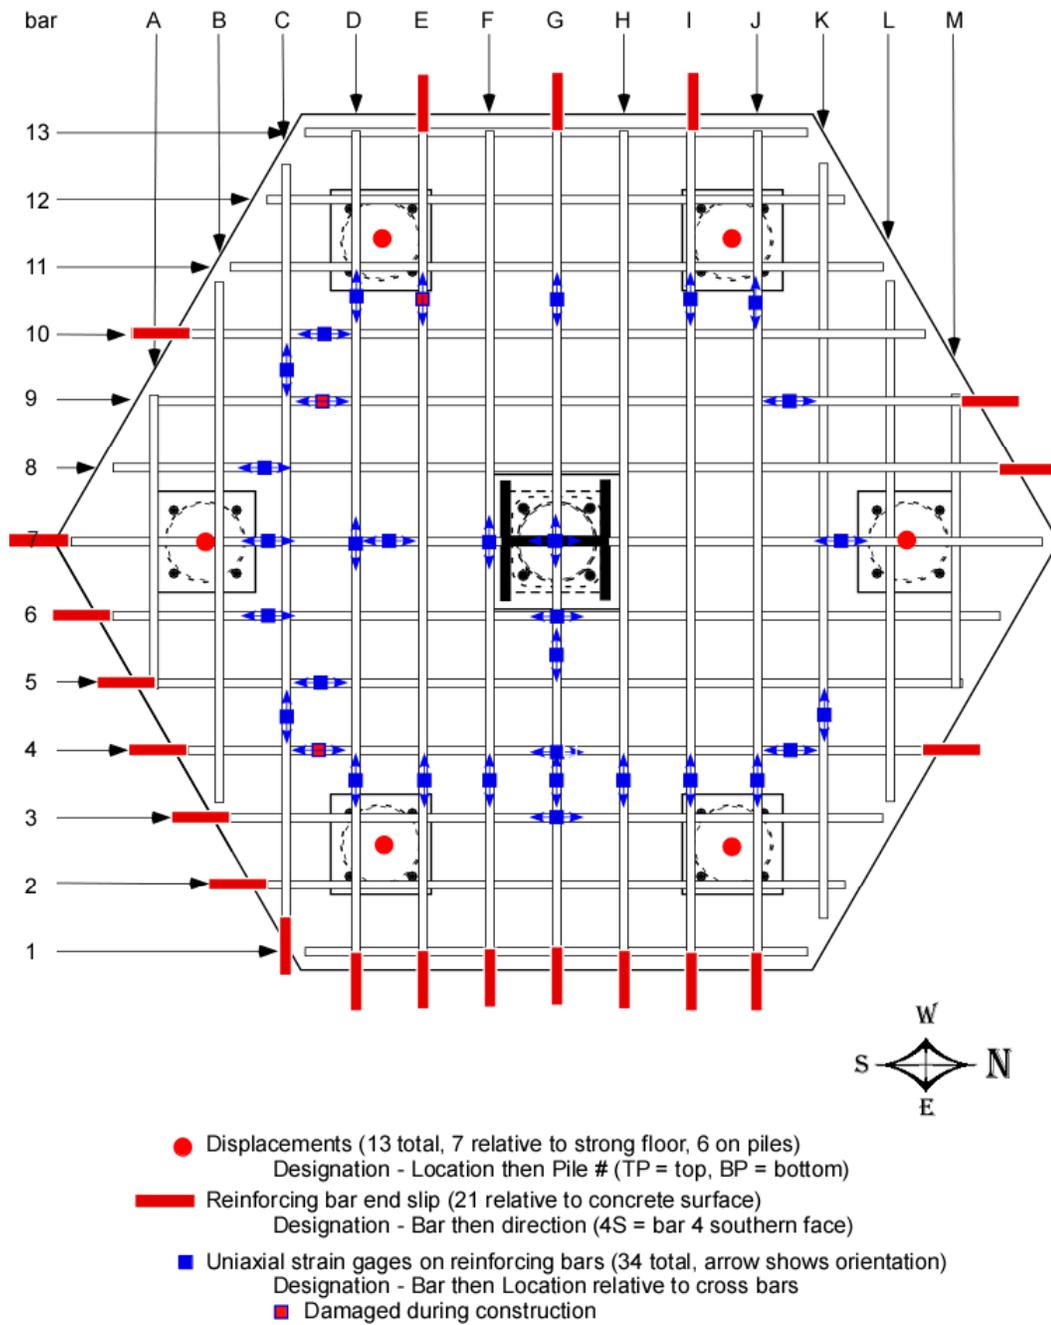
Figure 3.2.7: Instrumentation plan for specimen #7

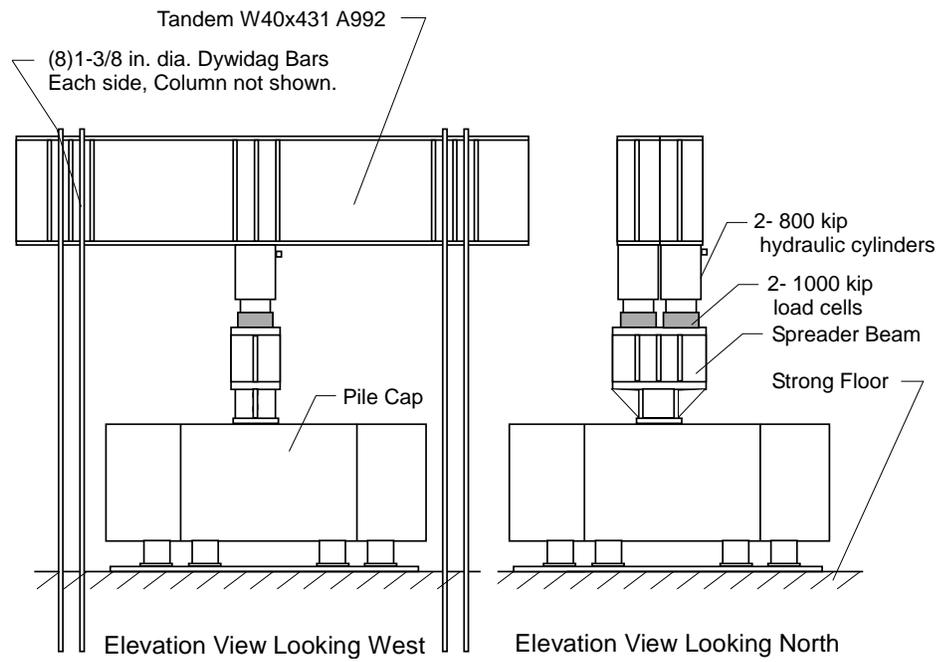
Figure 3.3.1: Schematic of test setup

Load was applied using two 3559 kN (800 kip) nominal capacity hydraulic cylinders. Load was measured directly with load cells placed in series with the hydraulic cylinders. The applied load was transmitted to a spreader beam which reacted against a W14x99 profile attached to a 7.6 cm (3 in.) thick steel bearing plate (Fig. 3.3.3). The bearing plate was placed on the concrete pile cap surface and grouted with hydrostone.

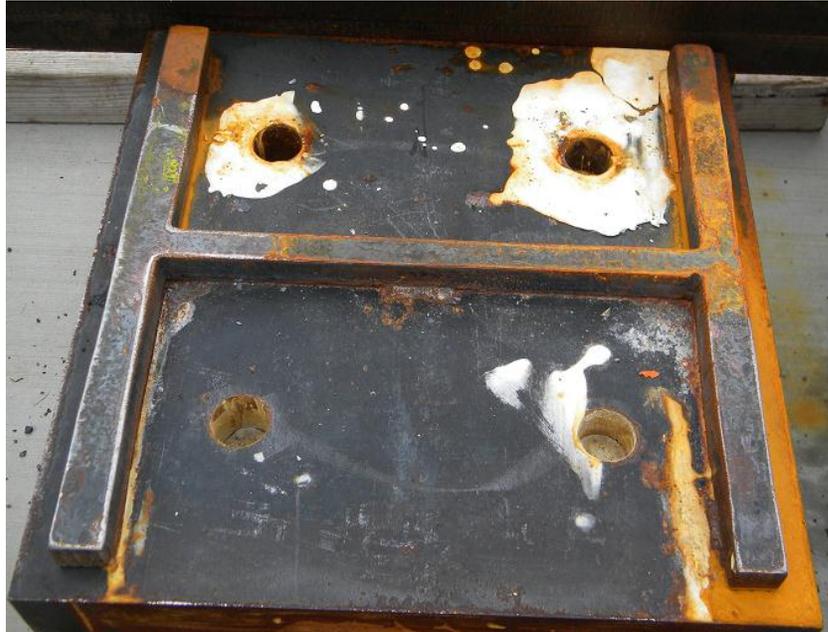
Figure 3.3.3: W14x99 profile attached to 3 in. bearing plate (note: white material is hydrostone used to grout baseplate)

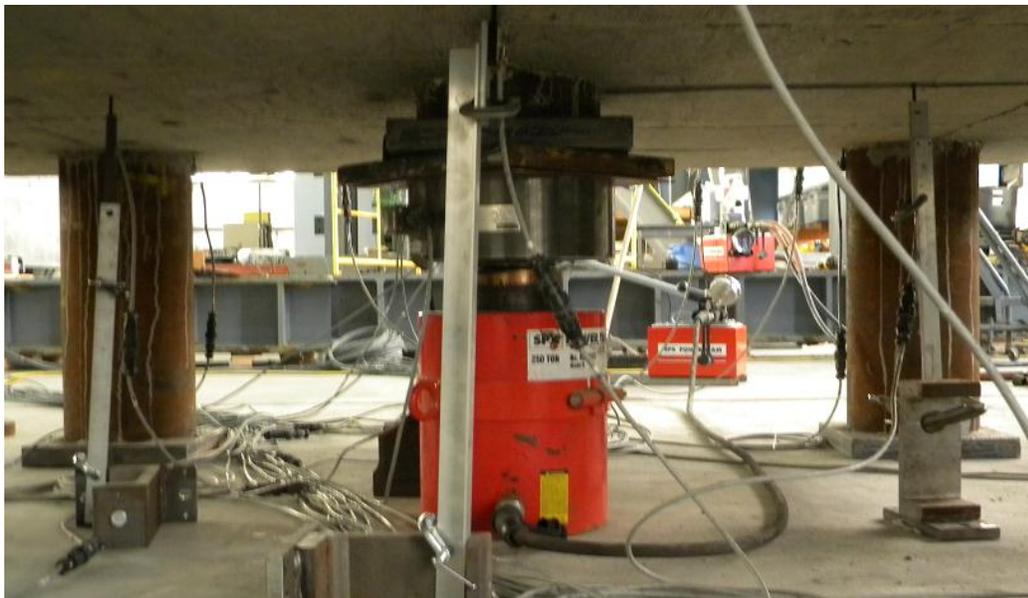
Figure 3.3.4: Hydraulic Cylinder and Load cell for center pile control with specimen #5

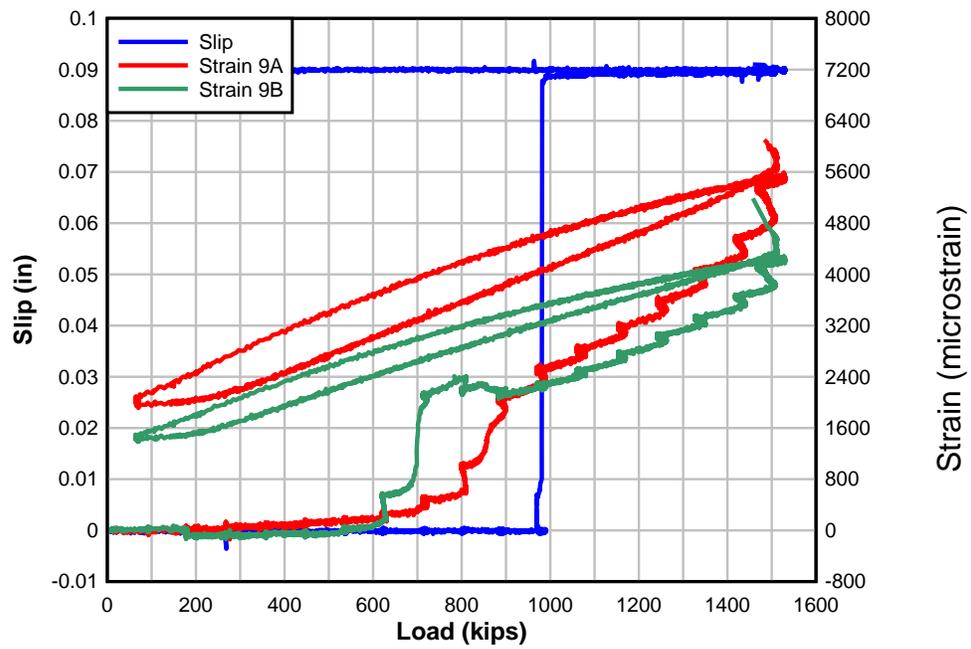
Figure 4.1: Example of spurious slip data due to concrete cracking affecting the instrumentation mount.

Reinforcement slip was monitored for several reinforcement bars in each specimen. Some measurable slip was observed for each of the specimens as described subsequently. To describe the slip and bond behavior of reinforcing steel, early studies commonly reported test results as the slip of the reinforcing bar at maximum load or stress, or the force or stress in the bar at a particular slip value. The common slip value used in the archival literature was 2.54 mm (0.01 in.) and was taken either at the loaded or unloaded end of the bar. It is important to recognize that much of the archival work was concerned with working stress conditions and the 2.54 mm (0.01 in.) slip value may not correspond to any particular limit state. However it does serve as an historical reference value and thus was chosen for use in this report as a reference value to distinguish slip at the ends of the reinforcing bars relative to the concrete surface. There were some instances where concrete cracking disturbed the instrument mounting and caused a jump in the sensor output. An example of this is shown in Fig. 4.1. As seen in this figure, after the observed jump the reinforcing bar does not show further slip even as the applied load increases. There were other instances where the sensors debonded from the concrete surface during testing. These

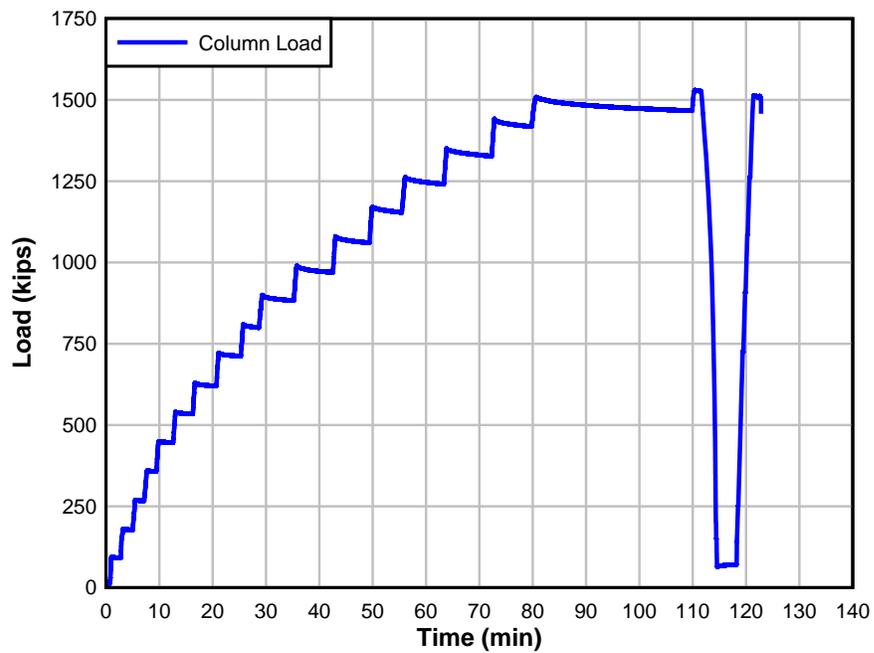
Figure 4.2: Column load vs. Time – Pile Cap #3

Pile Cap #3 was tested on May 23, 2011. The applied load history is shown in Fig. 4.2. The load- vertical displacement of the specimen (under the column load) is shown in Fig. 4.3. The specimen developed cracks at approximately 2891 kN (650 kips) and was loaded to the capacity of the hydraulic system, approximately 1530 kips. Failure was not reached at this load. The specimen was then unloaded. Upon unloading the specimen, additional cracks were observed at the top surface of the concrete pile cap. A map showing the progression of cracks is shown in Fig. 4.4. The specimen was then reloaded. It was able to achieve and briefly sustain a load of 6805 kN (1513 kips) before failure. At failure, the bottom center point of the pile was displaced 0.16 inches relative to the strong floor. The observed failure mode for Pile Cap #3 was one-way shear associated with one of the corner piles as shown in Fig. 4.5. Several locations indicated small amounts of reinforcing slip as seen in Fig. 4.6. The first reinforcing steel slip was observed at a load of 4003 kN (900 kips). None of the slip locations achieved the reference reinforcing bar slip of 2.54 mm

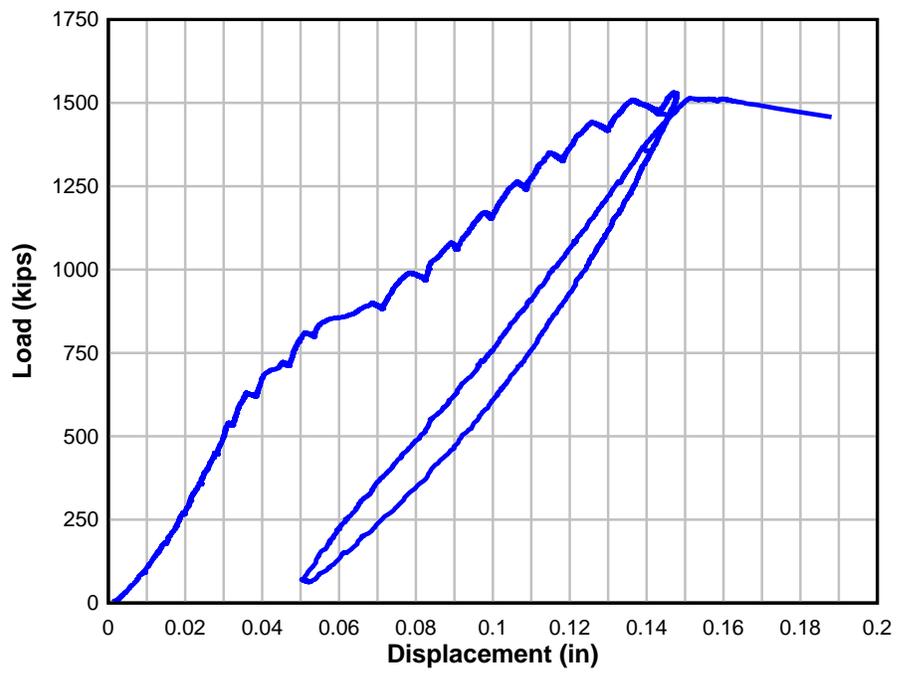
Figure 4.3: Column load vs. Centerline vertical displacement – Pile Cap #3

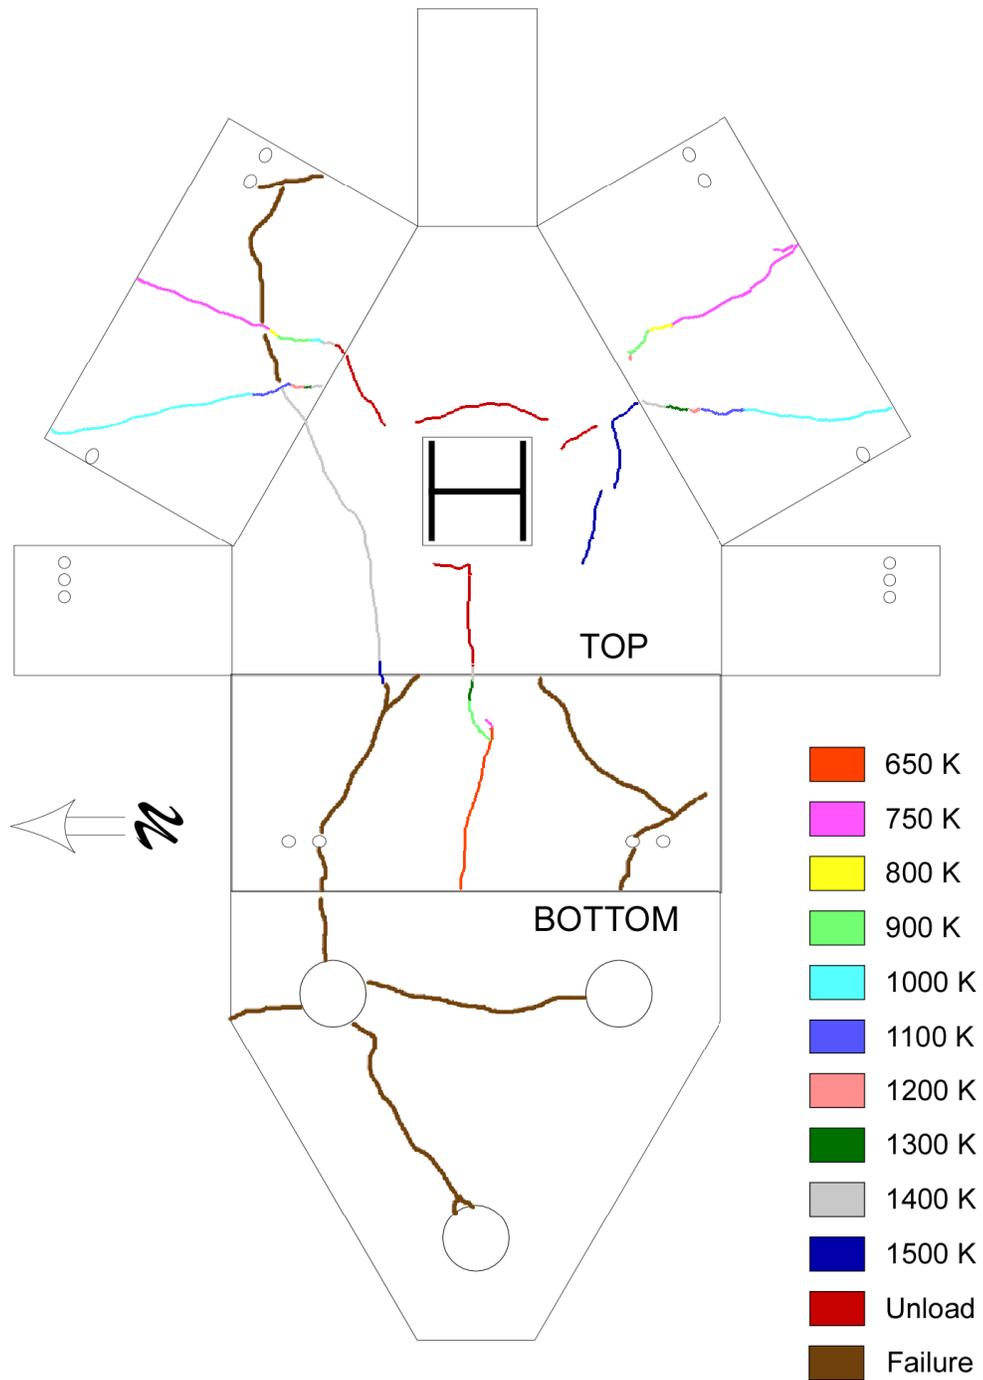
Figure 4.4: Crack maps – Pile Cap #3

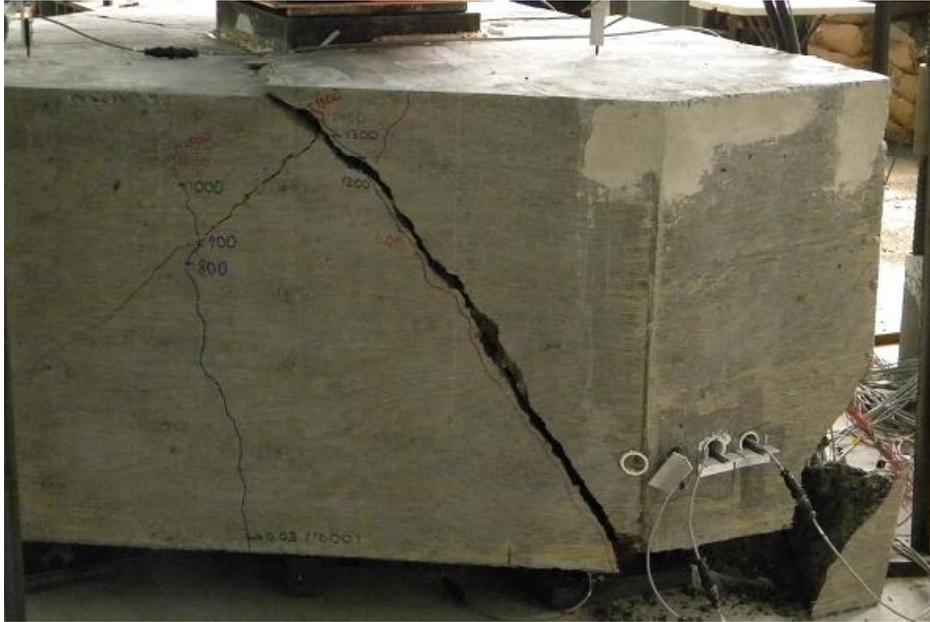
Figure 4.5: Failure of Pile Cap #3

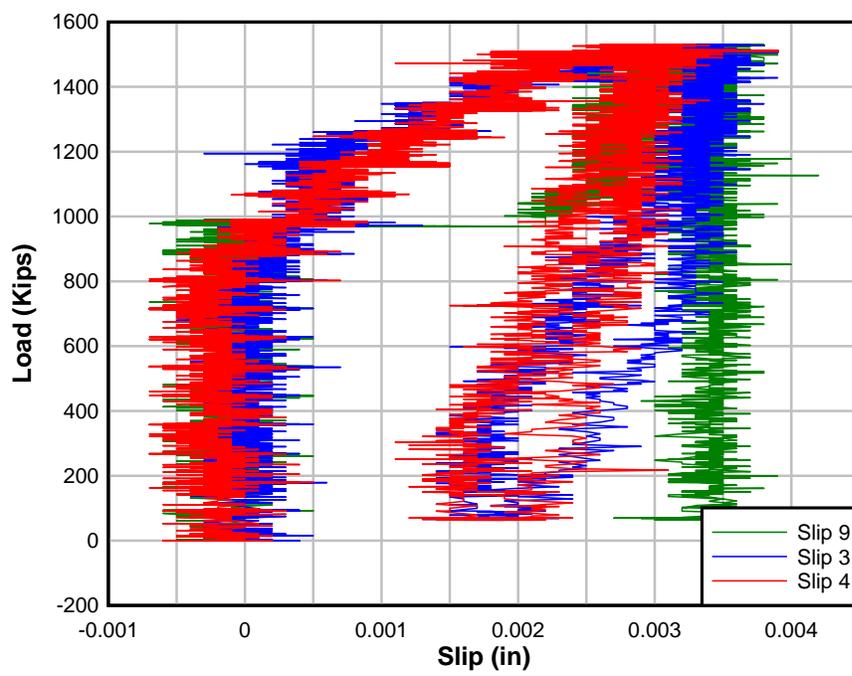
Figure 4.6: Slip of reinforcement – Pile Cap #3

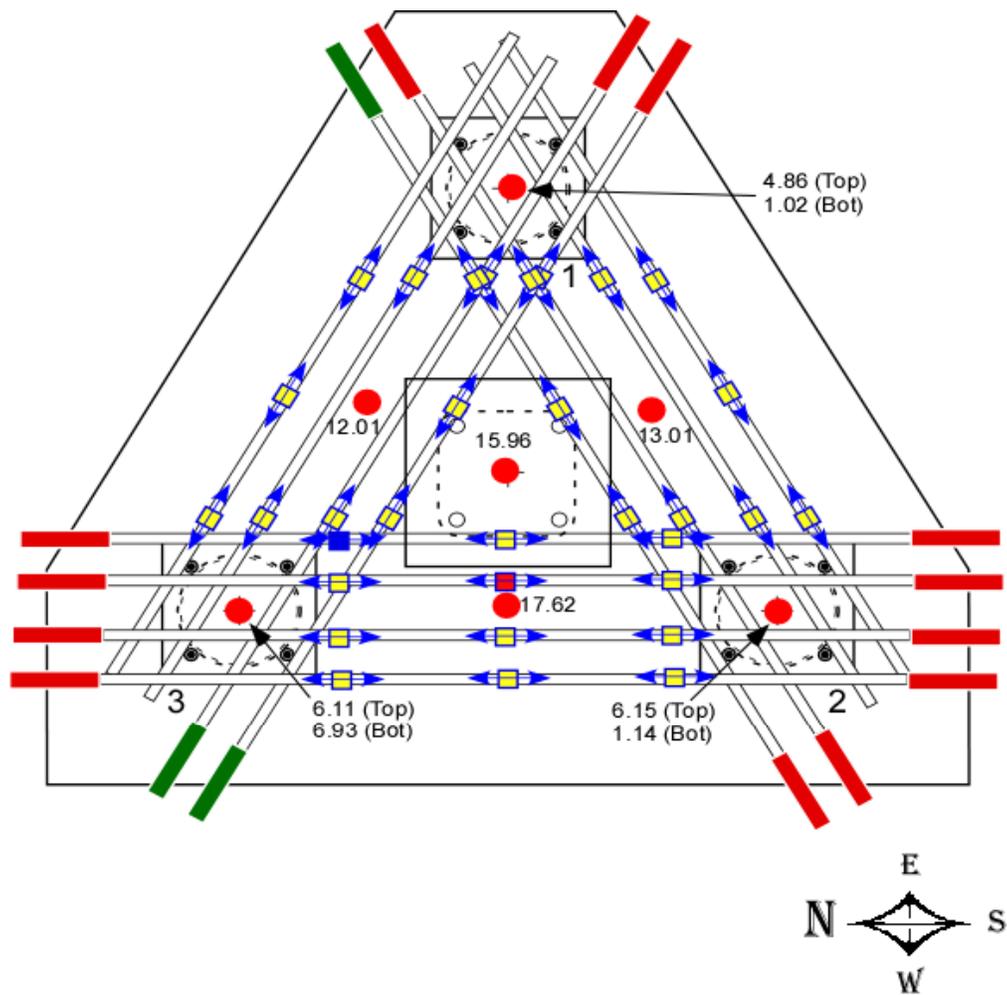
- Displacements just prior to failure (1/100 inches)
- Reinforcing bar end without slip
- Reinforcing bar end with slip
- Uniaxial strain gages on reinforcing bars
 - Damaged during Construction
 - Yielded

Figure 4.7: Conditions at failure for Pile Cap #3

(0.01 in.) The locations of instrumented reinforcing bars at yield when the specimen failed are shown in Fig. 4.7. As seen in the figure, the small amount of rebar slip did not adversely affect the ability of the reinforcing steel to achieve yield across the specimen.

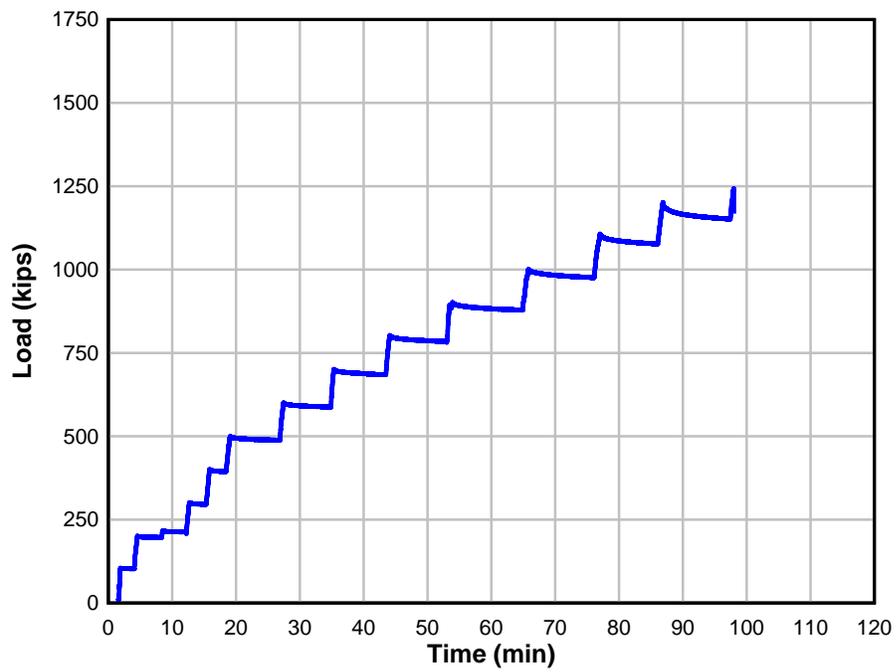
Figure 4.8: Column load vs. Time – Pile Cap #4

Pile Cap #4 was tested on April 22, 2011. The applied load history is shown in Fig. 4.8. The load-centerline vertical displacement of the specimen is shown in Fig. 4.9. Initial cracking was observed at an applied load of approximately 2224 kN (500 kips) and cracks were observed on all four sides of the specimen. The load was increased until failure a peak load of 5530 kN (1243 kips). At failure, the bottom center point of the pile was displaced 50.8 mm (0.20 inches) relative to the strong floor. The observed failure mode for Pile Cap #4 was punching shear of the column base plate through the specimen as shown in Fig. 4.11. Several locations indicated small amounts of reinforcing slip as seen in Fig. 4.12. The slip was first observed at a load of (2224 kN) 500 kips. Only four locations achieved the reference slip of 2.54 mm (0.01 in.), the earliest at a load of 4450 kN (1000 kips). The locations of instrumented reinforcing bars at yield when the specimen failed are shown in Fig. 4.13. As seen here, the small amount of rebar slip did not adversely affect the ability of the reinforcing steel to achieve yield across the specimen.

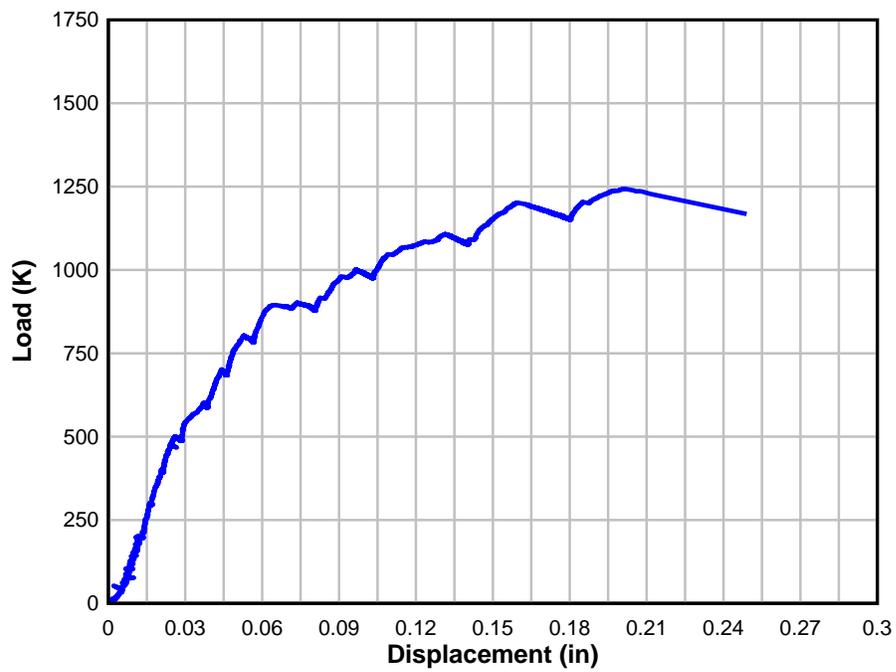
Figure 4.9: Column load vs. Centerline vertical displacement – Pile Cap #4
