Title: Behavior and Analysis of Pile Caps with Poor Anchorage Details.

BEHAVIOR and ANALYSIS of PILE CAPS with POOR ANCHORAGE DETAILS

A THESIS

Oregon State University

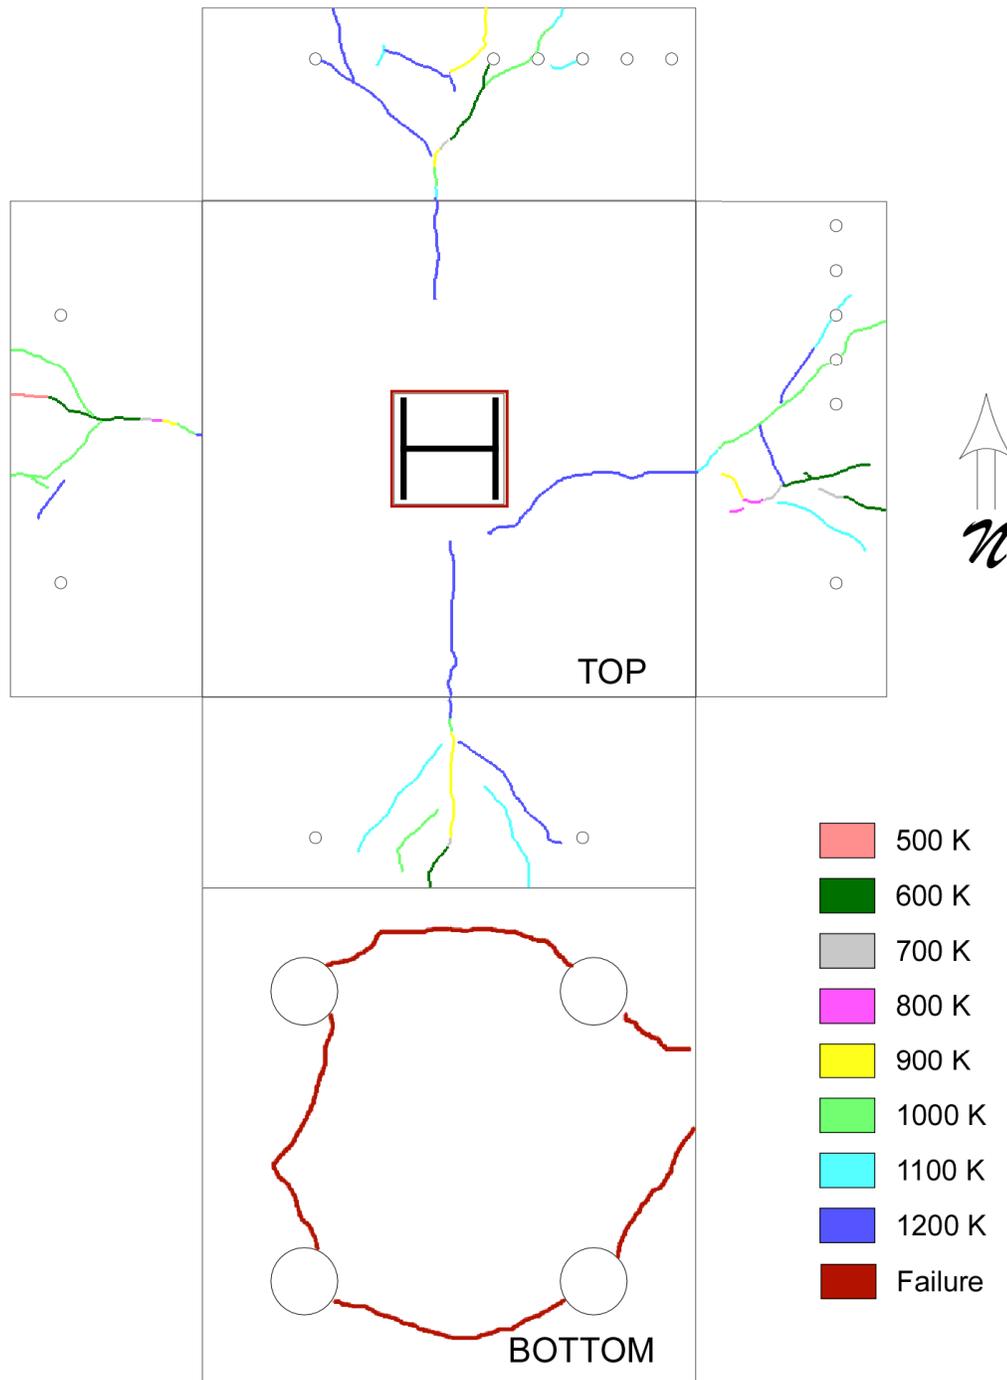
Figure 4.10: Crack maps – Pile Cap #4

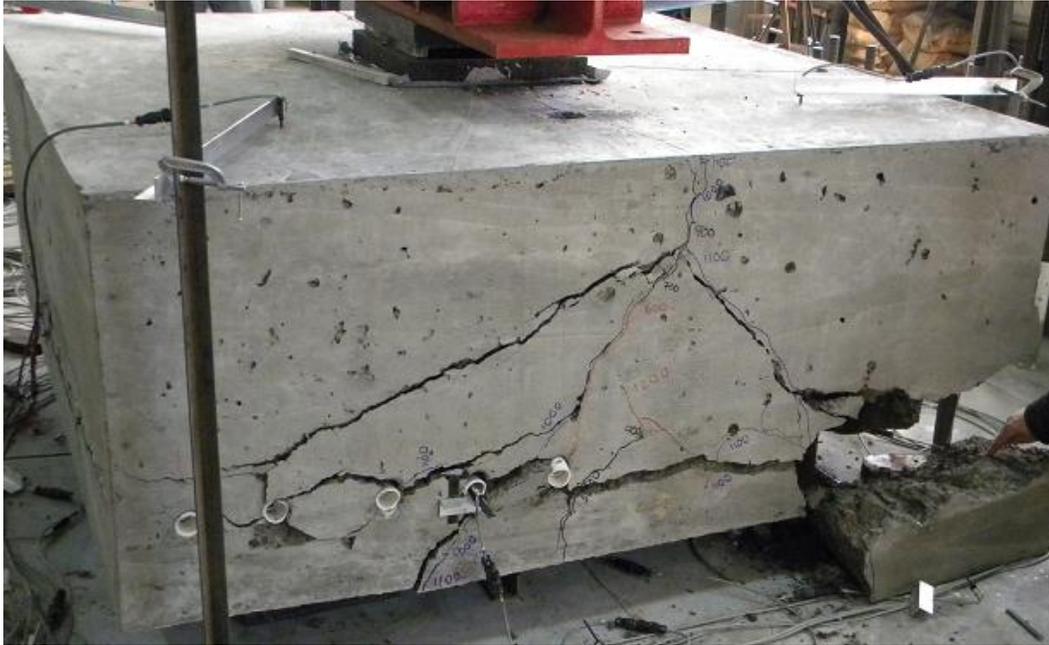
Figure 4.11a: Failure of Pile Cap #4

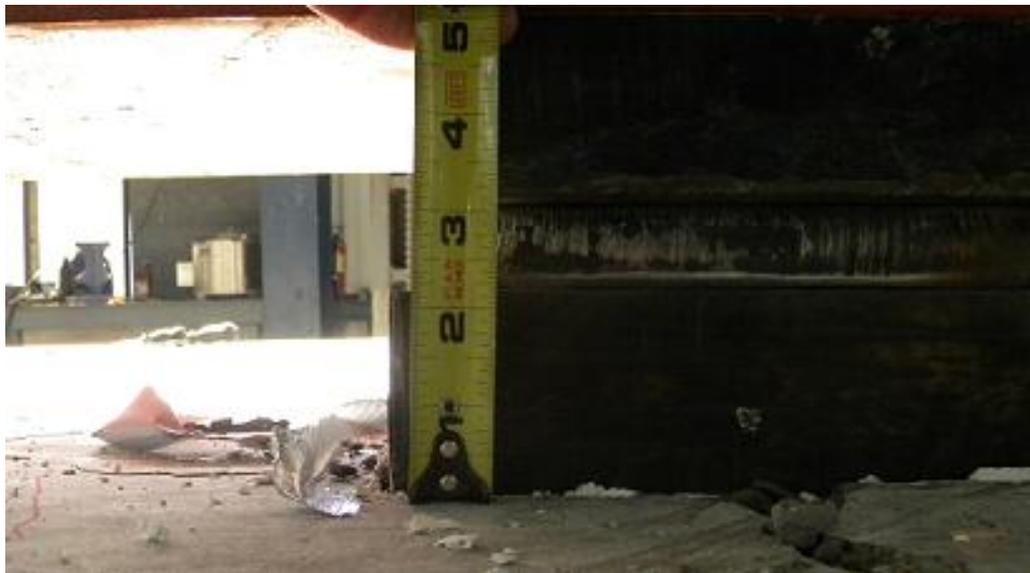
Figure 4.11b: Punching of 3 in. thick bearing plate at failure of Pile Cap #4

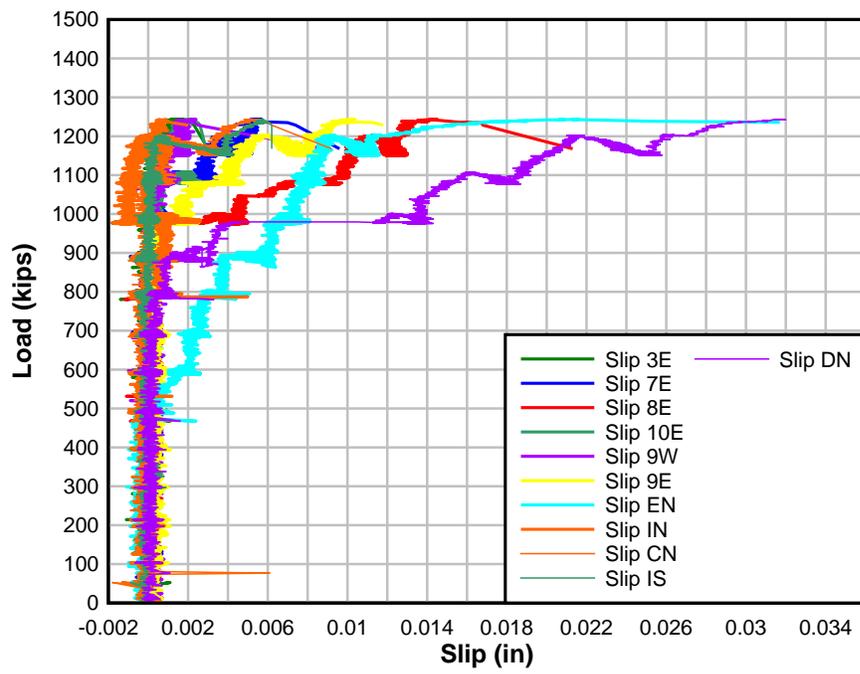
Figure 4.12: Slip of reinforcement – Pile Cap #4

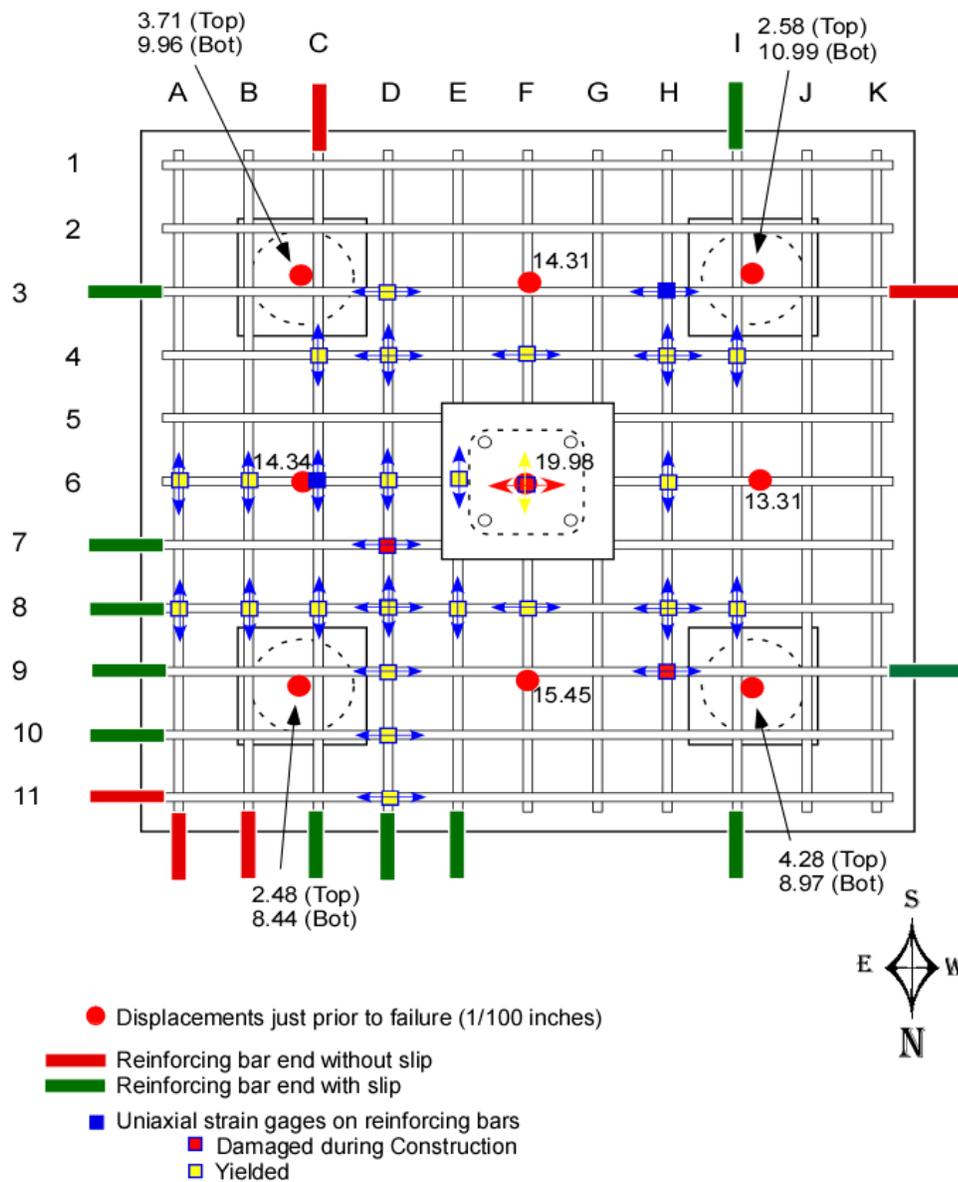
Figure 4.13: Conditions at failure for Pile Cap #4

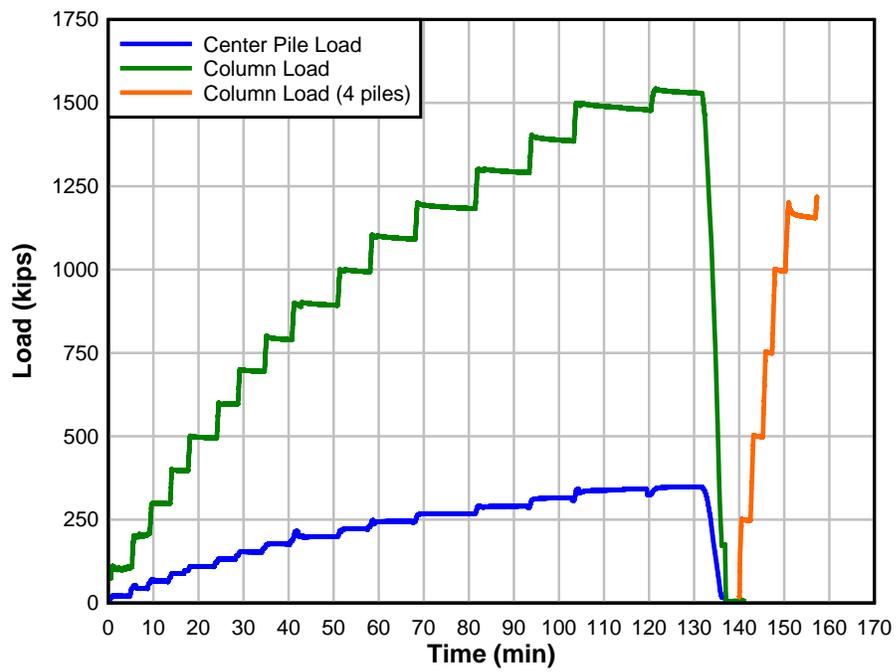
Figure 5.14: Column load vs. Time – Pile Cap #5

was conducted in two parts: 1) the center pile was active and 2) the center pile was removed. The applied load history is shown in Fig. 4.14 with the center pile load also shown in this figure. The load-centerline vertical displacement of the specimen is shown in Fig. 4.15. During part 1, the specimen did not fail and the limits of the hydraulic loading system were reached at a maximum load of 6859 kN (1542 kips). The center displacement observed at this load was 27.4 mm (0.108 in.) at around 2224 kN (500 kips), initial cracking was observed on the southern face however it wasn't until approximately 4003 kN (900 kips) that cracking was observed on all 4 sides of the specimen. Observed crack patterns and corresponding loads are shown in Fig. 4.16. The first slip readings were recorded at 5960 kN (890 kips) however it wasn't until 6228 kN (1400 kips) that the reference slip of 2.54 mm (0.01 in.) was reached.

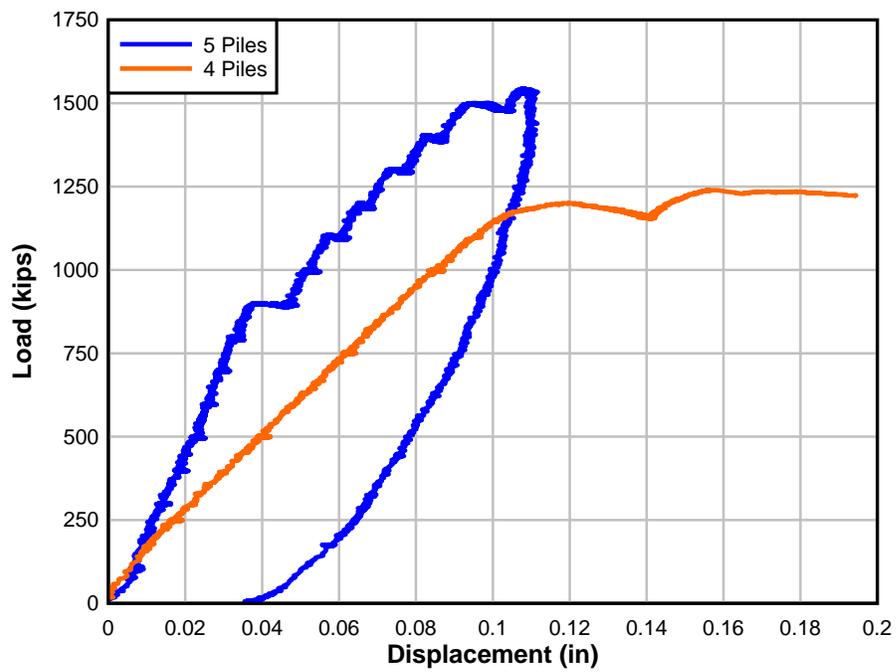
Figure 4.15: Column load vs. Centerline vertical displacement – Pile Cap #5

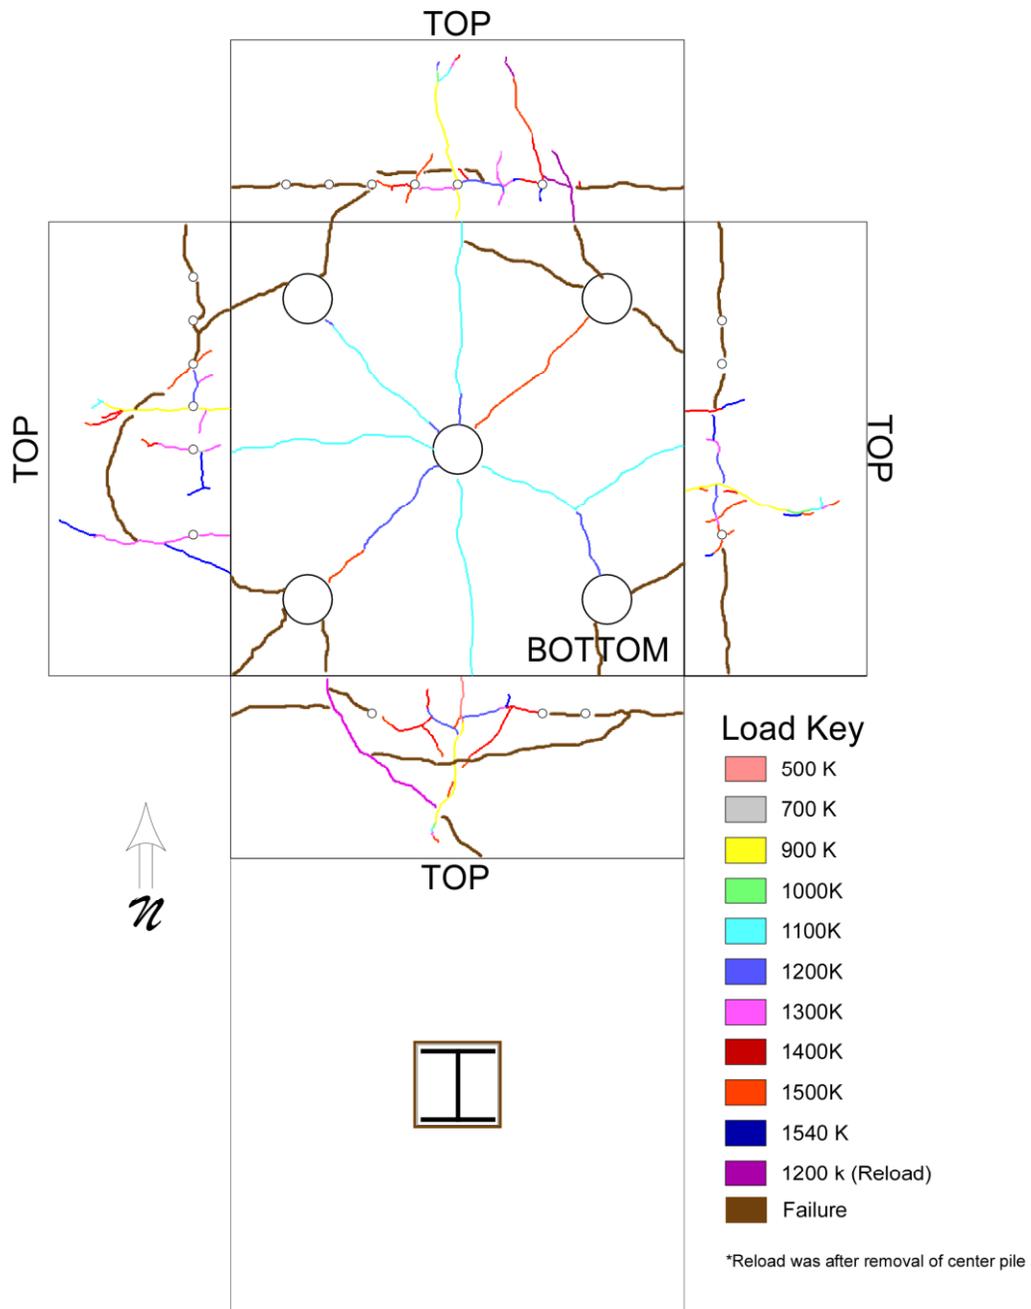
Figure 4.16: Crack maps – Pile Cap #5

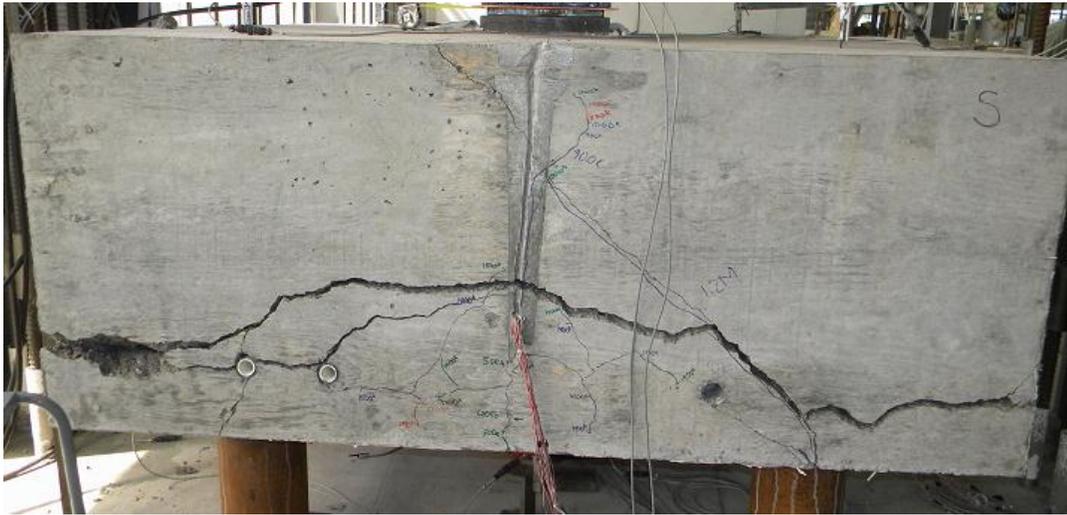
Figure 5.17a: Failure of Pile Cap #5

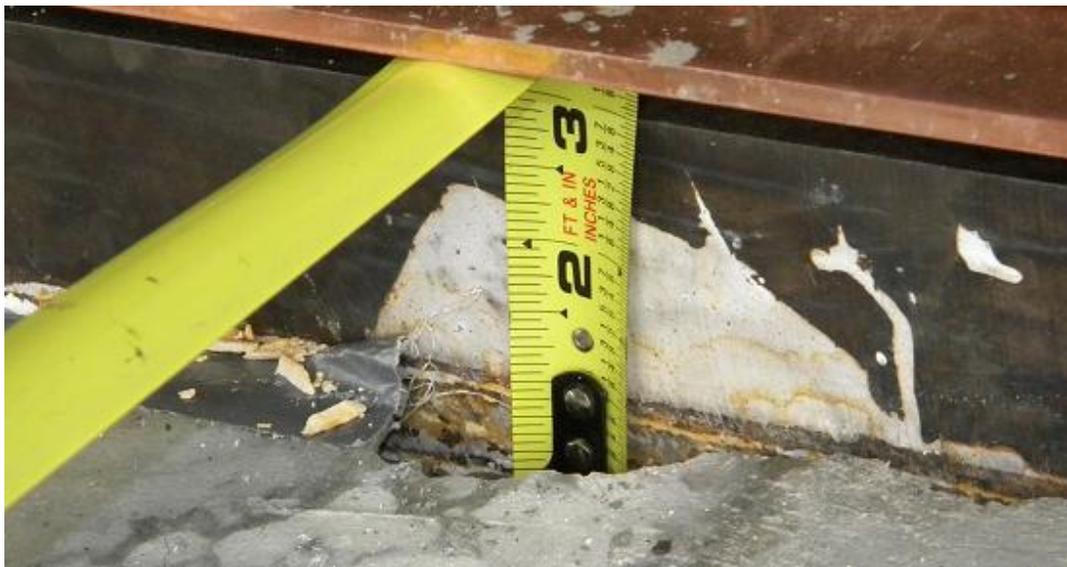
Figure 4.17b: Punching of 3 in. thick bearing plate at failure of Pile Cap #5

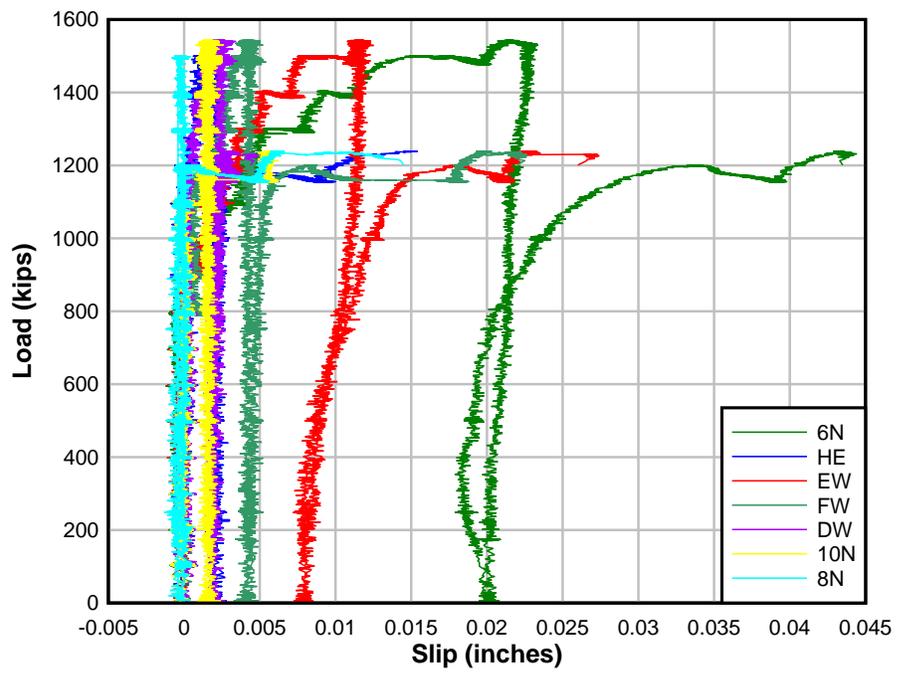
Figure 4.18: Slip of reinforcement – Pile Cap #5

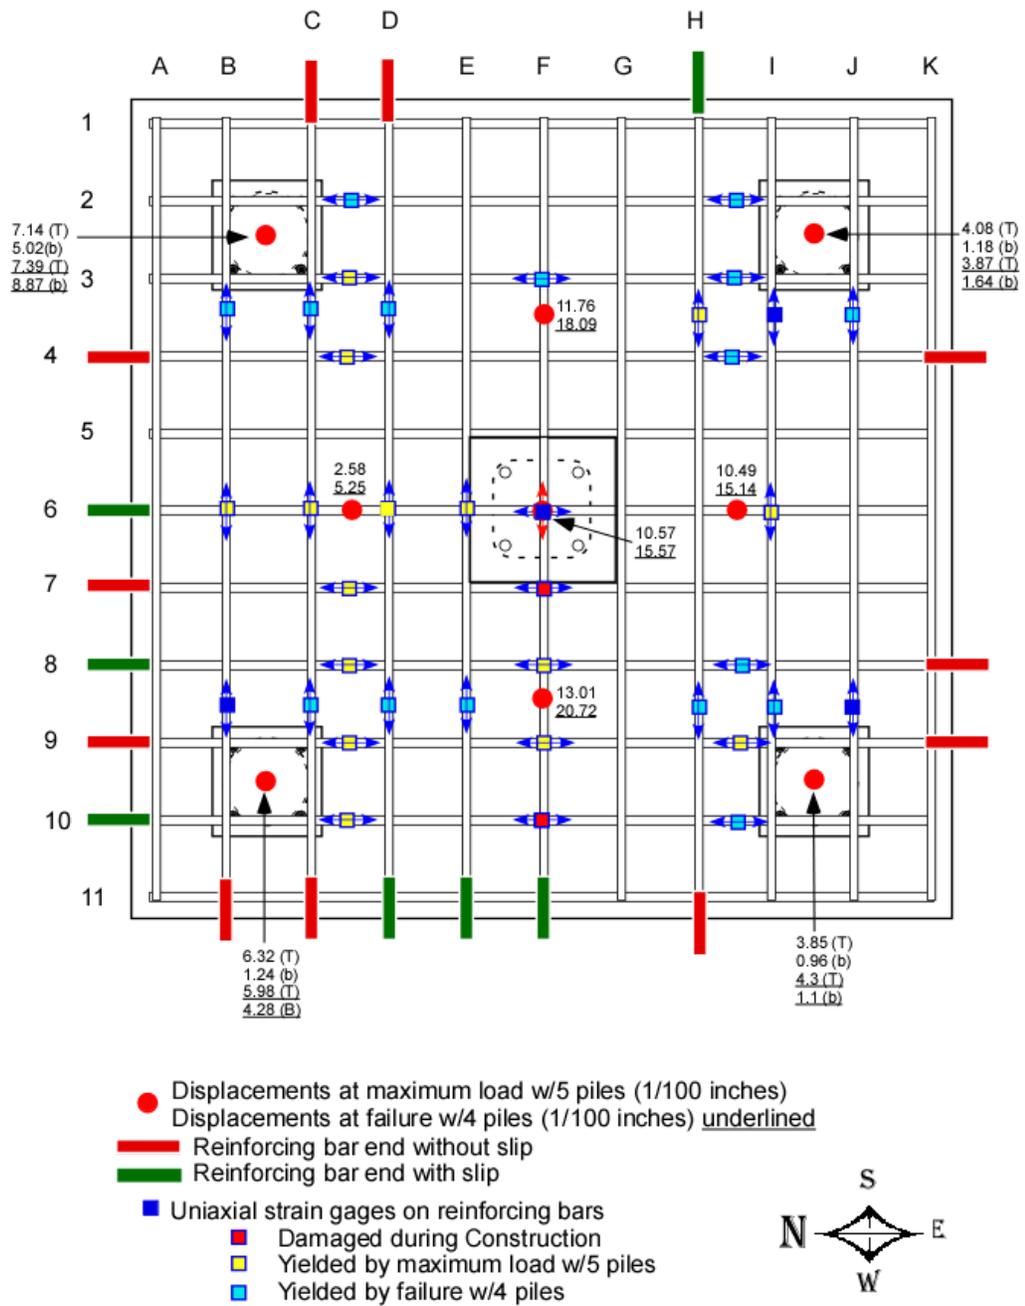
Figure 4.19: Conditions at failure for Pile Cap #5

After reaching the limits of the hydraulic loading system, the applied load was taken off the specimen and the center pile was removed. Then the test repeated. The applied load history for this part is also shown at the end of Fig. 4.13. The applied load-vertical deformation at the center of the pile cap is also included in Fig. 4.14. The load was increased until failure at a peak load of 5511 kN (1239 kips). The specimen was softer and exhibited more distributed and wider cracking with the center pile removed as seen in Fig. 4.16. At failure, the bottom center point of the pile was displaced 40.6 mm (0.16 in.) relative to the strong floor. The observed failure mode for Pile Cap #5 with the center pile removed was punching shear of the column base plate through the specimen as shown in Fig. 4.17. The same reinforcing bar that indicated small amounts of reinforcing slip with the center pile active showed higher amounts of slip when the pile was removed as seen in Fig. 4.18. The locations of instrumented reinforcing bars at yield are shown in Fig. 4.19.

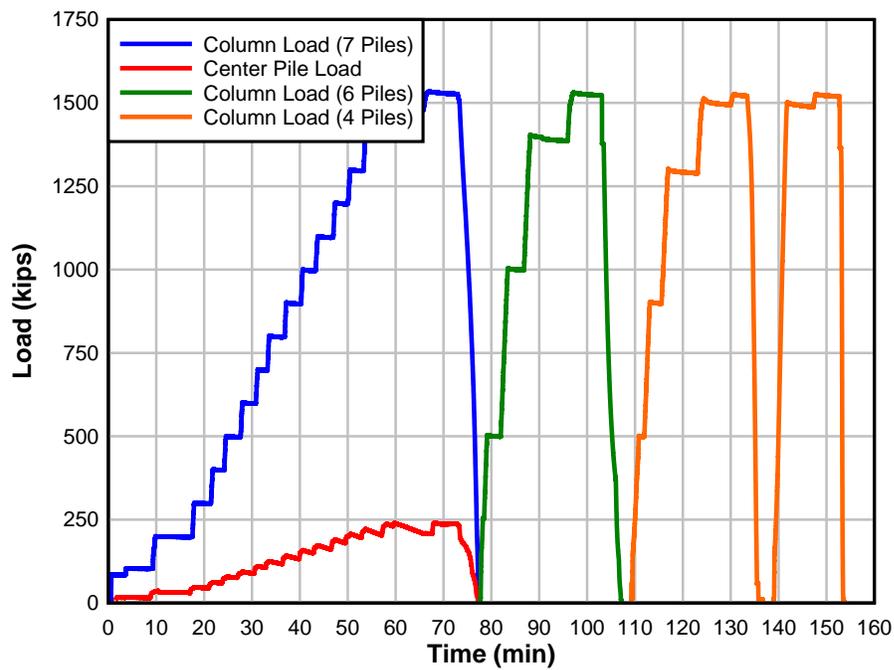
Figure 4.20: Column load vs. Time – Pile Cap #7

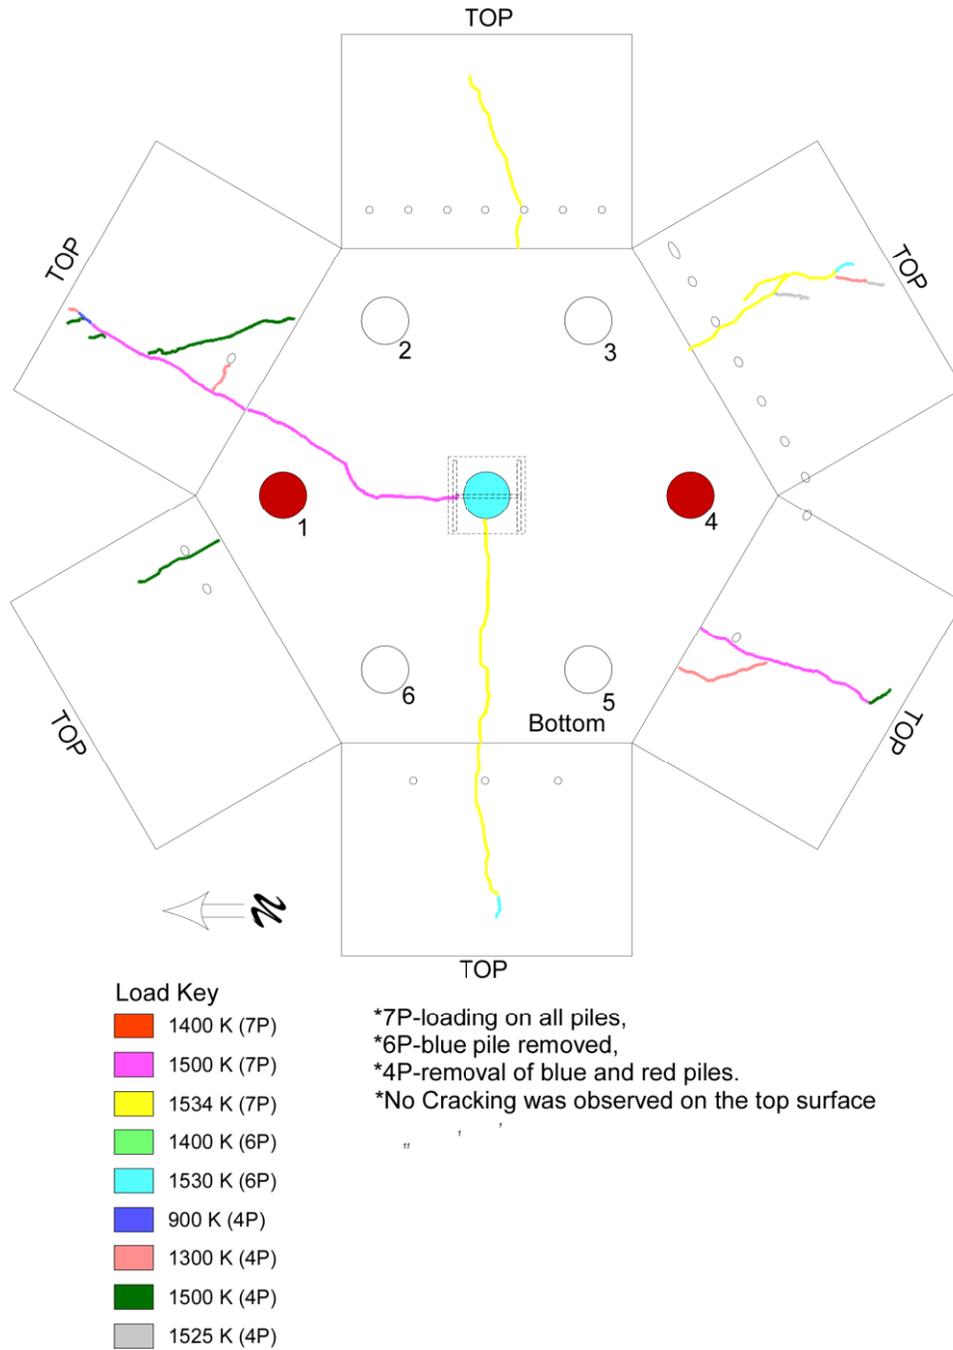
Figure 4.22: Crack maps – Pile Cap #7

and the test repeated as Part 2. The data for Part 2 are shown in the same figures as those in Part 1. Additional cracking and deformations were observed for the specimen during Part 2 of the test as seen in Fig. 4.22. Again the maximum capacity of the hydraulic loading system was reached and the specimen did not fail. At the maximum applied force of 6810 kN (1531 kips), the center displacement was 16 mm (0.063 in.) (initial point was reset to zero). In this configuration, the reference slip was reached in 2 bars at approximately 6228 kN (1400 kips). After reaching the limits of the hydraulic loading system, the load was again removed and then two piles were cut off as seen in Fig. 4.24. These were the northern most and southernmost piles (labeled 1 and 4 in Fig. 3.7). This was Part 3 of the test and the load was again applied to the specimen. The limit of the hydraulic loading system was again reached without specimen failure. The maximum applied force was 6788 kN (1526 kips) and the center pile cap displacement was 29 mm (0.115 in.) (initial displacement value was reset to zero). The displacements vs. load for all three cases are shown in Fig. 4.21 and the response of the reinforcing bars exhibiting slip is shown in Fig. 4.25. Failure was never reached and thus the failure mode is unknown. The locations of instrumented reinforcing bars at yield during the different parts of the test are shown in Fig. 4.26.

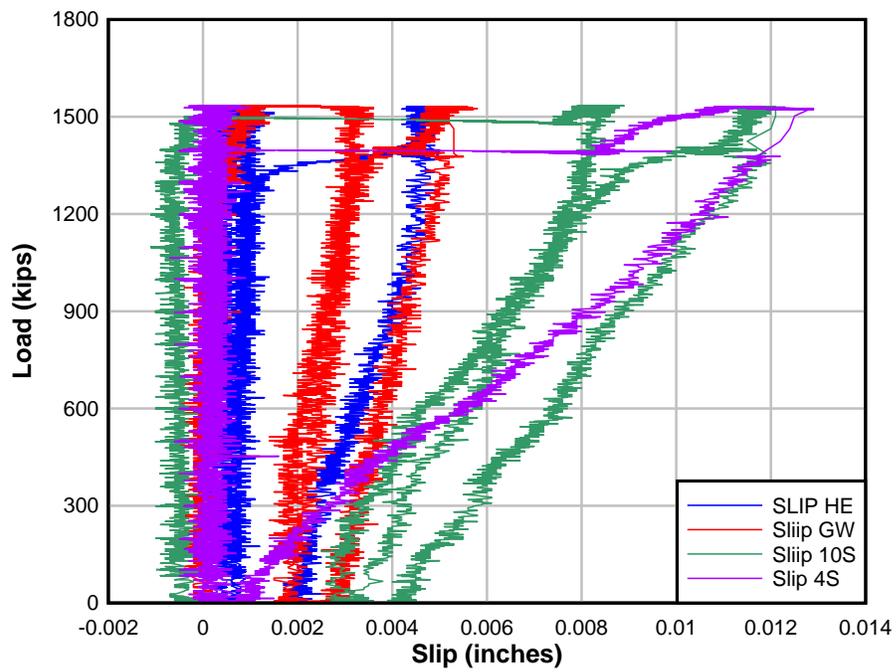
Figure 4.23: Slip of Reinforcement for Pile Cap #7 with 7 and 6 piles intact

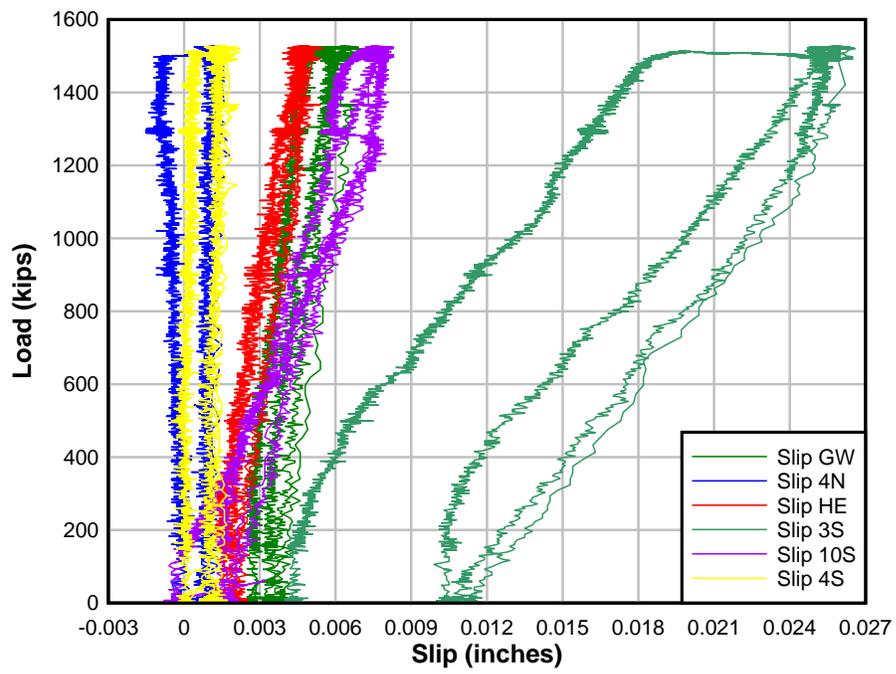
Figure 4.25: Slip of Reinforcement for Pile Cap #7 with 4 piles.

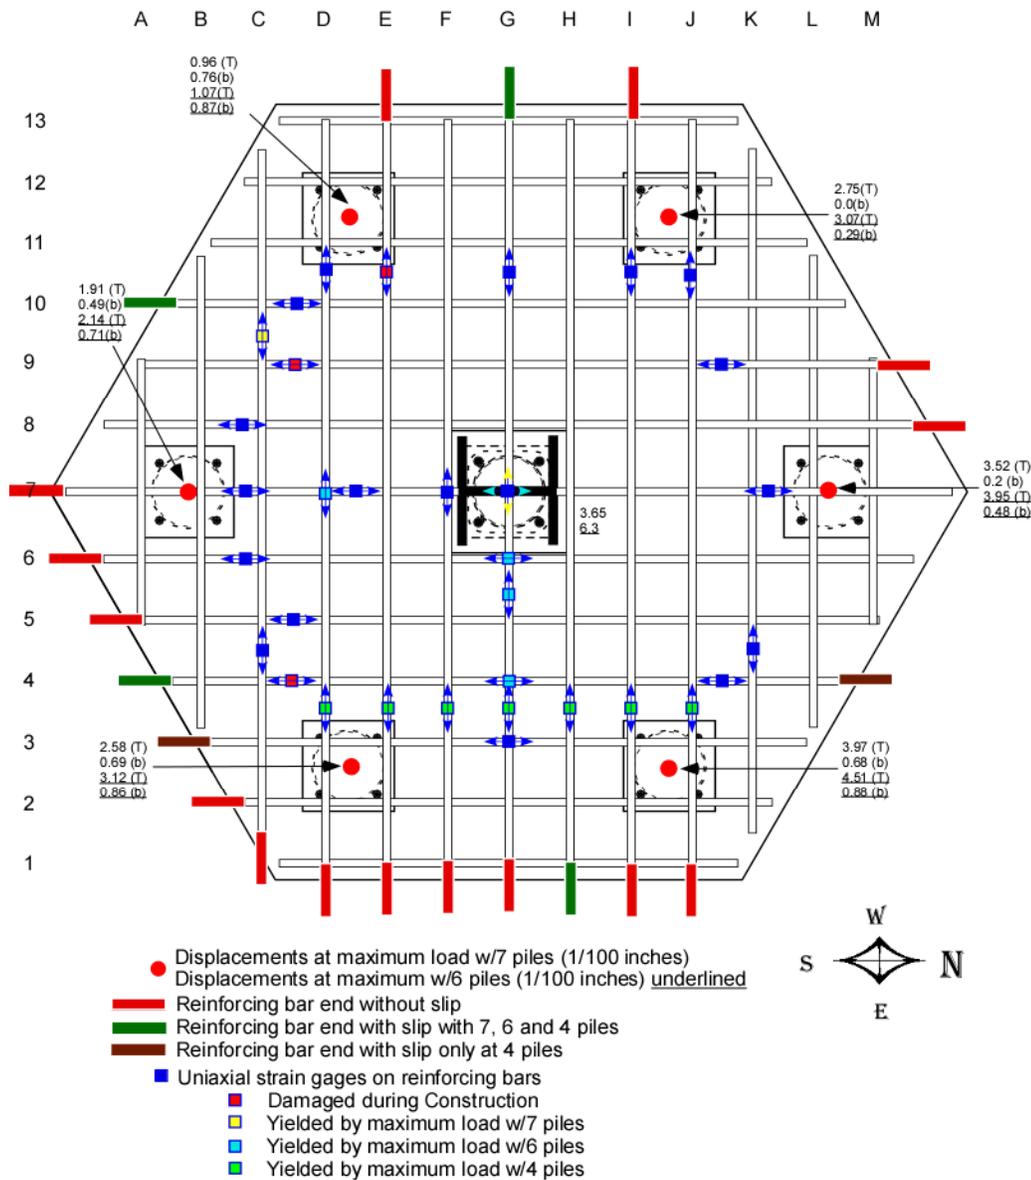
Figure 4.26: Conditions at maximum load for Pile Cap #7

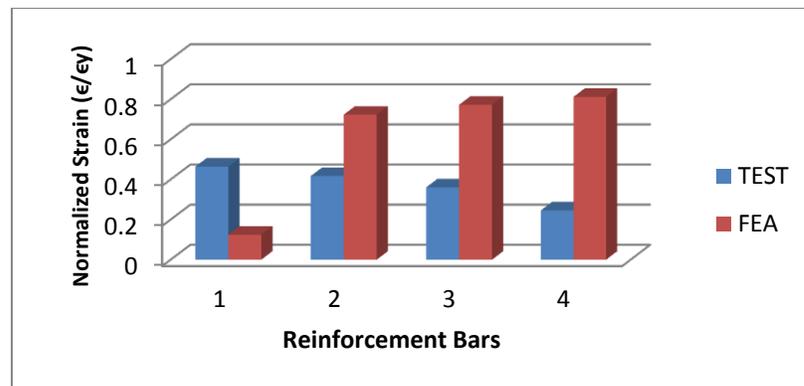
Figure 5.8: Pile Cap #3 Normalized reinforcement strain

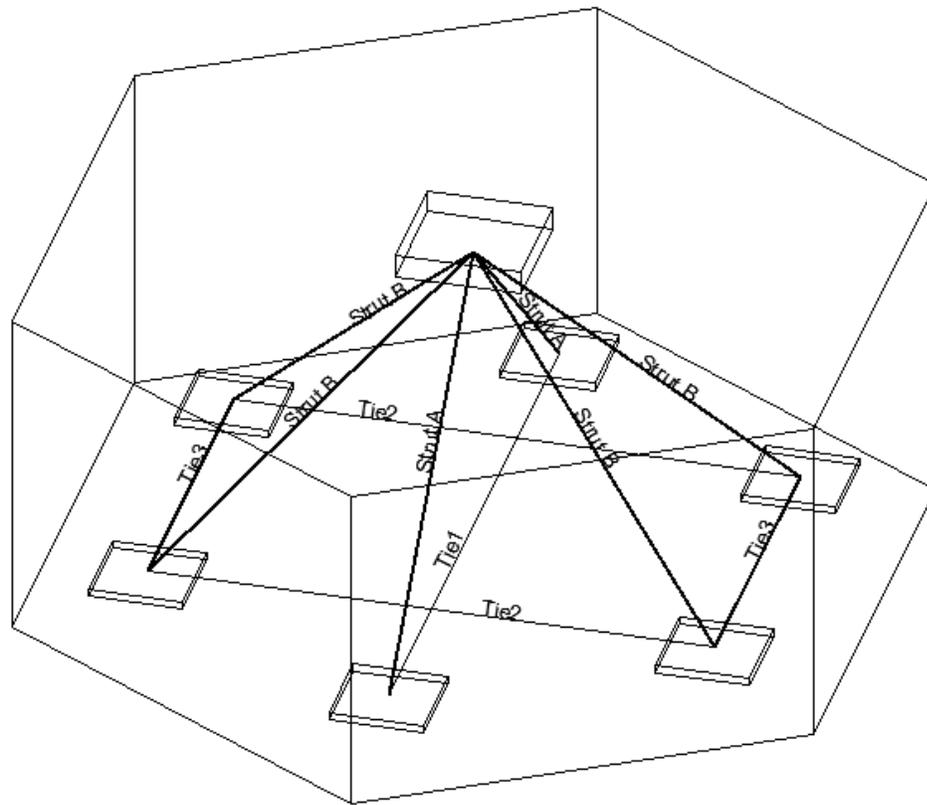
Figure 5.14: Pile Cap #7 assumed S&T geometry

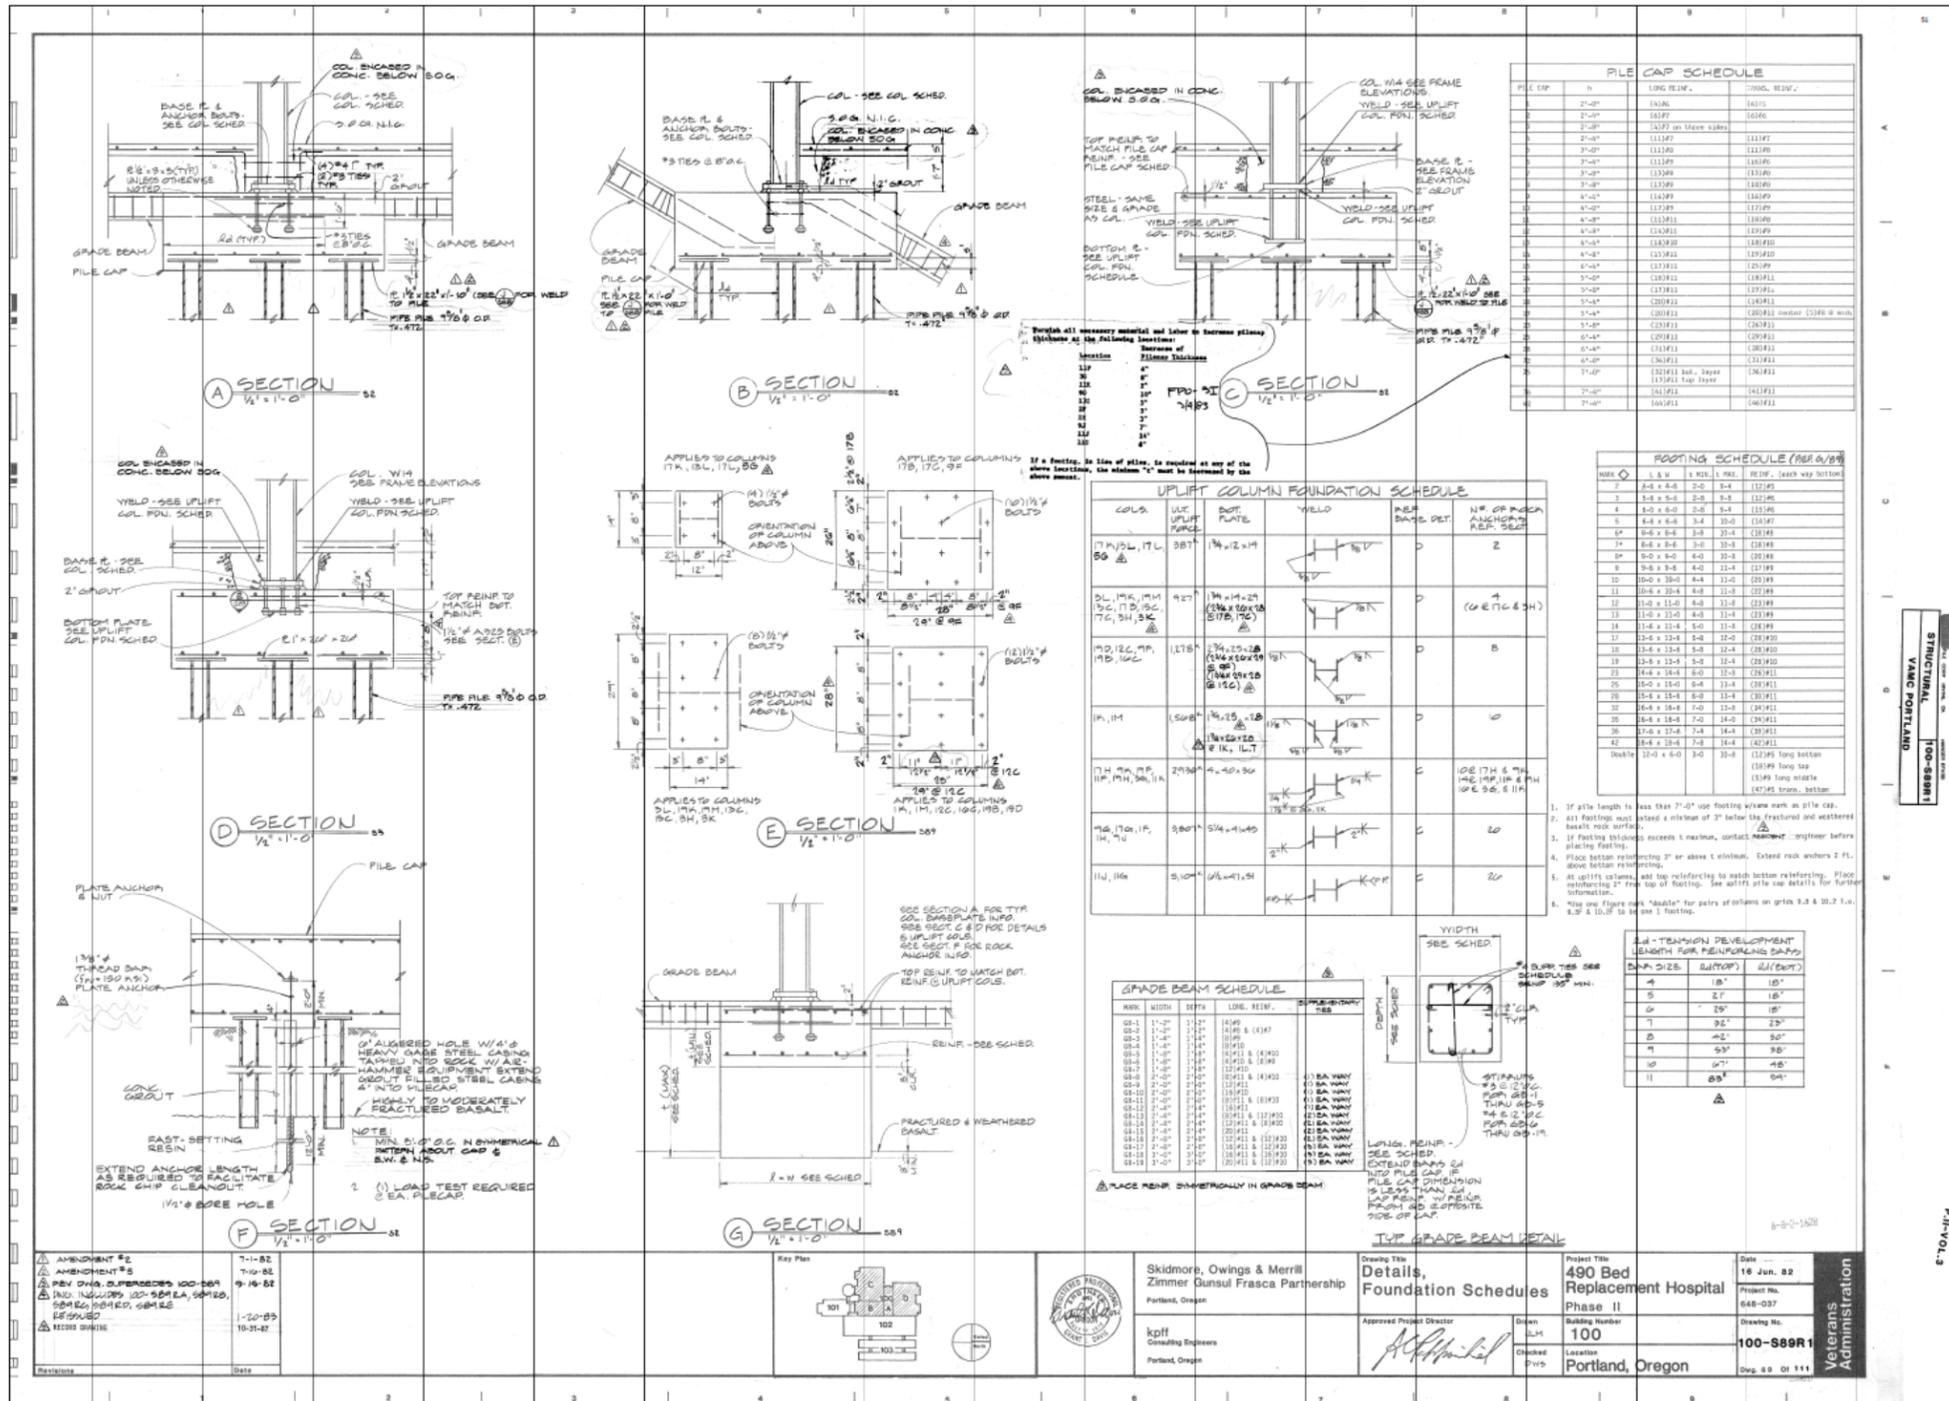
Figure A.2: Original Design Drawing (2 of 3)

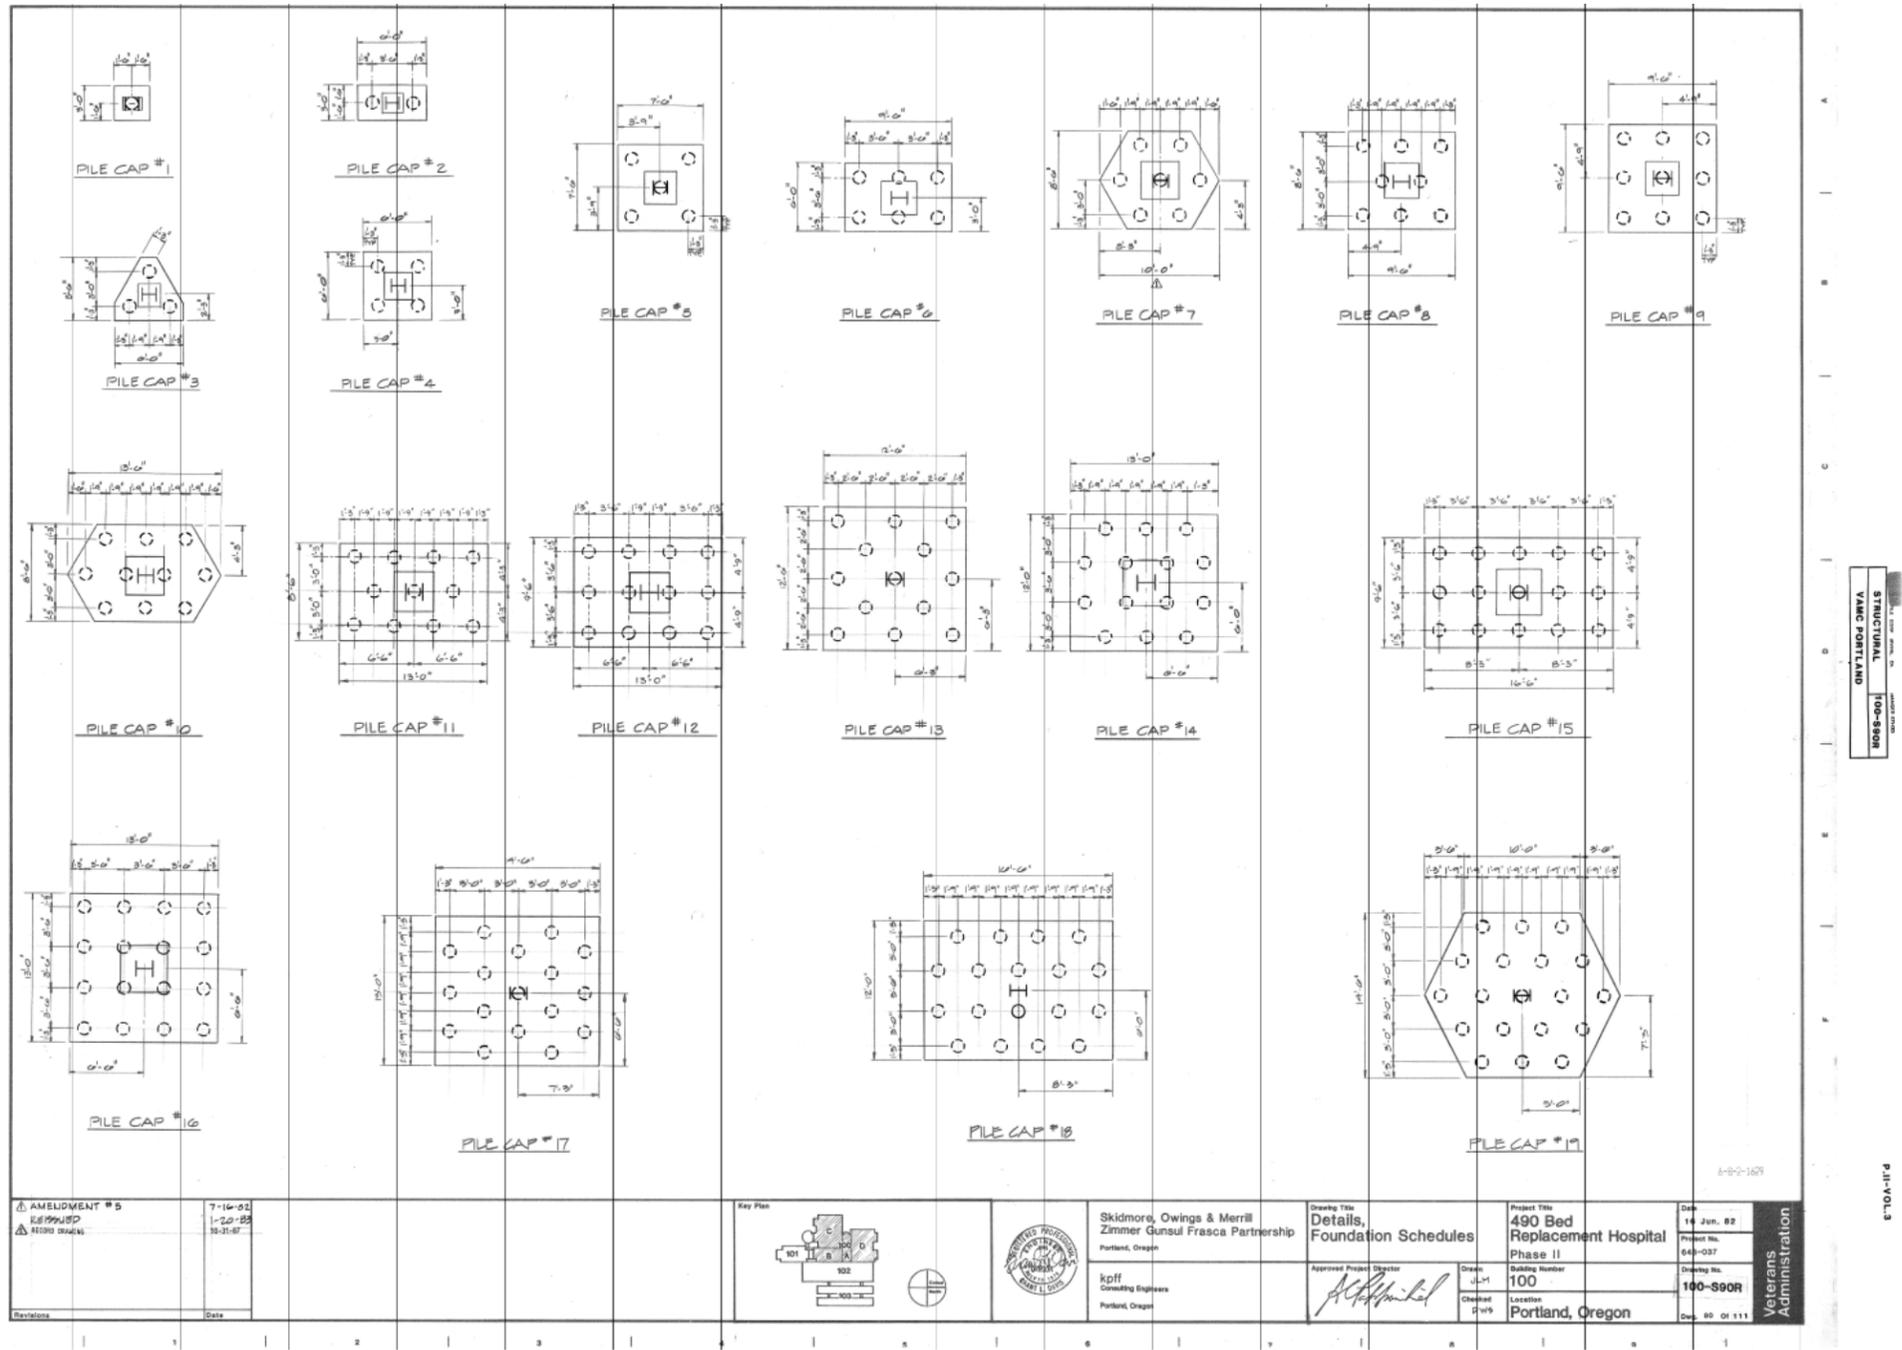
Figure A.3: Original Design Drawing (3 of 3)

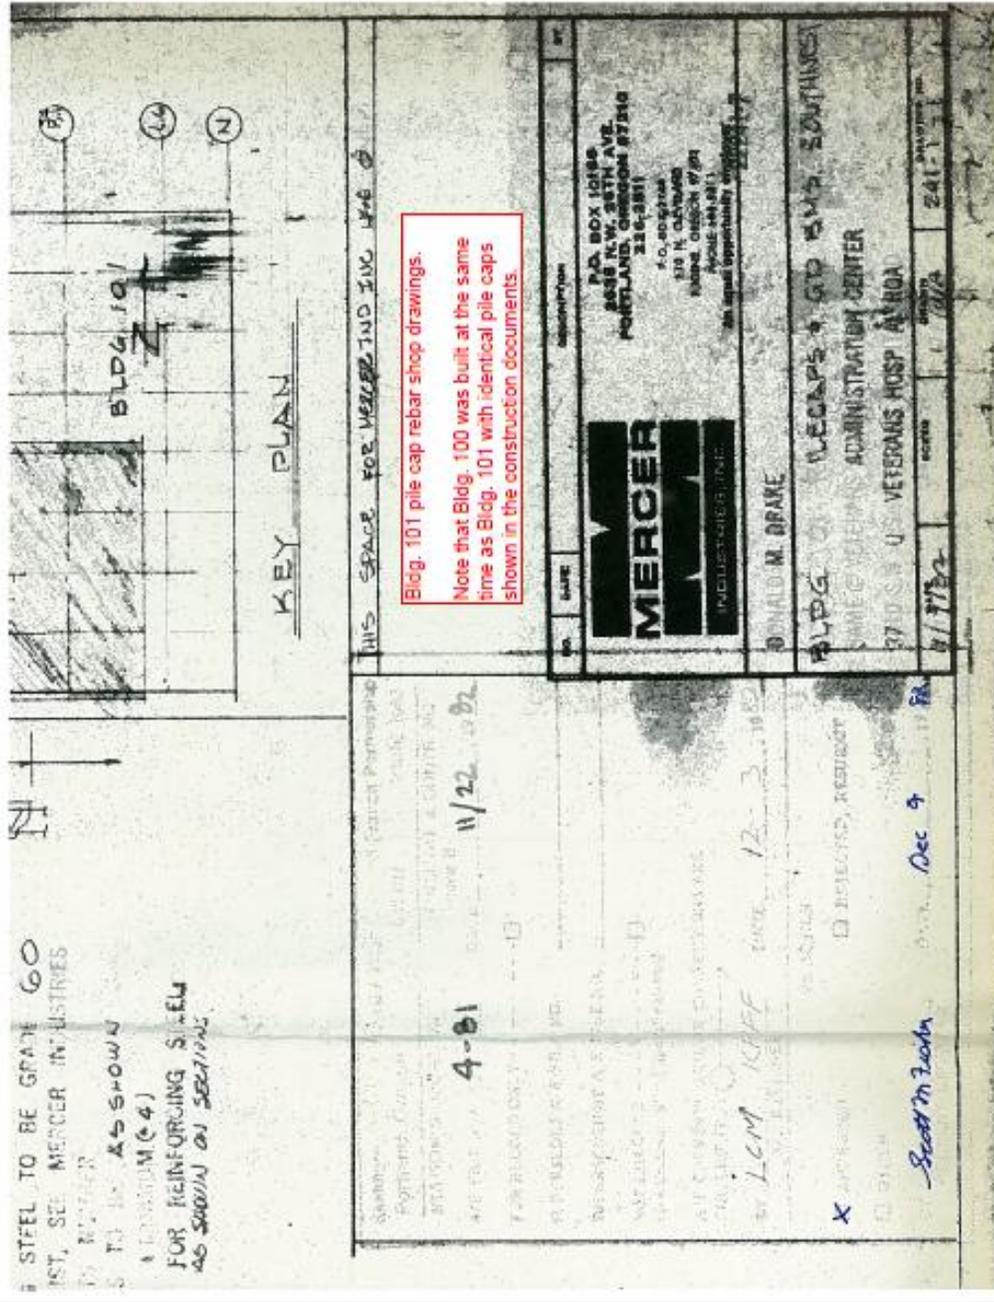
Figure B.1: Shop Drawings of In-Situ Pile Caps (1 of 4)
