Title: Behavior and Analysis of Pile Caps with Poor Anchorage Details.

BEHAVIOR and ANALYSIS of PILE CAPS with POOR ANCHORAGE DETAILS

A THESIS

Oregon State University

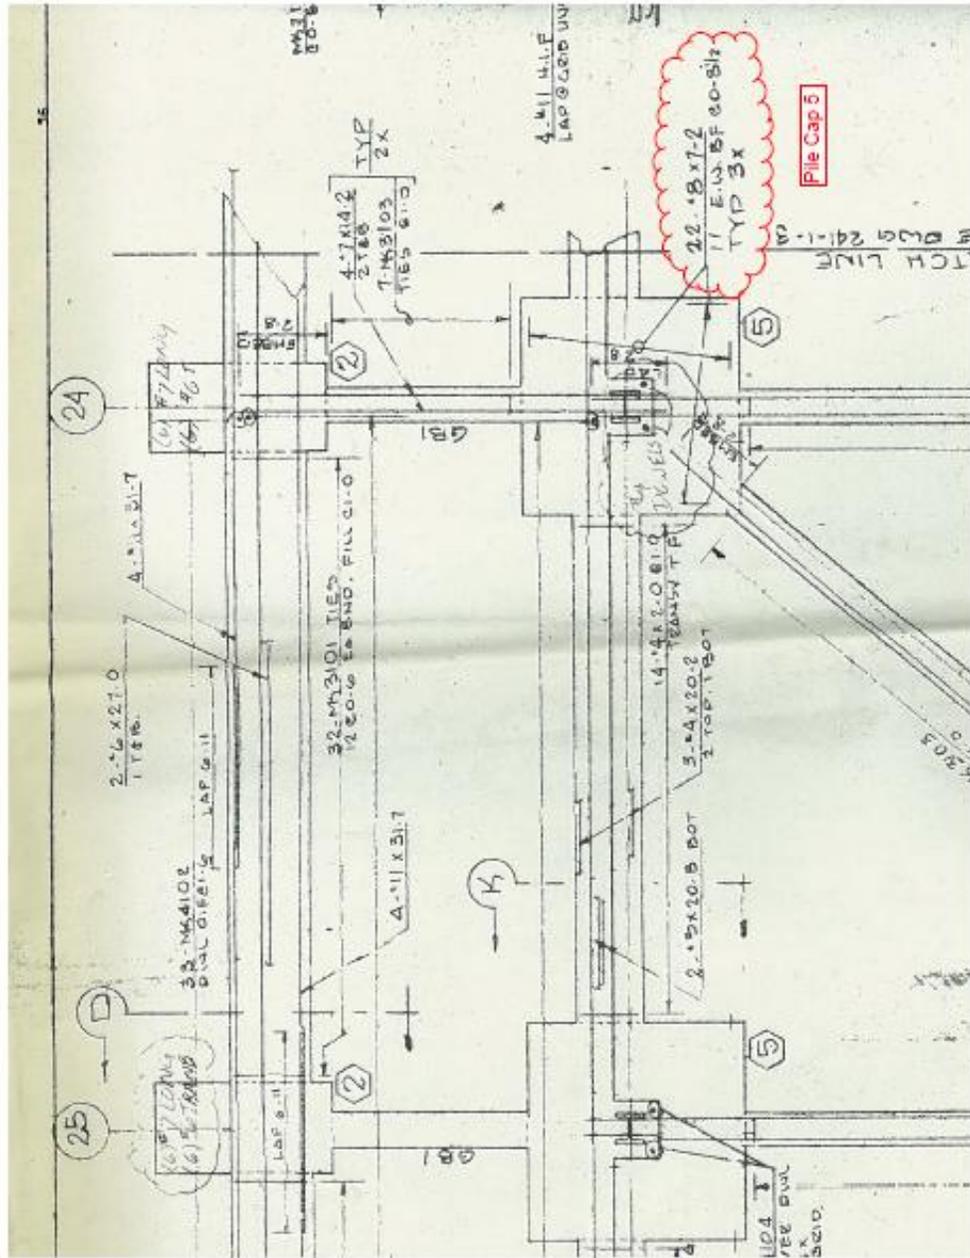
Figure B.3: Shop Drawings of In-Situ Pile Caps (3 of 4)
