Flood History and Sedimentation at the Mouth of Redwood Creek,
Humboldt County, California

A THESIS
submitted to
Oregon State University

in partial fulfillment of
the requirements for the
degree of
Master of Science
Completed June 9, 1983
Commencement June 1984

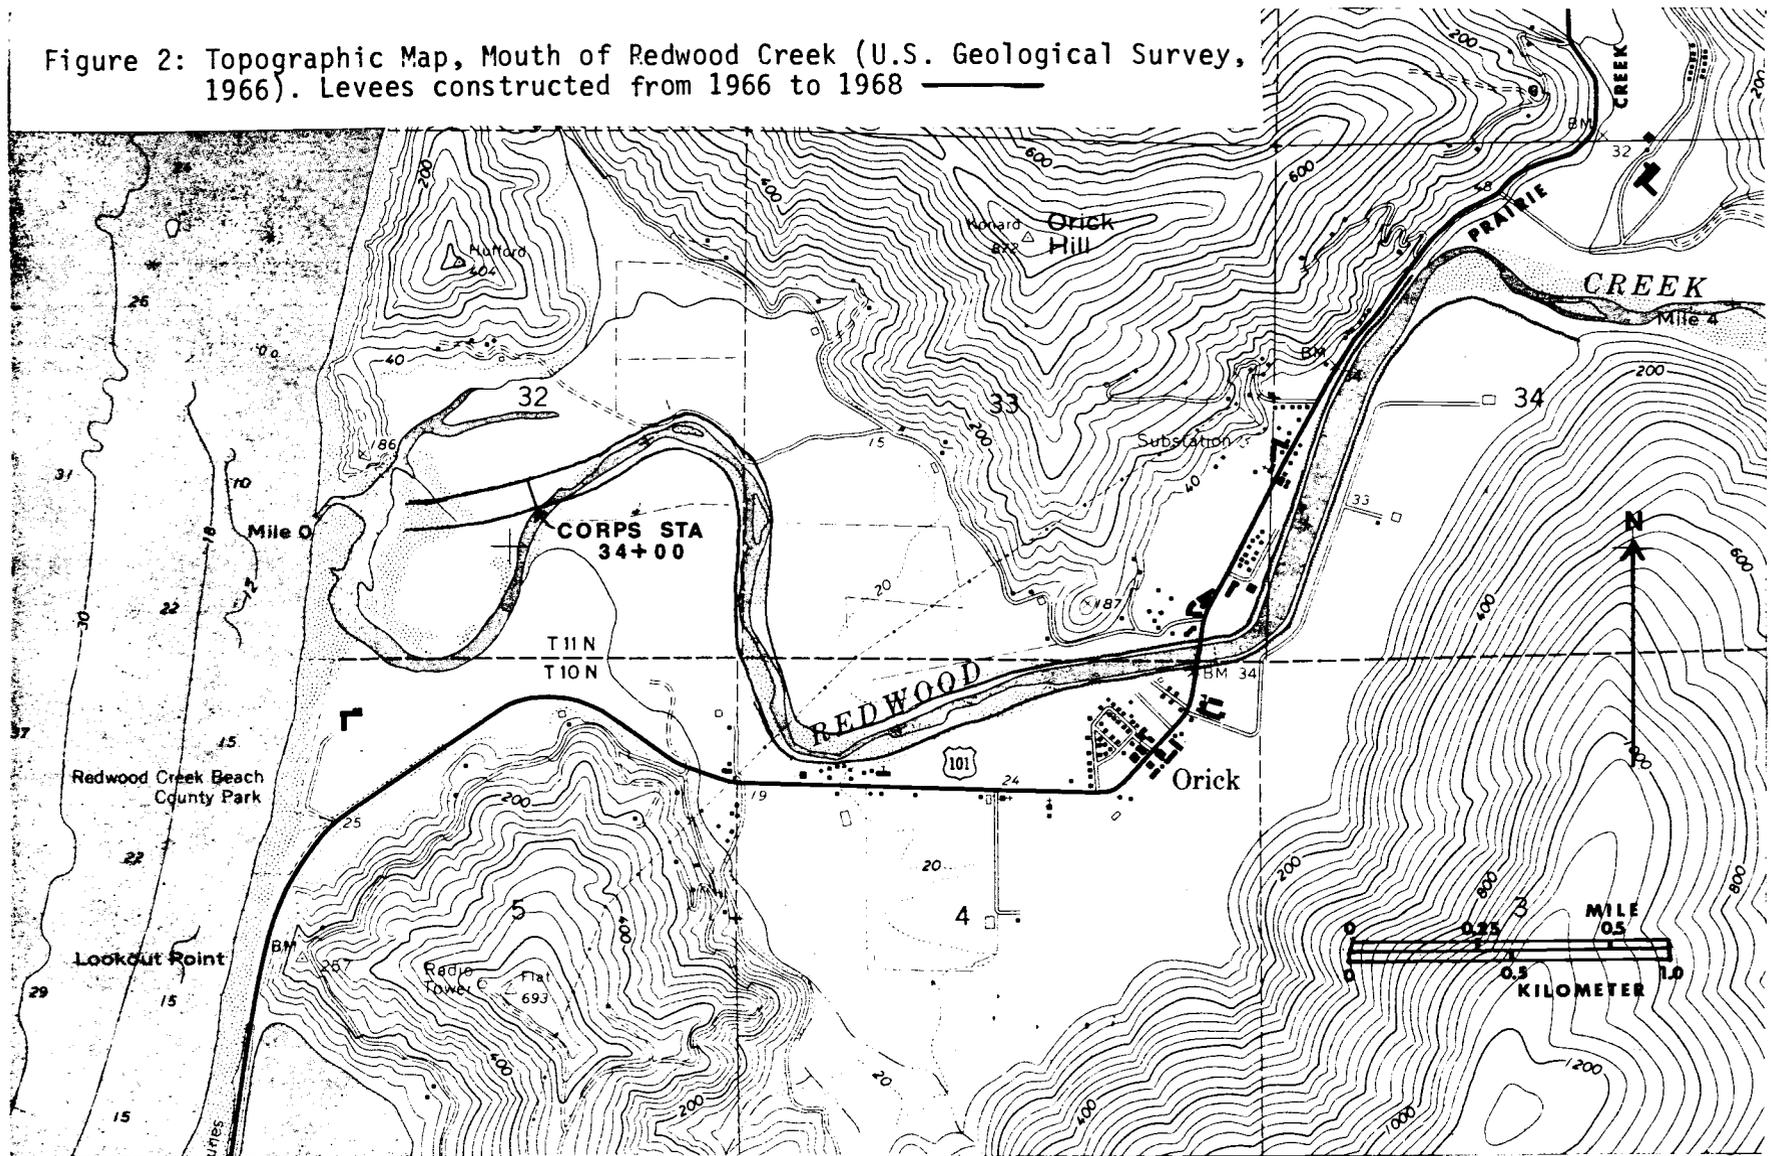
Figure 2: Topographic Map, Mouth of Redwood Creek (U.S. Geological Survey, 1966). Levees constructed from 1966 to 1968

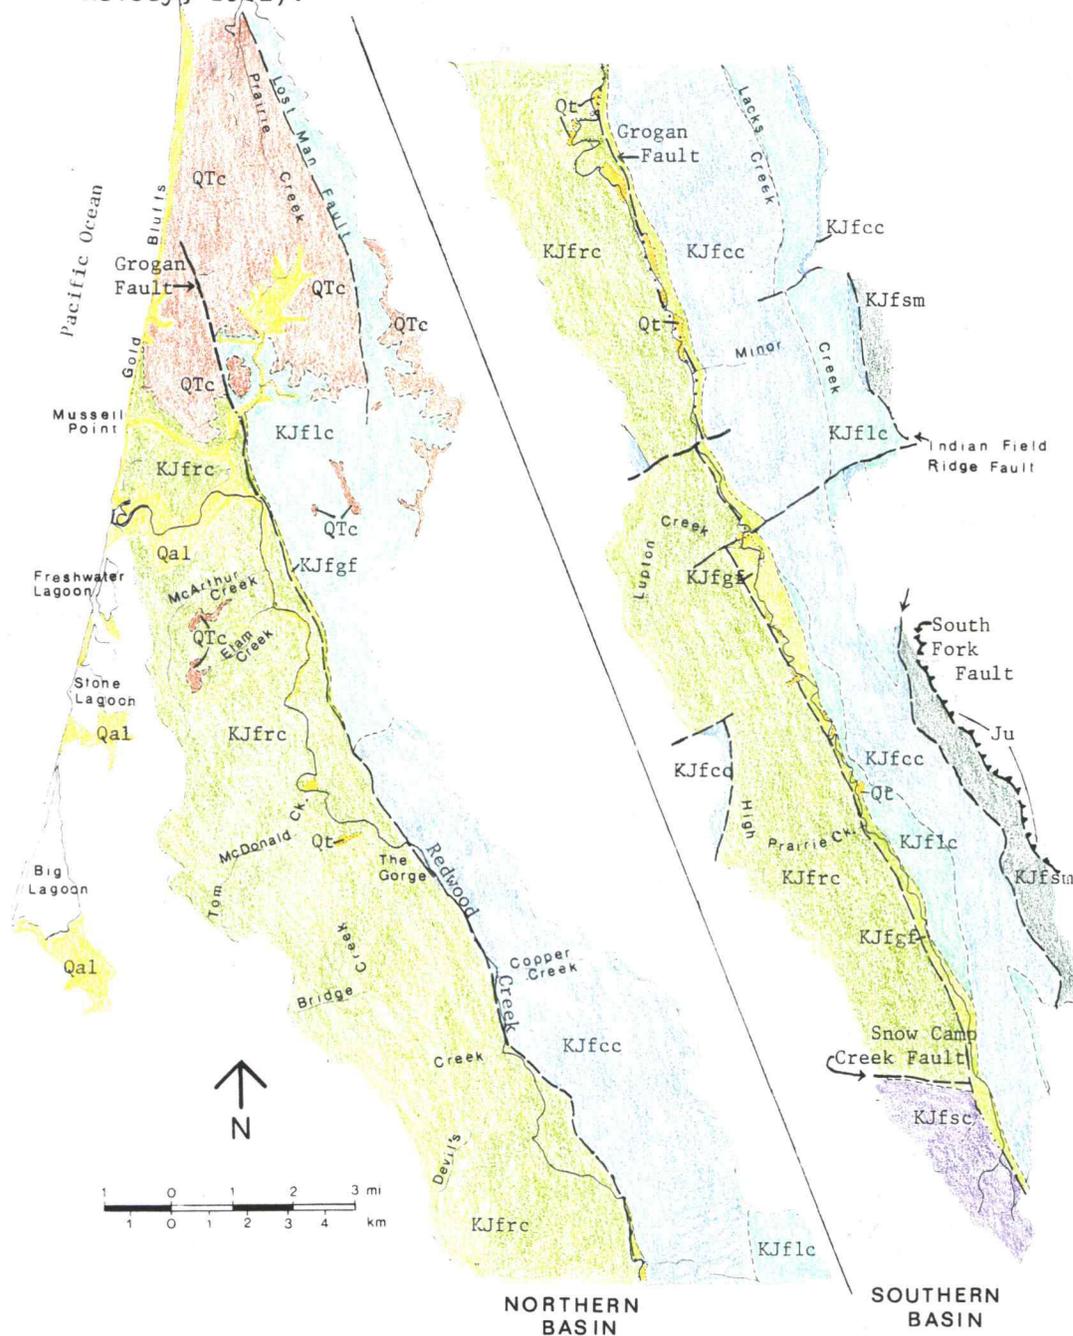
Figure 4: Geologic Map of Redwood Creek Drainage Basin and Vicinity (from Harden, Kelsey, Morrison, and Stephens, 1982; and Kelsey, 1982).

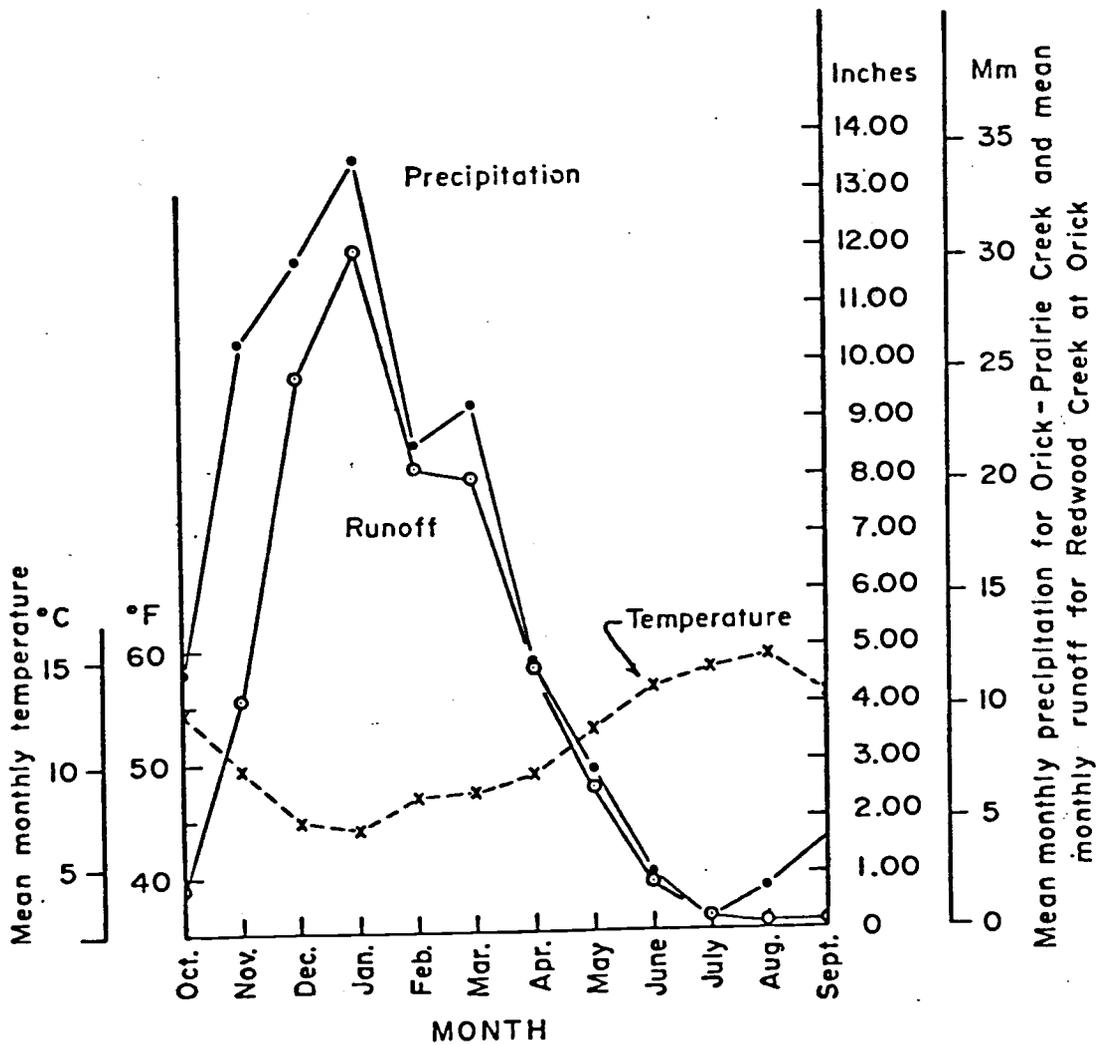
Figure 5: Mean Monthly Precipitation and Temperature for Orick-Prairie Creek State Park and Mean Monthly Runoff for Redwood Creek at Orick for Water Years 1954-1972 (from Janda and others, 1975, p.21)

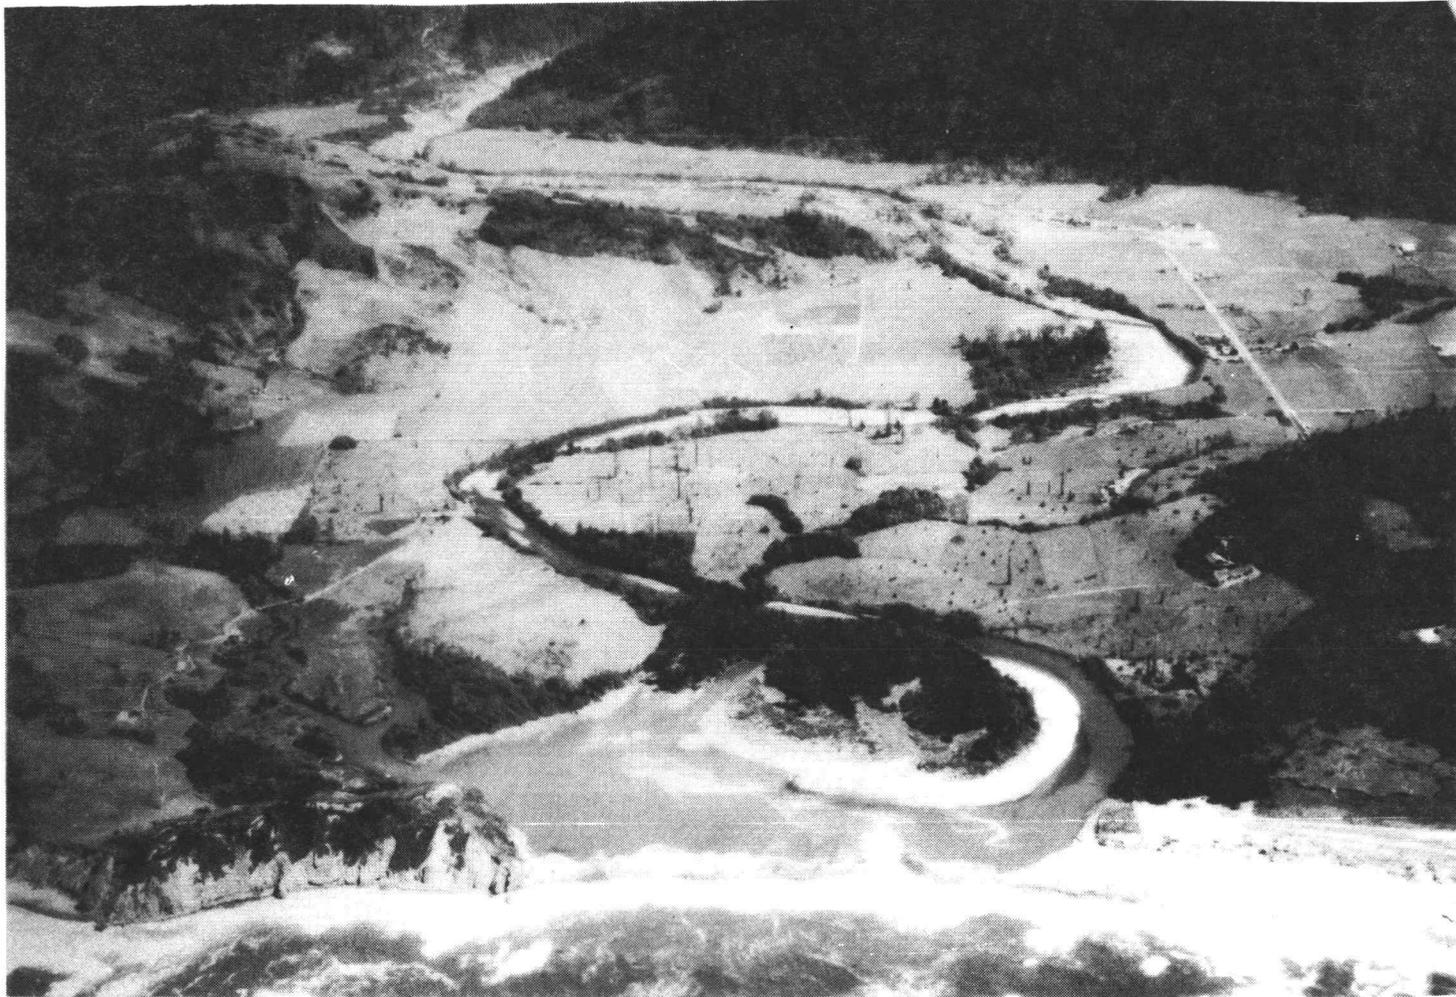
Figure 6: Oblique Aerial Photograph, Mouth of Redwood Creek, September, 1948.

Each method used to examine the effects of flooding on the morphology of lower Redwood Creek covers a different time scale. Prehistoric and early historic flood features have been preserved on the floodplain (Figure 6). Here, the term floodplain refers only to the area inundated by streamflows greater than bankfull, downstream from the confluence of Redwood Creek and Prairie Creek (Figure 7). These morphological features are discussed with dendrochronological evidence of flood magnitudes from 1600 to 1964. From aerial photography for the period 1931-1981, details of erosion and deposition across the floodplain and mouth have been interpreted. Bathymetric profiles document the 1964-1981 period before and after channelization of Redwood Creek.

Dendrochronological techniques were applied to assess the relative stability of the natural channel configuration near the mouth. The spruce-alder forest located between the downstream meander and former overflow channels (Figure 6) was mapped using 1967 aerial photography. Annual growth rings were visible on many stumps left from spruce harvested in 1978. Counted ages were adjusted to account for the time since harvest (3 years) and time to attain stump height (assumed to be 2 years). Standing live spruce and selected alder were dated from increment cores taken at breast height (3 years added). Indistinct annual rings in the alder cores were counted with the aid of a dendrochronometer.

Prehistoric overflow features and possibly former stream channels are evident on the Redwood Creek floodplain. The two fingers of the north slough appear to have been scoured by high flows. On the south side of the floodplain, an arcuate patch of willows (FC, Figure 7) is visible on a 1948 oblique aerial photo (Figure 6). Several "swampy" places and sloughs in this area drained into Strawberry Creek and the middle slough during overbank flows (Barlow, Appendix A).

The presence of numerous stumps in early photographs (e.g., Figure 6) indicates that spruce forest was once more extensive in the Orick Valley. At the mouth of Redwood Creek, spruce were removed from the north side of the middle island prior to levee construction. In 1978, some trees also were completely removed from the middle island when roads were bulldozed to harvest the spruce. Tree age distribution shows that the grove on the middle island was not established after a single flood (Figure 8). Older Sitka spruce (Picea sitchensis) are clustered together, but the distribution is generally all-aged. This distribution is unlike that of floodplains near laterally migrating channels having even-aged meander scrolls (Everitt, 1968). The characteristic ridge and swale topography (Hicken, 1974, p. 414) is also absent on the middle island.

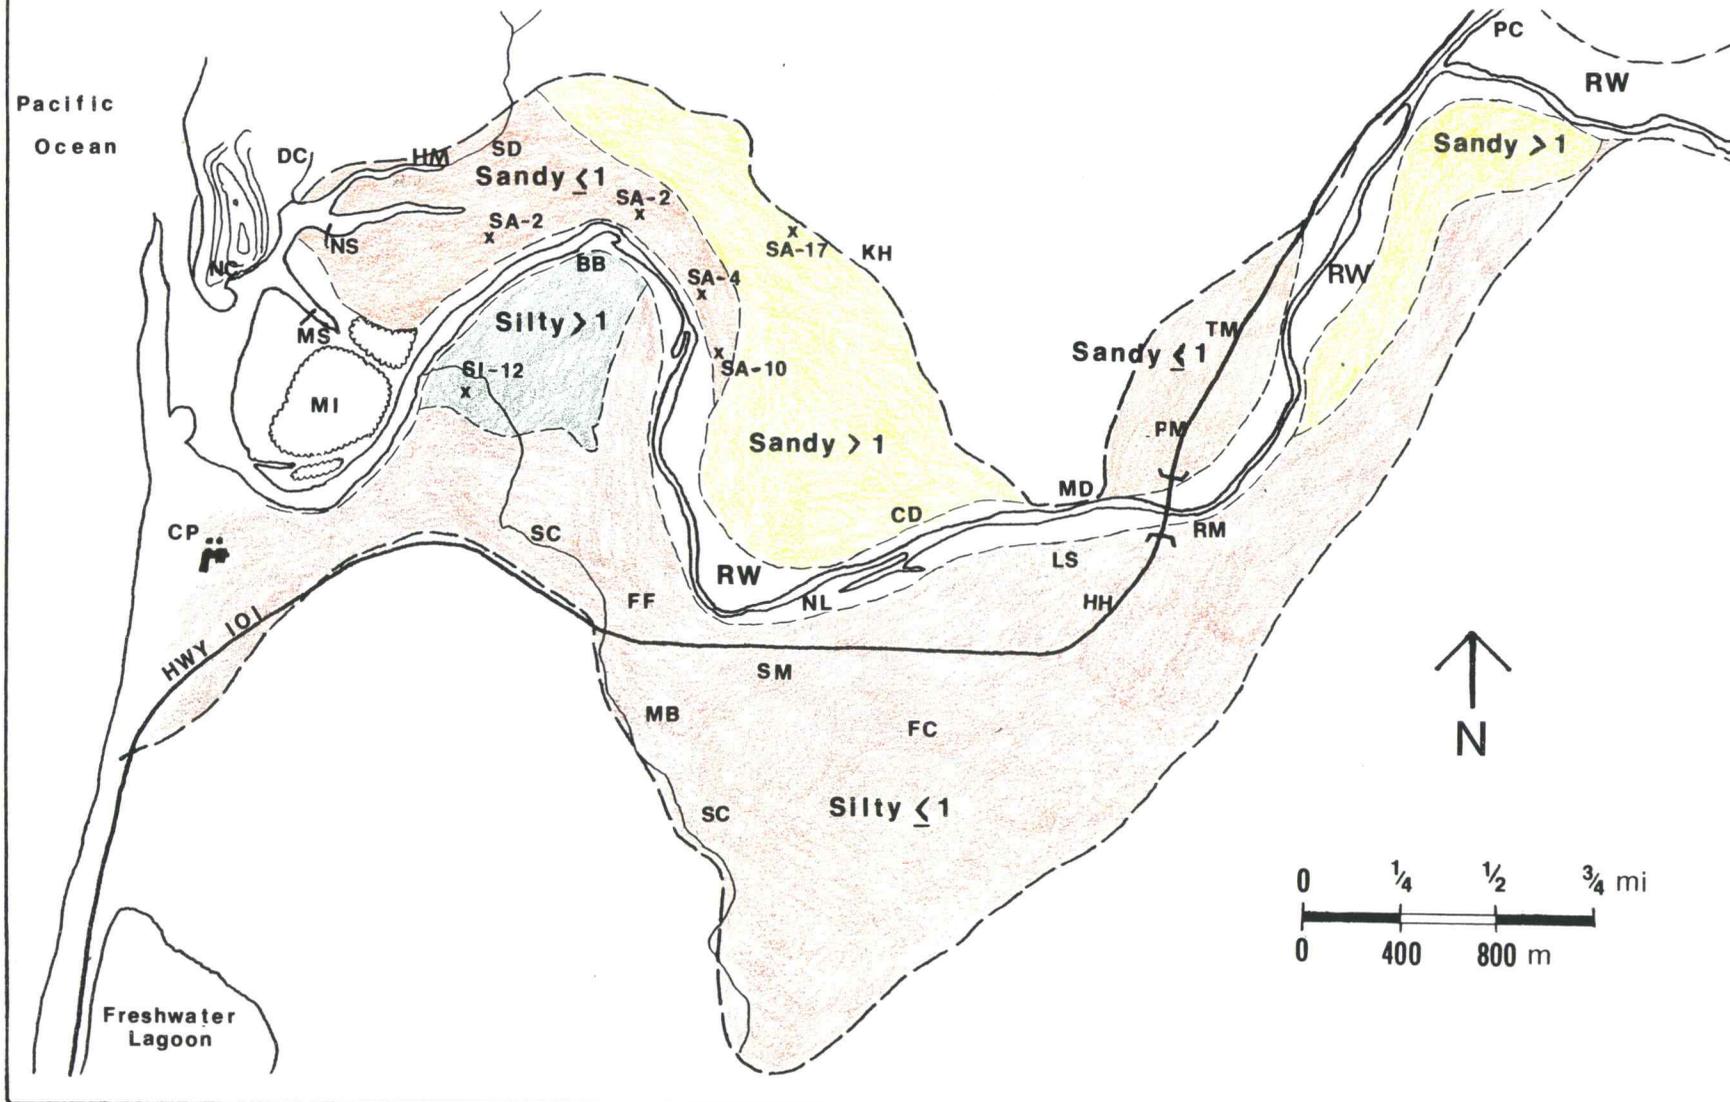
Figure 7: Redwood Creek Floodplain, 1964 Flood Deposits and Selected Cultural Features

Significant deposition between the middle and north sloughs was observed in aerial photos from January 13, 1965 (Figure 18). The slow recession of the 1964 flood contributed to extensive deposition across the entire floodplain (Figures 7 and 13). At the point of overbank flow, slight increases in the height or stage of a stream produce large increases in the inundated area. During flood recession, if high waves and/or storm tides back up the flow and increase the inundated area, velocity decreases. When the competence of sediment-laden flood waters declines, material is deposited in the embayment.

mouth allowed waves to enter and break against the middle island (White, Appendix A). Waves were also observed propagating up past Baines' bend (BB, Figure 7) during other floods (S. Barlow, Appendix A). Wave diffraction created lobate deposits at the north and south extremities of the open mouth (Figure 18). Within two weeks after the 1964 flood, a new bar emerged offshore from south to north. Embayment deposits were subject to direct reworking by waves until the new bar formed across the mouth.

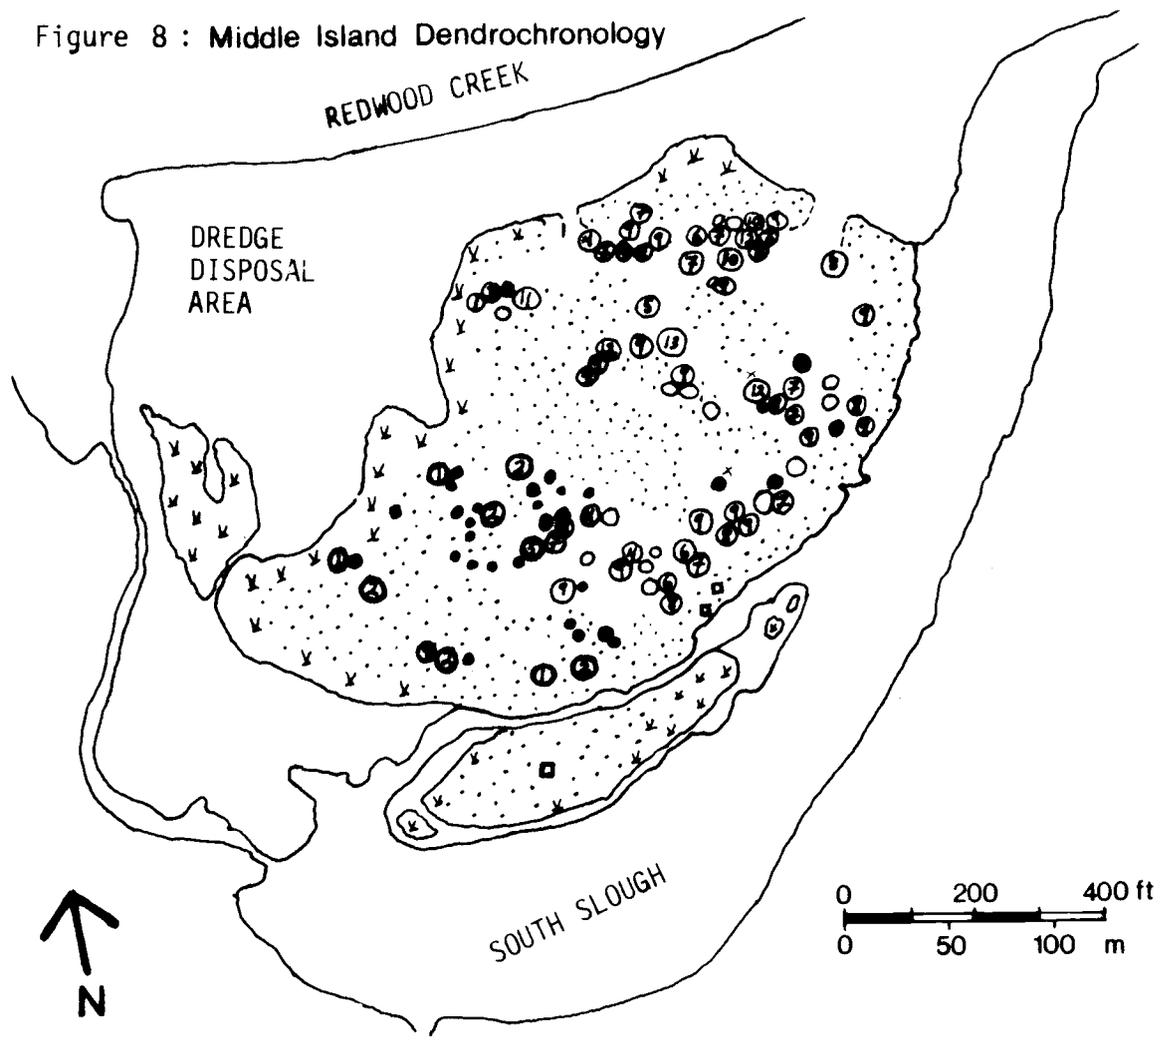
Figure 8 : Middle Island Dendrochronology

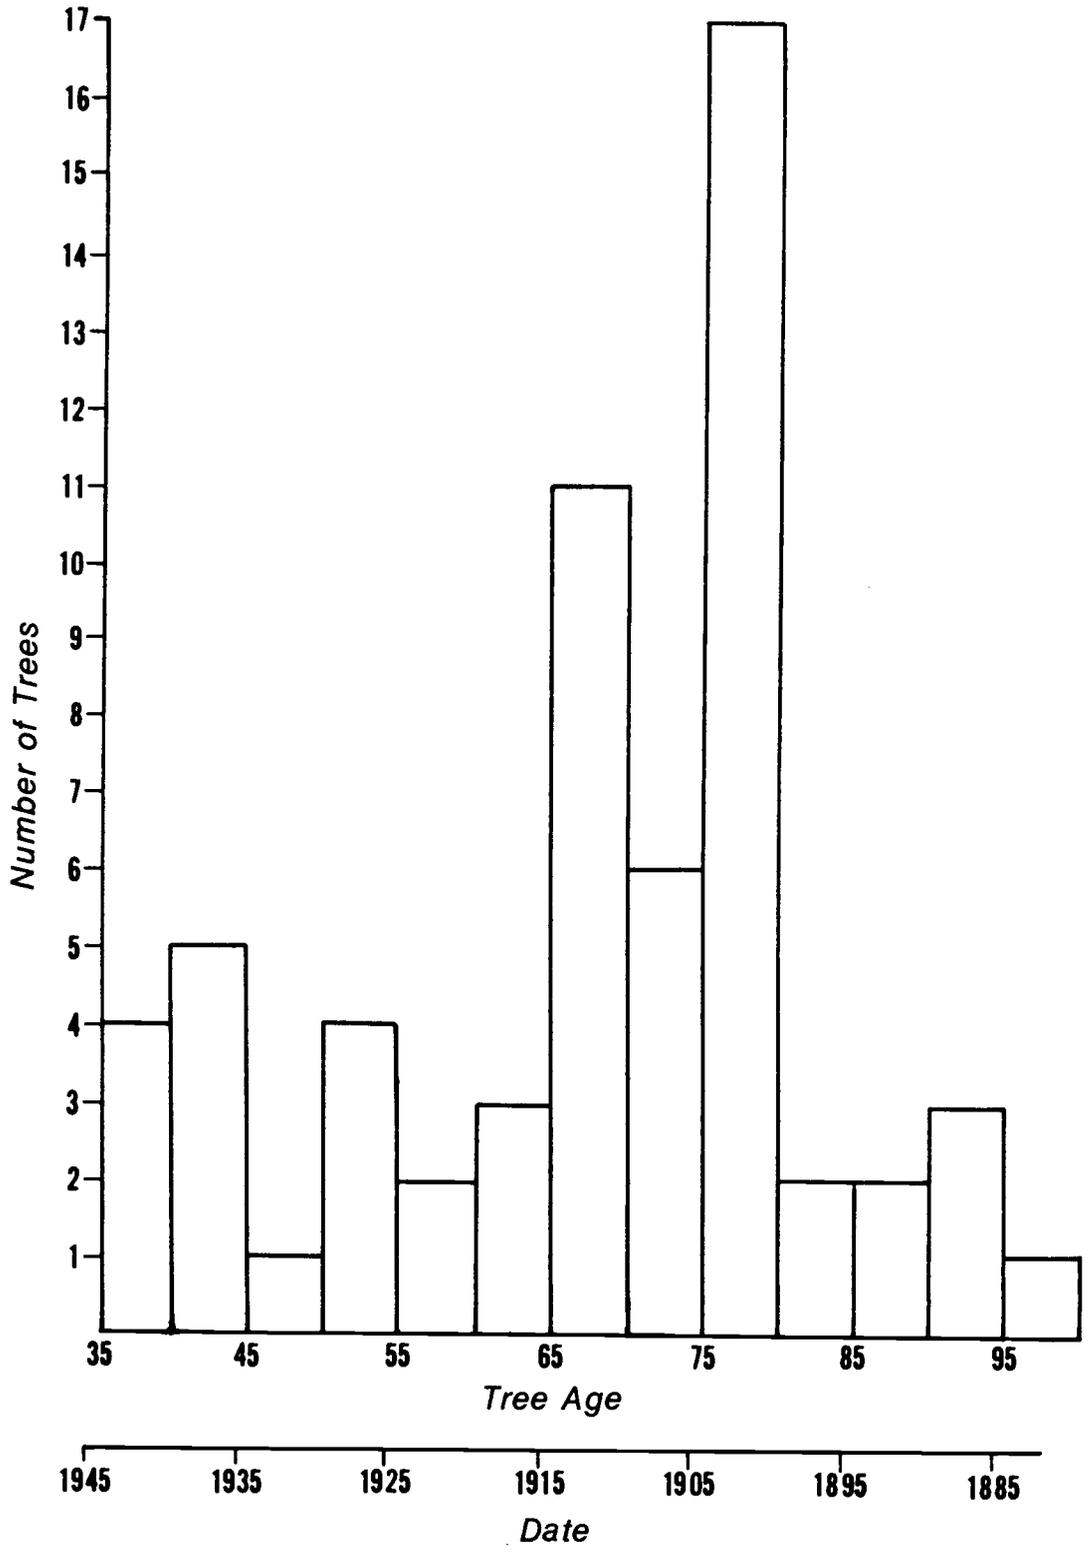
Figure 9: Age Distribution of *Picea sitchensis* on the Middle Island, Mouth of Redwood Creek.

sites or protected by accumulations of large organic debris may have been destroyed by flooding and/or storm waves. Recurrent scouring of flood channels across the middle island would alter the tree age distribution shown in Figure 9.

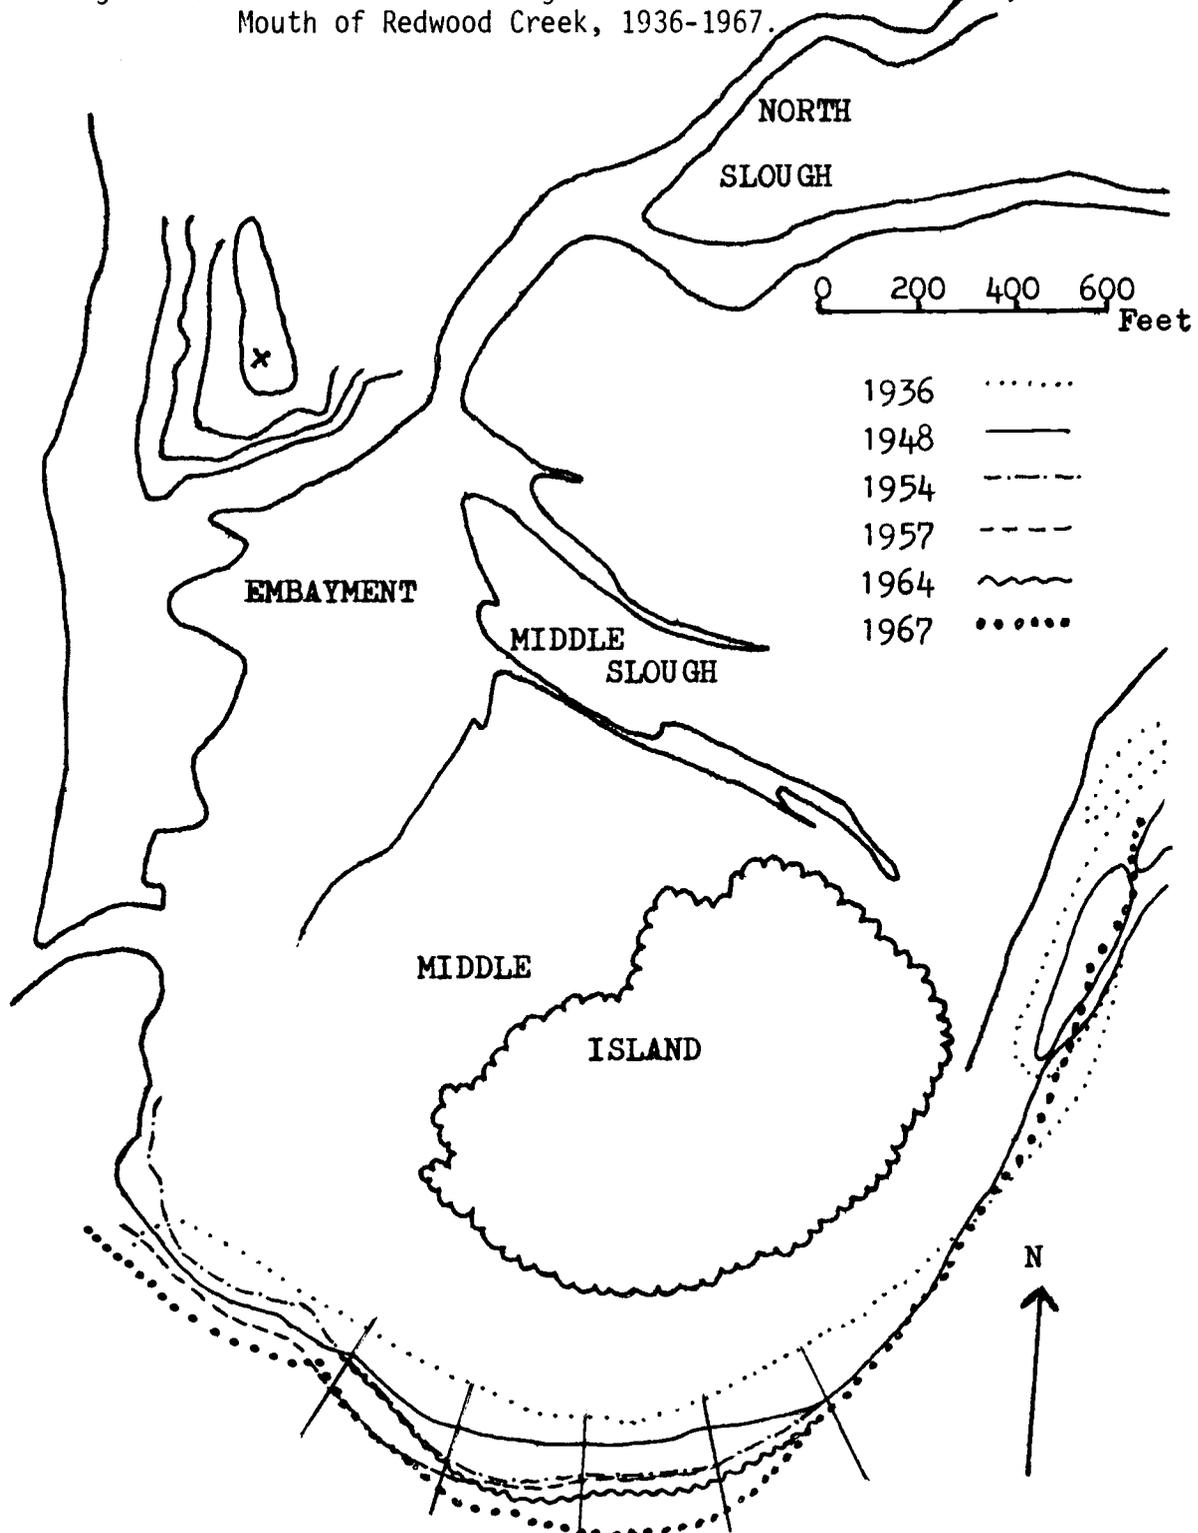
Figure 10: Bank Positions Along the Last Downstream Meander, Mouth of Redwood Creek, 1936-1967.

Average bank positions obtained from these lines. See Figure 11.

Sediment accumulations along the east side of the embayment adjacent to the middle island, middle slough and north slough (see Figure 10) persist through the seasons. The deposits have been modified by the complex interaction of river current eddies against the north cliffs, currents in the mainstem and middle slough as well as tidal height and wave energy. Despite the variability introduced by these interactions, there has been a noticeable trend toward accretion of sediment in the area between the middle and north sloughs (Figures 15-17). This trend probably results from flood transport of sediment from the basin.

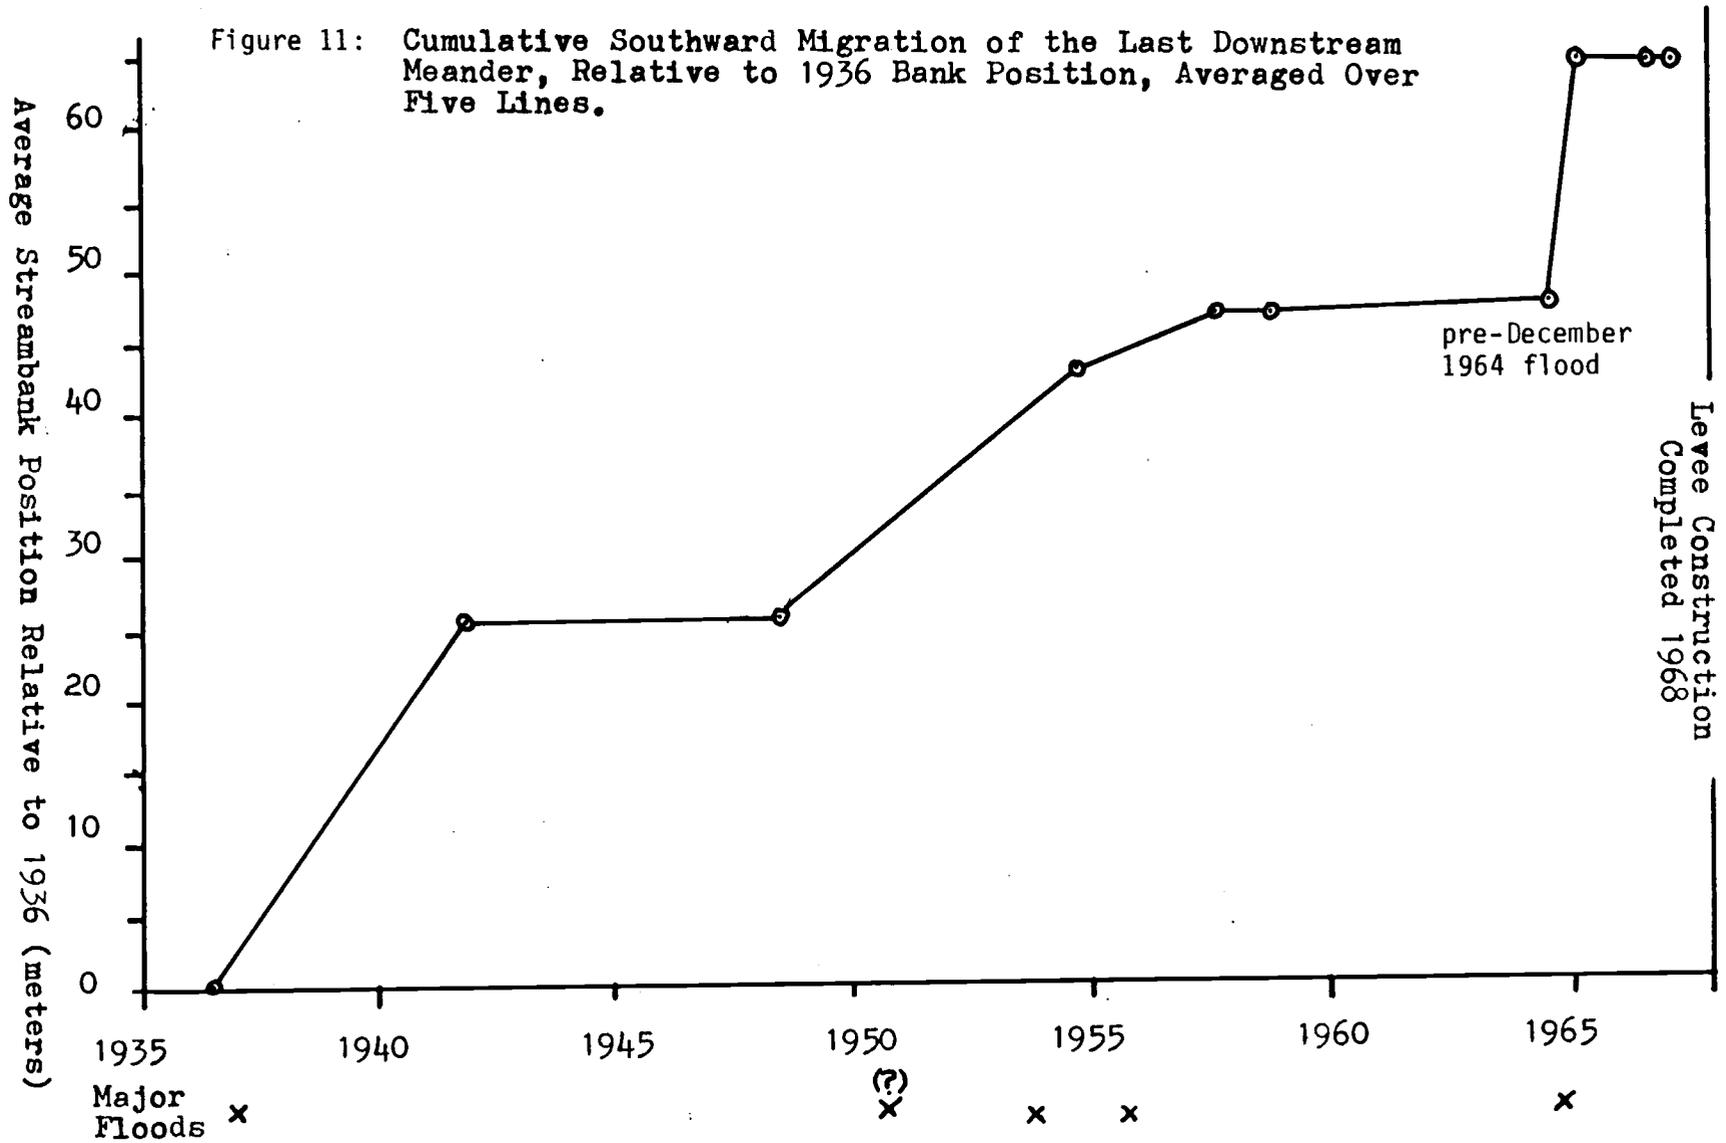
Figure 11: Cumulative Southward Migration of the Last Downstream Meander, Relative to 1936 Bank Position, Averaged Over Five Lines.

The discontinuous pattern of migration along the last downstream meander during floods in 1953, 1955, and 1964 is consistent with the sequence described above (Nanson and Hickin, 1983, p. 332-334). Following a prolonged period of little or no streambank erosion (Figure 11), the concave bank migrated considerably during the January 1953 flood (Figure 10). Although the December 1955 flood attained the same peak discharge (Table 2), streambank erosion was not extensive (Figures 10 and 11). The 1955 flood may have exceeded bankfull level at a lower discharge due to the wider and more aggraded channel.

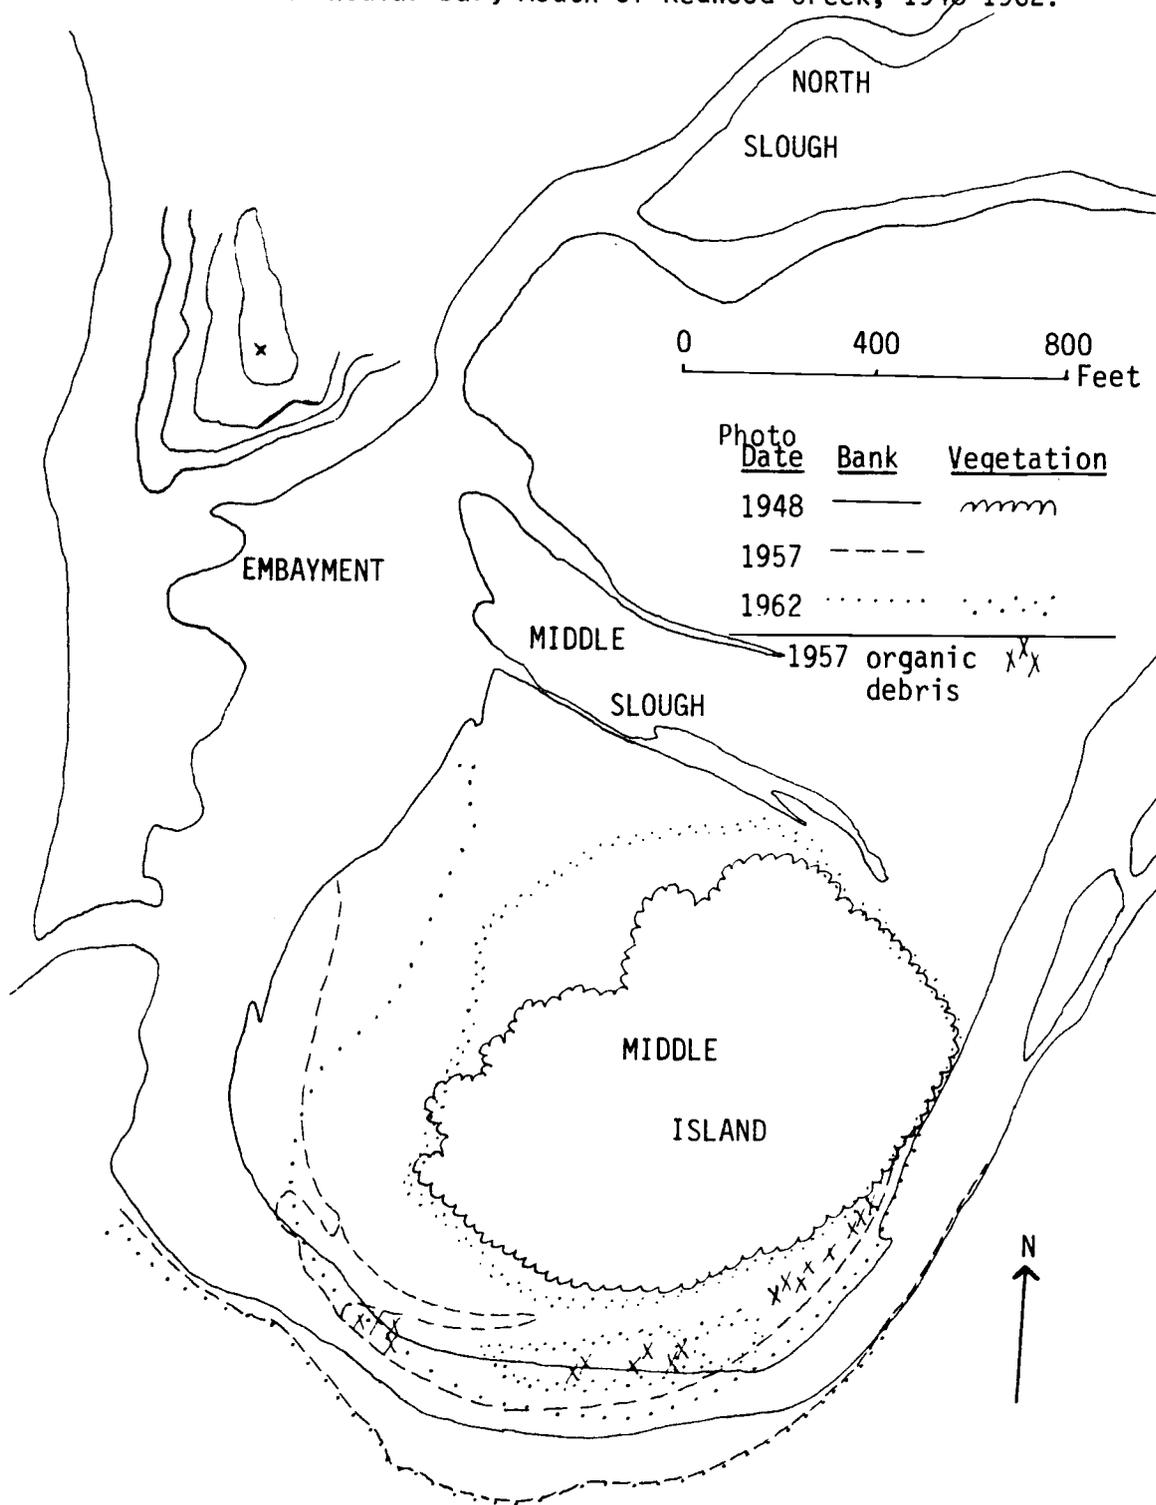
Figure 12: Migration of the Last Downstream Meander and Formation of an Insular Bar, Mouth of Redwood Creek, 1948-1962.

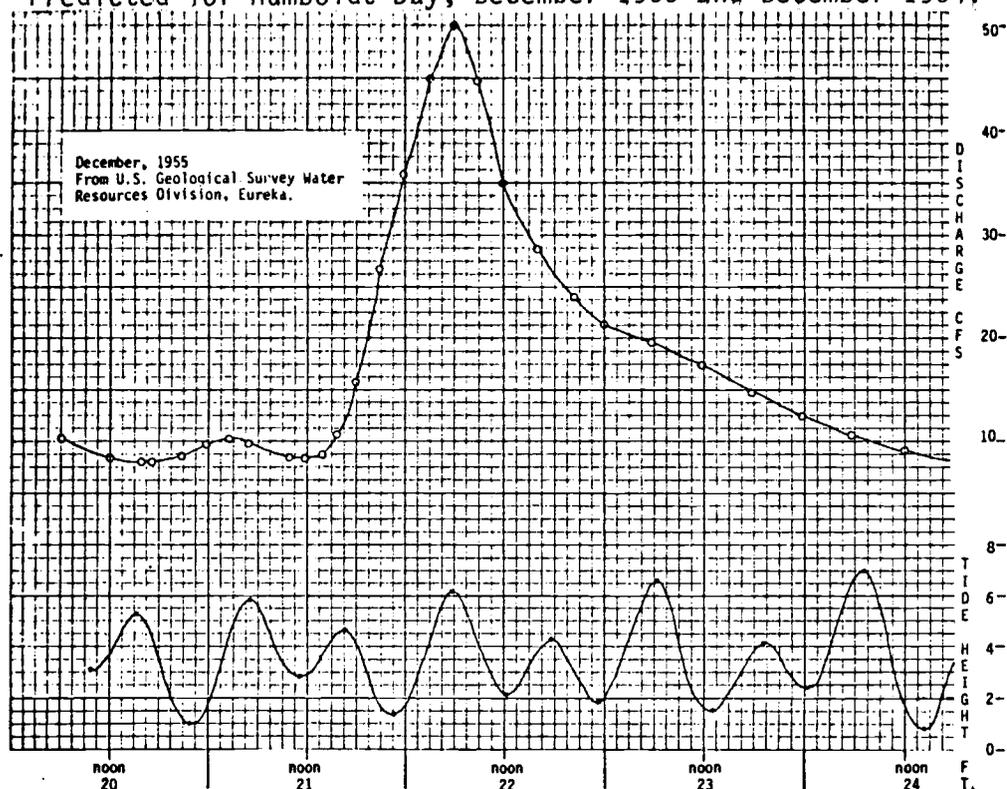
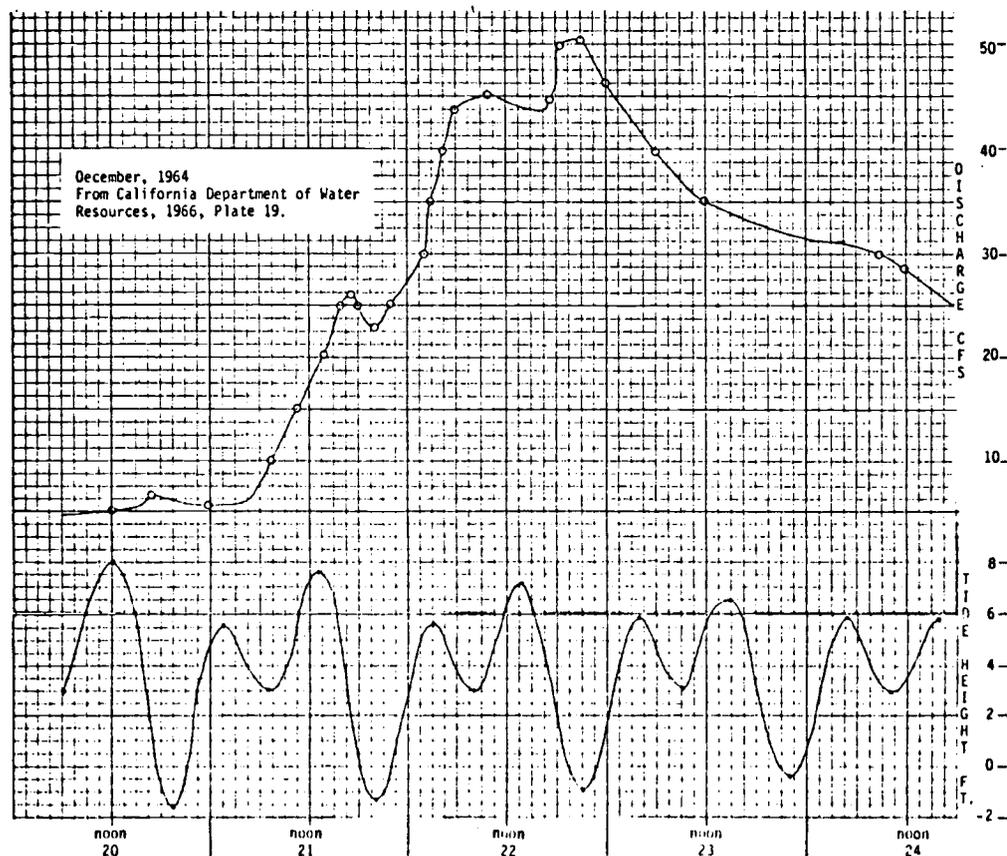
Figure 13: Peak Flows Gauged for Redwood Creek at Orick and Tides Predicted for Humboldt Bay; December 1955 and December 1964.

floods were gauged at Orick (Figure 13). If slumping were an important mechanism, rapid recession of the 1955 flood coupled with ebbing tides should have caused extensive streambank erosion.

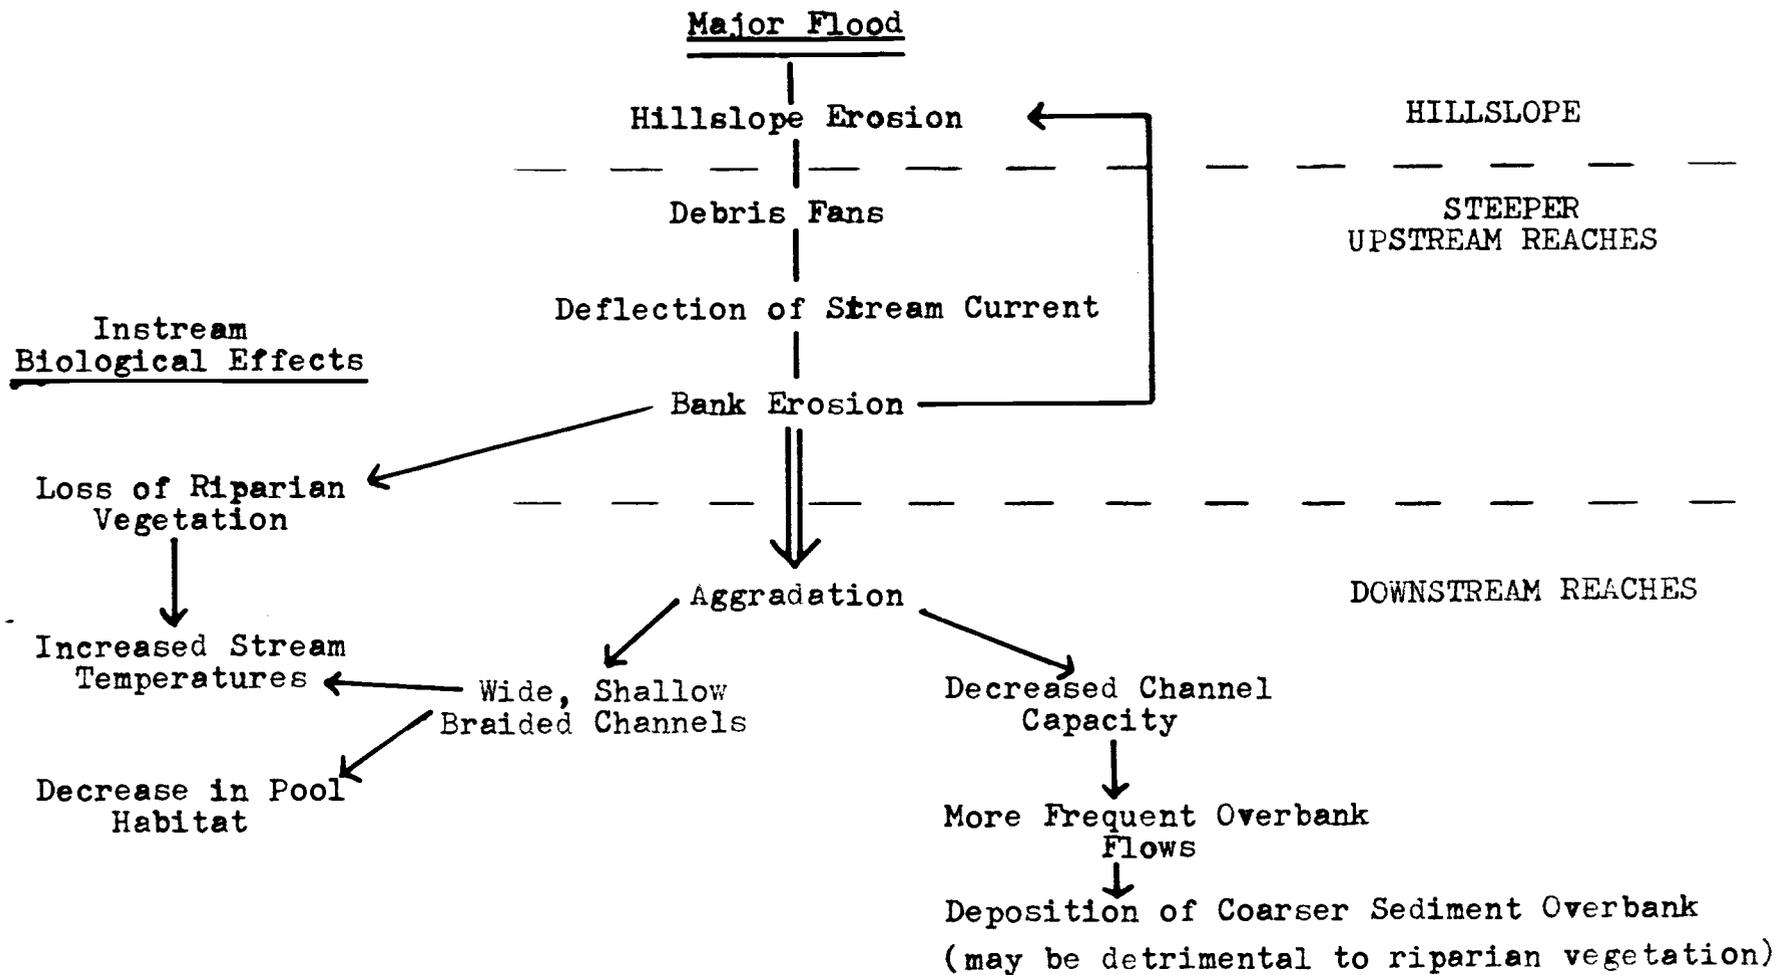
Figure 14: Effects of Aggradation (modified from Janda and others, 1975, Figure 56).
