Flood History and Sedimentation at the Mouth of Redwood Creek,
Humboldt County, California

A THESIS
submitted to
Oregon State University

in partial fulfillment of
the requirements for the
degree of
Master of Science
Completed June 9, 1983
Commencement June 1984

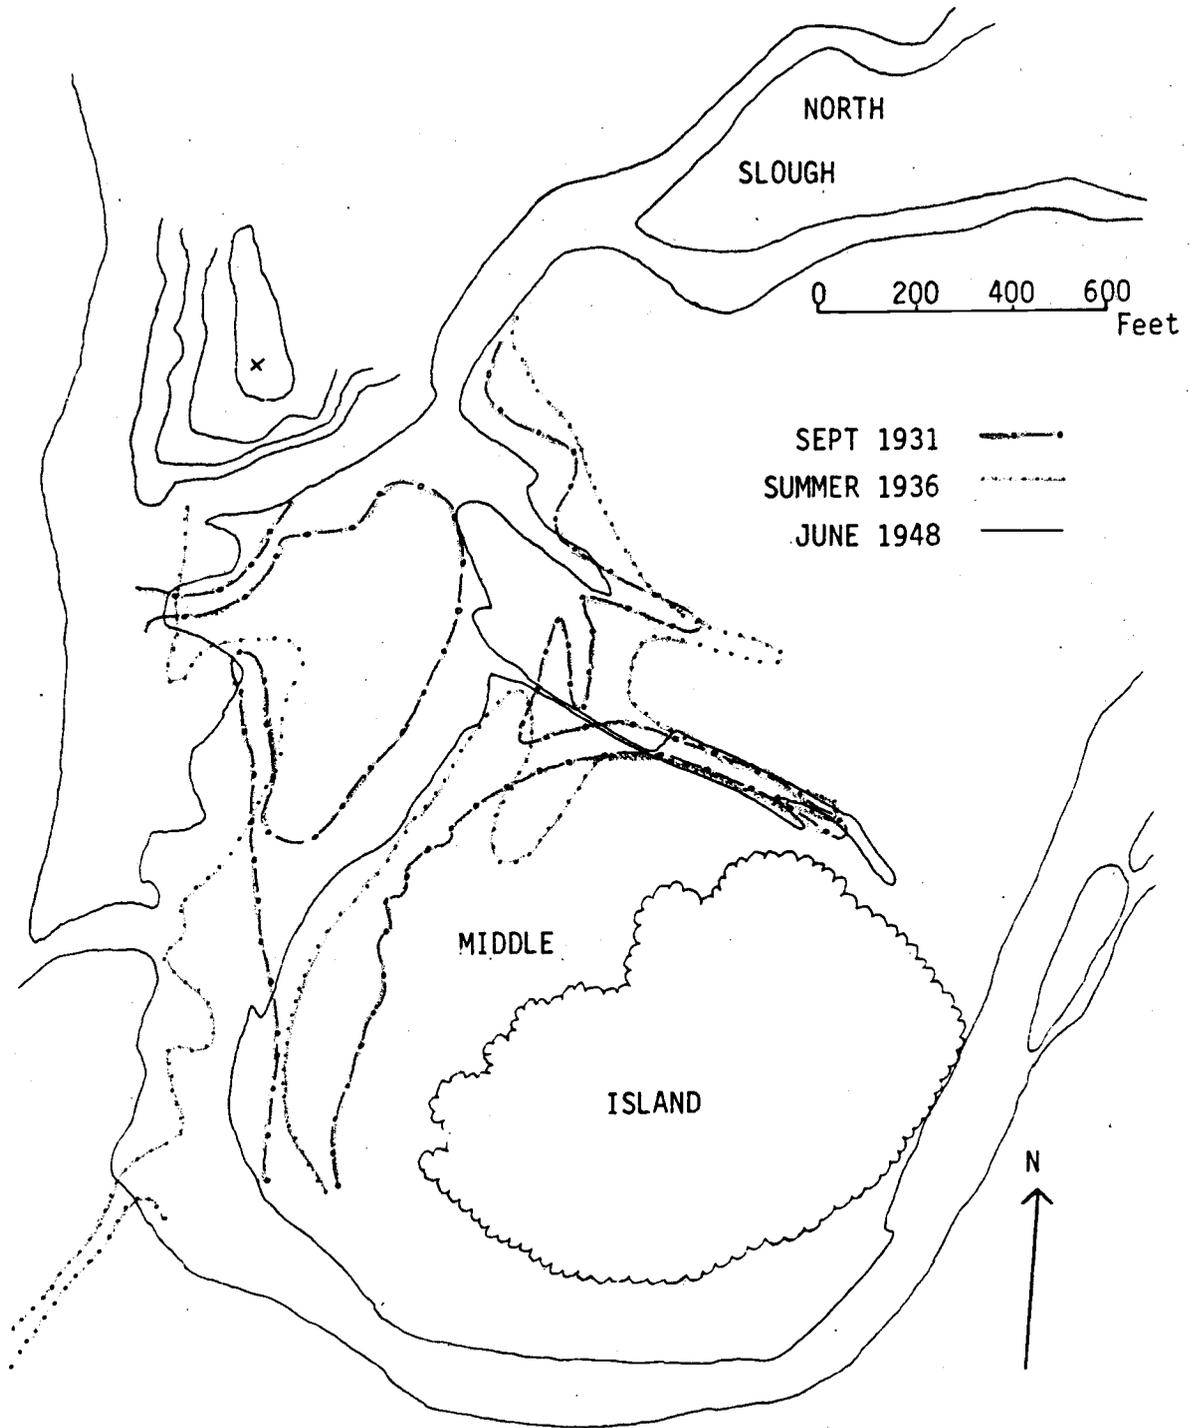
Figure 15: Embayment Shorelines, 1931-1948.

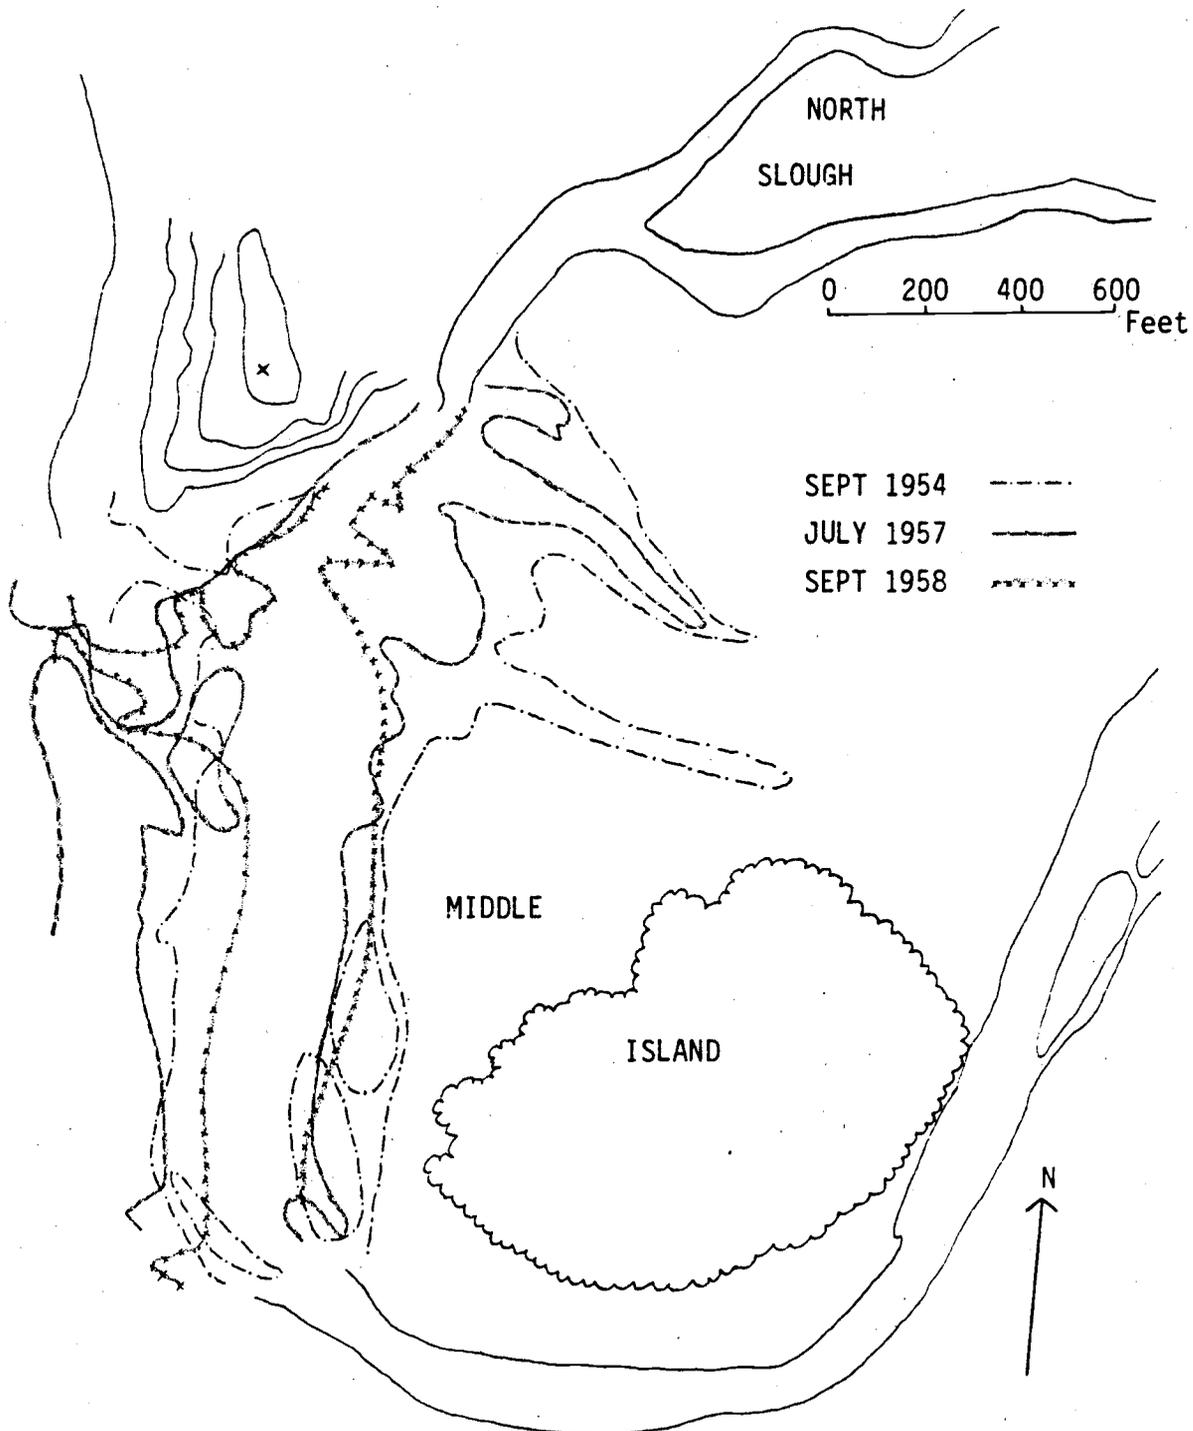
Figure 16: Embayment Shorelines, 1954-1958.

smaller deposit of this type was present in July, 1957 (Figure 16). Seasonal sedimentation processes, structures and morphology are documented in more detail in the following section.

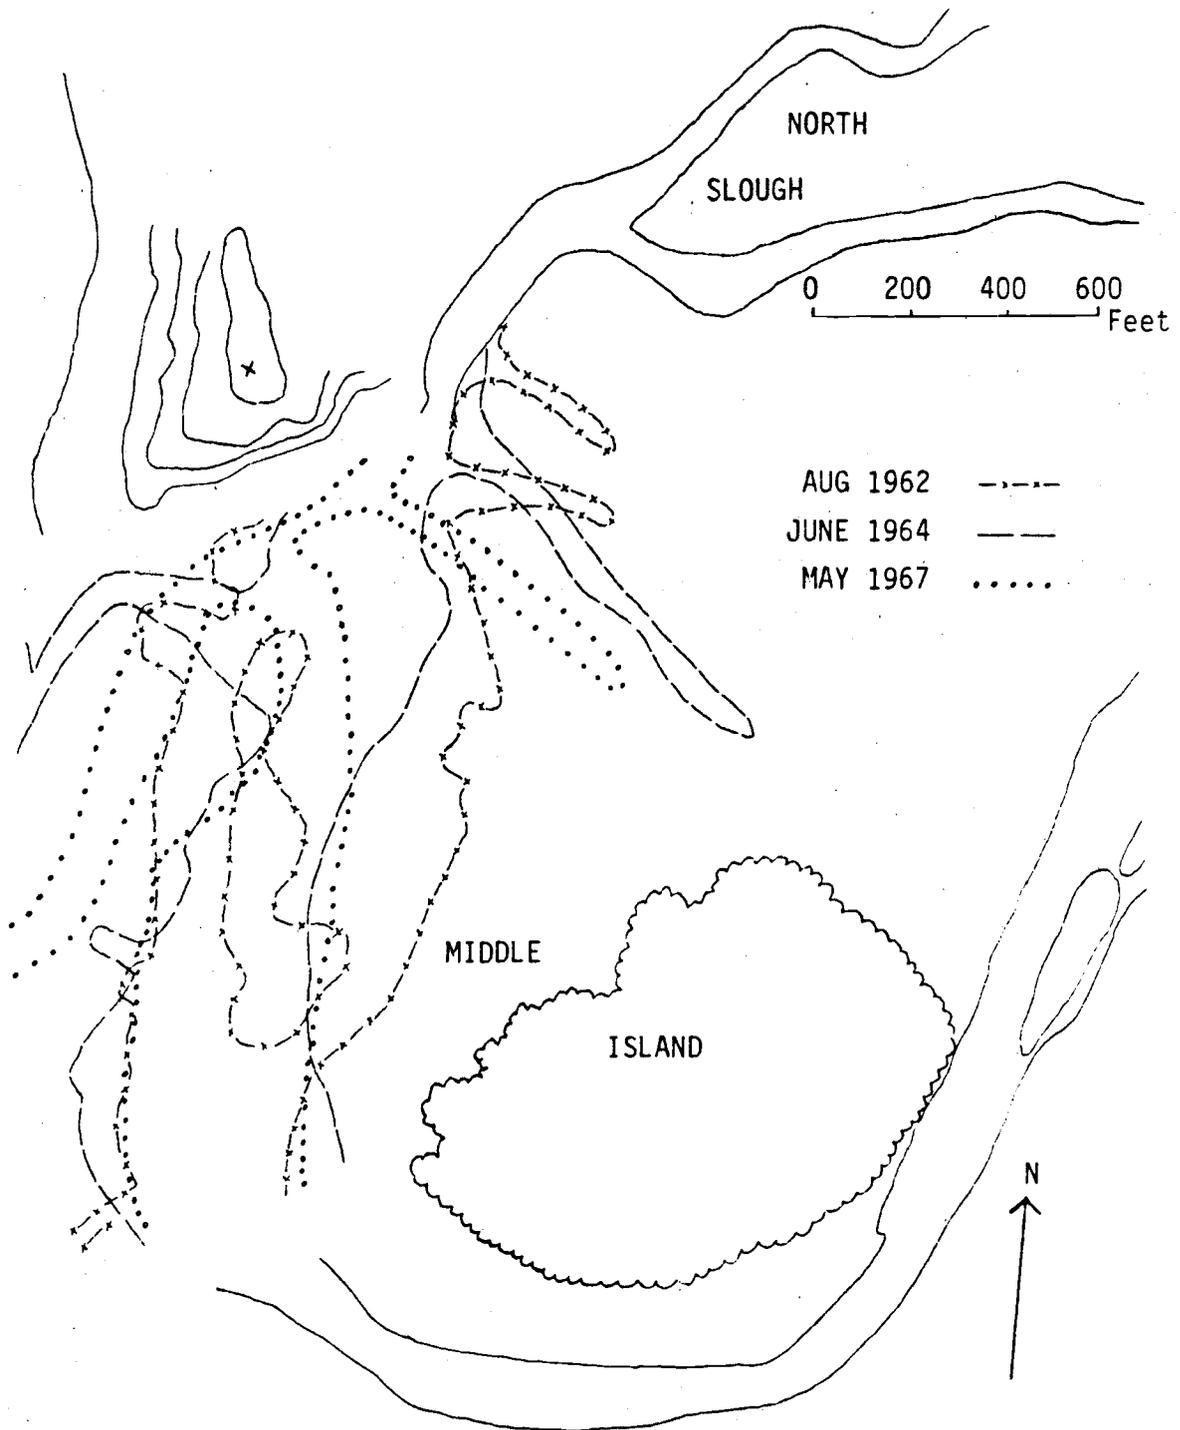
Figure 17: Embayment Shorelines, 1962-1967.

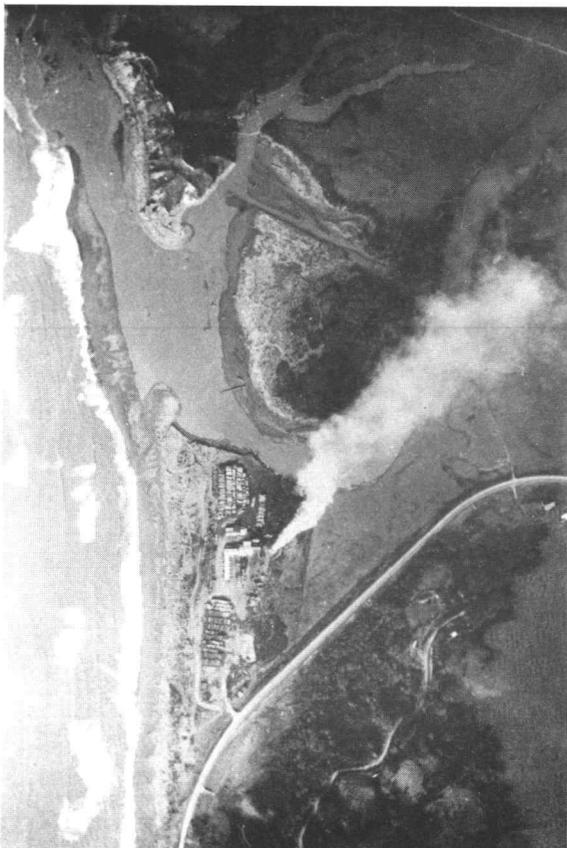
Figure 18: Aerial Photographs Showing Extent of Scour of Beach Berm Following Major Floods

a) January 13, 1965
following flood of December 15-23, 1964

Significant deposition between the middle and north sloughs was observed in aerial photos from January 13, 1965 (Figure 18). The slow recession of the 1964 flood contributed to extensive deposition across the entire floodplain (Figures 7 and 13). At the point of overbank flow, slight increases in the height or stage of a stream produce large increases in the inundated area. During flood recession, if high waves and/or storm tides back up the flow and increase the inundated area, velocity decreases. When the competence of sediment-laden flood waters declines, material is deposited in the embayment.

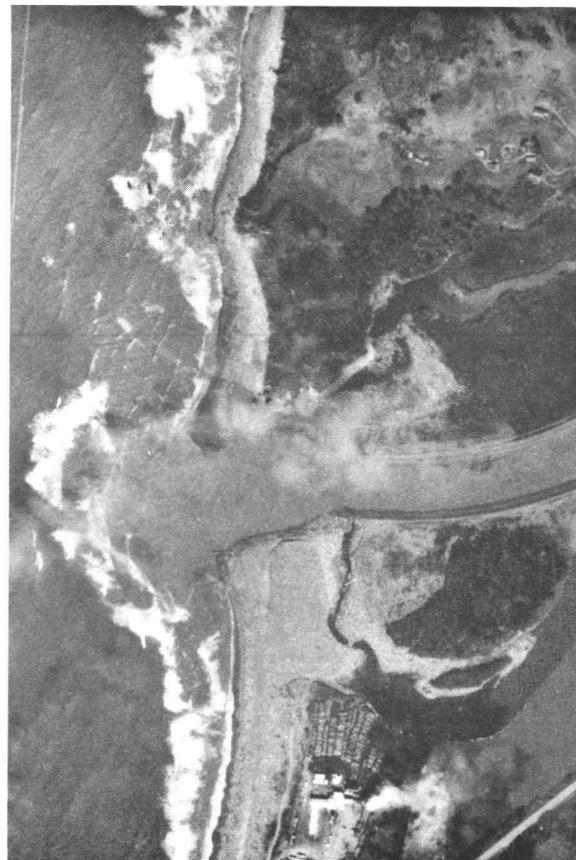
b) March 7, 1972
following flood of March 1-4, 1972

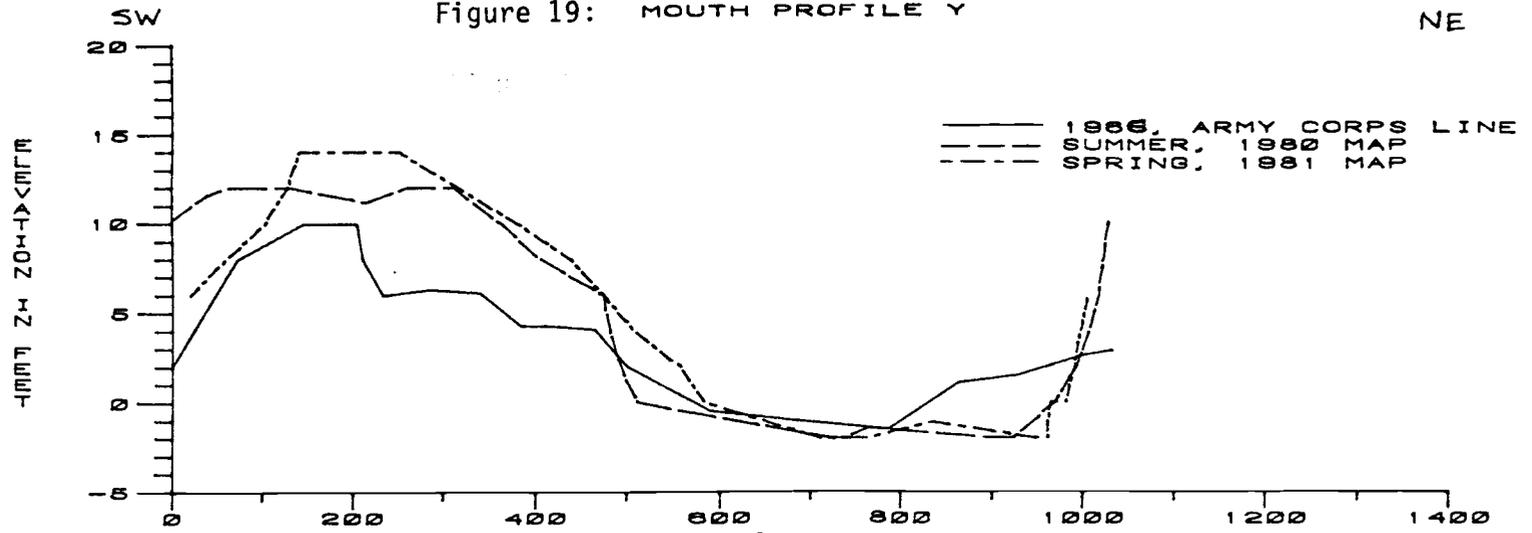
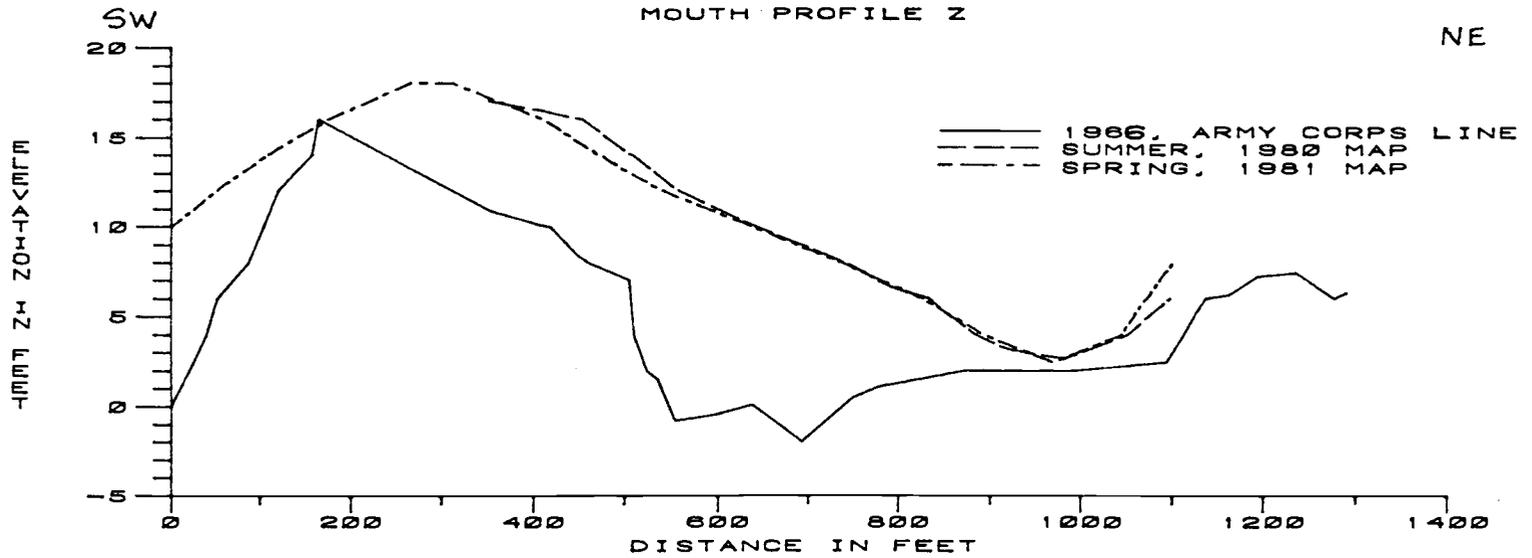
Figure 19: MOUTH PROFILE Y

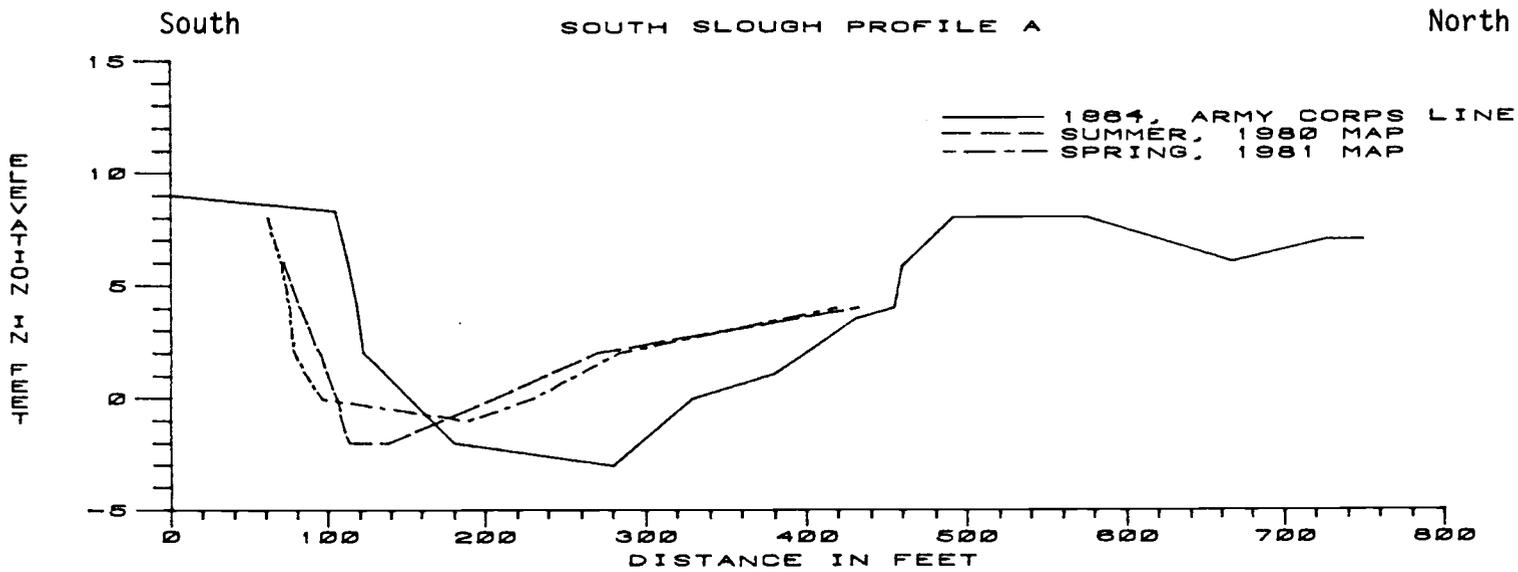
Figure 21: South Slough Profile A.

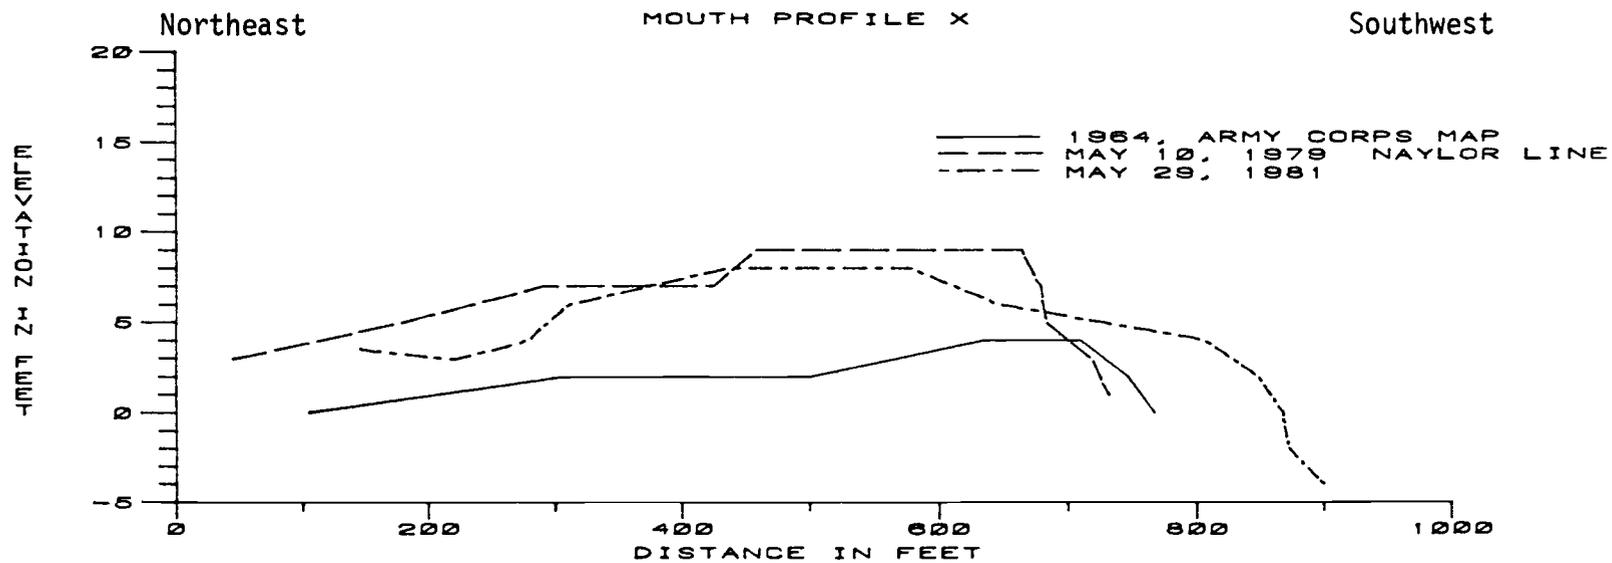
Figure 22: Mouth Profile X.

position. Across Mouth Profile X (Figure 22), 0.6-1.8 meters (2-6 ft) of sediment accumulated between 1964 and 1979, although the elevation of the subaerial deposit varies from year to year due to its direct exposure to waves.

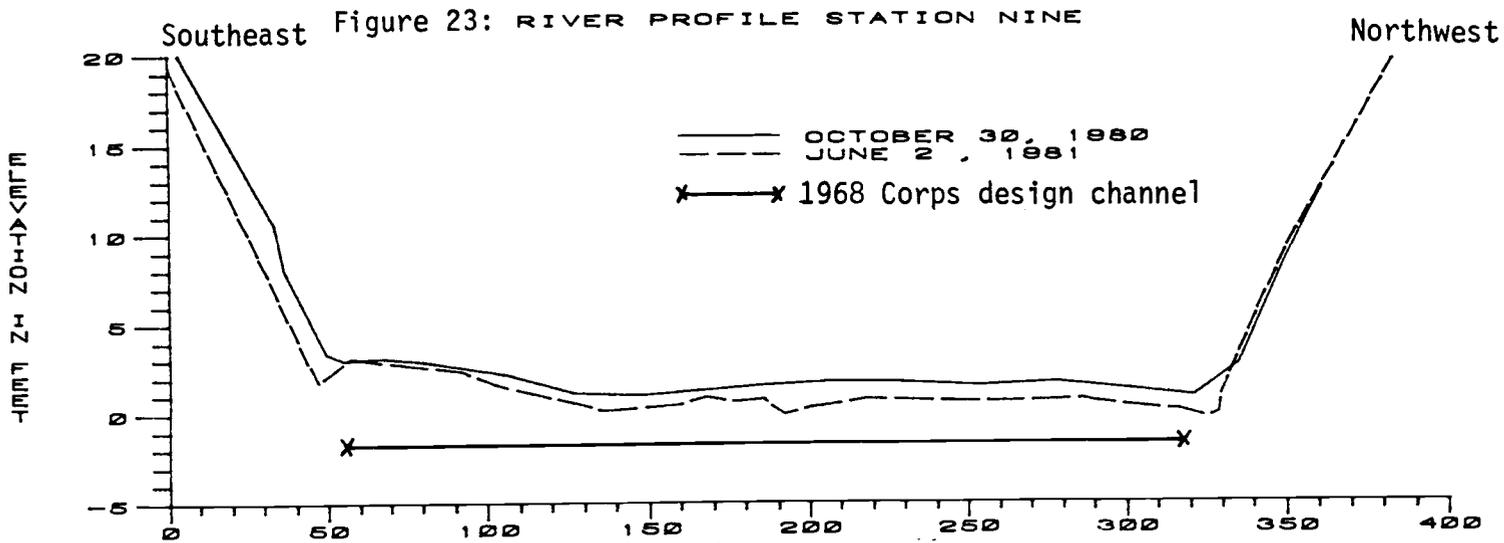
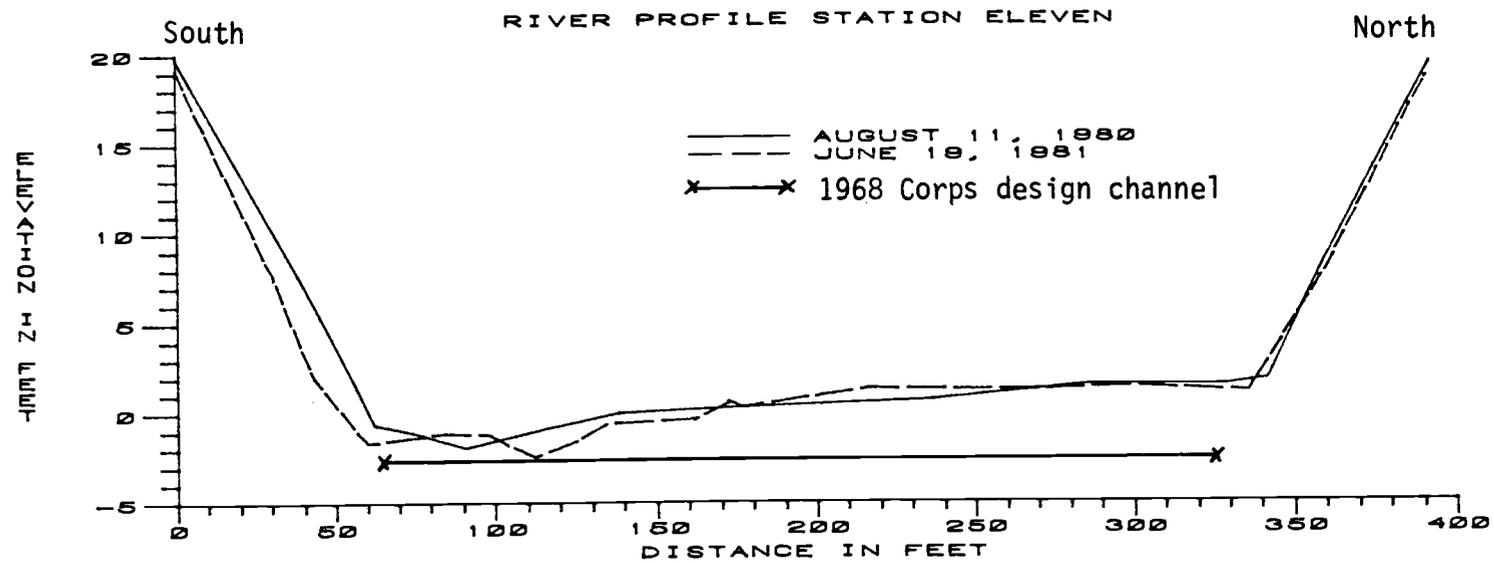
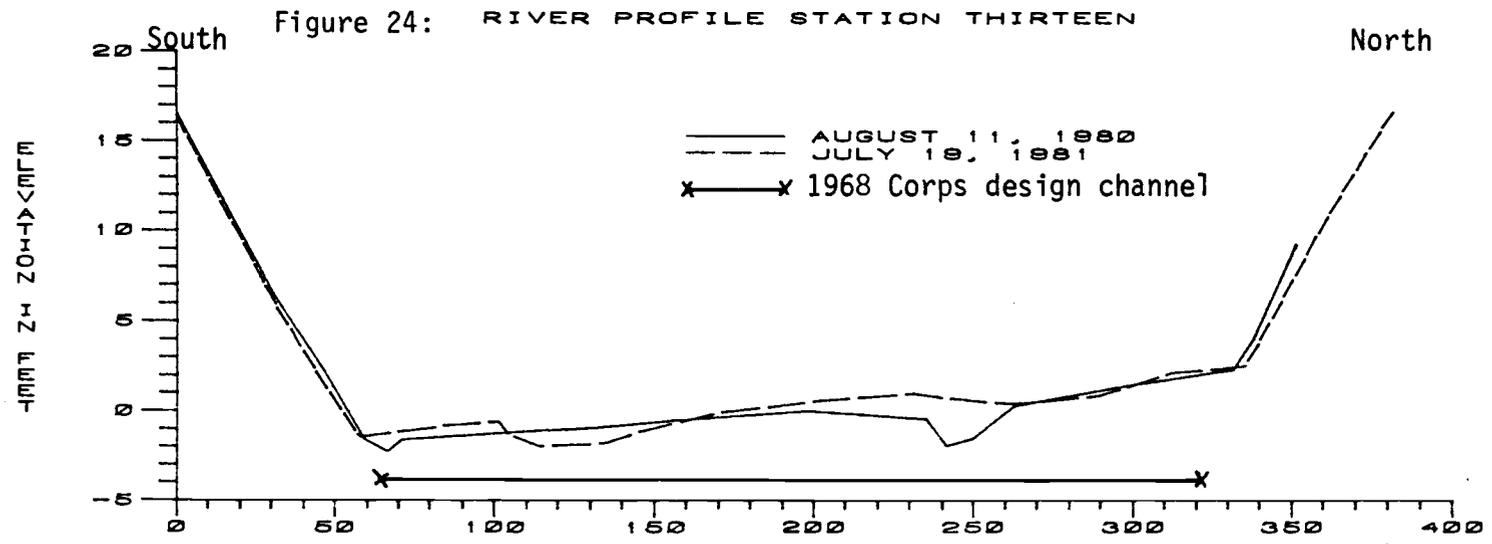
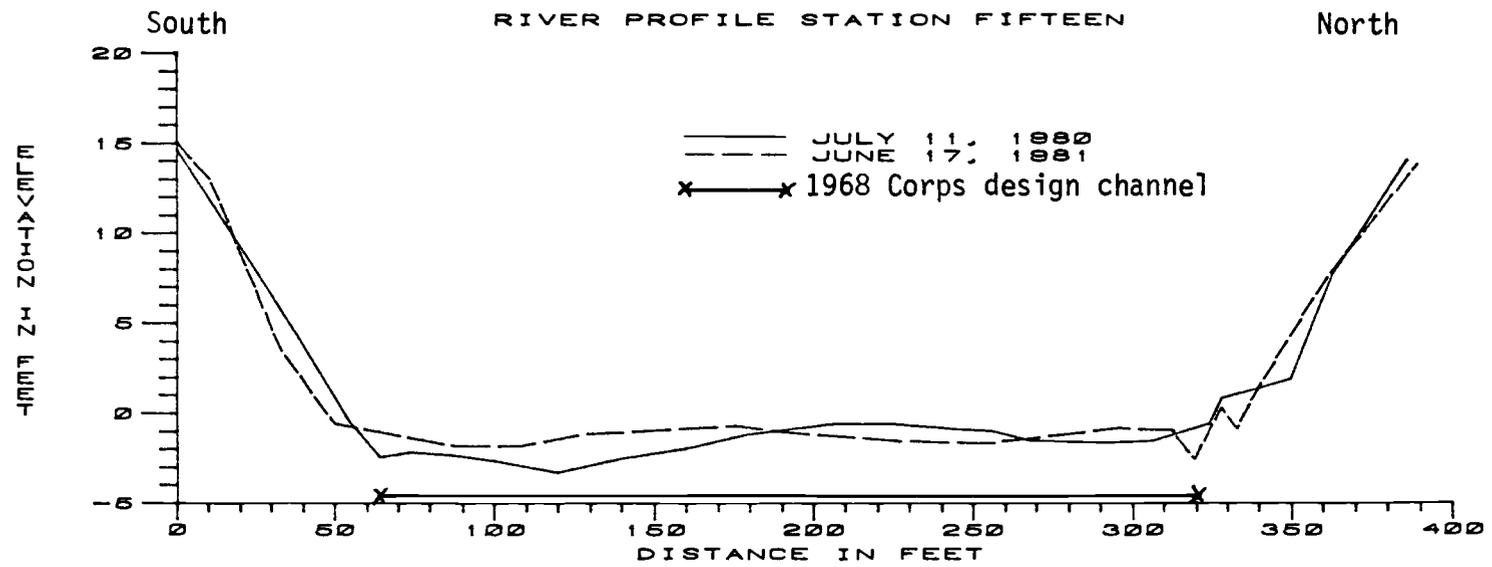
River Station Profiles 9 through 15 (Figures 23 and 24) illustrate the amount of aggradation between the levees since the design channel was excavated. Griggs and Paris (1982) found that aggradation along the lower San Lorenzo River lowered the stream gradient toward the pre-channelization equilibrium value. This process also reduced the theoretical capacity of the flood control project. The stream gradient along Redwood Creek between each of the River Station Profiles is quite variable, and a more detailed longitudinal survey is needed between the levees. Channel surveys from approximately 2.3 kilometers (1.4 mi.) upstream of the mouth to the Highway 101 bridge (M.A. Madej, 1981, written communication) showed a decrease from the design gradient, 0.14 percent, to 0.11 percent in 1980.

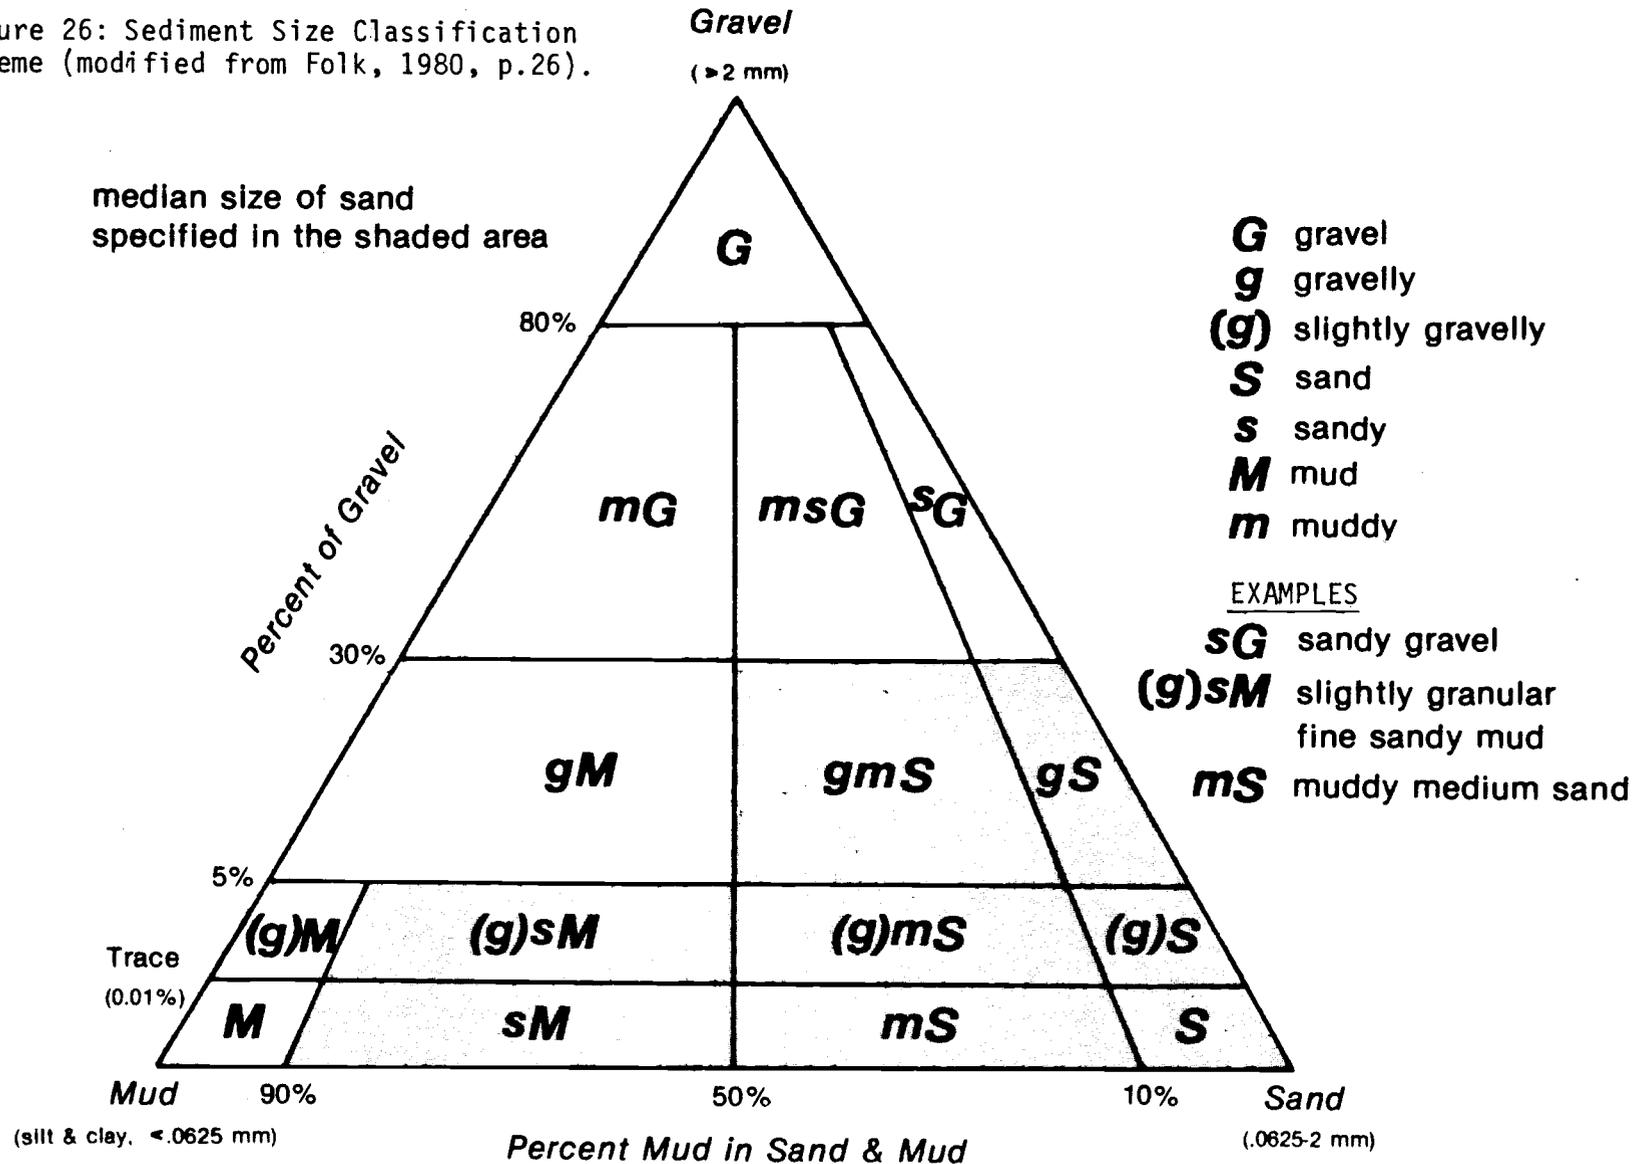
Figure 26: Sediment Size Classification Scheme (modified from Folk, 1980, p.26).

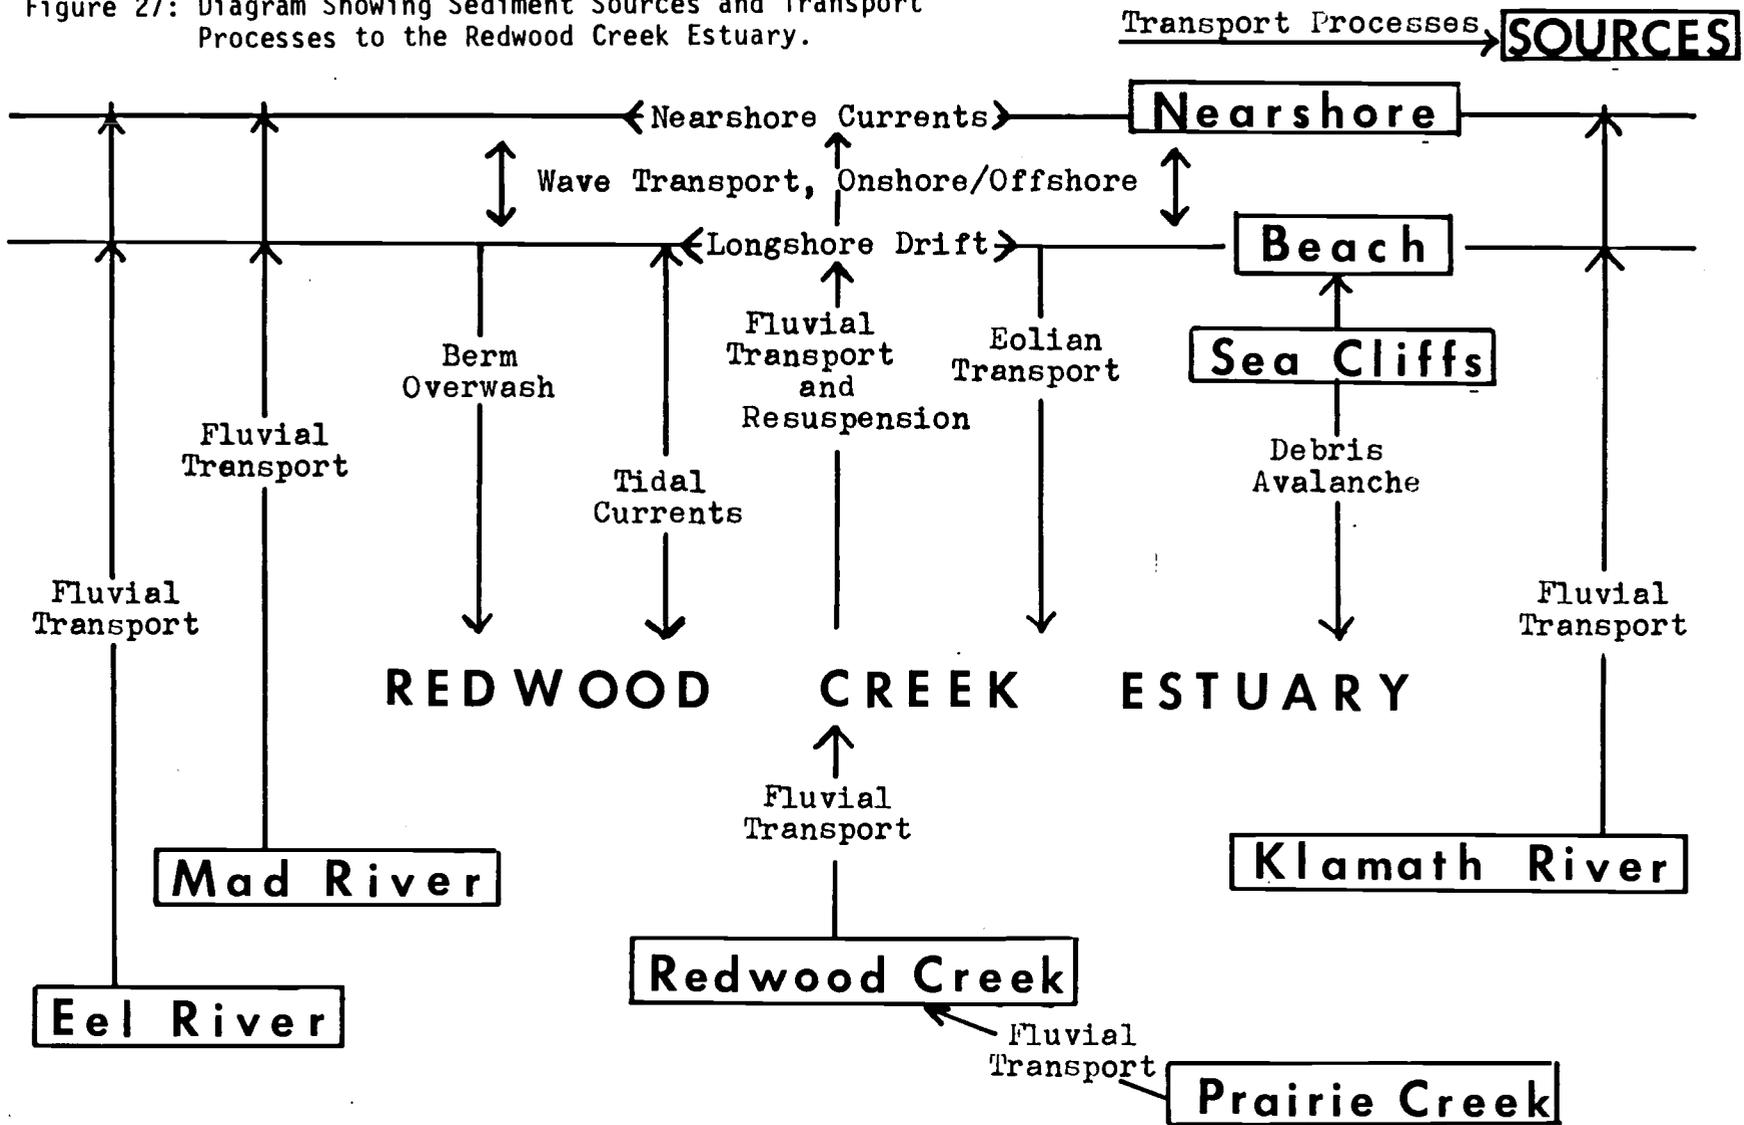
Figure 27: Diagram Showing Sediment Sources and Transport Processes to the Redwood Creek Estuary.

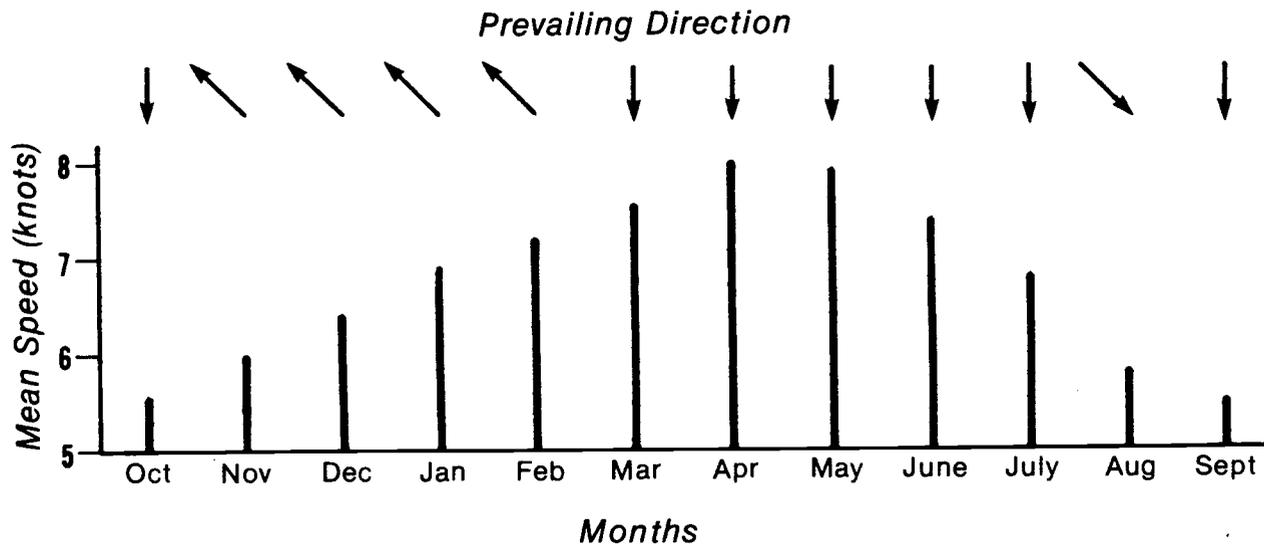
Figure 28:
Monthly Average Wind Velocities at Eureka, California (54-year record)
(published by U.S. Dept. of Commerce, modified from Carlson and Harden,
1975, table 4)

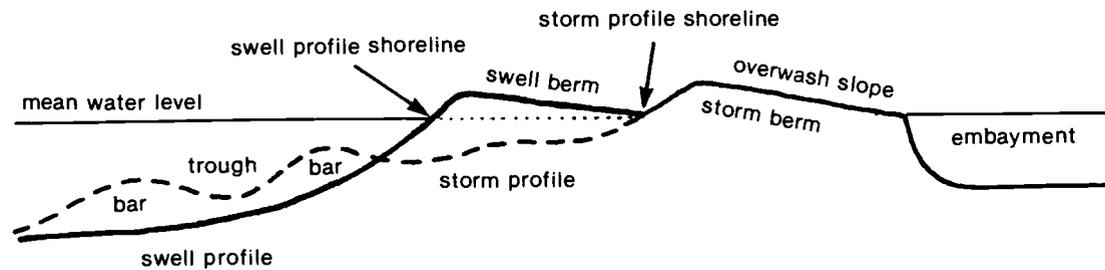
Figure 29:
Beach Profiles for Storm (winter) Conditions and Swell (summer) Conditions
 (modified from Bascom, 1954 and Komar, 1976, p. 289)

Berm: The nearly horizontal portion of the beach or backshore
Storm profile: Almost no berm, sand shifted into offshore bars, gentle slope
Swell profile: Wide berm, smooth offshore, steeper slope

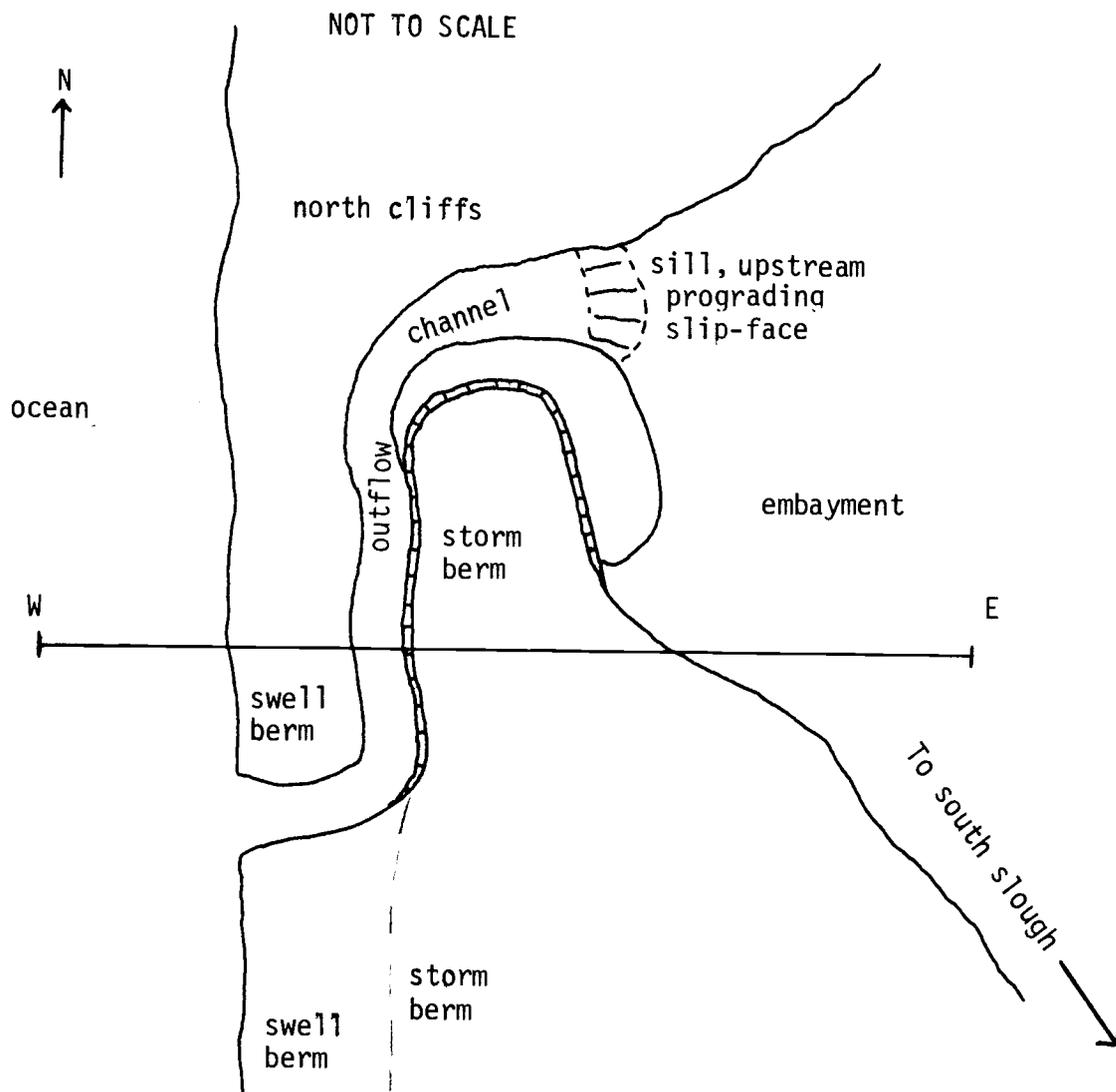
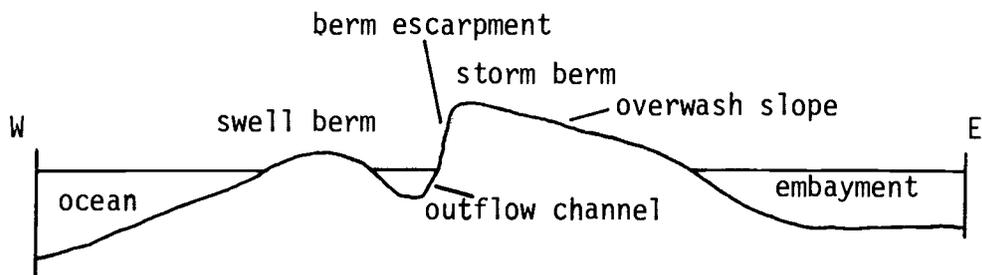
Figure 30: Typical Summer Morphological Features, Mouth of Redwood Creek.

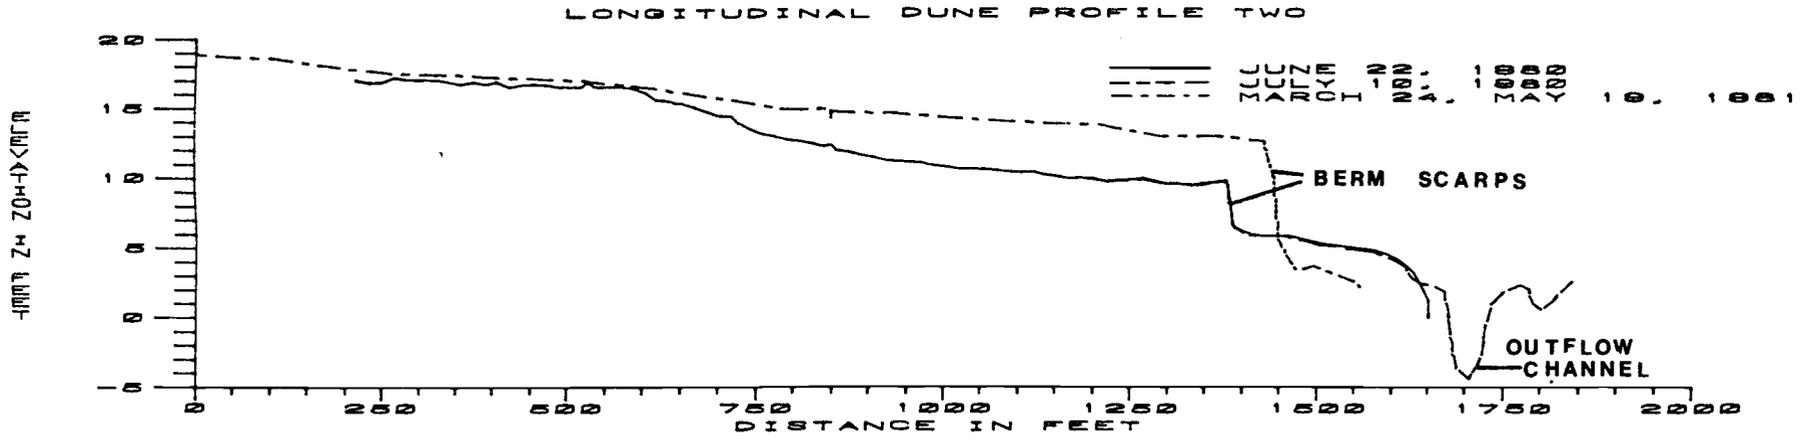
Figure 31: Longitudinal Dune Profile Two.

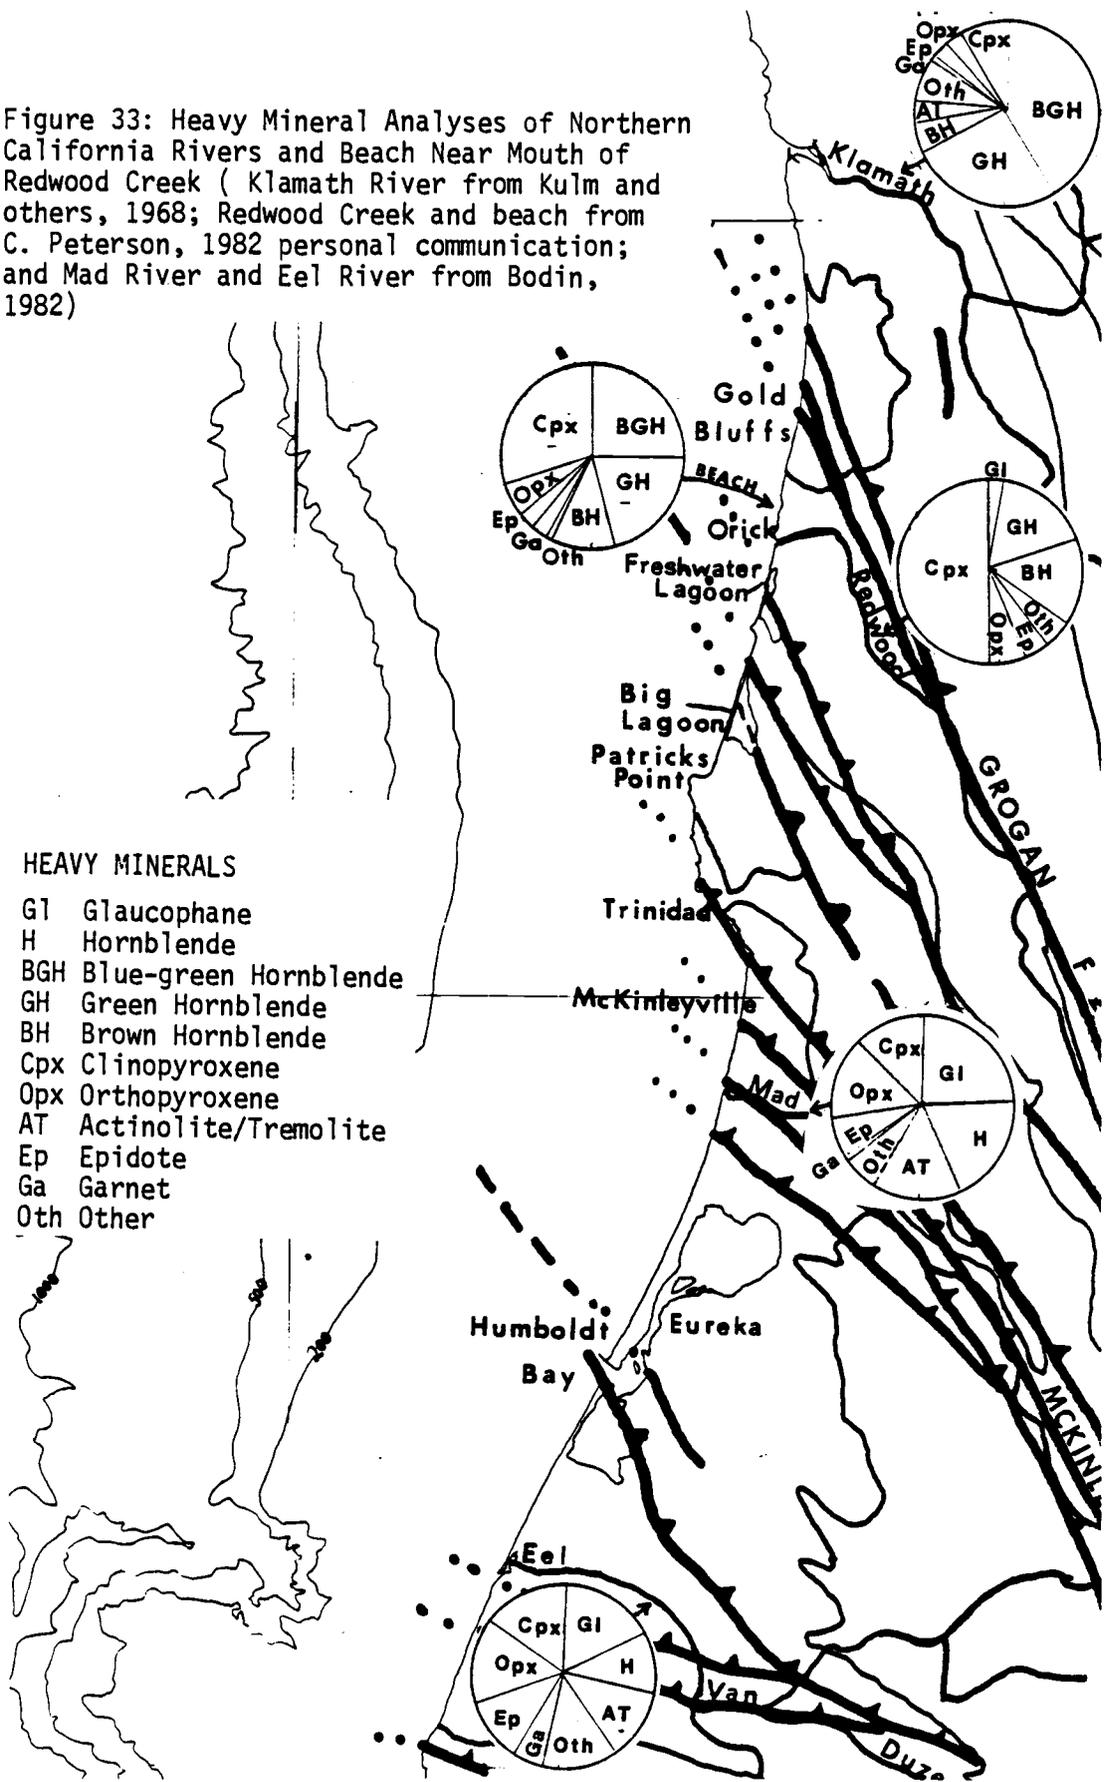
Figure 33: Heavy Mineral Analyses of Northern California Rivers and Beach Near Mouth of Redwood Creek (Klamath River from Kulm and others, 1968; Redwood Creek and beach from C. Peterson, 1982 personal communication; and Mad River and Eel River from Bodin, 1982)
