Flood History and Sedimentation at the Mouth of Redwood Creek,
Humboldt County, California

A THESIS
submitted to
Oregon State University

in partial fulfillment of
the requirements for the
degree of
Master of Science
Completed June 9, 1983
Commencement June 1984

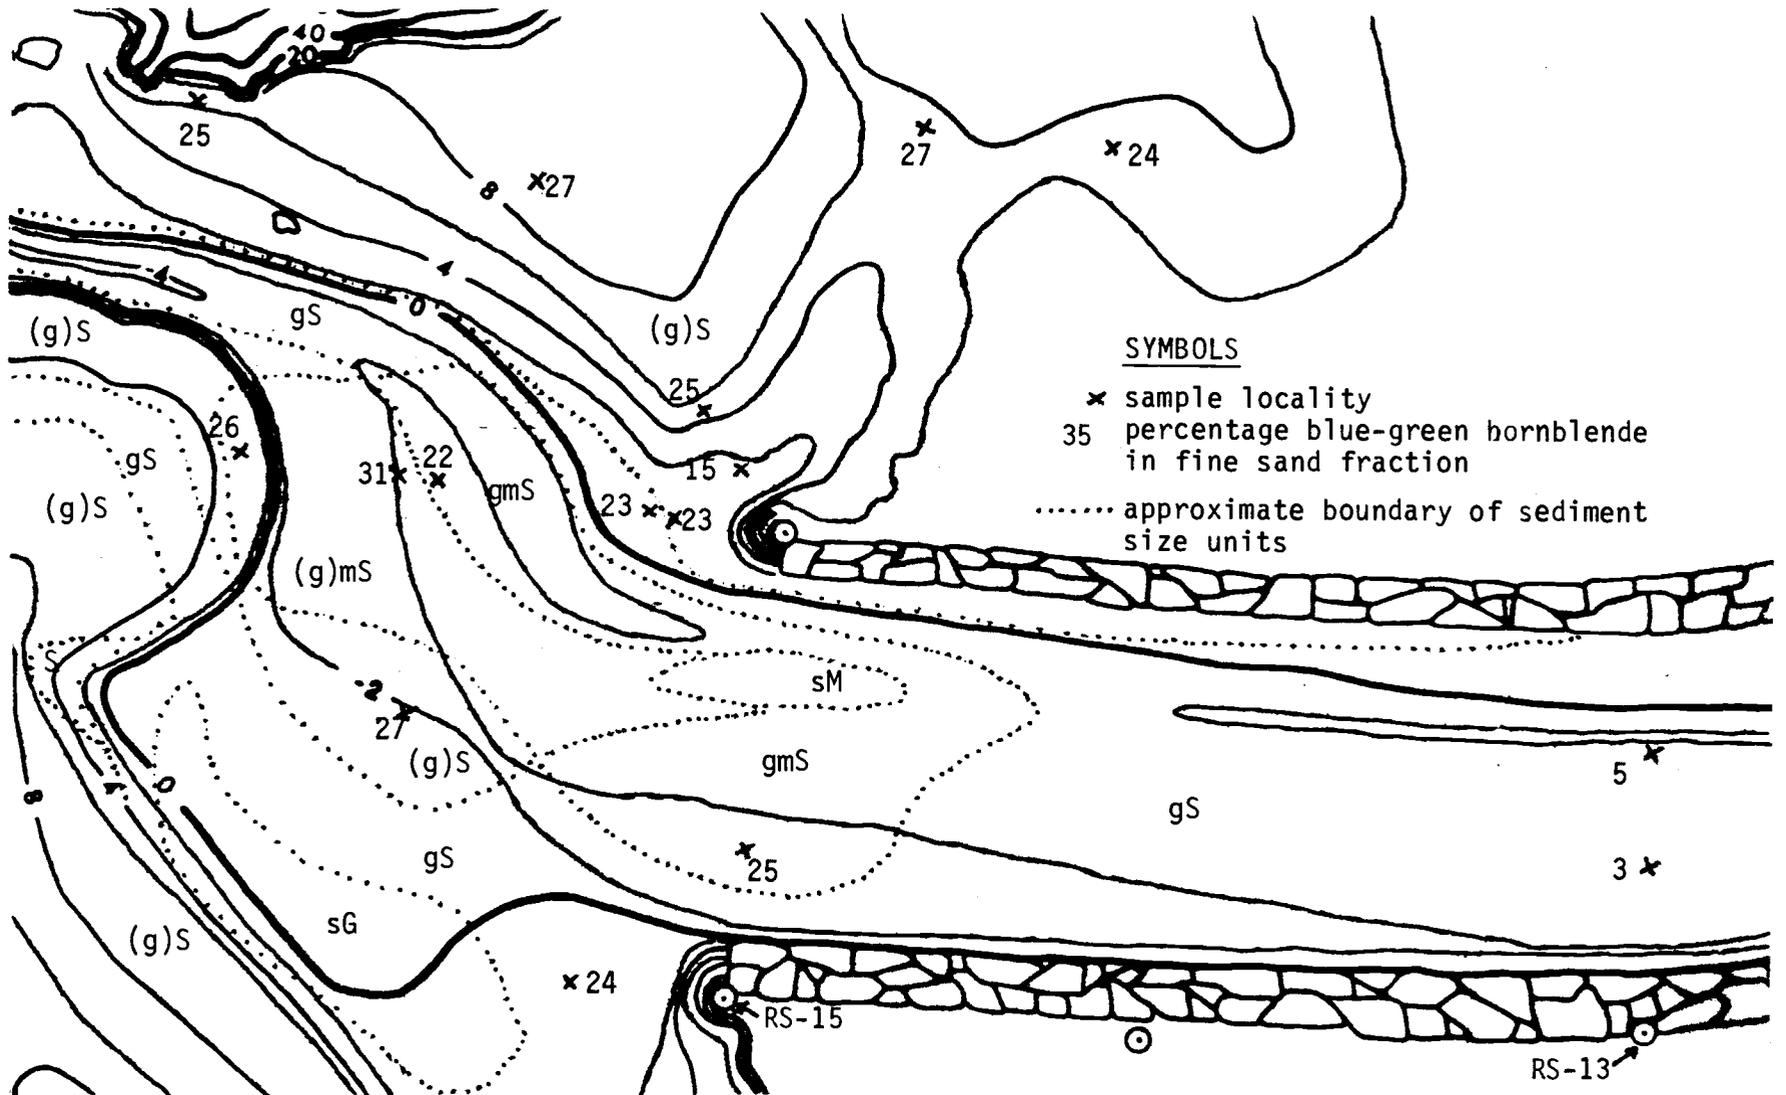
Figure 34: Lower Redwood Creek, Blue-Green Hornblende Content and Sediment Size Distribution, Summer 1980. See Figure 26 for Sediment Size Classification Symbols.

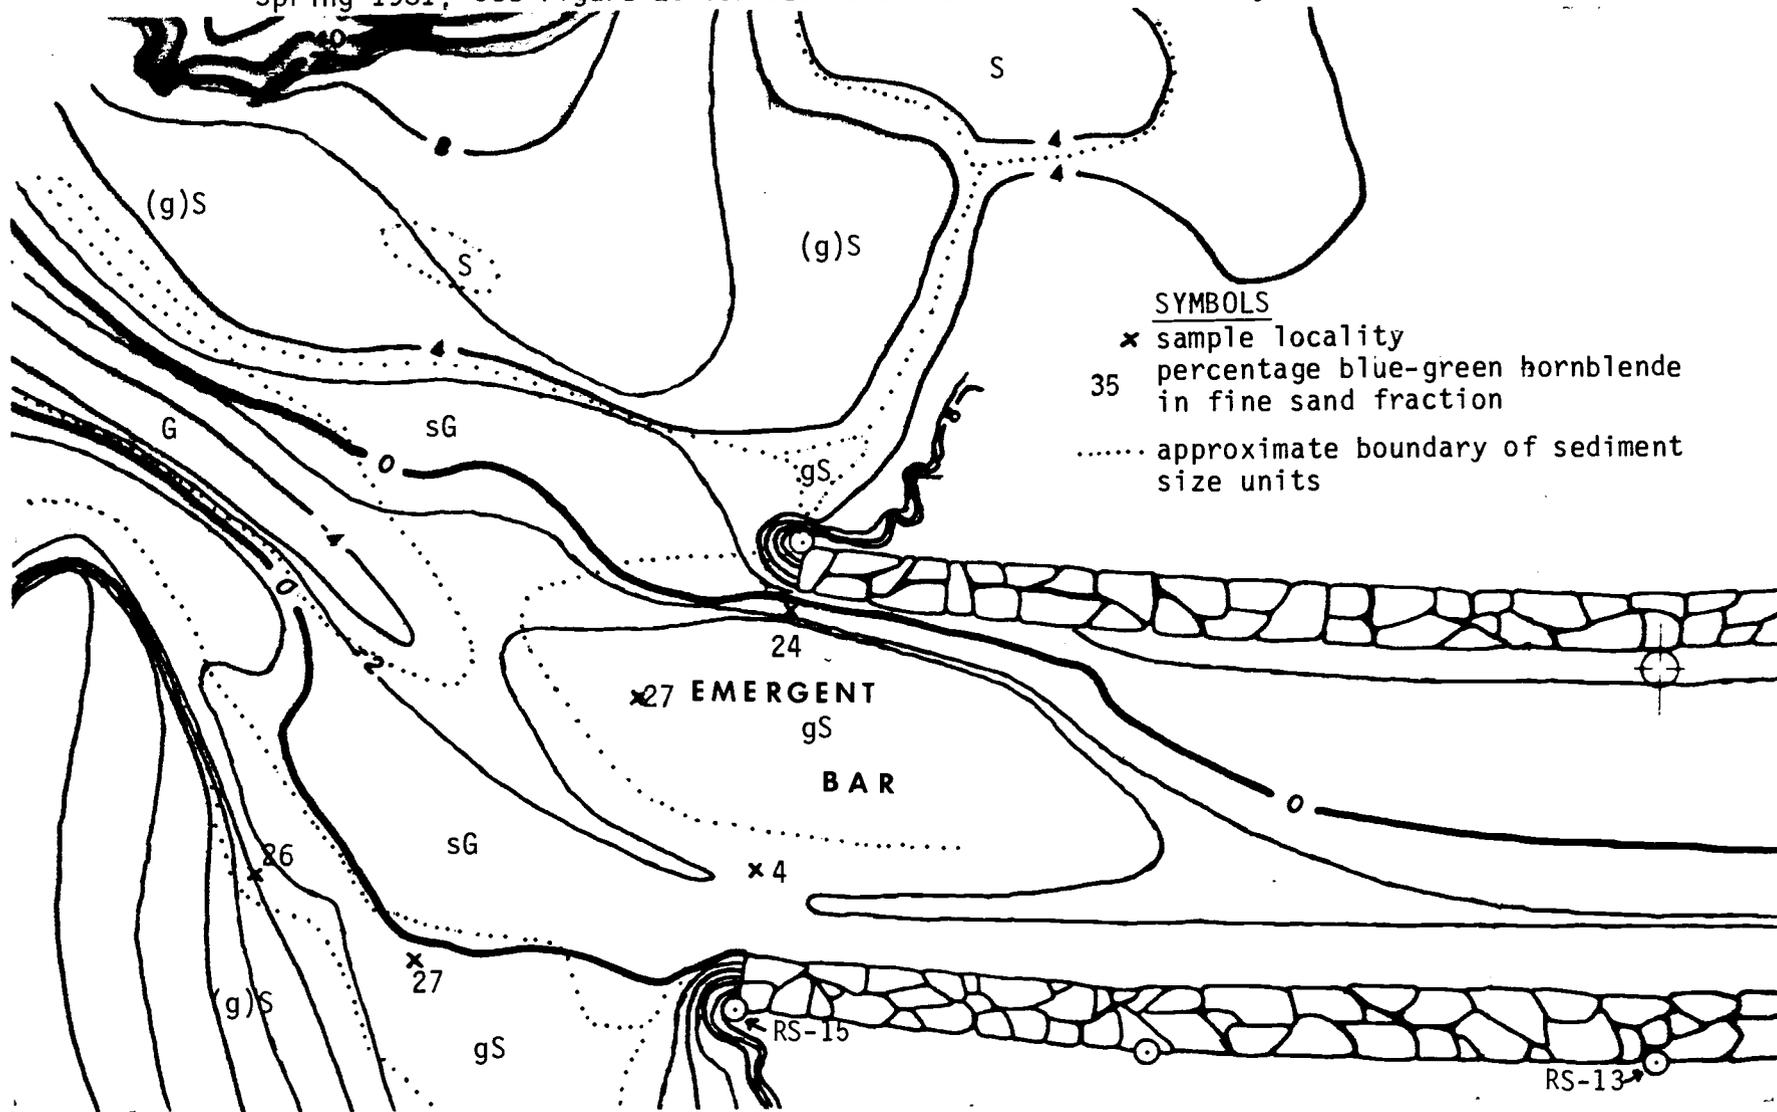
Figure 35: Lower Redwood Creek, Blue-Green Hornblende Content and Sediment Size Distribution, Spring 1981, See Figure 26 for Sediment Size Classification Symbols.

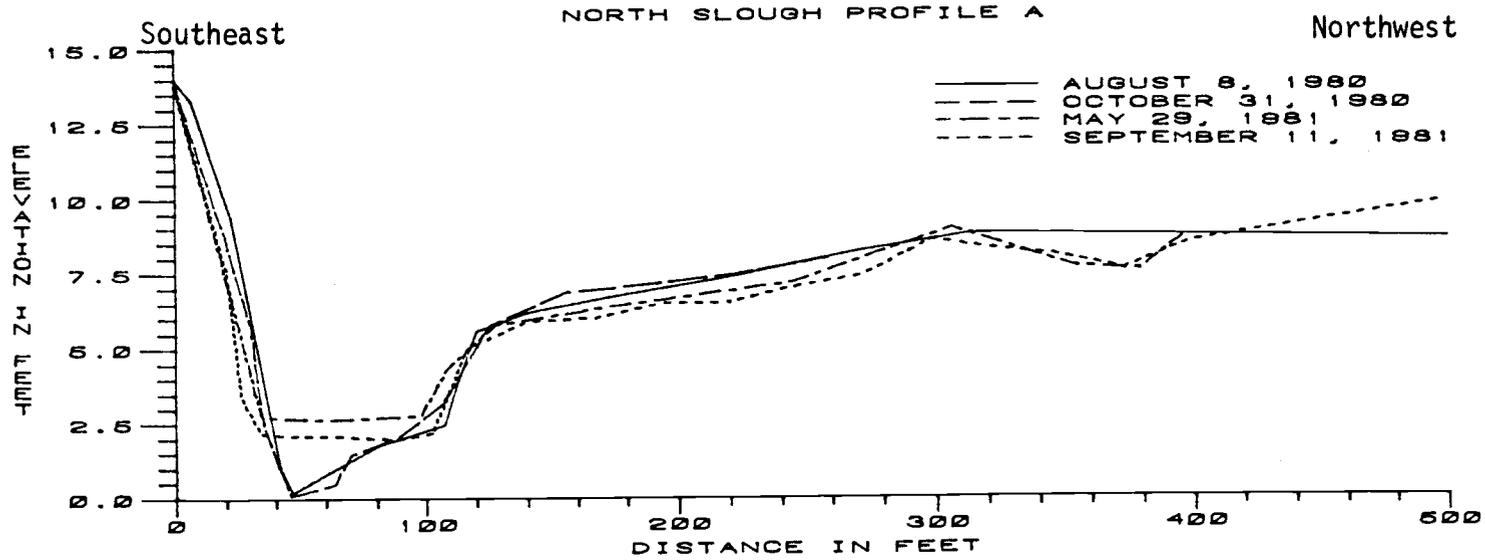
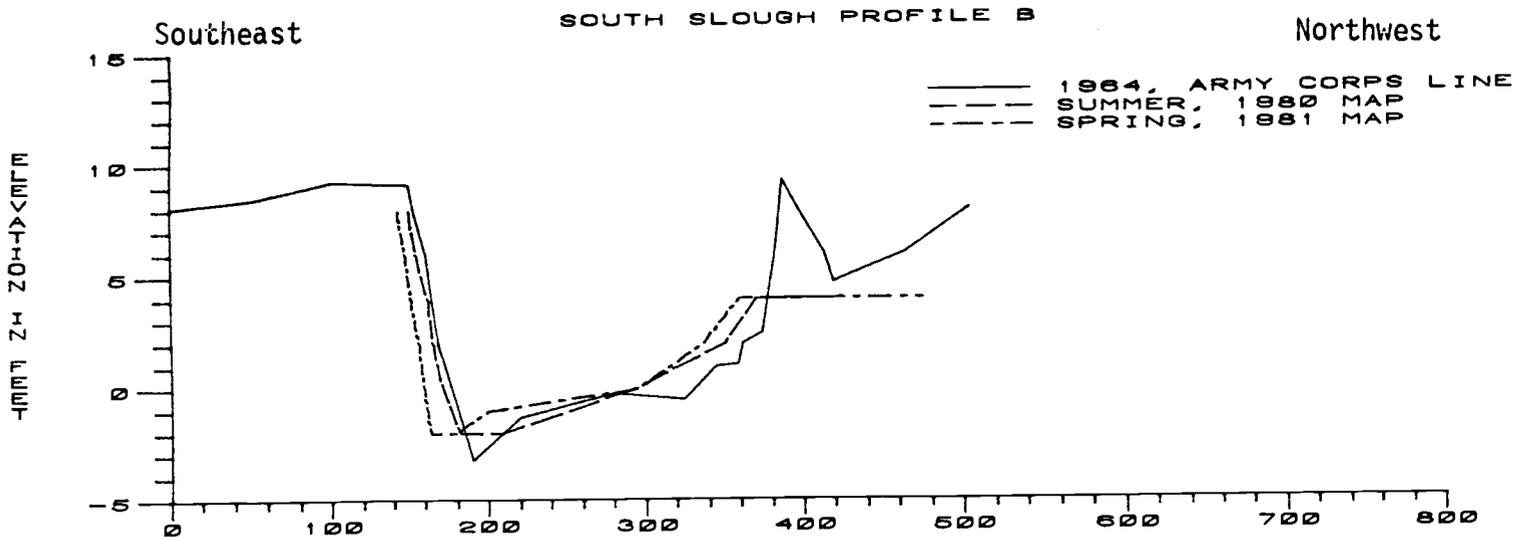
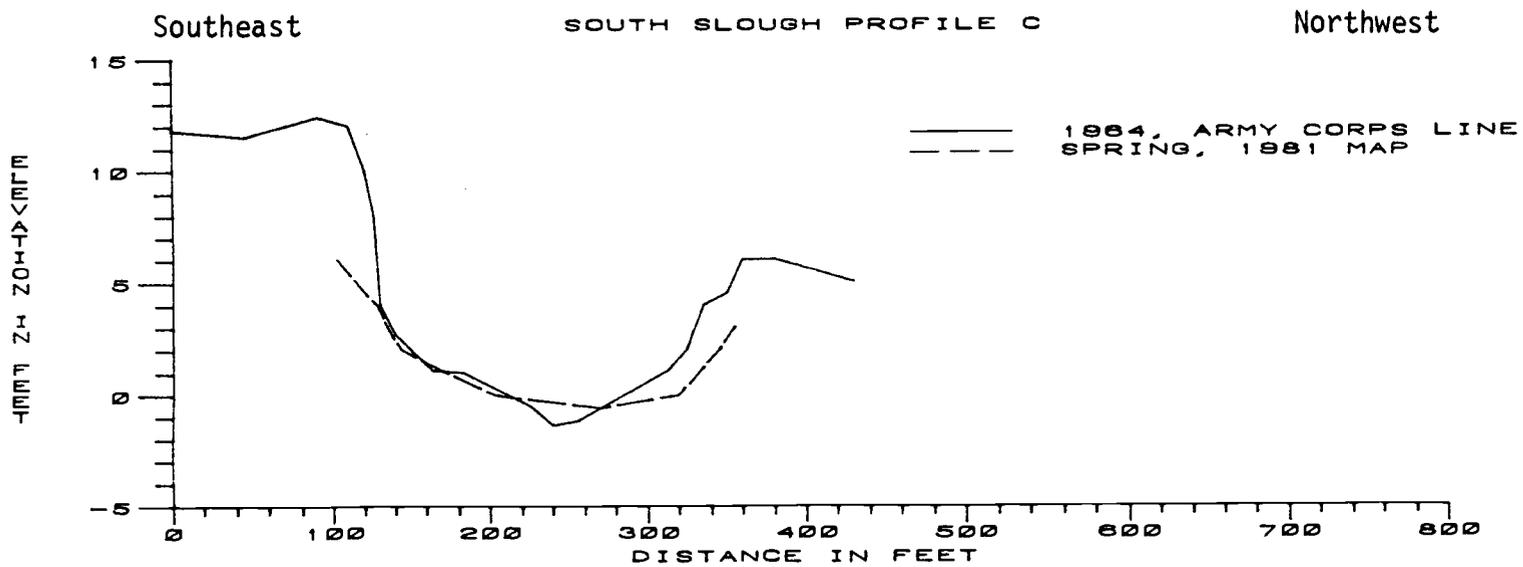
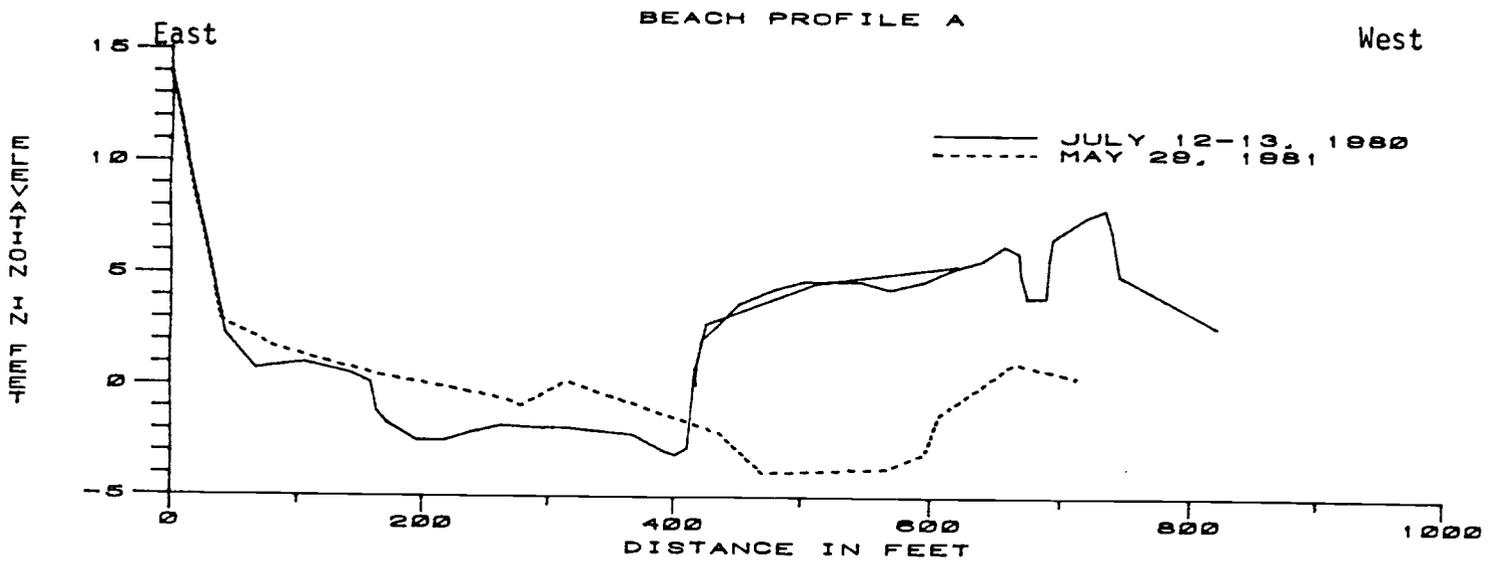
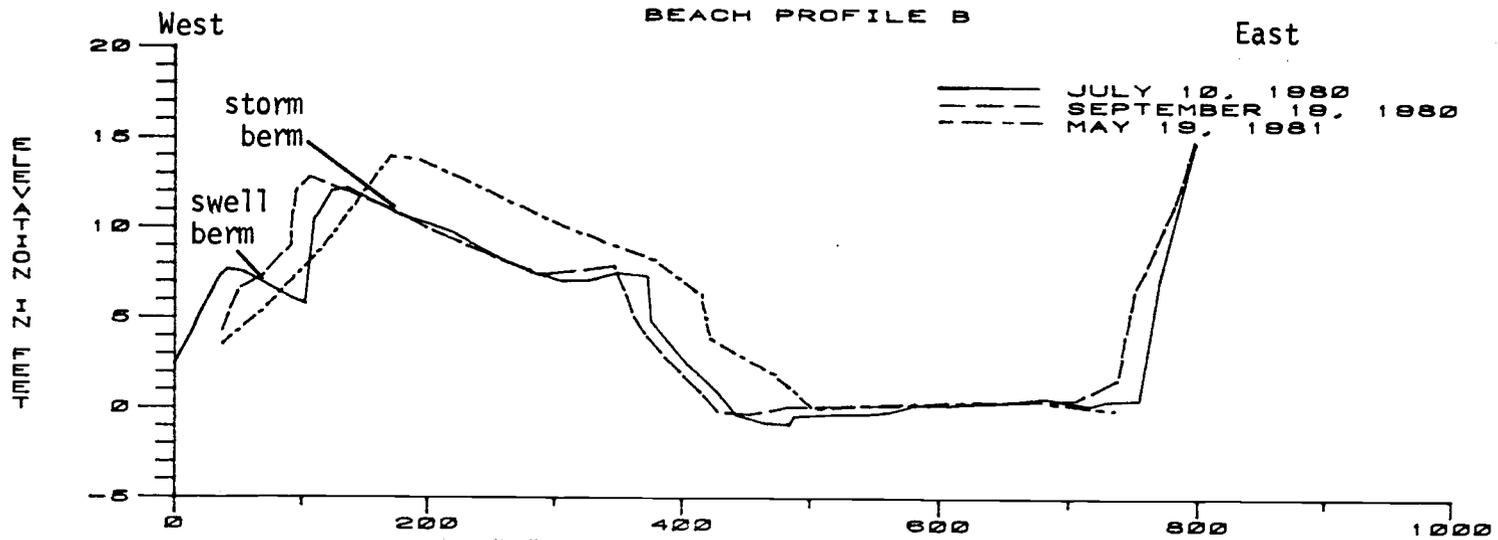
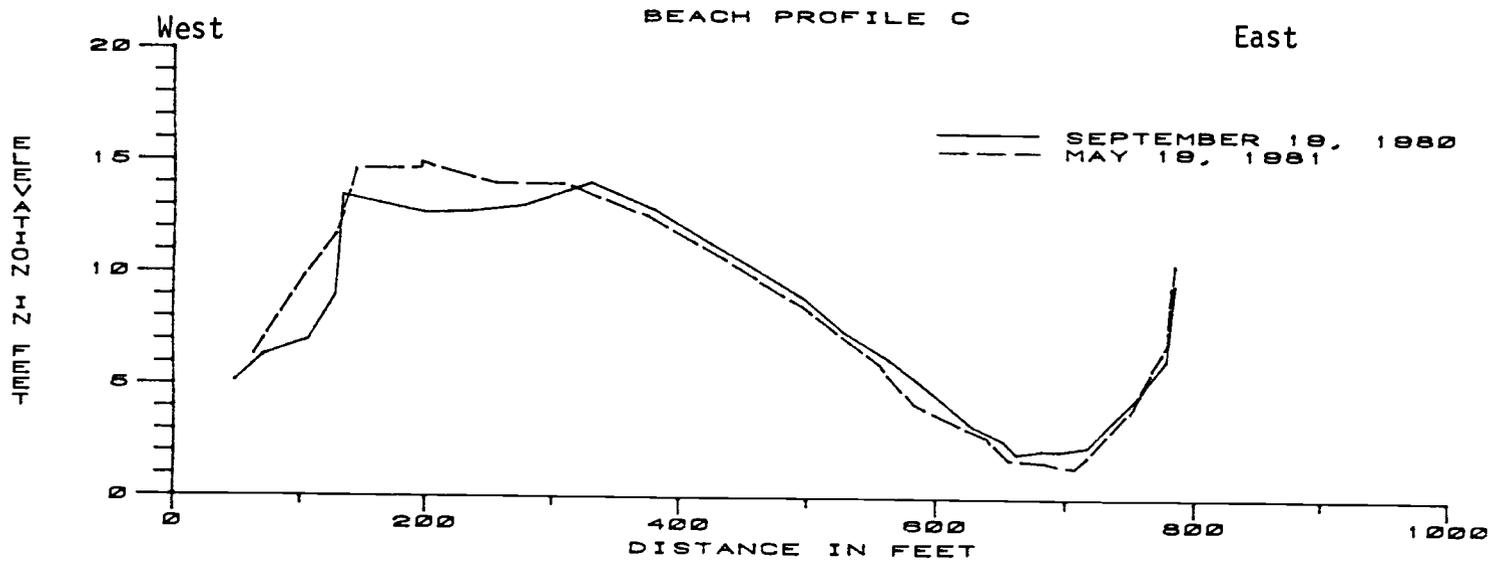
APPENDIX C
ADDITIONAL SURVEYED TOPOGRAPHIC / BATHYMETRIC PROFILES
(For Profile Locations, See Map Plate 1)
