HABITAT IMPROVEMENT PROJECT

Tex Creek Project
Number 10

Closing Report

PROJECT TITLE: Habitat Improvement to Enhance Anadromous Fish Production

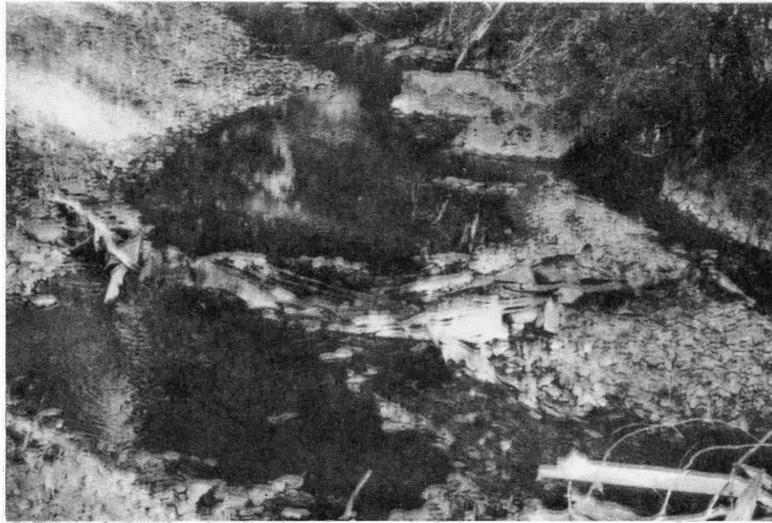
Figure 1. Weir No. 6 showing effects of spring runoff on plastic sheeting barrier.

After two summer's observations it was apparent that the short weirs that crossed only the streambed (Nos. 1 through 5) were not effective. The all-plastic weir No. 6 that traversed the valley floor was raising water and maintaining a flow a short distance above and below it. The high water during spring runoff tore and shedded the plastic where it crossed the stream channel, reducing the height that the water level could be raised.

Weir No. 6 that traversed the valley floor did raise water and maintained a flow in the creek throughout the normal dry period. In 1963 it was maintaining a flow over a total of 26 yards, 18 yards above and 8 yards below the site. However, water action on the plastic undoubtedly reduced the efficiency of the structure.

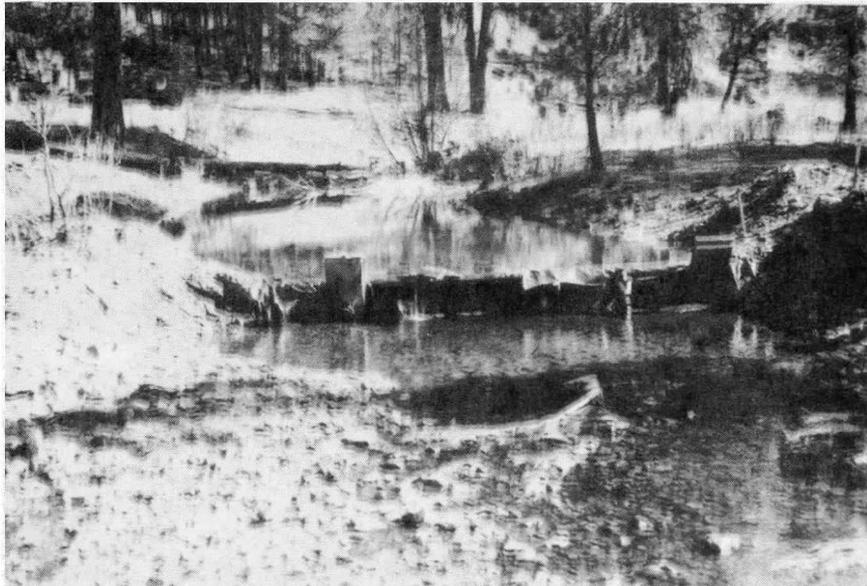
Figure 2. Weir No. 7 maintaining a summer flow above and below itself in 1964.

Weir No. 7, the V design with the wooden backing, was the most successful of the weirs. After the opening was blocked it was maintaining a flow of 70 yards upstream in 1963 and maintained a continuous flow in 1964. However, in 1964 water conditions throughout the drainage were above average. Weir No. 8, the plastic and wooden weir installed 75 yards downstream from weir No. 6 did not raise water or noticeably change the flow at weir No. 6. The inability to raise water may have been due to a loose back-fill that permitted the water to escape around or under the plastic sheeting. Another contributing factor is that one wing could not be extended completely across the valley floor because of a U. S. Forest Service road. The gravel stratum under the road could allow substantial amounts of water to escape around the weir.

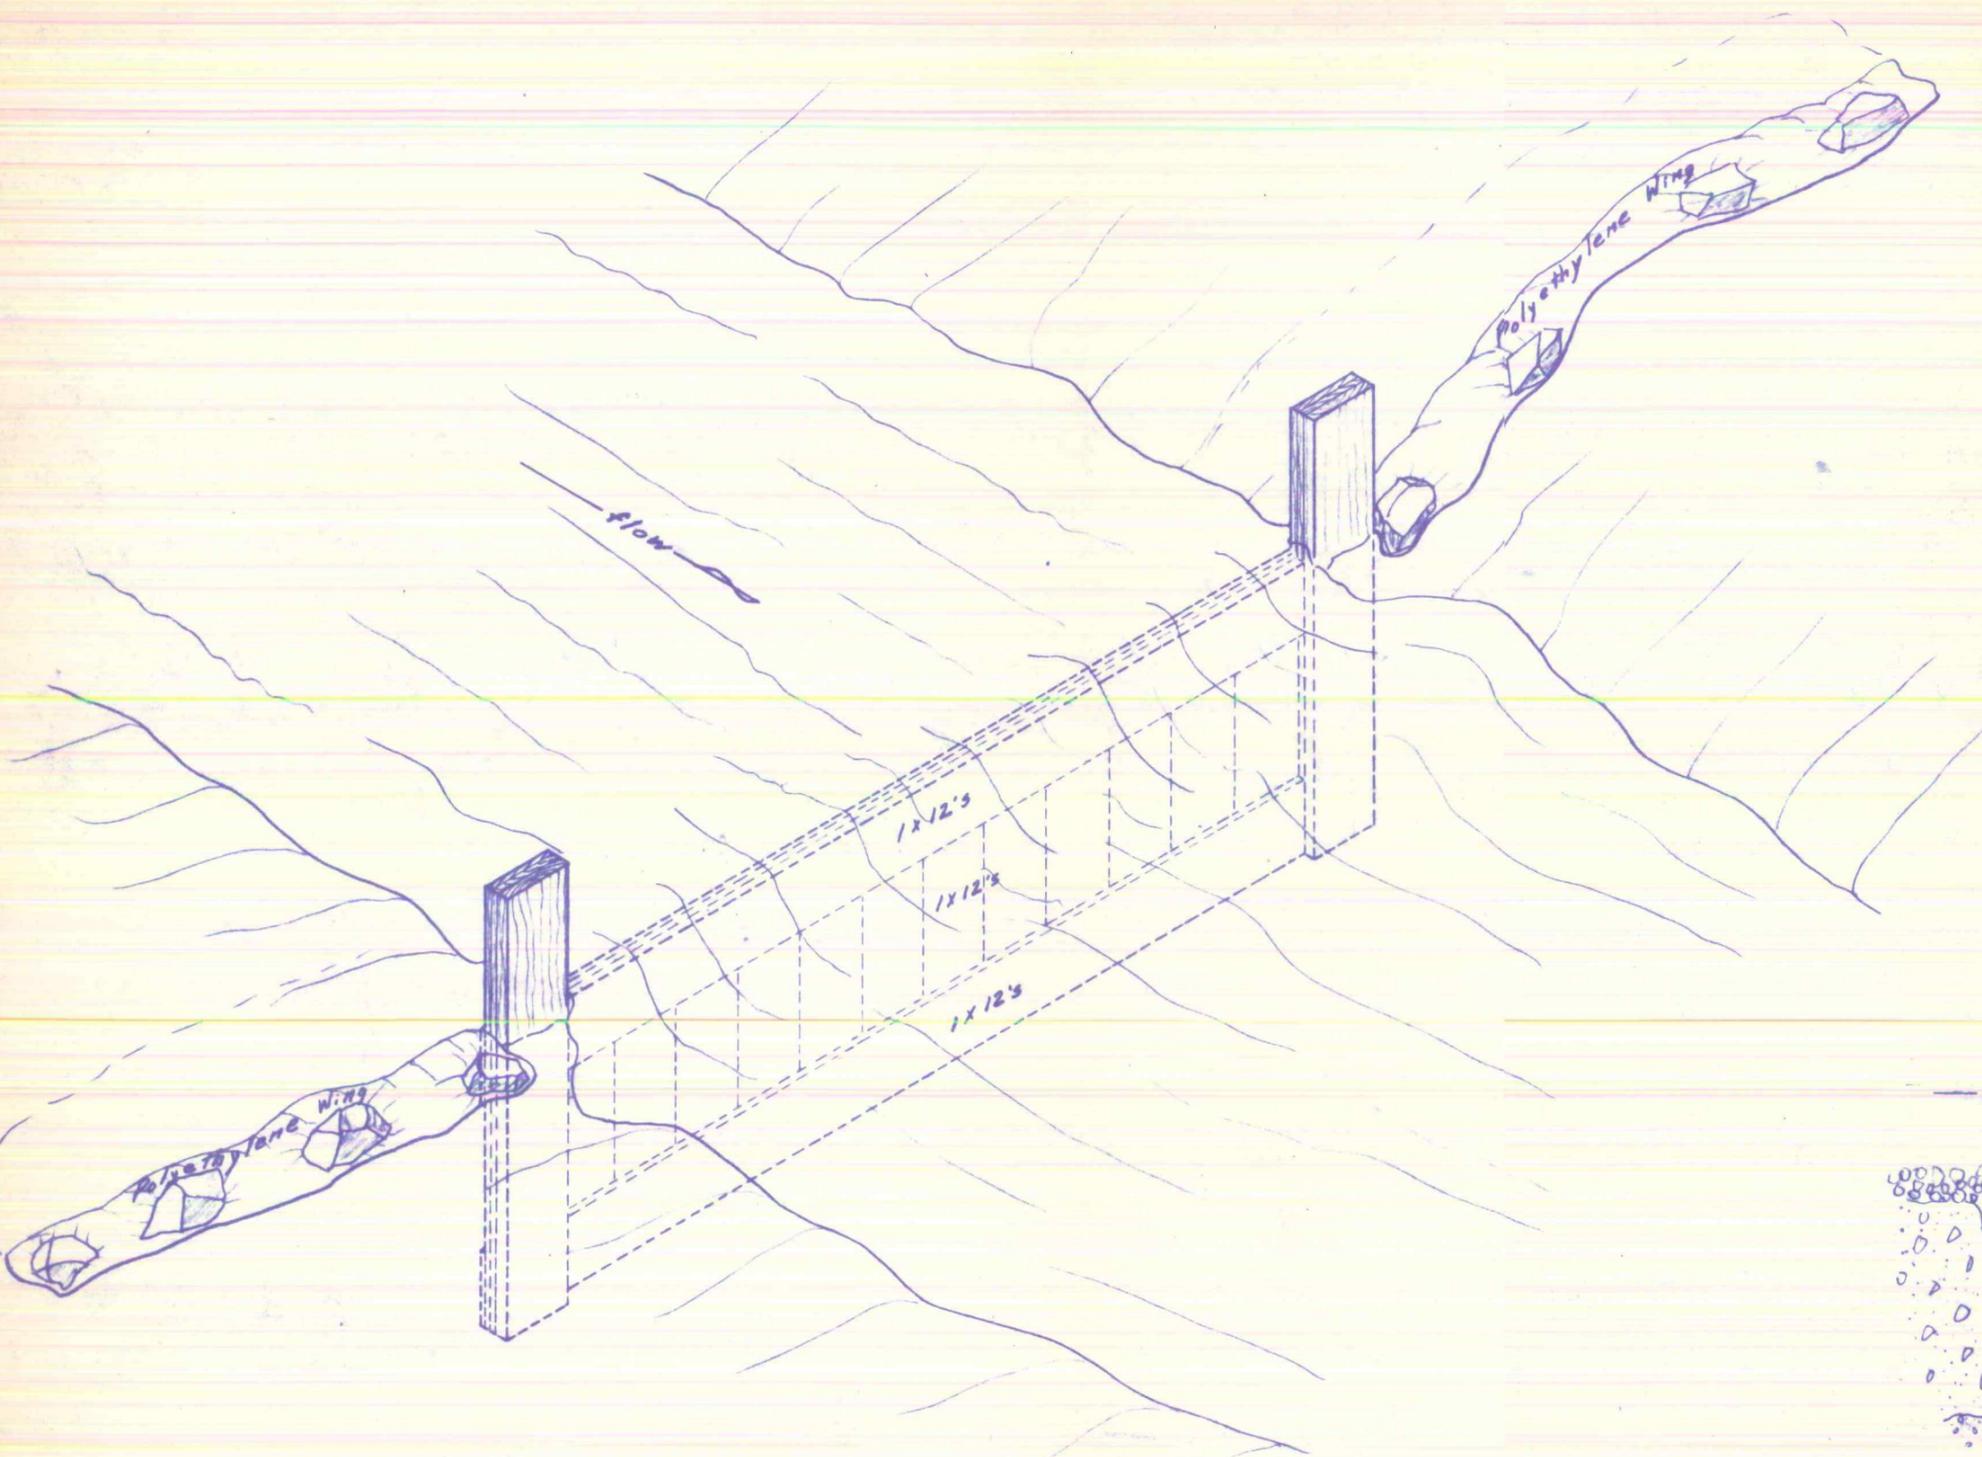
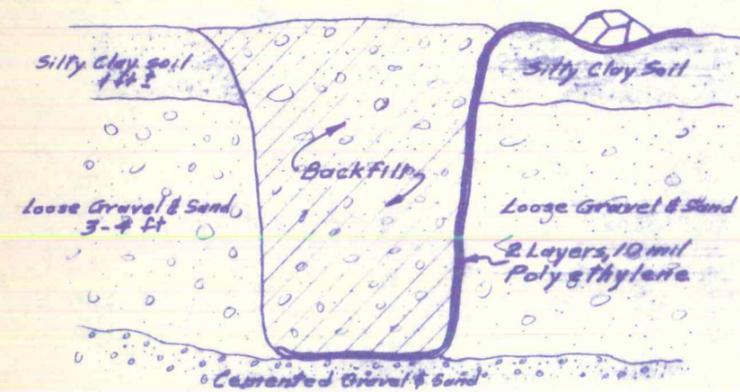
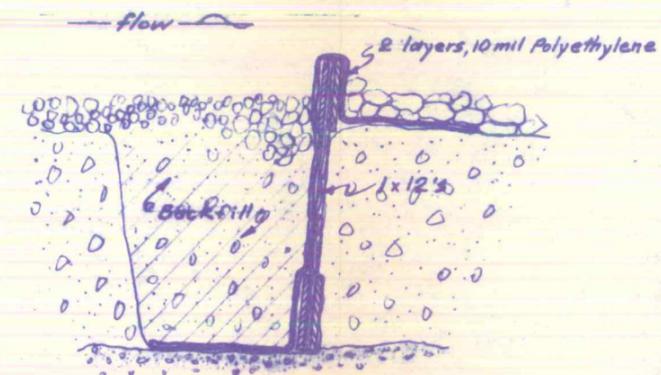
TEX CREEK WEIR

DOWNSTREAM VIEW

TYPICAL WING CROSS-SECTION

TYPICAL WEIR CROSS-SECTION

Using the experience gained from the first weirs, it was decided to construct two more. These were numbered 7 and 8 (see Table 1). They were constructed of plastic and extended across the valley floor. To protect the plastic from tearing where the weir crossed the stream channel, the plastic was backed with a 3- by 16-foot wall of rough 1- by 12-inch lumber. The top of the wall was level with the streambed.

The plastic wings of the weir that extended from the stream to the edge of the valley were not placed at a 90-degree angle to the flow as in the past. Instead they were placed at a 50-degree angle to the stream course. This gave the weirs an appearance of an open blunt-pointed V. It was hoped that the V shape would guide subterranean water back to the channel.

Weir No. 7 was further modified by having 2- by 12-inch wooden uprights placed at each end of the plank wall extending 2 feet above it. As the plastic was installed the top edge was maintained 1.5 to 2 feet above the creek bed level. To prevent the plastic from being pulled into the ditch when back-filling, the upper edge was held in place by wooden stakes. The weir then provided a fairly impervious layer from the subterranean water level to a height of 1.5 to 2 feet above the stream level. The only places water could work through the barrier were where the plastic was lapped around the ends of the weir, and through the space between the uprights. The various modifications were installed so that

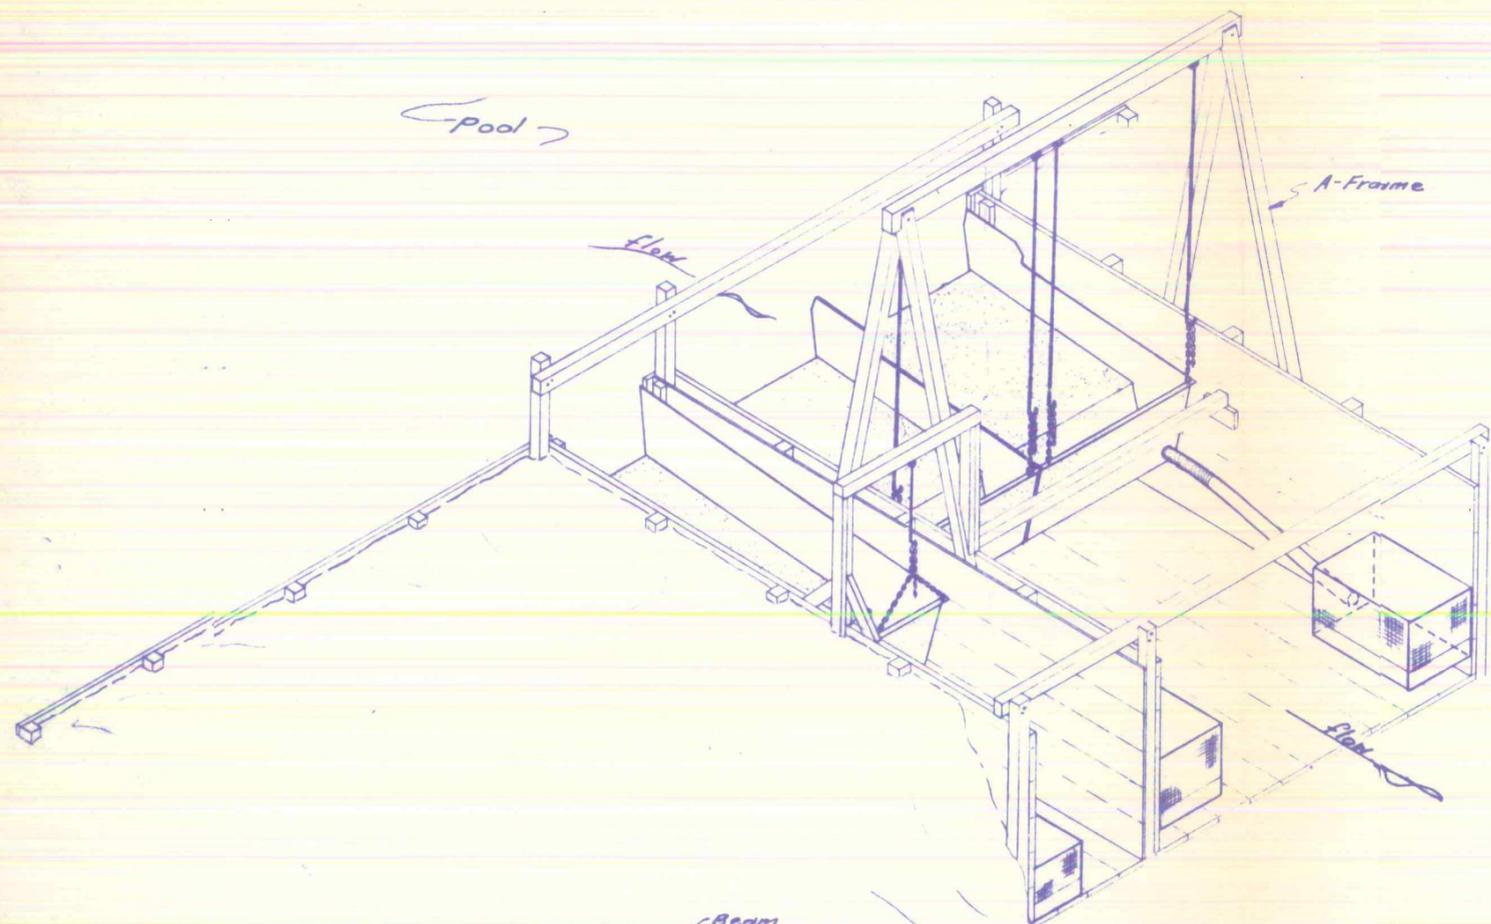
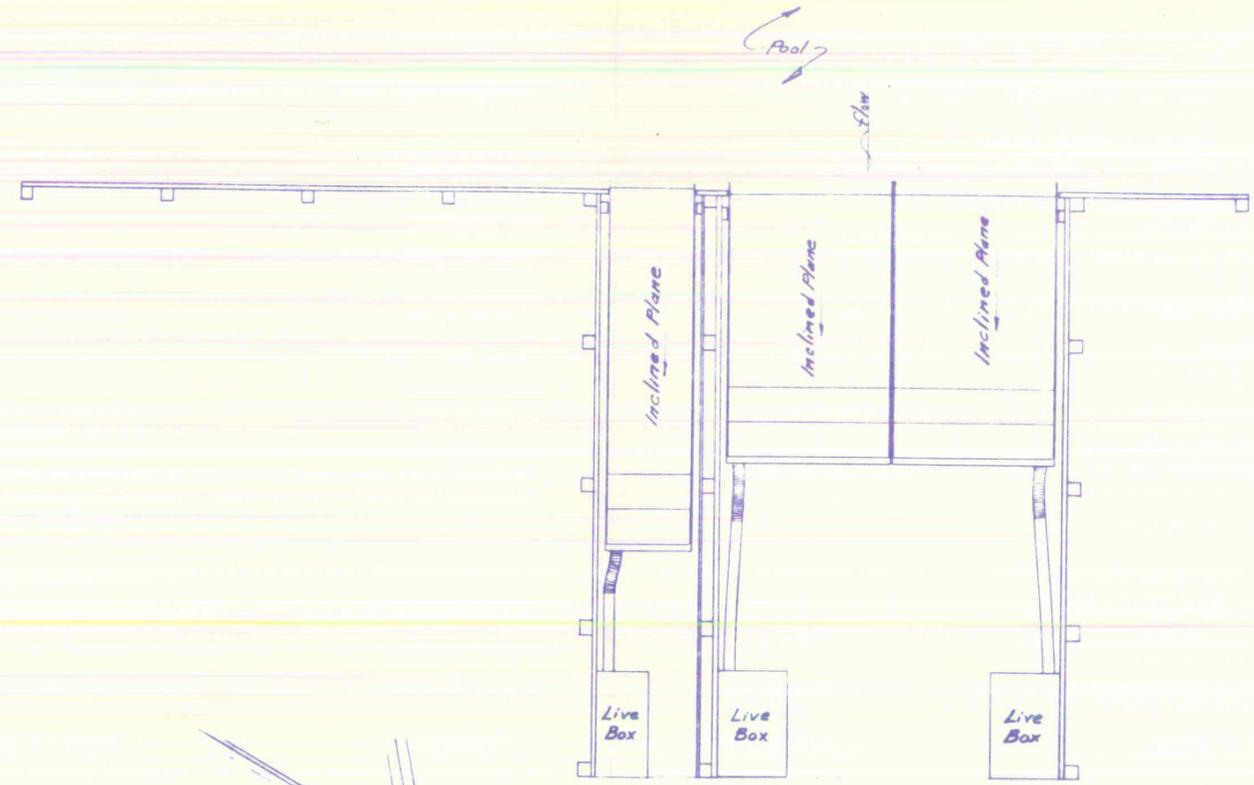
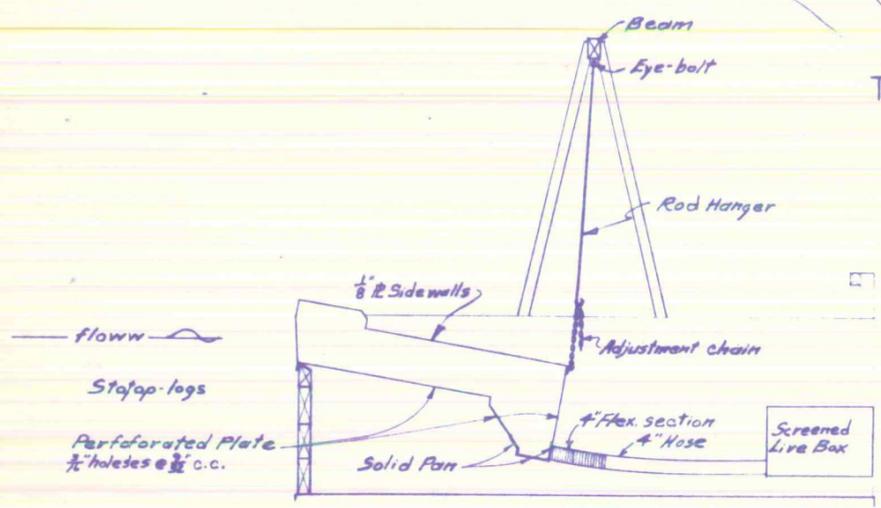
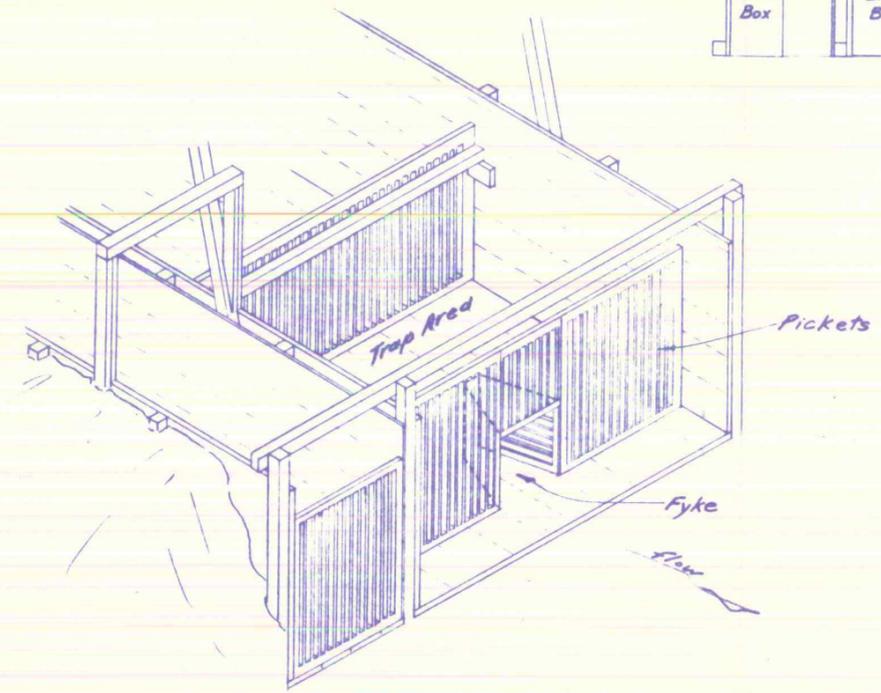
TEX CREEK
TRAPPING FACILITY

TRAPPING DOWNSTREAM MIGRANTS

PLAN

TYPICAL SECTION

TRAPPING UPSTREAM MIGRANTS

The Tex Creek installation was a combination of a downstream juvenile trap and an upstream adult trap. The outmigrant trap originally consisted of two inclined wolf-type traps. Later, a third screen was constructed for the bypass flume. The latter was used only during times of high runoff. The bottoms of the two original screens were made of 1/8-inch perforated plate with 3/16-inch holes on 9/32-inch centers. One screen was later modified by redrilling the holes to 7/32-inch. The larger holes increased the water losing capacity without any apparent reduction in fish handling efficiency. The bottom of the bypass trap was made of woven 16-gauge screen wire with four holes per inch. The material

Originally the trapped fish were collected in a pan at the rear of each trap. During the peak runoff, as the screen became plugged with debris, the water would overflow the incline causing extreme turbulence in the holding area. The turbulence resulted in some mortality of the collected fish. To prevent mortality, a four-inch pipe was attached by means of a flexible joint to each trap. The fish could then move out of the collecting pans down the pipes and into metal holding boxes. The flexible joint on the pipe was necessary for the adjustment of the screens as water conditions changed. Because the pipe extended into the trap box approximately 10 inches, the flexible joint was also necessary to allow the pipe to be backed out during fish removal. Occasionally a pipe would become plugged with a bark chip, pine cone or other debris, but generally the system functioned satisfactorily. The bottom of the trap boxes were painted white to facilitate location of the fish during their removal.

The adult trap was of a standard picket and weir design. Several modifications to the original structure were made. At first it was possible for the adults to move up under the inclined screens where removal with a dip net was difficult. A series of pickets installed immediately behind the screens eliminated the difficulty. To prevent molesting of the trapped adults by visitors, a cover of 2- by 4-inch lumber was installed over the holding chamber. Access to the chamber for fish removal was through a locked door.
