Load Distribution in Light-Frame Wood Buildings under Experimentally Simulated Tsunami Loads

David Linton¹; Rakesh Gupta², M. ASCE; Dan Cox³, M. ASCE; John van de Lindt⁴, M. ASCE

This paper presents the results of a test program whose goal was to better understand the contribution of individual elements to the performance of typical light-frame wood structures during tsunami loading. The intent was to be able to replicate failures in a structural engineering laboratory that were observed during laboratory experiments of hydraulic loading on wood walls at the NEES Tsunami Facility at Oregon State University. The elastic and inelastic response of shear walls, out-of-plane walls, and a full light-frame wood structural system subjected to varying lateral loads were observed using Digital Image Correlation (DIC). DIC provided a non-contact, three-dimensional measurement system that returned displacement results measured at multiple areas of interest on the wall surface. Overall, these experiments show that the elastic stiffness and ultimate capacity of the shear wall is significantly higher at full height compared to intermediate heights on the wall, and the ultimate lateral capacity

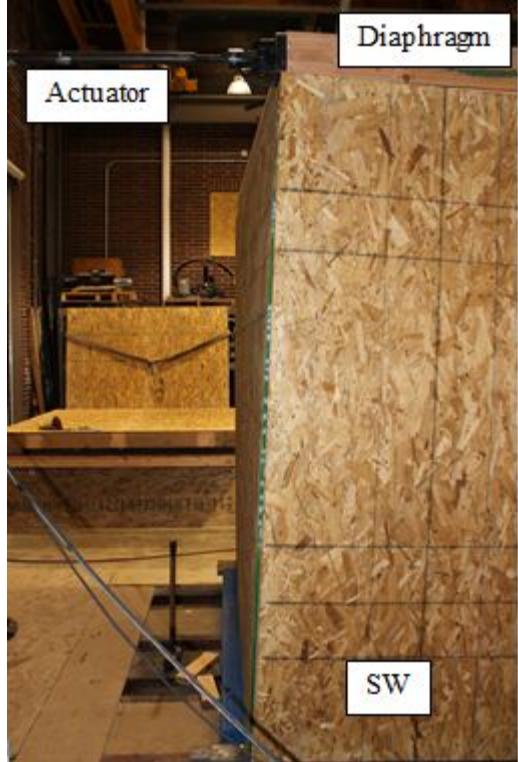
Fig. 7: FAIL2 loading setup

After the OOP tests two different failure tests, “FAIL1” and “FAIL2”, were performed on the complete structural system (setup 2C). FAIL1 consisted of a horizontal distributed load applied across the middle three studs (grids C, D, E), normal to the OOP wall at 0.61 m (2 ft) above the base of the wall. A steel HSS section, shown in Fig. 6, was attached to the hydraulic actuator to simulate a distributed load. FAIL2 was a point load applied at the corner of the diaphragm (A8), shown in Fig. 7, is similar to the monotonic shear wall tests discussed above. Both tests were performed at a rate of 7.62 mm/min (0.3 in/min).

system performed quite a bit differently than the individual shear wall, because it was not laterally braced. The horizontal in-plane deflection (δI) in Fig. 12B is similar, but the full system only carried about 90% of the ultimate load compared to the individual shear wall. The full system had about three times the amount of out-of-plane deflection; whereas the individual shear wall was laterally restrained and had very little out-of-plane deflection. With the full system only being laterally restrained by the out-of-plane wall, with the increased out-of-plane deflection there was significantly less vertical deflection (Fig. 12, $\delta 2$) compared to the laterally restrained shear wall. Fig. 7 shows the deflected shape of the full structural system at maximum extension of the hydraulic actuator.

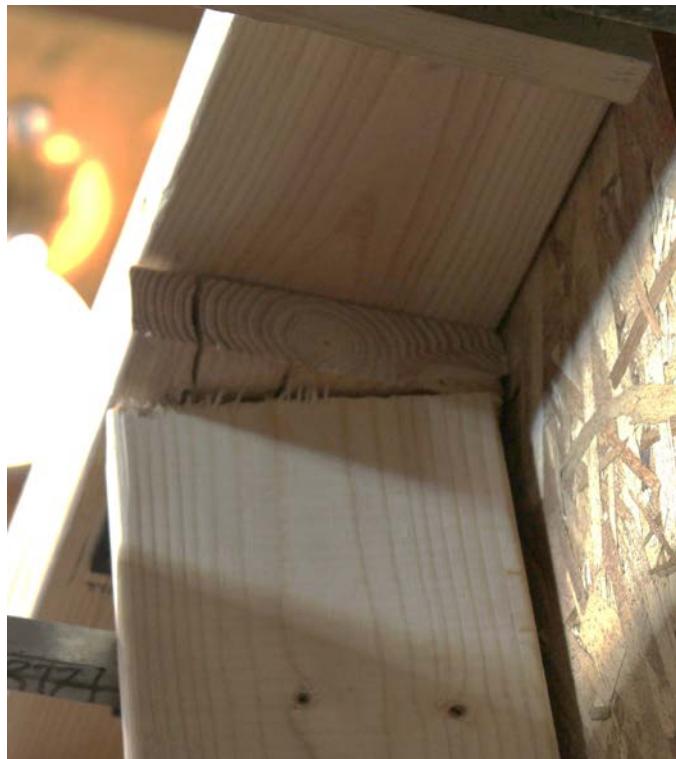
Fig. 11: Top plate splitting at stud connection

A similar trend discussed above from the elastic tests is continued with the failure tests at grids 2, 4, 6, and 8. Fig. 10 shows the load vs. deflection curves for the failure tests from SW2 (grid 2), SW3 (grid 6), SW4 (grid 4), and SW5 (grid 8). The data from SW1 was not plotted because the load cell was improperly setup and maxed out before the wall failed. Similar to the elastic stiffness results from Fig. 9 the intermediate grids (2-6) show significantly lower capacities compared to grid 8. The sudden drop in load for SW3 was a result of the top plate splitting at the stud end nail farthest from the OSB sheathing. Due to the stud rotating this particular nail was highly stressed and caused the top plate to split, shown in Fig. 11.

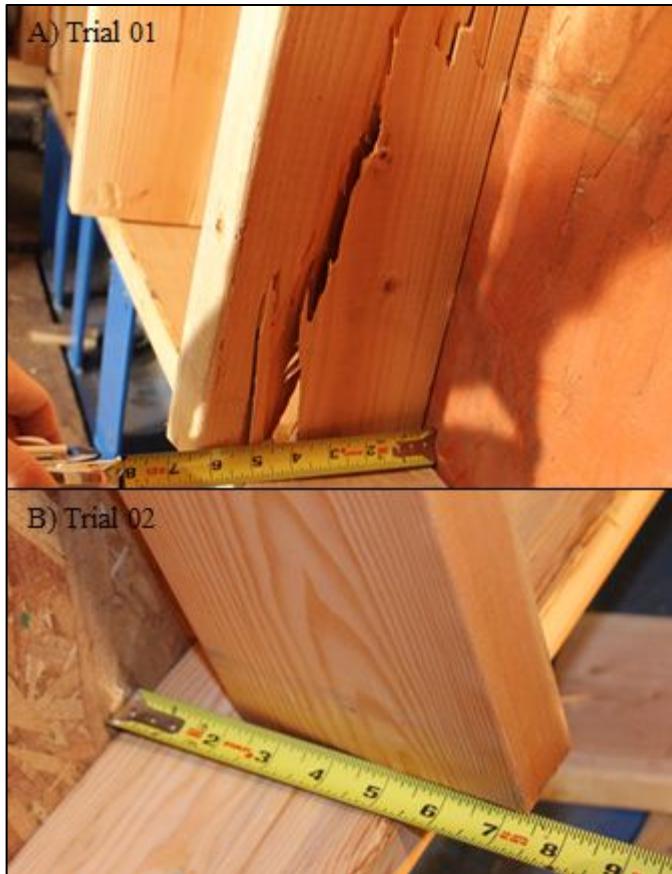
Fig. 15: FAIL1 failures: A) Trial 01 stud splitting, B) Trial 02 stud to bottom plate connection failure

The failures of the out-of-plane wall stud to bottom plate connection that were observed during laboratory experiments in the Large Wave Flume at Oregon State University (Linton, 2012) were reproduced during two trials of the FAIL1 experiment. Fig. 15 shows the failures from Trial01 (Fig. 15A) and Trial02 (Fig. 15B). During each trial the same connection failure observed during the wave tank tests was successfully reproduced in the FAIL1 experiment. The loads vs. deflection results from both trials are shown in Fig. 16. The deflection is the average from grids C2, D2, and E2. The small drop in load at approximately 20 mm of deflection for Trial01 was from the stud splitting at the connection as shown in Fig. 15A. The observed failures are important because it shows that in order to improve the performance of light-frame wood structures during a tsunami event the stud to bottom plate connection needs to be strengthened. This connection could be easily improved with the addition

of a simple metal bracket, with many different options available that are common in wood construction. With this connection properly secured the load path would be complete between the studs and bottom plate, thus allowing for more efficient use of the available capacity of the full structural system.
