# Landslides OF OREGON: North Coast

Oregon State University  
Extension Service  
SEA GRANT Marine Advisory Program

JOHN V. BYRNE &  
WILLIAM B. NORTH  
DEPARTMENT OF  
OCEANOGRAPHY  
Oregon State University

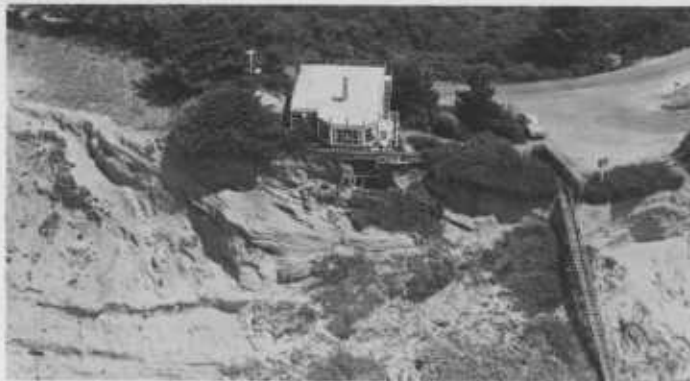
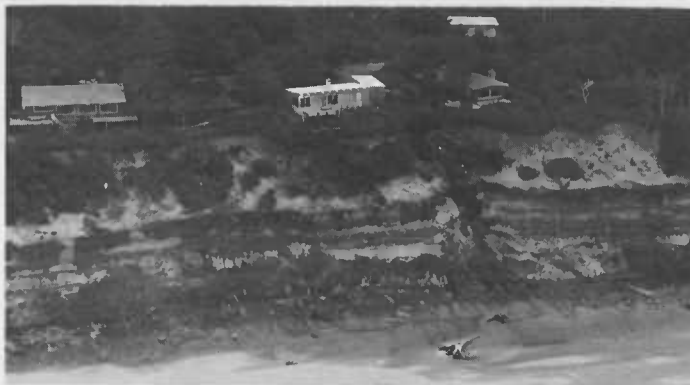
**Figures 2 and 3.** Beachfront homes perch precariously above landslide areas. Retreat of cliffs becomes obvious from the air.

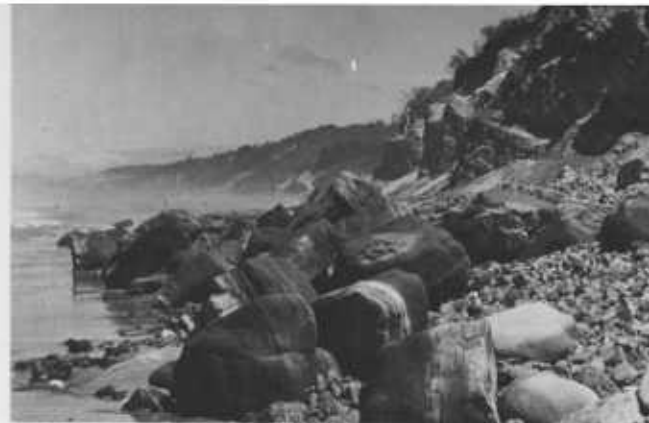
**Figure 4.** Rock and debris slump.

Landslide type*	Nature of slip surface
Slump	Concave
Slide	Planar
Fall	Indeterminate—movement essentially vertical
Shift	Indeterminate—movement indeterminate

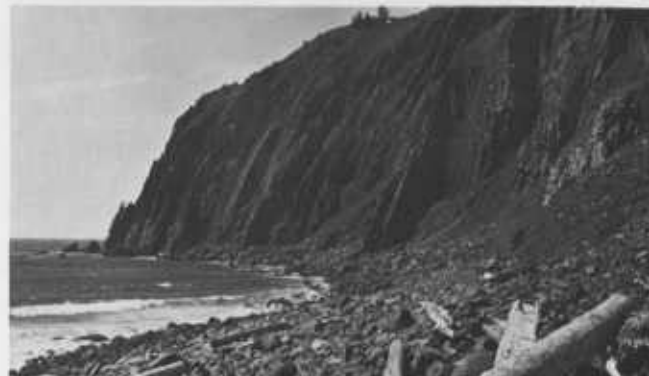
**Figure 5.** Block and rubble slide.

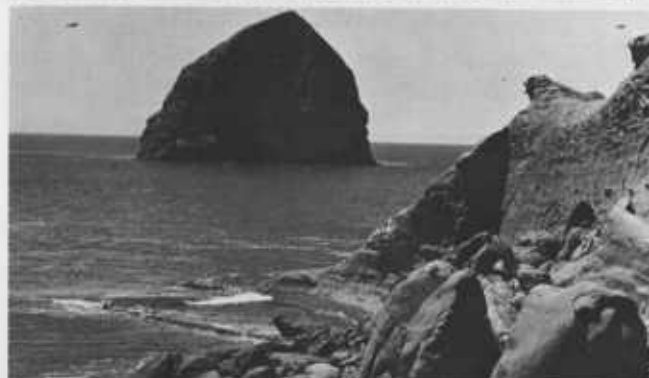
**Figure 6.** Rock fall.

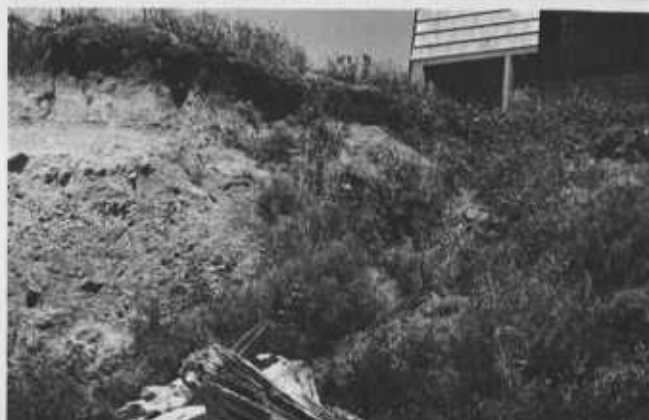
**Figure 7.** Debris shift.

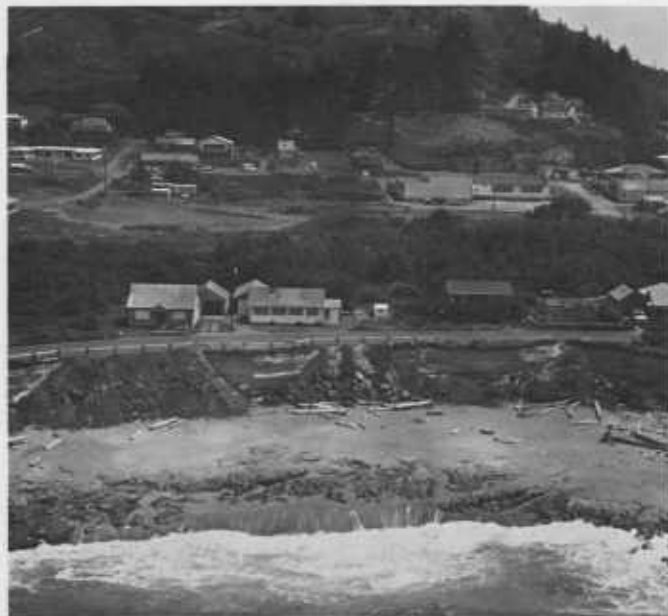
Figure 8. Road crews have dumped fill dirt and rock in an attempt to minimize slide activity near roadway.

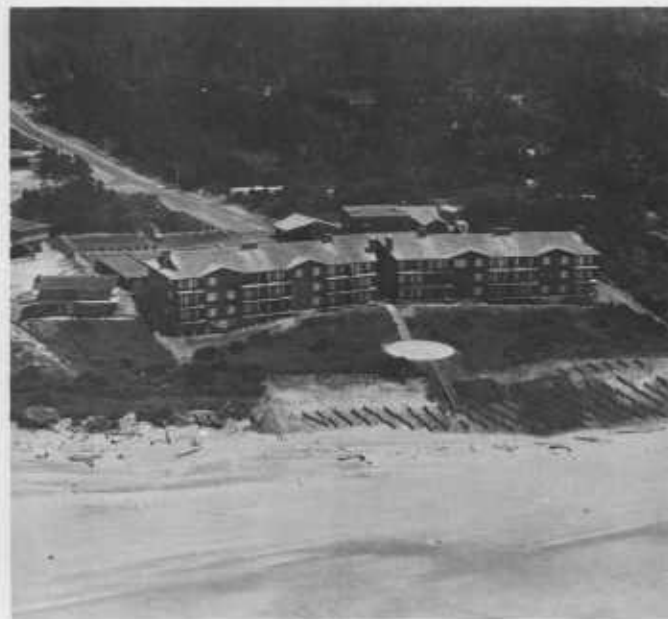
Figure 10. A coast resort motel has installed fencing and plantings to minimize slides in a slump area.

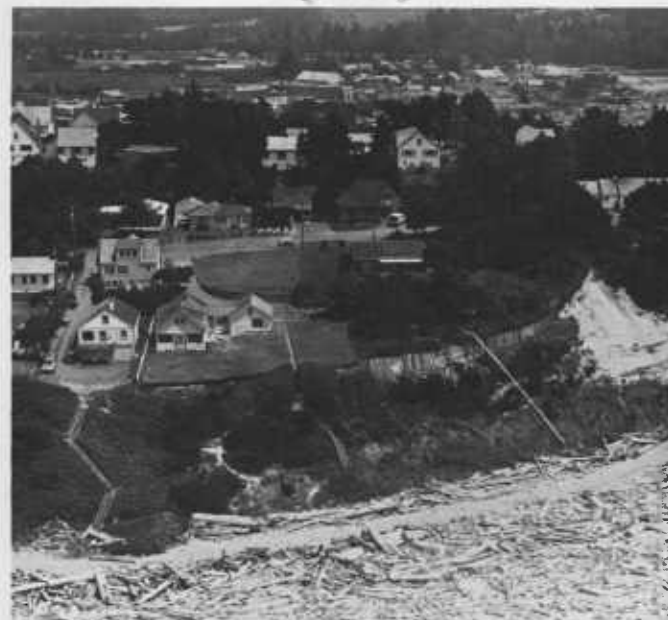
Figure 11. Dense foliage (left) and planking are two effective and inexpensive means of landslide prevention.

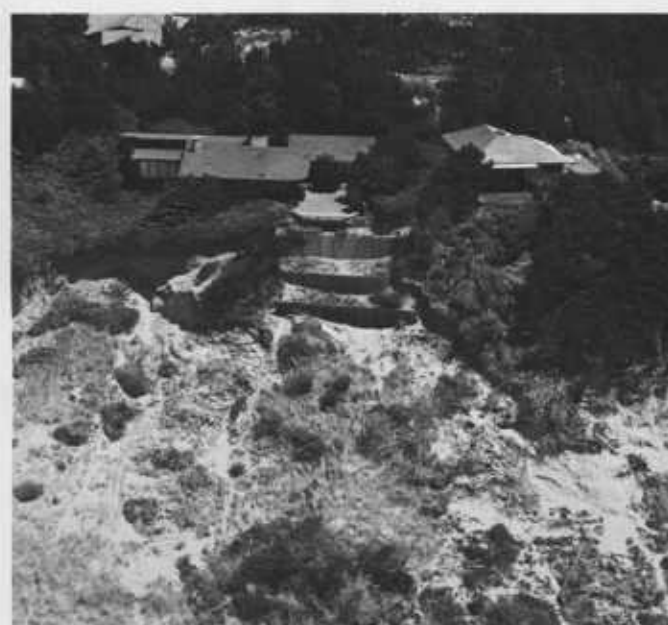
Figure 12. Tiered fencing has successfully deterred serious landsliding near this cliff-side beach house.

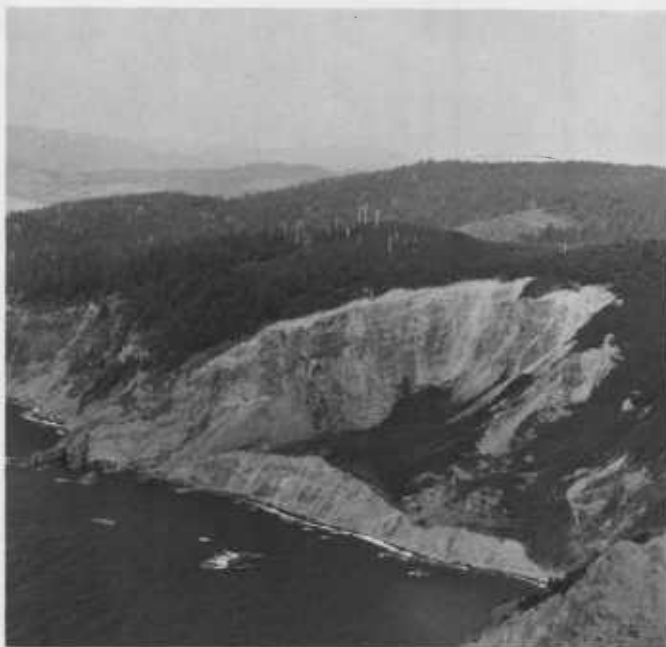
**Figure 13. Rock-  
terrace slump  
which has de-  
stroyed 20 acres  
of land on  
Cascade Head.**

Losses due to landslides have been extensive in some regions. Ecola Park, just north of Cannon Beach, and Cascade Head, north of Lincoln City, have undergone considerable alteration. Landsliding has destroyed or disrupted more than 200 acres of land in four separate slides. In 1961, the Ecola Park landslide moved about 125 acres during a two-week period. On Cascade Head, a slide in 1934 carried 20 acres of pasture down toward the sea (Figure 13). Two other landslides on Cascade Head have each destroyed more than 14 acres of grazing land.

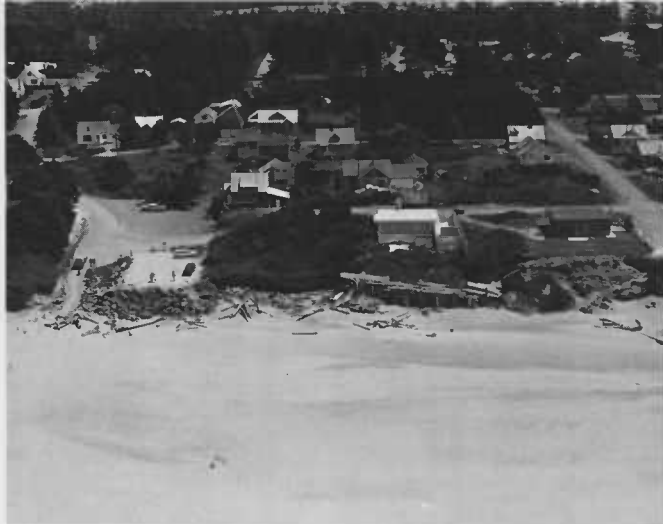
**Figure 14. Boulders (left) and stacked pilings weight the cliff base and prevent land loss from sliding.**

In the Oceanlake area of Lincoln City and near Seal Rock, north of Waldport, attempts are now being made to control the undercutting of the terrace material. Basalt boulders or riprap, piled at the base of the cliffs serve to weight the cliff base and prevent outward movement (Figure 14). Riprap also lessens the wave impact on the cliff base by providing a leading edge of resistant material to absorb much of the wave energy.

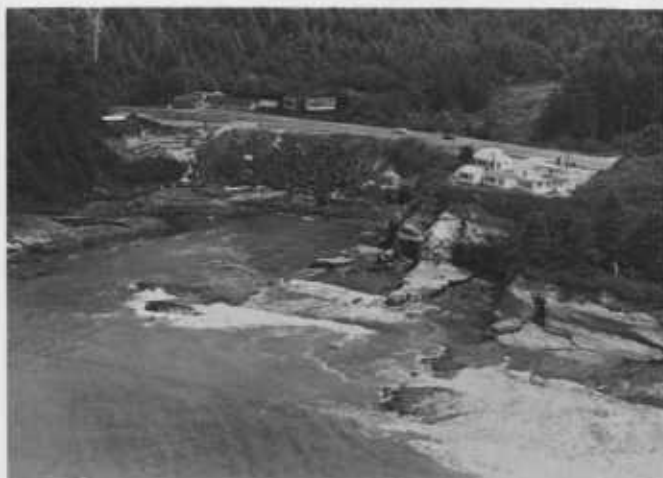
**Figure 15. Riprap at Boiler Bay helps to slow down landsliding and to protect U.S. Highway 101.**

On U. S. Highway 101 at Boiler Bay, north of Depoe Bay, a successful attempt has been made to prevent waves from undercutting the highway on the east edge of the bay (Figure 15). The entire geological formation at Boiler Bay and the sand slope beneath the highway has been covered by riprap. This inexpensive measure has retarded cliff recession and probably has saved a section of the highway.

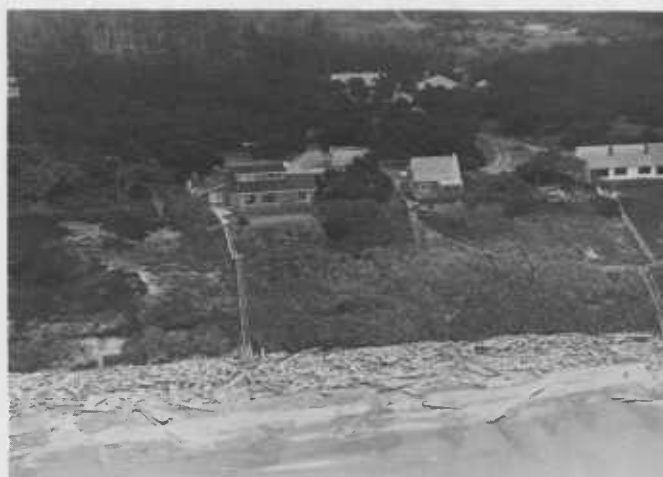
**Figure 16. Property owners with grass and shrub plantings on coastal banks have had little trouble with slides.**

in place and help to prevent rain and runoff from eroding property (Figure 16). On the inhabited slopes of Tillamook Head, property owners who allow brush and grass to flourish have had little trouble with slippage or destruction of stairs or structures on the hillside. Even in very soft terrace sands of Lincoln City, the few attempts at planting to stabilize slopes have helped ease local erosional problems. Extensive planting of grass on unconsolidated sands along the beach at Salishan is helping to hold steep slopes.

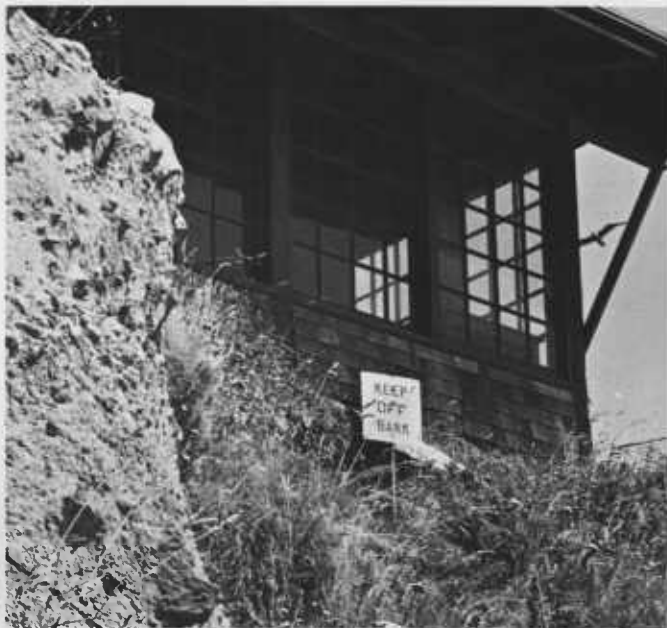
**Figure 17. A simple "keep off" sign is sometimes an effective preventive measure for landslides.**

Other preventive measures include terracing and reduction of cliff angle by lowering and leveling the cliff top and dumping extra material in front of the cliff. Wooden rain covers have been built on some cliffs. Warning signs and fences (Figure 17) have partially succeeded in protecting cliff faces from public destruction.
