Supplemental figure 1.

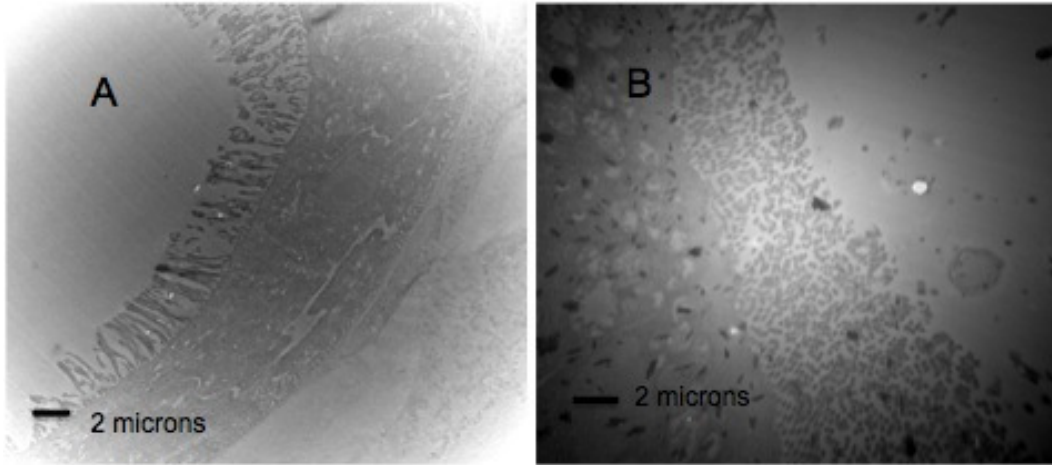
Figure 1. (A) TEM image of an unstained FBS OH-SWCNT exposed *D. magna* section. A tare in the section caused changes to the contrast of the imaged area. (B) TEM image of a stained control *D. magna* section. The changes in contrast are due to imaging near the TEM grid boundary.
