Title: Characterization of Oxide Growth of Aluminum Alloy 6061 for Nuclear Research and Test Reactors

Characterization of Oxide Growth of Aluminum Alloy 6061 for Nuclear Research and
Test Reactors

A THESIS

Oregon State University

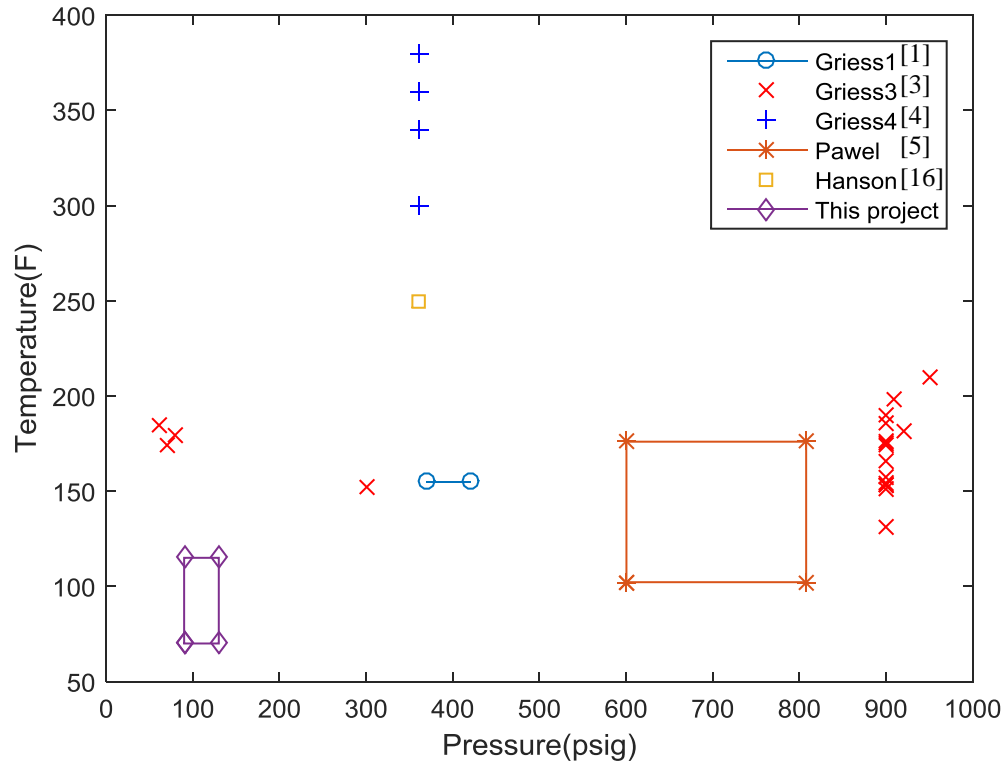
Figure 2.1 shows the pressure and temperature ranges used to develop the existing correlations and the temperature and pressure range for this project, data collected from [1, 3-6, 15]. As shown in the figure, the experimental conditions of this project, the purple area, are different from the others. By testing under these conditions, the objectives of extending the existing database of aluminum alloy corrosion and testing existing correlations under new experimental conditions were fulfilled.

Figure 2.1. Experimental conditions from previous work and this project [1, 3-6, 15]

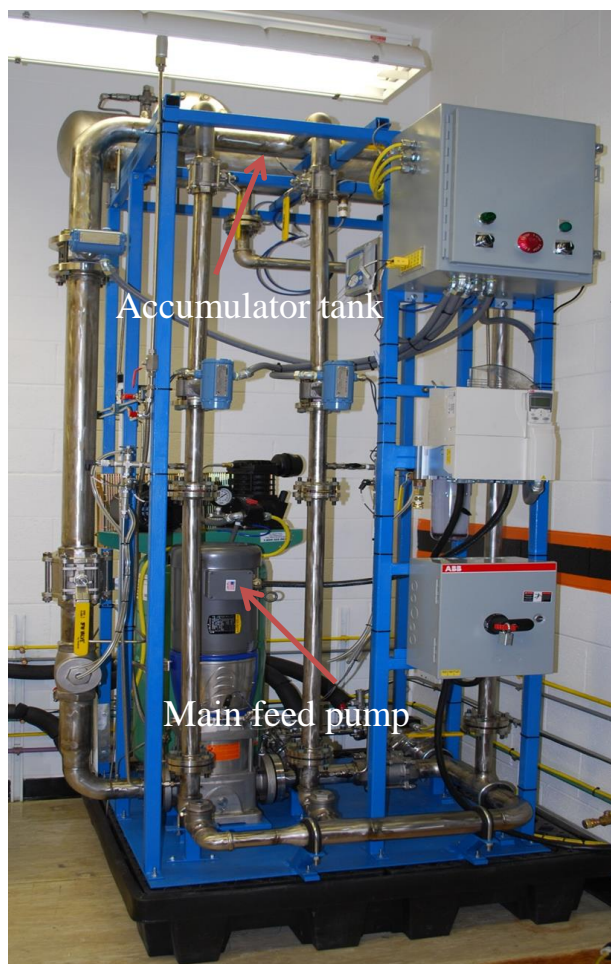
coupons were placed. A compressor was used to maintain the pressure between 90 to 130 psig. The water-cooling system controls the temperature of the coolant. Test conditions used in the test loop are shown in Table 3.1.

Figure 3.1. Test loop facility

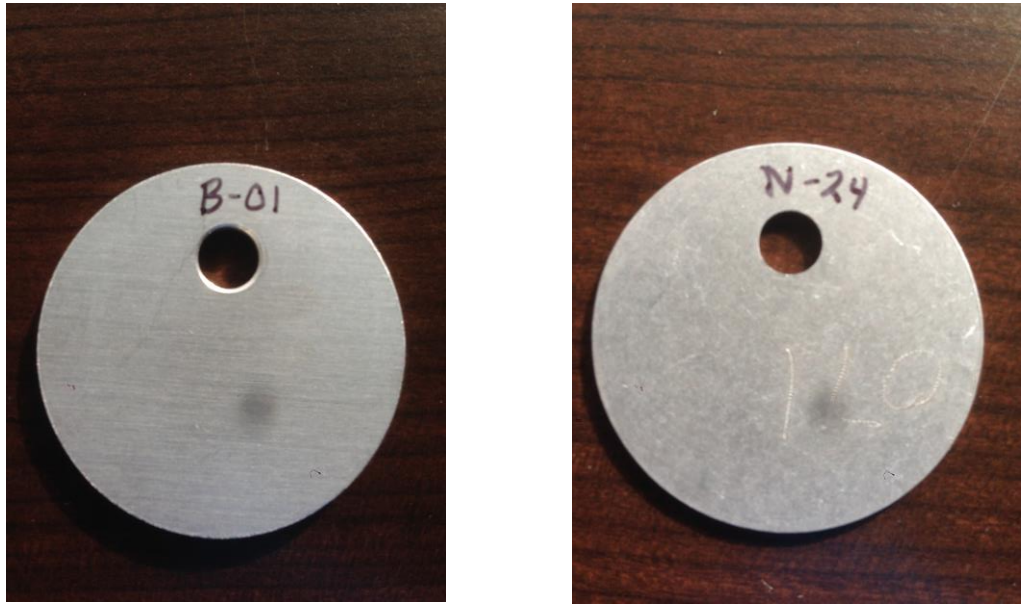
Two types of coupons were prepared. One type was pre-filmed with an oxide layer and the other type received no pre-filming. Coupons were labeled with numbers and letters B or N, which represented boehmite pre-filmed and non-pre-filmed, respectively. A representative picture of coupons is shown in Figure 3.2. The average surface roughness for pre-filmed coupon was 0.17 μm with a 0.02 μm standard deviation. The average surface roughness for non-pre-filmed coupon was 0.27 μm with a 0.04 μm standard deviation. Round coupons were punched from aluminum alloy 6061-T0 plates of both types of samples. The pre-filmed plates form a boehmite layer in the autoclave, so that the surface of the pre-filmed coupon had a uniform boehmite layer on both sides, however, the rim of the coupon did not have an oxide layer. Both types of coupons had the same diameter of 1.25 inches. The pre-filmed coupon was 0.102 inch thick. The non-pre-filmed coupon was 0.051 inch thick. Each coupon had a 0.25-inch diameter hole close to the edge in order to hang them on a rod.

Figure 3.2. Boehmite pre-filmed coupon (left) and non-pre-filmed coupon (right)

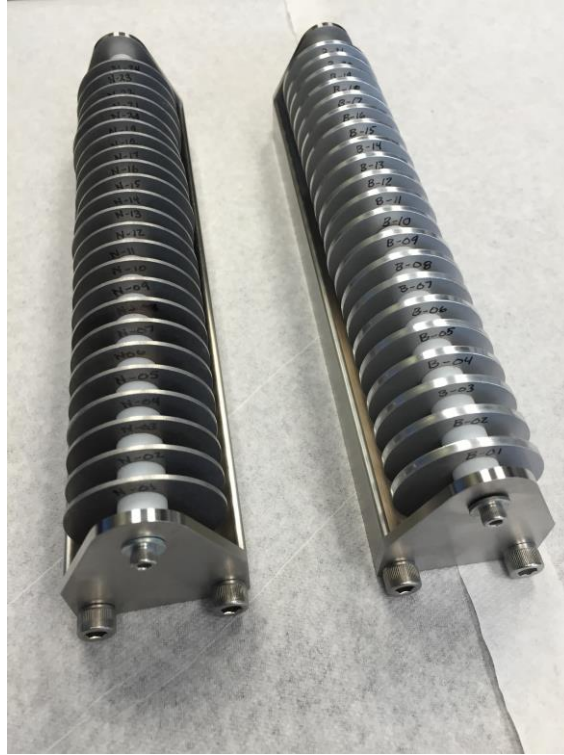
The coupon-labeling scheme is shown in Appendix A. The 24 pre-filmed coupons and 21 non-pre-filmed coupons were hung on two separate ceramic rods, which were fixed on two test trains. Each coupon on the rod was separated with a ceramic nut. At least one of each type of coupons was extracted from the trains per month for analysis. Extra coupon extraction was needed based on the examination requirement. A picture of the trains with coupons mounted is shown in Figure 3.3.

Figure 3.3. Coupon trains with coupons

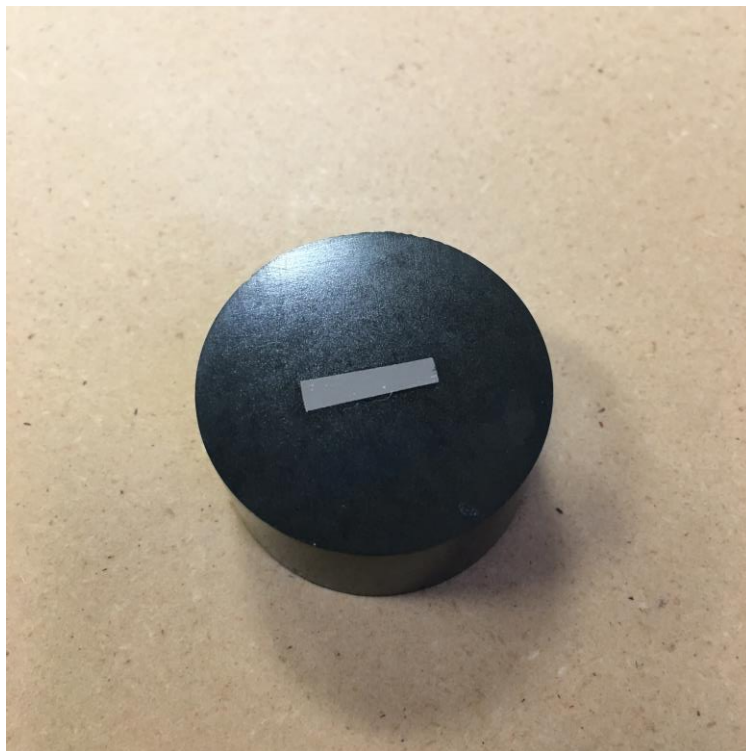
These coupons needed preparation for Scanning Electron Microscopy (SEM) analysis. After exposure in the test loop, a small piece was cut off from the coupons using a slow speed saw with a diamond blade. Then, the piece was mounted in bakelite with the cross-section facing up on the mount surface. Next, the samples were polished using sandpaper and polishing wheels. Last, the samples were cleaned by water and dried using compressed air. Figure 3.4 shows an example of prepared cross-section sample. The rest of the coupon, as shown in Figure 3.5, was cleaned with soap water and water for surface analysis. The details about sample preparation can be found in Appendix A.

Figure 3.4. Prepared cross-section sample from a pre-filmed coupon

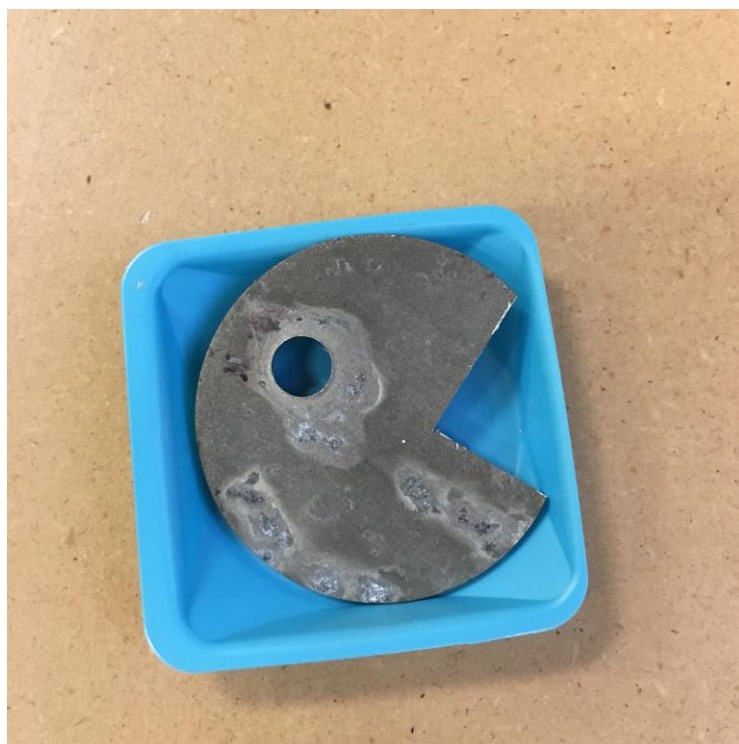
Figure 3.5. A non-pre-filmed coupon after a sectioning

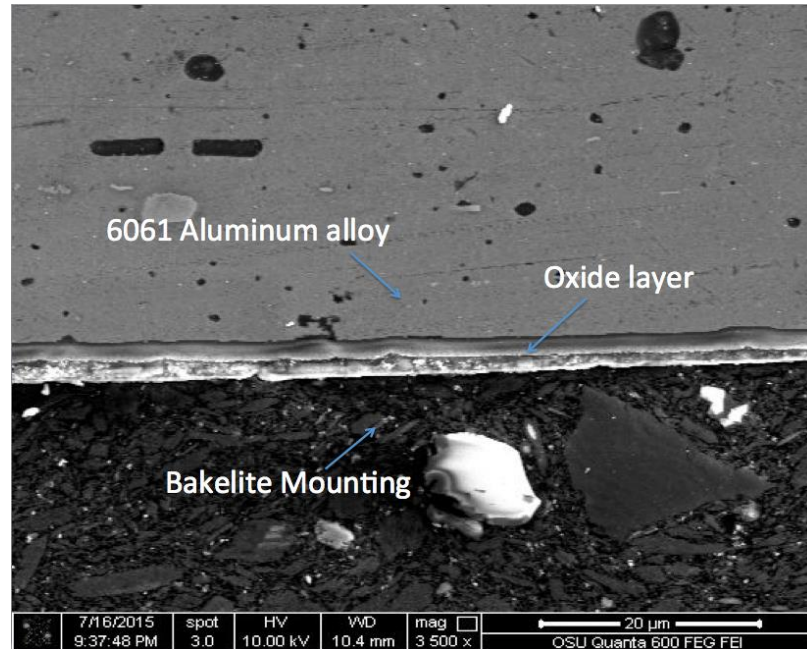
SEM is an important method to obtain sample images, which were used in the following analysis to measure the oxide thickness. SEM-EDS was also a main method to obtain the sample's oxide chemical compositions. To improve the quality of the SEM images, the prepared samples were fixed on a stud with metal adhesive tape to increase the sample's electrical conductivity. For each sample's cross-section, eight images were taken from eight evenly distributed locations on both sides of the sample. To make data consistent and minimize error, all images were taken at 3500X magnification. An image of original pre-filmed sample is shown in Figure 3.6. The oxide layer is clearly shown in the middle of the image. Also any defects presented in the oxide layer could be easily detected. When taking the image, a screen rotation was applied to ensure the oxide layer was always horizontal in the picture to make future analysis easier. Other images of cross-sections were taken to show some defects of the oxide layer to help explain some experimental phenomenon. These figures can be seen in result section and in Appendix B. Images of the coupon surfaces were also taken by SEM to determine the shape and distribution of oxide.

Figure 3.6. Cross-section image of original pre-filmed coupon

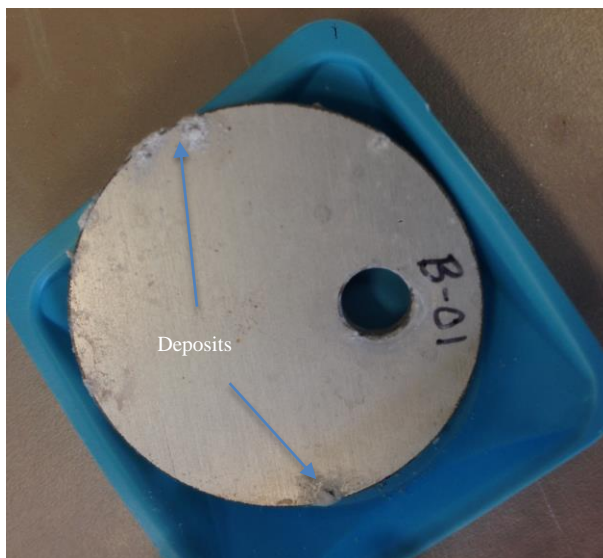
Figure 4.3. Deposit spots distribution on pre-filmed coupon from first month

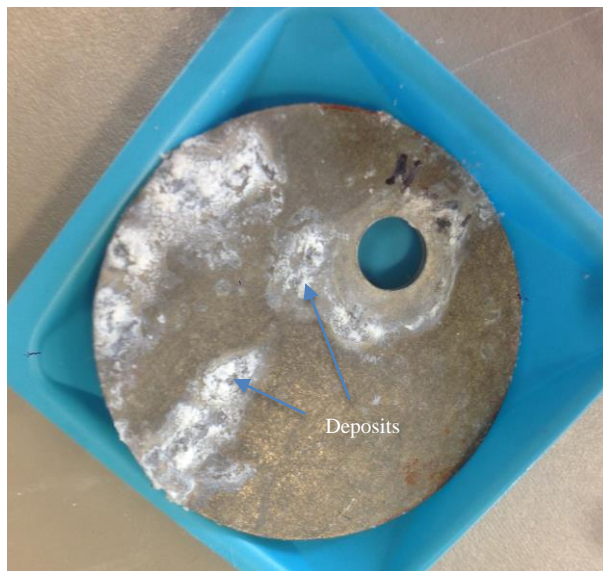
Figure 4.4. Deposit spots distribution on non-pre-filmed coupon from first month

From the SEM images of samples' cross-sections, compared to the pre-filmed samples, it is clear that non-pre-filmed samples tend to form uneven and thicker oxide layers on the surfaces. Also, non-pre-filmed samples tend to form more deposits, which is a sign

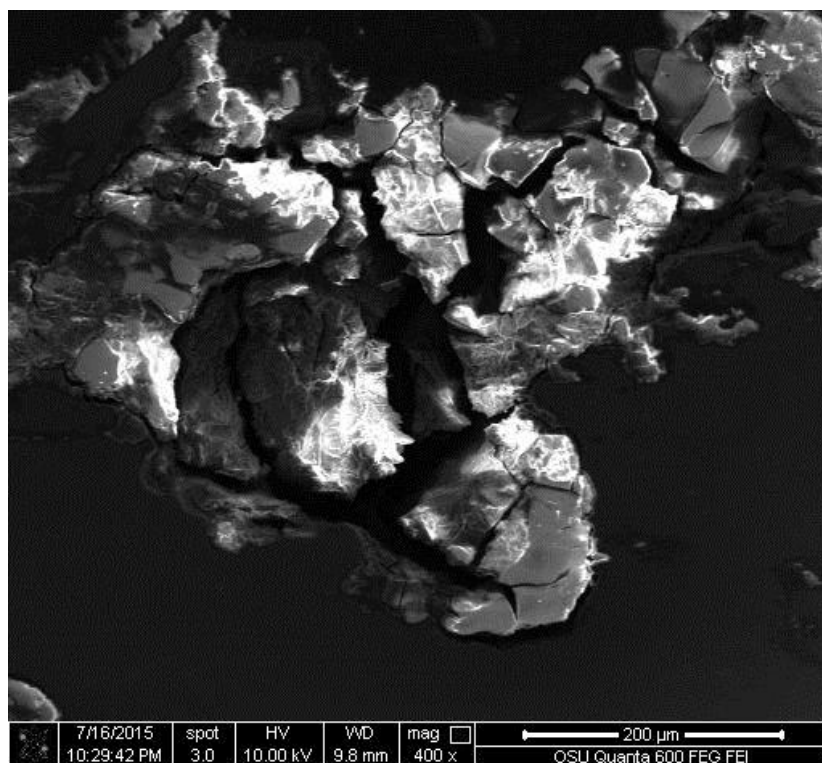
of faster corrosion. More aluminum was being consumed to form deposits from a localized corrosion, which usually leads to pitting as shown in Figure 4.5. Pitting diminishes the mechanical strength of cladding and could lead to fuel release. Faster corrosion and uneven oxide distribution on the surface can form a very thick oxide layer at some spots, as shown in Figure 4.6. These regions would have much lower heat transfer capacity due to the thicker oxide layer.

Figure 4.5. Pitting on non-pre-filmed sample from second month

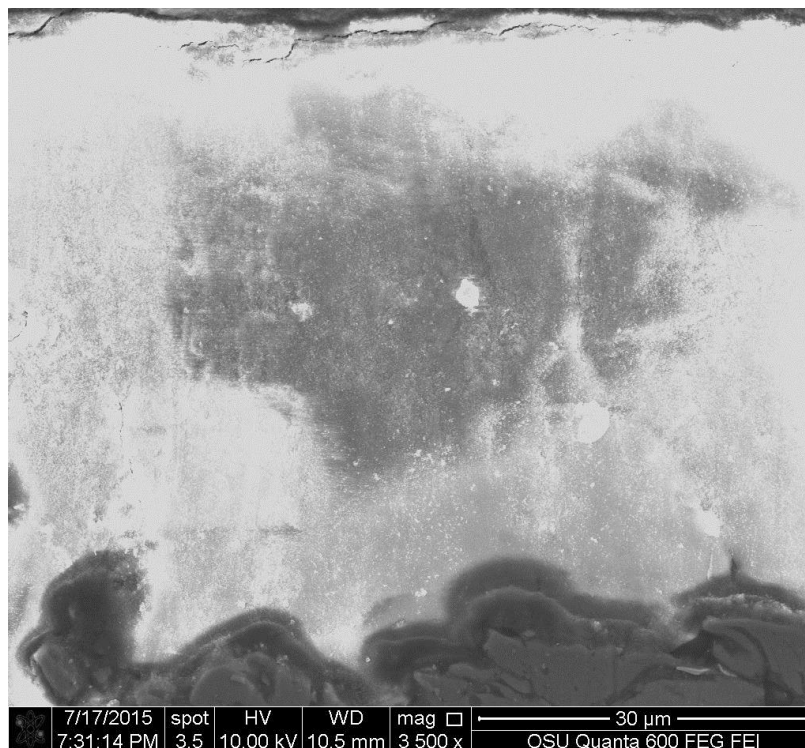
Figure 4.6. Extraordinary oxide layer on a non-pre-filmed coupon from third month

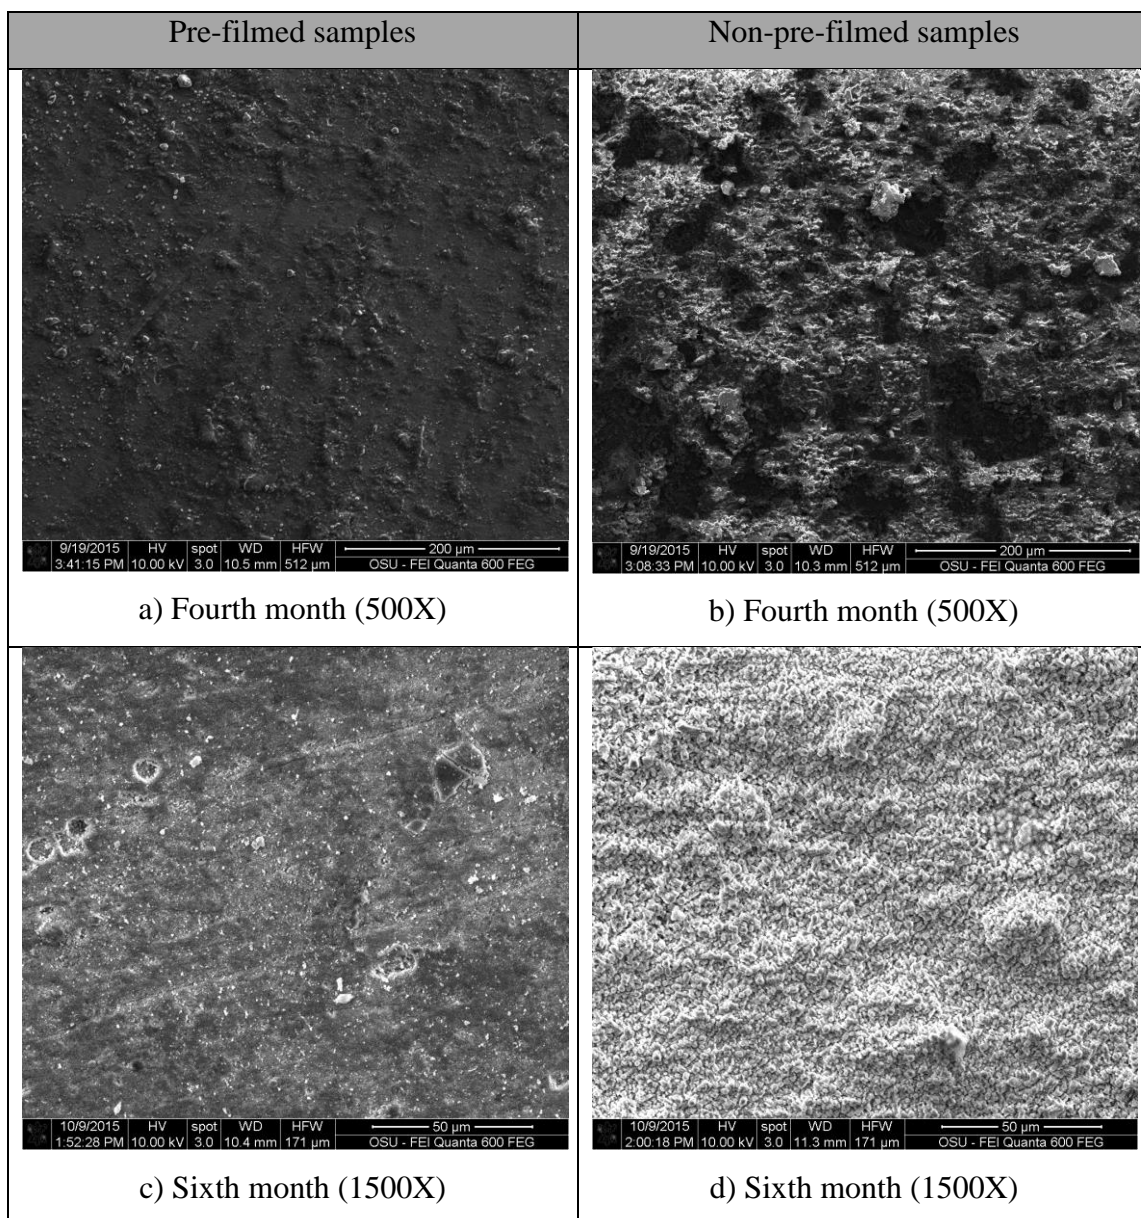
Images of samples' surfaces also show that non-pre-filmed coupon have more prominent corrosion. In Figure 4.7, the surface comparison clearly shows the surface situation. The pre-filmed samples' surfaces are covered by a uniform oxide layer compared to the surface of non-pre-filmed sample. The non-pre-filmed samples' surfaces are covered by an uneven oxide layer. Deposit spots are all over the non-pre-filmed sample from sixth month. Beneath those spots, pits may be present. In comparison, the pre-filmed sample's surface from the sixth month is very flat and clean. A few pits seen in the image might not have been caused by corrosion, but from defects on the original coupon as shown in Figure 4.8. According to this figure, some pits can be clearly seen on the surface of original pre-filmed coupon. These pits may come from fabrication. The original non-pre-filmed coupon, as shown in Figure 4.9, has some scratches and pits on the surface. The average roughness of non-pre-filmed coupon is larger than that of pre-filmed coupon. The higher roughness contributed to the uneven oxide growth on the non-pre-filmed coupons.

Figure 4.7. Surface comparison

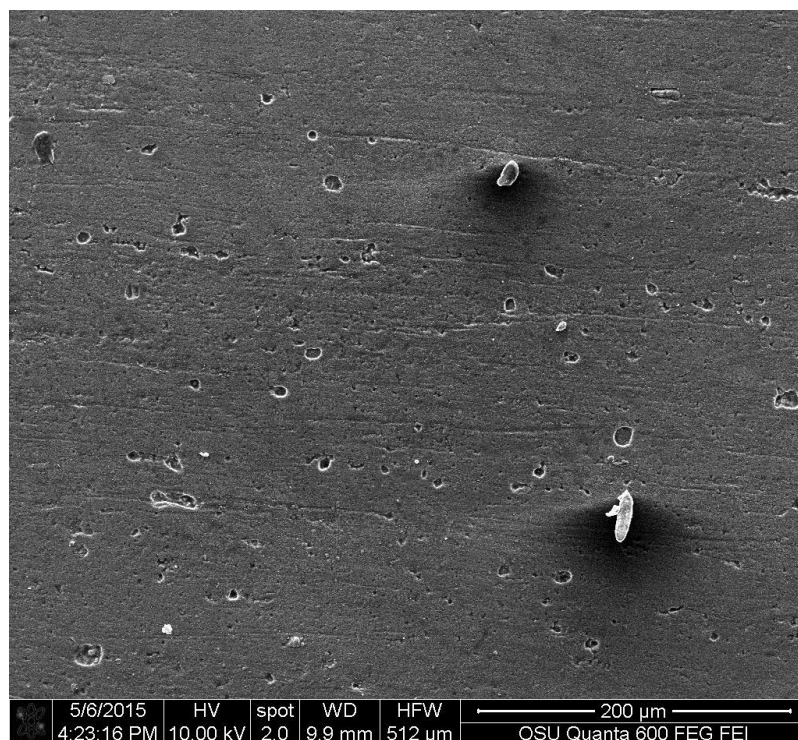
Figure 4.8. Surface of original pre-filmed coupons (500X)

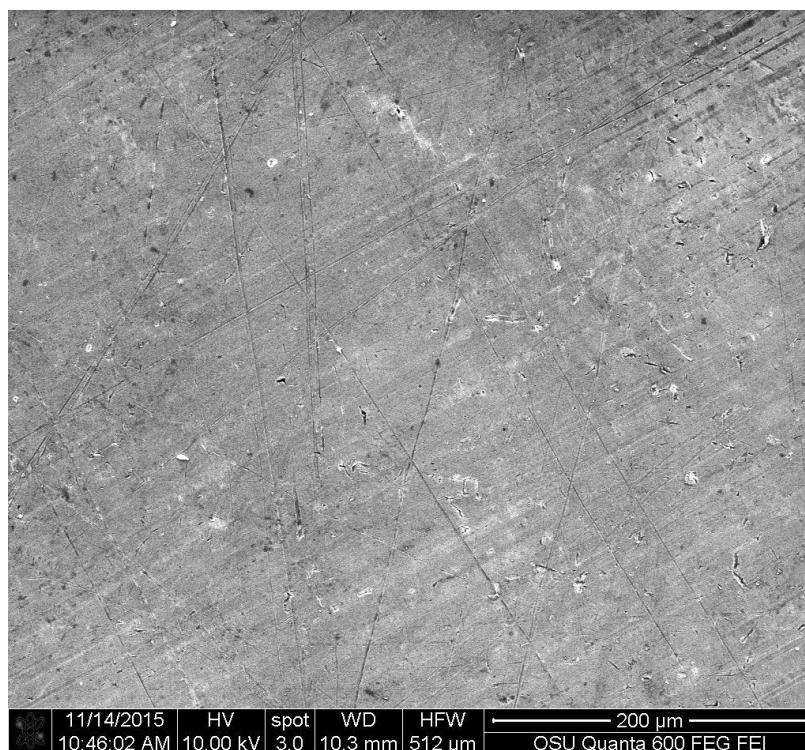
Figure 4.9. Surface of original non-pre-filmed coupons (500X)

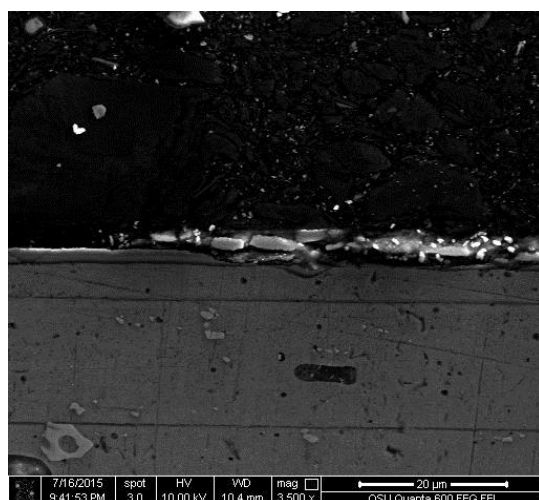
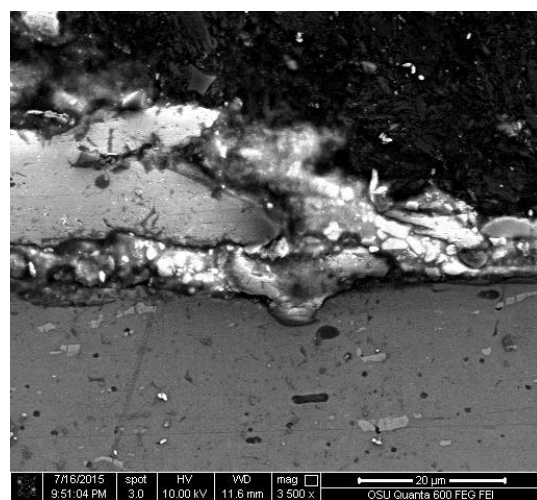
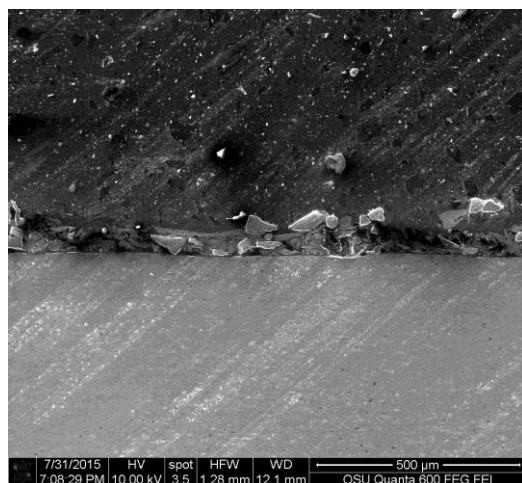
However, some defects were also observed from pre-filmed samples. Some spots on the pre-filmed coupons were not covered by an intact pre-film as shown in Figure 4.10a, which could lead to a faster corrosion process since the aluminum alloy 6061 had directly contact with coolant. Because of the broken oxide pre-film, irregular oxidation happened, as shown in Figure 4.10b, which could also diminish the alloy's mechanical strength and lead to fuel release. Loose adhesion of oxide layer indicates oxide layer spallation as shown in Figure 4.10c, which could be a reason of having a thin oxide thickness and making weight gain analysis inaccurate.

a) Original sample

b) First month

c) Fourth month

Figure 4.10. Defects observed from pre-filmed samples

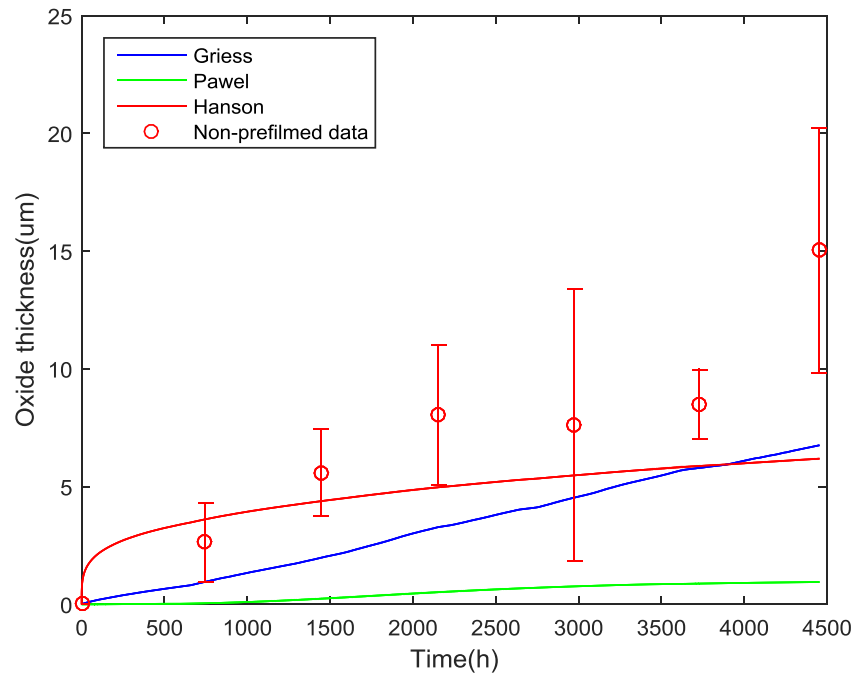
Figure 4.11. Oxide thickness of non-pre-filmed coupons

Figure 4.11 shows the predicted oxide thickness curves with time using Griess, Pawel and Hanson correlations along with the average oxide thickness of non-pre-filmed coupons. According to the plot, it's clear that the average oxide thicknesses on the non-pre-filmed coupons were greater than the predictions of all correlations after 1 month of exposure. The oxide thickness grew significantly in the first month, then the growth rate of oxide decreased in the second month of exposure and stayed at a relatively stable value in the following months. According to the plot, the average oxide thickness of the fourth month decreased. And the oxide thickness for the fifth month almost didn't increase. Possible explanations include:

The SEM operation and ImageJ analysis followed the given procedures, which should help eliminate the human error. However, the error bars for the fourth month measurement data were very large. In fact, the error bar for the pre-filmed sample from fourth month is the biggest among all months. This suggests that the reason for the thickness decrease for the fourth month may be caused by stochastic uncertainty. Breakaway oxidation is also possible. The trend could be parabolic until a point where the samples start to spall and the oxide layer stops growing in a parabolic trend and gain thickness linearly again. The fourth month sample could have had spallation, which caused the decrease in oxide thickness. A large oxide thickness increase was observed for the sixth month measurement data. The best possible explanation is also stochastic uncertainty and breakaway oxidation.

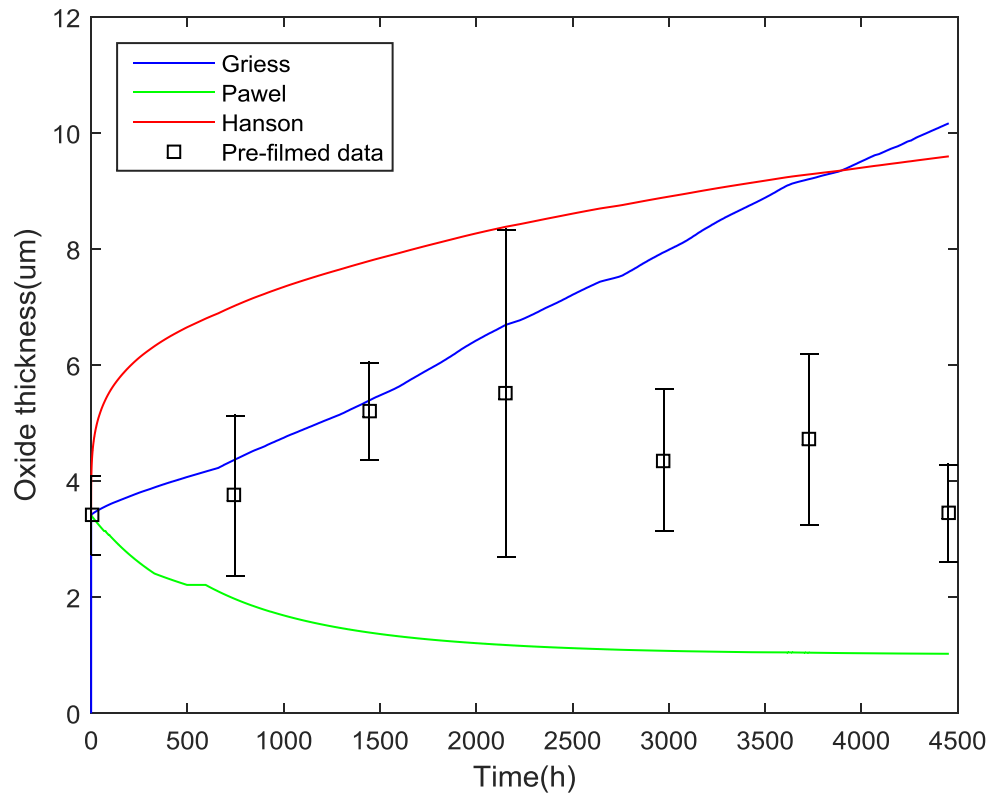
Figure 4.12. Oxide thickness of pre-filmed coupons

Figure 4.12 shows the predicted oxide thickness curves with time using Griess, Pawel and Hanson correlations along with average oxide thickness of pre-filmed coupons.

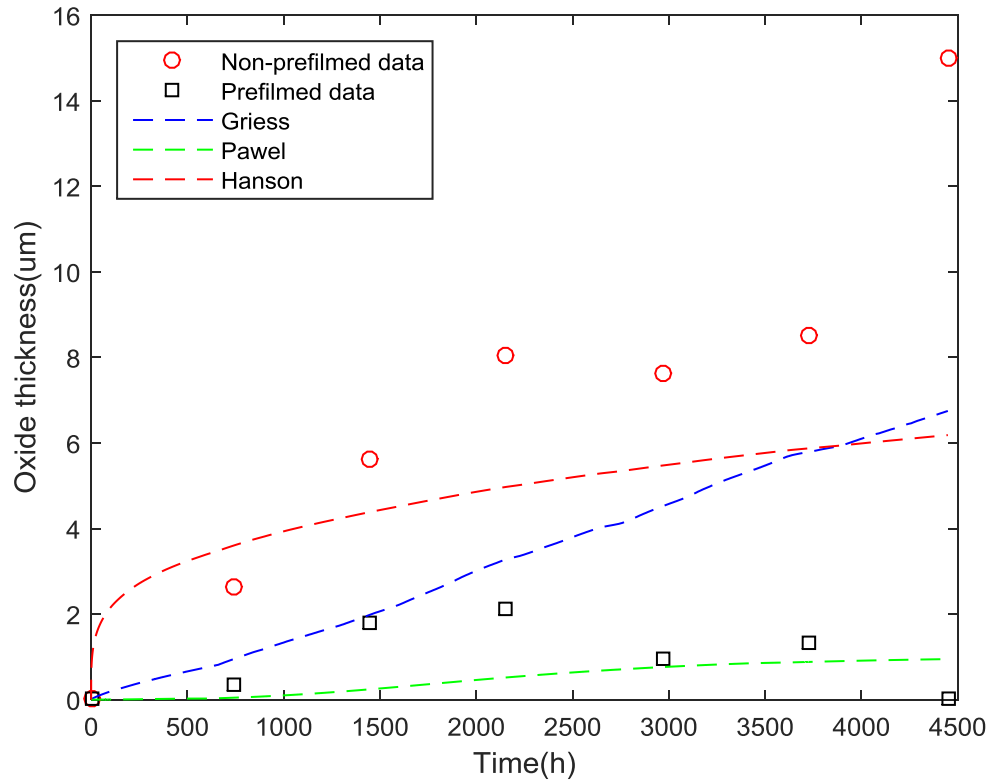
Figure 4.13 shows the net change of the average oxide thickness from the measurement data and oxide thickness predictions for both types of coupons. This plot clearly shows that the oxide growth rate of non-pre-filmed coupons is much higher than the pre-filmed coupons.

Figure 4.13. Oxide thickness net change of pre-filmed and non-pre-filmed samples

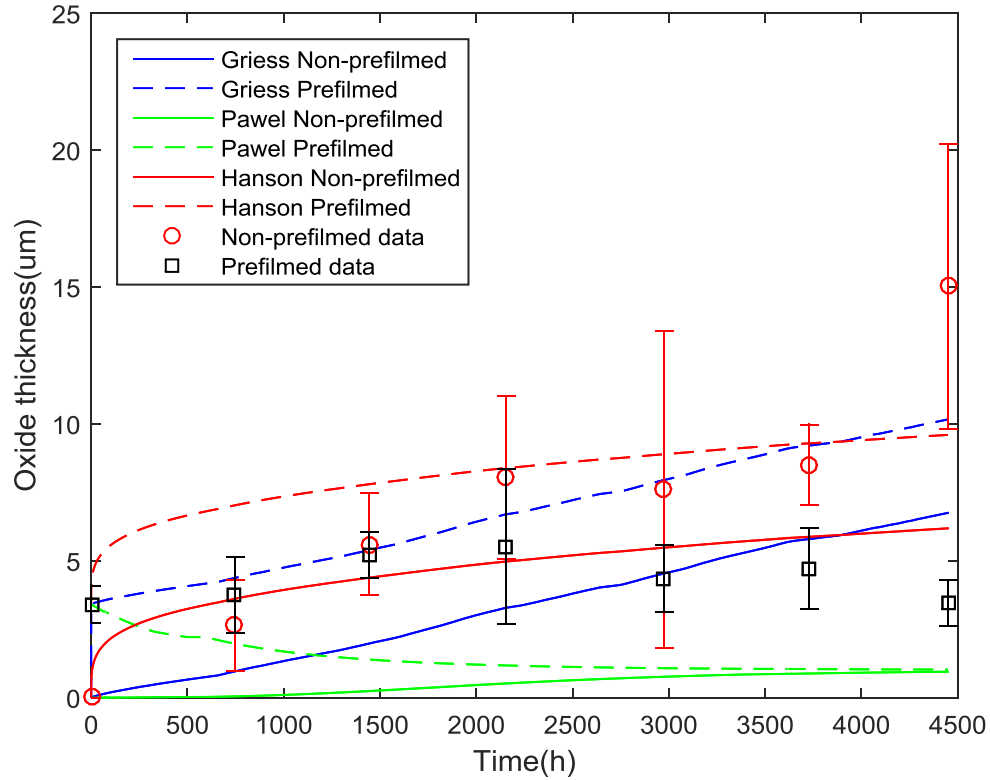
Figure 4.14 shows the total oxide thickness for both types of samples. For the pre-filmed samples, the Griess correlation fits the first three months data and then over predicts the oxide thickness for months four through six. Using this correlation would provide additional safety margin in real reactor operation. The Hanson correlation over-predicts oxide thickness for the pre-filmed samples through the entire experiment. But it under estimates the non-pre-filmed samples' oxide thickness for months two through six. Pawel correlation under-predicts the oxide thickness too much for the non-pre-filmed sample. And it provides a negative oxide thickness increase for pre-filmed sample caused by the small power in the correlation.

Figure 4.14. All measurement data and prediction curves

While none of the correlations appropriately follow the development of oxide growth on the surface of either sample-sets, the pre-filmed coupons measure smaller oxide thicknesses than that predicted for Hanson and Griess correlations, while the non-prefilmed coupons measure thicker than any of the correlations predict. This is paramount to the safety of the reactors as correlations are used to support the safety analysis of the reactors that have pre-filmed oxide on cladding. The oxide thickness from safety analyses is thicker than it actually is therefore the state of cladding is conservatively assessed by the Hanson and Griess correlations.

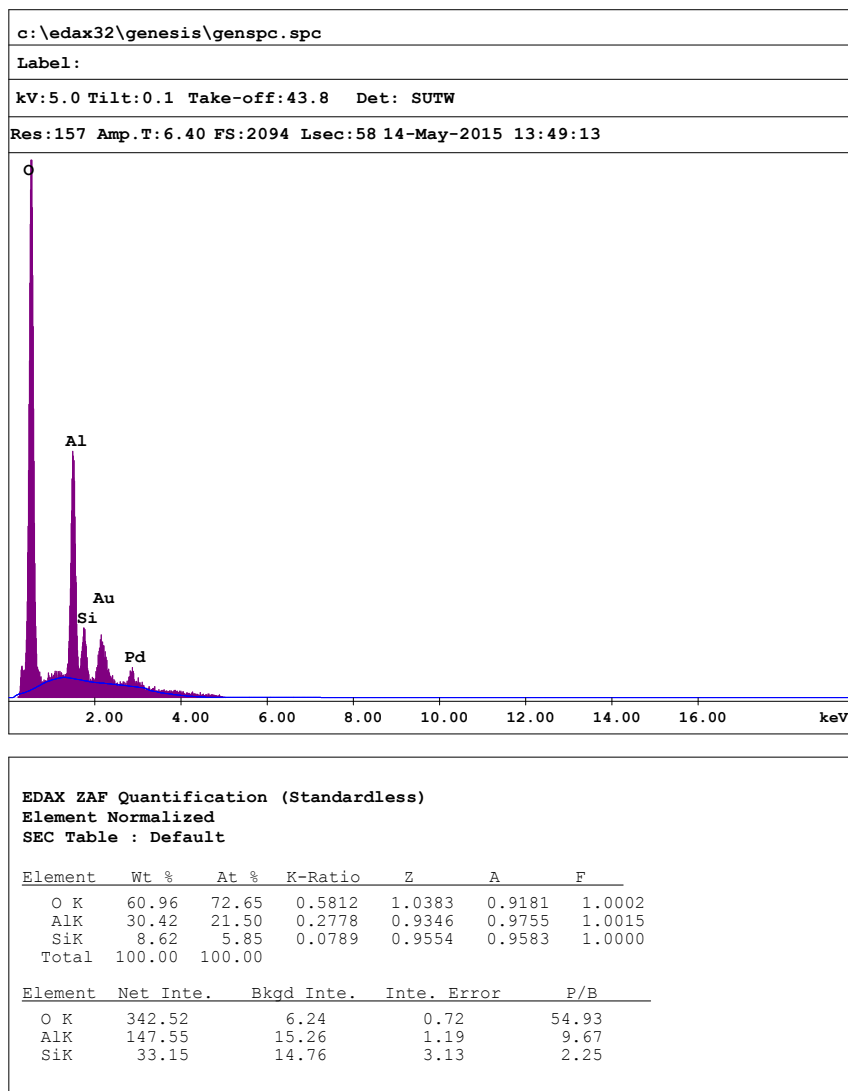
53.3%; the aluminum weight percentage is 45%. For bayerite, the oxygen weight percentage is 34.6%; the aluminum weight percentage is 61.5%. EDS analysis was applied to determine the chemical composition of the deposit and oxide layer. One thing to note is that the standard deviation of the result may be up to 10% for a simple system like oxygen and aluminum. EDS analysis was conducted on the deposits from the first month and fourth month. The reason for doing an analysis for the deposit from first month coupon was because of the cotton-like deposit on the surface was not expected. The chemical composition of deposit needed to be analyzed. The analysis for the fourth month was conducted to compare with the results from first month. According to the first month results, which are shown in Figure 4.15 and Figure 4.16, the aluminum and oxygen percentages from non-pre-filmed coupons are lower than those from the pre-filmed coupons. This is because the result for pre-filmed sample doesn't include the Au and Pd. This leads to an increase in the percentage of the oxygen and aluminum. The presence of Au and Pd from the results is because of the coating process of sample preparation for SEM analysis. The silicon shown in the result was either from the aluminum alloy or from the water in the test loop. Water chemical analysis indicated silica was present. Silicon is also one of the compositional elements of 6061 aluminum alloy, though in much lower concentrations. In all the results, the oxygen percentages were at least 20% higher than the aluminum percentages. In boehmite, the percentage of the oxygen is higher than that of the aluminum. Therefore, the substances of the deposit on both types of coupons were possibly the same (boehmite) or a mixture composed of mainly boehmite with small amount of bayerite.

Figure 4.15. EDS result of deposit formed on pre-filmed sample from first month

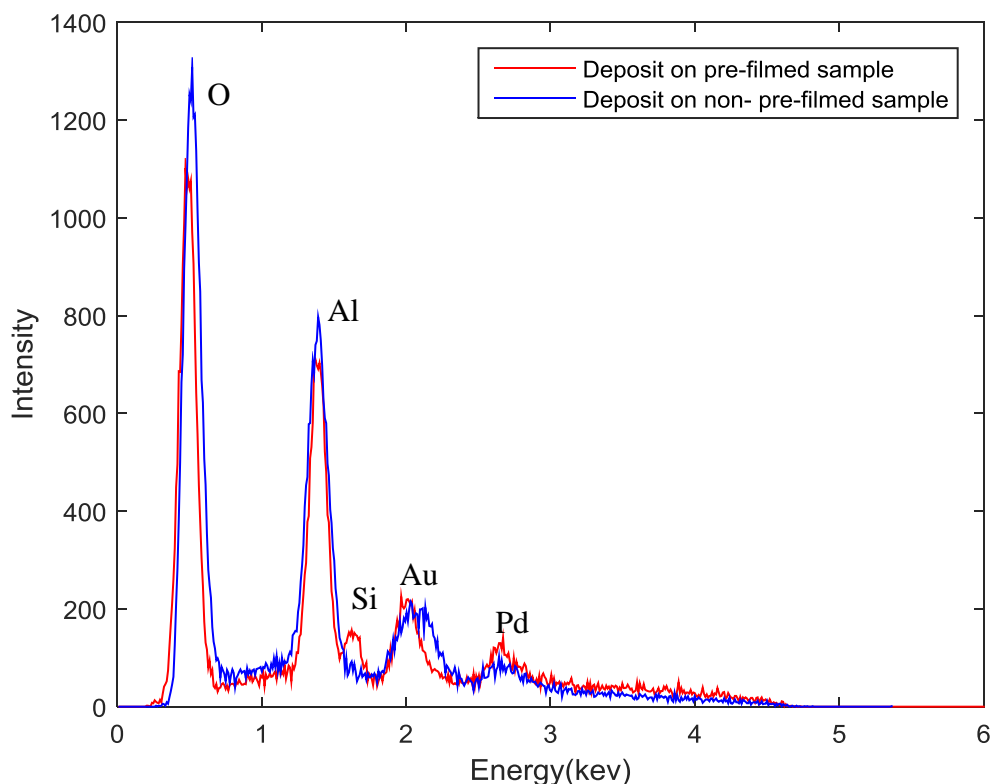
Figure 4.19. Deposit from both type of coupons from fourth month

Figure 4.19 shows deposit EDS results comparison from the fourth month. The red spectrum represents deposit of pre-filmed sample and the blue spectrum represents deposit of non-pre-filmed sample. The trends of these two spectrums are similar and don't have a significant change compared to the deposit spectrum from first month. This again indicates the chemical compositions of deposits are the same on both type of samples.

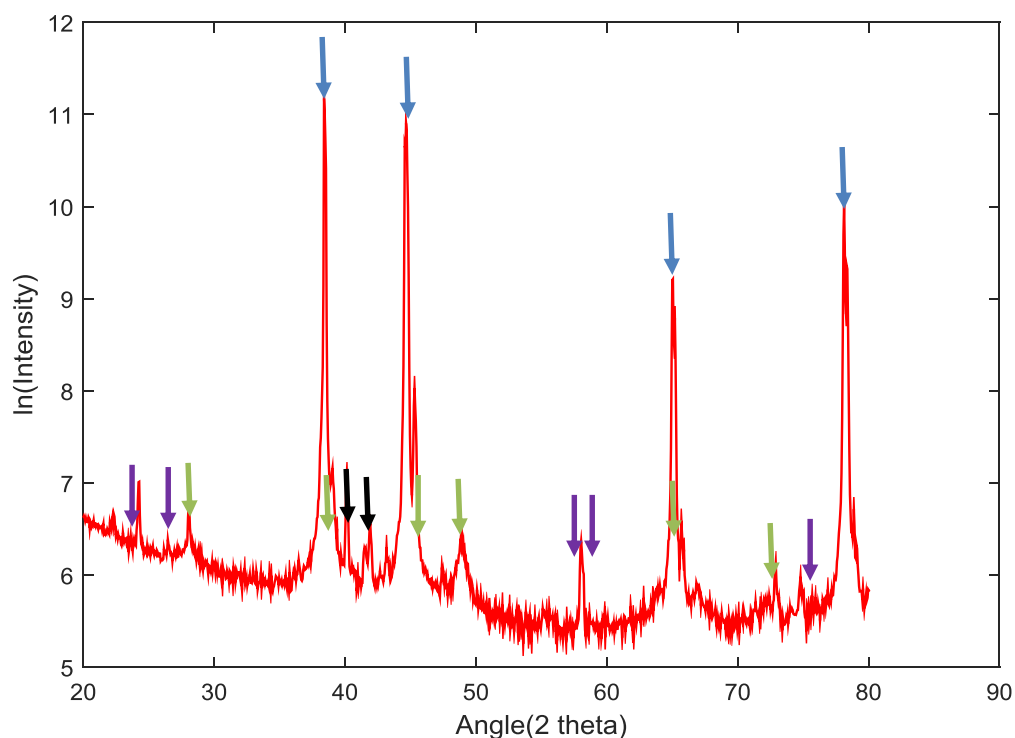
aluminum alloy was just beneath the oxide layer that was being scanned. Any surface defect such as cracking and pitting would expose the aluminum alloy to the X-ray and lead to strong intensity peaks for aluminum in the result. Also, other substance peaks may appear at the same position, which increases the intensity and enhances the height of those peaks. The peaks marked with green are in accordance with peaks of boehmite. These peaks cover most of the secondary peaks in the results indicating that the substance composed oxide layer probably is boehmite. Some peaks of boehmite appear at the same position of aluminum's peak, so that these peaks are contributing to the high peaks for the aluminum. After peaks of aluminum and boehmite are identified, there are still a few small peaks left unidentified. The black and purple marks represented gibbsite with different crystal structures. However, among all the marks for gibbsite structure, only a small portion of these marks that are showing in the figure located at unidentified peaks. Therefore, a small amount of gibbsite could be found in the sample.

Figure 4.20. XRD results for the original pre-filmed sample

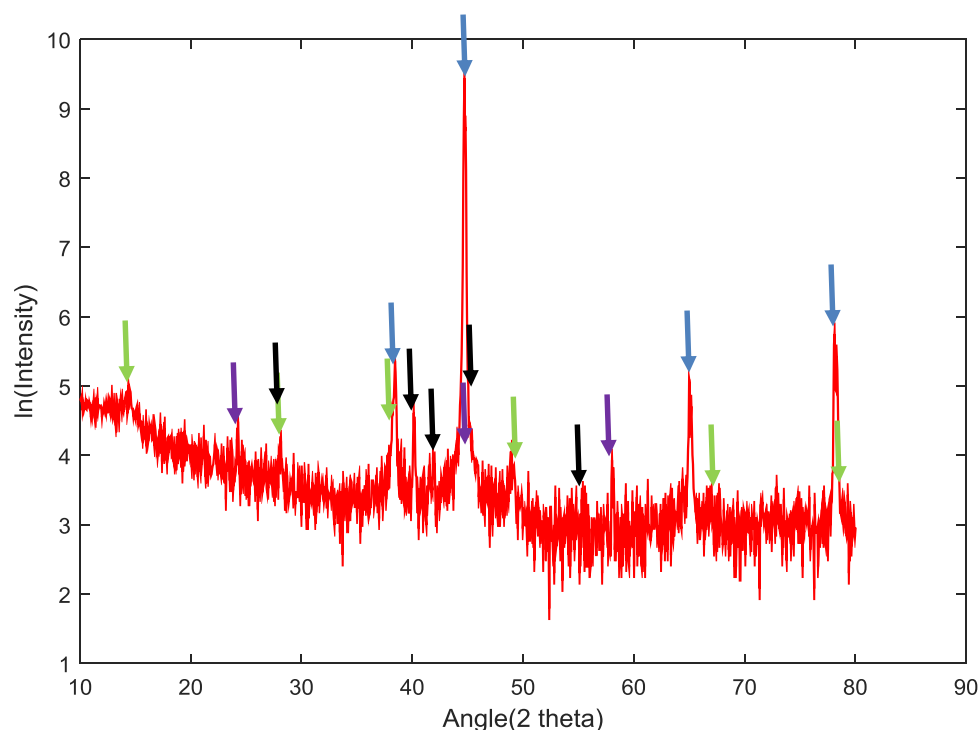
Figure 4.21 shows XRD results of the pre-filmed sample from third month. The peaks marked with blue are in accordance with peaks of aluminum. The peaks marked with green are in accordance with peaks of boehmite. Green marked peaks covered most of the secondary peaks in the results. It is believed that those secondary peaks are the XRD results for the oxide layer. As mentioned above, there are two reasons that those highest peaks indicated aluminum not the oxide layer. Therefore, the secondary peaks most likely are the peaks of interest, which are the peaks of oxide layer. So it is reasonable to infer that boehmite is the potential substance that composed the oxide layer on the pre-filmed sample from third month. Peaks marked with purple are in accordance with boehmite ($Al_2O_3 \cdot H_2O$). And the peaks marked with black are in accordance with peaks of gibbsite. Therefore, the gibbsite and boehmite possibly exist in the sample.

Figure 4.21. XRD results of pre-filmed sample from third month

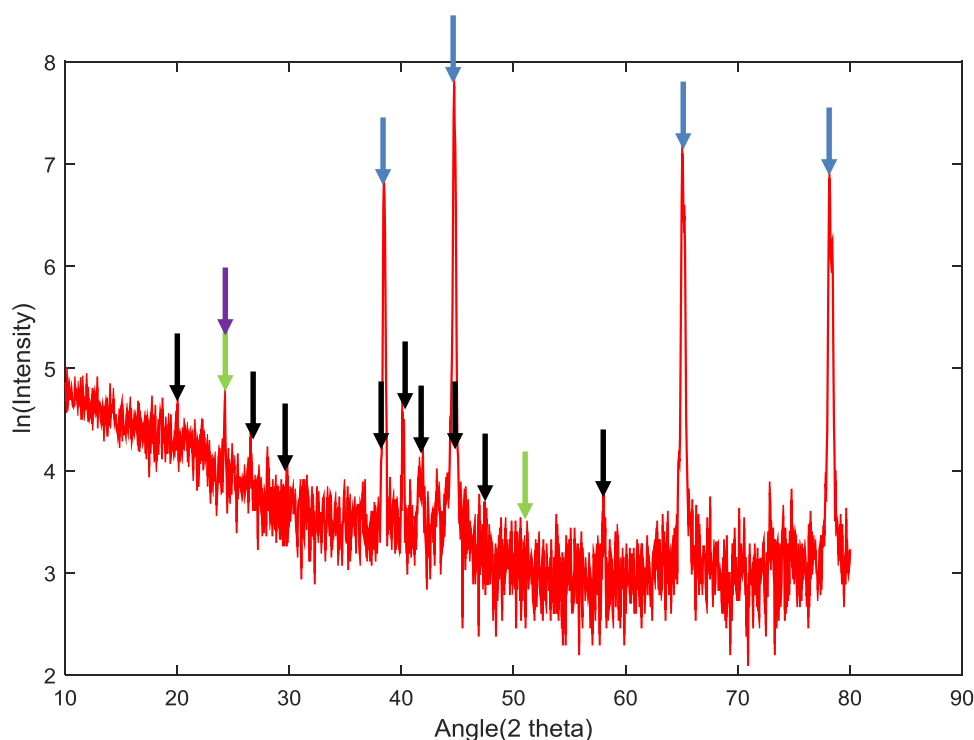
In Figure 4.22, the peaks marked with blue are in accordance with peaks of aluminum. The secondary peaks marked with green are in accordance with peaks of boehmite. Therefore, the potential substance composed the oxide layer is also boehmite for the non-pre-filmed sample from third month. The peaks marked with black are in accordance with the peaks of gibbsite. The peaks marked with purple are in accordance with the peaks of aluminum hydroxide.

Figure 4.22. XRD results of non-pre-filmed sample from third month

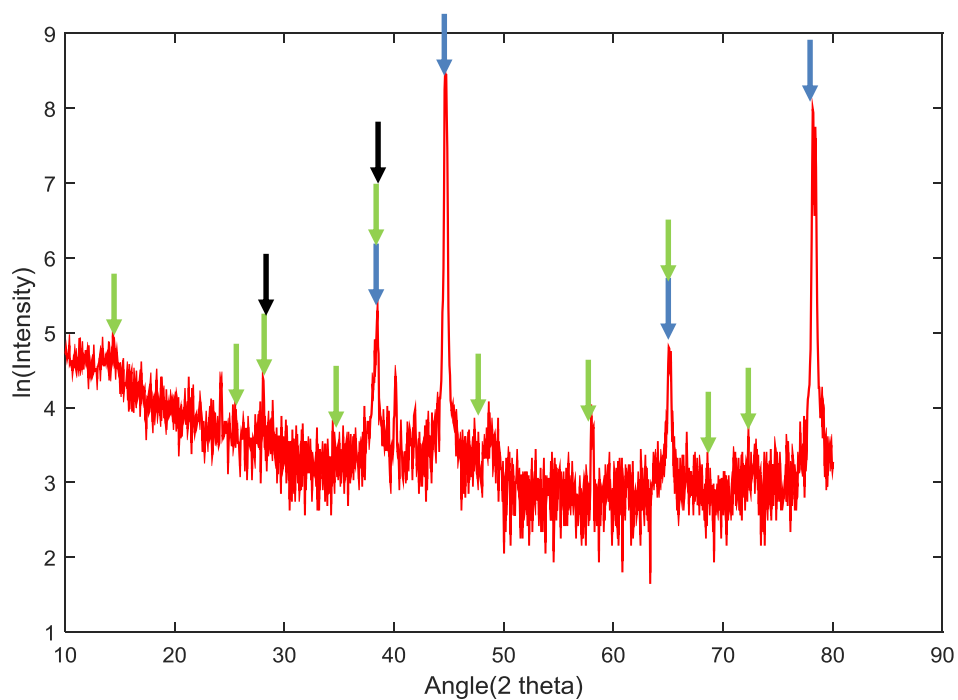
The XRD analysis results for the pre-filmed and non-pre-filmed samples from fourth month are showed in Figure 4.23 and Figure 4.24, respectively. In Figure 4.23, the peaks marked with blue are in accordance with the peaks of aluminum. The peaks marked with green and black are in accordance with the peaks of boehmite with different crystal structures. As it is shown in the figure, the boehmite peaks fit most of the obvious peaks in the result, which indicates that the oxide layer is composed of boehmite. A few small peaks are not identifiable. The reason for this is possibly because of the excessive background reducing, which is one of the operations to

analyze the X-ray scan results. Since the peaks are similar to those from previous results, the potential substance that provides those peaks is possibly gibbsite.

Figure 4.23. XRD results for the pre-filmed sample from fourth month

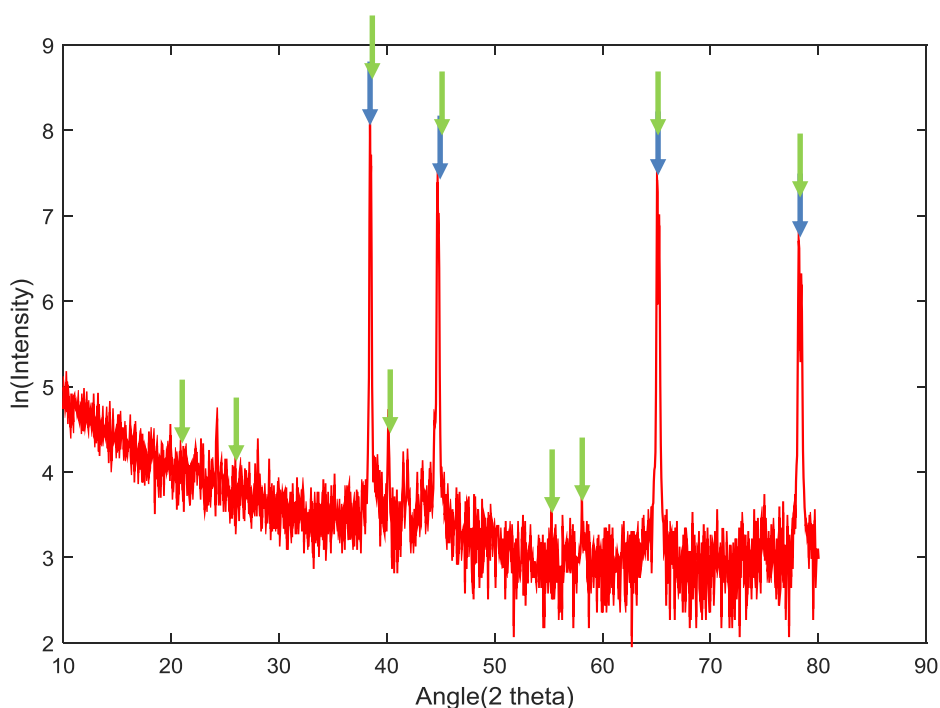
In Figure 4.24, most of peaks are covered by peaks of boehmite. Therefore, the substance that composes the oxide layer could be inferred as boehmite for the non-pre-filmed sample from fourth month.

Figure 4.24. XRD results for the non-pre-filmed sample from fourth month
