Title: Characterization of Oxide Growth of Aluminum Alloy 6061 for Nuclear Research and Test Reactors

Characterization of Oxide Growth of Aluminum Alloy 6061 for Nuclear Research and
Test Reactors

A THESIS

Oregon State University

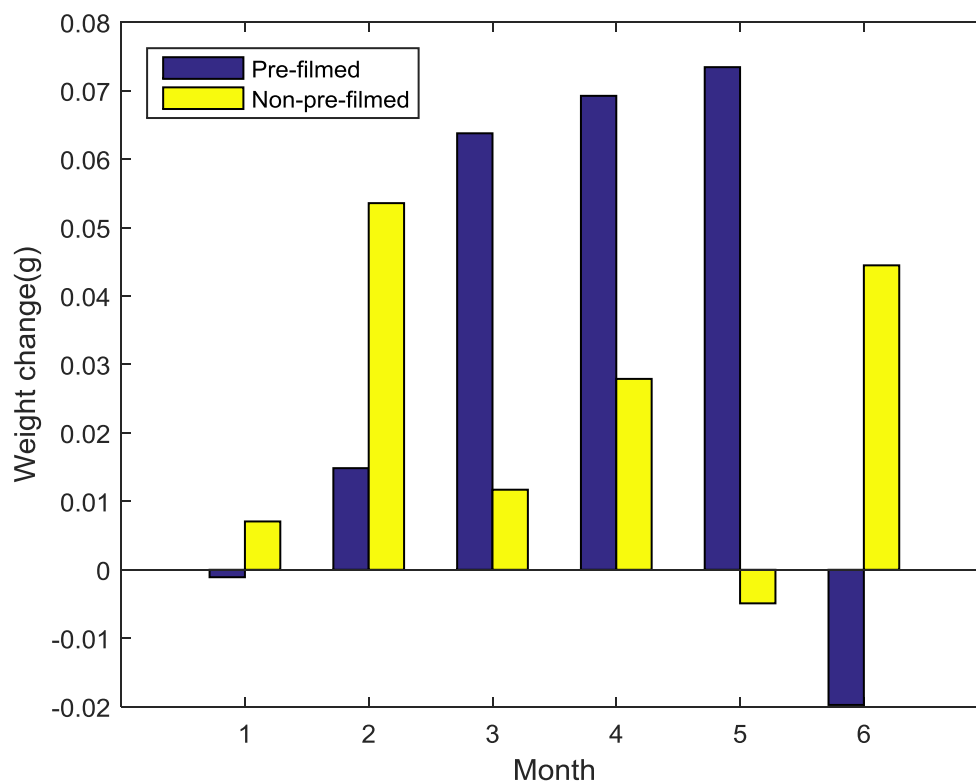
Therefore, the weight gain analysis is unreliable for corrosion analysis as the corrosion product loss is very difficult to avoid through the experiment process. Corrosion product could be lost during the corrosion test, coupon collecting process and unexpected accidents through measuring process. Those uncontrollable and unexpected weight loss make weight gain analysis too inaccurate to provide reliable data for this study.

Figure 4.25. Coupons' weight changes
