The Ore Bin

Volume 38, No. 8
August 1976

BEACH EROSION ON SILETZ SPIT, OREGON

Paul D. Komar and C. Cary Rea

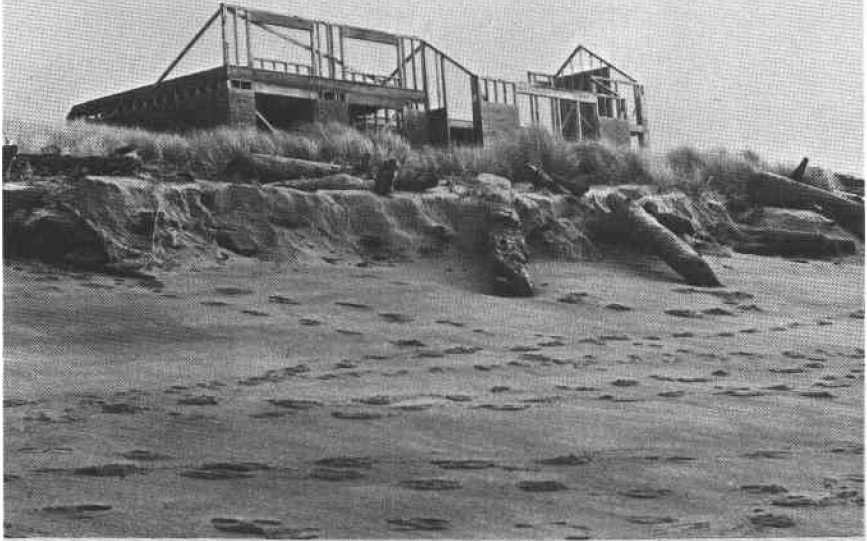
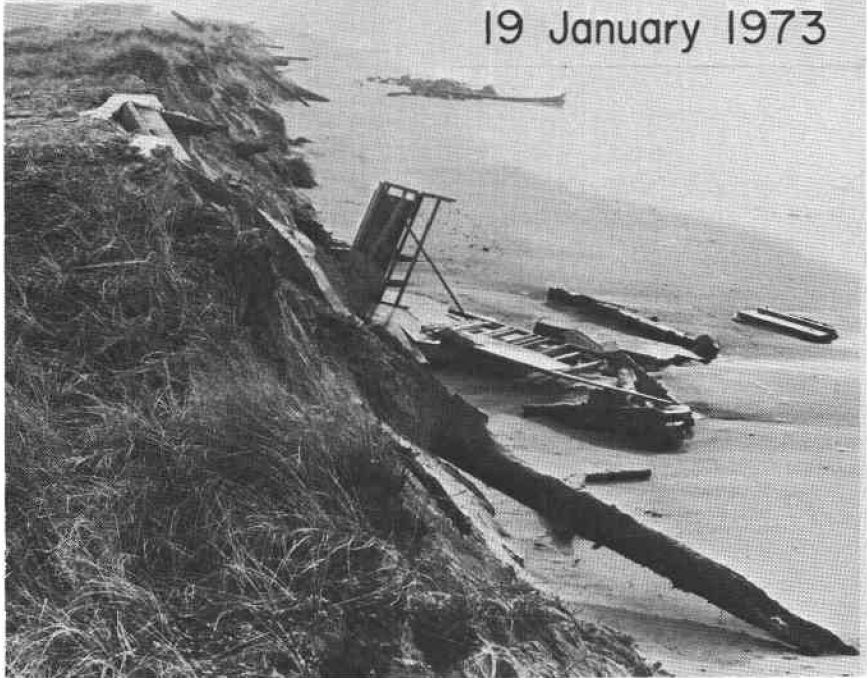
Figure 2. Erosion and destruction of the house under construction on lot 226 of Siletz Spit.

The severest episode of erosion occurred during the winter of 1972-73. One partially built home was destroyed (Figure 2), and others had to be protected by riprap on three sides (Figures 3 and 4). The worst erosion took place along a 650-meter stretch of the central spit, opposite the artificial lagoons cut into the bay side of the spit. Figure 5 diagrams the erosion to the base of the foredunes, the maximum recession amounting to 30 meters in a 3-week period. Individual homeowners placed riprap in front of their properties, but unprotected vacant lots continued to erode. Flank erosion in the empty lots made it necessary to protect the sides of houses so that the group of three houses ended on a promontory supported by riprap (Figures 3, 4, and 5).

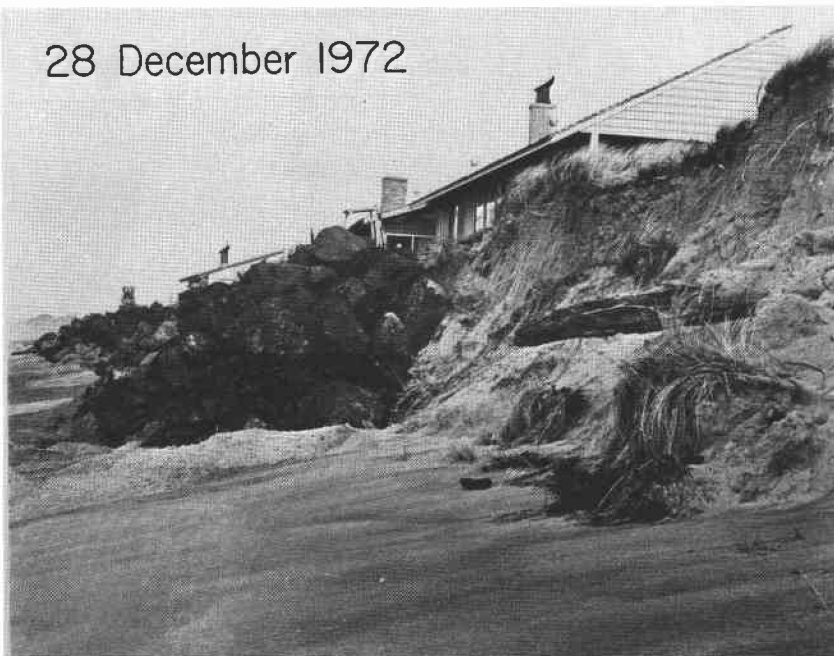
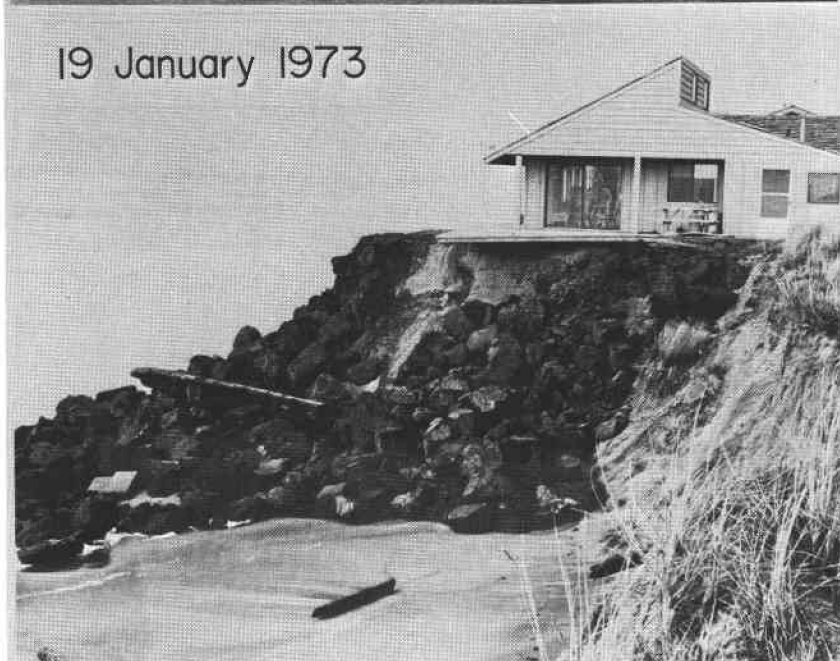
Figure 3. Erosion around the house on lot 229-A. Rapid erosion required placement of riprap fronting home in upper photo; but no riprap was installed in adjacent vacant lot, so erosion continued along the side as seen in lower photo.

Due to a disagreement between the developer, who owned the lots, and the individual leaseholders as to who should pay for the placement of the riprap, erosion to the empty lots was allowed to proceed until it threatened the road, at which time riprap was finally installed. The dispute is presently being settled in court.

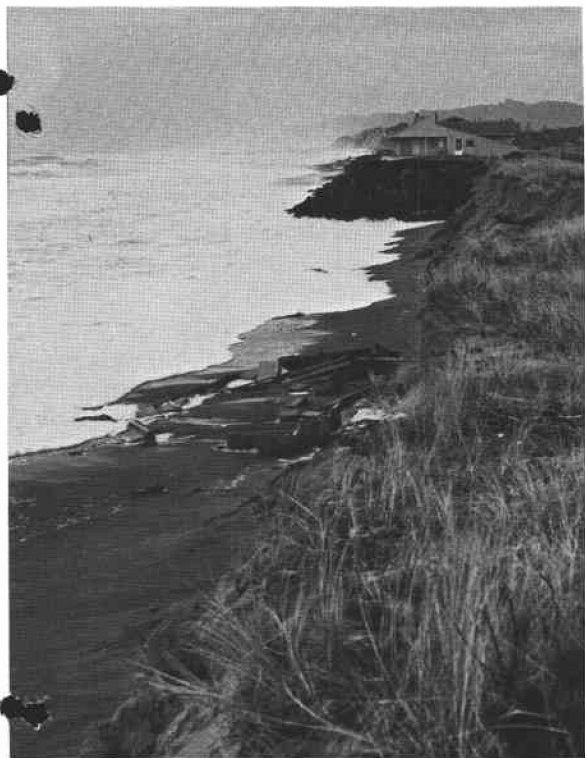
Figure 4. View of both houses of Figures 2 and 3.

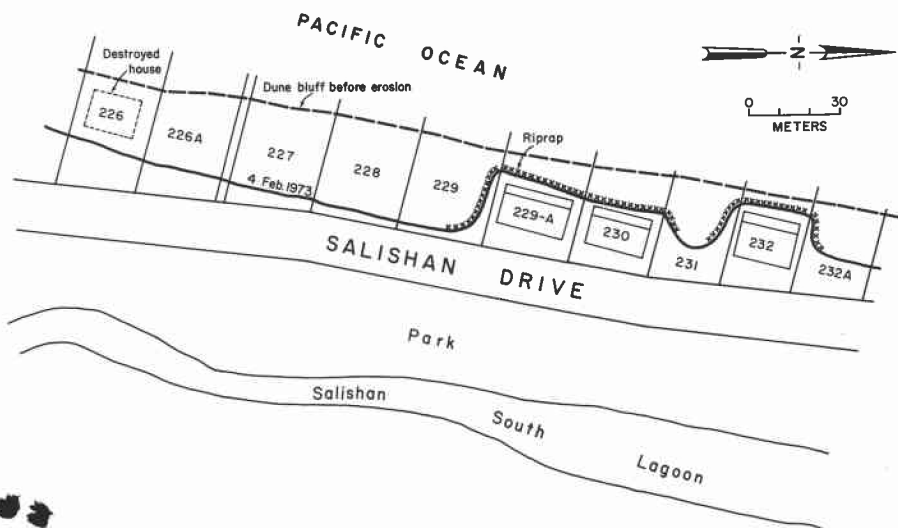
Figure 5. Successive surveys showing the retreat of the edge of the dune bluff. Riprap around lots 229-A through 232 prevented their erosion, but the erosion of the adjacent lots left them on a promontory extending out onto the beach.

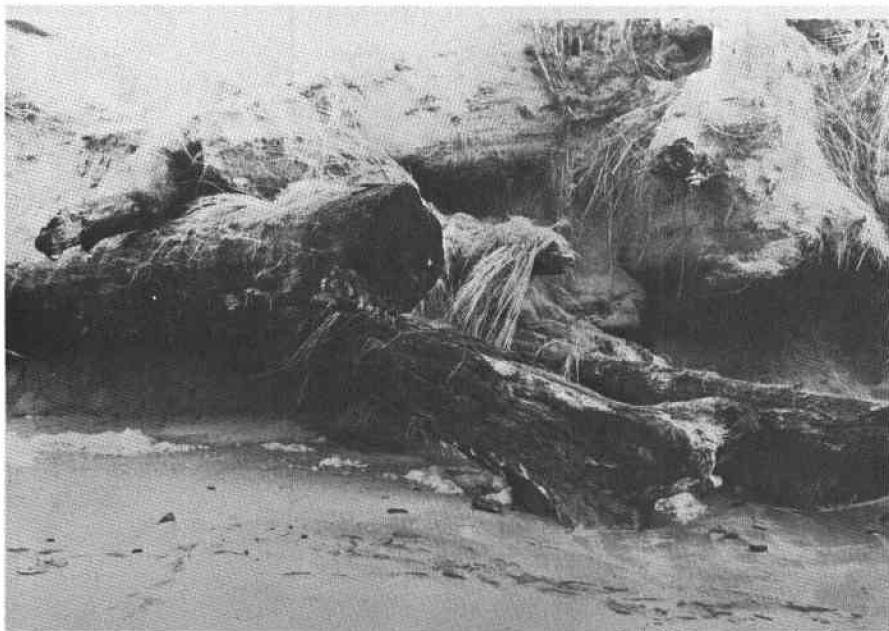
Figure 6. Logs exposed within the eroded dune bluff, many of which had been sawed.

Erosion of the dunes of the spit exposed numerous drift logs, many of which had been sawed (Figure 6). This indicates that spit development was contemporaneous with logging along the Oregon Coast. The influx of settlers and logging started about 1895. Sawed logs within the spit indicate that the portion on which the houses had been built suffered previous erosion some time after 1895. The dunes must have then built back out, incorporating sawed logs in the process, and become re-established.

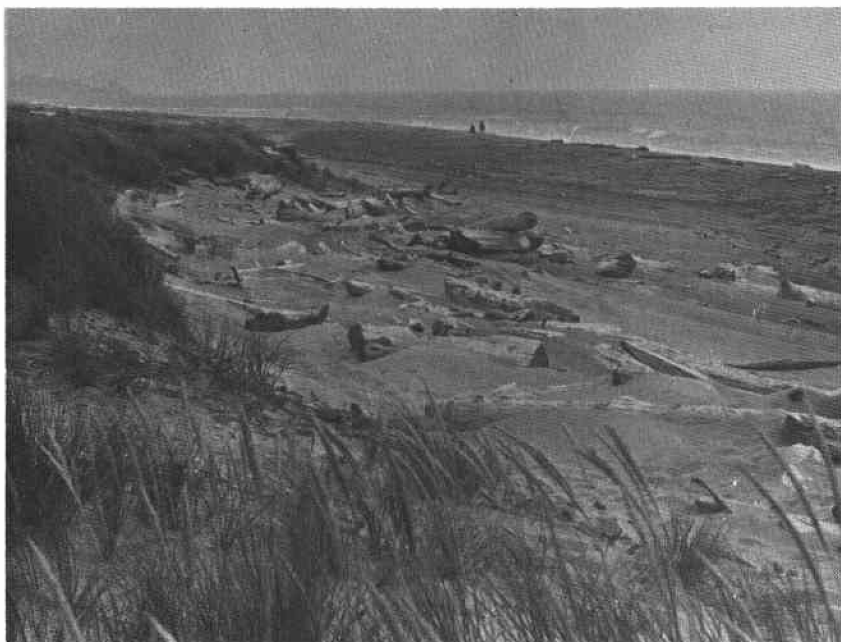
Figure 7. Logs deposited within small embayments eroded into the foredunes trap sands and help reestablish the foredunes.

This study also demonstrates that drift logs play an important role in the natural rebuilding of the foredune areas on spits (Figure 7). Large-scale removal of logs from these areas may be harmful.

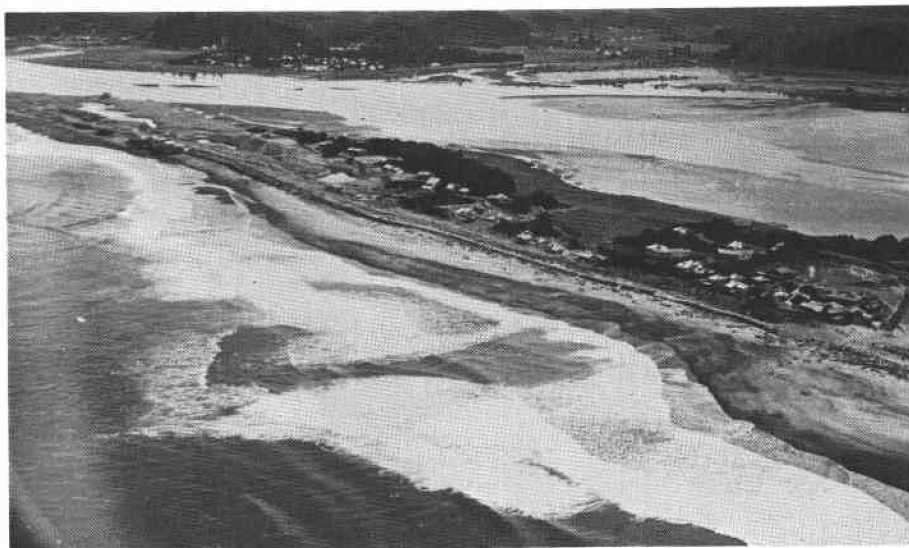
Figure 8. Irregular shoreline of bays and cusps are due to rip currents, one of which is shown in this photograph taken February 8, 1973.

The shoreline along Siletz Spit is typically very irregular (Figure 8) due to rip currents carrying sand offshore, hollowing out small bays on the beach with large cusps between them. At the time of erosion in 1972-73

a strong rip current was situated in one position for most of the winter. This rip current hollowed out a large embayment on the beach, entirely removing the portion of the beach above high tide level so that the wave swash was able to reach the dunes. The loose sand, offering no resistance to the waves, was easily eroded.

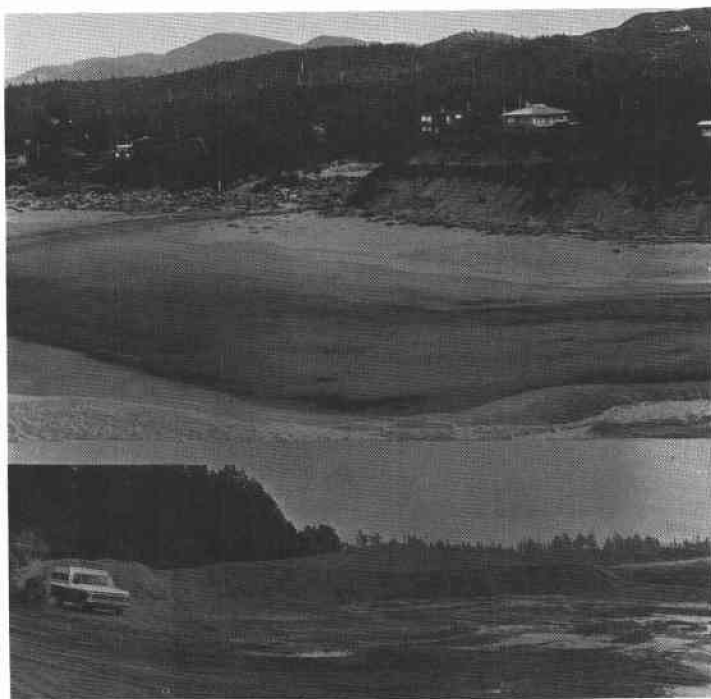
Figure 9. Sand mining from the beach at School House Creek, south of Siletz Spit. Sand was removed from the beach at low tide (upper photo) and piled just inland (lower photo).

The erosion of 1972-73 cut farther back into the dunes than earlier episodes of erosion, at least since 1939. Sand mining operations on the beach to the south of the spit (Figure 9) may account for some of this (Rea and Komar, 1975). Some 84,500 cubic meters of sand were removed between 1965 and 1971. The beach is composed of coarse sand which has only a small long-term source, principally erosion of the sea cliffs behind the beach along this stretch of coast except on Siletz Spit itself. The Siletz River carries mainly finer sands unsuitable for the beach. In other Oregon Coast estuaries that have been studied, apparently most or all of this river sand remains in the estuaries and is not a source of beach sand. Analyses of beach sand confirm that it is derived from erosion of local sea cliffs (Rea and Komar, 1975). Rocky headlands to the north and south prevent sand movement alongshore from sources such as the Columbia River. Thus, Siletz Beach is a pocket beach, stretching from Cascade Head in the north to Government Point in the south, with only a small natural source of beach sand.

For these reasons, removal of the sand by mining operations probably disrupted the natural budget of beach sand, the balance of sand gains and losses on the beach. With decreased volume, the beach was less able to protect the coastal property from wave attack, and accelerated erosion resulted. Therefore, although cycles of erosion to Siletz Spit are natural and are known to have occurred prior to beach sand mining, the mining operations probably caused increased erosion. Beach sand mining has subsequently been stopped.

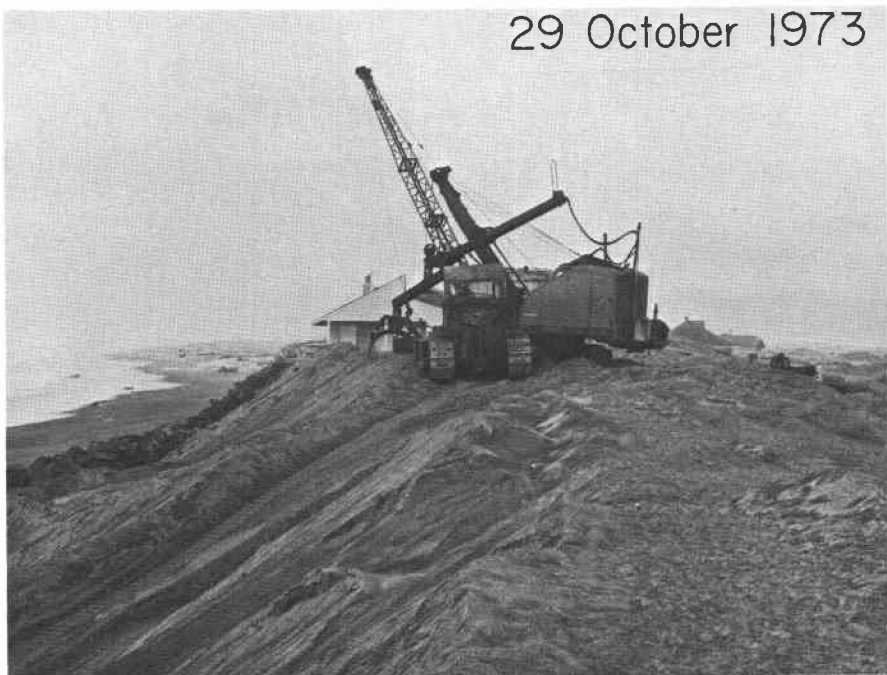
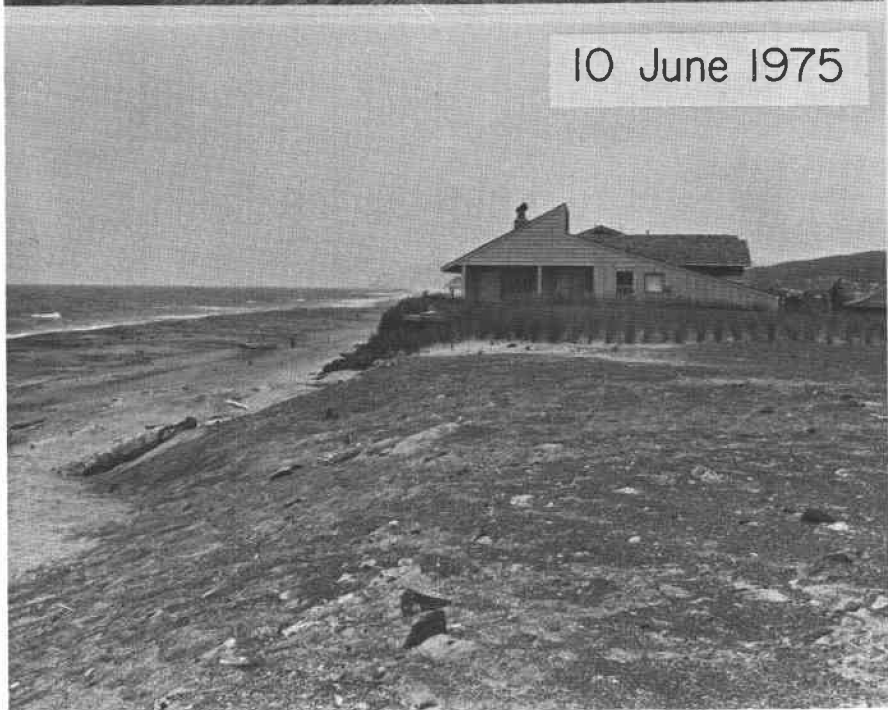
Figure 10. Restoration of the lots 228 and 229. Compare with Figures 3 and 4.

Some of the lots that were eroded in 1972-73 have been subsequently restored (Figure 10). These are either not protected or are inadequately protected: another winter of intense storms could bring renewed erosion. During this winter (1975-76) no rip current is located offshore from this area, and there is no erosion.

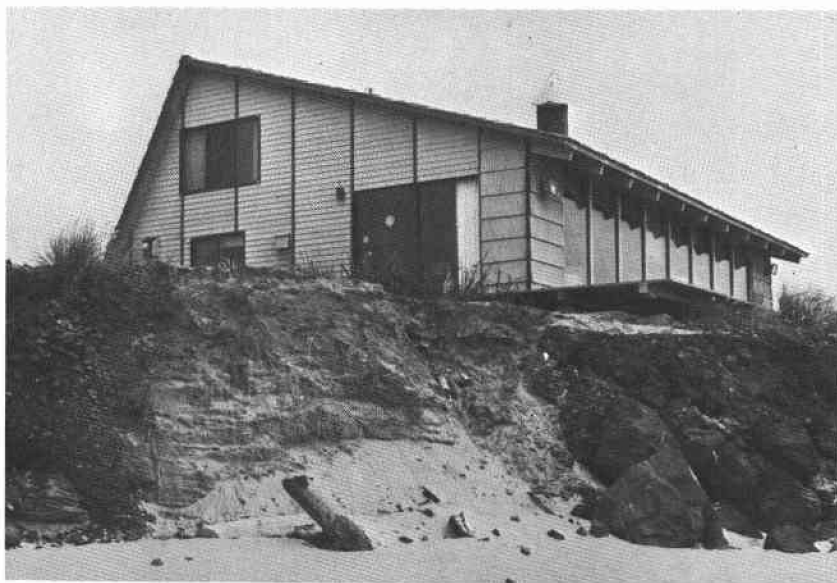
Figure 11. Erosion of the riprap fronting one of the homes, exposing some of the dune sands. Note small size of the rocks, which are easily removed by erosion.

Some houses for which riprap was installed in 1972-73 could be endangered by future erosion because the riprap protection is inadequate. In some cases the riprap has partially eroded, exposing the dune sands (Figure 11). This riprap was installed hastily in order to save the houses at the time of severe erosion in 1972-73, and installation did not follow the established engineering procedures for riprap construction. Even more important, stones of inadequate size were used because of their availability: these are easily washed away by waves.

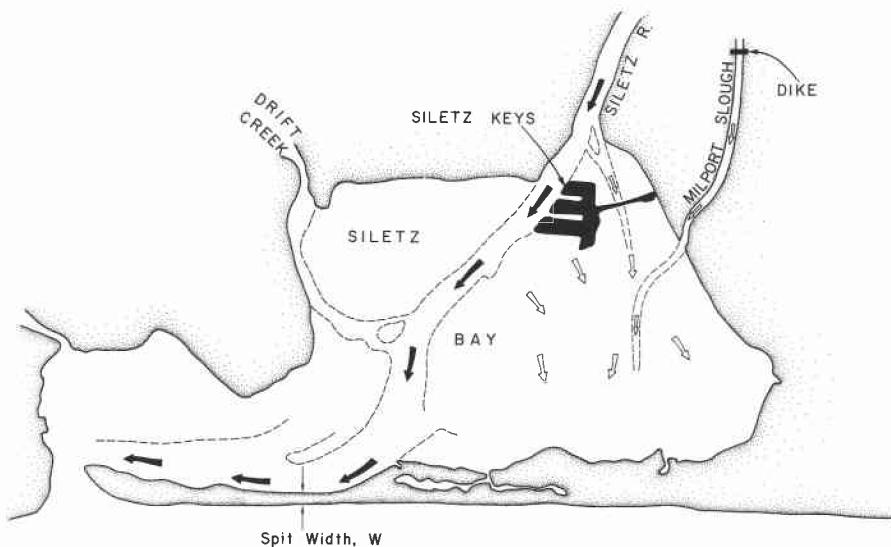
Figure 12. Siletz River flow through the estuary. Open arrows show how flood waters formerly spilled into the south bay, prior to diking of Milport Slough and to placement of Siletz Keys fill. Not shown is the fill for the new highway bridge, which also prevents spill in the Siletz Keys area. Now flood waters flow down main channel as shown by the black arrows, directed at back of spit.

Erosion has been occurring on the bay side of the spit where the flow of the Siletz River through the bay impinges on the spit near its north end (Figure 12). The progress of this erosion was studied with aerial photographs and old surveys dating back to 1875, the original survey of this area. Fortunately, one of the section lines passed directly across the eroded area (Figure 13). This provided measurements of the distances A, B, C, D, and E in Figure 13. These distances were measured on the series of aerial photographs dating back to 1939. The results are shown in the graph of Figure 13.

Recent landfills in Siletz Bay (Figures 12 and 15) have probably aggravated the erosion problem. Both the Siletz Keys fill and the dike on the Millport Slough prevent flood discharge spill into the south bay. Prior to these fills, flood waters flowed in part into the south bay, dissipating their energy. Now that the fills prevent this spill, the full flood discharge of the Siletz River is directed toward the back of the spit into the area that is eroding. Riprap has reduced the expected increase in erosion, but whether the riprap will continue to be effective is questionable.

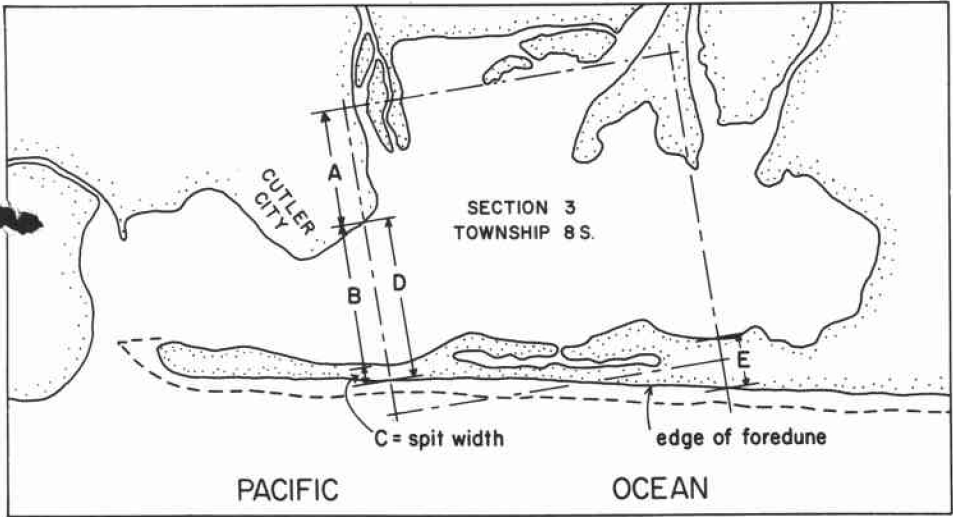
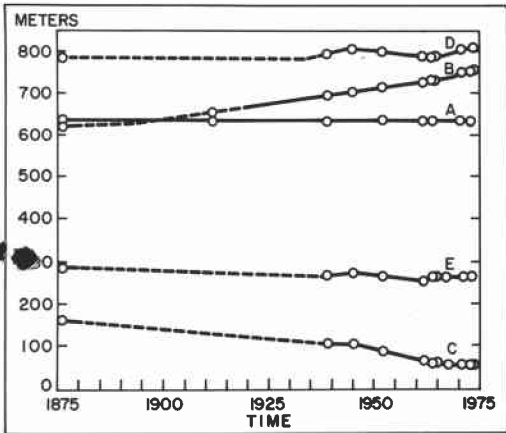
Figure 13. Data from old surveys and aerial photographs showing the progressive decrease in the spit width C due to erosion on the bay side.

In 1875 the width of the spit, C, was 163 meters. By 1939 it had decreased to 102 meters. Now it is only 52 meters wide. The progressive increase in the distance B across Siletz Bay shows that the 111-meter decrease in the spit width was due entirely to erosion on the bay side. The edge of the foredunes (taken as the seaward limit of the spit width) fluctuated somewhat in position due to the cycles of erosion and dune reformation discussed above but did not change its overall position in those 100 years. This is reflected in the irregularity of the distance D in Figure 13. The erosion on the bay side appears to have been fairly steady until recently when riprap was installed to stop the erosion (Figure 14).

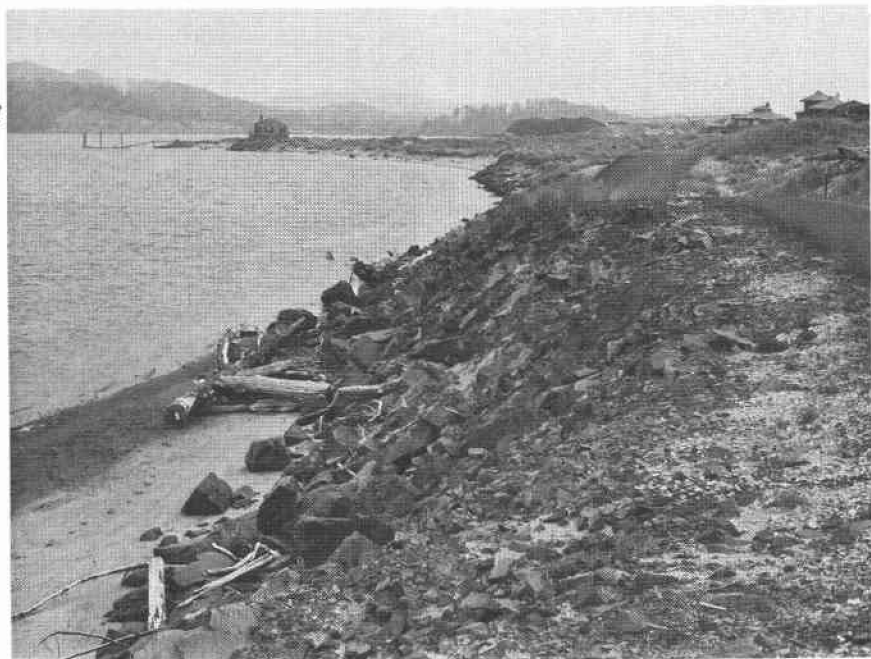
Figure 14. Riprap placed on the bay side of the spit to prevent or decrease erosion.

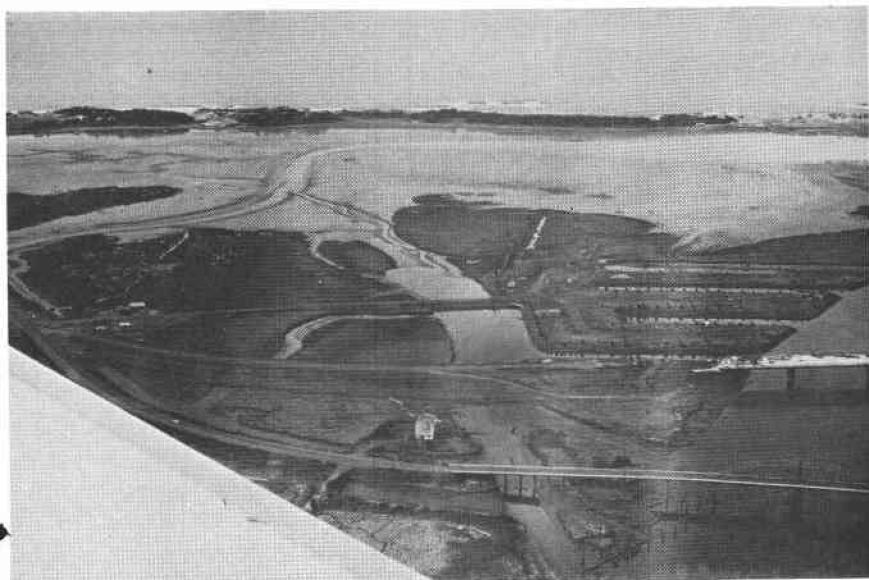
Figure 15. Aerial view of the Siletz Keys fill and the approaches to the old and the new highway bridges. Note how the access road to the Siletz Keys and the approach to the new bridge both block the channel leading to the south bay.

Removal of the dike on the Millport Slough would partly eliminate this aggravation and would improve water circulation in the south part of the bay. Removal of the dike-entrance to Siletz Keys is no longer sufficient because the recent construction of a new bridge for Highway 101 over the Siletz River has also blocked that spill channel (Figure 15). A conduit under the approach to the bridge would also be necessary.
