Shoreline Erosion on Sauvie Island, Oregon: Perceptions and Management Practices

**Season Long, MS Candidate
(Non-thesis)**

**Marine Resource Management Program
College of Oceanic and Atmospheric Science
Oregon State University
Corvallis Oregon, 97331**

Presented June 18th, 2007

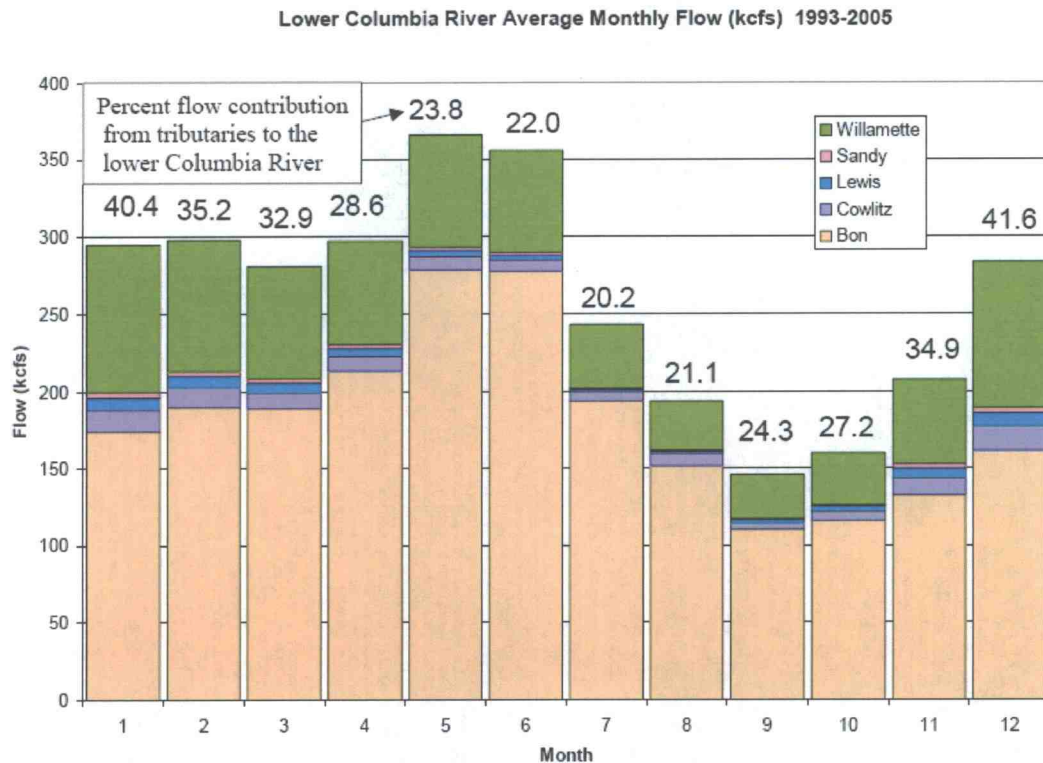
Figure 3 Lower Columbia River monthly flow and contributing river (US Army Corp of Engineers, 2006)

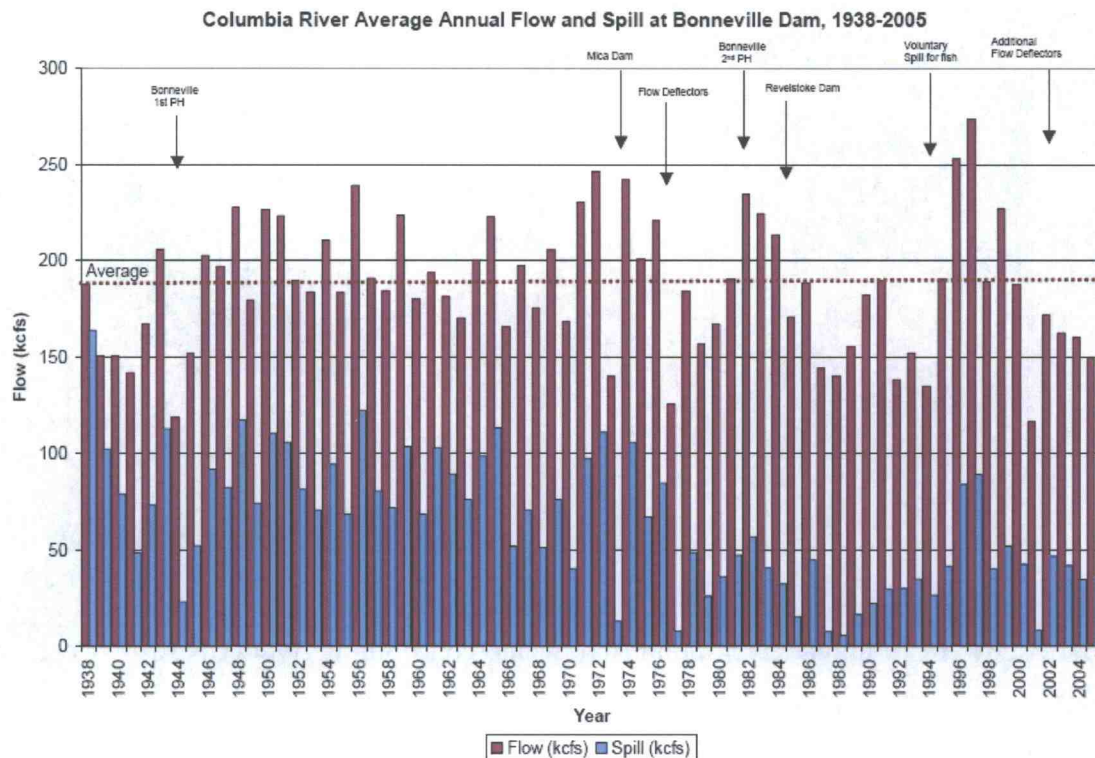
Figure 4 Average annual flow of annual flow at Bonneville Dam (US Army Corp of Engineers, 2006)

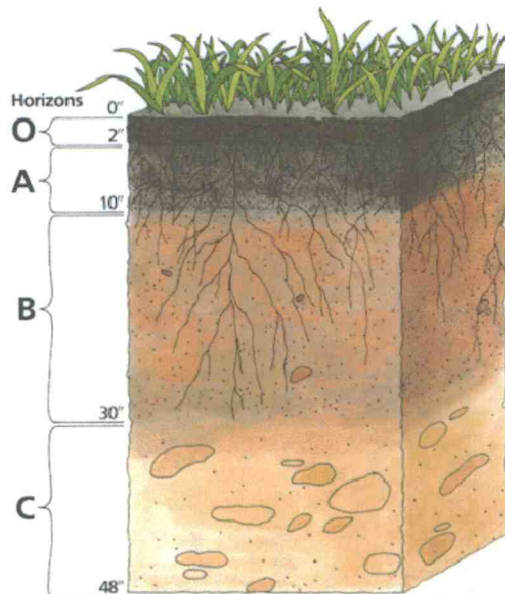
Figure 5 General soil profile describing the top 48 inches of loam (Pike County Conservation District, 2007)

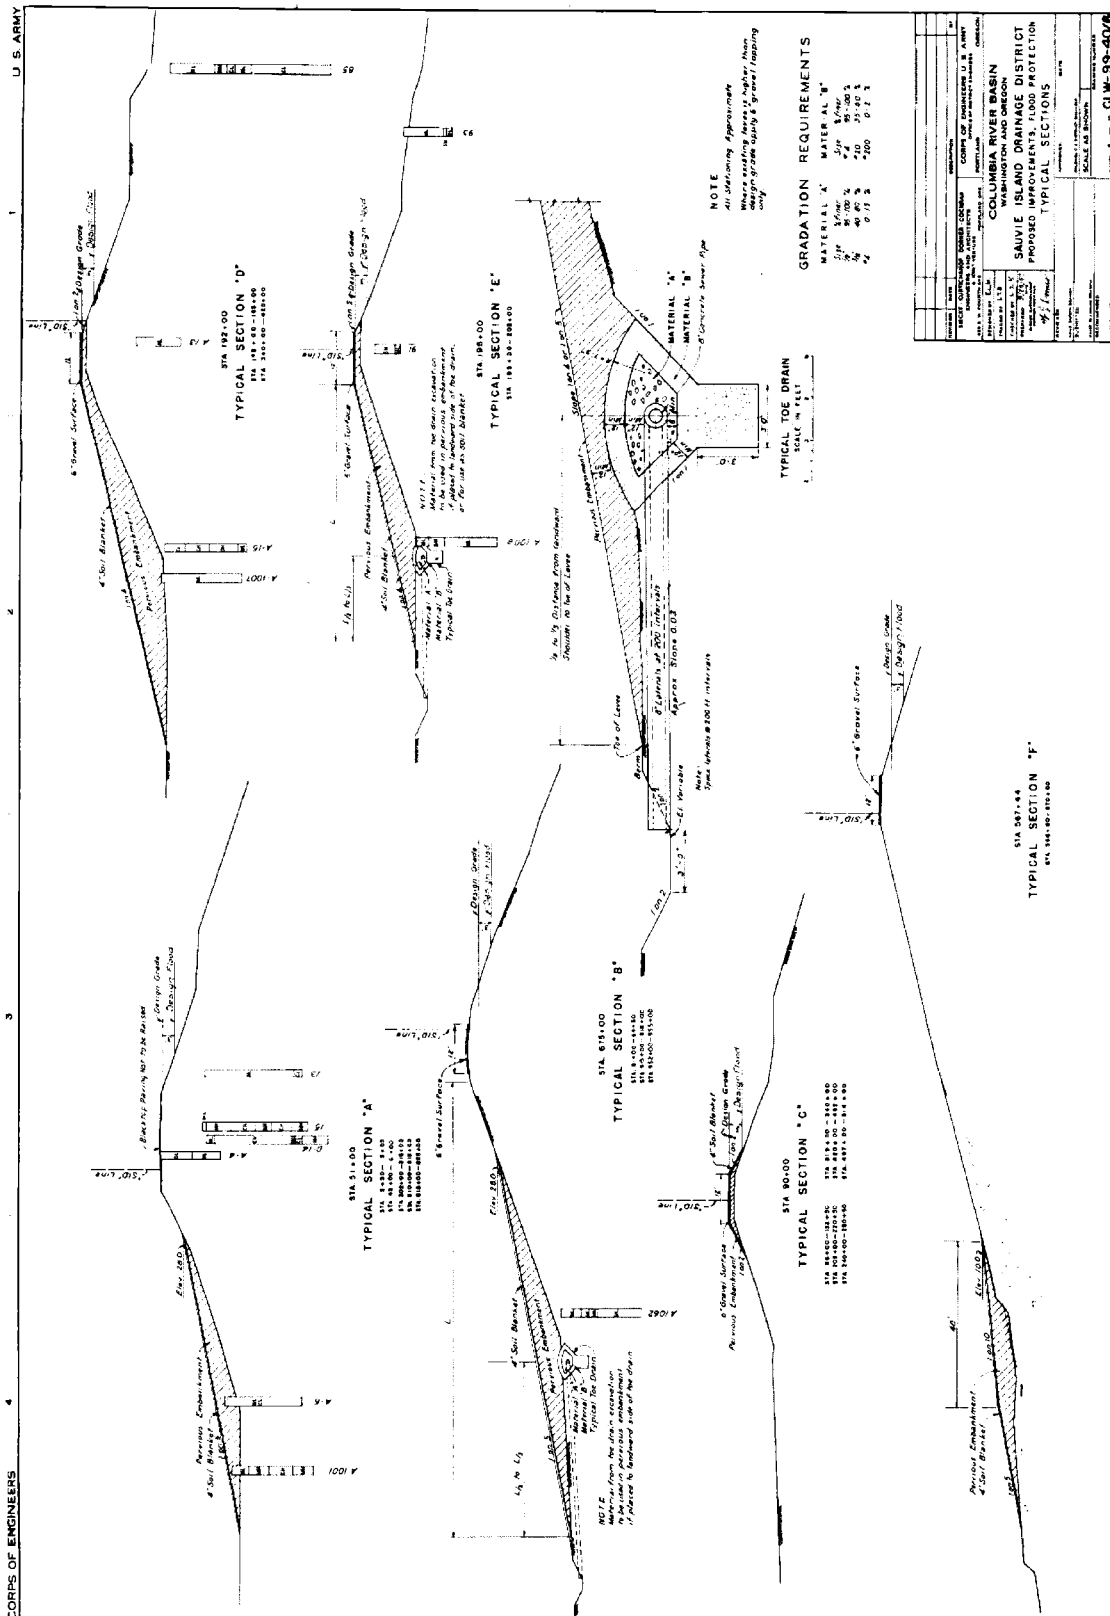
Figure 7 Selected levee improvements along "Big Dike" on Sauvie Island (US Army Corp of Engineers, 1960)

The second dike referred to as the “North Dike” was completed in the early 1940s, and contains approximately 1,600 acres. It was constructed in a similar fashion as the Big Dike using dredged material from adjacent waterway, as well as, sand from other locations. This 26 foot core of the dike was then covered with an additional foot of topsoil from adjacent land. Improvements have been done over the years to repair several breaches including: three breaches in 1996, two breaches in 1964, and one breach in 1946. Today the U.S. Army Corp of Engineers (ACOE) regularly monitors the integrity of the dike while the Oregon Department of Fish and Wildlife (ODFW) maintains

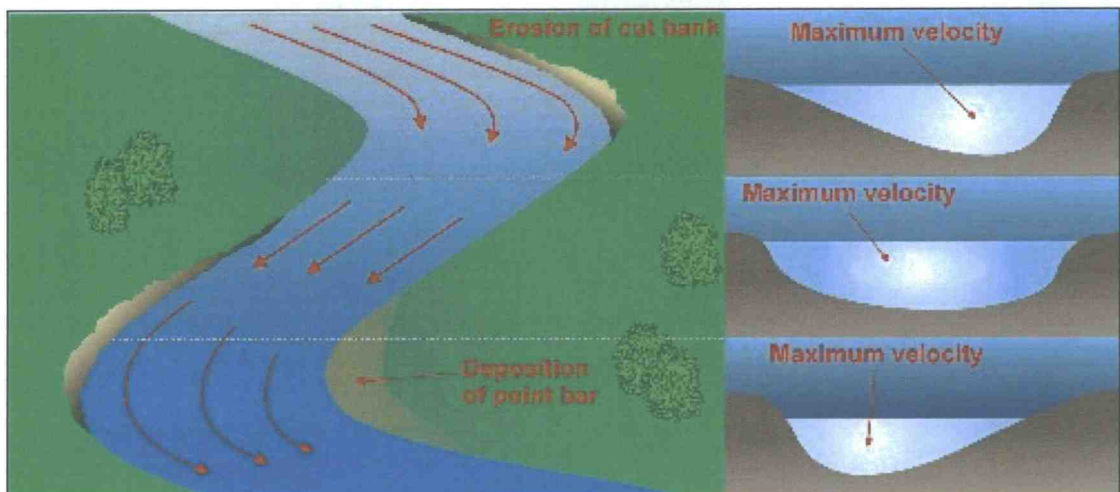
Figure 8 Maximum velocity of river flow and subsequent erosion on outside of the bend while deposition occurs along the interior (Idaho Department of Transportation, 2007)

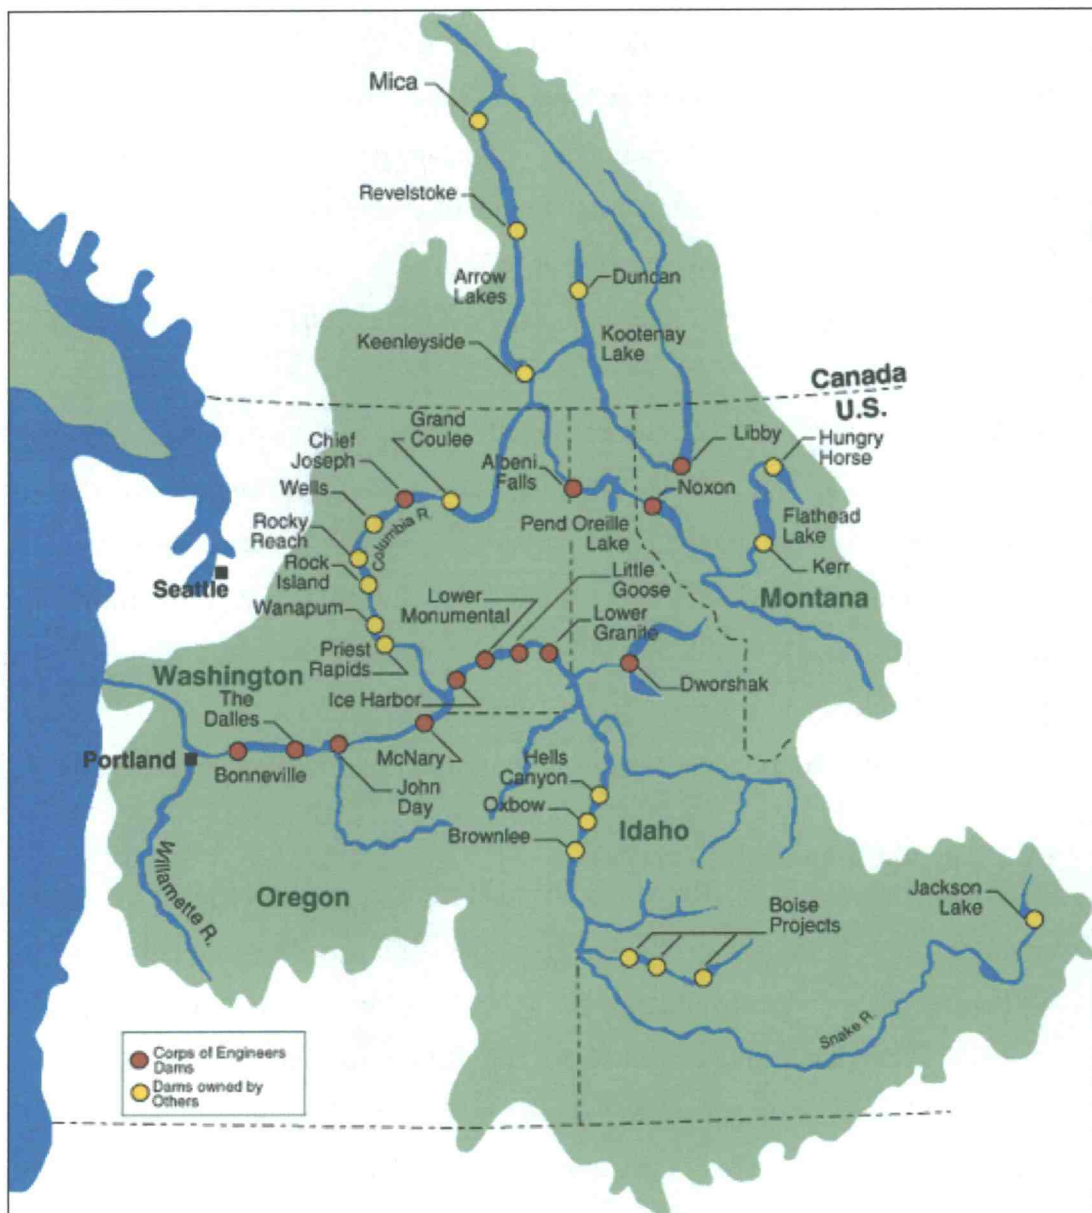
Figure 9 Private and federal dams located in Columbia River Watershed (BPA, 2001)

The mainstream of the Columbia River has 14 dams, 3 in Canada and 11 in the United States (Figure 9). Eight of the dams have lock to facilitate navigation. Most of these structures were built after the Food Control Act of 1936 was passed. These dams have dramatically altered the natural flow of the river, creating a series of stair steps, and slack waters reservoirs. Although the construction of these dams has provided many benefits to

Peak river flows and, sediment transport has been substantially reduced by the construction of dams on the main stem and tributaries of the Columbia River. Historically, during peak flows and flooding events the river would discharge 90 percent of its sediments, inundating floodplains with nutrient rich water while depositing sediment,

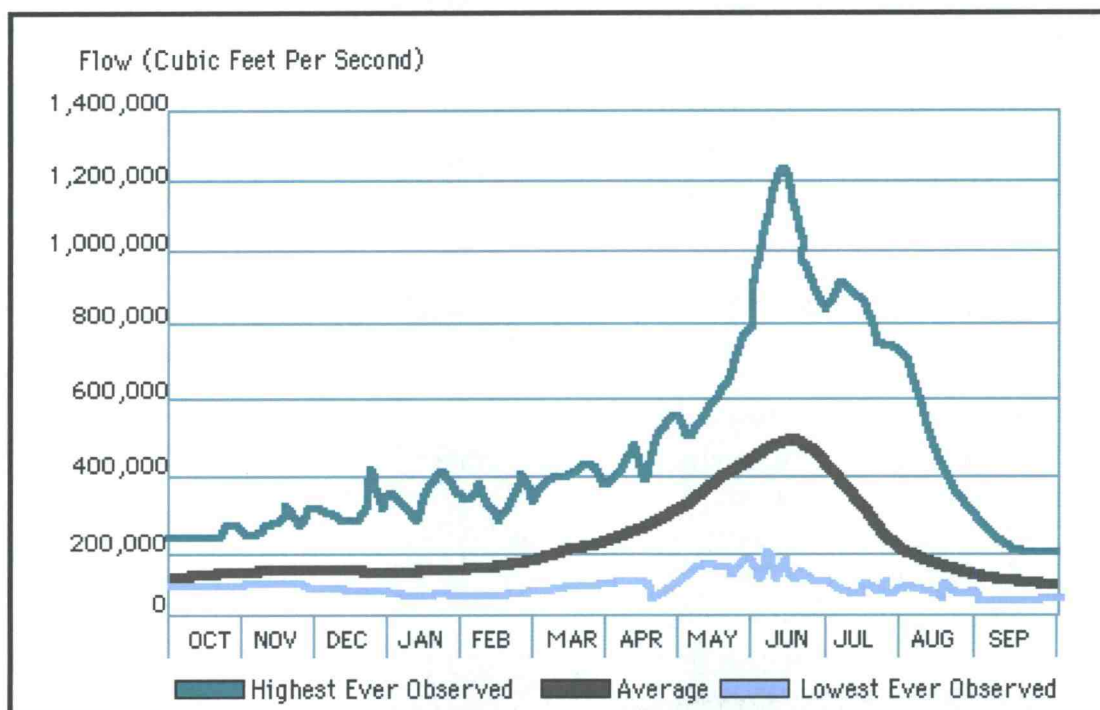
Figure 10 Columbia River streamflow October through September (BPA, 2001)

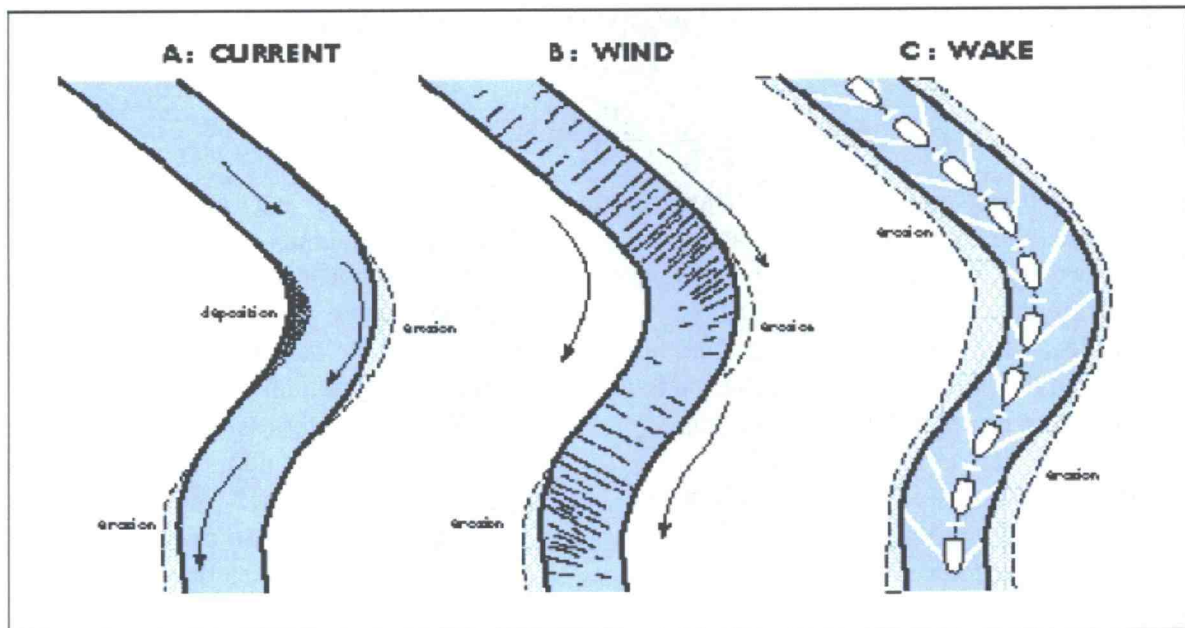
Figure 11 Erosion and deposition patterns dependent on type of erosive interaction; current, wind, and wake. (Department of Primary Industries, Water and Environment, Tasmania, 2007)

There are two types of waves generated from vessels; bow and stern wake. Bow wake is produced when water is pushed out of the way by the hull of the ship; while stern wake is produced by water filling up the space where the boat just left. The magnitude of ship wake is influenced by the type of boat (e.g., barge, tugboat, and powerboat), characteristics of the vessel (hull, bow shape, and ship draft), and the speed of the vessel (Asplund, 2000). These wave generating factors can also affect “drawdown” which is caused by ship propellers forcing large amounts of water from beneath the boat. On the shoreline the displacement of water from the vessel results in water being pulled away from the shore, resulting in offshore transport of sediment. Furthermore, the proximity of the vessel to the shoreline and characteristics of the bank (boundary conditions, soil type, and steepness), can effect their intensity and untimely the degree of shoreline impact (Figure 11).

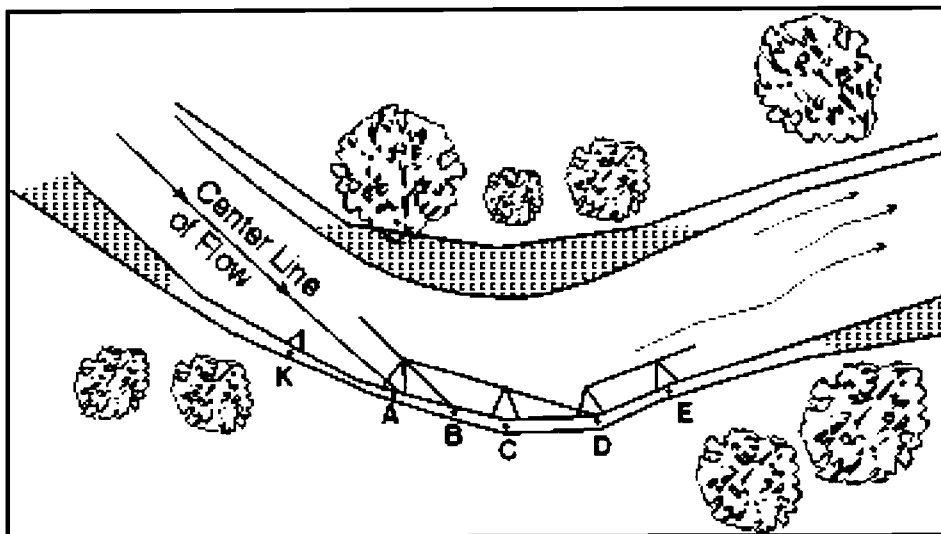
Figure 12 Deflectors can be used to control streambank erosion on the outside bends of meanders, however, this current can then impacting adjacent bank downstream (USDA, 1996)

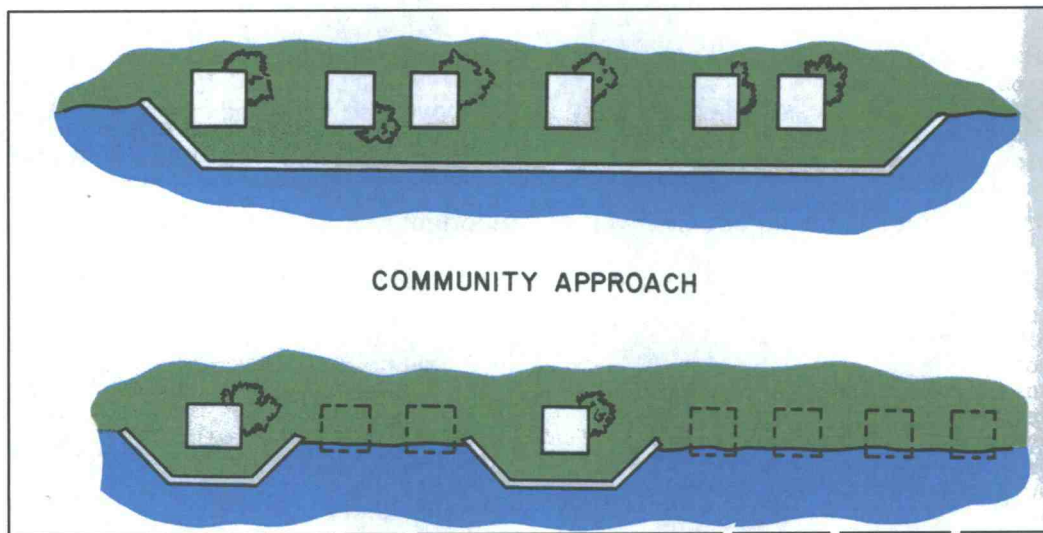
Figure 13 Accelerated bank erosion can occur downstream of revetment structures denoted by arrows (US Army Corp of Engineers, 1981)

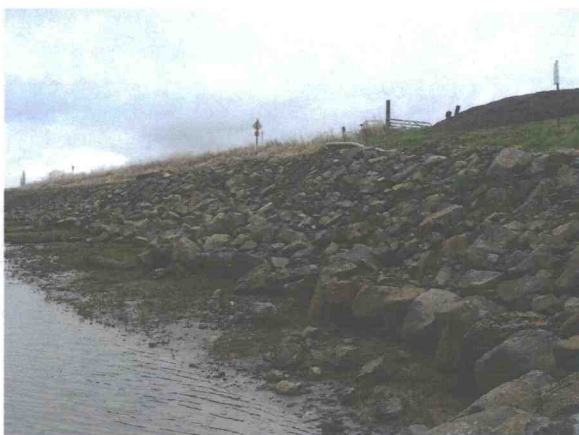
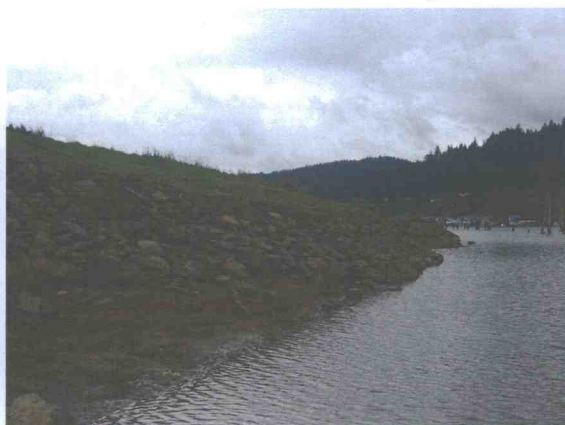
Post Rip-rap Sunken Village Site (Winter, 2007)

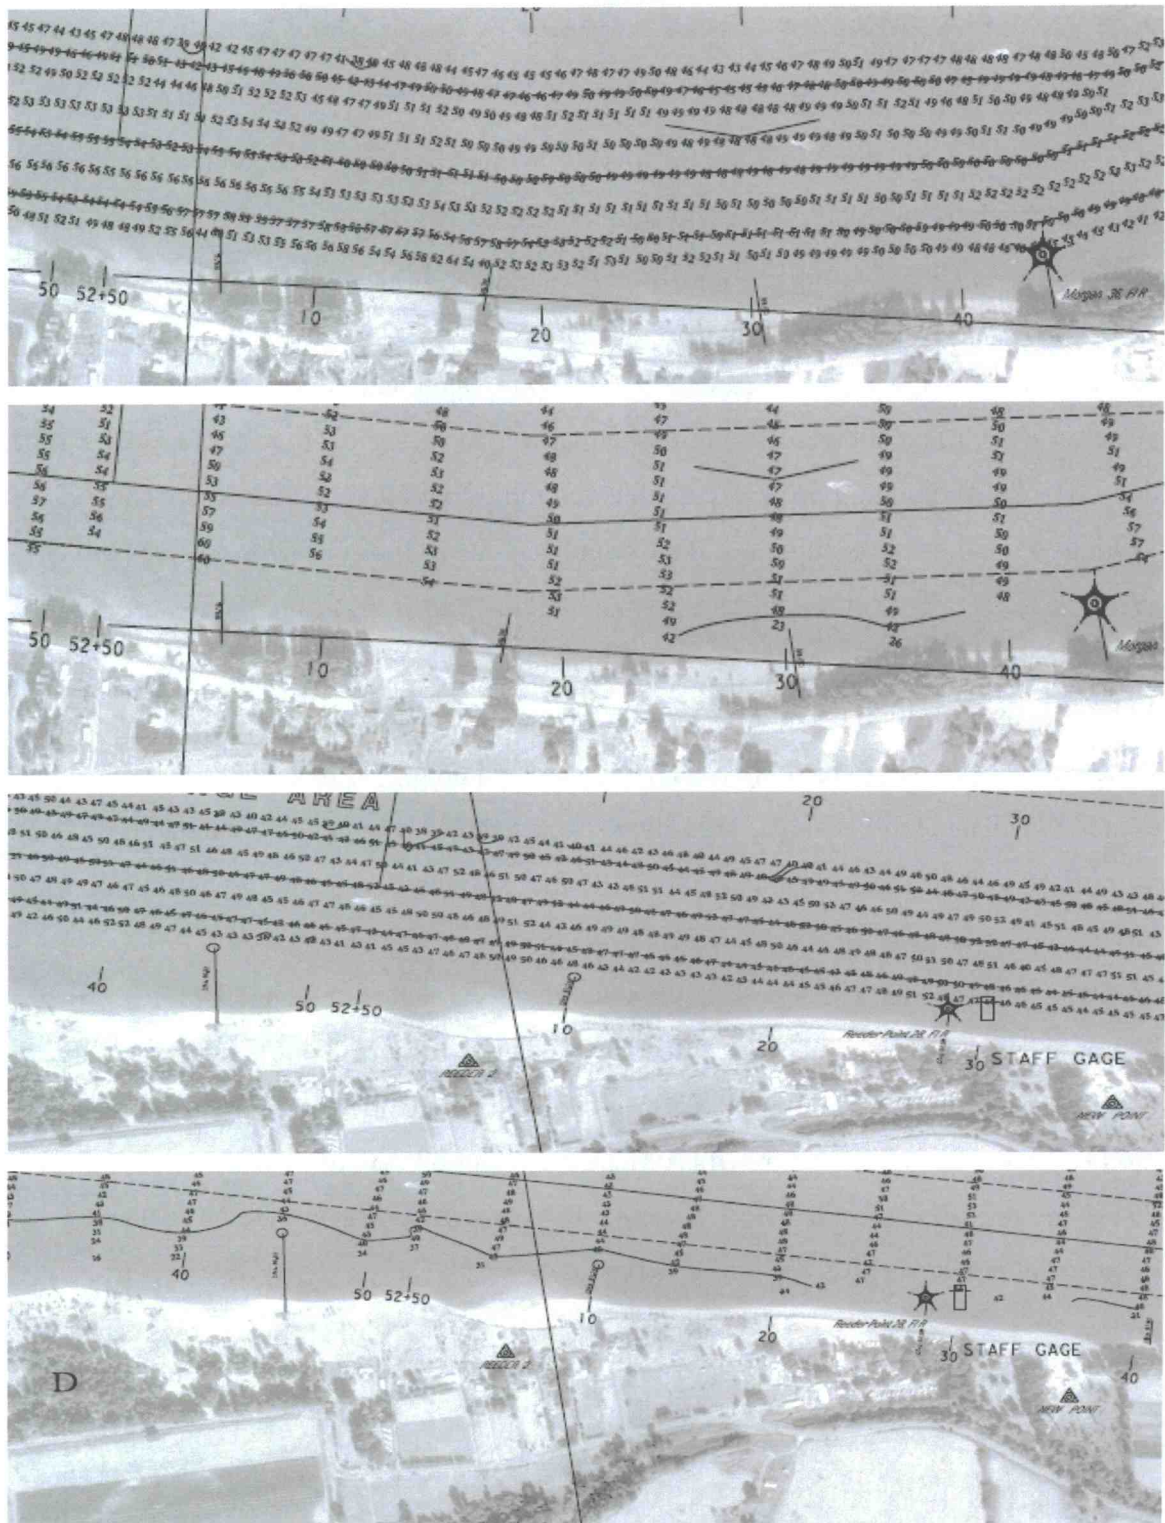
Figure 15 Cross lines and channel lines are used to determine dredging maintenance on the Columbia River. Here are two locations along Sauvie Island that have been surveyed
 A) Channel-line Morgan Bar B) Cross-lines Morgan Bar C) Channel-lines Willow Bar/ Reeder Beach D) Cross-lines Willow Bar/ Reeder Beach (US Army Corp of Engineers, 2007)

The Lower Columbia River navigation channel has been dredged to maintain a minimal depth to insure the safe navigation of ships (US Army Corp of Engineers, 1998). Dredging has been primarily done by the Army Corp of Engineers, which began in 1878, with a 20 foot deep channel along the lower 178 kilometer of the Columbia River. The navigation channel was increased to 25 feet deep in 1899, and then to 30 deep in 1918, to accommodate larger ships. In 1976 the channel was increased again to 600 ft wide x 40ft deep. The latest dredging project, completed in the fall of 2006, increased the channel depth to 43 feet from the mouth of the Columbia River to the confluence of the Willamette. This project used both a hopper and pipeline dredge to remove the eight million cubic tons of sediment to create the channel, and will require the removal of an additional three million cubic tons per year to maintain it (Hulse et al. 2002). The deep-draft channel can be dredged up to 5 feet deeper, and up to 100 feet wider than the authorized channel dimensions. This allows time for the sediment and bedload (waves of sand reaching 4 to 8 feet high and 300 to 400 feet long) to fill back in up to the authorized dimensions over the course of the next year (US Army Corp of Engineers, 1998). The dredging maintenance schedule is determined by cross section and channel lines which determine where the sediment has filled in the channel (Figure 15). The current dredge channel is approximately 230-700 feet from the Sauvie Island shoreline. Additionally, dredging has also occurred along the Willamette River portion of Sauvie Island; however, due to the presents of toxic materials at near by "Superfund site" no dredging has occurred along the Lower Willamette River in over 10 year.

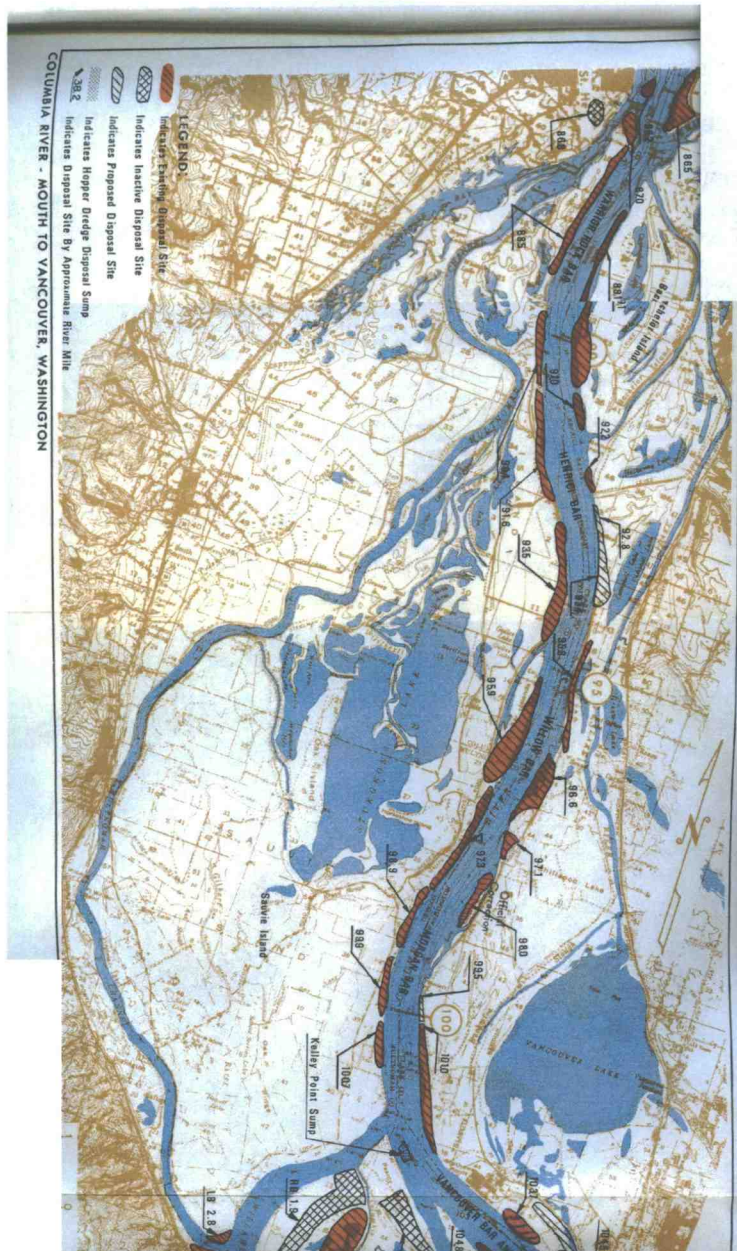
Figure 16 Beach renourishment sites along Columbia River in 1975 (US Army Corp of Engineers, 1975)

Dredging of the deep-draft shipping channel of the Columbia River has required disposal of massive quantities of sediment, resulting in creation of new islands, filling of many wetlands, and changes in historic shoreline sedimentation. Some of dredge sediment has been used for beach renourishment projects, including sections of Sauvie Island (Figure 16, Table 3). These projects added large amounts of sand to the shoreline, ranging from 10-15 feet high and up to 150 feet wide. This changed the bank compositions to a much larger grain size which ultimately may be contributing to accelerated erosion in these areas (US Army Corp of Engineers, 1975). However, with the increasing concern for shallow water salmon habitat dredge spoil operation along the Sauvie Island shoreline have ceased, the last beach re-nourishment project along limited section of the island occurring in 1986.

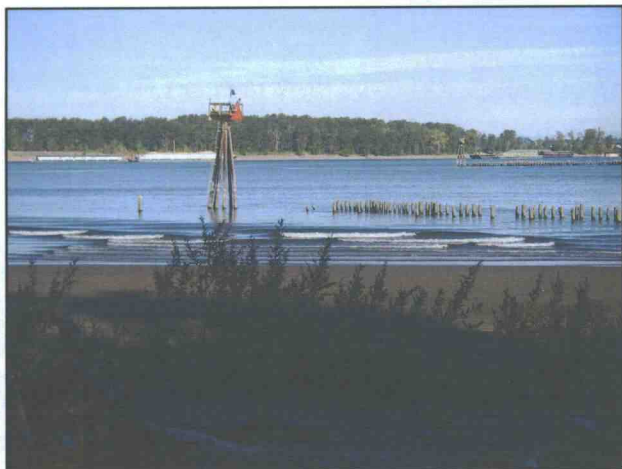
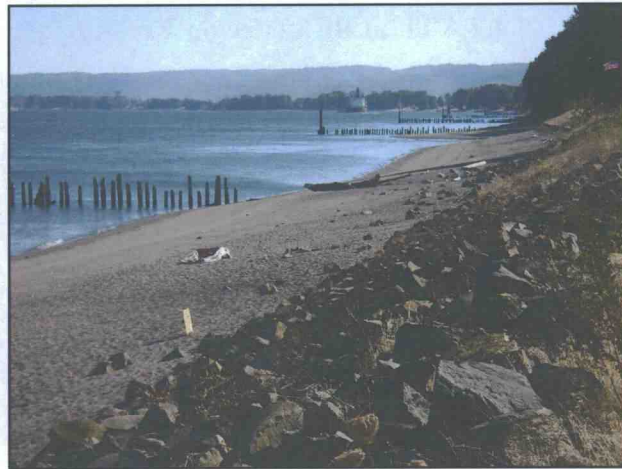
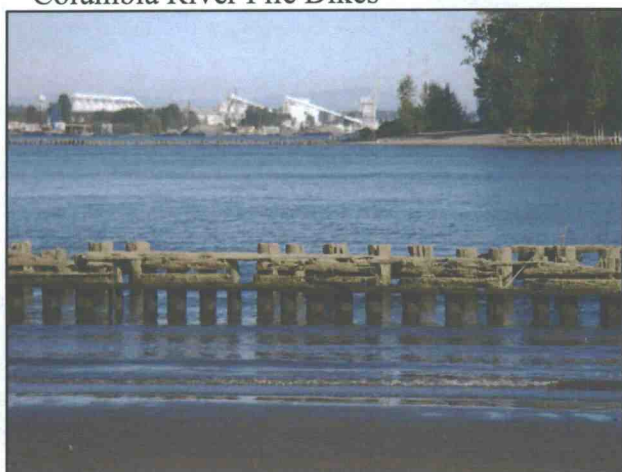
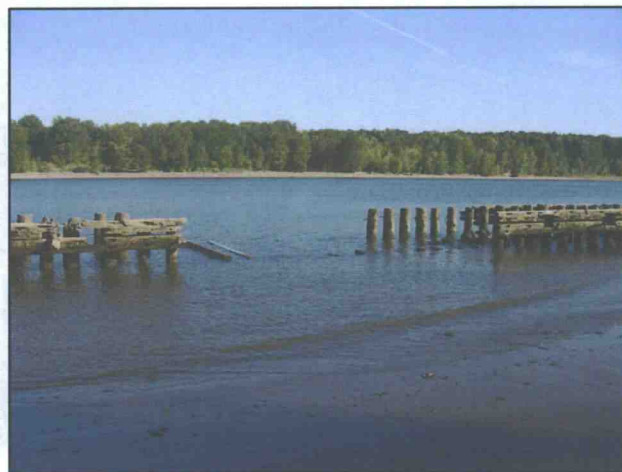
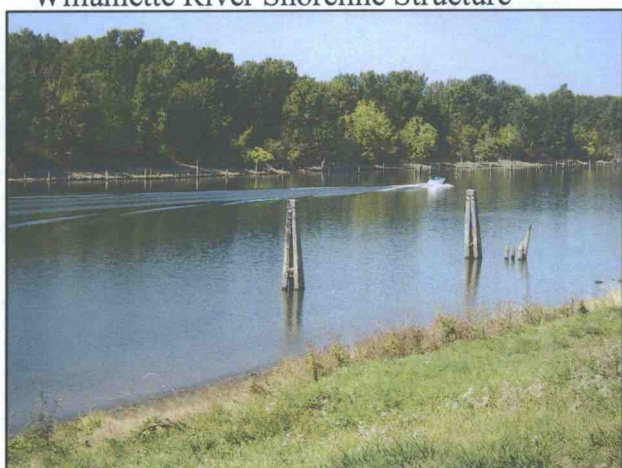
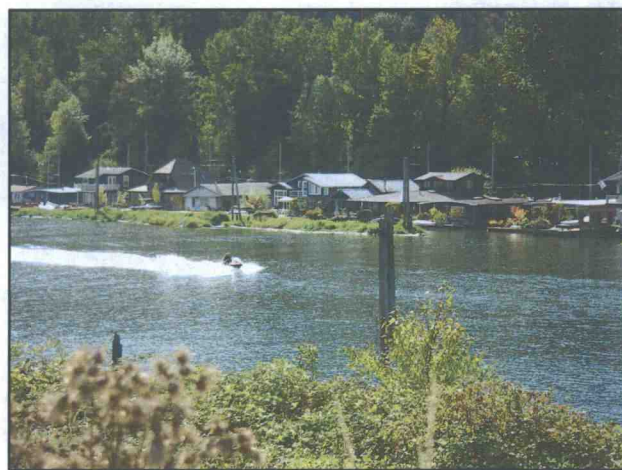
Columbia River Pile Dikes

Willamette River Shoreline Structure

Multnomah Channel Log rafts and Dolphins

Figure17 Shoreline Structures along waterways bordering Sauvie Island

In 1871 the Portland District of the ACOE set out on a multipurpose project to improve the navigation from the mouth of the Columbia River to the Willamette River, a distance of more than 100 miles. In addition to dredging, tree snag removal, and revetment work; man-made structures were built into the channel to improve the shipping lane. Wing dams (also known as pile dikes), extend only part way into the river, forcing water into a fast-moving channel. This reduces the rate of sediment accumulation in the channel, while allowing sand and sediment to collect near the bank where the water is moving more slowly (Wenji and Puqing, 2002). However, studies have found that while accumulation results upstream of the pile dike, downstream there can be sediment depletion (US Army Corp of Engineers, 1981). As of 1980 there were 198 pile dikes located along the Lower Columbia River, including several that still exist along Sauvie Island (Figure 17). Ten pile dikes were placed along the lower Willamette River at Sauvie Island between 1926 and 1931 (Hulse et al. 2002). Historically, these structures were used to maintain the channel depth as an alternative to additional dredging. However, this method is no longer used because predatory fish can use these structures as hiding spots to prey on salmonid fry.

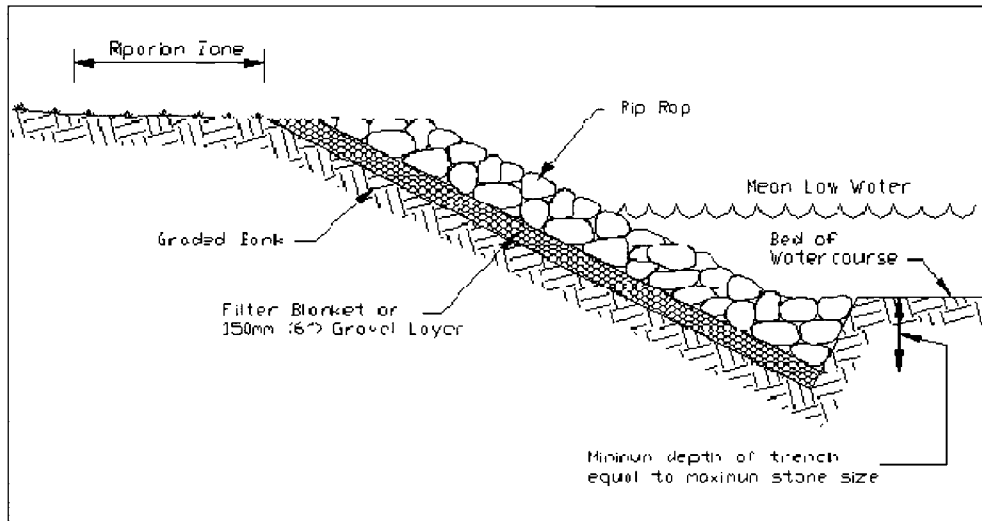
Figure 18 Typical cross section of rip-rap streambank protection
(The New Brunswick Department of Agriculture, 2007)

due to improper settling, and undersize stones displaced by large waves or currents. (US Army Corp of Engineers, 1998)

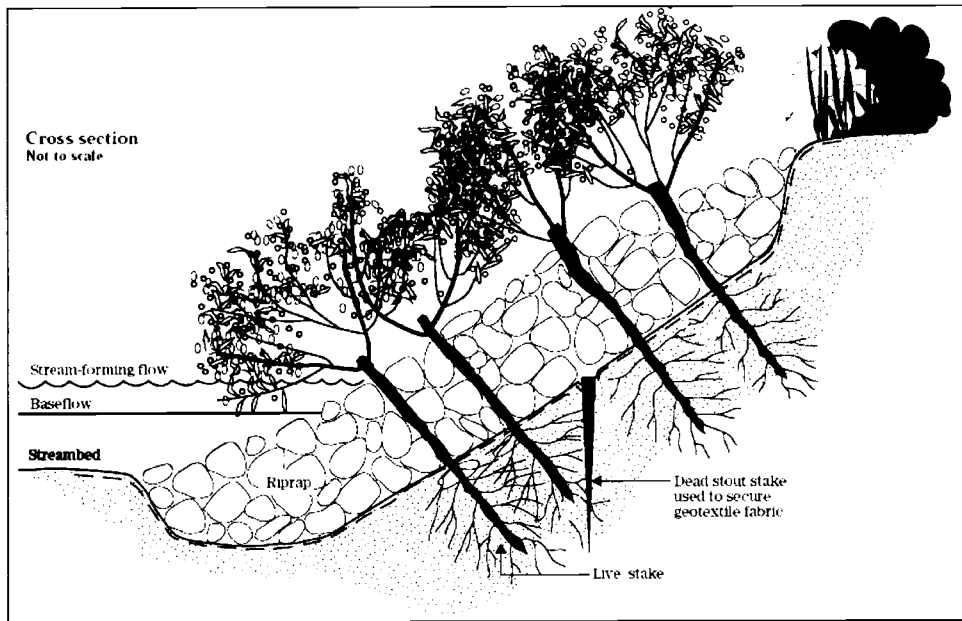
Figure 19 Cross section of rip-rap structure showing intermittent planting of vegetation (USDA, 1996)

When live stakes are used with riprap, the process is called a joint planting, and creates a living structure (Figure 19). The live stakes should be planted into the soil below the riprap (between the rocks) and below the filter layer (Sotir et al.1995). Joint planting can provide a considerable amount of shade and cover, trapping sediment, improve drainage (by removing moisture), and eventual binding and reinforce soils with root balls. To increase the success rate of plantings it is important to use vegetation (ASDA, 1996) that is 1.5 inches in diameter and sufficiently long enough to reach soil behind the rip-rap. Joint planting along this area may include: willows, red osier dogwood, cottonwoods and grasses can then be planted along the benches or on the slop of the rip-rap.

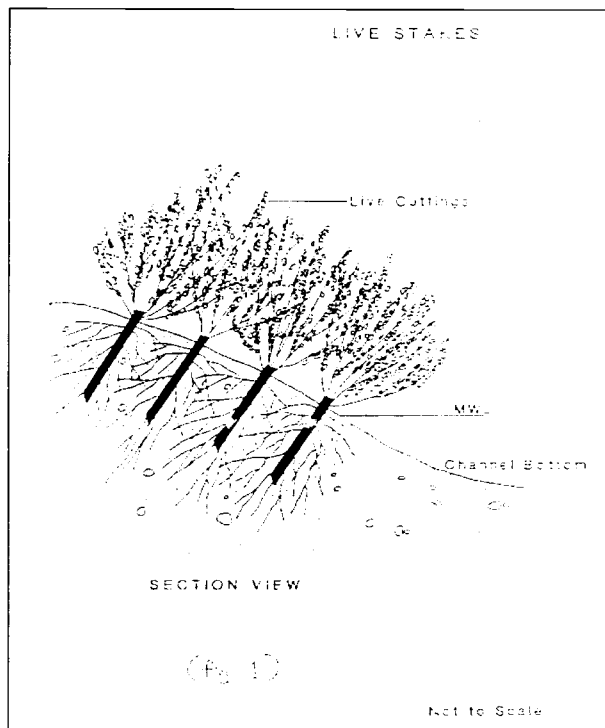
Figure 20 Live stakes: example of live bioengineering project (Oregon Department of State Lands, 2007)

Bioengineering is the processes of using living plants to control for erosion and for restoring riparian habitat. Willows and cottonwoods are widely used along stream bank because they grow easily from stem or root cuttings. Live staking (figure 20) consists of planting stem cut to between 2.0 -2.5 feet inserted into the stream bank at a right angle, allowing only 20% of the stake to be exposed. Other important elements of bioengineering include: grading/ or terracing the bank before planting, flow deflectors or bank armoring (Oregon Department of State Lands, 2007).

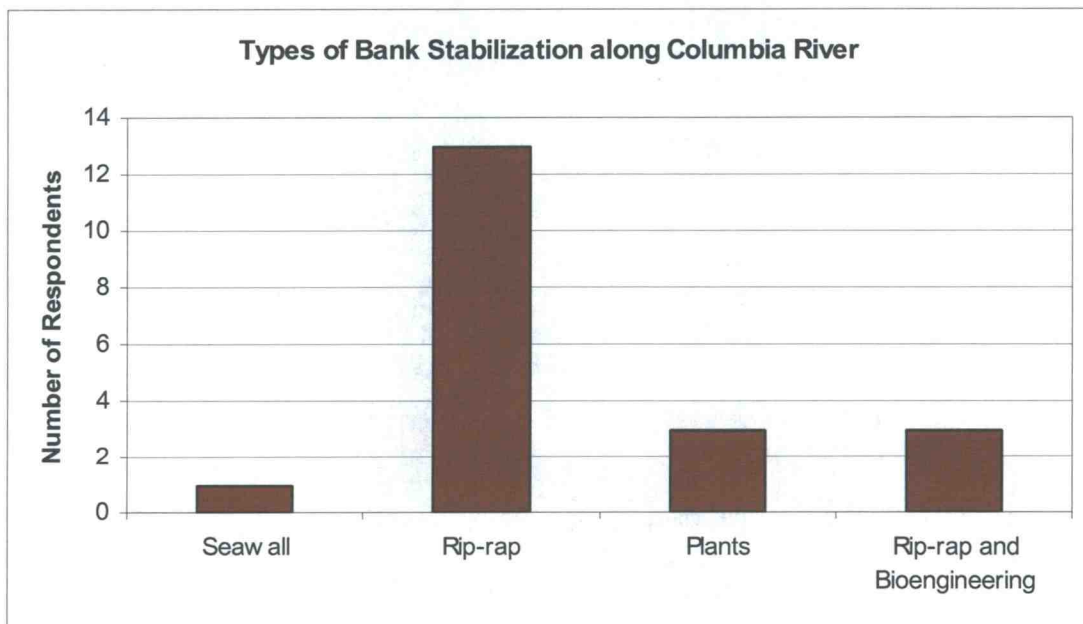
Figure 30 Types of protective structures installed along the Columbia River to prevent shoreline erosion, location of these revetment structures can be see in Figure 30

Although not examined in this survey, virtually all of the Willamette River shoreline of Sauvie Island is rip-rapped, most likely by the Corps of Engineers to prevent erosion adjacent to the deep-draft ship channel. Furthermore, one resident along the Multnomah Channel indicated that rip-rap was going to be installed in the fall of 2006, probably at the Sunken Village site.

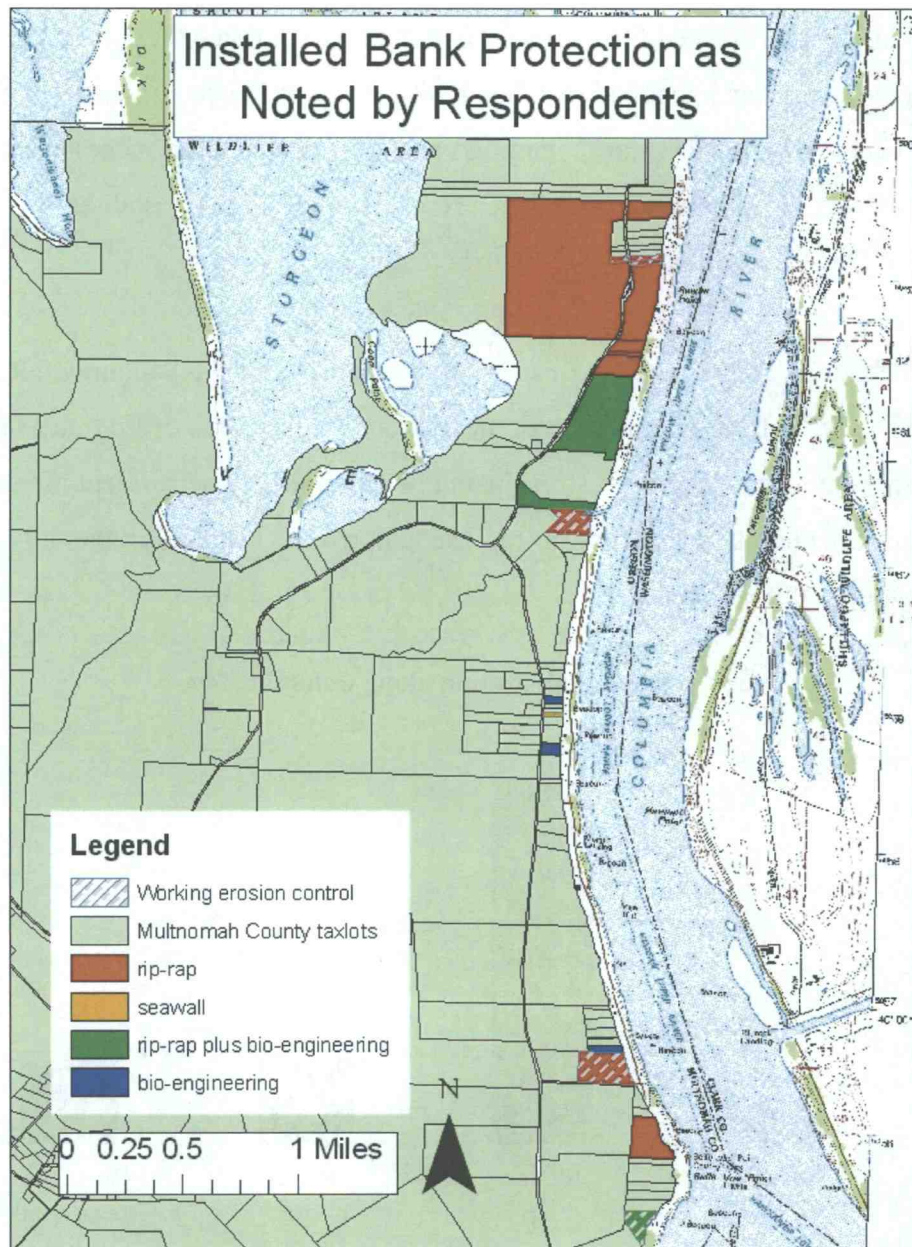
Figure 31 Installed bank protection and success rate along Columbia River as noted by respondents

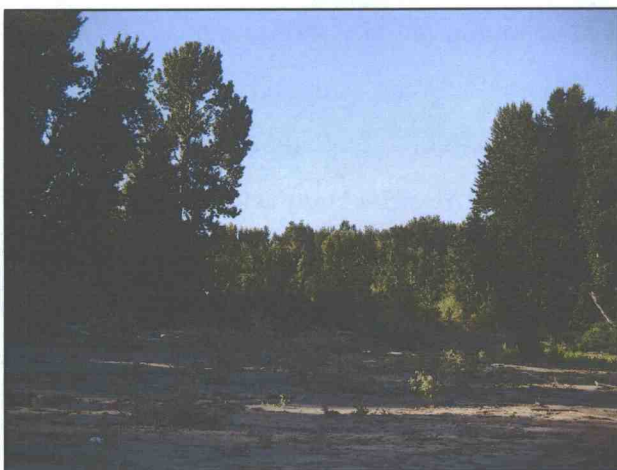
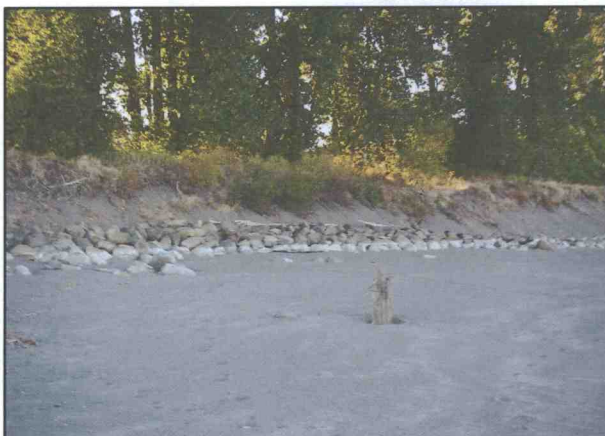
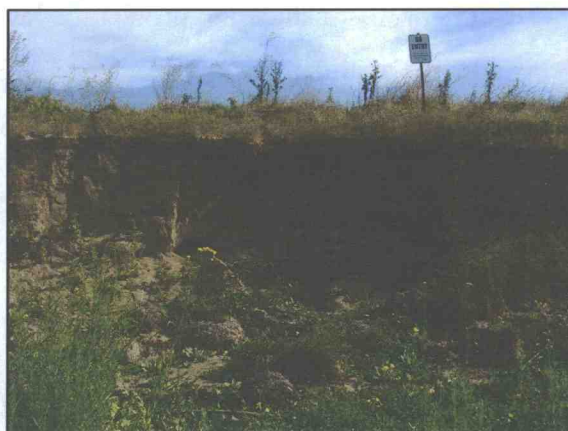
Figure 32 Site Visits to Reeder Beach, Farm House, the Confluence of the Willamette River and Columbia River, and Sunken Village

Confluence of the Willamette River and
Columbia River

Farm House

Sunken Village

Four sites where erosion was occurring were visited by the author at the invitation of property owners, three of which were along the Columbia River and one along the Multnomah Channel (Figure 32). At Reeder Beach, there was evidence of recent erosion; a rip-rap revetment had been installed in fall 2006. At Farm House, also on the Columbia River, circular backwash, probably due to ship wake, was carving out the bank. Upstream at the confluence of the Willamette and Columbia Rivers, extensive debris that has accumulated there is impacting the shoreline, particular during high water events, causing loss of vegetation and affecting the bank recovery process. Finally, along Multnomah Channel at the “Sunken Village” Native American village site, there was evidence that cultural artifact looting had damaged the shoreline. In the fall of 2006, a rip-rap revetment was installed to protect the levee and remaining artifacts. Site visits were conducted again at Reeder Beach and at Sunken village in the winter of 2007 to document revetment installation (Figure 33).

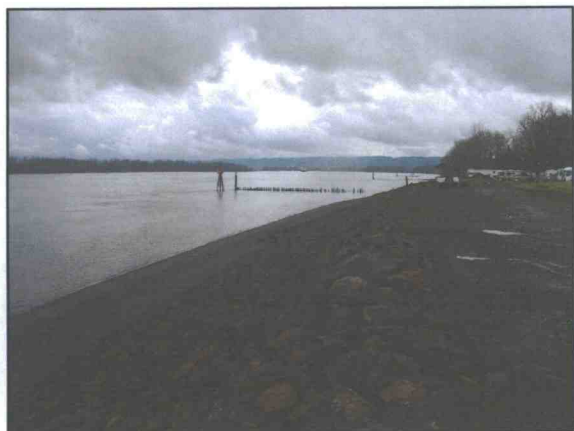
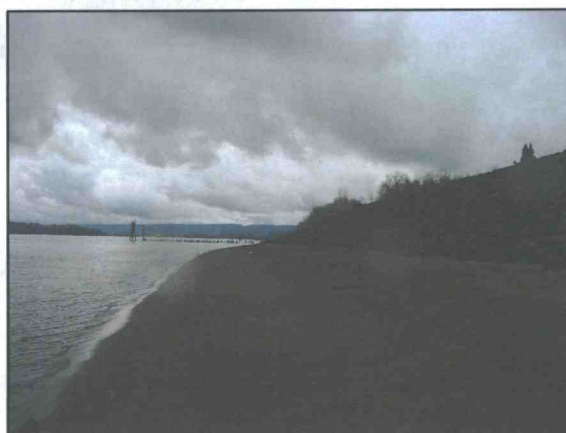
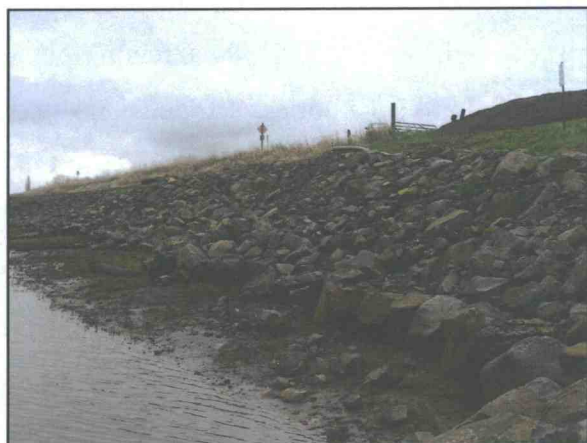
Reeder beach

Reeder Beach

Sunken Village

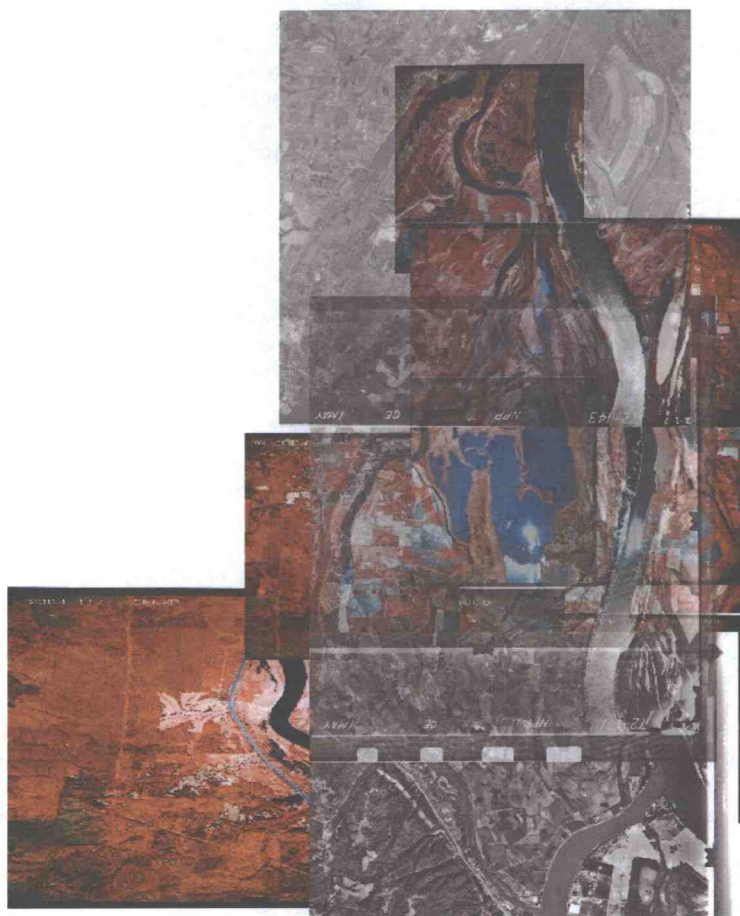
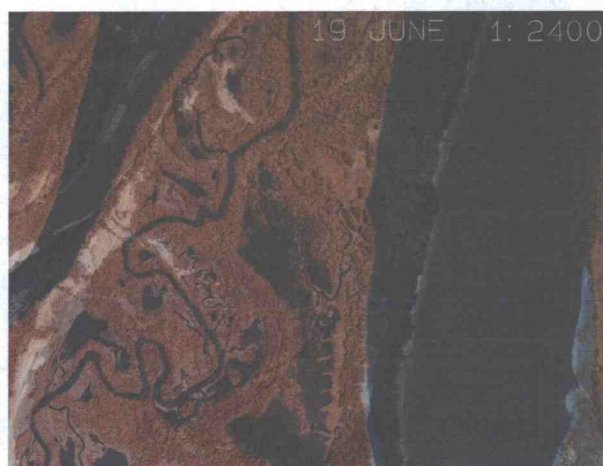
Figure 37 GIS Referenced Maps 1972 and 2004, map A shows larger overall view of georeferenced photos containing all of Sauvie Island, maps B and C are close-ups of map A highlighting demarcation between year classes

Georeferenced Sauvie Island Photos 1972 and 2004

Although the images provided in this section are the most current information available, there were still complications with generating the primary GIS map. First, when geo-referencing the 1972 Sauvie Island image to the 2005 orthophoto, complications with formatting resulted in irregularities in the positioning of the 1972 photos in relation to the 2005 orthophoto. This was likely caused by differences in camera angle, location, and elevation. To rectify this problem as many as 15 to 18 geo-referenced points were added to each map. However, the map remained approximately 1000 feet off-center in some cases (Figure 37). The main contributing factor to this problem was the disproportionate magnitude of reference points between the north and south sections of the island. The northern 12,000 acres is primarily composed of the Sauvie Island Wildlife Area, which had very few reliable geographic points to references, which were crucial in order to align photos. Second, shadowing from trees and shrubs, and the reflection of the sun off the river surface, made it difficult to distinguish a continuous shoreline in some areas. For these reason, only visual observation using the Arc GIS measuring tool were calculated.
