Shoreline Erosion on Sauvie Island, Oregon: Perceptions and Management Practices

**Season Long, MS Candidate
(Non-thesis)**

**Marine Resource Management Program
College of Oceanic and Atmospheric Science
Oregon State University
Corvallis Oregon, 97331**

Presented June 18th, 2007

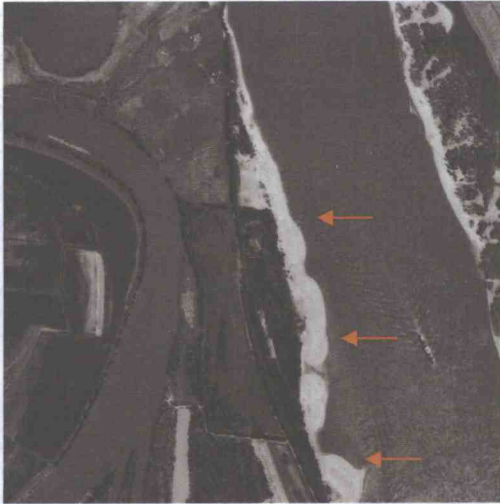
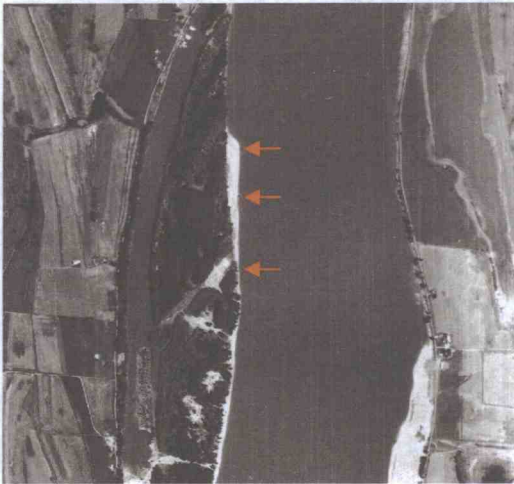
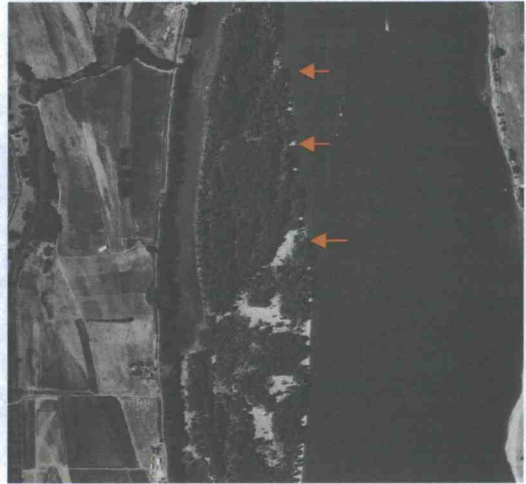
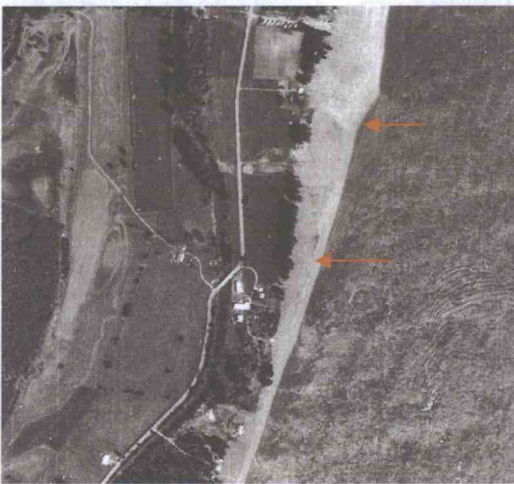
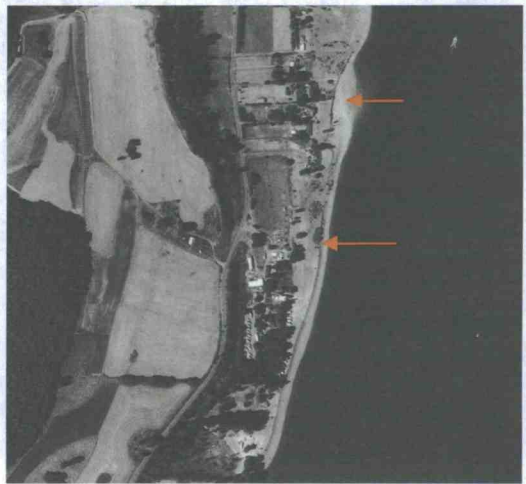
Figure 38 Aerial Photo Comparisons ODFW, Willow Bar and Reeder Beach from 1972, 2004 and 2005. Noted bank erosion indicated by arrows.

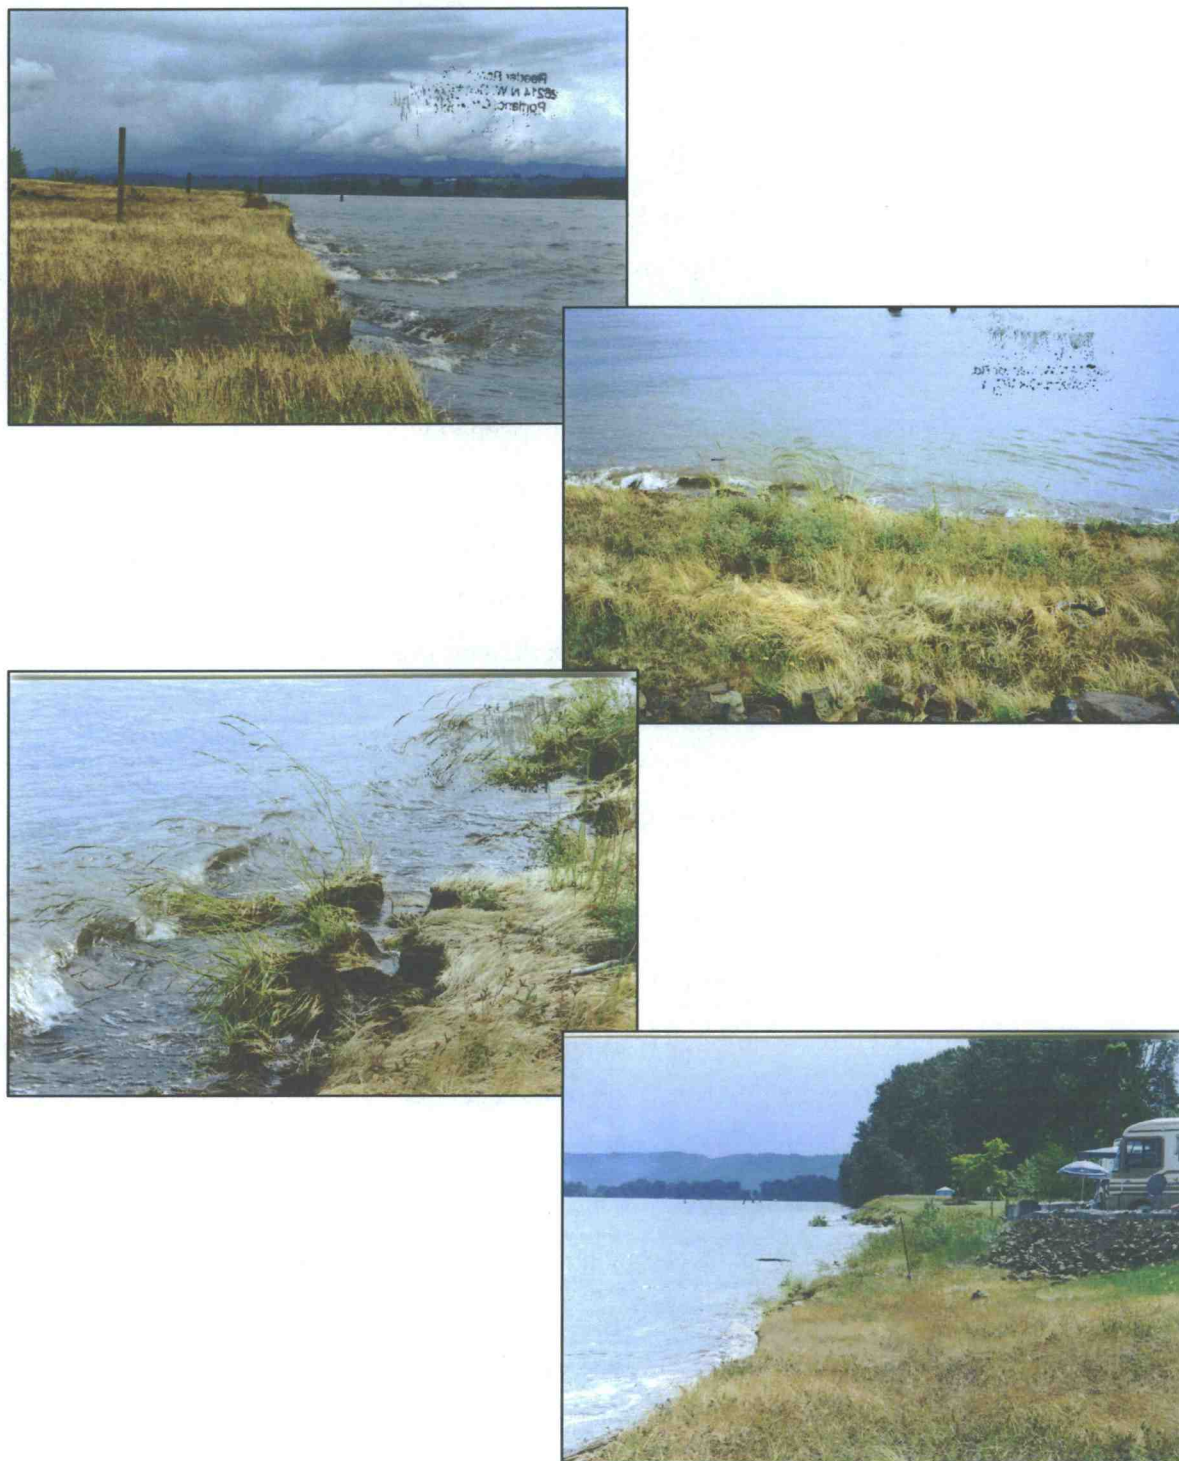
Figure 40 Reeder Beach 1997 Flood crest (20 feet at St. Helens in 1997, and 23.5 feet in 1996 (Portland 23.5 and 28.6) (Water and Climate Center Home Page, 2007)

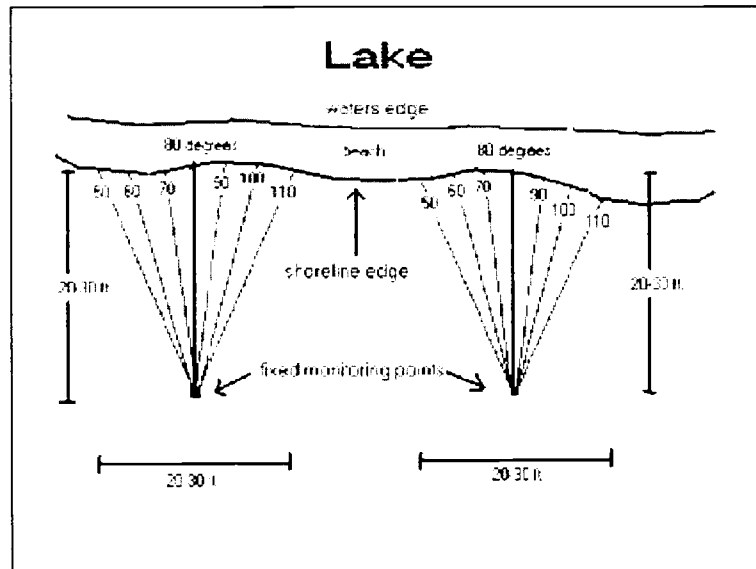
Diagram #2 illustrating height measurements
