## Little North Santiam Mining District

## Cultural Resource Inventory Report

March 1985

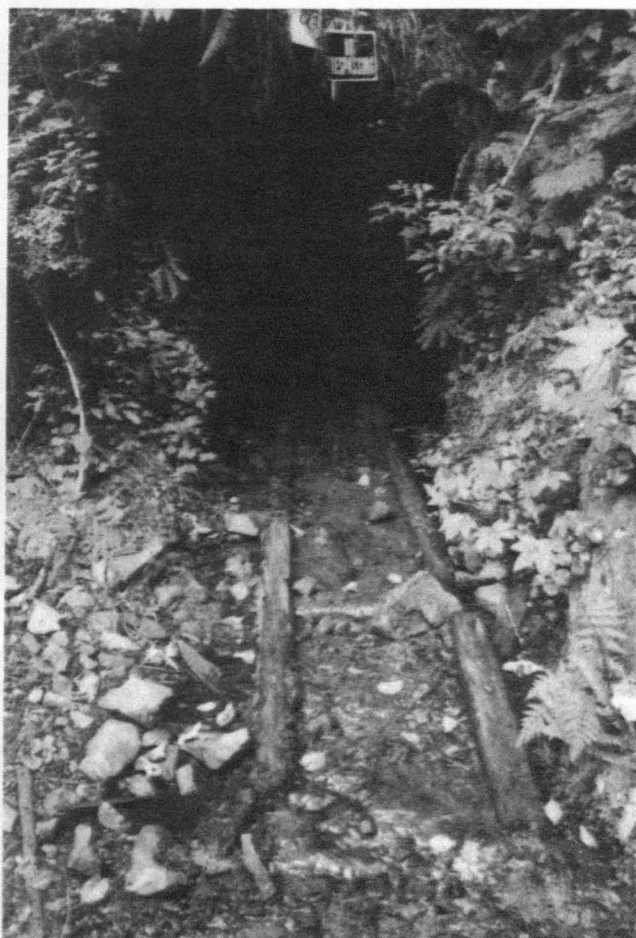
Crown Mine portal showing wooden rails

The main adit was located and found to be open and in good condition although a small creek was flowing from the portal. A pair of wooden rails was visible running into the adit. Metal strips measuring 1 inch x  $\frac{1}{4}$  inch x 4 feet were originally nailed to the rails.

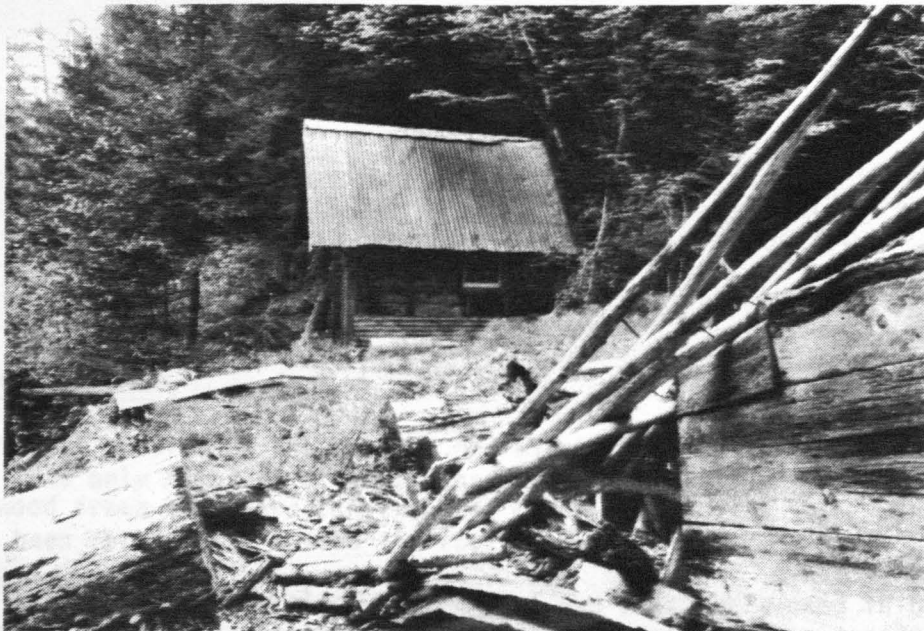
Small cabin at the entrance to Gold Creek M and M tunnel.  
Collapsed pole building is in right foreground.

The track originally ran between two buildings. To the west is an 8- x 12-foot frame construction shack resting on a log foundation. To the east is a collapsed structure. This was also frame construction, using poles for framing, sawn boards for siding, and a corrugated metal roof.

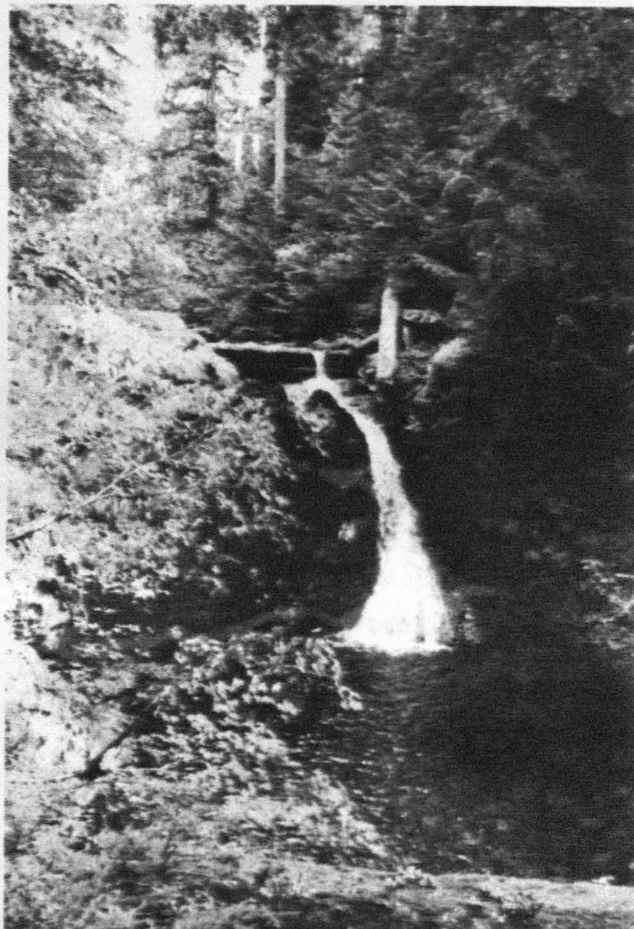
Log dam and falls on Gold Creek above the Gold Creek M and M tunnel.

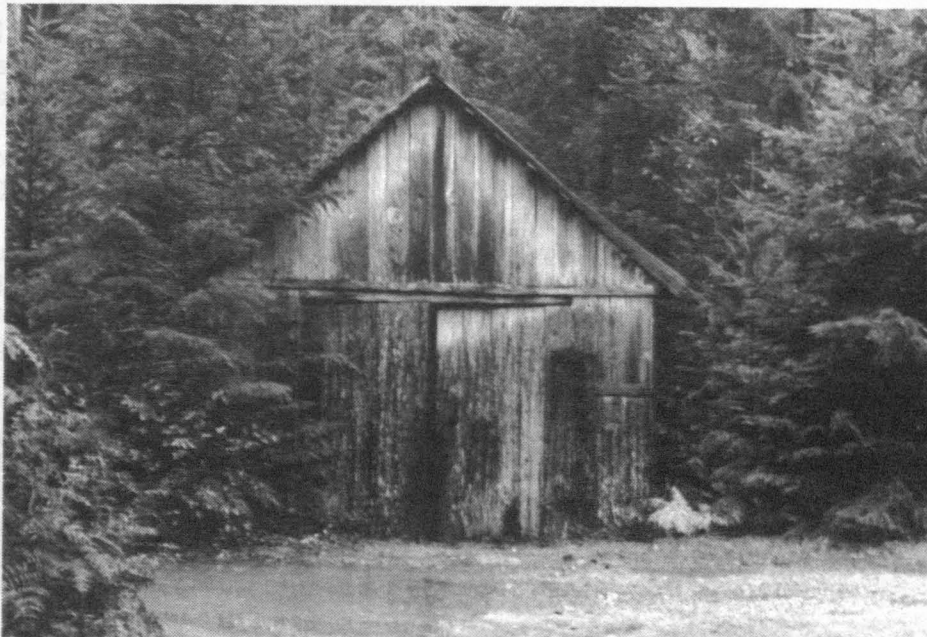
Shed at the Merten Sawmill

The structural portion of the sawmill now exists as two piles of boards and timbers. The only standing structure appears to be a storage shed or garage. This is wood frame and board construction measuring 15 x 18 feet. The original roof has been replaced by rolled tin roofing.

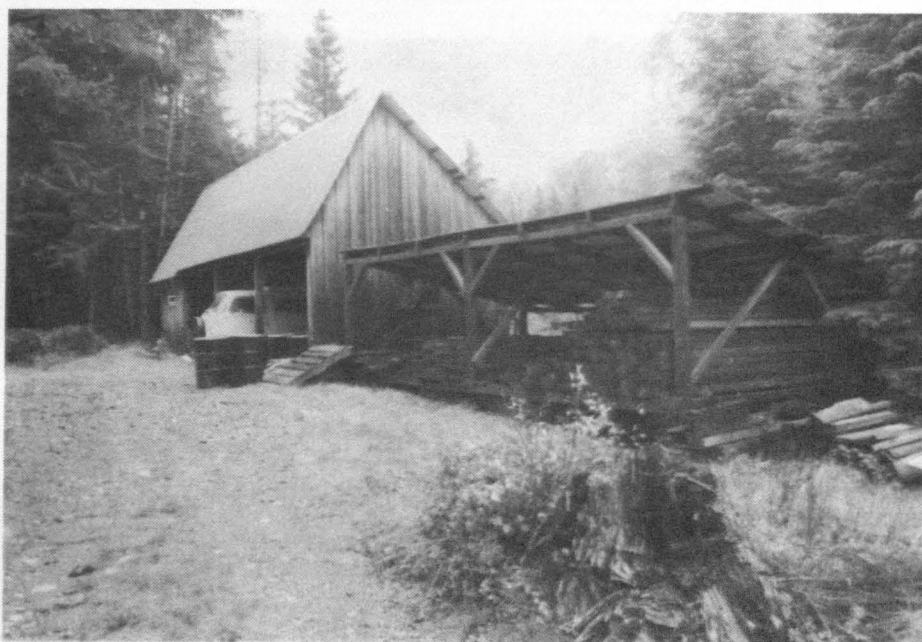
Recent lumber and equipment sheds behind the new "big house."

Other newer structures include a pelton shed and an equipment shed near the cookhouse and a garage and lumber shed between the new lodge and the river. These buildings and the lodge are all of frame construction and use rough sawn board and bat siding reflective of the style of the earlier buildings.

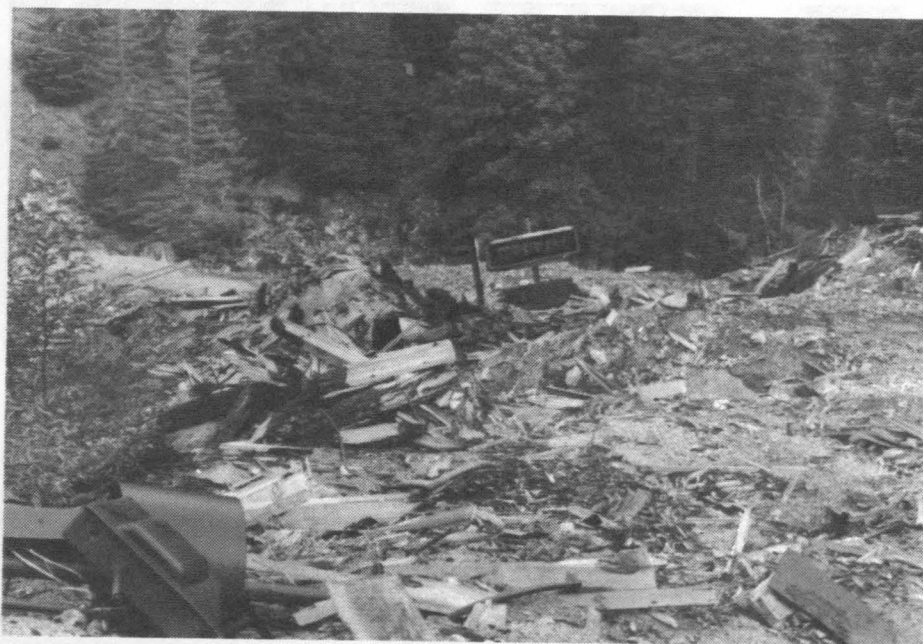
Remains of water Amalgamated ore mill site.

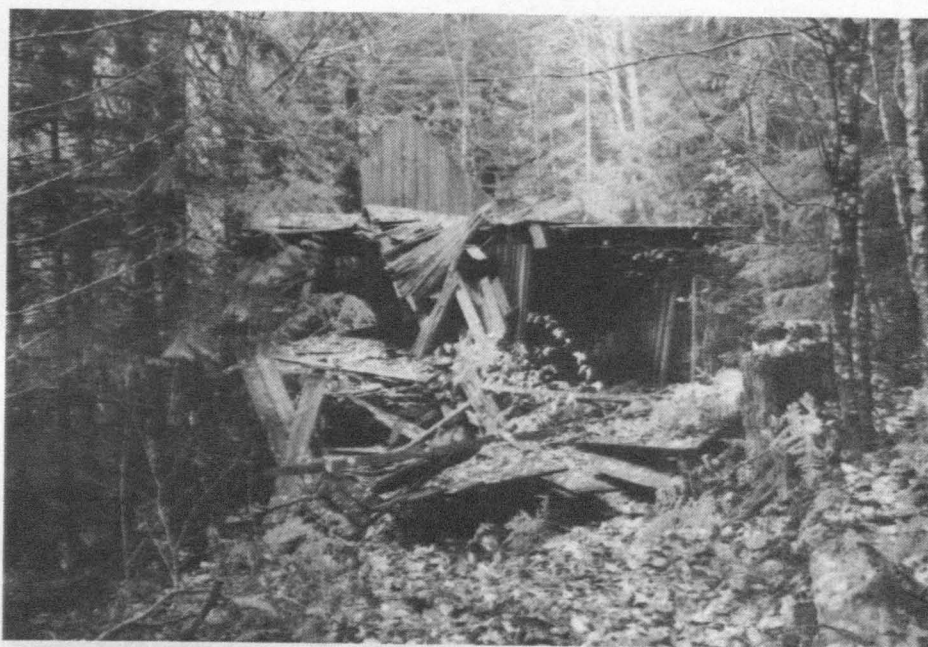
Remains of structure east of Amalgamated ore mill site.

The remains of a multi-roomed, frame construction building stand just east of the Amalgamated mill site. This building appears to be included on the 1934 map. It had a shake covered gabled roof, now collapsed. The siding was the same rough sawn board and bat exhibited on the other structures at this site. The south and west walls have collapsed.

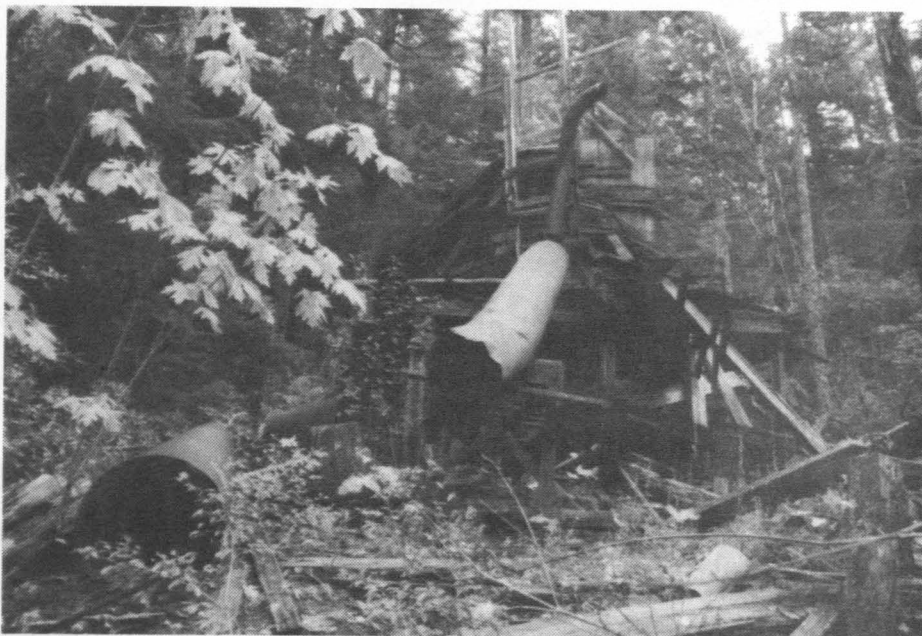
Remains of water tank above the Amalgamated ore mill.

The water tank, which was circular and about 15 feet in diameter, is in poor condition. Part of the sides still stand, but only because it had been lined with plywood sometime in the past.

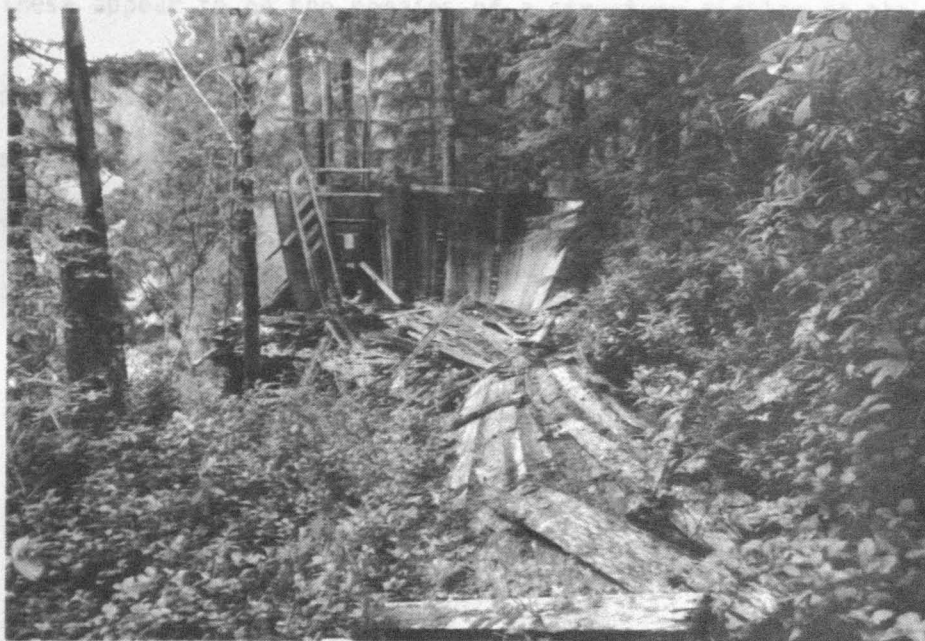
Remains of water tank with collapsed flume in right foreground.

The flume line identified on the map was found to be collapsed. It was constructed of rough sawn lumber supported by rough sawn timbers. It ran for about  $\frac{1}{2}$  mile from a log dam on Flume Creek, a tributary of Opal Creek, to a water tank above the Amalgamated ore mill. From the water tank it dropped through an 18-inch steel penstock to the mill. The log dam was 8 feet high and 30 feet long. Rock and silt have filled in behind the dam, and the creek runs through an eroded channel under the south end.
