A Dual-Objective-Based Tornado Design Philosophy¹

John W. van de Lindt², M. ASCE, Shiling Pei³, M. ASCE, Thang Dao⁴, A.M. ASCE, Andrew Graettinger⁵, M. ASCE, David O. Prevatt⁶, M. ASCE, Rakesh Gupta⁷, M. ASCE, and William Coulbourne⁸, M. ASCE

¹ Submitted to the *ASCE Journal of Structural Engineering*, September 2011; Revised version submitted, January 2012.

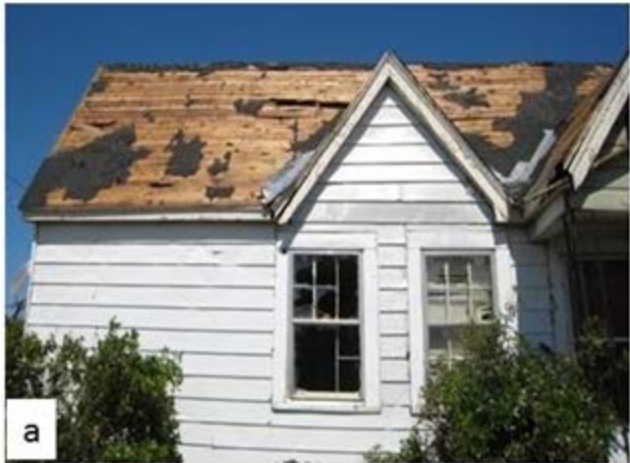
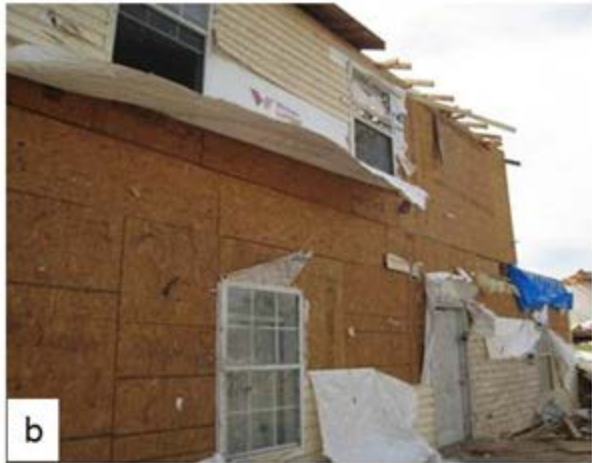
197 DOD2: Loss of roof covering: Loss of roof covering may be due to aging of roofing
198 material or improper fastener schedule. With high wind-rated roof shingles and correct
199 installation details, damage shown in Figure 6a could be reduced or eliminated. The
200 potential difficulty of implementing this component level change is low.

201 DOD2: Loss of vinyl/metal siding: Siding materials are often torn off by strong wind due
202 to geometry and improper installation details. An example of observed siding damage is
203 shown in Figure 6b. The space between the siding and sheathing behind it often makes

Figure 6: Examples of observed Level 2 Degree of Damage (a) loss of shingles, (b) loss of siding.

204 siding one of the first components to be damaged in strong wind, particularly siding on
205 roof gables. Hurricane rated siding installed with fastener penetration into studs and
206 sheathing material, can significantly increase the capacity of siding. The potential
207 difficulty of implementing this component level change is medium.

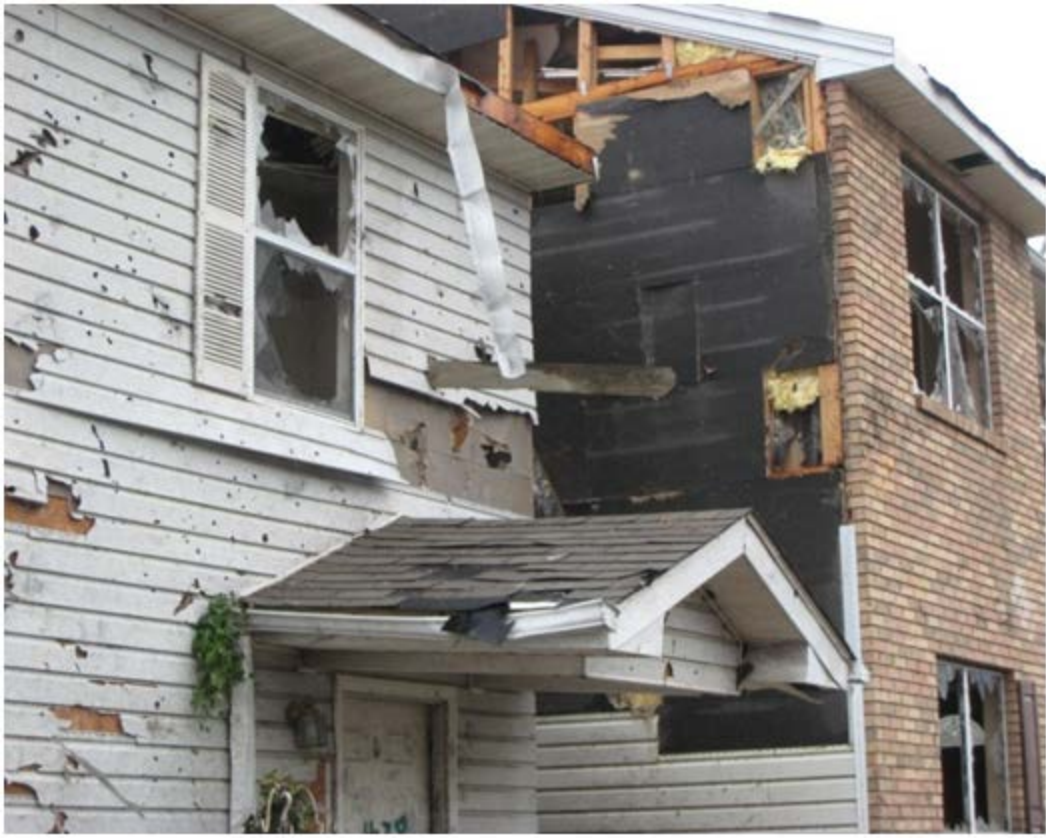
208 DOD3: Broken glass in doors and windows: The damage to door glass and windows,
209 examples of which are shown in Figure 7, is difficult to design against due to the high
210 debris content within a tornado. There is no economical way to strengthen the glass
211 components of a building envelope to prevent missile intrusion, however, the use of
212 storm shutters may reduce windborne debris penetration for lower wind speeds, but likely
213 not for wind speeds in excess of 140 mph. The potential difficulty of implementing this
214 component level change is high.

Figure 7: Example of observed Level 3 Degree of Damage, broken windows.

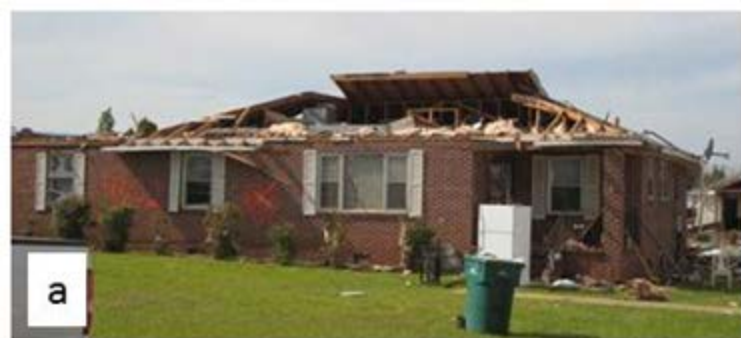
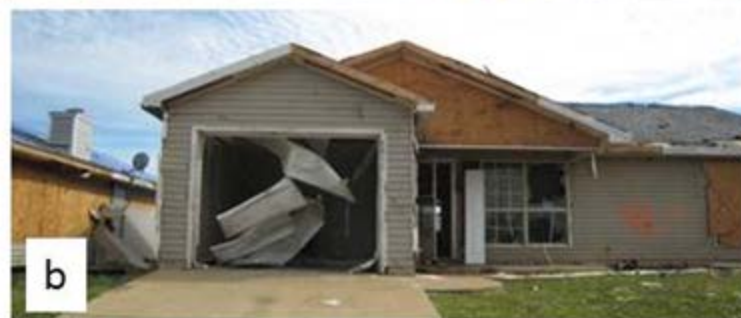
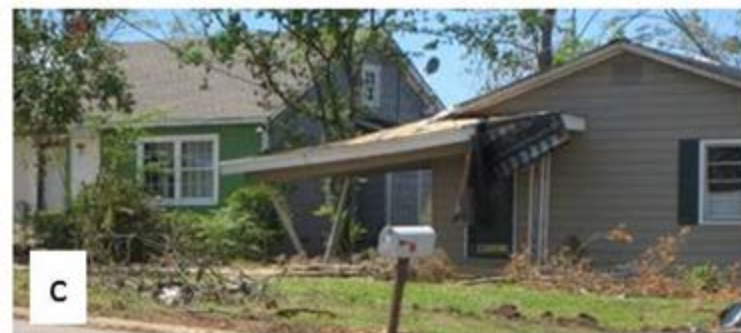
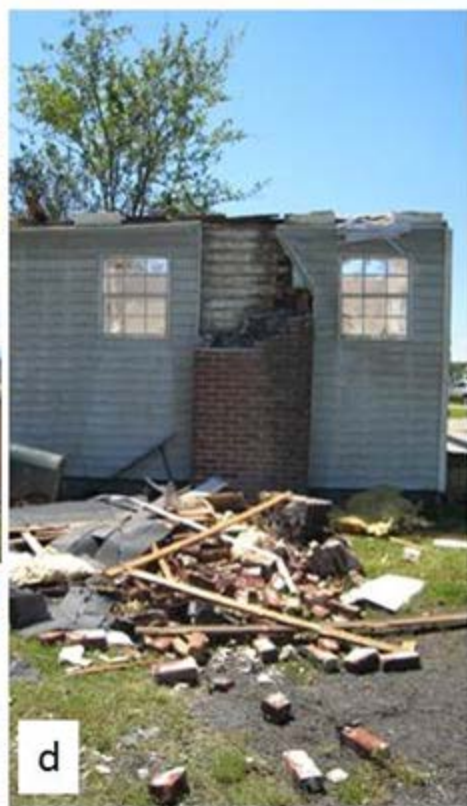
215 DOD4: Uplift of roof deck and loss of significant roof covering material: Roof coverings
216 are typically not designed for significant internal pressure. High internal building
217 pressure is common in high wind due to breaches in a windward wall as a result of
218 window breakage, and the same phenomenon is assumed to occur in a tornado.
219 Significant roof damage can occur as shown in Figure 8a. Specifying a design limit state
220 in which internal pressure is considered, and ensuring a continuous vertical load path, are
221 mitigation strategies. The potential difficulty of implementing this component/system
222 level change is medium.

223 DOD4: Garage door blown inward: Garage doors are a very commonly observed weak
224 link in residential building envelopes, as shown in Figure 8b. Once a garage door fails,
225 further breaching of the main portion of the house can occur because attached garages are
226 often frame back into the main house. With proper detail in bracing design and use of

229 DOD4: Failure of porch or carport: A porch or carport is often an under designed
230 extension of the roof system that creates a weak link at the interface with the main
231 structure, i.e. where the porch or carport frames back into the main roof system. Poles
232 supporting porches and carports are often inadequately connected to the foundation
233 allowing for uplift and failure as seen in Figure 8c. Once these weak interfaces are
234 designed properly, extended roofs for porches and carports will withstand wind speeds
235 beyond 90 mph, perhaps even as high as 140 to 150 mph. The potential difficulty of
236 implementing this component level change is low.

237 DOD4: Collapse of chimney: With proper lateral load design, the performance of
238 chimneys in tornadoes can be significantly improved. Brick chimneys in old construction
239 are typically stacked bricks or unreinforced masonry and are susceptible to collapse in
240 tornado force winds as shown in Figure 8d. Designing for lateral loads on chimneys can
241 be addressed relatively easily in new construction. Making chimneys part of a strong
242 “core” for an entire wood frame building is also suggested. The potential difficulty of
243 implementing this component level change is medium.

Figure 8: Examples of observed Level 4 Degree of Damage, (a) significant roof damage, (b) garage door blown in, (c) porch damage, and (d) chimney collapse.

227 wind-rated garage door systems, garage door failure can be mitigated. The potential
228 difficulty of implementing this component level change is low.

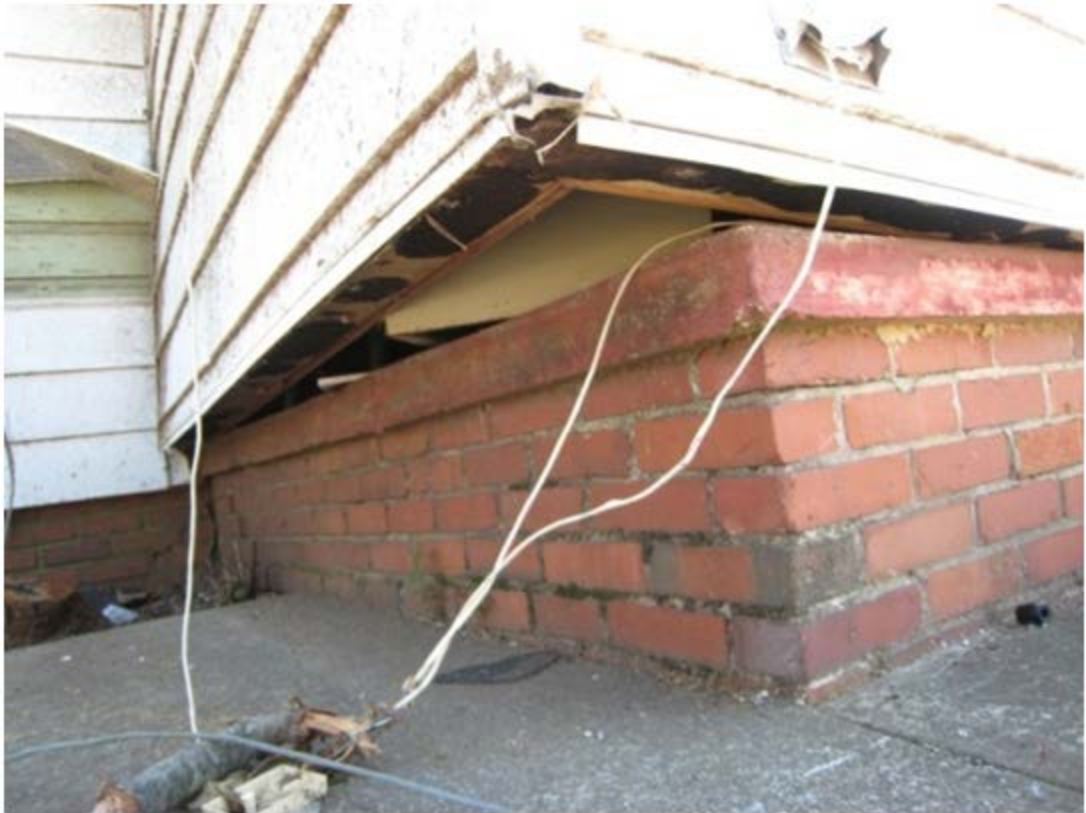
244 DOD5: House shifts off foundation: Significant wind speeds are required to shift an
245 entire building off a foundation, even if the building is poorly anchored to the foundation.
246 An observed example of a building shifting off a foundation is shown in Figure 9.
247 Although engineering design can address the foundation slippage relatively easily, the
248 level of lateral force may just damage the other structural components if the foundation
249 holds. The design of the foundation and anchors must be done in coordination with

Figure 9: Example of observed Level 5 Degree of Damage, building shifted off of the foundation.

250 structural lateral force resisting systems similar to earthquake systems. The potential
251 difficulty of implementing this system level change is medium.

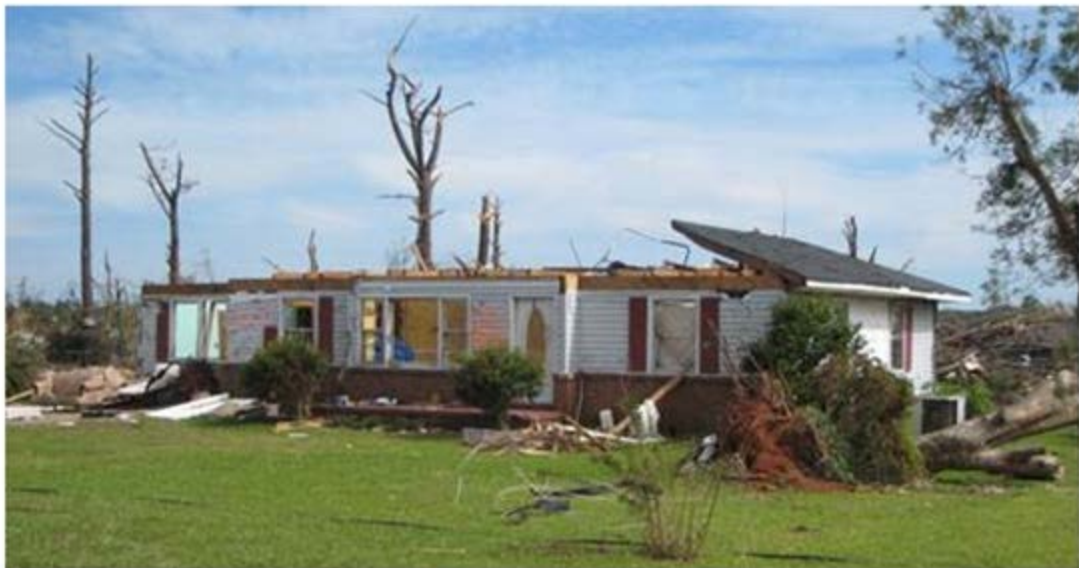
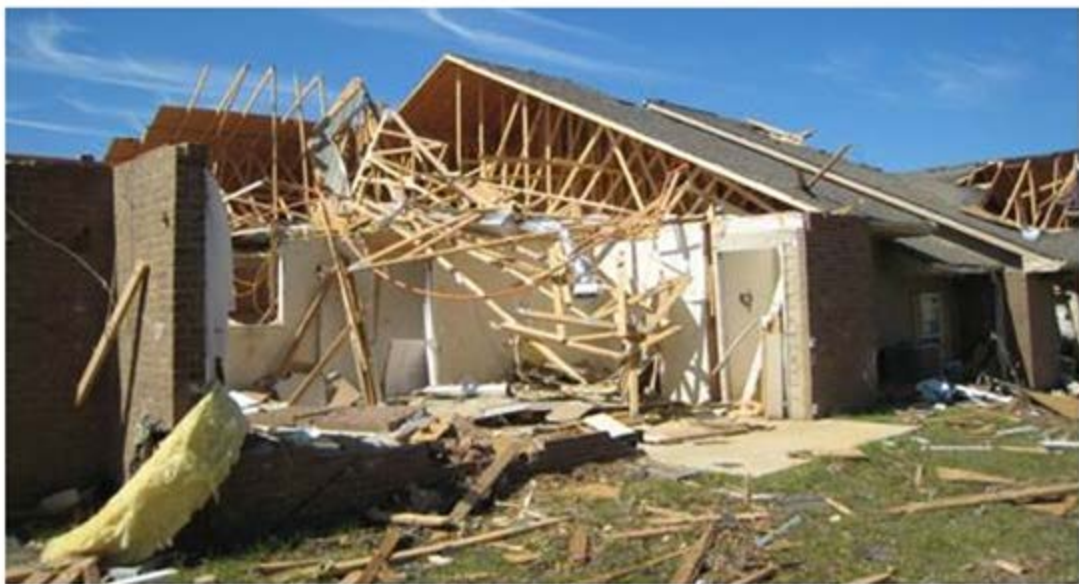
252 DOD6: Large sections of roof structure removed: Failure of the majority of the roof
253 structure, examples of which are shown in Figure 10, may be mitigated through the use of
254 connection hardware and non-conventional member sizes for roof trusses. This may be a
255 good practice for custom designed or specific buildings. The potential difficulty of
256 implementing this system level change is medium.

Figure 10: Example of observed Level 6 Degree of Damage, large sections of roof removed.

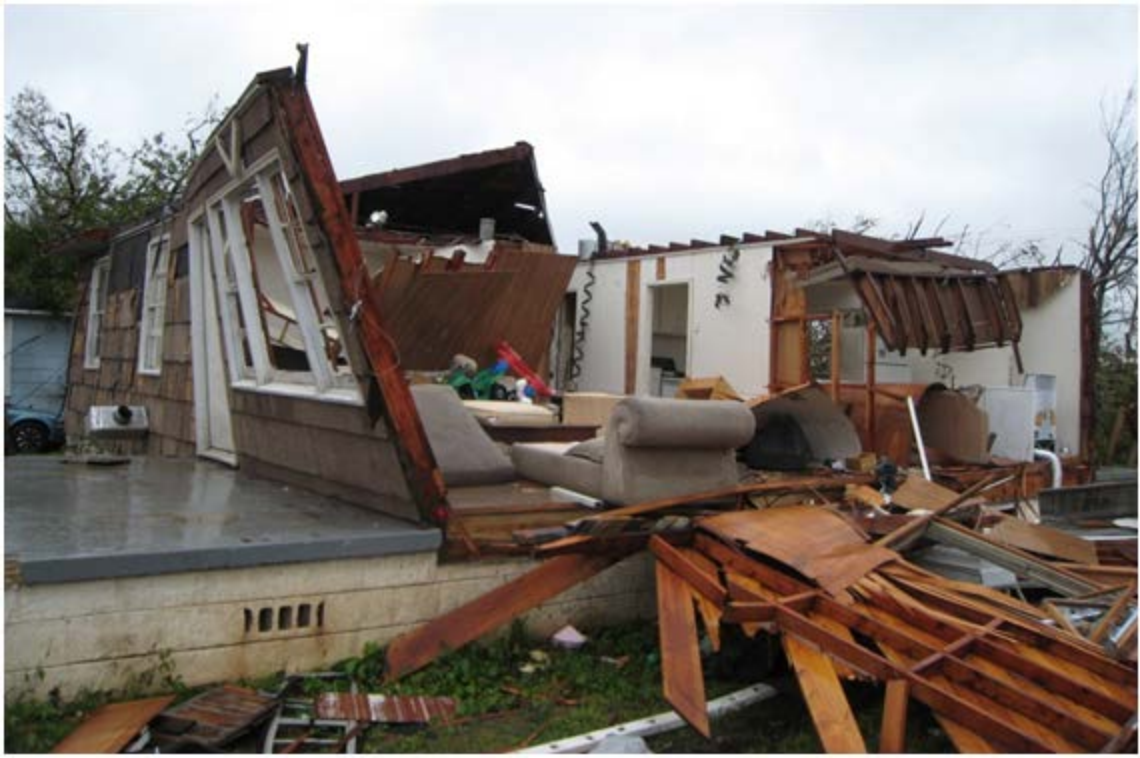
257 DOD7: Exterior walls collapsed: A safe room or shelter is the best means of protecting
258 the lives of the occupants in the event of wind speeds in excess of 160 mph (e.g. DOD7-
259 DOD10). The majority of exterior walls of a wood framed structure will collapse in wind
260 with speeds in excess of 160 mph. An observed example of a building where the exterior
261 walls collapsed is shown in Figure 11. The potential difficulty of implementing this
262 system level and alternative method change is high.

Figure 11: Example of observed Level 7 Degree of Damage, exterior walls collapsed.

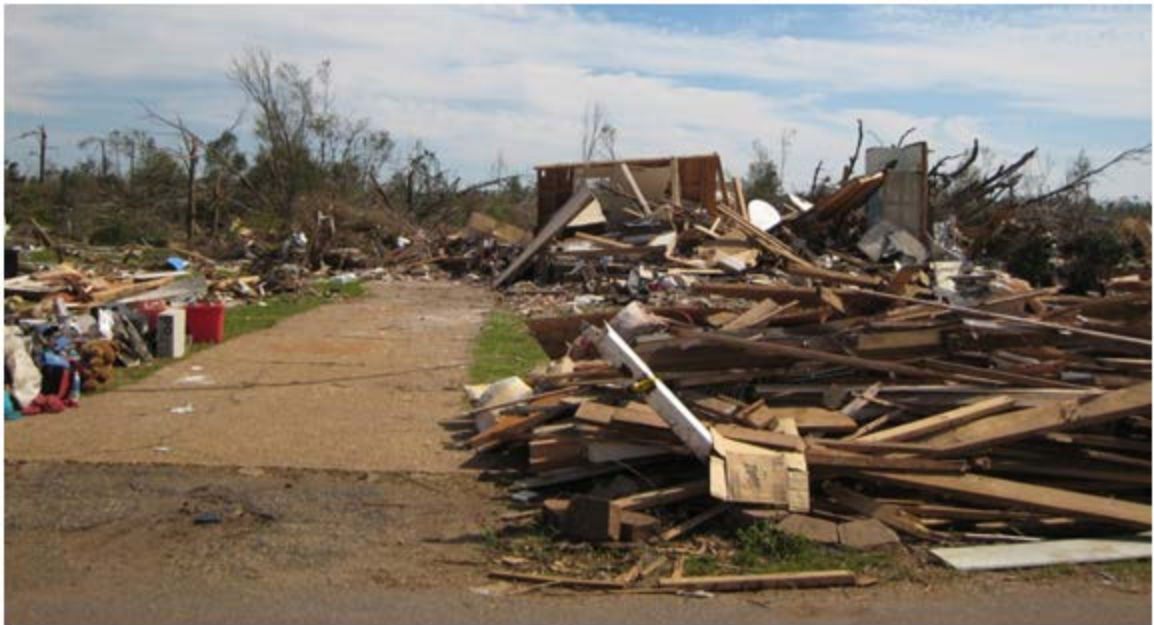
263 DOD8: Most walls collapsed: An observed example of a building where most of the
264 walls collapsed is shown in Figure 12.

Figure 12: Example of observed Level 8 Degree of Damage, most walls collapsed.

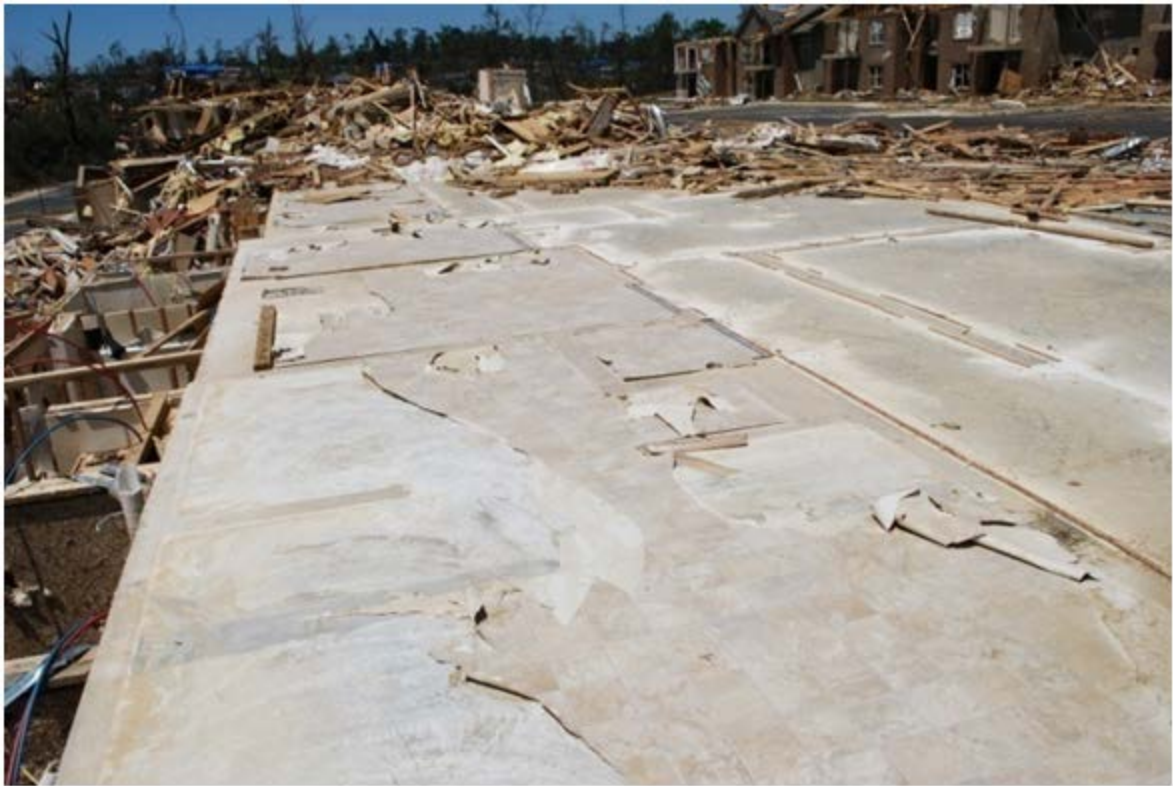
Figure 13: Example of observed Level 10 Degree of Damage, newly constructed (2010) apartment complex with slab swept clean.

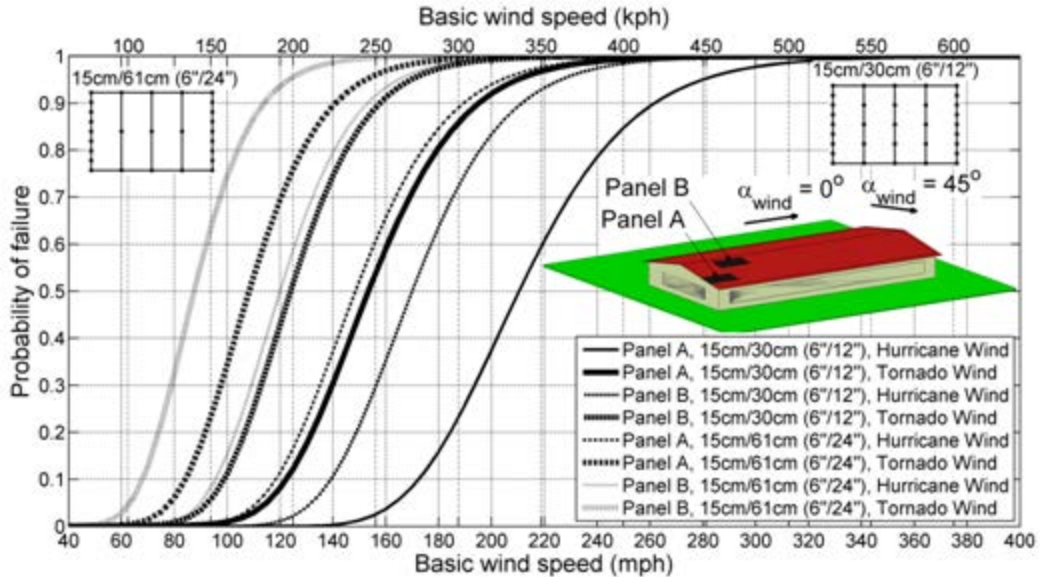
336 Figure 15 shows the fragility curves of the two panels with different nail patterns under
337 the wind load induced by hurricane wind and the approximate tornado wind loading. It
338 can be seen from Figure 15 that the lowest risk of failure is for panel A, nail pattern
339 15cm/30cm (6"/12") under the hurricane wind (the far-end curve on the right). If this
340 panel is subjected to the approximated tornado wind, the fragility shifts to the left and is
341 indicated by the large bold curve. Comparing these two curves, one can see that panel A
342 with nail pattern 15cm/30cm (6"/12") almost has zero probability of failure at hurricane
343 wind $V = 224$ kph (140 mph), but this panel has a probability of failure of 30% if it is
344 under a tornado wind with the same wind velocity. The worst case is panel B with a nail
345 pattern of 15cm/61cm (6"/24") under tornado wind, whose fragility curve is represented

346 by the curve on the far-left end. One can see that this panel has less than 10% failure
347 probability under hurricane wind velocity 150 kph (93 mph), but 63% probability of
348 failure if the house is subjected to a tornado with the same wind velocity (approximately
349 an EF1 tornado wind speed).

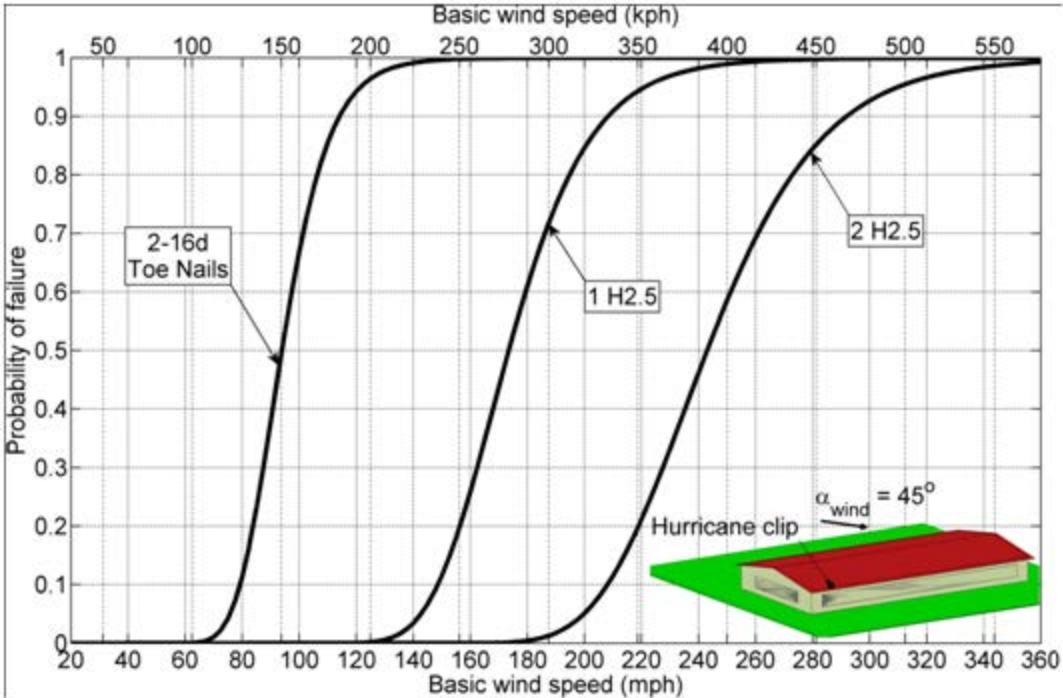
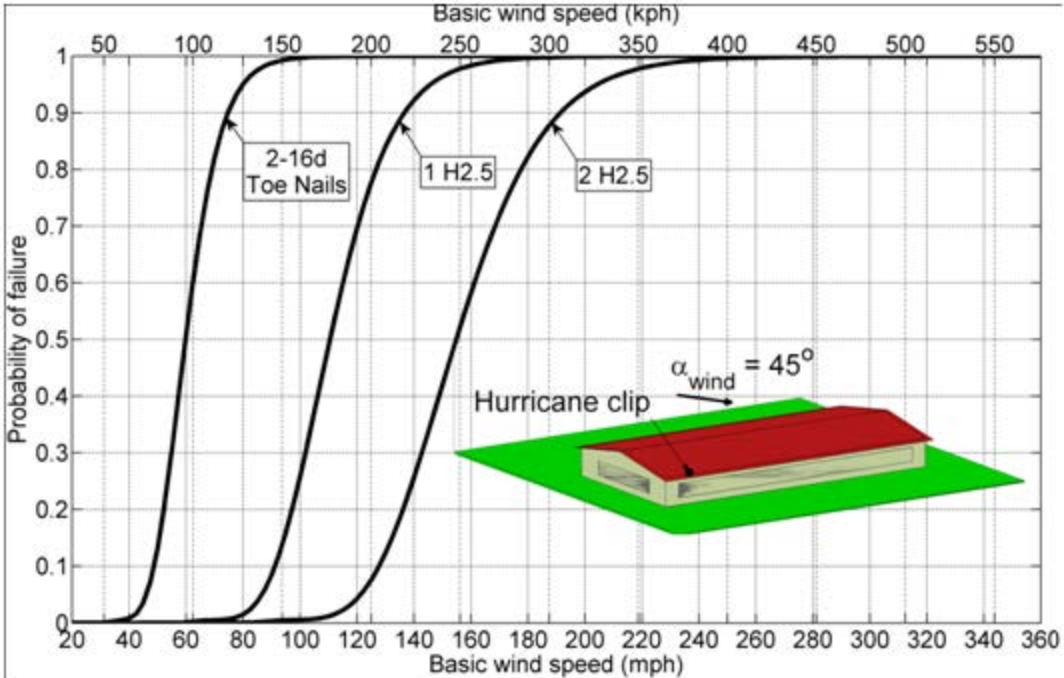
350 A fragility analysis was also used to illustrate the failure of the roof-to-wall connection.
351 This roof-to-wall connection is close to the location where the largest wind pressure
352 occurs and is shown in the inset images in Figure 16a and 16b. The wind direction used
353 in the calculation is 45° , which is the same as the wind direction that induces the
354 maximum wind pressure on the roof. Again, the fragility curves for a single hurricane
355 clip, double clip, and toe nailing under the wind load from a hurricane is shown in Figure

356 16a. Note that toe nails have a 67% probability of failing at 160 kph (100 mph) but that
357 simply replacing them with a single H2.5 hurricane clip virtually eliminates the
358 likelihood of failure. In a tornado, recall from the earlier discussion that the uplift and
359 other pressures are higher than a straight line wind and thus the amplification factor was
360 modeled as a uniformly distributed random variable based on the range given by Haan et
361 al (2010). Although this is approximate and clearly additional work is needed, it is
362 applied here to help introduce the additional uncertainty associated with tornado wind
363 loading into the resulting fragilities. It can be seen that if the roof truss is connected to
364 the wall with a H2.5 hurricane clip, the probability of failure for the hurricane clip is
365 about 49% to 89% if loaded by an EF2 tornado (expected wind speed range of 111 – 135

366 mph). If two H2.5 hurricane clips are used, and assuming the wood truss can develop the
367 full force in the connectors, there is only approximately a 2% to 18% failure probability
368 in an EF2 tornado. This illustrates the damage reduction possibility for a single damage
369 mechanism through the use of hardware. Finally, it should be noted that in the tornado
370 pressure calculations the building was assumed to have been breached whereas the
371 envelope was assumed to remain intact in the hurricane pressure analysis.

Figure 16: Fragilities for roof to wall connection failure in a (a) hurricane and (b) tornado
