**Hatfield Marine Science Center
Dynamic Revetment Project
DSL permit # 45455-FP**

**Monitoring Report
February, 2015**

February 11, 2015

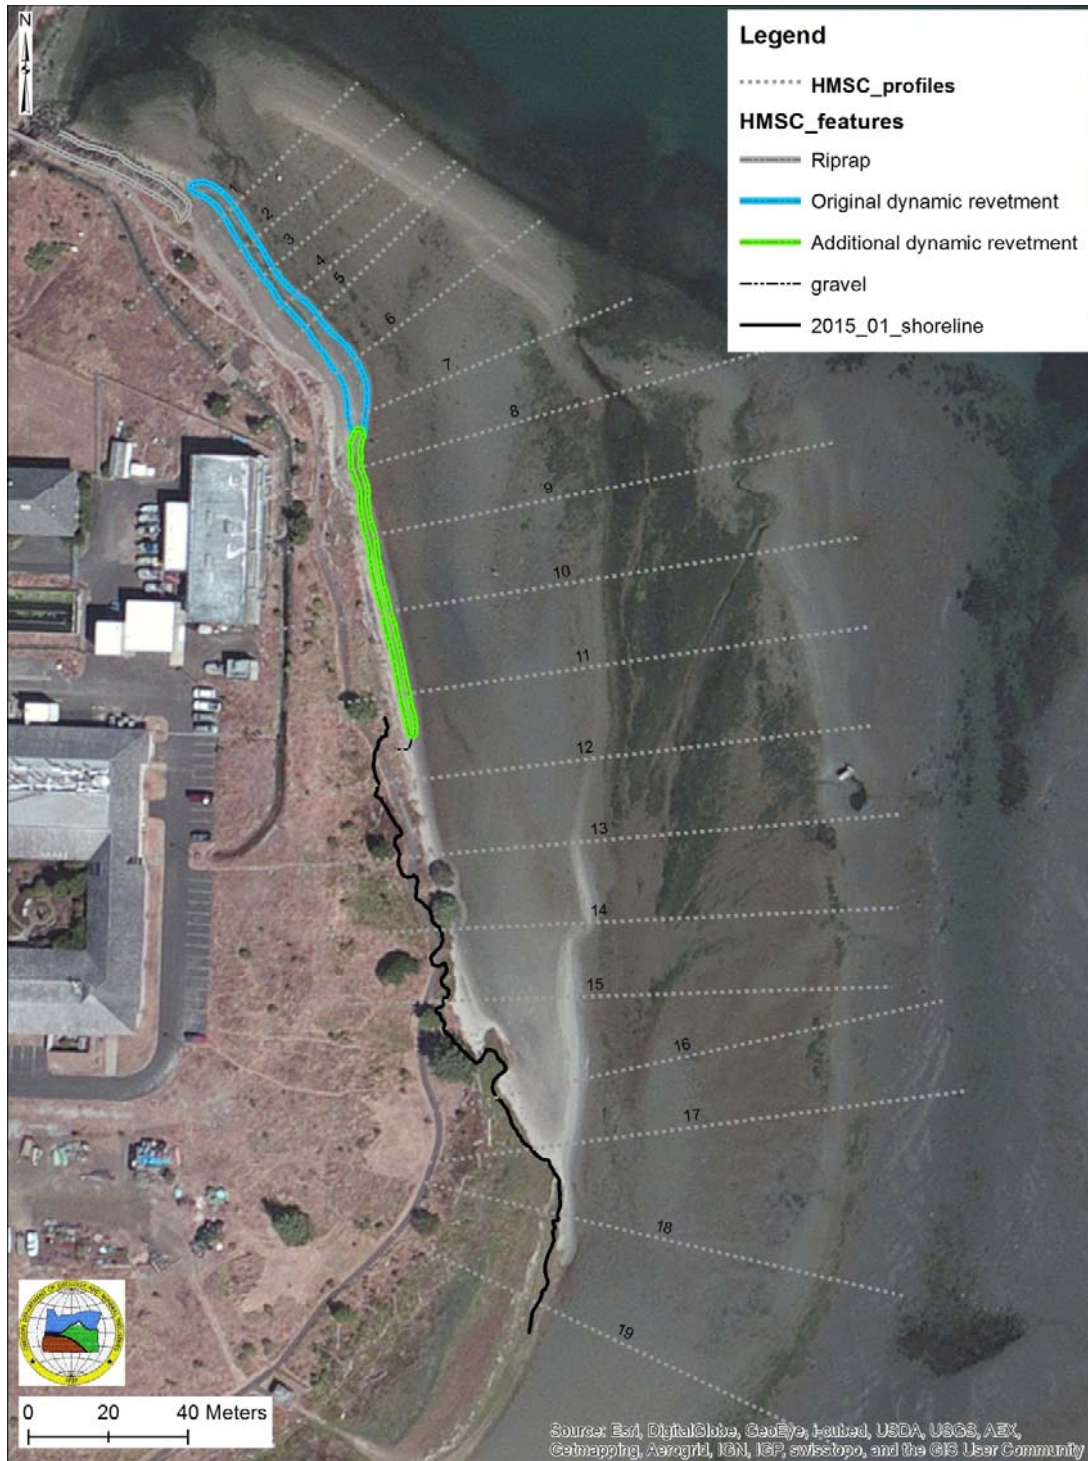
Figure 2.2: Location map showing the HMSC beach and shoreline monitoring network. Blue shaded dashed line denotes the cobble ‘lag’ toe of the original dynamic revetment, green shaded dashed line denotes the cobble ‘lag’ toe for the expanded section and grey shaded dashed line denotes the location of rip rap rock. Solid black line depicts the most recent (January 2015) measurement of the erosion scarp.

For the purposes of this study, we established 15 beach profile transect lines along the estuary trail (Figure 2.2), which extends from the HMSC wharf in the northwest, southward approximately 290 m (~950 ft). Of these, 5 of the lines were originally established in May 2006 (1-5) to document changes on the original gravel beach constructed there in late 2006, while the remaining 10 lines were established in July 2011. An additional 3 transect lines were established in May 2014 (Table 2.1), expanding the monitoring network further to the south (Figure 2.2).

Figure 2.3 depicts the measured changes in the original gravel beach (Figure 2.4) area (blue dashed line in Figure 2.2). Examination of these data and results from the adjacent transects (6-12) confirm that the placement of gravel on the beach face and a lower cobble “lag” berm located at the juncture between the sandy beach and the inter-tidal mudflats, has been successful in stabilizing further retreat of the beach. This is characterized by the fact that there have been negligible changes to the gravel beach morphology in this area over time. Nevertheless, while the gravel beach is considered to be stable, there is some evidence of minor erosion taking place on the upper portion of the gravel beach where it merges with the sandy backshore. This response is entirely due to the occurrence of wind driven waves coupled with high tides, which enable the waves to reach to higher elevations on the profile (effectively exceeding the gravel beach) where they erode the sandy backshore. As noted in our original design, the gravel beach structure would need to have been built to a higher elevation to mitigate these effects, or combined with an artificial dune (*letter to HMSC by Allan, J.C. 2006*).

Further south between Transects 6-11 (Figure 2.5, green dashed line in Figure 2.2), the beach survey data indicate that the expanded gravel beach section is also considered to be stable, such that erosion of the beach and backshore has essentially ceased. Note that the degree of erosion that took place in this area is captured by the changes that took place between July 2009 and our first survey of the new gravel beach area undertaken in July 2011. In Figure 2.5 the baseline for our current monitoring efforts is the 2009 LIDAR. Despite the apparent stability of the gravel beach, our most recent survey undertaken on January 9th 2015 confirmed that the Transect 6 profile site is experiencing some erosion; this was noted in our previous report. As can be seen in Figure 2.6, the erosion is confined entirely to the upper part of the beach profile (located between the 2-3 m elevation). It is likely that the erosion at Transect 6 reflects the fact that this area of the beach may be feeding gravel to the areas adjacent to it (Figure 2.7). For example, Transect 5 shows clear evidence of it having gained gravel over the past few years. As noted in our previous reports, we recommend that HMSC consider adding some additional gravel to this portion of the existing dynamic revetment in order to safe guard its volume.

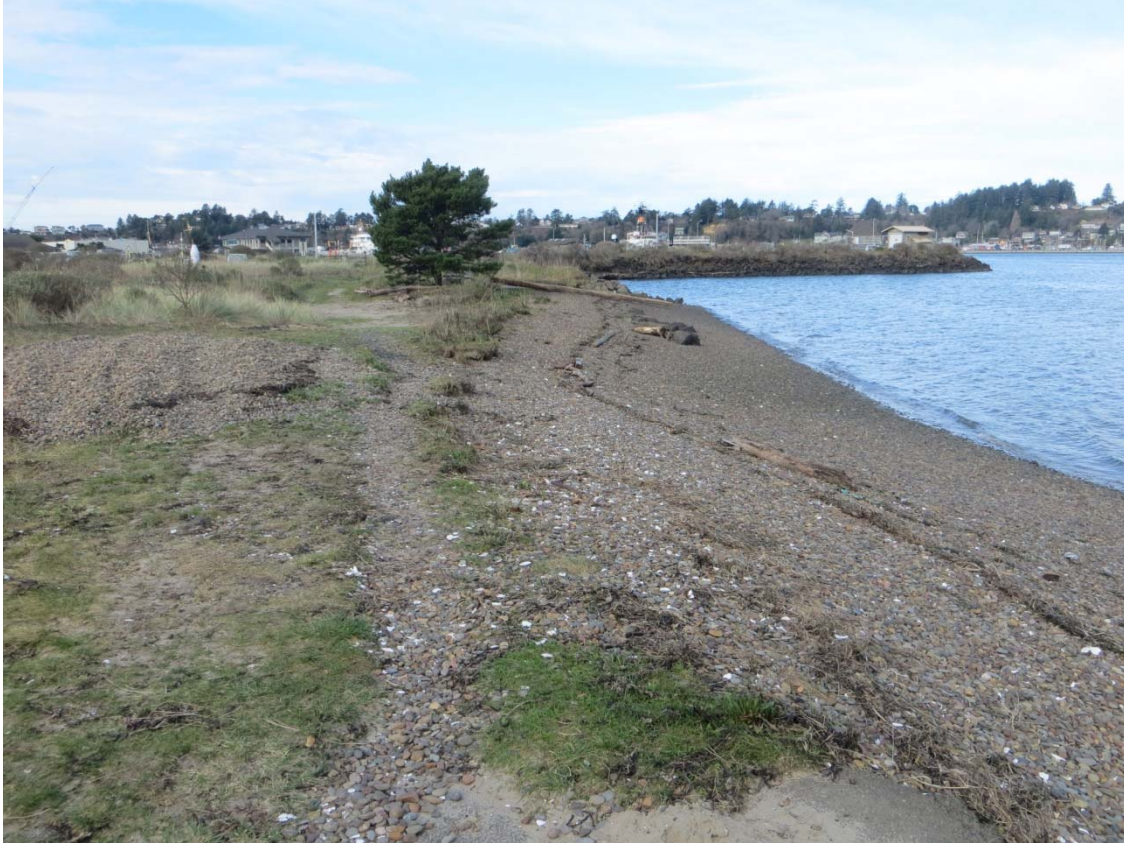
Figure 2.4: View looking northwest across the original gravel beach. Photo depicts the effects of periodic inundation due to high tides along with some minor erosion of the top of the sandy beach [Photo by J.C. Allan, January 9th 2015].

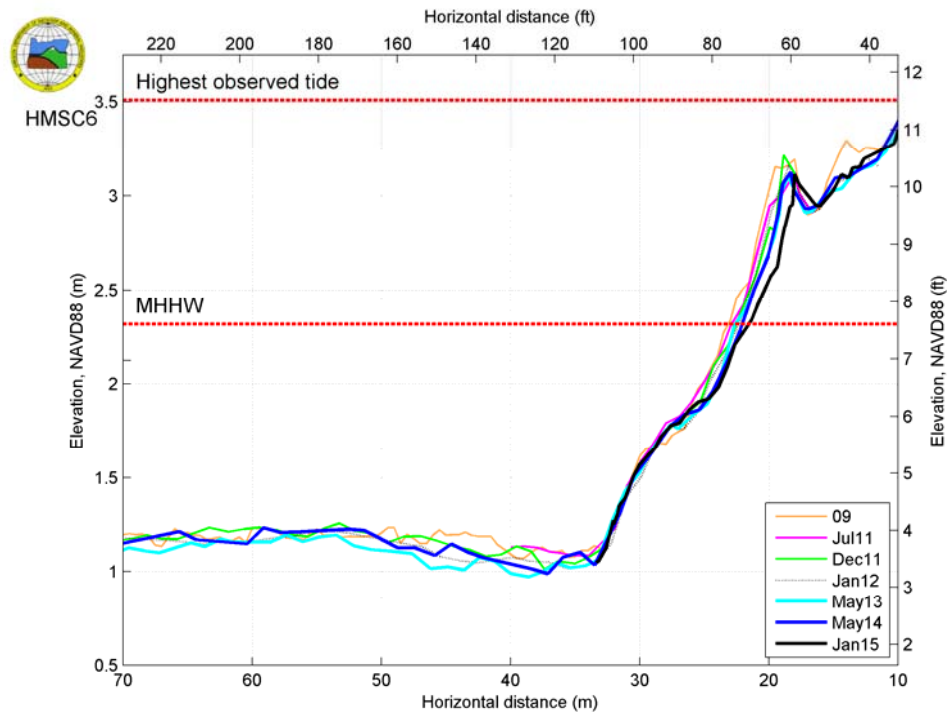
Figure 2.6: Measured profile changes at the Transect 6 profile site, showing evidence of erosion along the upper gravel beachface.

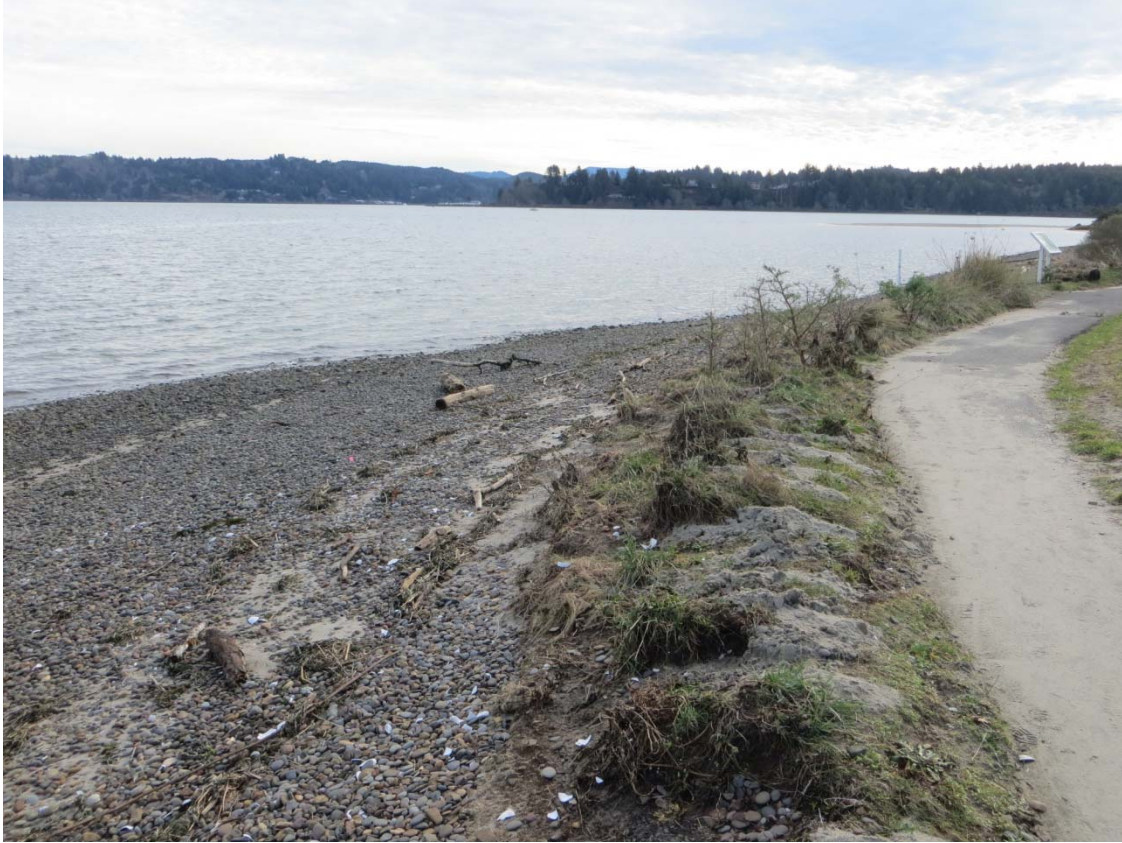
Figure 2.7: Erosion of the upper gravel beach and backshore occurring near the Transect 6 profile site [Photo by J.C. Allan, January 9th 2015].

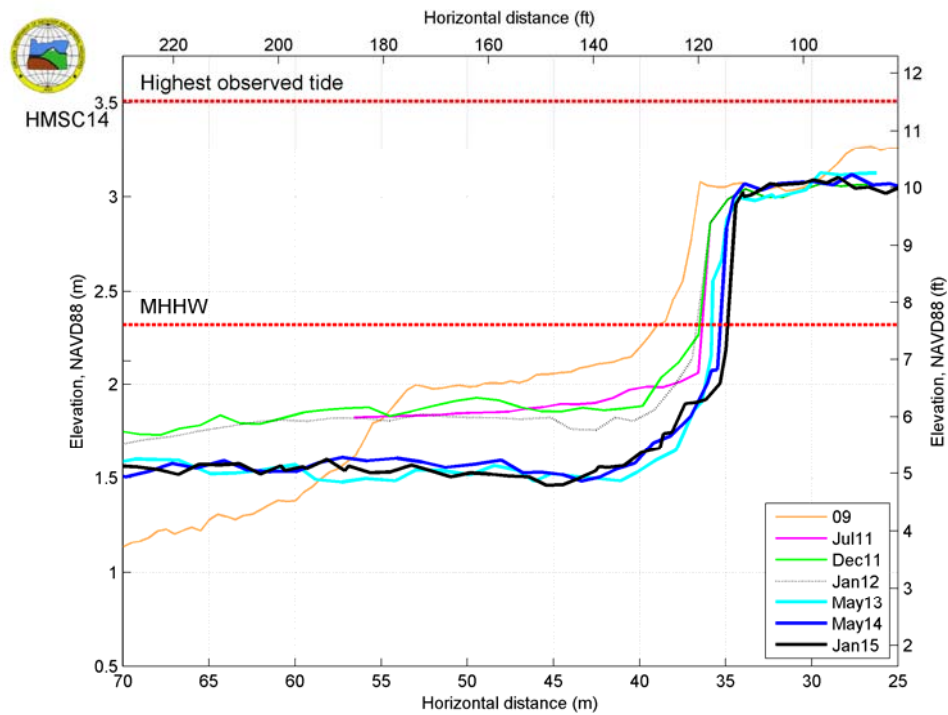
Figure 2.9: Measured profile changes at the Transect 14 profile site, showing the landward translation of the entire beach profile.

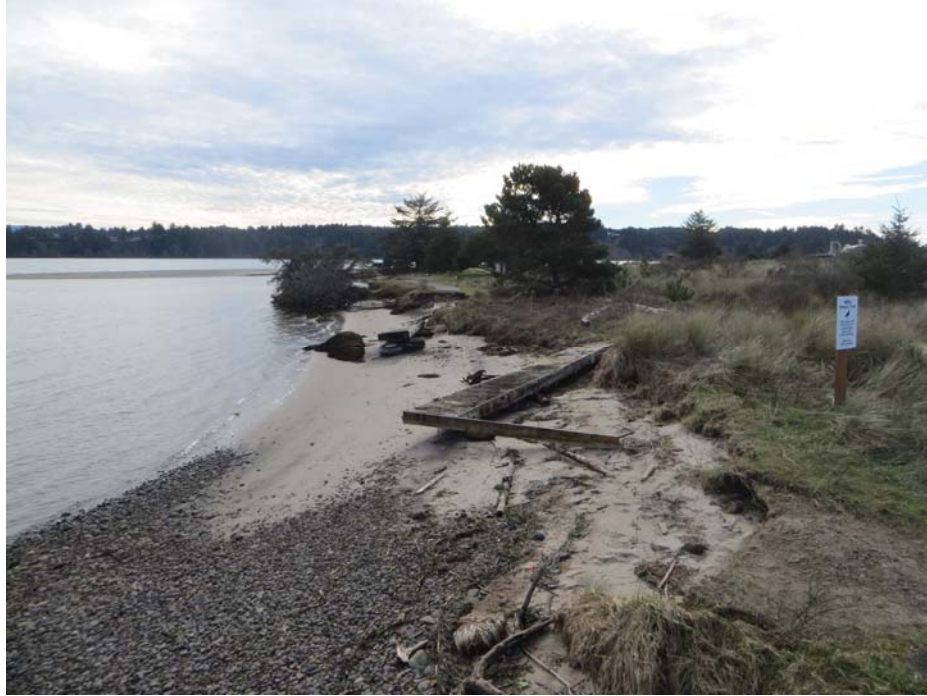
Figure 2.10: Recent erosion taking place in the control area [Photo by J.C. Allan, January 9th 2015].

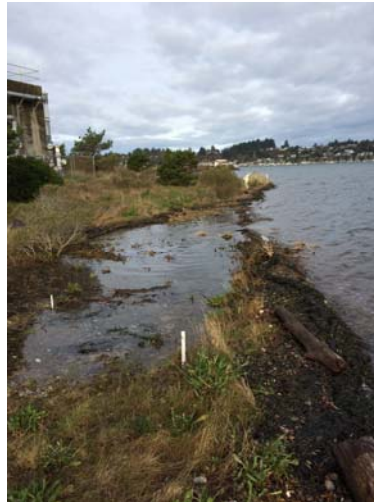
Figure 3.1. View of the DRP shoreline (December 2014) showing algal wrack line on the upper shore. Note woody debris.

Mixed algae and seagrass samples were collected on October 3, 2014 from the wrack line deposited by the previous high tide at five random locations from the Reference beach, the DRP beach, and from the wrack line in the 2007 DRP area, termed DRP Reference. Figure 3.1 shows a typical algal wrack line along the DRP area. Samples of wrack were obtained by using scissors to cut segments of the wrack line which were rapidly placed in labeled plastic bags. Samples were placed in a walk in freezer until they could be thawed and sorted. The wrack samples consisted mostly of green macroalgae and the seagrass, *Zostera marina*. Wrack samples were processed by a combination of rinsing, sieving and picking the wrack material in plastic tubs. The algae/seagrass biomass material was saved for each replicate and dried in an oven at 70° C for 5 days. The final dry weight of each wrack sample was determined. Organisms were sorted, identified and counted. Densities for wrack associated organisms in higher taxonomic groupings are expressed per unit dry wrack biomass.

The lower average vegetation cover at the DRP sites has been a consistent result during the monitoring, and was present in the pre-project samples. DRP quadrats 1-3 occur at lower elevation than most other sample locations, and as described in previous reports, there is also a topographic low spot in the shoreline near beach profile 9 (Figure 3.1), which allows the back shore area to be more frequently flooded by fall and winter King tides.

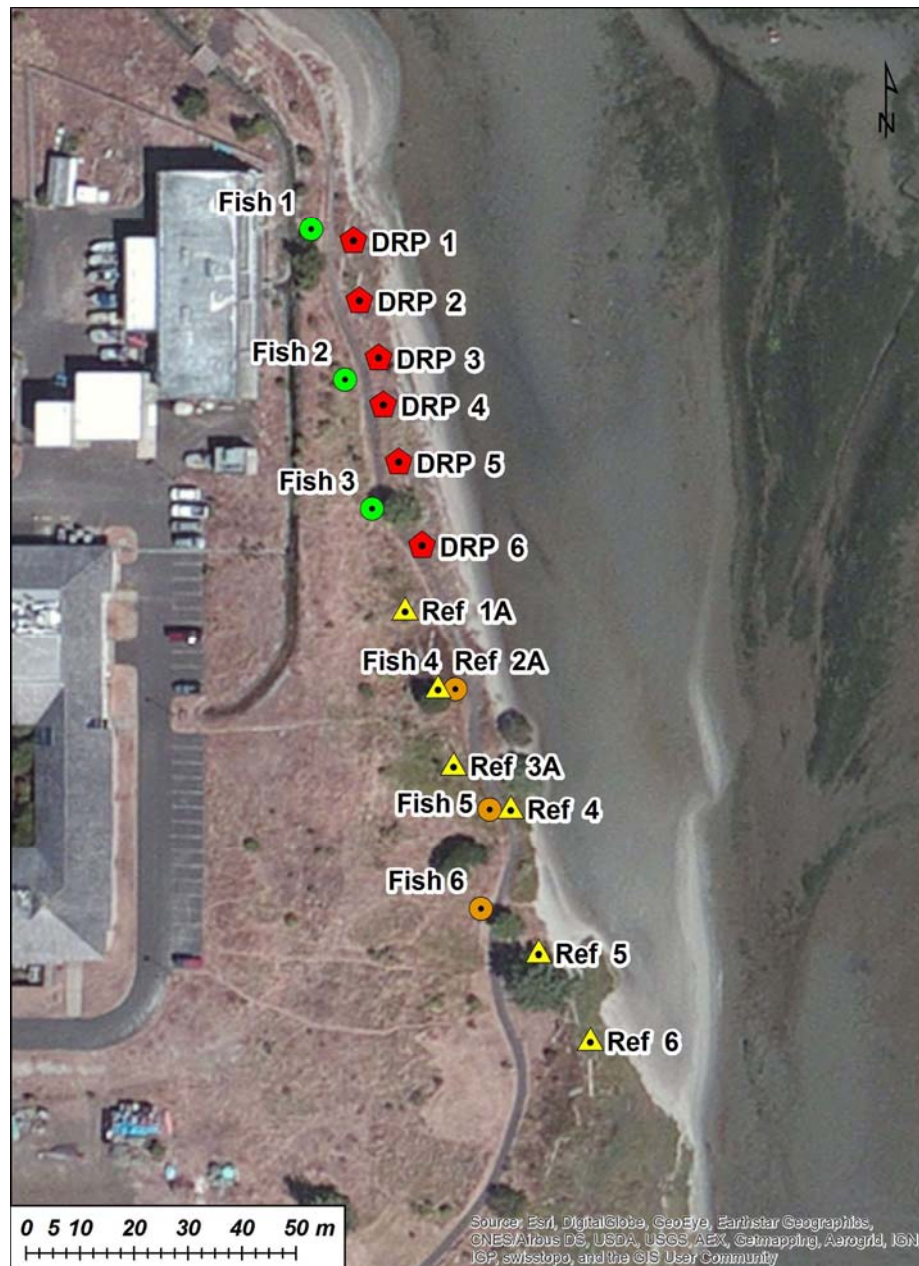
Figure 3.5: Vegetation plots in DRP (red symbols, DRP 1-6) and Reference (yellow symbols, Ref 1-6) survey areas. Locations of fish sampling transects are shown as green (DRP, Fish 1-3) and orange (Reference, Fish 4-6) symbols.

From January through November of 2014, intertidal fish were captured with a 50-ft (15.3 m) shore seine towed perpendicularly to the shore for a distance of 50 ft (15.3 m) at three permanent sampling sites along the DRP shoreline and three permanent sites along the Reference shoreline (Figure 3.6). This sampling was performed once per month at spring high tide in order to sample as much of the high intertidal habitat as possible. All fish captured in the seine were held for no more than 15 minutes in a container of ambient bay water while they were measured and identified to the lowest possible taxonomic level before being released at the point of capture.

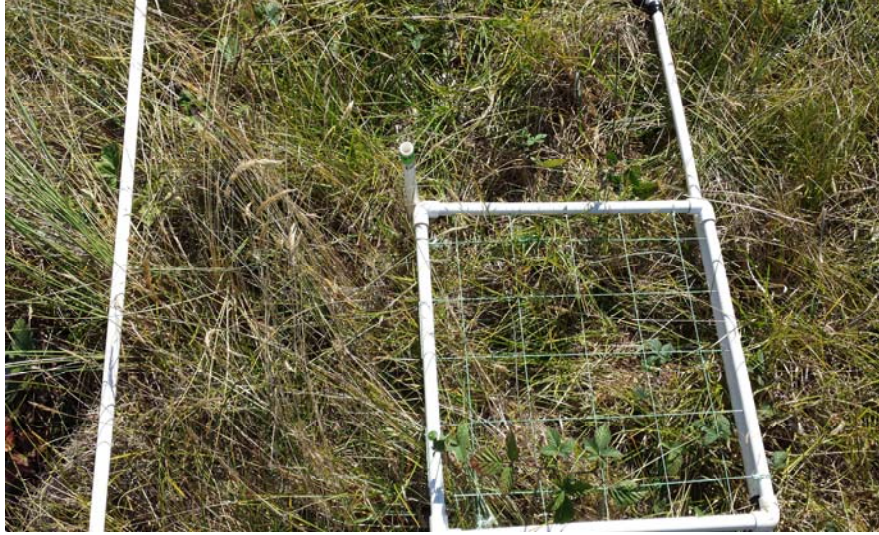
Figure 3.6: Close up of 1-m² quadrat used to determine plant presence-absence with the 0.25-m² quadrat used to determine percentage cover of vegetation, October 2014.

Vascular plant presence or absence (usually at the species level) was visually assessed by scanning one 0.25 -m² quadrat within each 1-m² quadrat (Figure 3.6, 3.7). Plant percent cover was assessed by visually evaluating the percentage that each plant species contributed to the overall plant community present within the 1-m² quadrat. Percent cover estimates also considered non-plant substrata such as open or bare ground and detrital material. Photographs of each quadrat were taken from several perspectives.

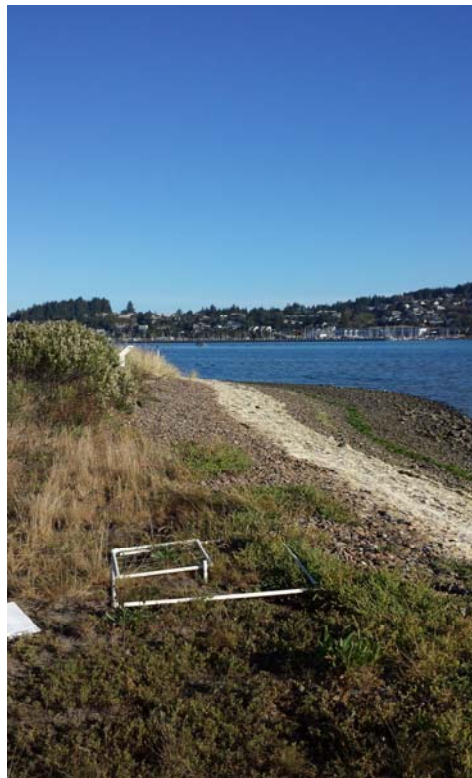
Figure 3.7: Vegetation monitoring Quadrat DRP 1, October 2014. View to northeast.

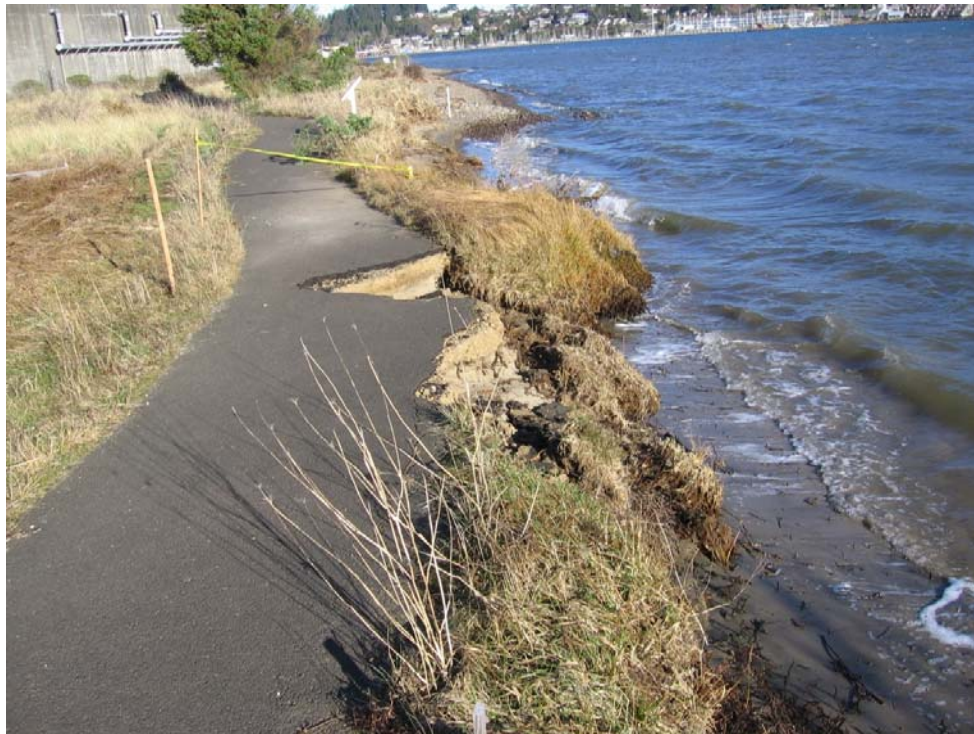
Figure 4.1: View of collapsed section of HMSC nature trail, February 3, 2012.

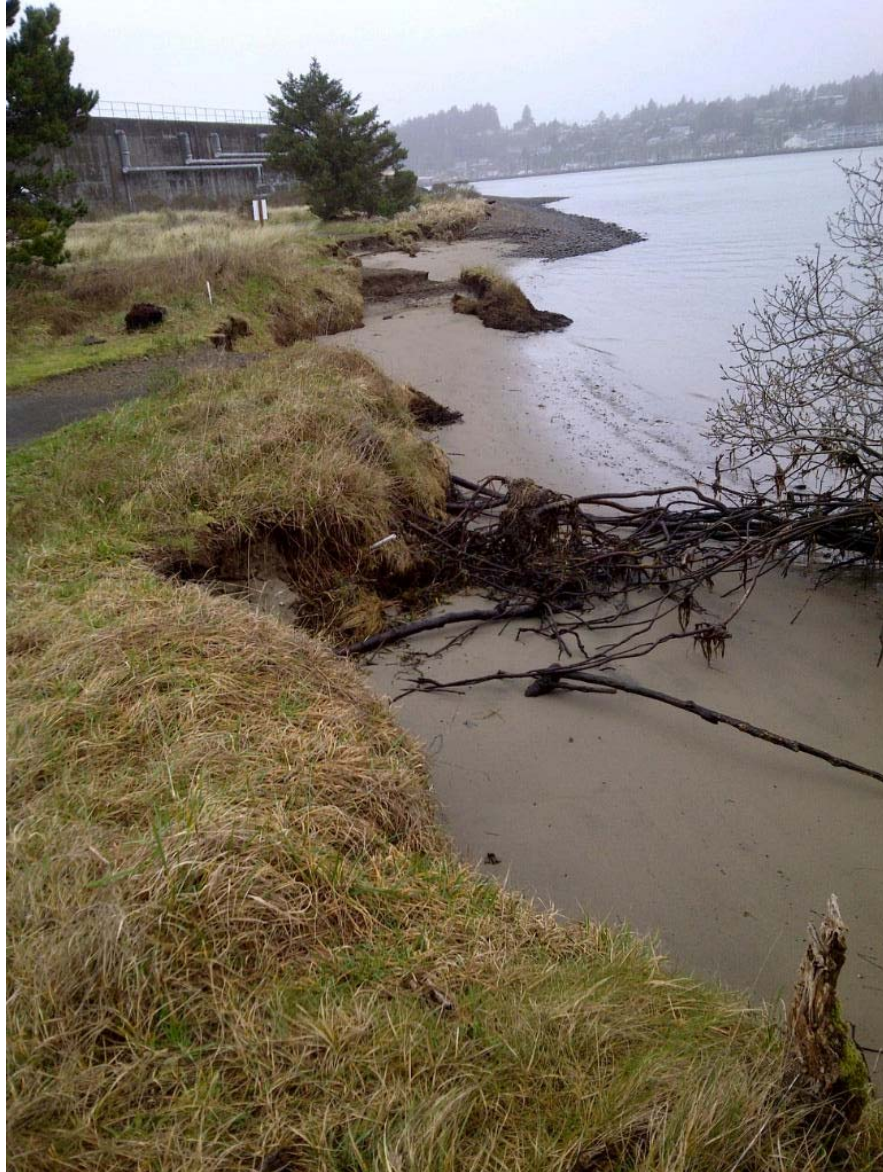
Figure 4.3: View of eroded section of HMSC nature trail, February 14, 2014. The terminus of the 2011 dynamic revetment is seen in the upper center of the photo, and the offset caused by shoreline erosion is clearly visible.

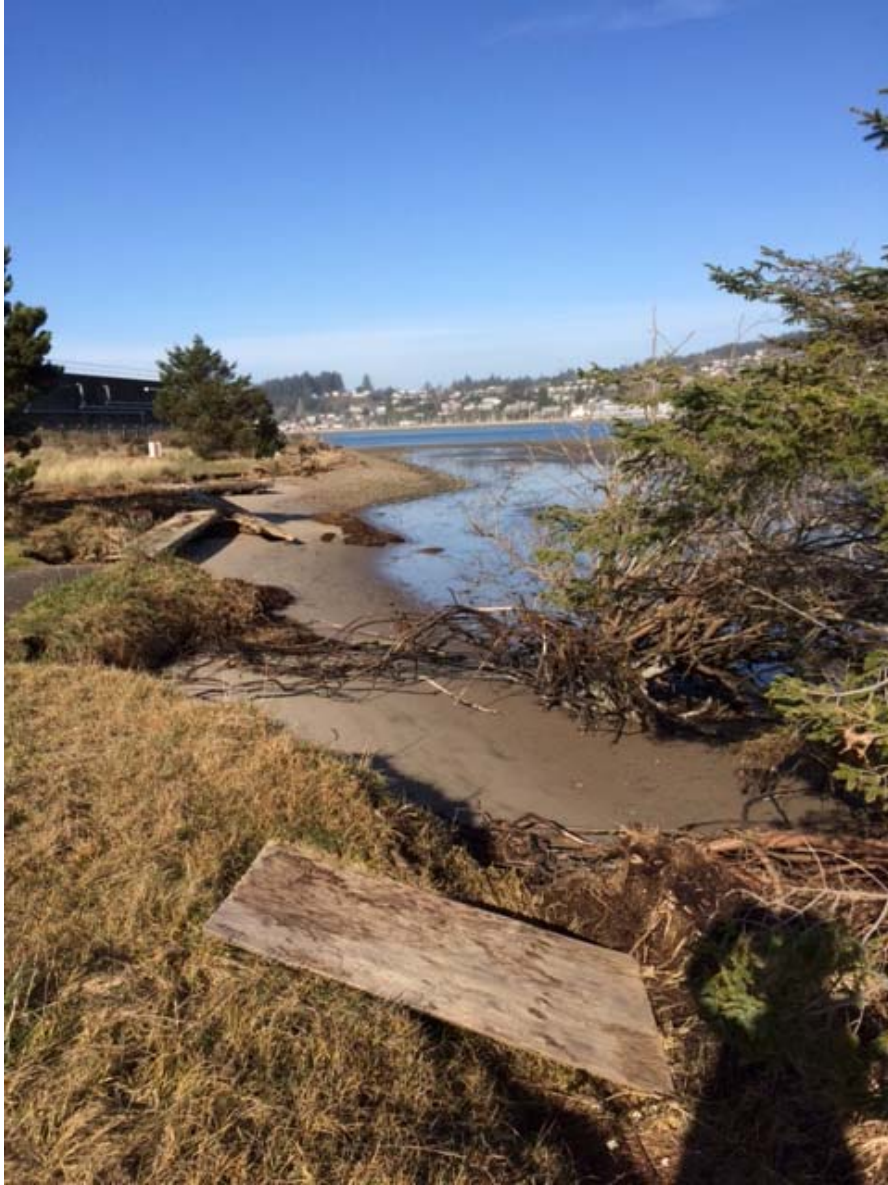
Figure 4.4: View of eroded section of HMSC nature trail, January 26, 2015. Erosion has continued unabated landward of the original position of the asphalt nature trail. Several floating docks broke loose during storms and stranded on this section of shore.

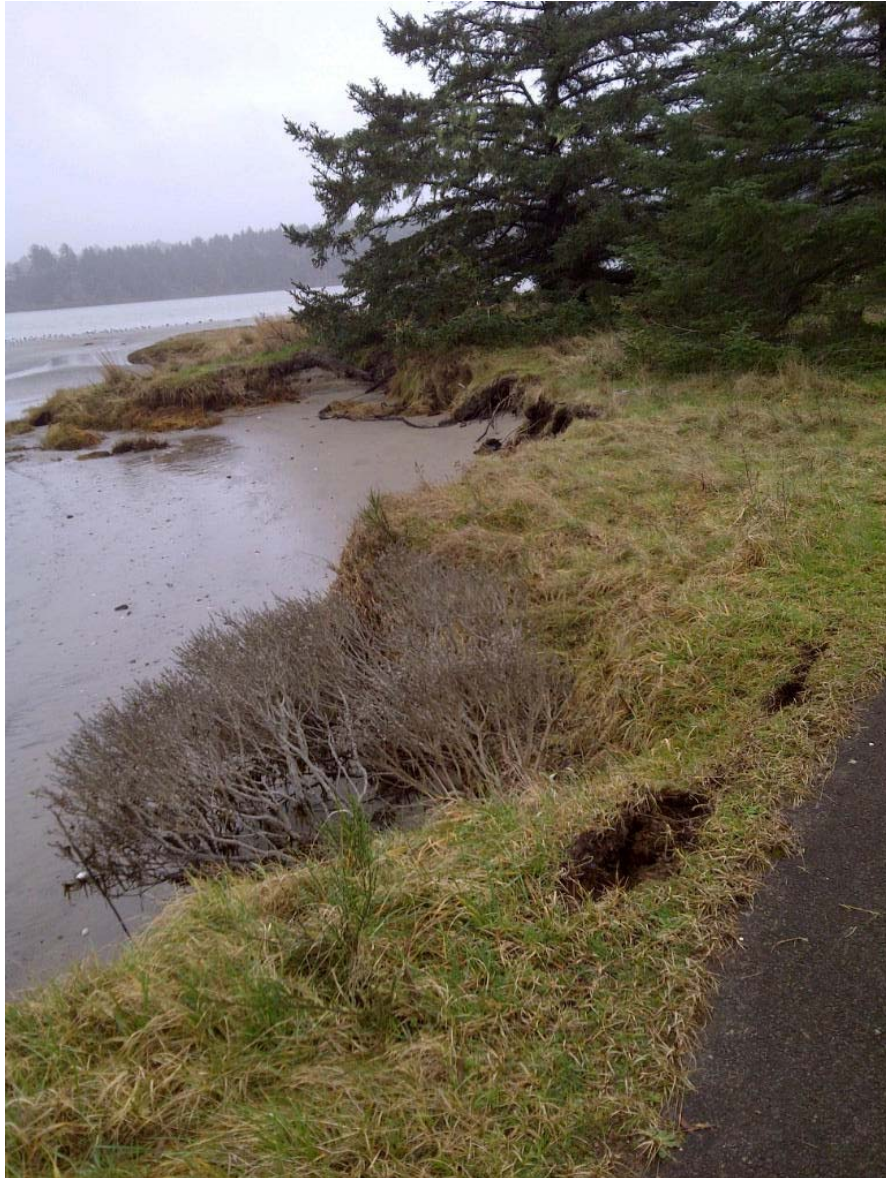
Figure 4.5: View to the south of the 2011 DRP in the Reference area (February 14, 2013), showing collapsed banks with 4 foot vertical scarps. In the upper left, erosion is now starting to attack low salt marsh habitat on the point and beyond which has not previously been exposed to erosion.

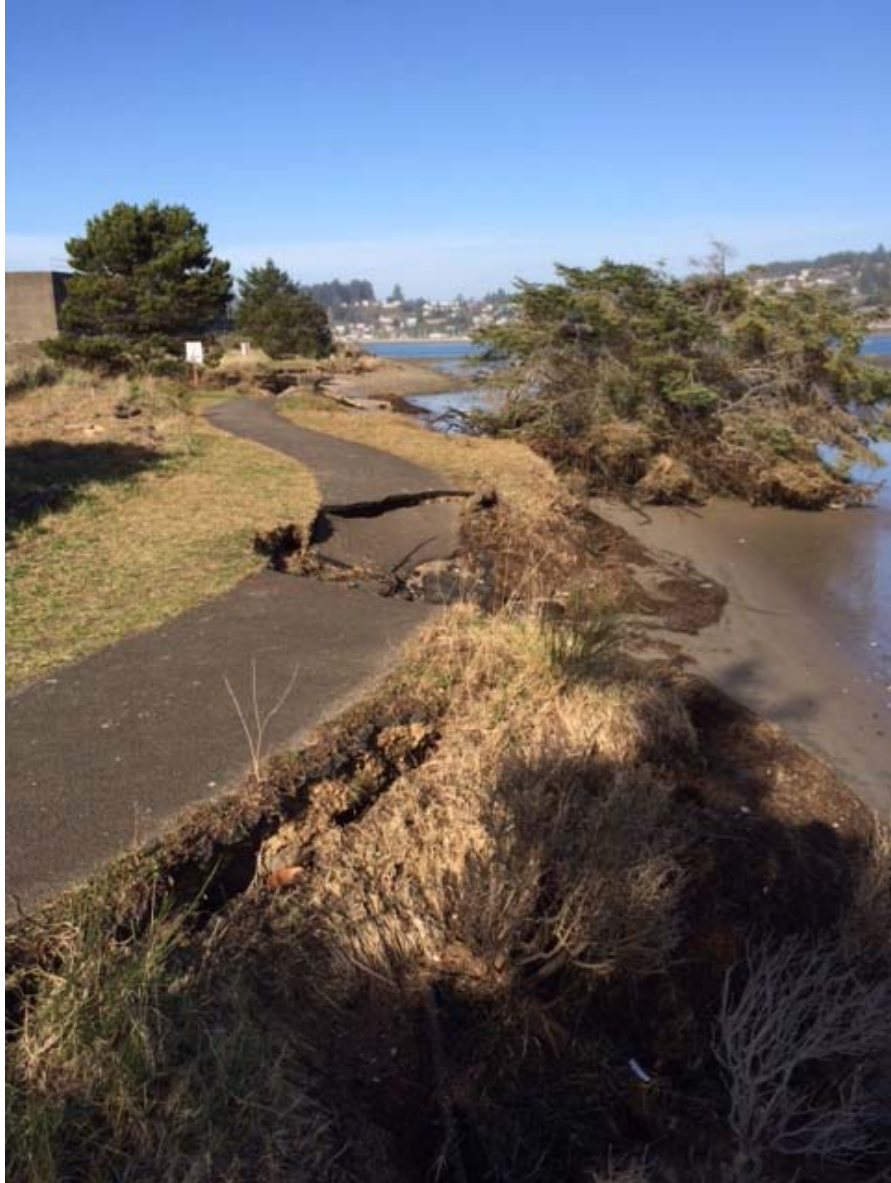
Figure 4.6: View to the north in the Reference area (January 26, 2013), showing collapsed banks with vertical scarps and additional section of collapsed asphalt due to continued rapid erosion.

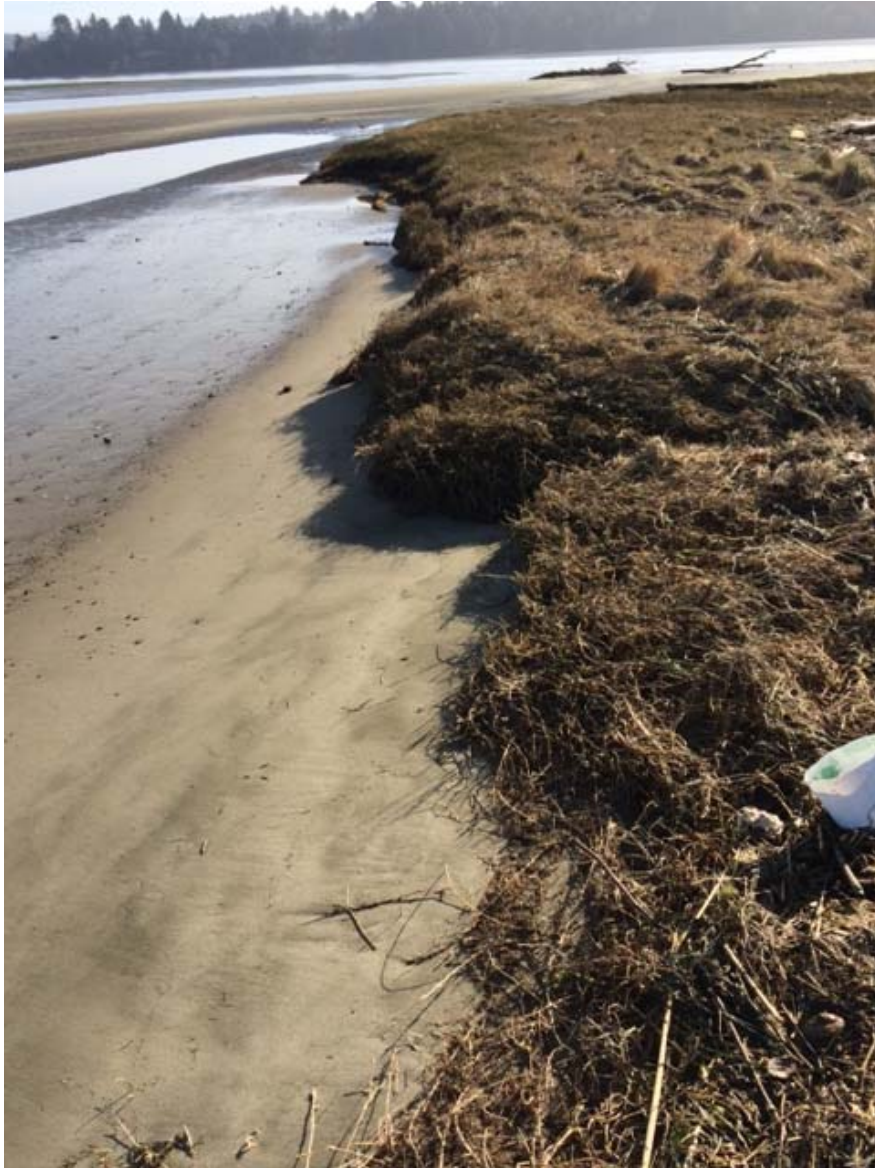
Figure 4.7: Erosion is now starting to attach low salt marsh habitat beyond the area which previously been exposed to erosion. Note presence of vertical scarping.

As described in more technical detail in Section 2.2, as of February, 2015, both the 2007 and 2011 DRP shoreline sections appear mostly stable, while erosion has continued to occur in the Reference area immediately to the south of the DRP. “King” tides occurring from November – February coupled with east wind driven wave action have continued to roll back the shoreline vegetation, and steep vertical scarps at the vegetation edge are the norm along this shore section. Erosion in the unprotected Reference area in the period 2009-2014 has been as great as 11 m (36 ft). The effect of erosion during 2014 can be seen in comparison of Figures 4.1 through 4.4, taken from a similar spot on the HMSC Nature Trail. Erosion in 2014 continued to create vertical banks of collapsed sod, with salt marsh vegetation collapsing and being eroded away (Compare Figures 4.5 and 4.6). Erosion has begun to accelerate for low salt marsh habitat beyond the southern edge of the currently proposed new project area, which has not been exposed to erosion before (Figure 4.7).
