# Landslides OF OREGON: North Coast

BY JOHN V. BYRNE  
AND WILLIAM B. NORTH  
DEPARTMENT OF OCEANOGRAPHY  
OREGON STATE UNIVERSITY  
Published by the Oregon State University  
Sea Grant Marine Advisory Program

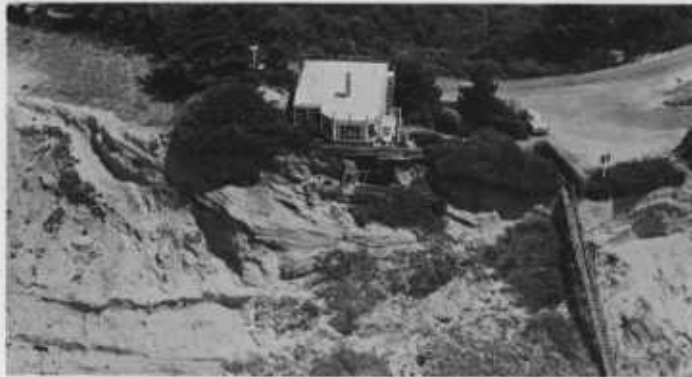
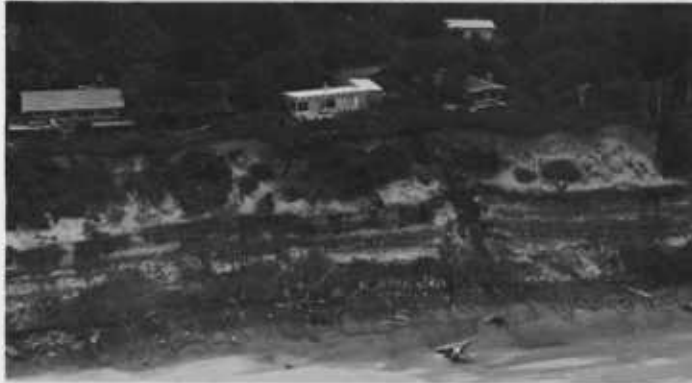
**Figures 2 and 3.**  
*Beachfront homes  
perch precariously  
above landslide  
areas. Retreat of  
cliffs becomes  
obvious from the  
air.*

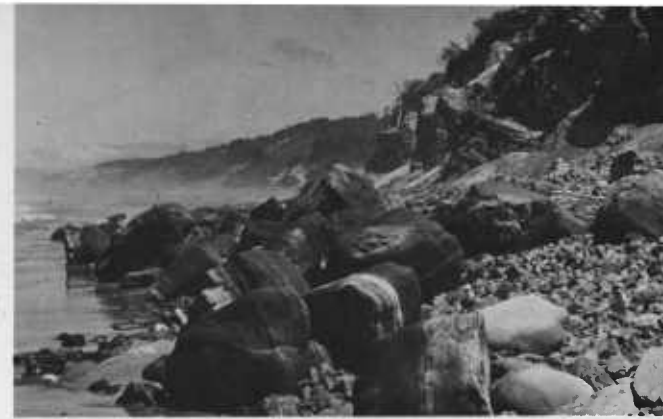
**Figure 4.** *Rock  
and debris slump.*

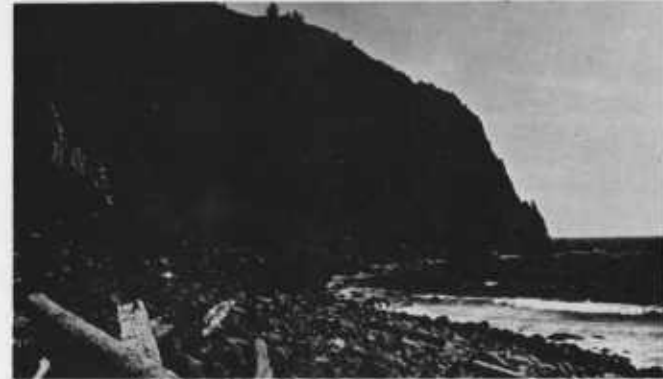
**Figure 5.** *Block  
and rubble slide.*

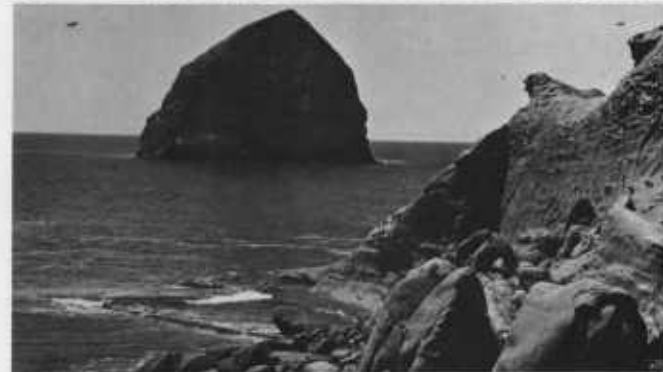
**Figure 6.** *Rock  
fall.*

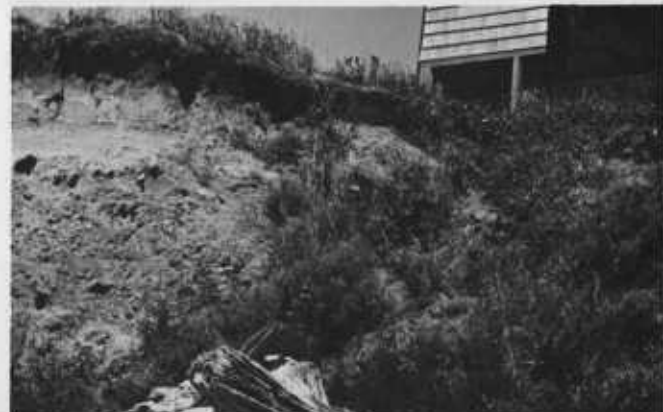
**Figure 7.** *Debris  
shift.*

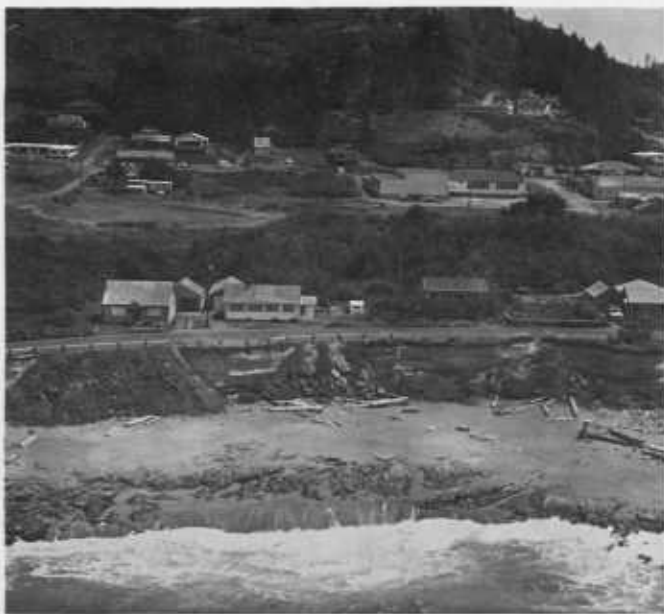
Figure 8. Road crews have dumped fill dirt and rock in an attempt to minimize slide activity near roadway.

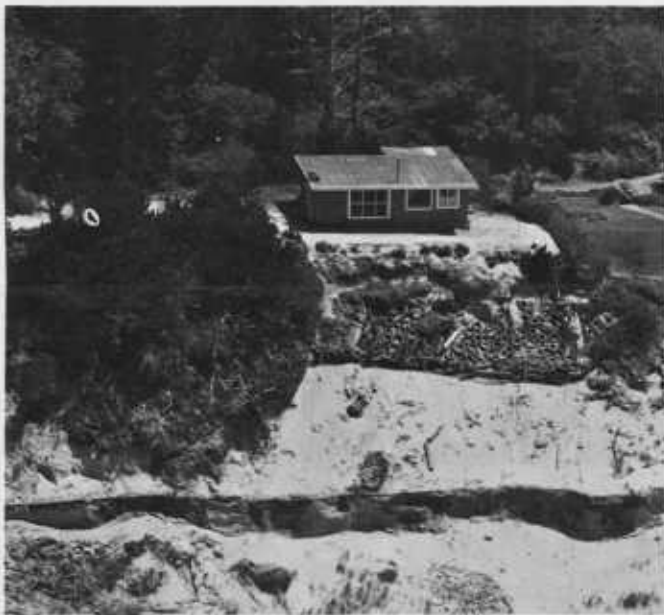
Figure 9. A unique method of slide prevention. A home owner has used old tires as riprap.

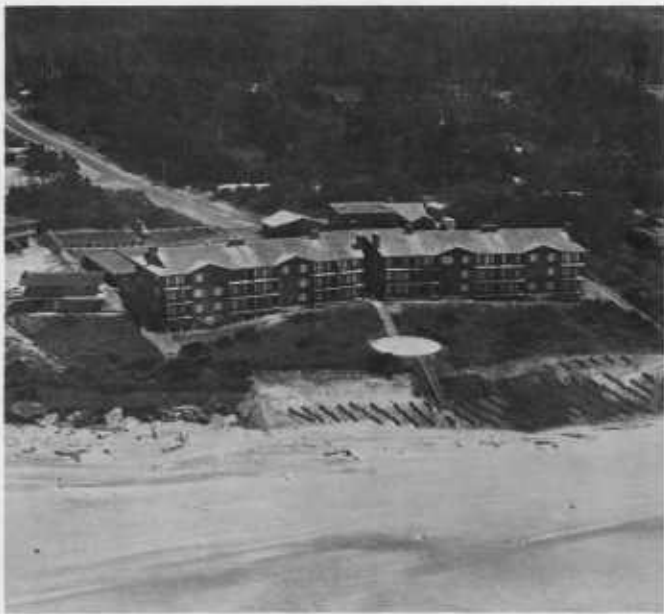
Figure 10. A coast resort motel has installed fencing and plantings to minimize slides in a slump area.

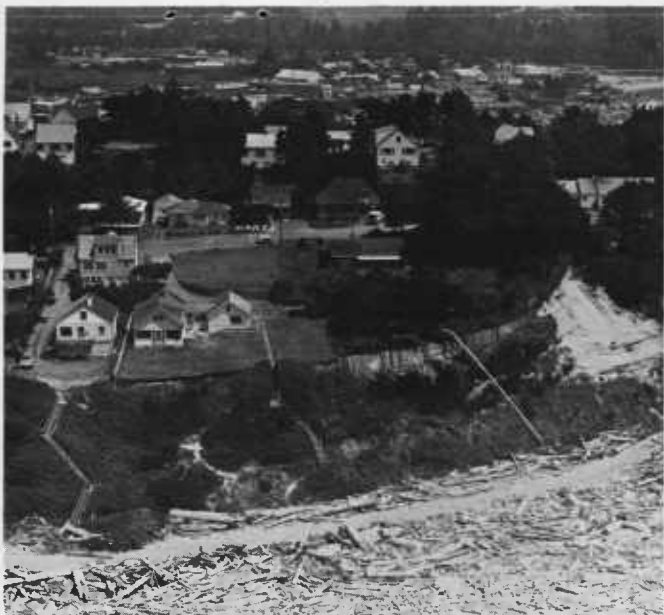
Figure 11. Dense foliage (left) and planking are two effective and inexpensive means of landslide prevention.

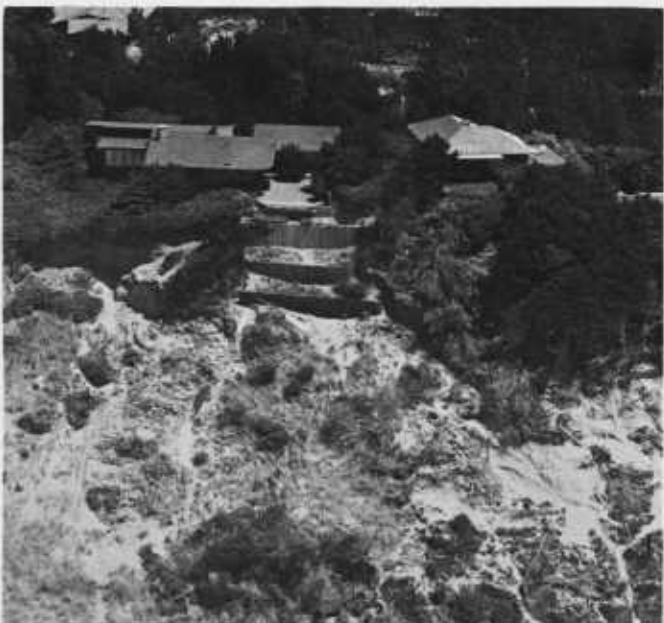
Figure 12. Tiered fencing has successfully deterred serious landsliding near this cliff-side beach house.

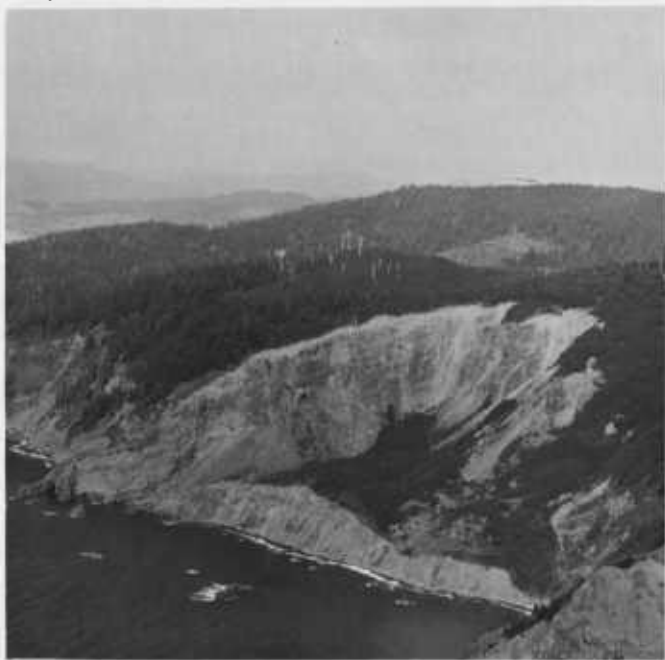
**Figure 13. Rock-terrace slump which has destroyed 20 acres of land on Cascade Head.**

Losses due to landslides have been extensive in some regions. Ecola Park, just north of Cannon Beach, and Cascade Head, north of Lincoln City, have undergone considerable alteration. Landsliding has destroyed or disrupted more than 200 acres of land in four separate slides. In 1961, the Ecola Park landslide moved about 125 acres during a two-week period. On Cascade Head, a slide in 1934 carried 20 acres of pasture down toward the sea (Figure 13). Two other landslides on Cascade Head have each destroyed more than 14 acres of grazing land.

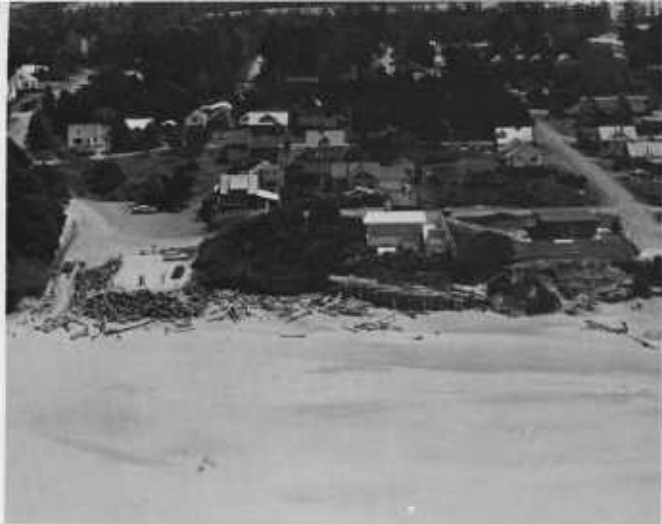
**Figure 14. Boulders (left) and stacked pilings weight the cliff base and prevent land loss from sliding.**

In the Oceanlake area of Lincoln City and near Seal Rock, north of Waldport, attempts are now being made to control the undercutting of the terrace material. Basalt boulders or riprap, piled at the base of the cliffs serve to weight the cliff base and prevent outward movement (Figure 14). Riprap also lessens the wave impact on the cliff base by providing a leading edge of resistant material to absorb much of the wave energy.

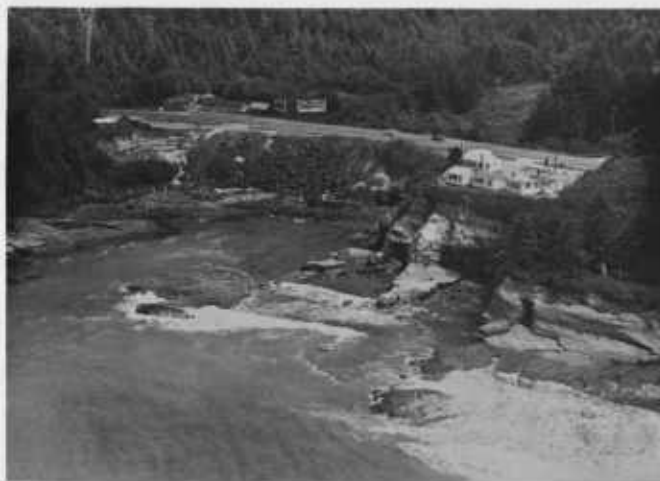
**Figure 15. Riprap at Boller Bay helps to slow down landsliding and to protect U.S. Highway 101.**

On U. S. Highway 101 at Boiler Bay, north of Depoe Bay, a successful attempt has been made to prevent waves from undercutting the highway on the east edge of the bay (Figure 15). The entire geological formation at Boiler Bay and the sand slope beneath the highway has been covered by riprap. This inexpensive measure has retarded cliff recession and probably has saved a section of the highway.

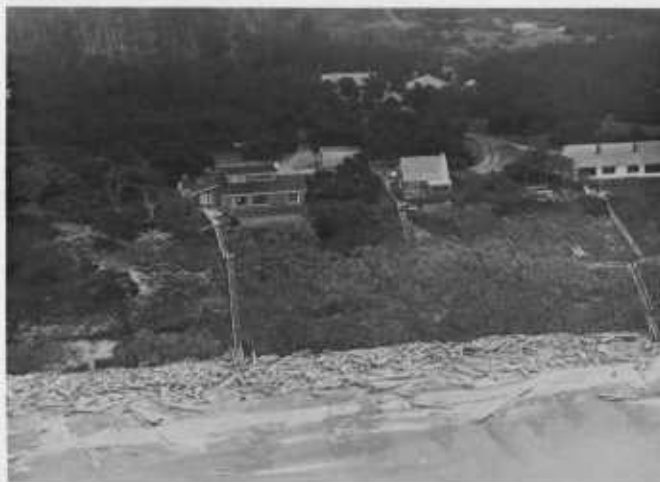
**Figure 16. Property owners with grass and shrub plantings on coastal banks have had little trouble with slides.**

in place and help to prevent rain and runoff from eroding property (Figure 16). On the inhabited slopes of Tillamook Head, property owners who allow brush and grass to flourish have had little trouble with slippage or destruction of stairs or structures on the hillside. Even in very soft terrace sands of Lincoln City, the few attempts at planting to stabilize slopes have helped ease local erosional problems. Extensive planting of grass on unconsolidated sands along the beach at Salishan is helping to hold steep slopes.

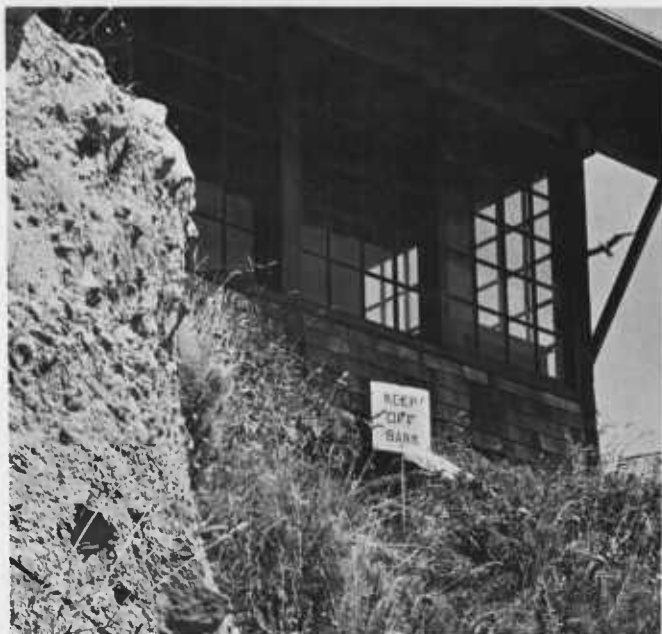
**Figure 17. A simple "keep off" sign is sometimes an effective preventive measure for landslides.**

Other preventive measures include terracing and reduction of cliff angle by lowering and leveling the cliff top and dumping extra material in front of the cliff. Wooden rain covers have been built on some cliffs. Warning signs and fences (Figure 17) have partially succeeded in protecting cliff faces from public destruction.
