Ali Jafarnejad for the degree of Master of Science in Civil Engineering presented on August 22, 2017.

Title: Investigation of Effectiveness of Radar Speed Signs and Additional Lighting for Speed Control in Highway Construction and Maintenance Work Zones

Oregon State University

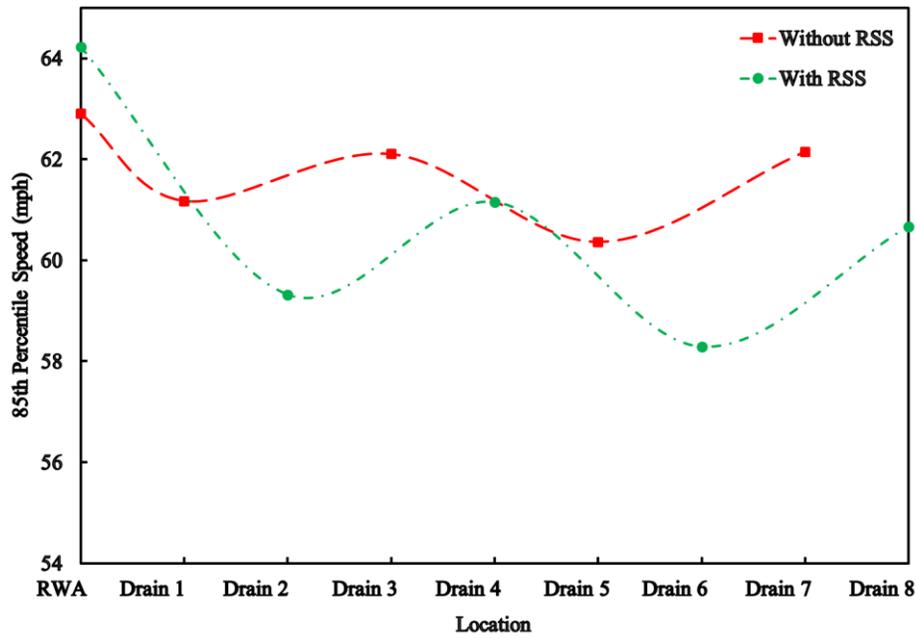
Figure 2.1 Vehicle speed (85th percentile) at different locations during operation time, I-84, Vactoring.

Figure 2.1 illustrates how the 85th percentile speed changed from the RWA signs to the end of the work zone at Drain #8 for both cases (with and without RSS turned on). The 85th percentile speeds on both nights were above the 55 mph regulatory speed limit on this section of roadway. As seen in figure 2.1, the speeds with the RSS turned on were lower than without the RSS turned on. It should be taken into consideration that the free flow speed (speed at RWA sign) in Day 2 with RSS was consistently higher than on Day 1 without the RSS turned on over the course of the testing time period.

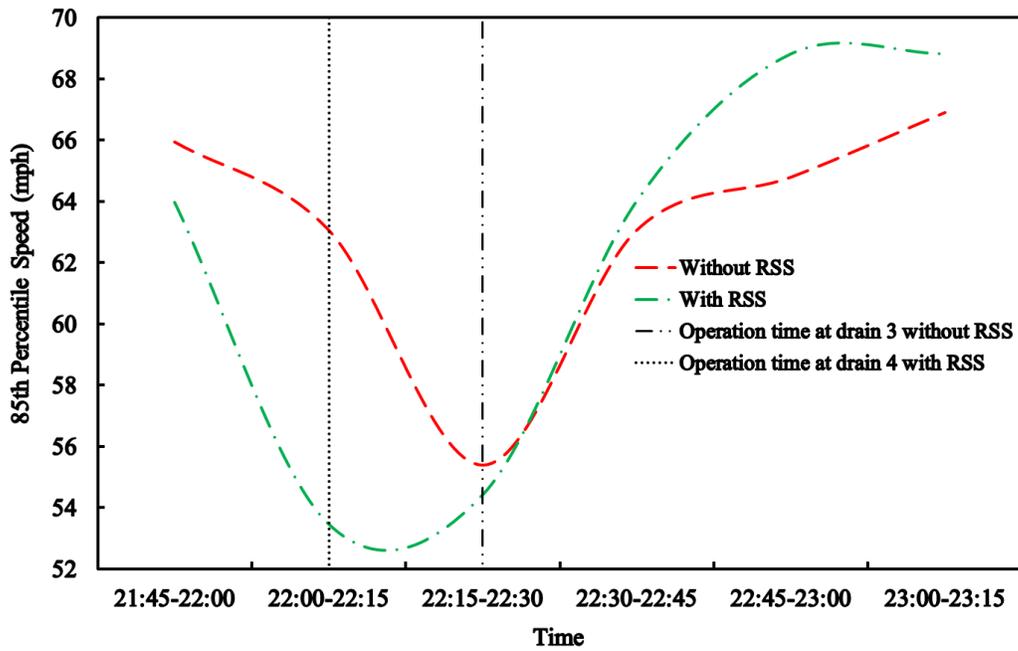
Figure 2.2 Vehicle speed (85th percentile) at drain 3 (without RSS) and drain 4 (with RSS) during operation time, I-84, Vactoring.

A comparison of 85th percentile speeds at Drain #3 (without RSS turned on) to that at Drain #4 (with RSS turned on) is shown in figure 2.2. Drains #3 and #4 were selected for illustration purposes only; similar charts showing comparisons between adjacent drains are provided in the full report (22). It can be seen that the vehicle speeds are lower when adjacent

to work equipment. For example, between 22:15 and 22:30 on Day 1 without the RSS turned on, the work took place at Drain #3. At this time, the 85th percentile speed was approximately 55.4 mph. On the second day of testing (with the RSS turned on), the work on Drain #4 took place earlier in the evening. From 22:15-22:30 on Day 2 there was no work going at Drain #4 and the 85th percentile speed was approximately 54.4 mph, slightly lower than the prior day at the adjacent Drain #3. On Day 2 with the RSS turned on, the 85th percentile speed at the location of the work equipment was less at 53.5 mph. During the whole period of operation, regardless whether the RSS display was turned on, the vehicles slow down as they approach the equipment and then speed up downstream of the work equipment. However, comparison of the figures shows that the 85th percentile speed was lower by approximately 7-8 mph with the RSS turned on as the vehicles approached the work equipment.

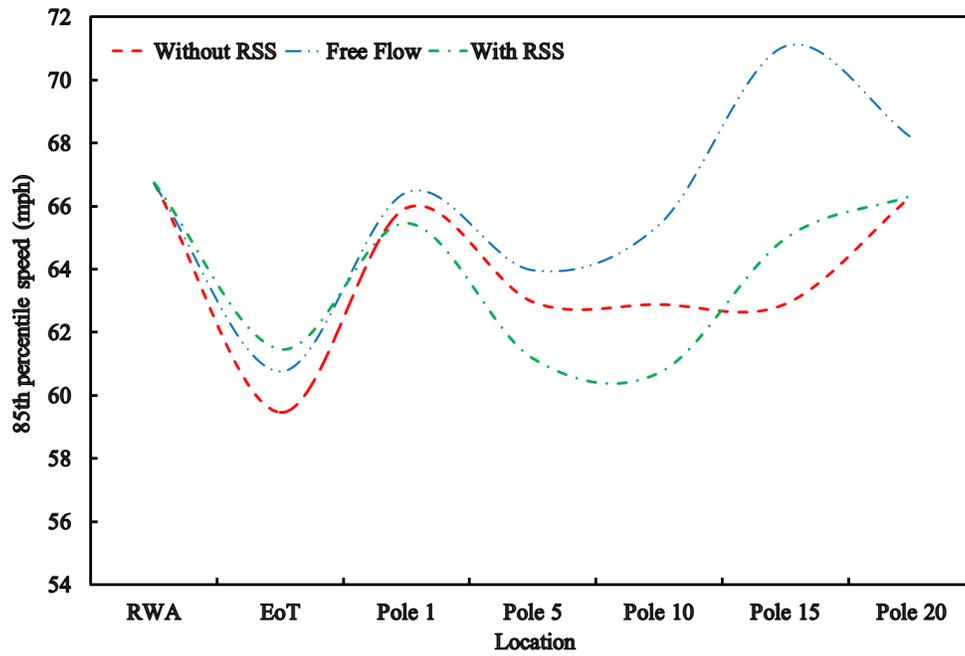
Figure 2.3 Vehicle speed (85th percentile) at different locations during operation time, I-205, Sweeping.

Similar to Case Study #1, the traffic analyzers also provided the opportunity to view the vehicle speeds at various locations through the work zone. Figure 2.3 illustrates how the 85th percentile speed changed from the RWA signs to the end of the work zone at Pole #20 for all cases (with and without RSS turned on, and free flow). As seen in the figure, for much of the work zone, the speeds with the RSS turned on were lower than without the RSS turned on. This difference ranged from approximately 1 to 3 mph.

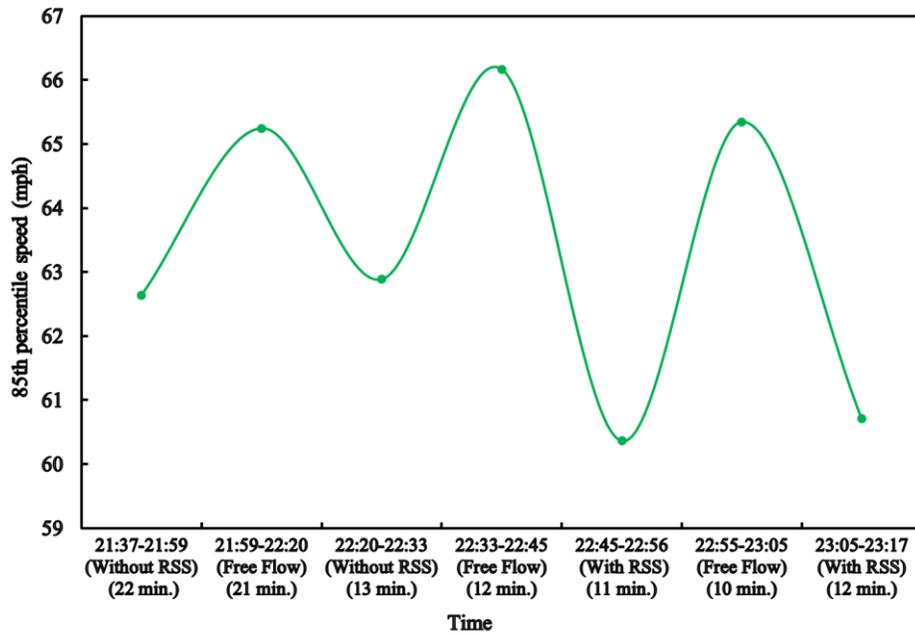
Figure 2.4 Vehicle speed (85th percentile) at pole 10 during operation time, I-205, Sweeping.

An 85th percentile speed over the testing period is illustrated in figure 2.4. The 85th percentile speed was consistently lower (by about 2 – 2.5 mph) than without the RSS turned on over the course of the testing time period. Free flow speeds while the sweeping equipment was

returning to the start of the work area to make another pass were always higher than the periods when the sweeping operation was taking place.

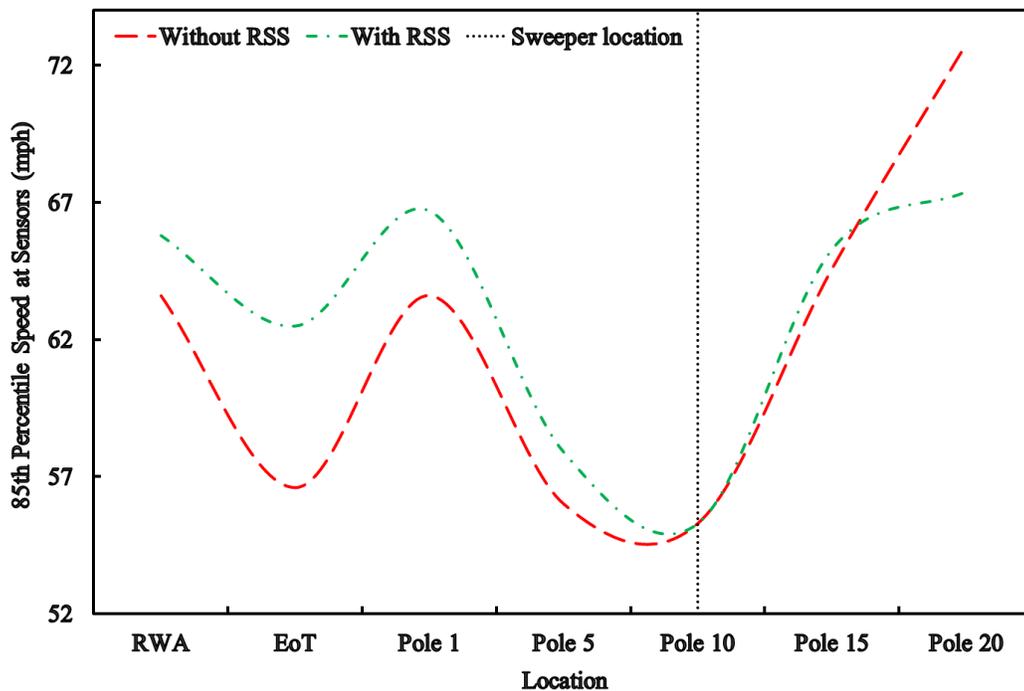
Figure 2.5 85th percentile speed at different distances from the operation, I-205, Sweeping, pole 10.

A comparison of 85th percentile speeds at Pole #10 with and without the RSS turned on is shown in figure 2.5. Pole #10 was selected for illustration purposes only. The figure illustrates the effect of the presence of the work equipment at Pole #10. The vehicles slow down as they approach the work operation and then speed up afterwards. Over the same distance, the amount of decrease was greater with the RSS display turned on. For example, from Pole #1 to Pole #10, the speeds decreased from approximately 67 to 55 mph (12 mph decrease) with the RSS turned on, and from approximately 64 to 55 mph (9 mph decrease) without the RSS turned on.

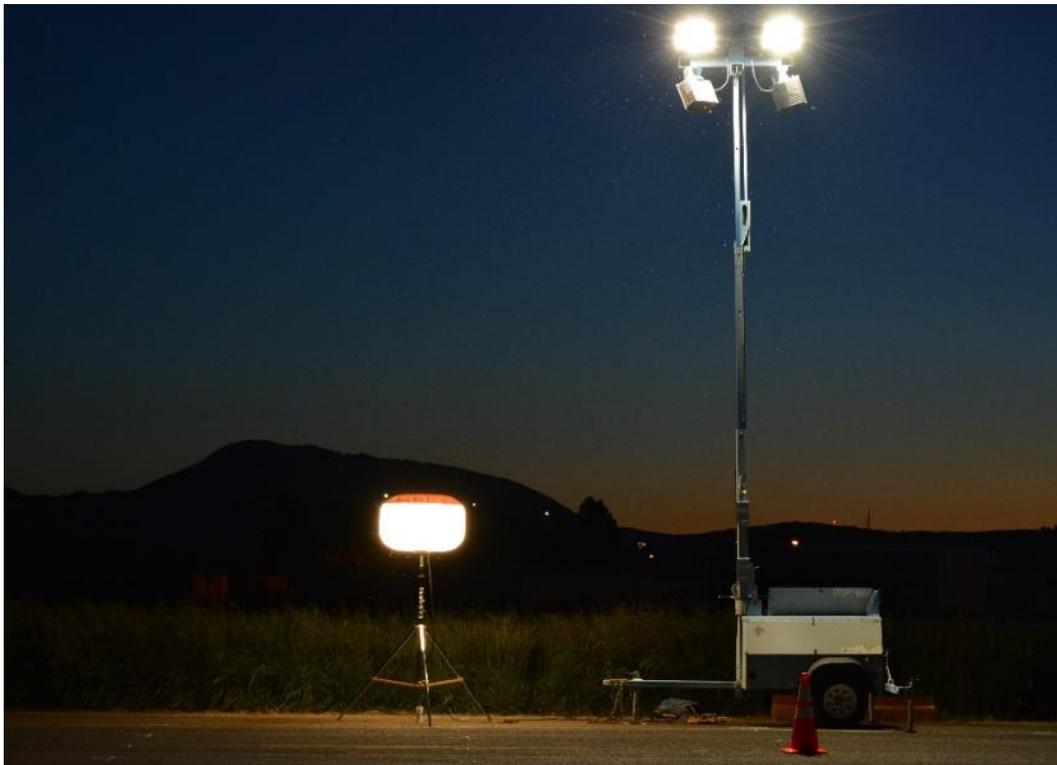
Figure 3.1 Lighting equipment tested: balloon light (left) and light tower (right).

Temporary lighting equipment used in case studies included a standard light tower (light plant) and a balloon light (Figure 3.1). The light tower includes four light fixtures containing 1,000-watt lamps mounted to a mast arm capable of holding the luminaires at various mounting heights and angles. The actual light towers available for use during each case study were provided by the contractor. For each case study, a balloon light was also implemented. The balloon light consisted of a large balloon-type luminaire atop a portable tripod mast and powered by a portable generator. It was an Airstar balloon light, Sirocco 2000, mounted on a tripod with two 1,000-watt halogen lamps surrounded by an envelope (balloon) that is 3 feet in diameter and 2 feet tall.

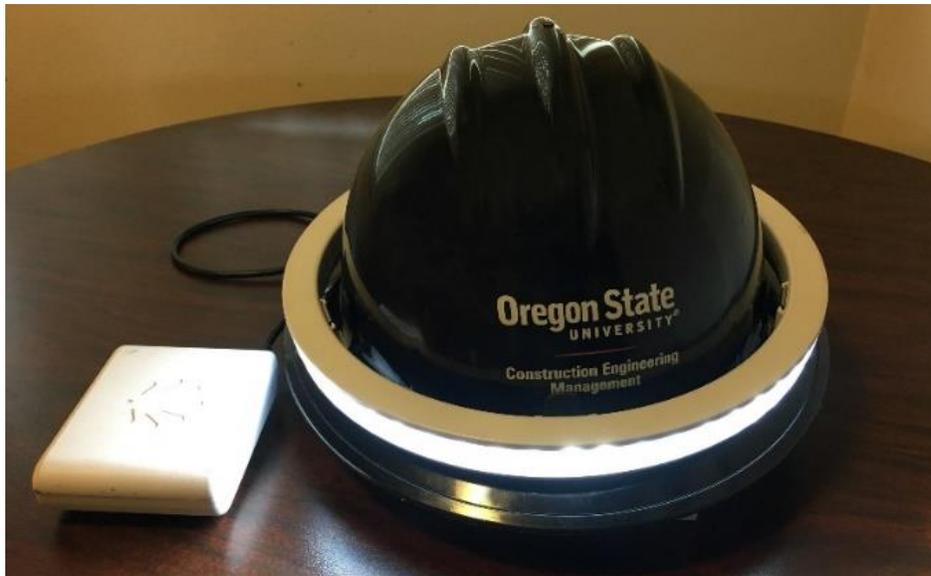
Figure 3.2 Personal wearable light (Halo Light by Illumagear) attached to hardhat.

The wearable light used by workers was a Halo Light by Illumagear attached to their hardhats. It produces a ring of light around the wearer, enabling him/her to see the surroundings and be seen in all directions. Providing up to 276 lumens of power in 360°, the light illuminates the wearer's task area and makes them more visible (Figure 3.2). Two workers, the density technician and dump person, who are on foot and typically located in more hazardous locations, were asked to wear a Halo Light. The workers were asked to turn on and off the light every two hours during each working shift. For example, from 0:00-02:00 the light was turned on and from 02:00-4:00 it was turned off.

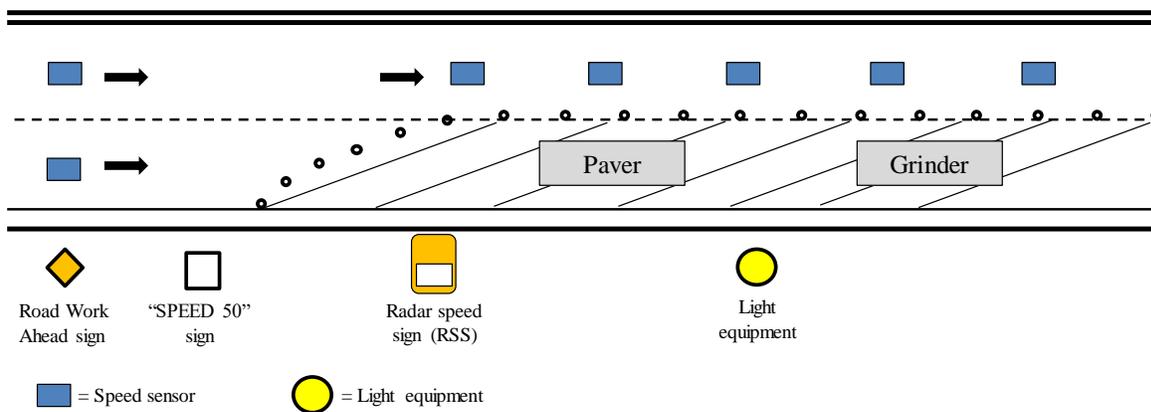
Figure 3.3 Example of traffic control devices, analyzers, and light equipment placement in the work zone.

A total of 17 portable traffic analyzers (NC-200 and NC-350) were used to collect vehicle data on the roadways. The data collected includes the passing vehicle speed, length, and time of passing. Prior to the start of work during each night of data collection, all of the traffic analyzers were programmed to start recording data at a designated time. The sensors were secured to the pavement using adhesive tape which completely covered each analyzer and its protective cover. The first two analyzers were placed near the “Road Work Ahead” (RWA) sign to capture vehicle speeds before the vehicles entered the work zone. One analyzer was placed at the end of the taper. Additional analyzers were placed in the travel lane at increments of approximately every quarter mile in the working area. Figure 3.3 shows an example of a plan view of the portable traffic analyzer placement for a typical night of testing. The locations of the portable traffic analyzers are indicated with rectangles in the figure. The sensors remained in place during the entire duration of the work on each work night. At the

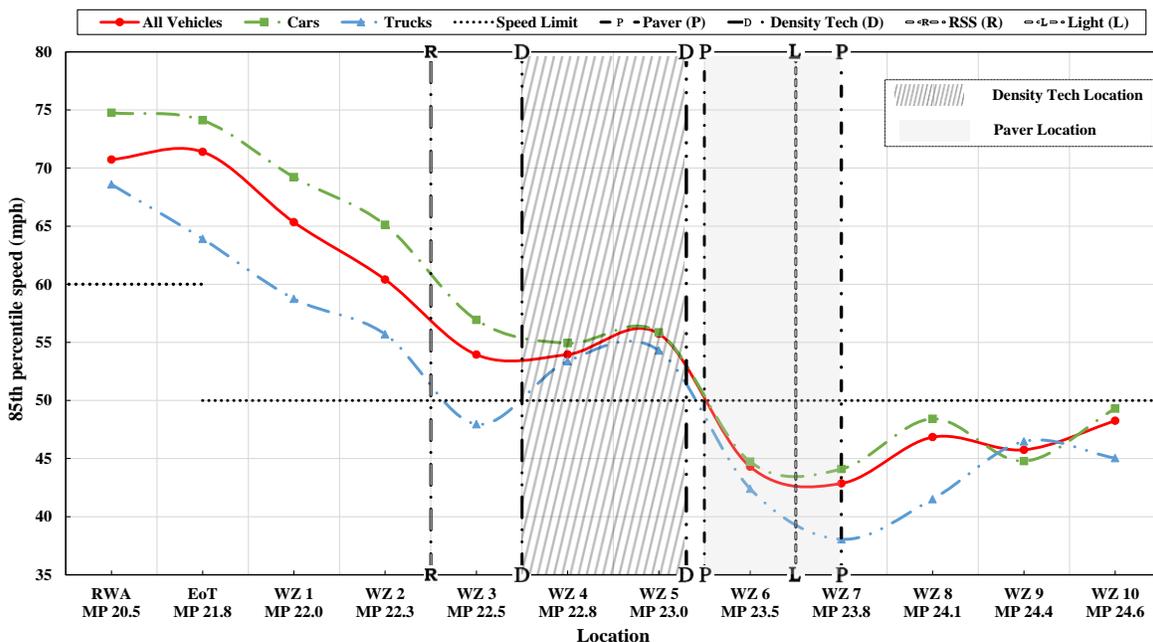
Figure 3.4 Vehicle speed (85th percentile) at different locations, 0:00-1:00, Day 3, Case study #1.

length) was typically 5 to 10 mph higher than the 85th percentile speed of trucks. The 85th percentile speed of all vehicles was commonly approximately 70-75 mph at the RWA sign. Entering the work zone, the vehicle speed decreased gradually until the RSS location. After the vehicles passed the RSS, if there was no construction equipment present, the vehicle speed increased. The lowest 85th percentile speed, ranging from 40-42 mph, typically occurred adjacent the paver. There is no noticeable change in 85th percentile speed around the light when it was in the middle of the paving train.

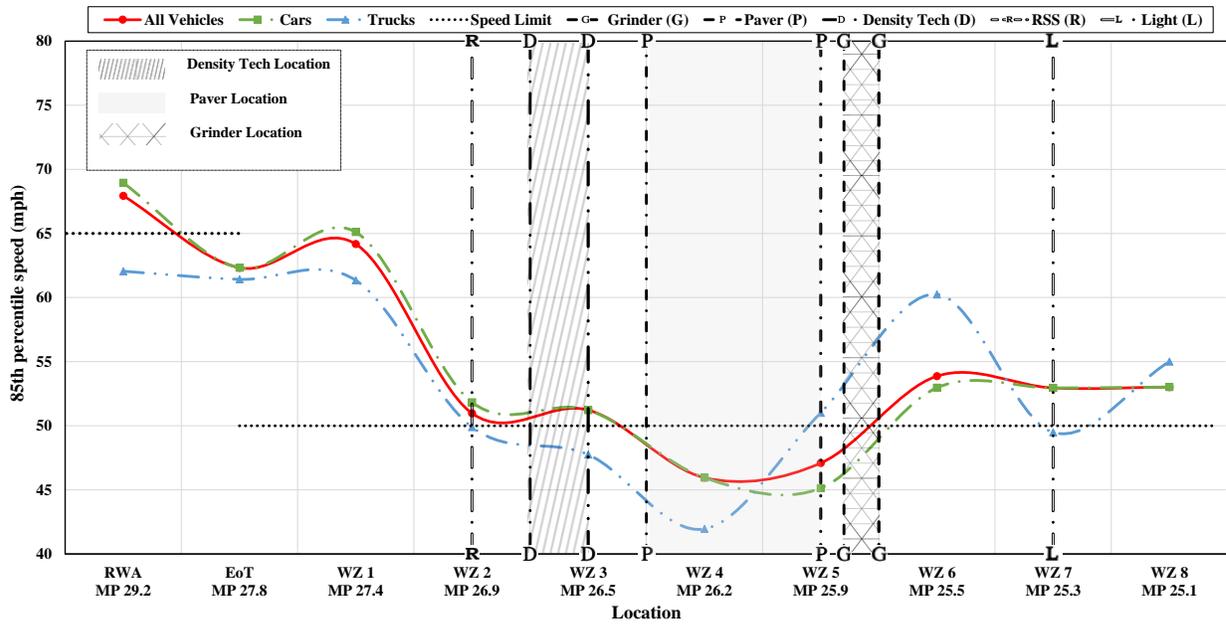
Figure 3.5 Vehicle speed (85th percentile) at different locations, 0:00-1:00, Day 3, Case study #2.

Figure 3.5 show how the 85th percentile speed changed from the RWA sign location to the end of the work zone on Day 3 for case study #2. Similar to case study #1, the locations of the grinder, paver, and density technician were tracked with a GPS unit to understand their impact on vehicle speed. The figures show that the 85th percentile speed of passing vehicles decreased from 65-70 mph at the RWA sign to a lower speed at the end of the taper (EoT) at milepoint (MP) 27.8. Speed continued decreasing until the location of the RSS. Then, if paving equipment was near the RSS, the decreasing trend would continue and after passing the paver the speed started to increase. Otherwise, after the RSS (without paving equipment present) the speed increased and then decreased again downstream near the paver. The sensor near the light (on this day, the balloon light) shows a subtle drop in 85th percentile vehicle speed.
