Geotechnical Effects of the 2015 Magnitude 7.8 Gorkha, Nepal, Earthquake and Aftershocks

by Robb E. S. Moss, Eric M. Thompson, D. Scott Kieffer, Binod Tiwari, Youssef M. A. Hashash, Indra Acharya, Basanta Raj Adhikari, Domniki Asimaki, Kevin B. Clahan, Brian D. Collins, Sachindra Dahal, Randall W. Jibson, Diwakar Khadka, Amy Macdonald, Chris L. M. Madugo, H. Benjamin Mason, Menzer Pehlivan, Deepak Rayamajhi, and Sital Uprety

This article summarizes the geotechnical effects of the 25 April 2015 M 7.8 Gorkha, Nepal, earthquake and aftershocks, as documented by a reconnaissance team that undertook a broad engineering and scientific assessment of the damage and collected perishable data for future analysis. Brief descriptions are provided of ground shaking, surface fault rupture, landsliding, soil failure, and infrastructure performance. The goal of this reconnaissance effort, led by Geotechnical Extreme Events Reconnaissance, is to learn from earthquakes and mitigate hazards in future earthquakes.

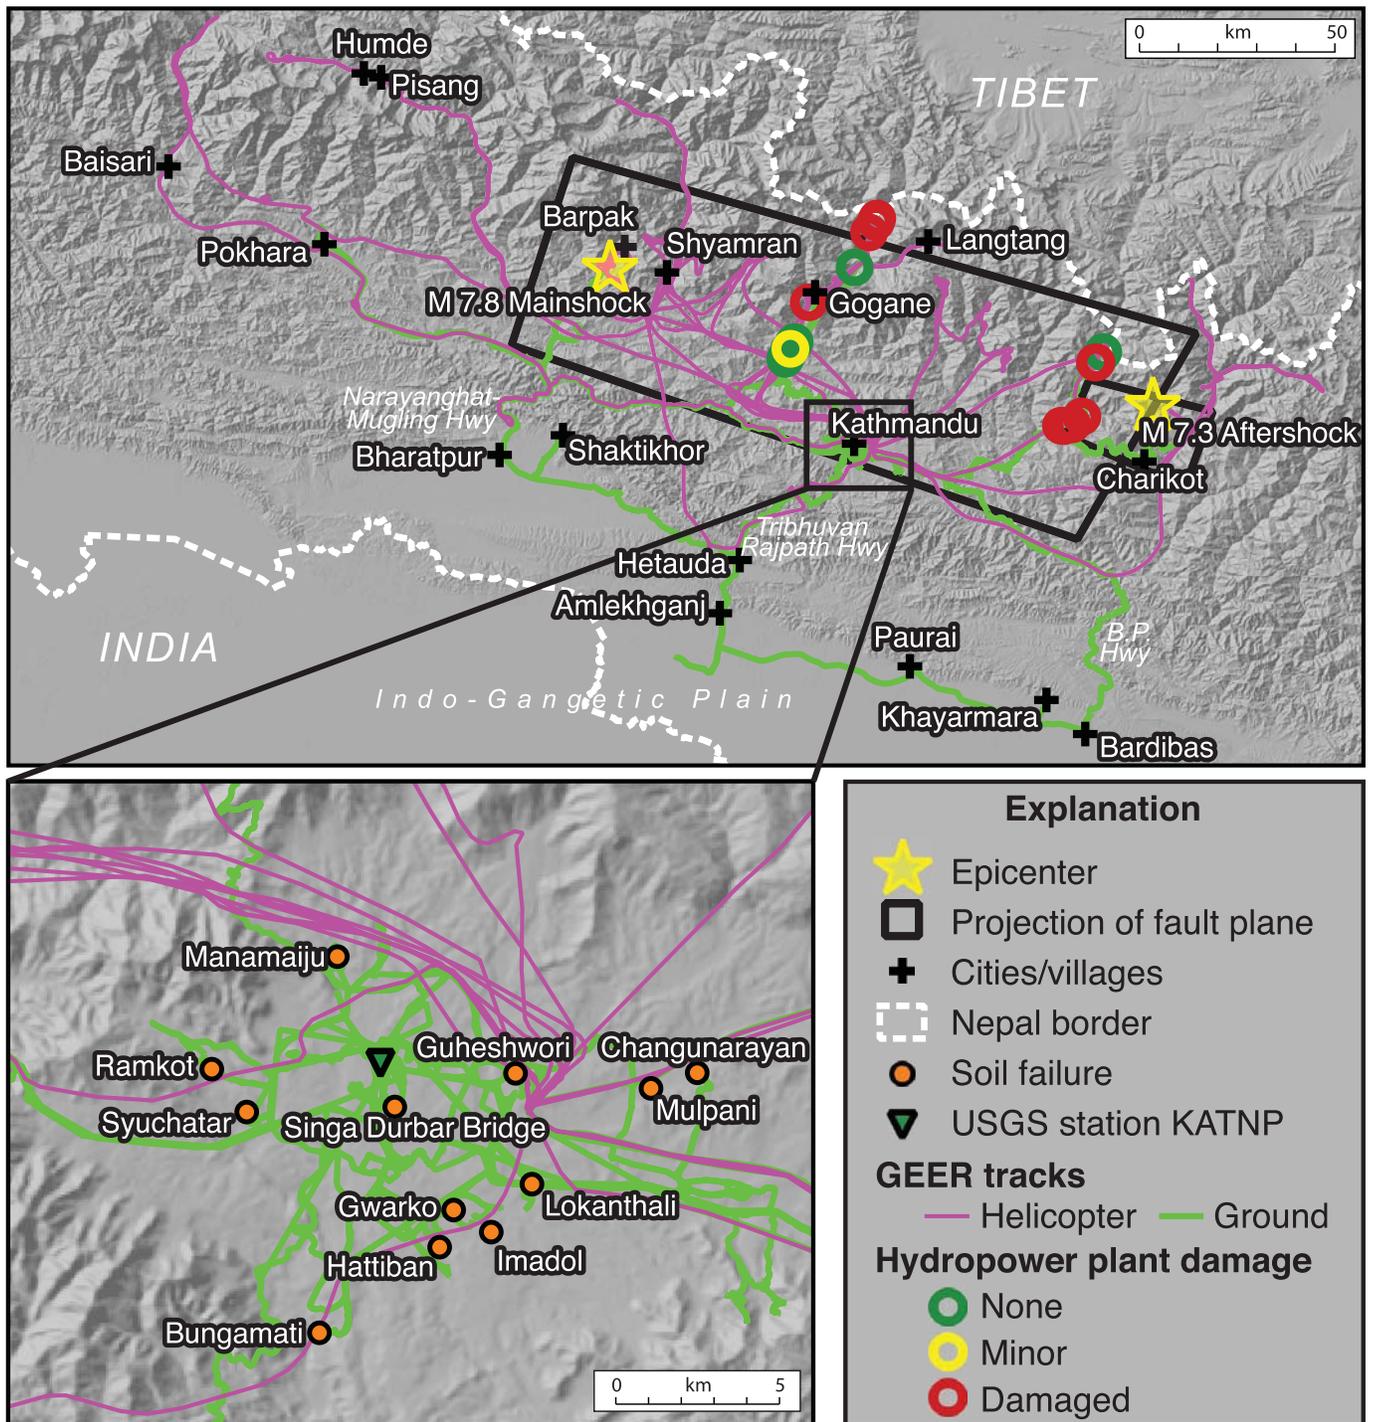
▲ **Figure 1.** (a) The epicenters and extent of the surface projection of the fault planes for the **M 7.8** mainshock and **M 7.3** aftershock, selected cities and villages referenced in this article, the Global Positioning System (GPS) tracks of the Geotechnical Extreme Event Reconnaissance (GEER) teams, and a simplified representation of the observed damage to hydropower projects. There are more hydropower symbols than there are hydropower projects visited by GEER, because we visited multiple sites (e.g., headworks, penstocks, dams, and powerhouses) associated with each hydropower project. (b) Enlarged view of the Kathmandu Valley shows the locations of soil failure investigated by GEER and the location of U.S. Geological Survey (USGS) station KATNP in Kathmandu. The basemap relief is from [Jarvis et al. \(2008\)](#).

Extensive ground-based field investigations of the MFT and MBT were conducted by members of the GEER team, as well as by other researchers ([Angster *et al.*, 2015](#)). The ground tracks in Figure 1 indicate where we looked for surface rupture

during our investigation. The MBT was observed along the Narayanghat–Mugling Highway north of Bharatpur and near the village of Shaktikhor, along the Tribhuvan Rajpath Highway north of the town of Hetauda, and along the B.P. Highway north of Bardibas (Fig. 1). No evidence of surface rupture or associated ground deformation, such as ground warping or tilting, was identified by the GEER team or reported by residents. Other effects of the earthquake, such as elevated groundwater levels and substantially increased spring and streamflow volumes, were reported in the watersheds all along the MBT for more than several weeks following the 25 April 2015 Gorkha earthquake.

GEER team members investigated most major drainages in the broad epicentral region of the Gorkha earthquake sequence (specific tracks are given in Fig. 1). We observed thousands of landslides and estimate that the total number of landslides triggered is in the few tens of thousands, which includes landslides in China that were not directly investigated in the field ([Collins and Jibson, 2015](#)). This estimate is consistent with previously developed relationships between earthquake magnitude and number of landslides: the [Malamud *et al.* \(2004\)](#) relationship predicts about 25,000 landslides, and the [Keefer \(2002\)](#) relationship predicts about 60,000 landslides for an M 7.8 earthquake.

The GEER team observed soil failure around the Kathmandu Valley in many locations (Fig. 1b). Most of the soil failures are classified as “incipient,” indicating evidence of soil failure that did not result in appreciable deformations. For example, sand boils, ground cracks, and minor building tilt (<2°) were observed in Manamaiju, but the buildings were not seriously damaged. Forecasts (e.g., Piya, 2004) of the amount and scale of liquefaction in the Kathmandu Valley were not realized for many possible reasons:

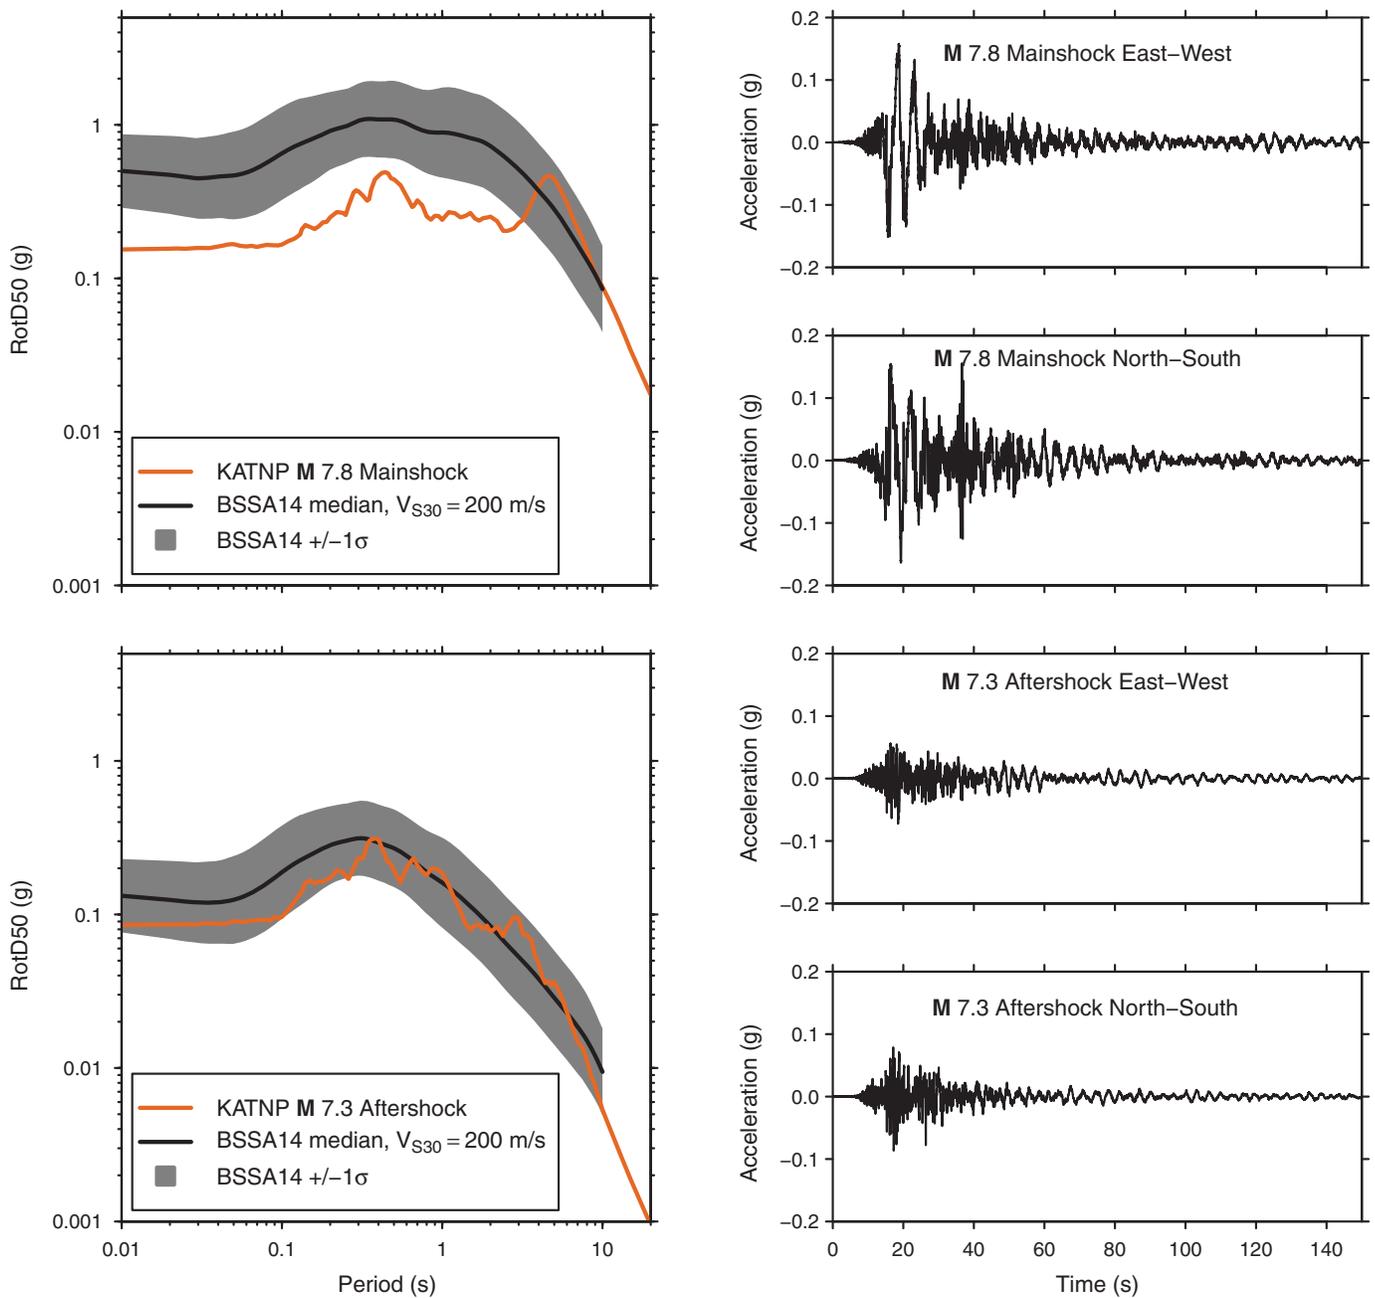
▲ **Figure 2.** Ground shaking from the (top row) **M 7.8** Gorkha earthquake and the (bottom row) **M 7.3** aftershock recorded at station KATNP. (Left) Orientation-independent response spectral acceleration (RotD50) compared with the [Boore et al. \(2014\)](#), labeled BSSA14) ground-motion prediction equation (GMPE). (Right) Horizontal-component time histories. V_{S30} is the time-averaged shear-wave velocity to 30 m depth.

The 2015 earthquake sequence was poorly recorded; and, as of the date of this publication, only one strong-motion recording has been made available to the greater scientific community (station KATNP, administered by the U.S. Geological Survey [USGS]; location given in Fig. 1b). (Other strong-motion instruments apparently recorded the earthquakes, but an embargo of the data has precluded access). The lack of near-source instrumental records highlights the importance of macroseismicity as the only means for quantifying the shaking intensity; this is discussed in detail by [Martin *et al.* \(2015\)](#). Despite the large magnitude of the 25 April 2015 mainshock (M 7.8) and the short distance from Kathmandu to the rupture plane (~ 10 km), station KATNP exhibited anomalously low energy at short periods (< 1 s). This is consistent with the findings of [Martin *et al.* \(2015\)](#), which show that, relative to the [Szeliga *et al.* \(2010\)](#) empirical equations, the shaking intensity was lower than expected at short distances (< 100 km) but consistent with expectations at larger distances (> 100 km). Figure 2 shows the rotation-independent response spectral acceleration RotD50 ([Boore, 2010](#)) against the [Boore *et al.* \(2014\)](#) ground-motion prediction equations (GMPEs) for both the M 7.8 mainshock and M 7.3 aftershock. Although the [Boore *et al.* \(2014\)](#) equations were developed primarily with ground motions from the western United States (WUS), they provide an approximate analog to Nepal because both are active crustal regions. Similarly, the GMPE selection scheme employed by ShakeMap ([Garcia *et al.*, 2012](#)) uses a WUS GMPE for this region. The [Boore *et al.* \(2014\)](#) equations predict a peak ground acceleration (PGA) of $0.49g$ for the M 7.8 earthquake, which is much higher than the recorded PGA of $0.16g$. Because of the data paucity, however, the factors that shaped the amplitude and frequency content of the mainshock are still poorly understood.

The low amplitude of short-period shaking in the mainshock is a peculiar characteristic of this event. The observation that the short-period energy of the M 7.3 aftershock is well modeled by [Boore *et al.* \(2014\)](#) is evidence that the lack of short-period energy is related to the specific source process of the M 7.8 mainshock rather than the properties of the crust or basin. Although the response spectrum of the mainshock appears to be rich in energy at long periods, the comparison to [Boore *et al.* \(2014\)](#) shows that it is not especially large for an earthquake of this size recorded at a soft soil site. For the comparisons in Figure 2, we assume the time-averaged shear-wave velocity in the upper 30 m (V_{S30}) is 200 m/s, based on horizontal-to-vertical ratios at station KATNP by [Paudyal *et al.* \(2012\)](#).

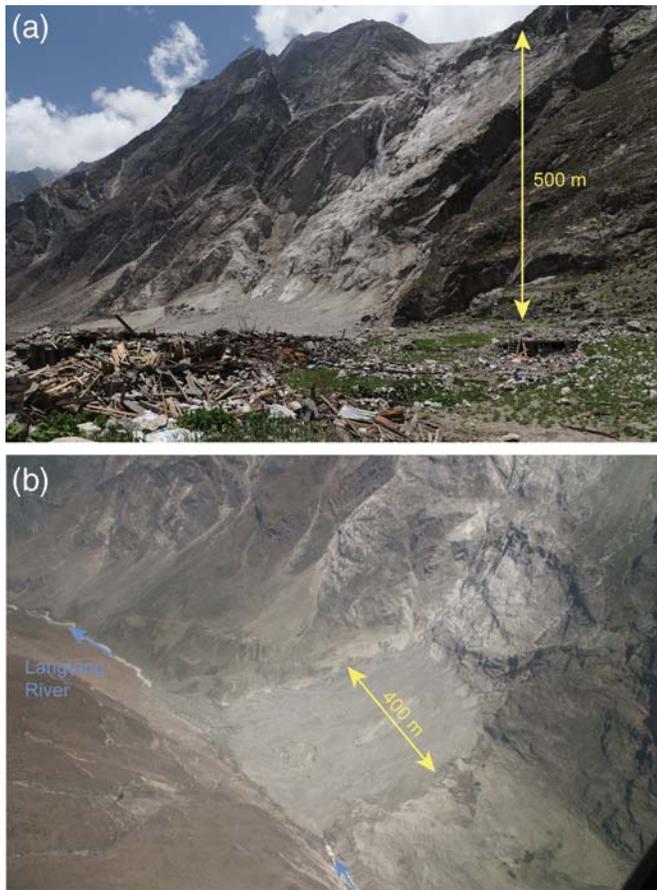
▲ **Figure 3.** The Langtang debris avalanche (28.2121° N, 85.4991° E), which destroyed the entire village of Langtang either through direct impact or by consequent air blast. An estimated 200 people were killed in this single event. (a) Oblique northwest view of deposit with cliff from which the debris became airborne. Buildings in foreground were pushed over by the ensuing airblast. (b) Aerial view of deposit showing location of the Langtang River tunnel through ice and debris (blue arrows). Reproduced from Collins and Jibson (2015).

The largest and most destructive landslide resulting from the earthquakes was the Langtang debris avalanche (see map in [Fig. 1](#); photo in [Fig. 3](#)), which began as a snow and ice avalanche and entrained debris before becoming airborne off a 500-m-tall cliff. Estimates of the velocity of the airborne landslide debris approach 100 m/s ([Collins and Jibson, 2015](#)). A few outlying structures on the east end of the village were not buried but were flattened by an accompanying air blast generated by the speed and volume of the debris avalanche. In

addition to destroying many structures, the air blast completely flattened the forest for about 1 km in each direction up and down the valley, as well as all the way up to the tree line on the south (opposing) valley slope. Trees were stripped of branches and bark and were laid down in a radial pattern outward from the deposit. The estimated volume of the Langtang landslide is 2,000,000 m³, and the estimated number of fatalities is approximately 200 (Collins and Jibson, 2015).

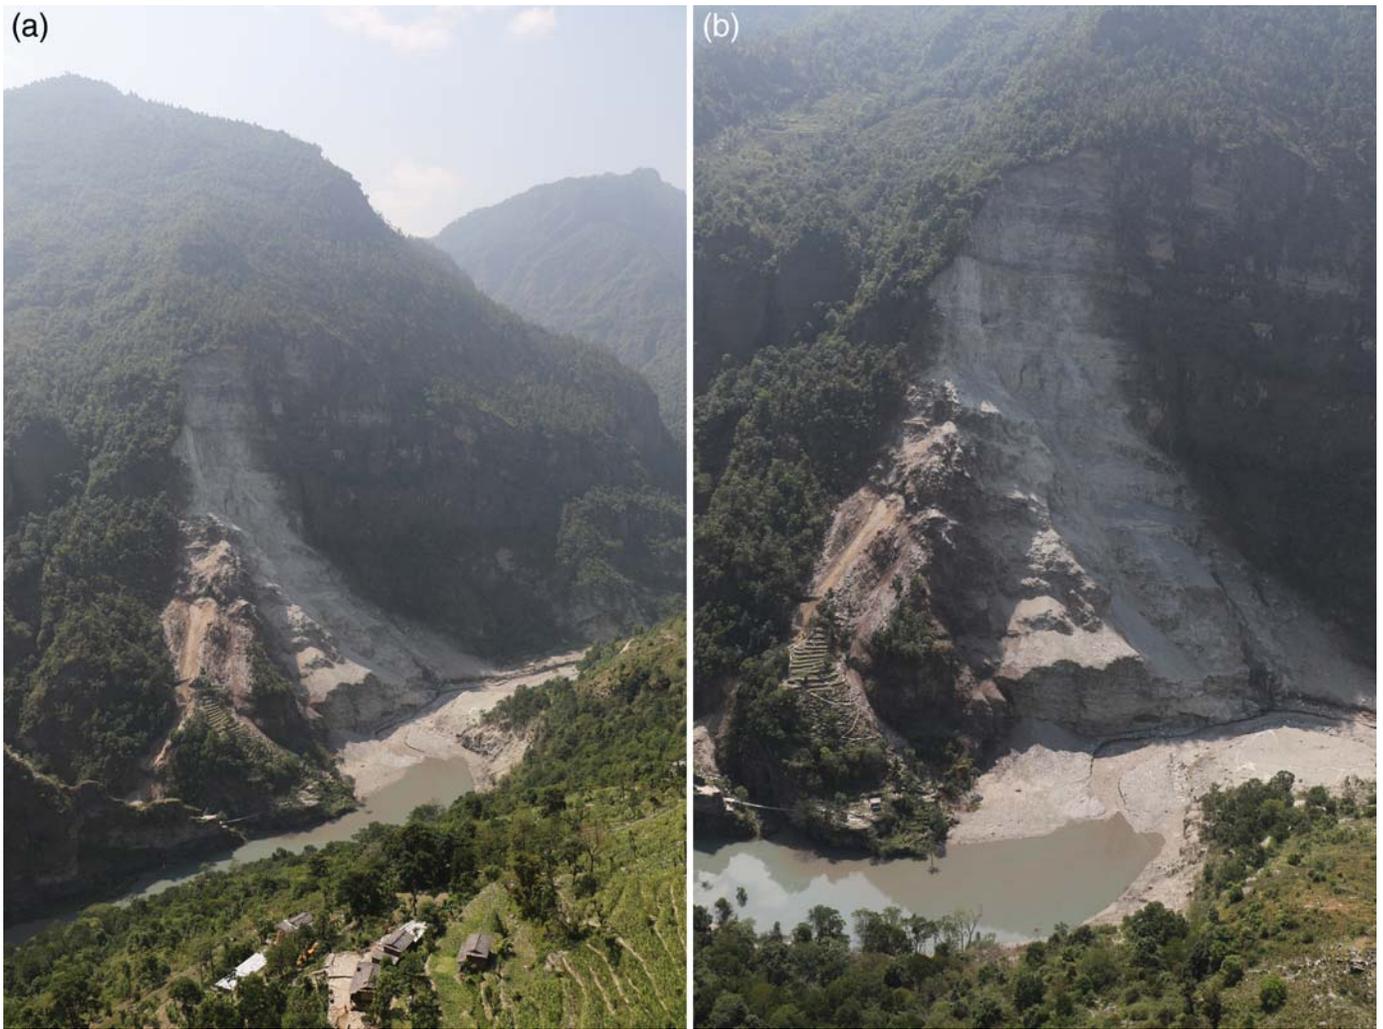
▲ **Figure 4.** Rock slide (28.4026° N, 83.6017° E) along the Kali Gandaki River on 24 May 2015 that buried the village of Baisari and blocked the flow of the river for 16 hours nearly one month following the main earthquake shock (a,b). Progressive failure of the nearly 350-m-tall rock mass through the weathered bedrock profile is thought to have led to its eventual collapse. Reproduced from [Collins and Jibson \(2015\)](#).

Several important valley-blocking landslides also occurred, the most notable of which buried the village of Baisari on the Kali Gandaki River (Fig. 4; 28.4026° N, 83.6017° E) several weeks after the mainshock. The rockslide at Baisari, with an estimated volume of 300,000 m³, failed progressively. According to interviews with members of the Nepal Army, cracks were observed in the cliff following the April 2015 M 7.8 earthquake, and these cracks widened during the M 7.3 earthquake on 12 May 2015. Ten days later, rocks began falling from the

cliff, prompting evacuation of Baisari. Two days after that, at about 1:00 a.m. local time on 24 May, the slope above the river failed; the resulting landslide dammed the river and buried the entire village, including 27 homes, under about 30 m of landslide debris. The lake overtopped the dam 16 hours later. Authorities were able to evacuate the downstream villages just prior to its failure.

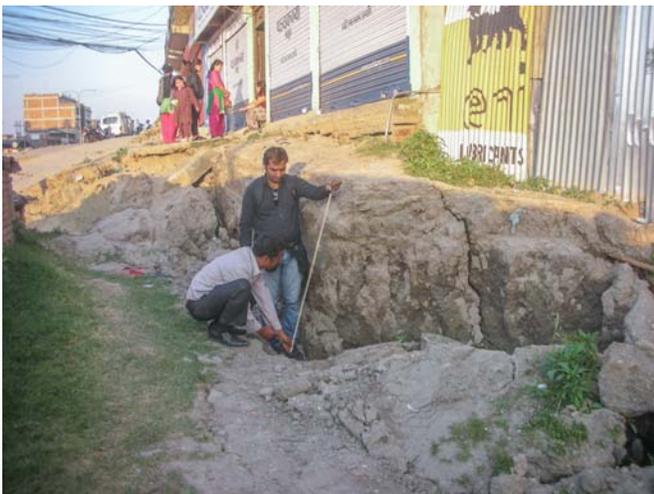
▲ **Figure 5.** Measurement of one of the locations having the largest offsets that was observed in the Lokanthali area along the Arniko Highway (27.67439° N and 85.36267° E).

Many of the soil-failure sites liquefied, as indicated by the presence of sand boils (e.g., Manamaiju, Bungamati, Changuarayan, and Mulpani). However, an interesting ground failure occurred along the Arniko Highway in Lokanthali (27.67439° N, 85.36267° E), where lateral cracks having 2-m-deep fissures and as much as 1.5 m of nearly vertical offset occurred over a large area on or near ground sloping toward a river channel (see the photo in [Fig. 5](#) and a map of the fissures in [Fig. 6](#)). The lack of evidence for liquefaction, reports that the failure progressed slowly, and the observation that the slip surface extended into the weak black cotton clay led to an initial assessment that these failures resulted from cyclic failure (i.e., structural breakdown of clay particles) in the black cotton clay, for which lab tests indicated moderate sensitivity and a liquidity index greater than one. Subsequent trenching and hand-

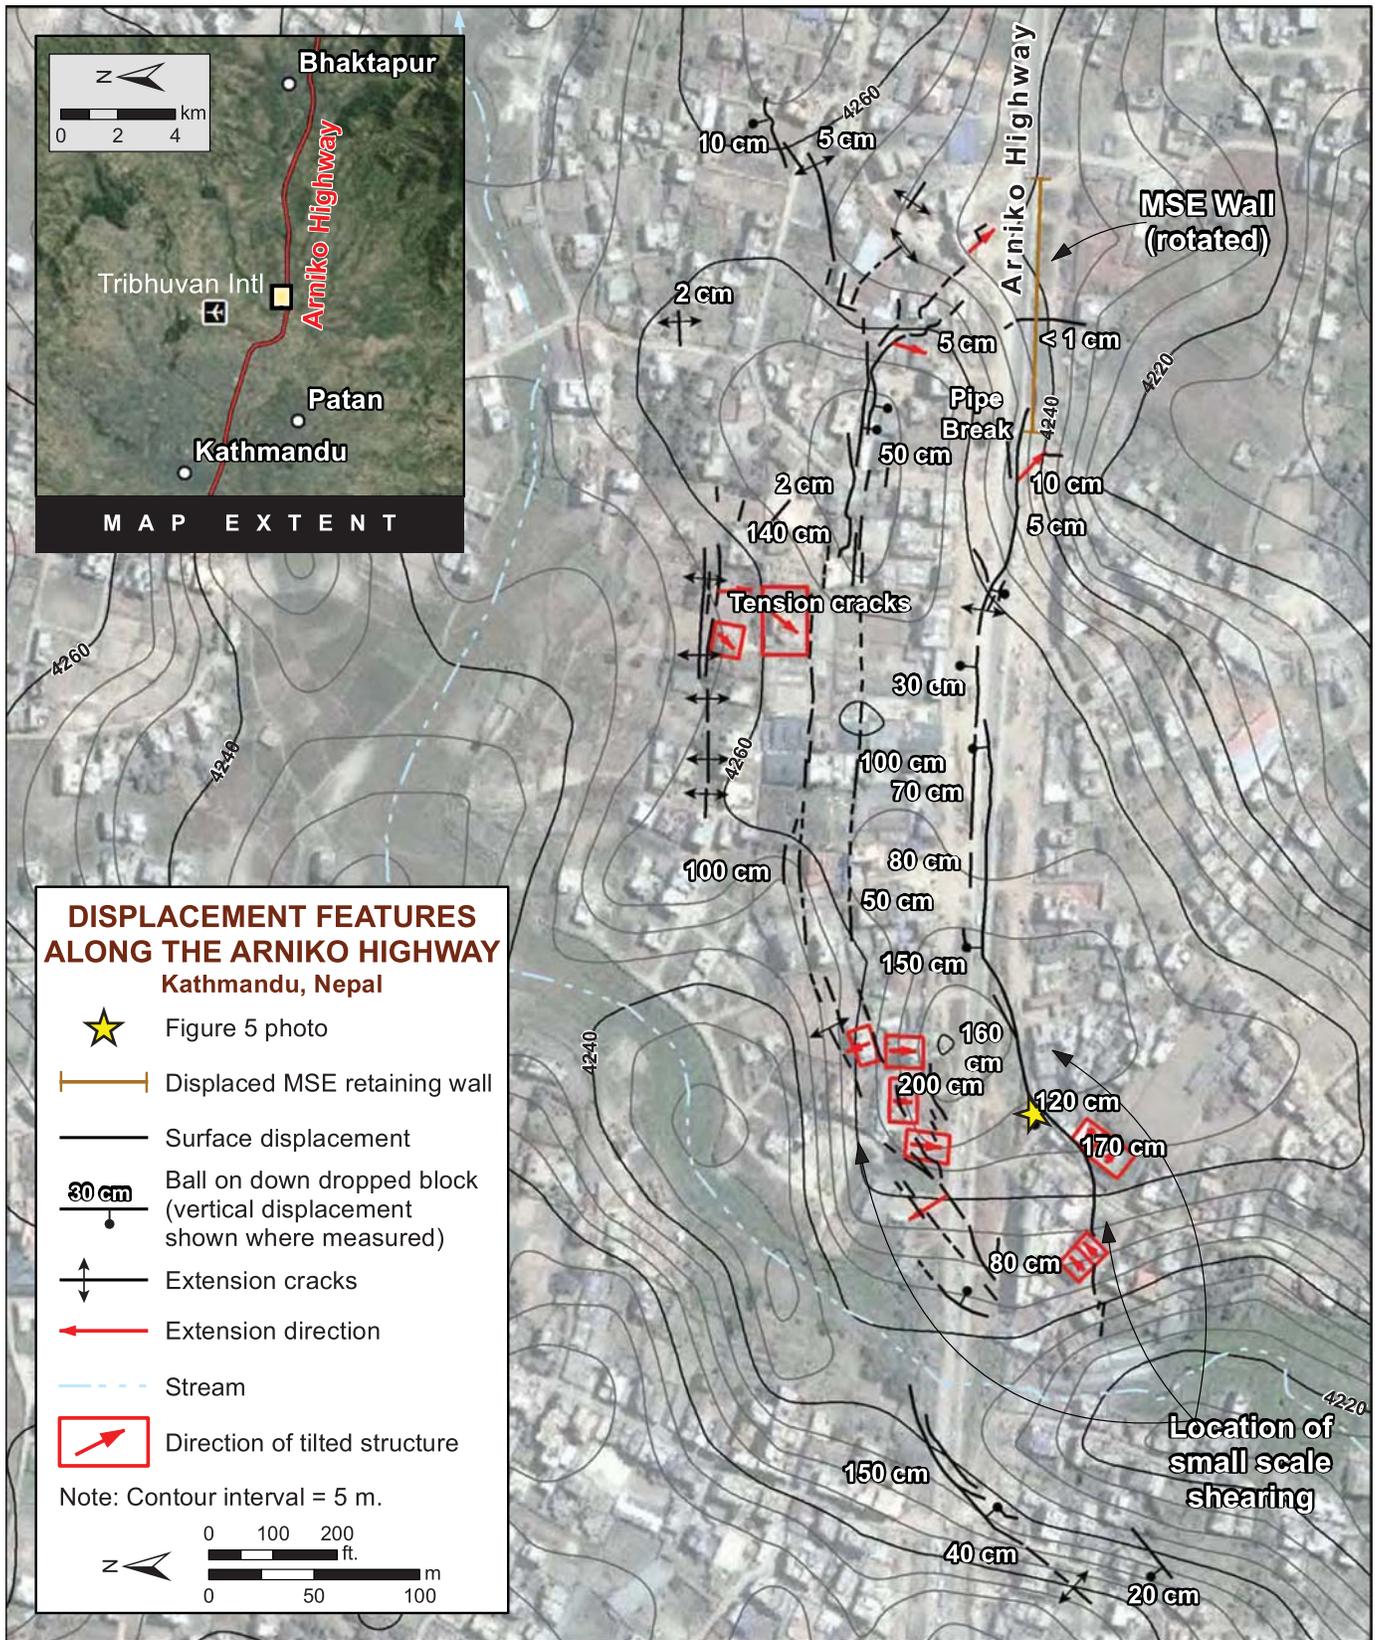
▲ **Figure 6.** Mapped ground cracks or fissures in the Lokanthali area along the Arniko Highway. Extensive cracking had lateral deformations as great as 2 m and vertical deformations as great as 1.5 m.

augering revealed more complex failure planes that were not evident on the surface. A 2.5-m-deep trench revealed buried liquefaction escape structures capped by fine-grained fluvial overbank deposits and fill layers. The 2015 slip surface appears to have offset a sand layer that had been injected from a previous event and extended down into a massive sand layer > 1 m thick, suggesting that these failures are lateral spreads. It is also possible that both cyclic failure and liquefaction contributed to the soil failure in and around Lokanthali. We saw similar ground fissures in Syuchatar (27.69723° N, 85.27408° E); however, that site did not experience the large displacements observed in Lokanthali.
