POTENTIAL HATCHERY SITES ON OREGON COASTAL STREAMS

Delbert G. Skeesick
Thomas F. Gaumer
Fish Commission of Oregon

Final Subproject Report
Prepared under
Anadromous Fisheries Act Project AFC-21
with the
Bureau of Commercial Fisheries,
Fish and Wildlife Service,
U.S. Department of Interior

November 1969

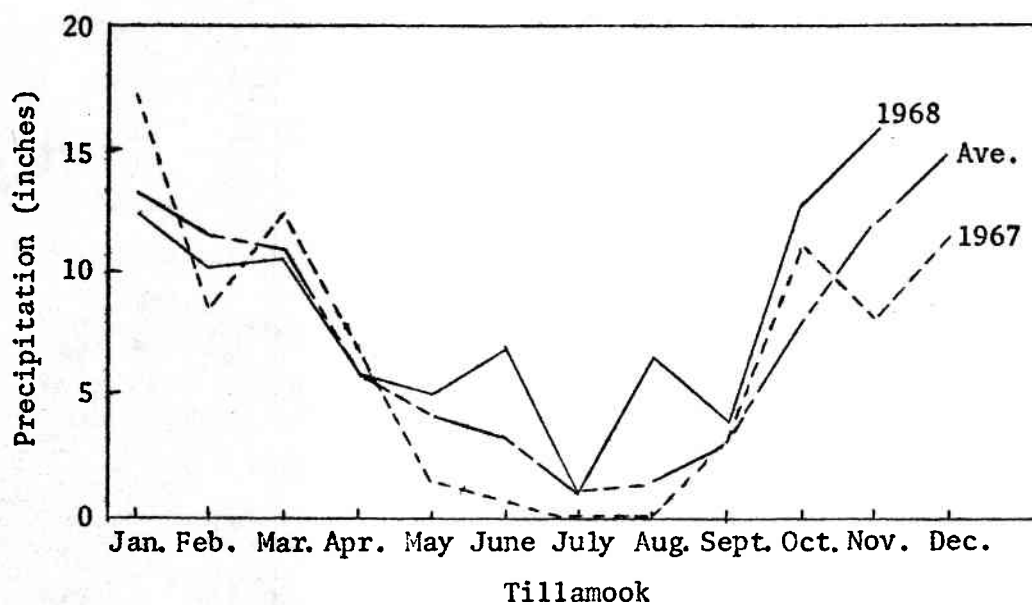
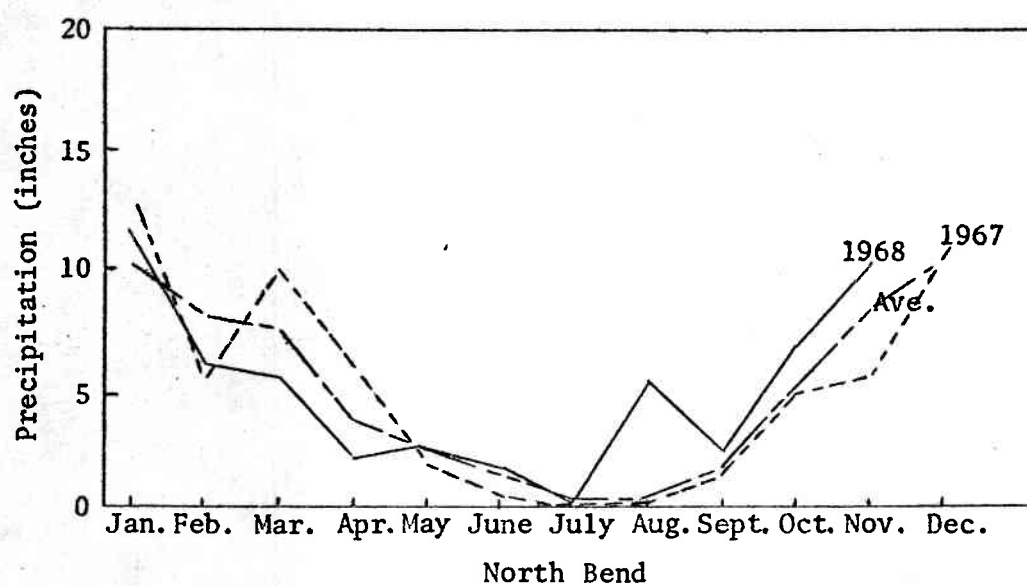
Figure 2. Comparative rainfall data from Tillamook and North Bend weather stations (U. S. Weather Bureau 1967-68).

The winter of 1967-68 was relatively mild along most of the coast. Rainfall was less than the average for each month in most north and mid-coast areas.

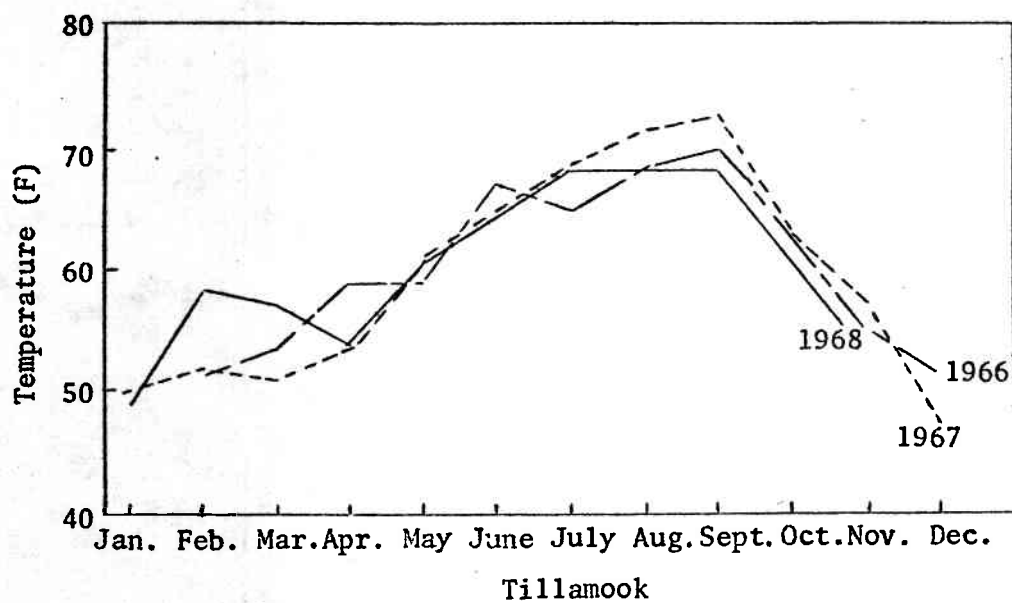
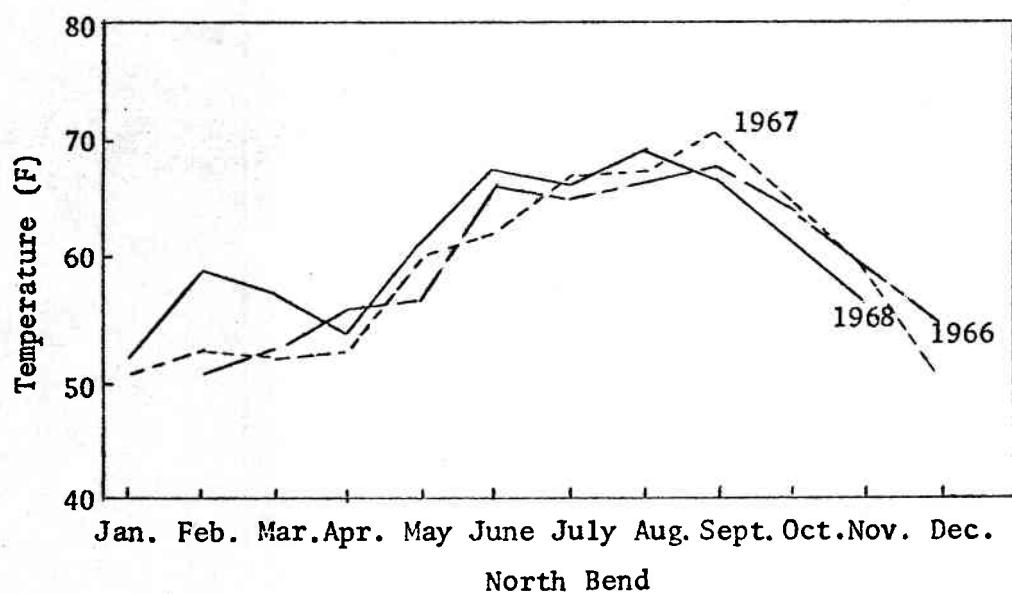
Figure 3. Comparative average maximum air temperature data from Tillamook and North Bend weather stations (U. S. Weather Bureau 1966-68).

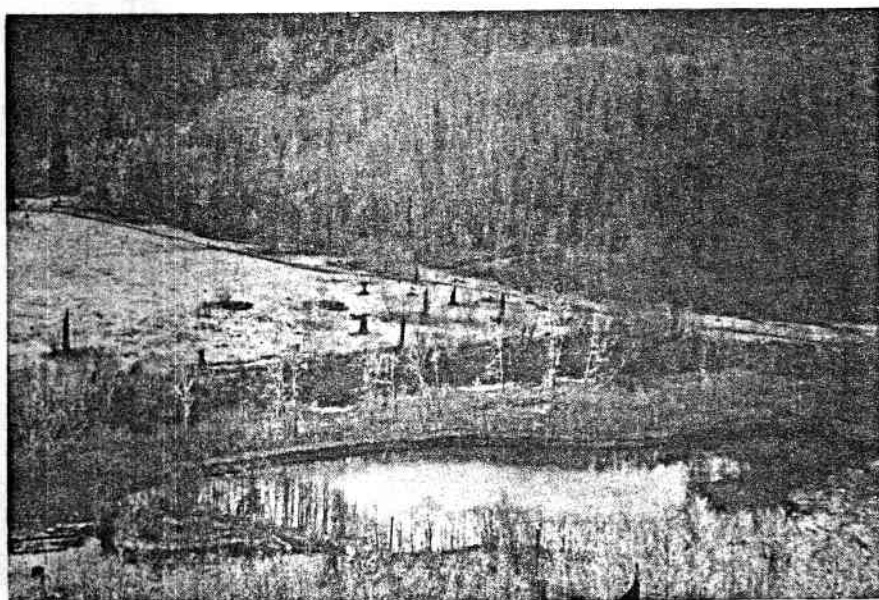
Figure 4. Hatchery site on South Fork Trask River. River flows from left to right.

The entire 52.2 square mile watershed above the hatchery site is part of the Tillamook Burn. All logging was completed several years ago and the watershed is in an excellent stage of regeneration. Most

Living conditions near the hatchery site are excellent. The area is a relatively wide canyon bottom surrounded by moderately sloping ridges. It is only 14 miles via paved road to Tillamook.

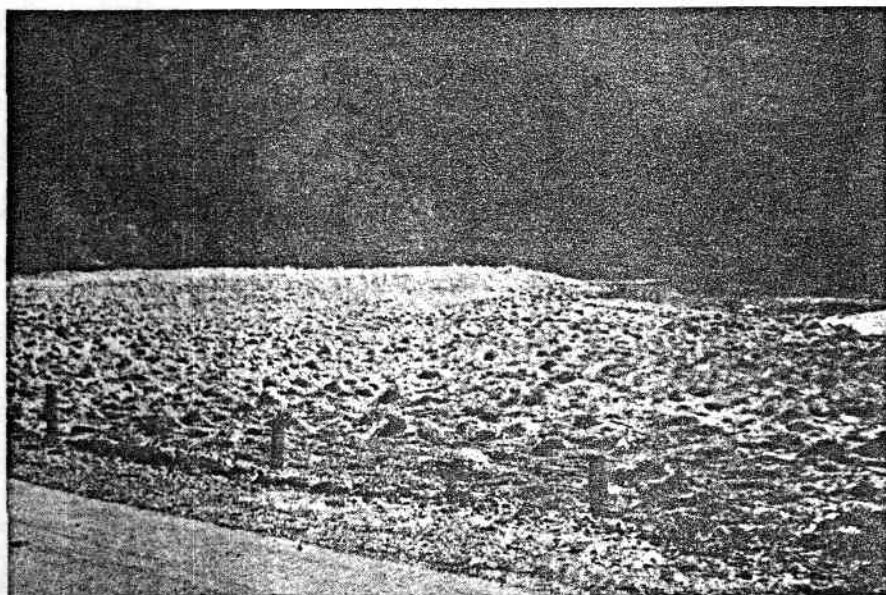
Figure 5. Hatchery site on Kilchis River. River flows from left to right behind row of alder trees.

Living conditions would be excellent near the hatchery site which is at the edge of flat farm land and is 7 miles by paved road from Tillamook. Mail and school bus routes are adjacent to the proposed site.

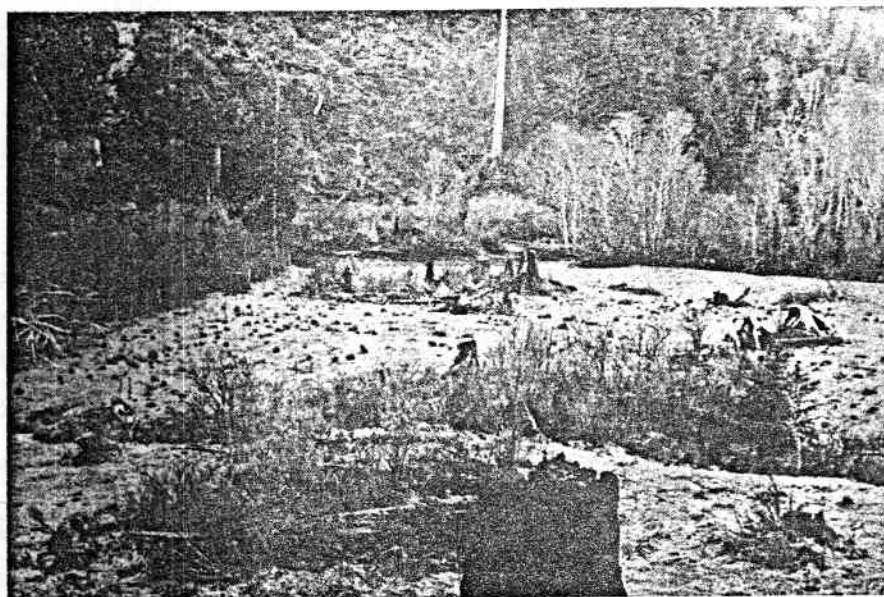
Site description. The hatchery site is a gentle slope that is currently being used for pasture land (Figure 6).

Figure 6. Hatchery site on Yachats River. River flows from left to right.

The U. S. Forest Service owns approximately 5 acres along the river and access road. There is unlimited area for expansion on land owned by Leonard Carson, Yachats, Oregon. A large meandering channel which was cut off when the river was straightened could be developed for additional rearing ponds.

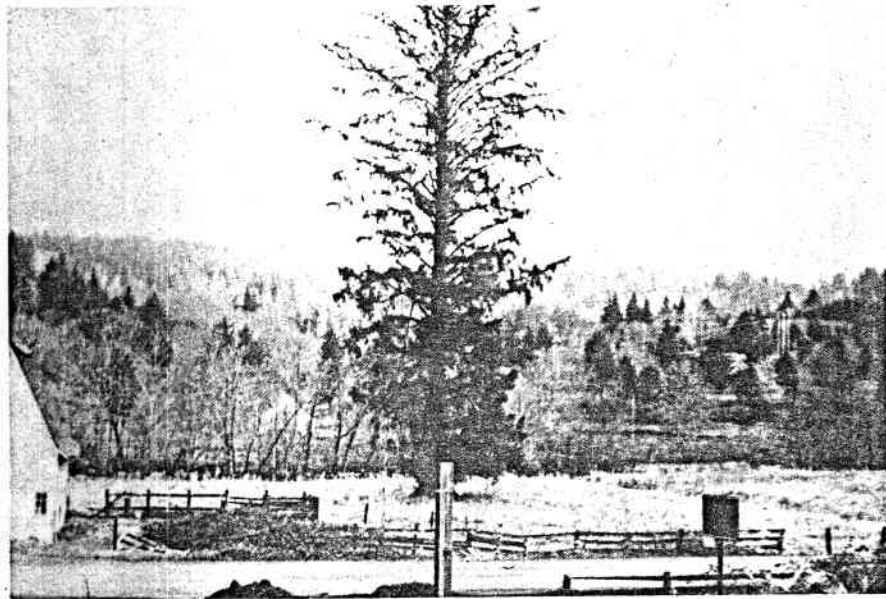
Figure 7. Hatchery site on Salmon River. River flows from right to left through row of alder trees.

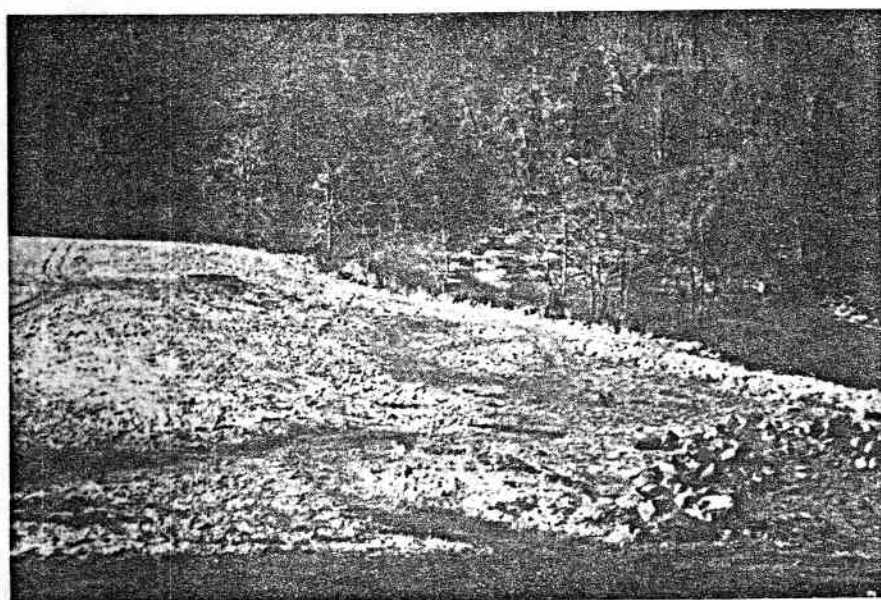
Figure 8. Hatchery site on Nestucca River. River flows from upper left to lower right.

The hatchery site is located just below river mile 27 near a large rock quarry. It is in the NW 1/4 of the SW 1/4 of Section 33, T3S, R8W.

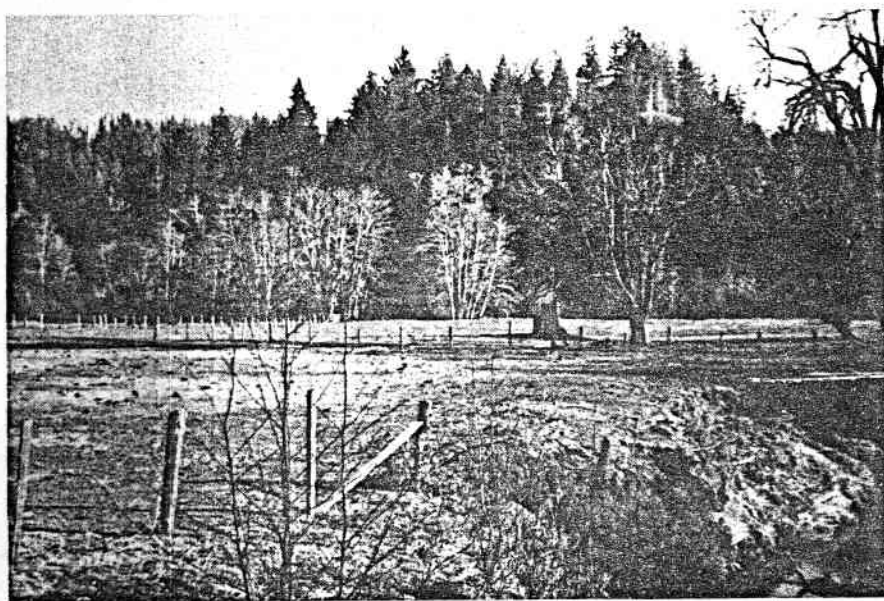
Site description. The hatchery site is open pasture land on the north side of the river east of the mouth of Condon Creek (Figure 9). The property is owned by Nolan J. Huntington, Florence, Oregon. There is area in excess of the needs of a hatchery, however, some of the land is subject to flooding. There is adjacent higher ground on which to locate dwellings. A paved county road lays along the north edge of the

Figure 9. Hatchery site on North Fork Siuslaw River.
River flows from left center to right center.
Condon Creek is in the right foreground.

property. Central Lincoln People Utility District already has sufficient power available at the site.

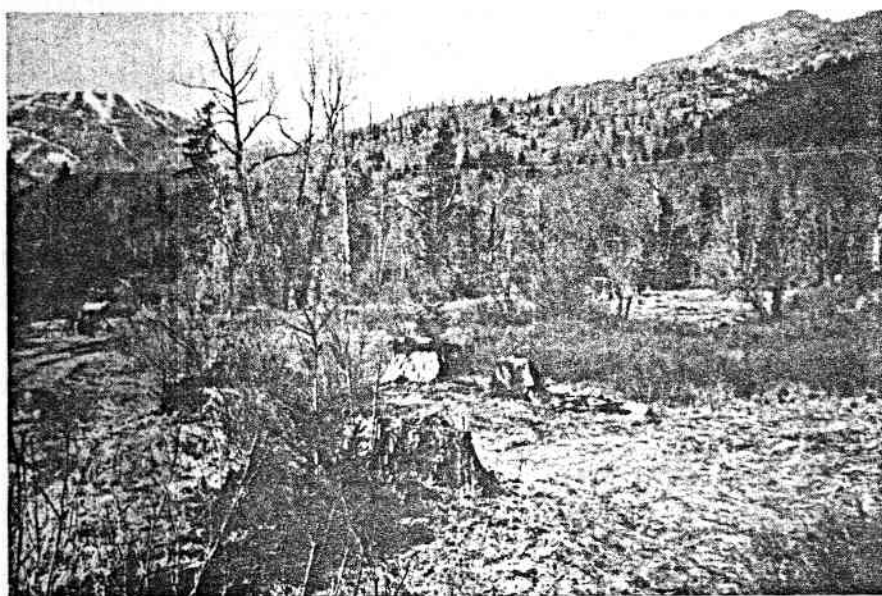
Figure 10. Hatchery site on Wilson River. River flows from right to left behind row of brush.

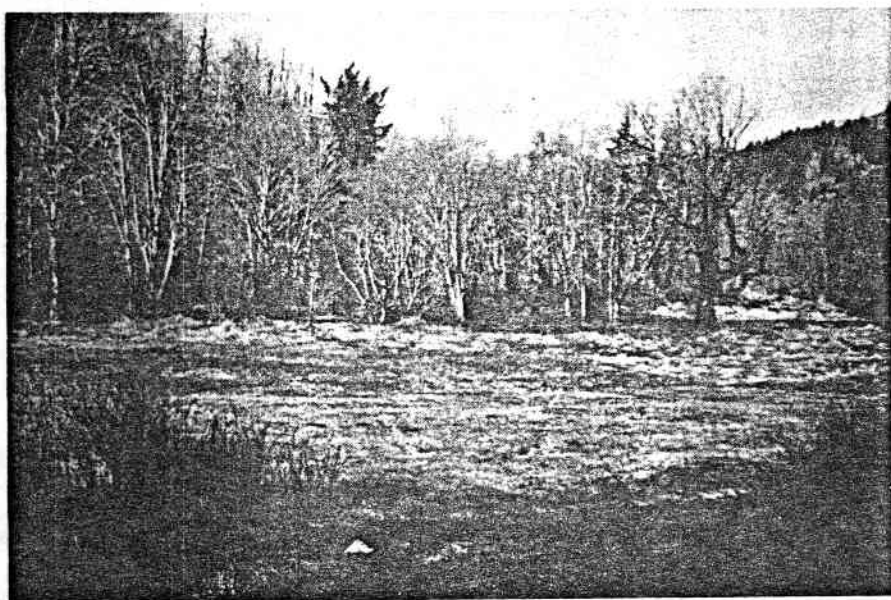
Figure 11. Hatchery site on Three Rivers. River flows from left to right.

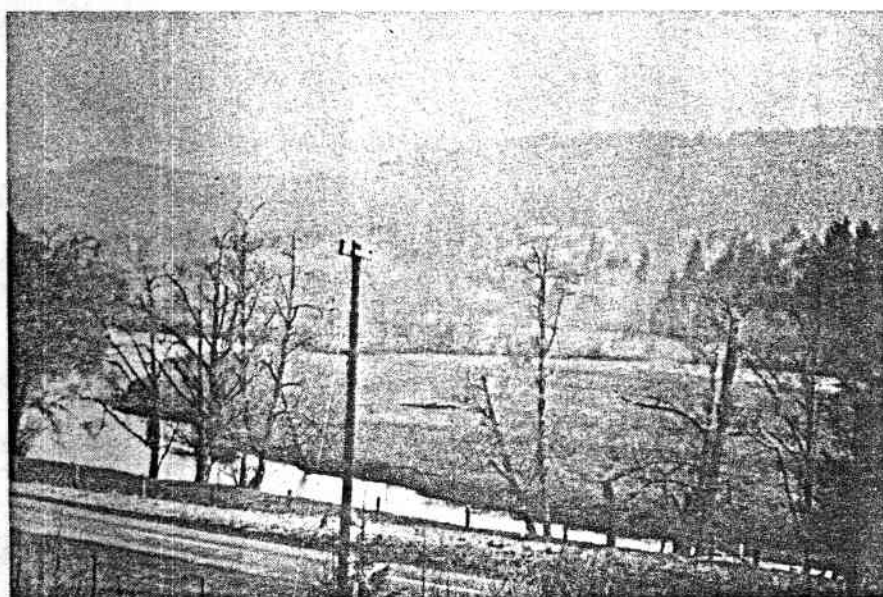
Figure 12. Hatchery site on Little Nestucca River. River flows from right to left.

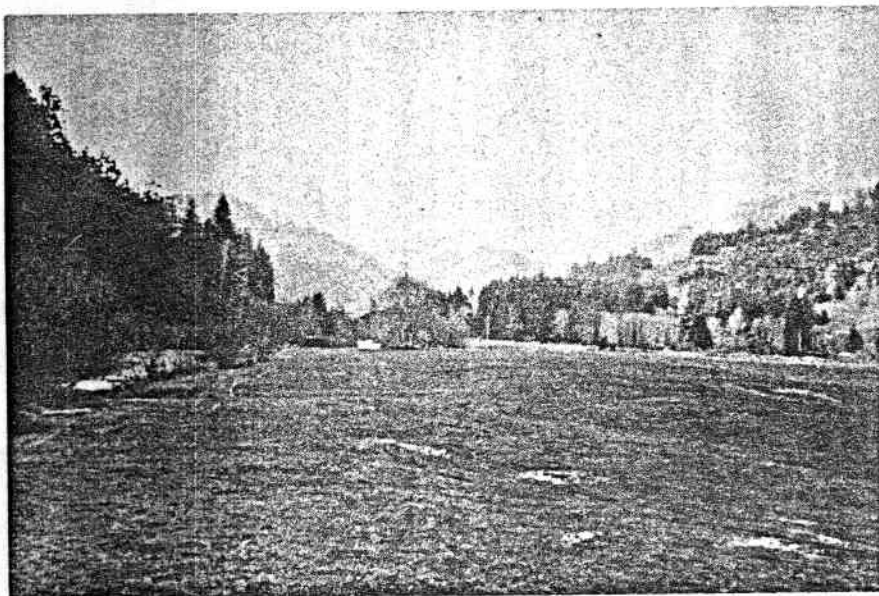
Site description. The hatchery site is open pasture land on the east side of the river (Figure 13). The area is flat with land in excess of hatchery needs. Flooding does not appear to be a problem. A paved county road follows the west bank of the river and a bridge crosses the river to the hatchery site. The property is owned by Jack McDonald, Route 1, Box 975, Bay City, Oregon.

Figure 13. Hatchery site on Miami River. River flows from center toward left foreground.

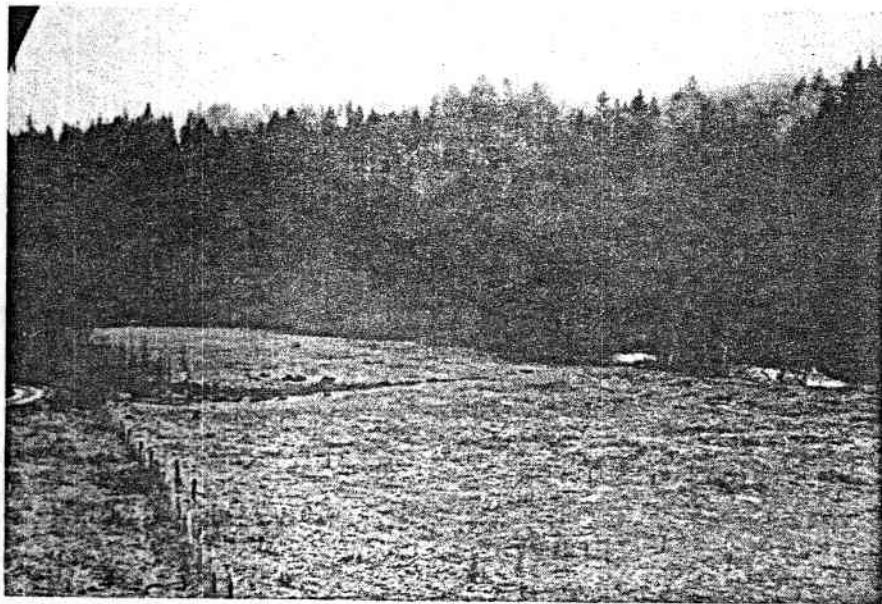
Figure 14. Hatchery site on Winchuck River. River flows from left to right.

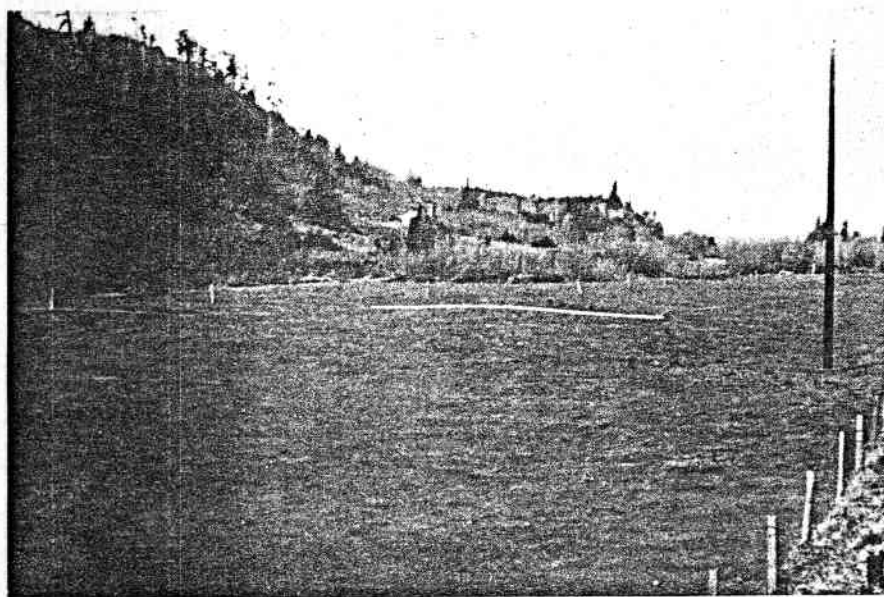
Site description. The hatchery site is a long, narrow field which is about 8 feet above the summer water level (Figure 15). It is owned by Mr. Eric Reuter-crona, Box 238, Sixes, Oregon. A major access road and power lines parallel the river past the hatchery site.

Figure 15. Hatchery site on Sixes River. River flows from left to right.

Extensive gravel in the lower river suggest that a Ranney Well development might improve water quantity and quality.

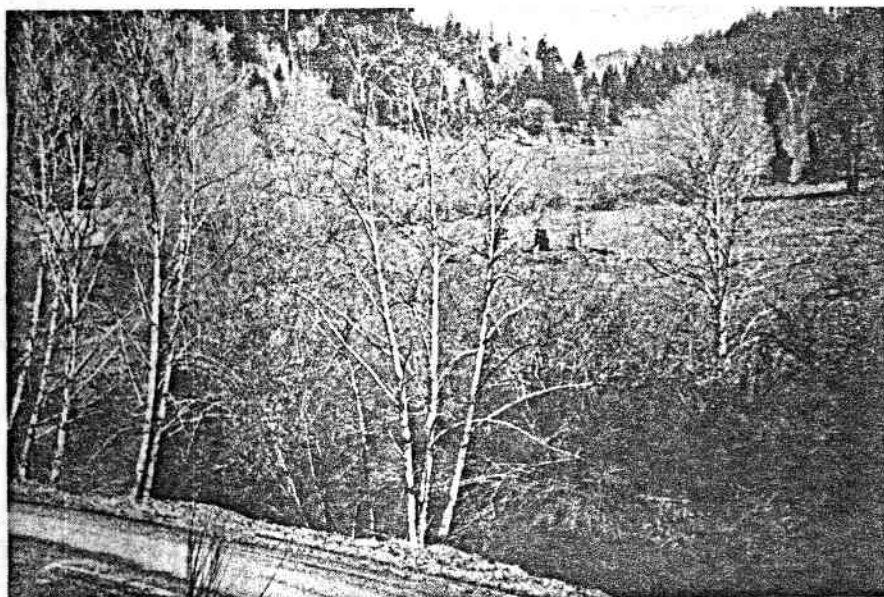
Figure 16. Hatchery site on Indian Creek, Siuslaw River system. Creek flows from center to lower right.

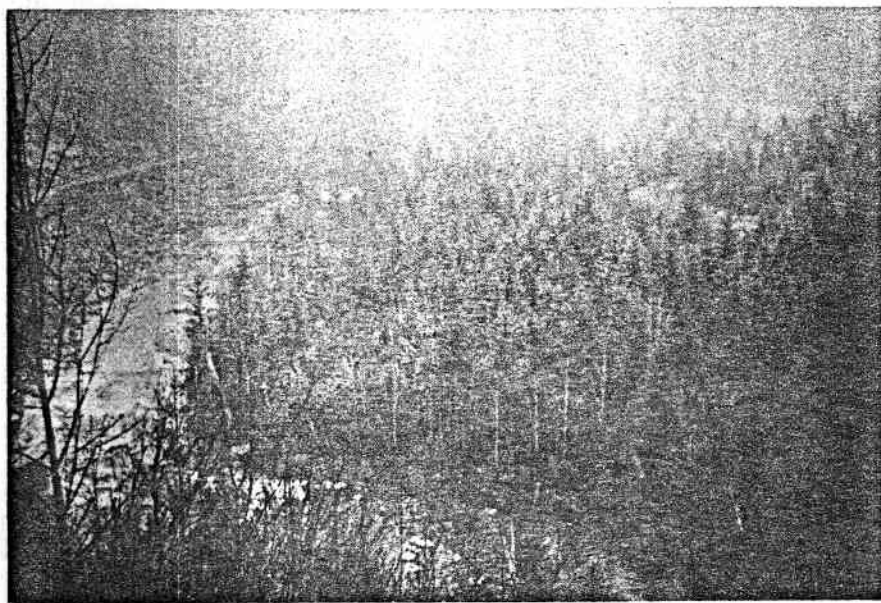
Figure 17. Hatchery site on North Fork Siletz River. River flows from lower right to upper right.

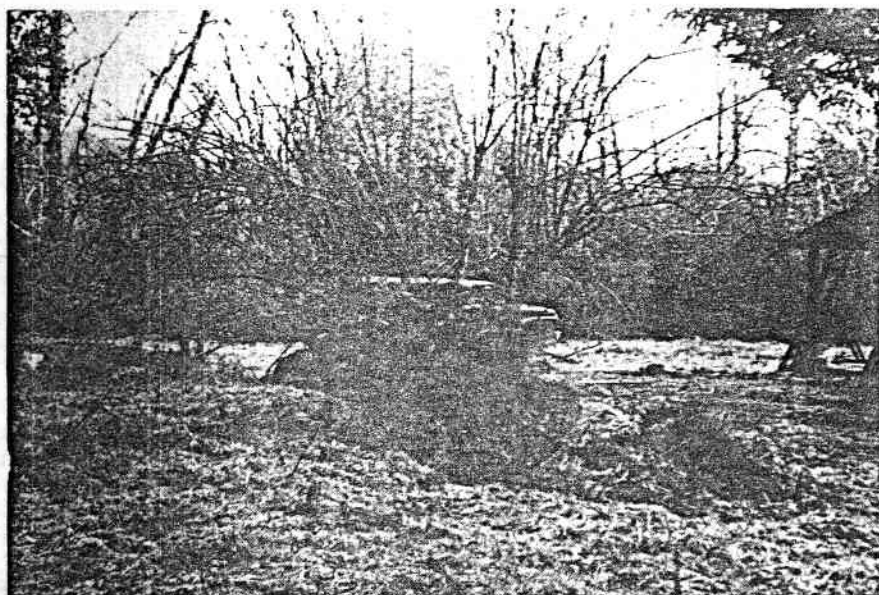
Site description. The hatchery site is a small tree-covered flat at the mouth of Mill Creek (Figure 18). The area available appears

Figure 18. Hatchery site on Chetco River. River flows from right to left behind row of brush.

marginal and would limit expansion. It is owned by May Blunt, Brookings, Oregon. A paved road and power lines parallel the south bank of the Chetco River to the hatchery site.

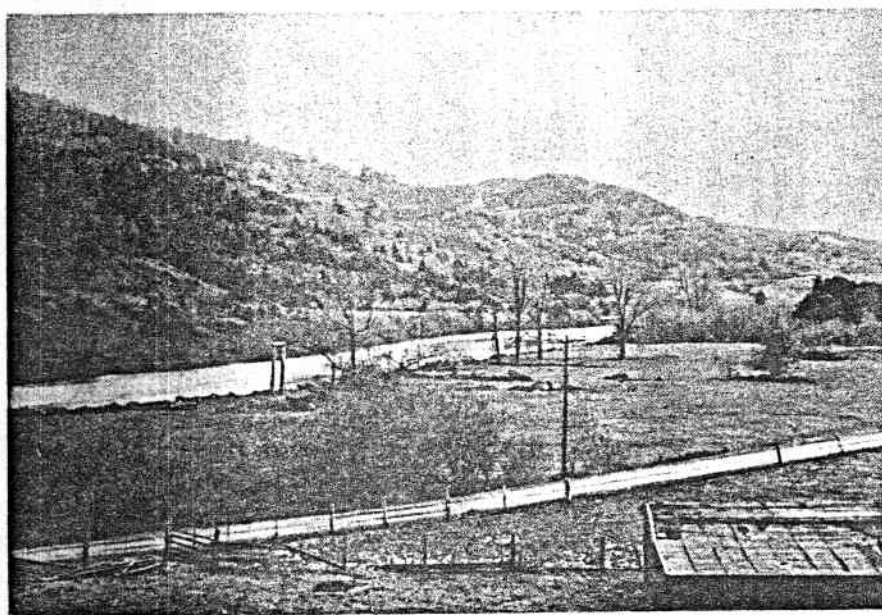
Figure 19. Hatchery site on Pistol River. River flows from left to right.

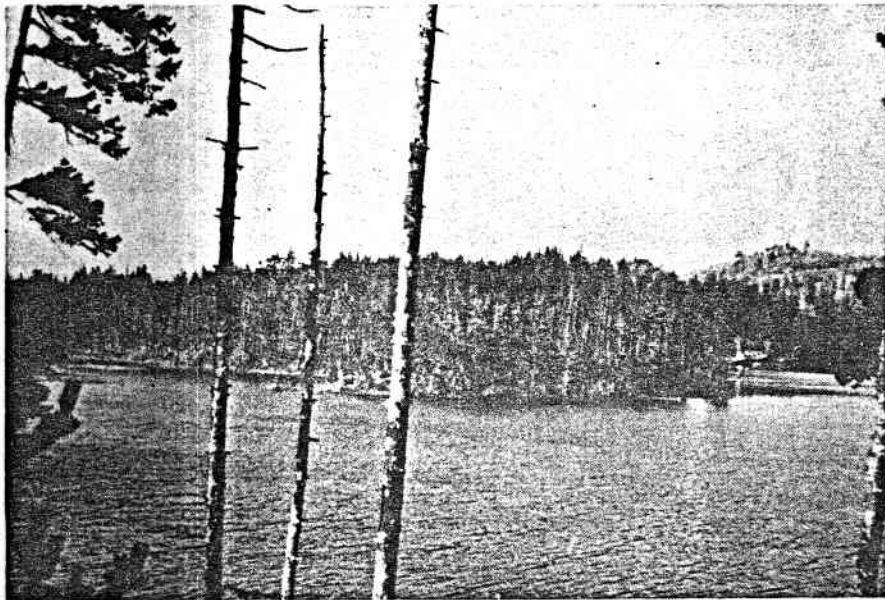
Figure 20. Hatchery site on Munsel Lake, Lane County, Oregon.

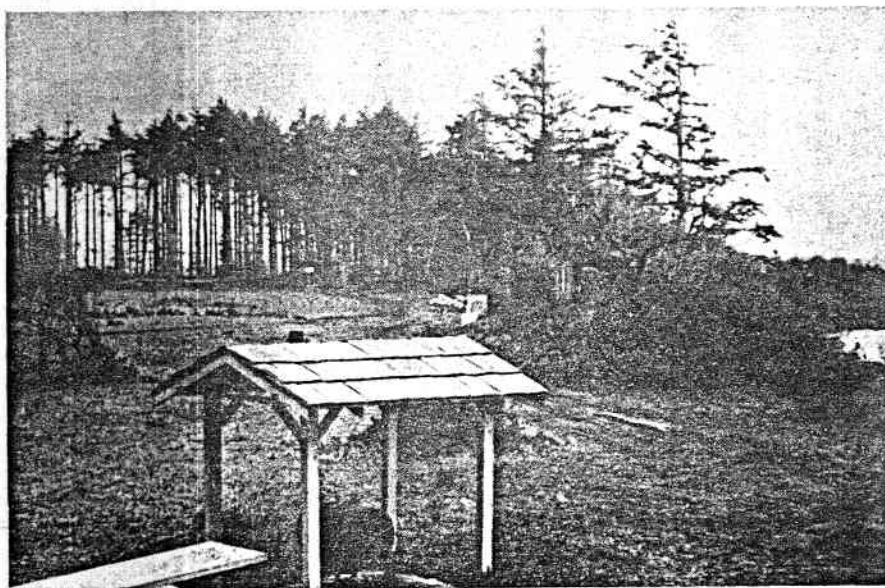
Figure 21. Hatchery site on Floras Lake, Coos County, Oregon.

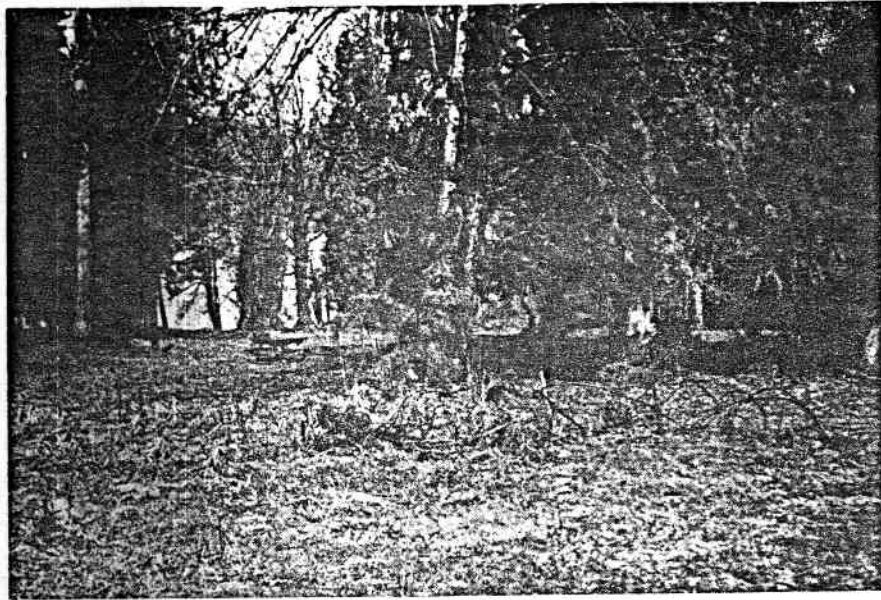
Figure 22. Hatchery site on Triangle Lake, Lane County, Oregon.

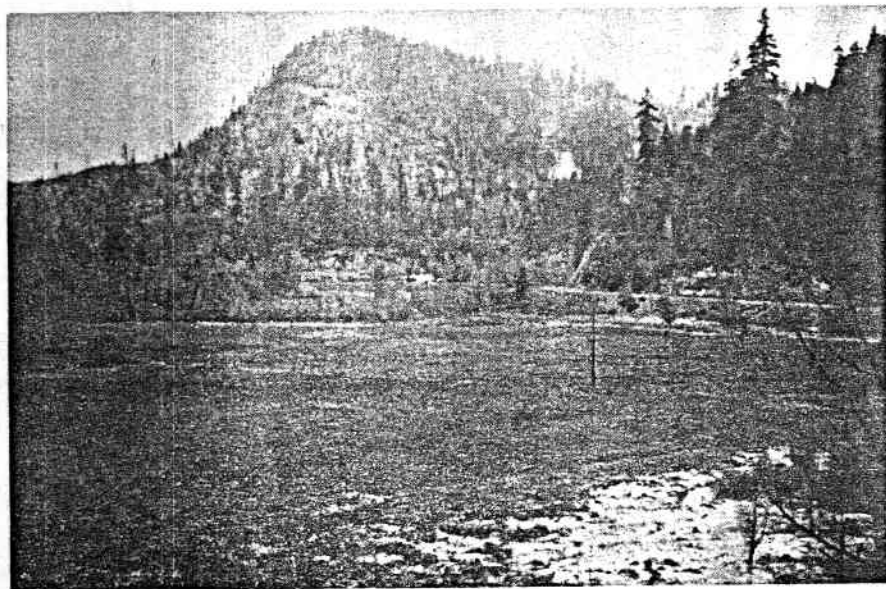
Figure 23. Hatchery site on Loon Lake, Douglas County, Oregon.
