THE SUITABILITY OF WESTERN LARCH (TAMARACK)
FOR USE AS SHAKES IN AREAS HAVING
A LOW DECAY POTENTIAL

RALPH K. PETER
Division of State and Private Forestry
Forest Service
Department of Agriculture
Portland, Oregon

November 9, 1970

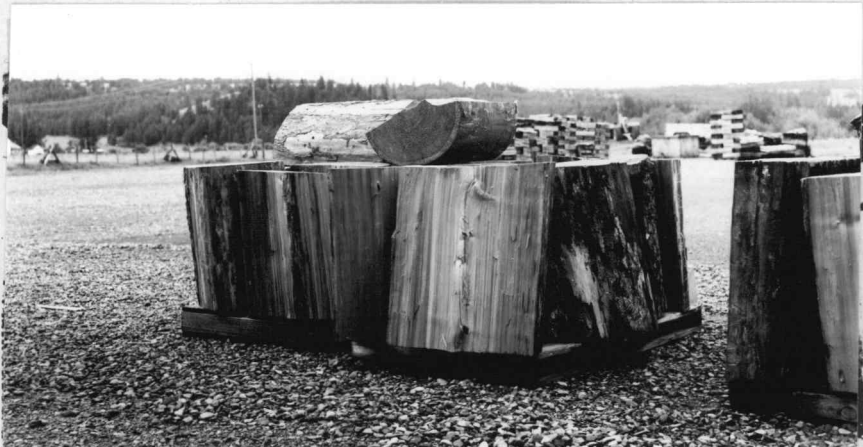
Shake bolts, cut from dead trees, as delivered by the loggers (as shown below), were examined at the Ukiah plant. The bolts were 24 inches long and averaged 18-24 inches in diameter. The narrow bands of sapwood ($1/2 - 3/4$ inches) were generally in various stages of decay. Some sapwood had insect holes but these holes do not penetrate the heartwood to any extent. Some of the bolts contained ring shake and all contained radial seasoning splits.

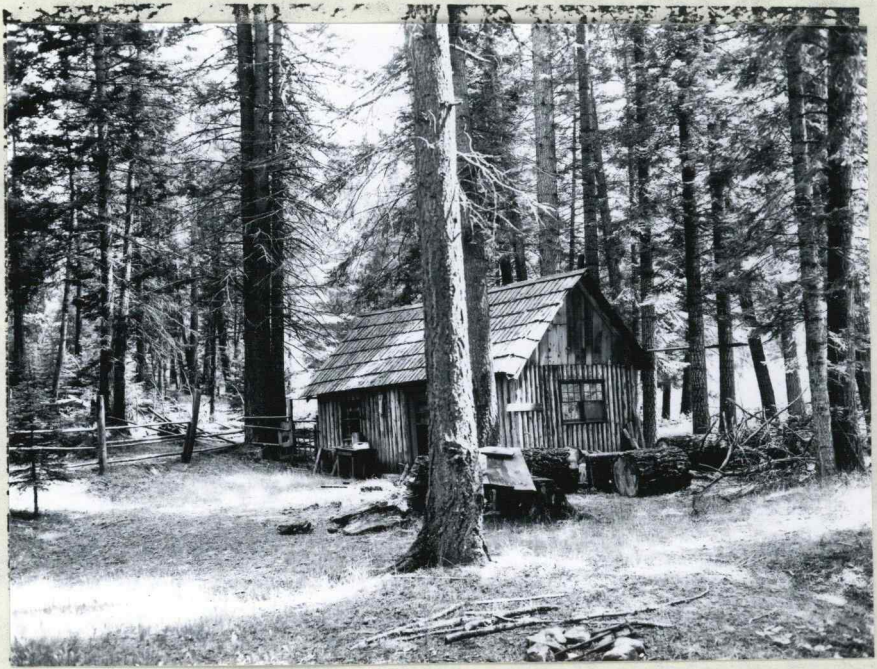
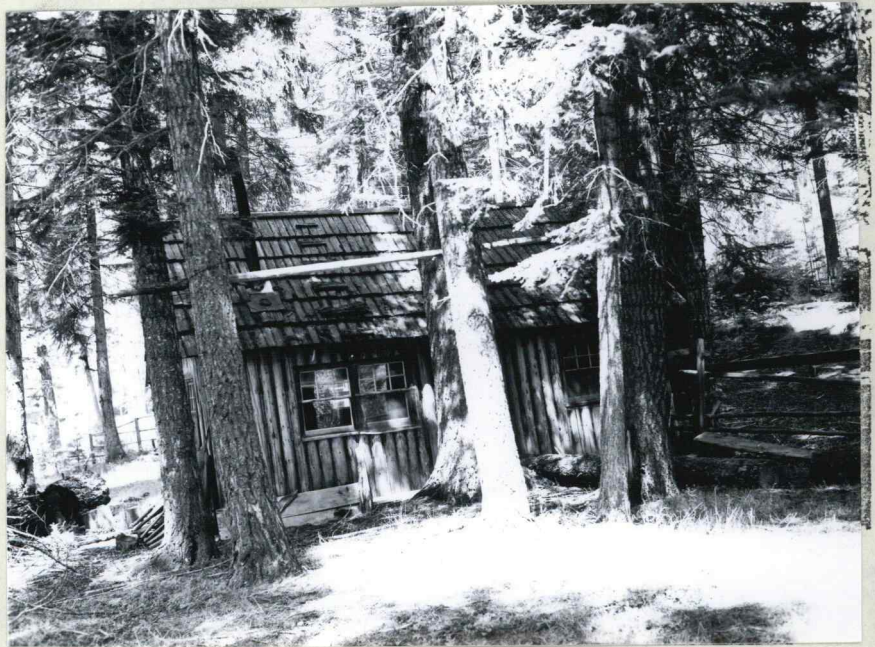
Ebb Hugh's
Cabin

The cabin is located in a narrow, wooded canyon within 50 feet of a fair sized trout stream. The location can be considered a relatively high decay hazard area. The pine foundation logs are severely decayed.

This roof is an excellent example of severe neglect. Moss, pine needles and dirt have been accumulating, apparently for years. In spite of this, the larch shakes are in excellent condition. Average thickness is one-half inch.

The right edge of the roof in the upper photo was damaged by a falling tree.

In the colored photo, reference the shake with the hunting knife. The left edge of this shake contains a narrow strip of sapwood. This is soft from decay. The heartwood is completely sound. No heartwood decay was found in any of the shakes except perhaps for about one-eighth inch of the exposed end-grain. Note the growth of moisture-loving moss.

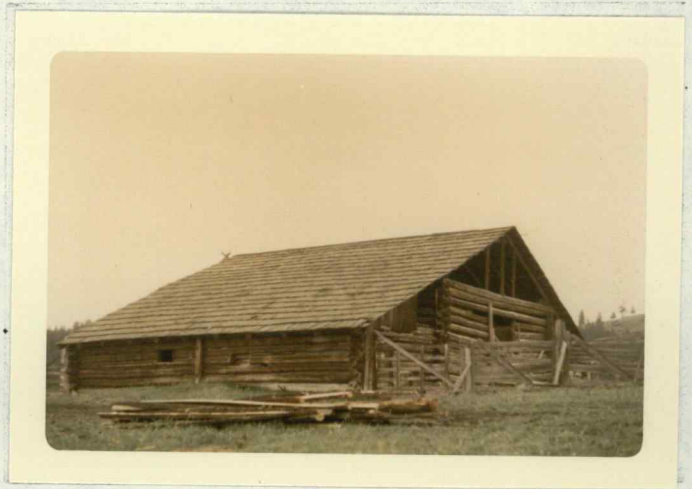
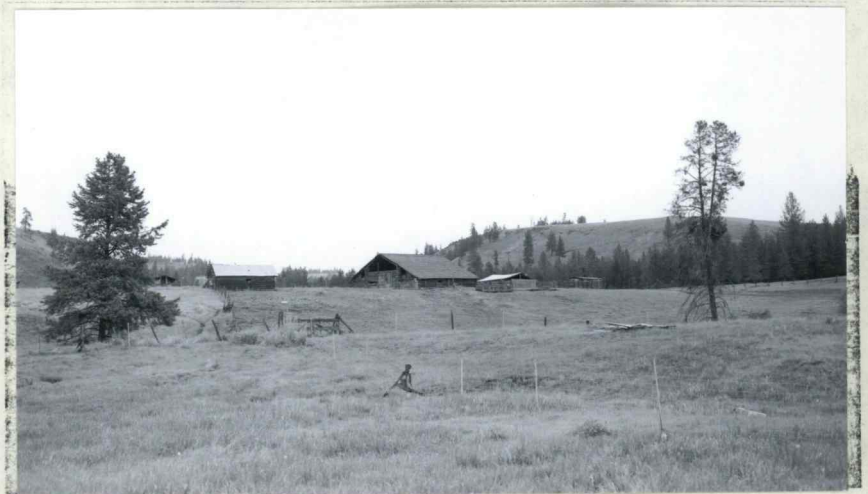
"The Pete Able
Place"

This barn was built by Tom Able, Sr., about 65 years ago. Foundation logs have decayed into the ground. Shakes are in excellent condition. Relatively little light can be seen through the roof from the inside. Pitch of roof appears to be shallower than normal. Even though it was raining, there was no indication of leakage.

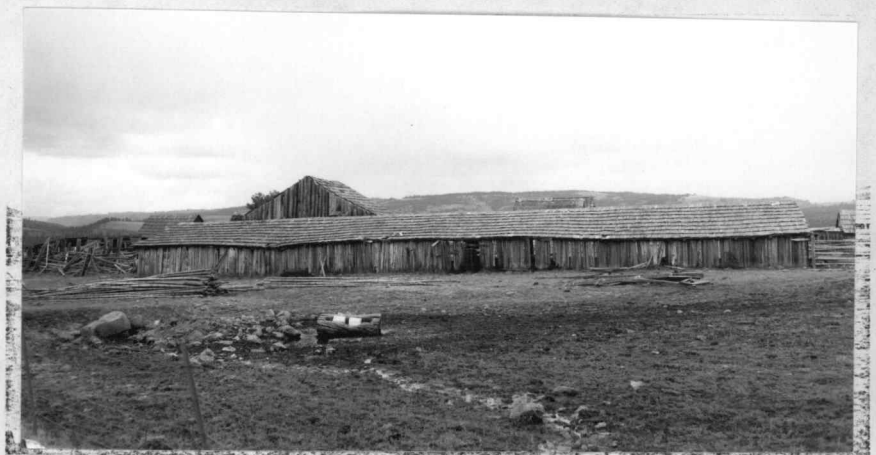
Photo No. 1 - Larch shakes are in poor condition. Some are spongy because of decay. Back side of roof has lost about one-third of the shakes.

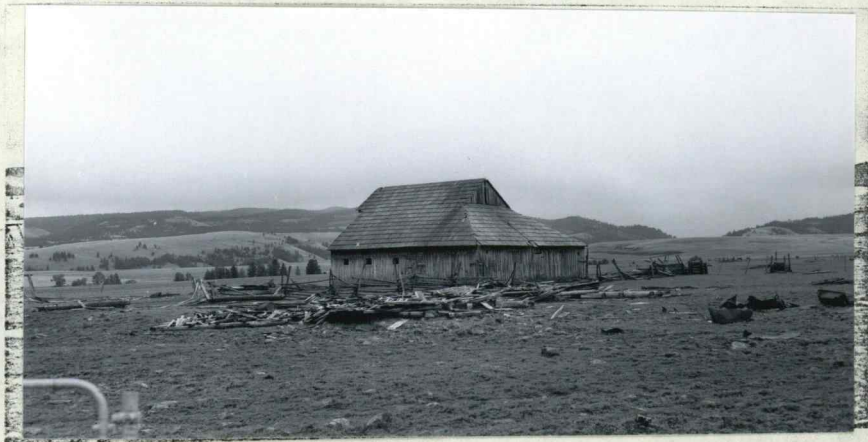
Photo No. 2 - Larch shakes on barn are in very sound condition. Very few shakes have been lost to the winds. Only minor repair needed.

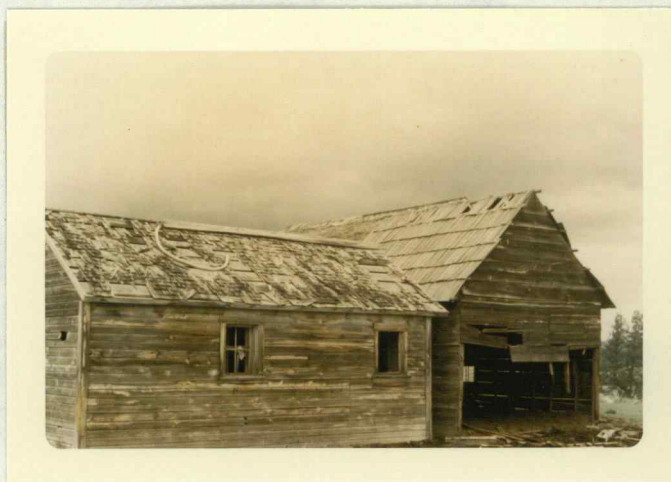
Photo No. 3 - Western red cedar shingles on left building are almost gone.

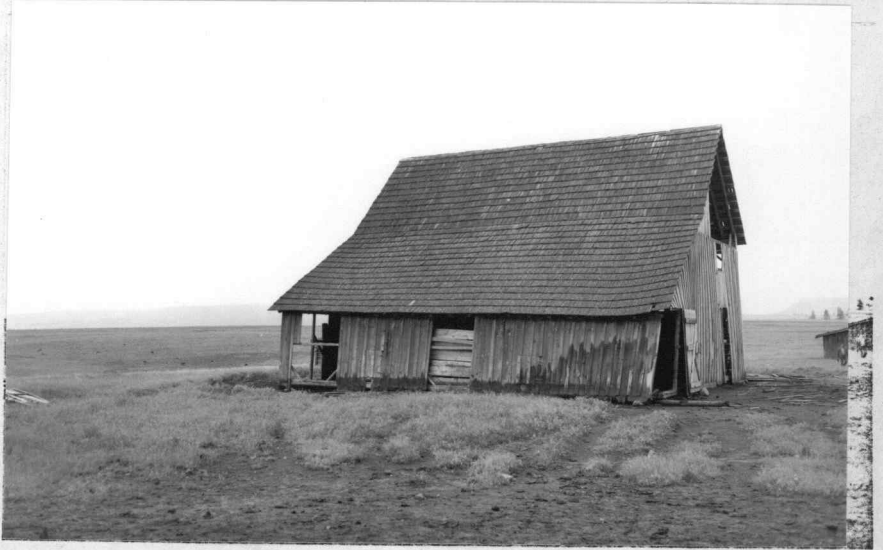
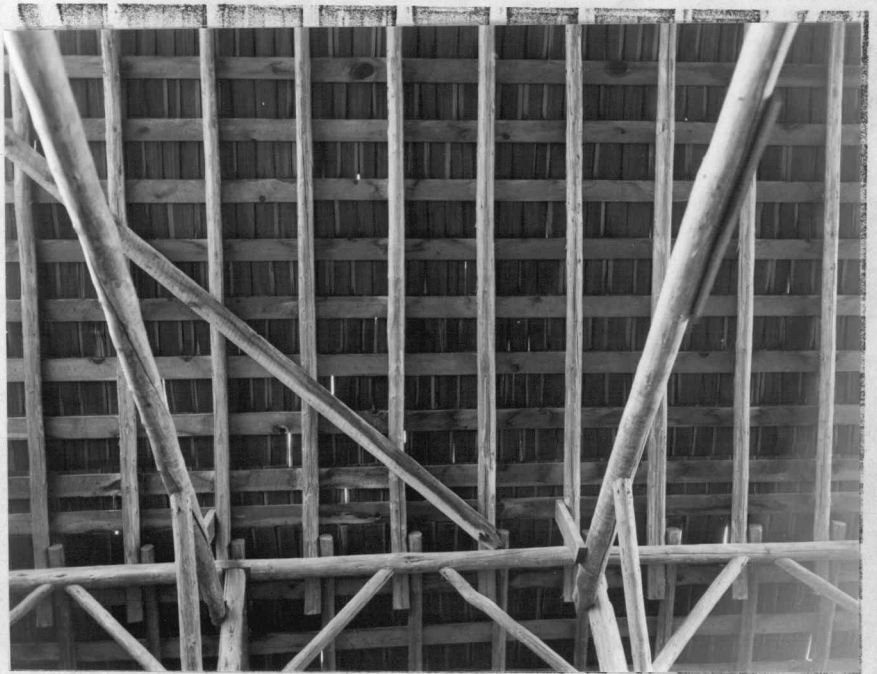
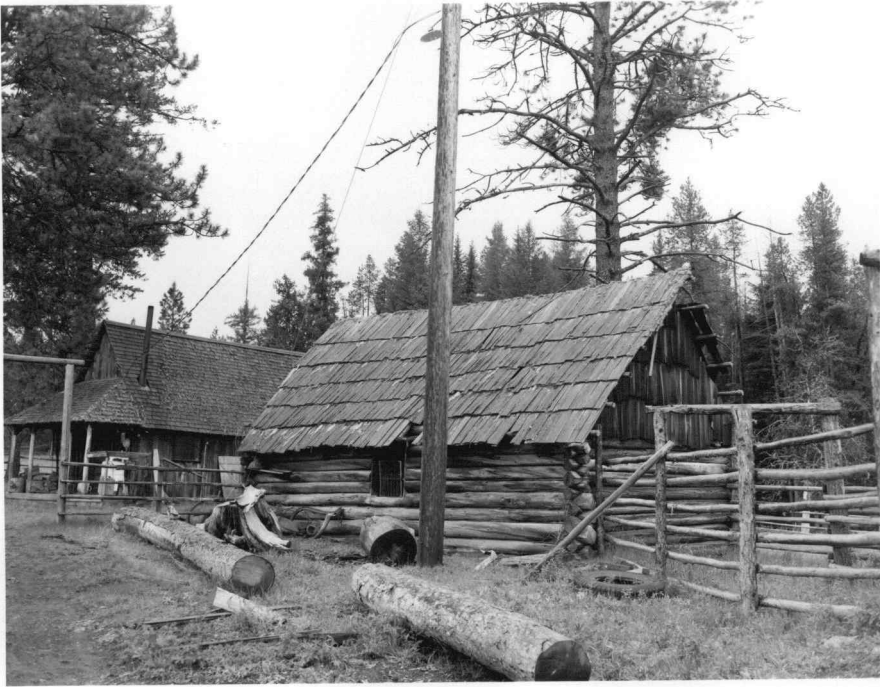
MEENGs HOMESTEAD

The cedar shingle roof of the residence (no photo taken) is gone and the building is in very poor condition. The remains of the front door panels were deeply etched by the sandblasting effect of blowing sands.

The larch shake roof of the barn is in very good condition and would require only minor repair to seal the few cracks. (See lower photo).

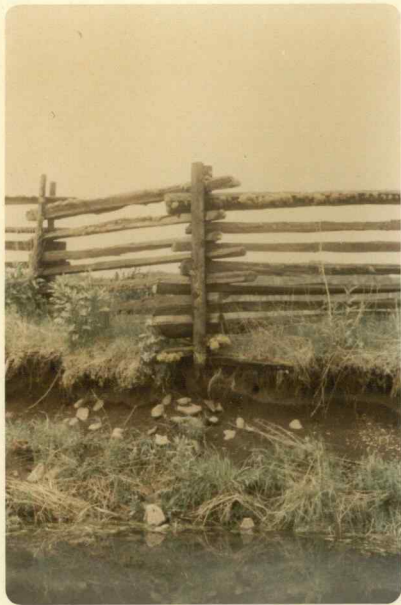
Base of post decayed.
Meandering stream,
over the years,
washed out base.

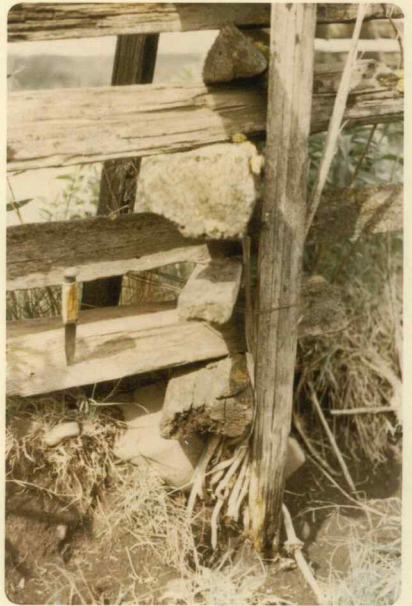
Rail completely
sound under
weathered surface.
Note heavy lichen
growth.

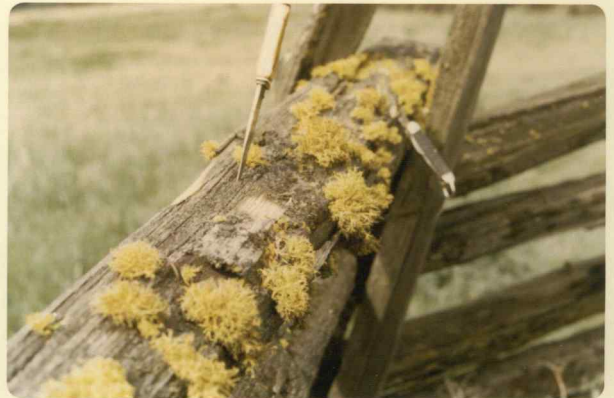
WESTERN LARCH RAIL FENCE AT UKIAH, OREGON

This fence illustrates the durability of western larch for off-ground use. A Mr. Faye Metty who would be about 90 years old and who drove stagecoach, was quoted as saying that he played on this fence as a boy.

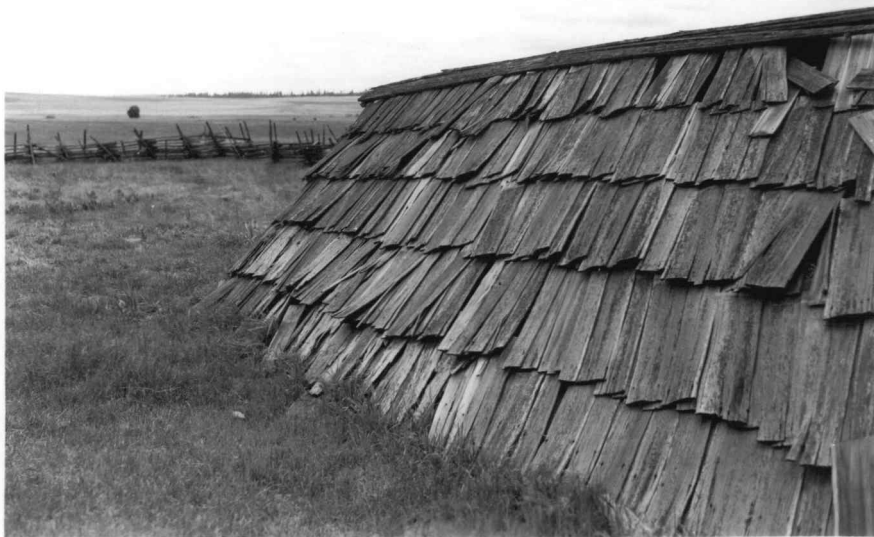
WESTERN LARCH SHAKE ROOF OF A COLLAPSED SHED
ALONG HIGHWAY 395 NORTH OF UKIAH

Shed collapsed because of decayed pine pole supports. Age is unknown.

Relatively little decay of shakes was noted. It was raining as this photo was taken. Several shakes were removed for inspection. Even though the under course shakes were wet from the rain, little or no decay was found. Greatest deterioration is due to weathering. Average shake thickness is only three-eighths of an inch.

Note the small amount of overlapping between courses. Also note the face nailing. The use of extruded nails indicates construction some time after the turn of the century - a good guess might be 1915-1930.

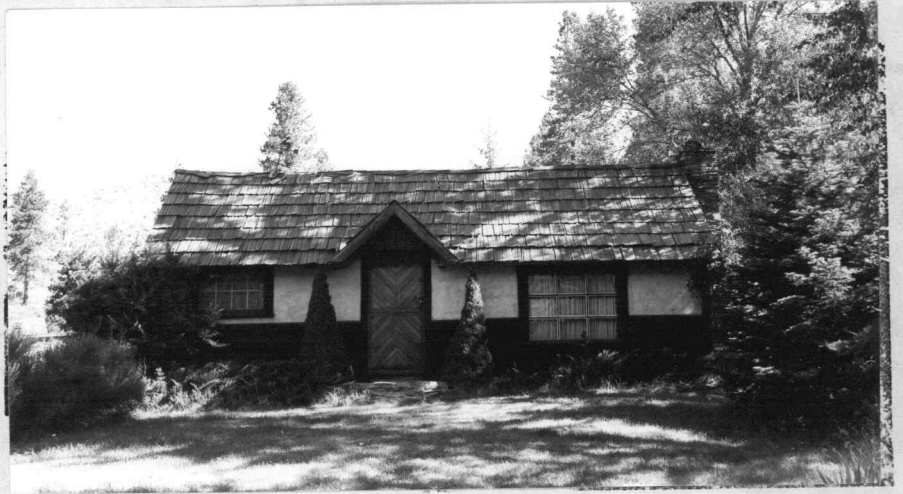
SPRICK RESIDENCE, NACHES, WASHINGTON

This small residence was built in 1946. The shakes are $\frac{3}{8}$ " to $\frac{1}{2}$ " thick, 30" long with 14" to the weather. Larch shakes are in excellent condition.

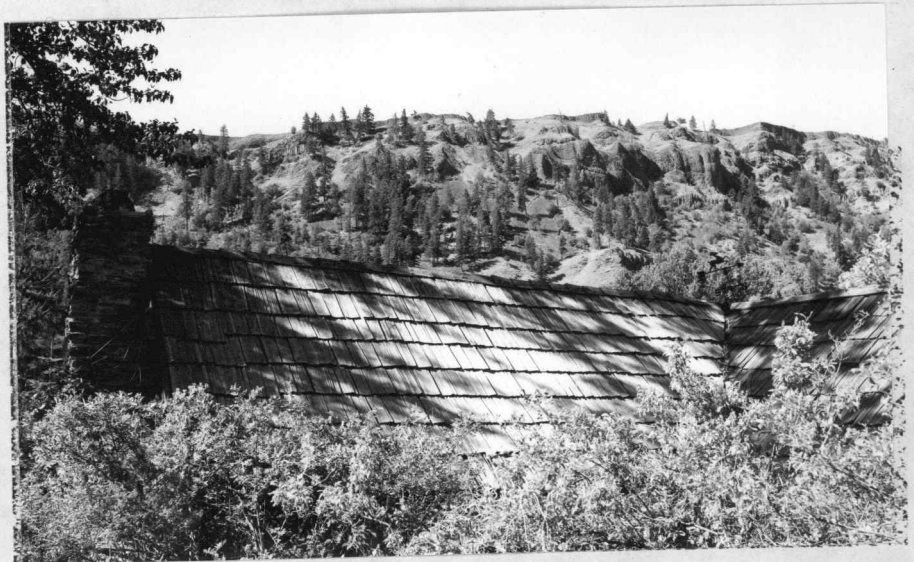
Back side of roof of above building. This face is 60% cedar and 40% larch.

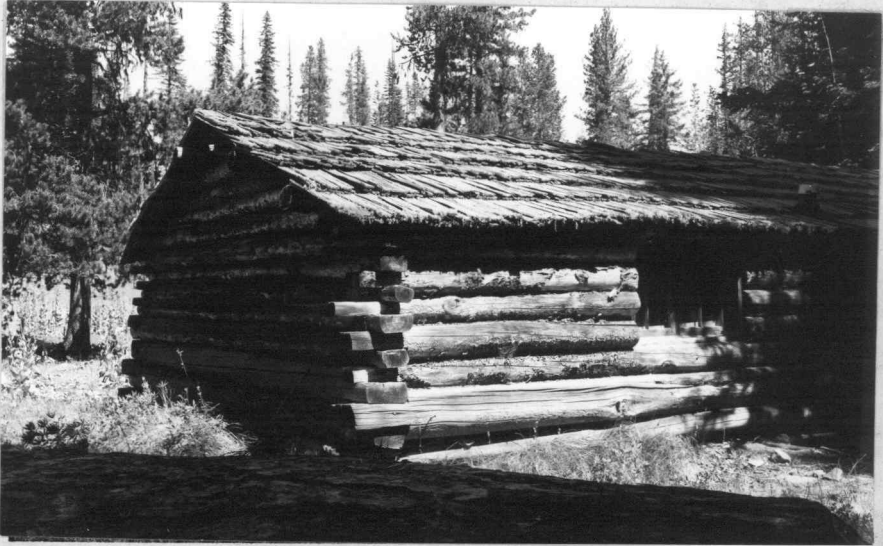
Nanum cabin, 17 miles N. of Ellensburg. This cabin is known to be at least 50 years old. The $\frac{3}{8}$ " to $\frac{1}{2}$ " larch shakes are in good condition with only little decay noted. Cabin is open and used by hunters for shelter.

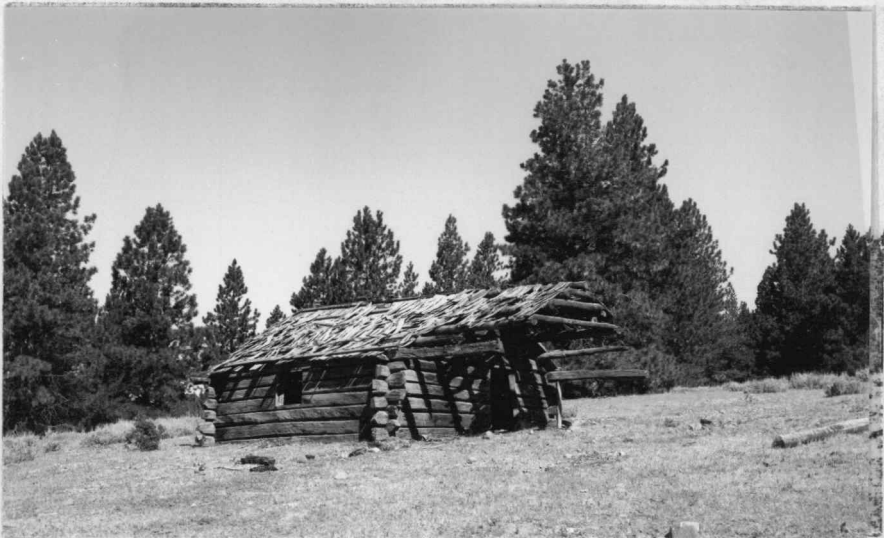
This cabin is part of an old Dutch settlement and believed to have been built in the 1880's. It has been reroofed at least once. The shakes are pine.

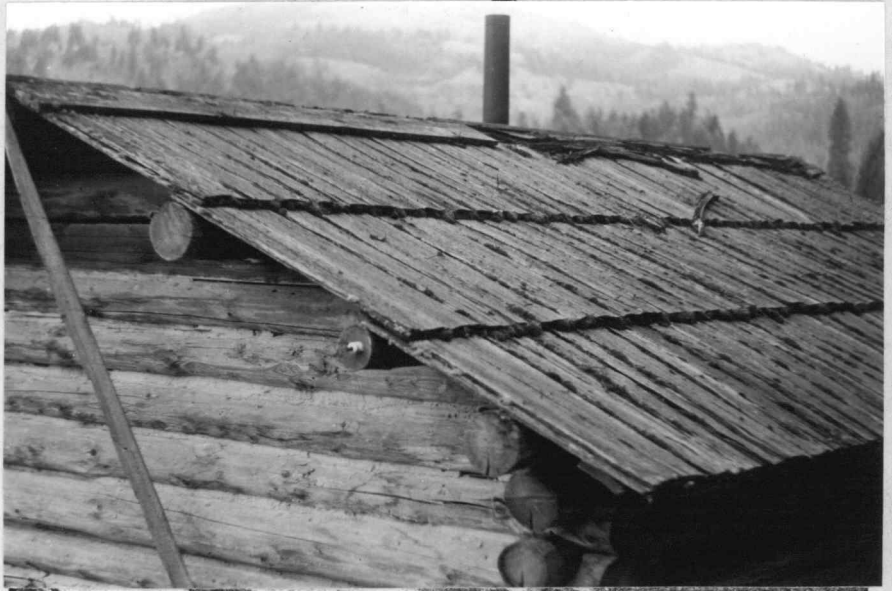
KONZ PLACE, REPUBLIC, WASHINGTON

Cabin built in 1932. Larch shakes are $1/4'' - 3/8''$ thick, 28" long with a 4" lap between courses. Some shakes have spots of decay. Wood species of decayed ridge board is unknown.

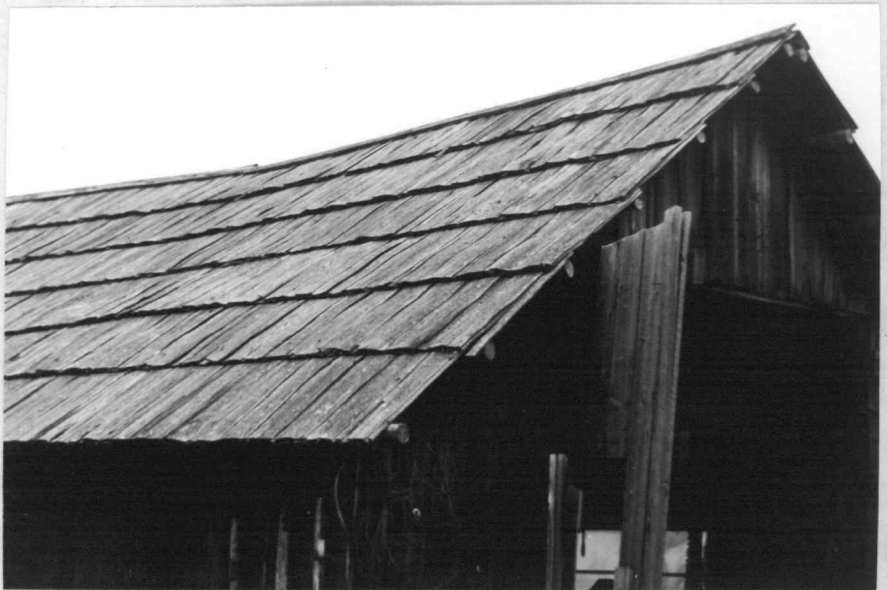
Tool building constructed in 1938. Shakes are in very good condition. Shake thickness and roof construction is same as above.

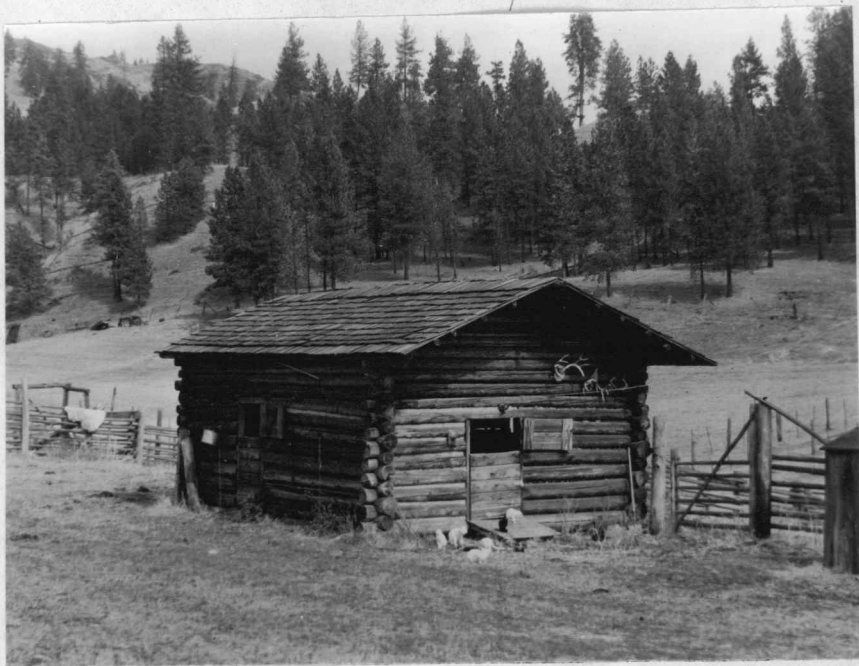
Young ranch at Republic, Washington. Fifteen year old larch roof is in excellent condition. Shakes average $1\frac{1}{2}$ " thick and are 20" long with 5" lap between courses.

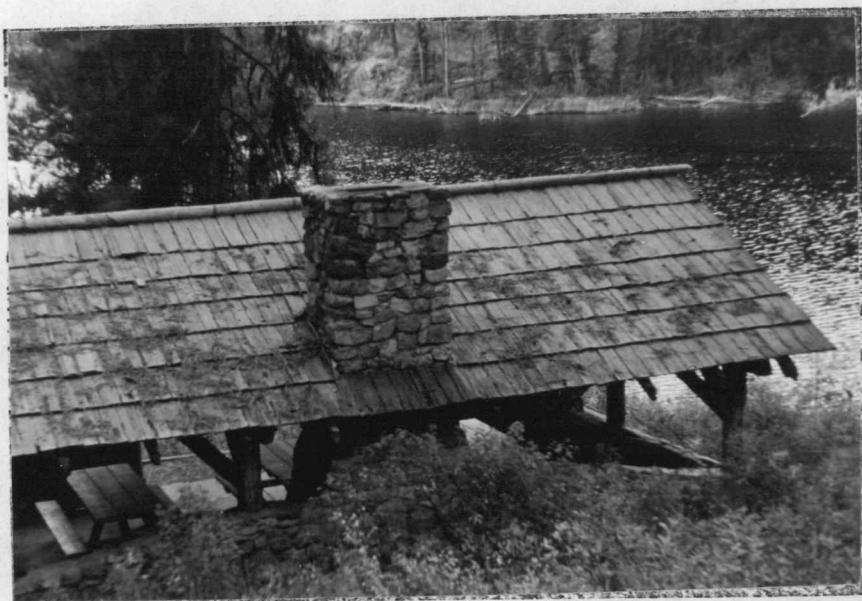
Forest Service shelter with larch roof. Structure was built by C.C.C. crews in 1934. Shakes are $\frac{3}{8}$ " - $1\frac{1}{2}$ " thick. A few decayed spots are noticeable. Structure is located at Swan Lake 16 miles south of Republic, Washington.

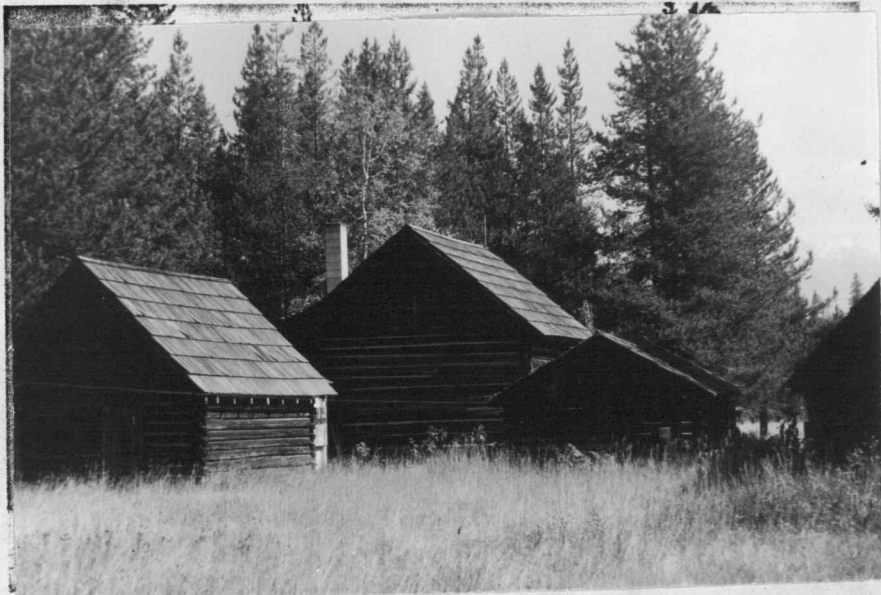
Photo No. 1 - Tom Peterson place. Homestead patent filed 1924. Buildings were constructed 1925-26. Photo shows residence and some outbuildings. Logs and shakes are larch and in excellent condition with only very minor indication of decay. Shakes are 24" long, 3/8" to 1/2" thick, and 4" lap between courses. Residence is still used as a vacation home.

In the North Fork of the Flathead River area (Montana), a good comparison was made between two homesteads about one mile apart. A Tom Peterson filed for a homestead patent in 1924 and built his house and outbuildings in 1925-26. Larch logs and shakes were used. The shakes are $\frac{3}{8}$ to $\frac{5}{8}$ inch thick. Buildings and roofs are in excellent condition and the place is still used for vacations.

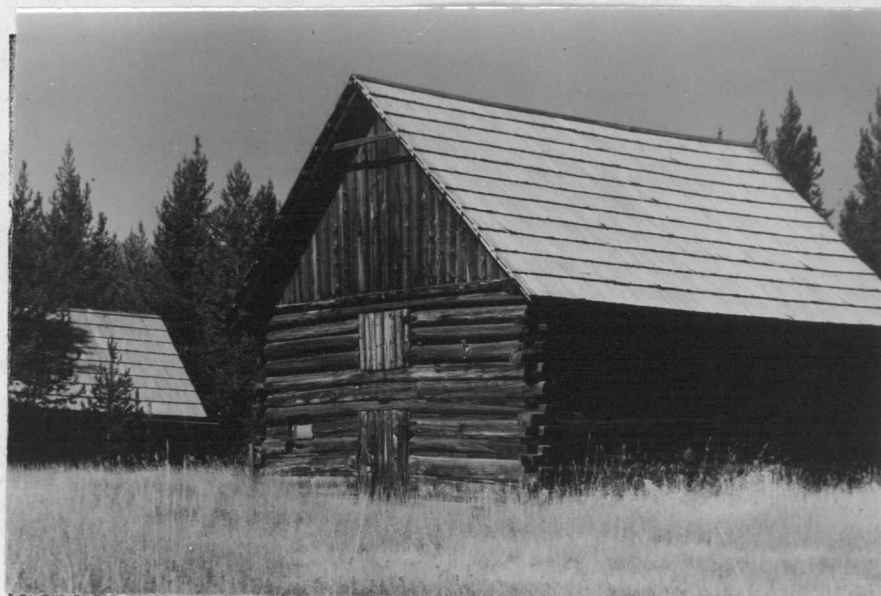
Photo No. 2 - Barn at Tom Peterson place. Shakes and logs in excellent condition.

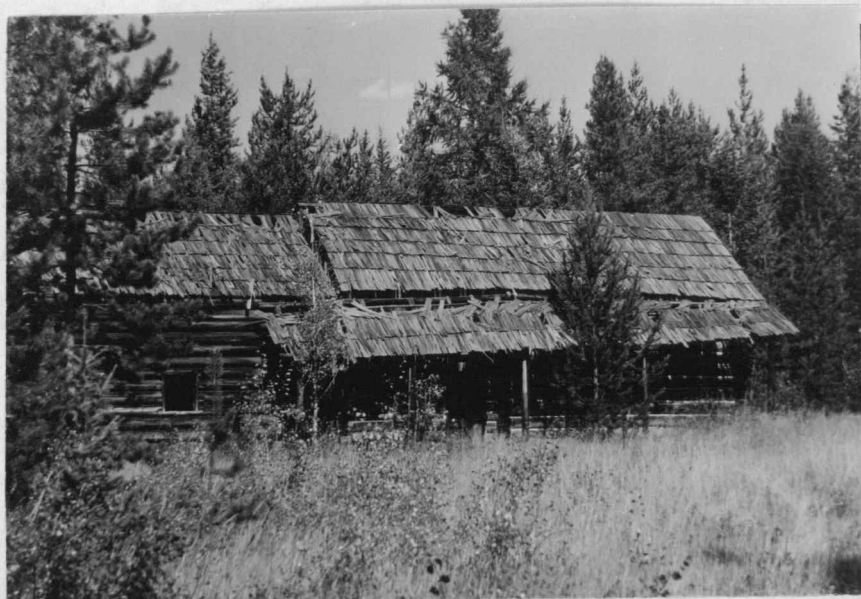
Photo No. 3 - F. H. "Bignose" Johnson filed homestead patent December 30, 1911. Building was constructed 1912. This place is within one mile of the Tom Peterson homestead and only about 13 to 14 years older. The small age difference does not account for the two extreme roof conditions. The shakes on this roof are only 1/4 inch thick. This thinness greatly reduced the weathering resistance and probably was the major contributing factor to the poor condition. Hole at ridge of roof was caused by fire.

A mile down the road, F. H. "Bignose" Johnson filed claim to his land on December 30, 1911, and built his house the following year using larch shakes which were only $\frac{1}{4}$ inch thick. Although there is very little decay in the shakes, they are twisted, warped and broken. Many are missing. There is an apparent 14 year age difference between the two places. The two extreme roof conditions, are believed to be primarily due to differences in shake thickness and not age.

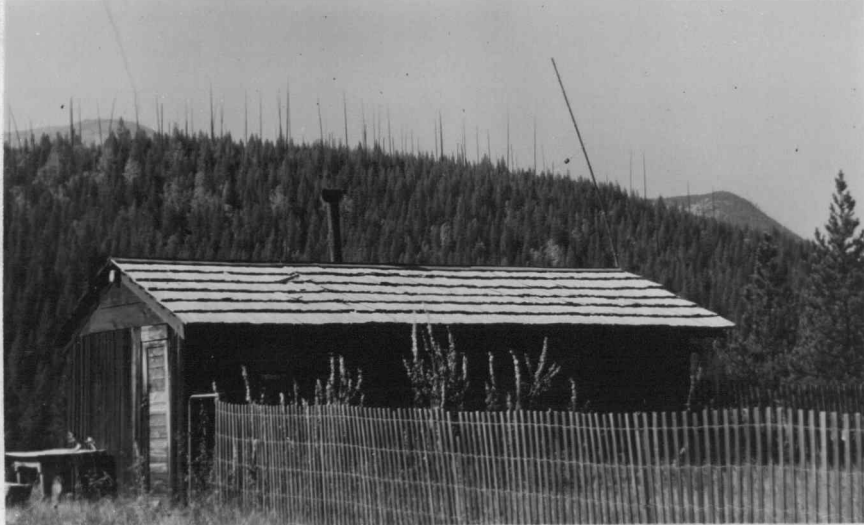
Photo No. 1 - Homestead patent filed by Axel Peterson March 3, 1915. Cabin built the same year. Larch shakes are 1/2" thick, 22" long with a 5" lap between courses. This cabin is within 5 miles of the Tom Peterson and "Bignose" Johnson homesteads.

Note the dead larch on hillside still standing from the 1910 - 1917 forest fires. The heartwood of these snags is still sound.

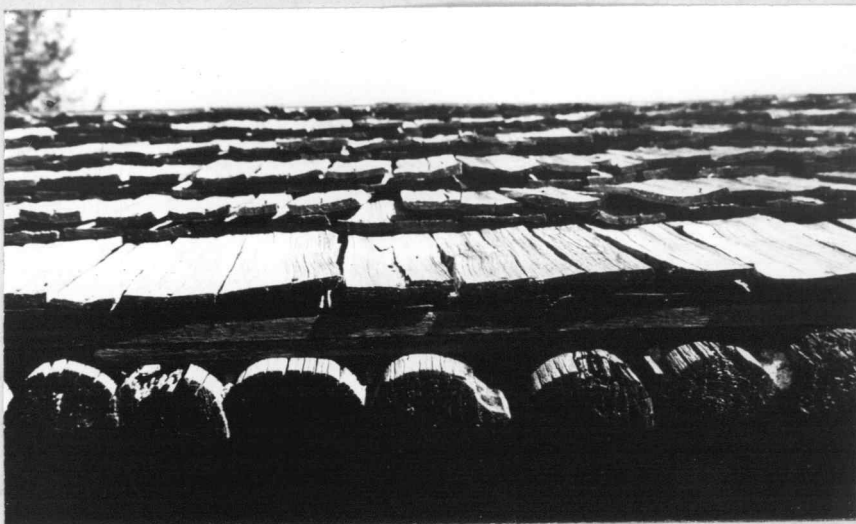
Photo No. 2 - Roof detail of above cabin. Shakes are in good condition. Compare this roof with "Bignose" Johnson's homestead which was built in 1912. This cabin is still used for vacations.

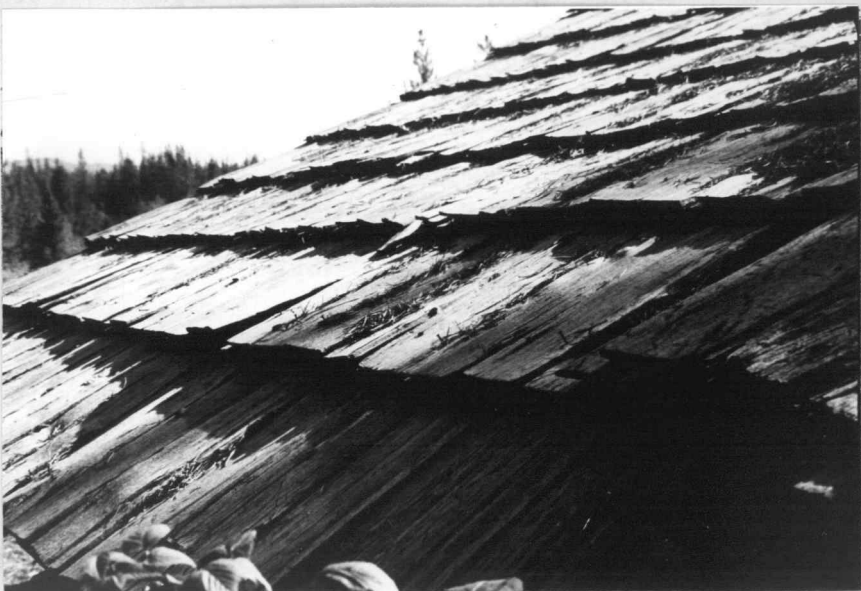
Photo No. 3 - Roof detail of low outbuilding at Mark's place. Built about 1916-18. Larch roof has a few decay spots.

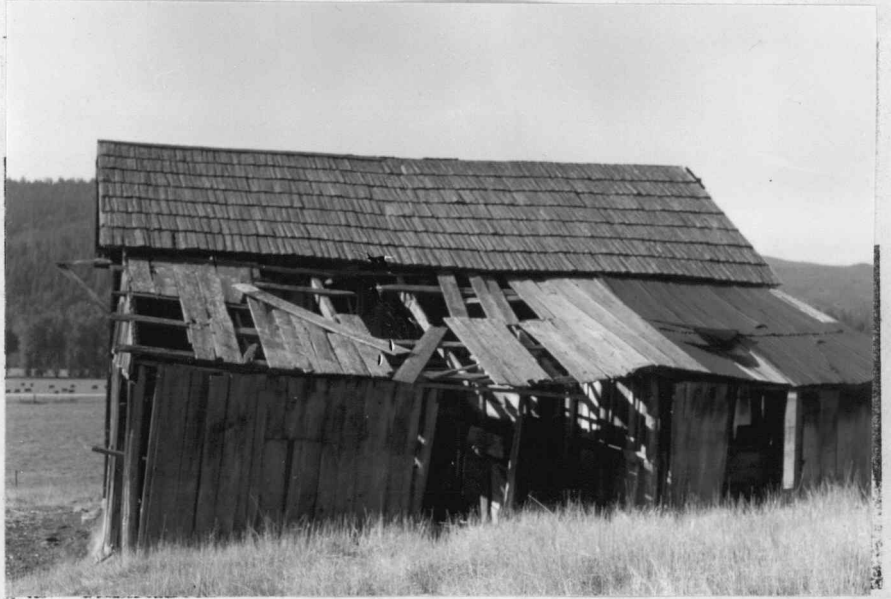
HUGH WILLIAMS PLACE, LOLO, MONTANA

This haybarn was old when the Williams family moved onto farm in 1919. Barn built with square nails. Larch shakes in good to very good condition. There has been no maintenance by the Williams family.

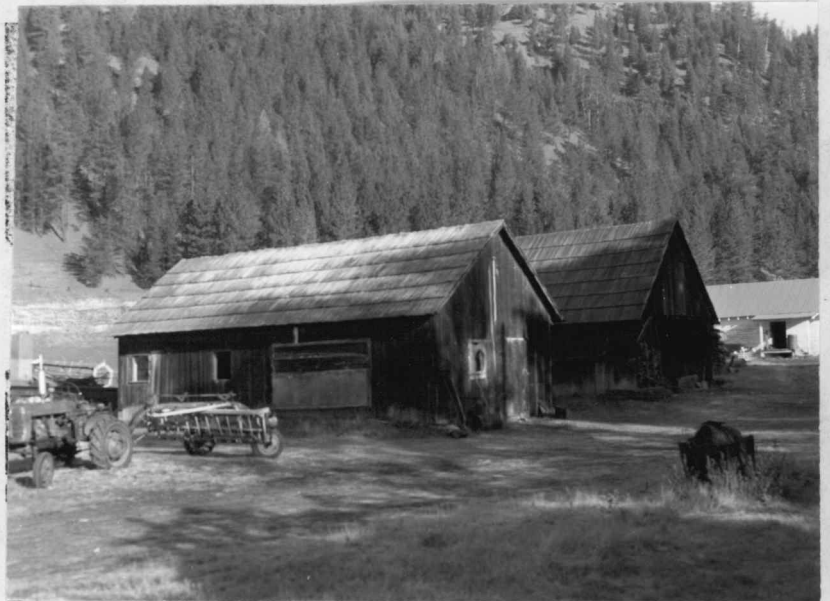
Building on left was constructed in 1930 and the one on the right in 1945. Both larch roofs are in excellent condition. The 1945 roof looks almost new.
