**Hatfield Marine Science Center
Dynamic Revetment Project
DSL permit # 45455-FP**

**Final Monitoring Report
February, 2016**

February 15, 2016

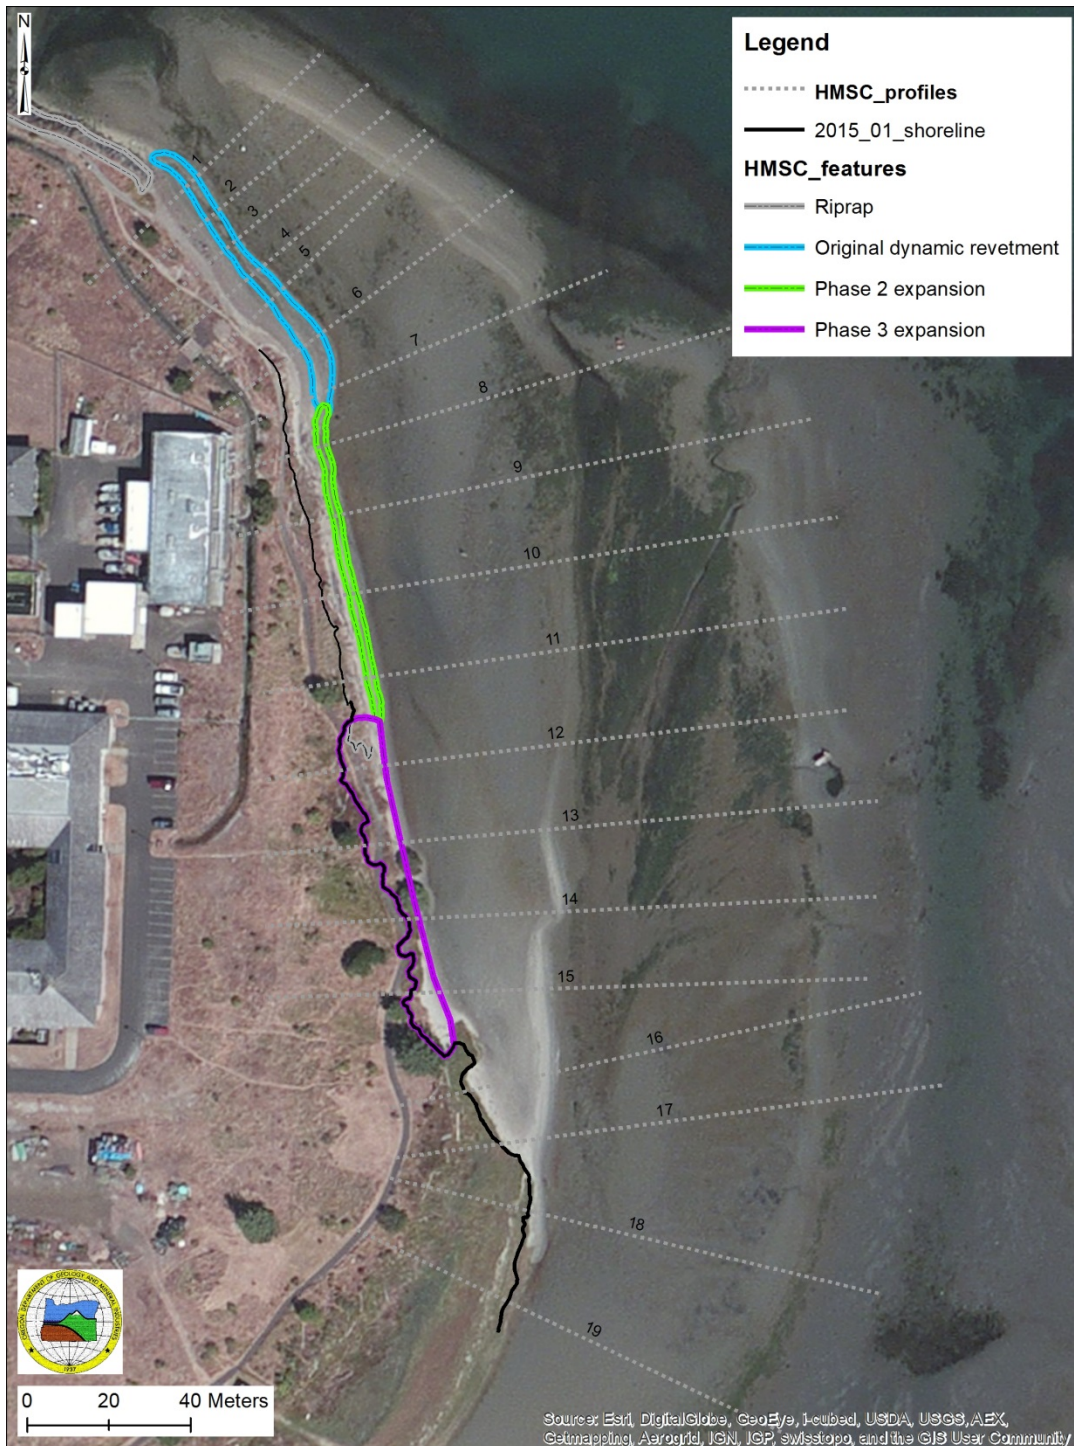
Figure 2.2: Location map showing the HMSC beach and shoreline monitoring network. Blue shaded dashed line denotes the cobble ‘lag’ toe of the original dynamic revetment (DRP 2007), green shaded dashed line denotes the cobble ‘lag’ toe for the expanded section (DRP 2011), purple represents the Reference (DRP 2015) area, and grey shaded dashed line denotes the location of rip rap rock. Solid black line depicts the most recent (January 2015) measurement of the erosion scarp.

For the purposes of this study, we established 15 beach profile transect lines along the estuary trail (Figure 2.2), which extends from the HMSC wharf in the northwest, southward approximately 290 m (~950 ft). Of these, 5 of the lines were originally established in May 2006 (1-5) to document changes on the original gravel beach constructed there in late 2006, while the remaining 10 lines were established in July 2011. An additional 3 transect lines were established in May 2014 (Table 2.1), expanding the monitoring network further to the south (Figure 2.2).

Figure 2.3 depicts the measured changes in the original gravel beach (Figure 2.4) area (blue dashed line in Figure 2.2). Examination of these data and results from the adjacent transects (6-12) confirm that the placement of gravel on the beach face and a lower cobble “lag” berm located at the juncture between the sandy beach and the inter-tidal mudflats, has been successful in stabilizing further retreat of the beach. This is characterized by the fact that there have been negligible changes to the gravel beach morphology in this area over time. Nevertheless, while the gravel beach is considered to be stable, there is some evidence of minor erosion taking place on the upper portion of the gravel beach where it merges with the sandy backshore. This response is entirely due to the occurrence of wind driven waves coupled with high tides, which enable the waves to reach to higher elevations on the profile (effectively exceeding the gravel beach) where they erode the sandy backshore. As noted in our original design, the gravel beach structure

Further south between Transects 6-11 (Figure 2.5, green dashed line in Figure 2.2), the beach survey data indicate that the expanded gravel beach section (DRP 2011) is also stable, such that erosion of the beach and backshore has essentially ceased. Note that the degree of erosion that took place in this area is captured by the changes that took place between July 2009 and our first survey of the new gravel beach area undertaken in July 2011. In Figure 2.5 the baseline for our current monitoring efforts is the 2009 LIDAR. Despite the apparent stability of the gravel beach, our most recent survey undertaken on January 11th 2016 confirmed that the Transect 6 profile site is experiencing some erosion; this was noted in our previous report. As can be seen in Figure 2.6, the erosion is confined entirely to the upper part of the beach profile (located between the 2-3 m elevation). It is likely that the erosion at Transect 6 reflects the fact that this area of the beach may be feeding gravel to the areas adjacent to it (Figure 2.7). For example, Transect 5 shows clear evidence of it having gained gravel over the past few years. As noted in our previous reports, we recommend that HMSC consider adding some additional gravel to this portion of the existing dynamic revetment in order to safe guard its volume.

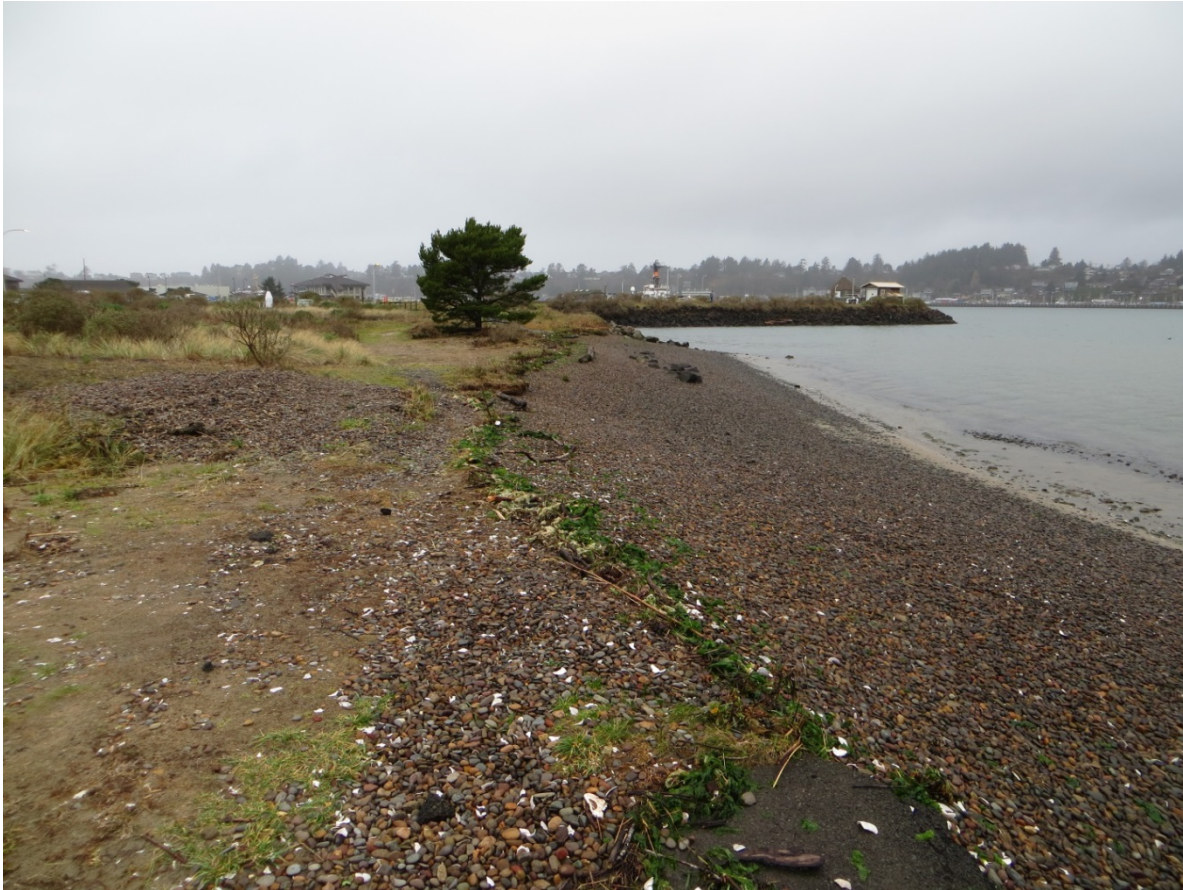
Figure 2.4: View looking northwest across the original gravel beach (DRP 2007). Photo depicts the effects of recent inundation by high tides along with some minor erosion of the top of the sandy beach [*Photo by J.C. Allan, January 11th 2016*].

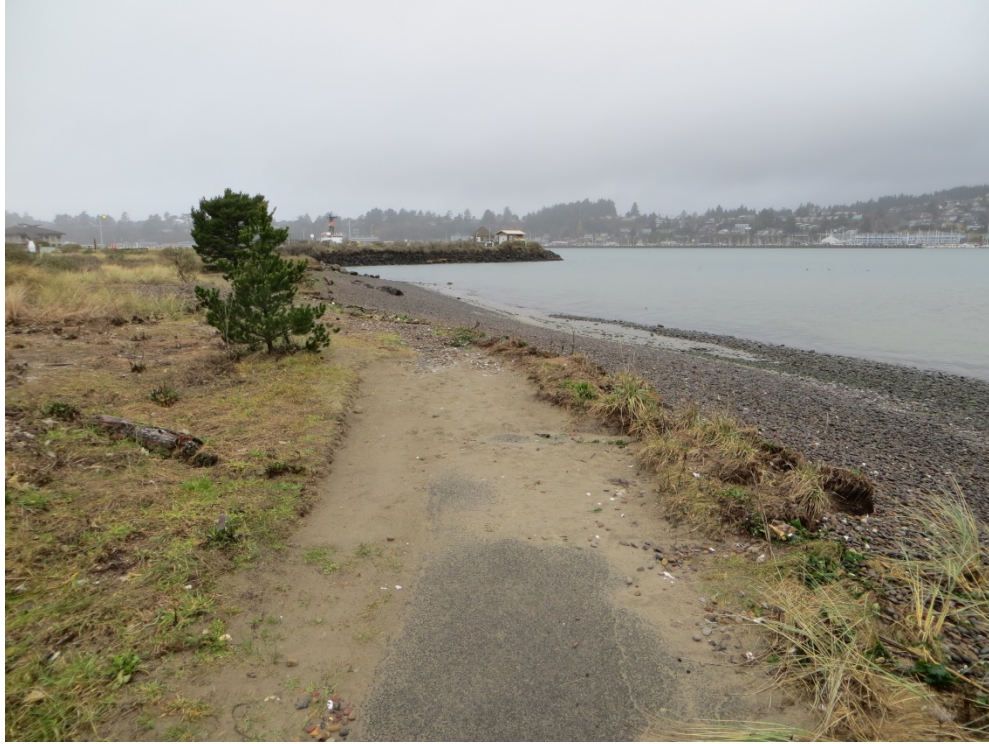
Figure 2.7: Erosion of the upper gravel beach and backshore occurring near the Transect 6 profile site [Photo by J.C. Allan, January 11th 2016].

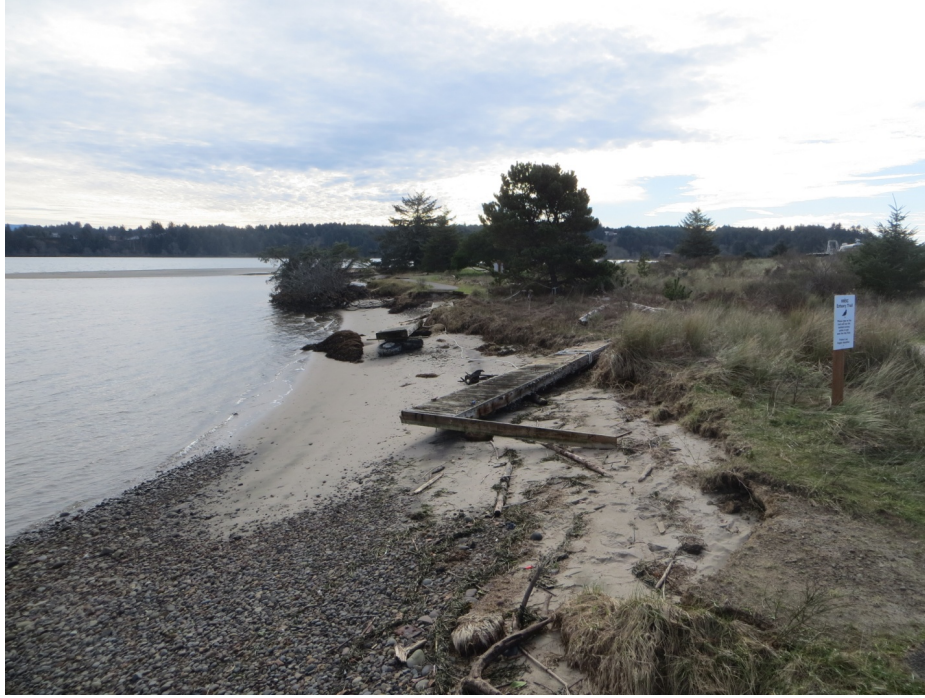
Figure 2.10: Erosion taking place in the phase 3 (Reference (DRP 2015)) construction area, prior to the area having been renourished with gravel [Photo by J.C. Allan, January 9th 2015].

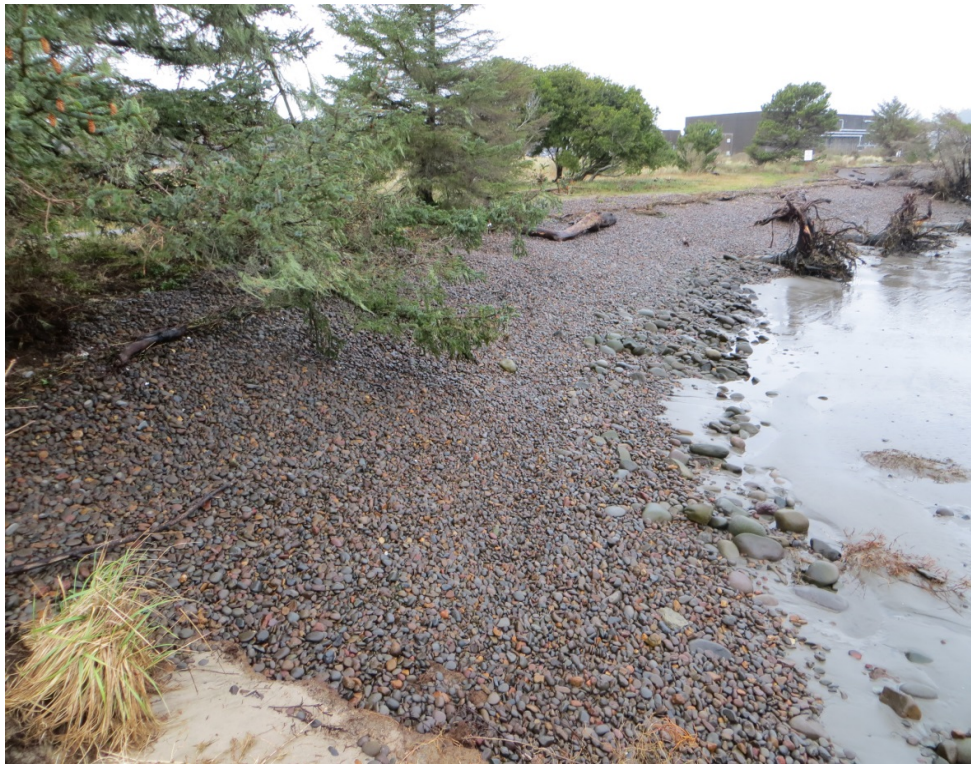
Figure 2.11: Expanded dynamic revetment (Reference (DRP 2015)) [Photo by J.C. Allan, January 11th 2016].

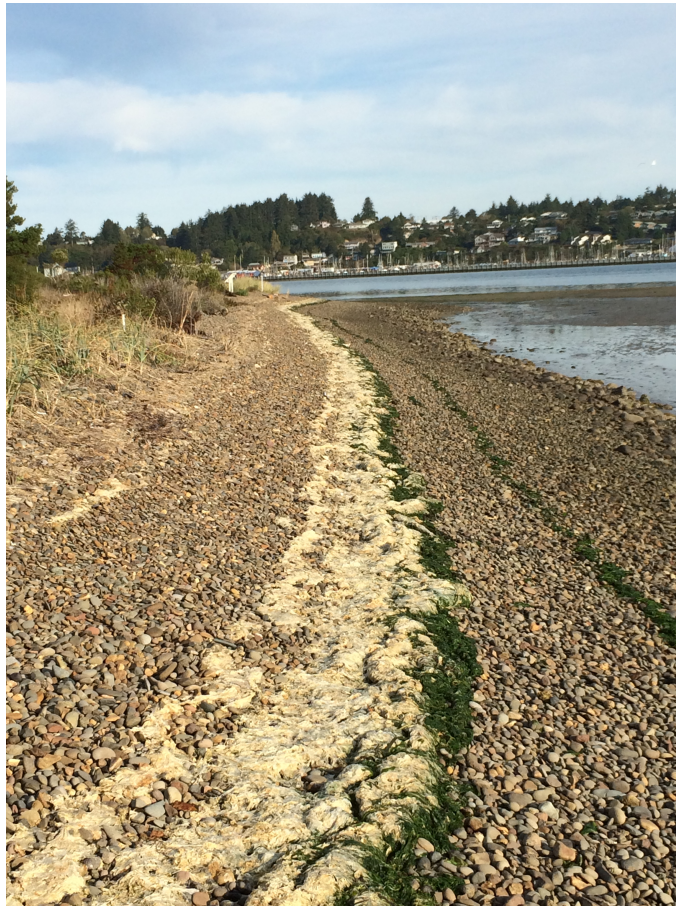
Figure 3.1. View of the DRP shoreline (October 15, 2015) showing the algal wrack line on the upper shore. [Photo by W.G. Nelson].

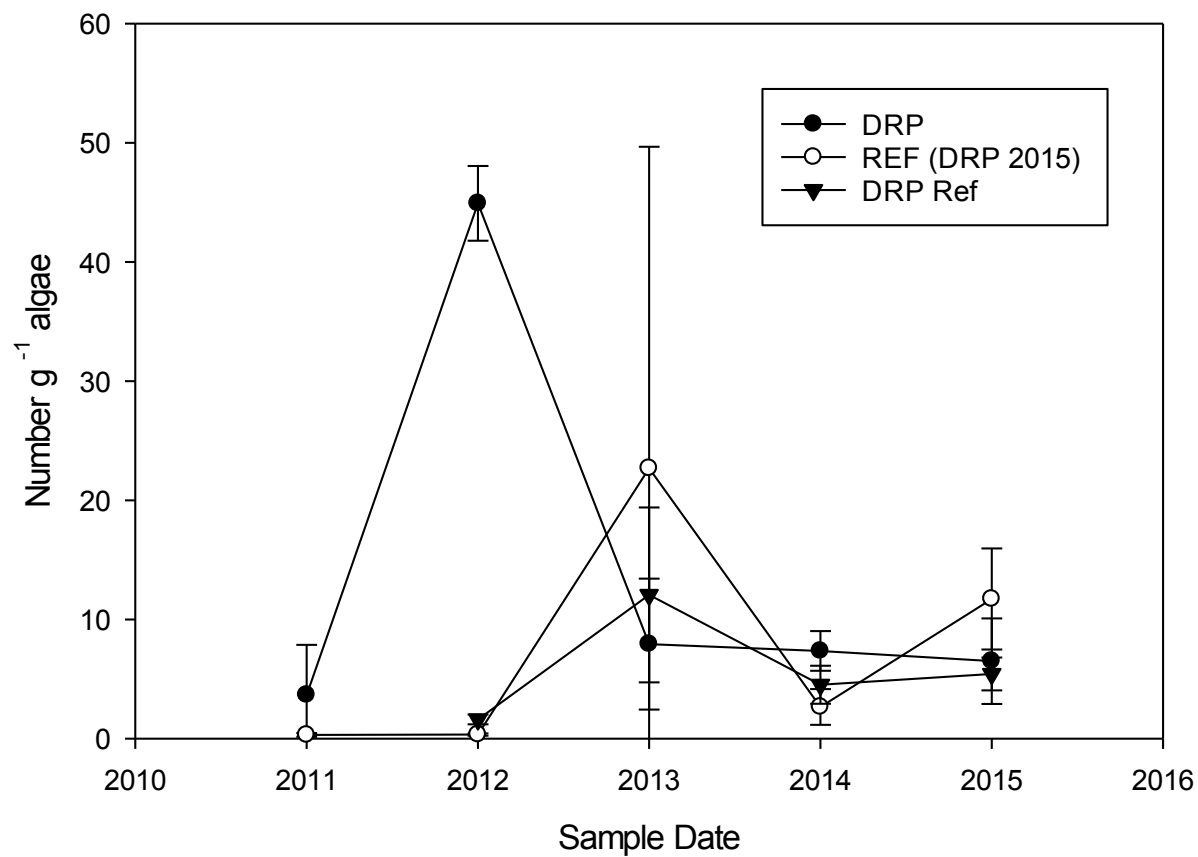
Figure 3.2. Comparison of the mean (± 1 s d) number of wrack organisms per g of plant dry-wt over the five years of the sampling program. The DRP Ref (2007) area was added as a sampling area in 2012.

Comparison of the number of wrack organisms per g of plant dry-wt over the five years of the sampling program is given in Figure 3.2. There has been considerable spatial and temporal

variability in this parameter. The most striking difference was the high number of organisms within the wrack material within the DRP (2011) project area in the year following the project (2012). This difference was not seen in 2013-2015. Although there have been statistical differences among sites from year to year, there has been no consistent pattern of elevated or depressed numbers associated with any particular area. Taxonomic composition of the wrack fauna has been generally similar both from year to year, and among sampling areas (e.g. Table 3.1)

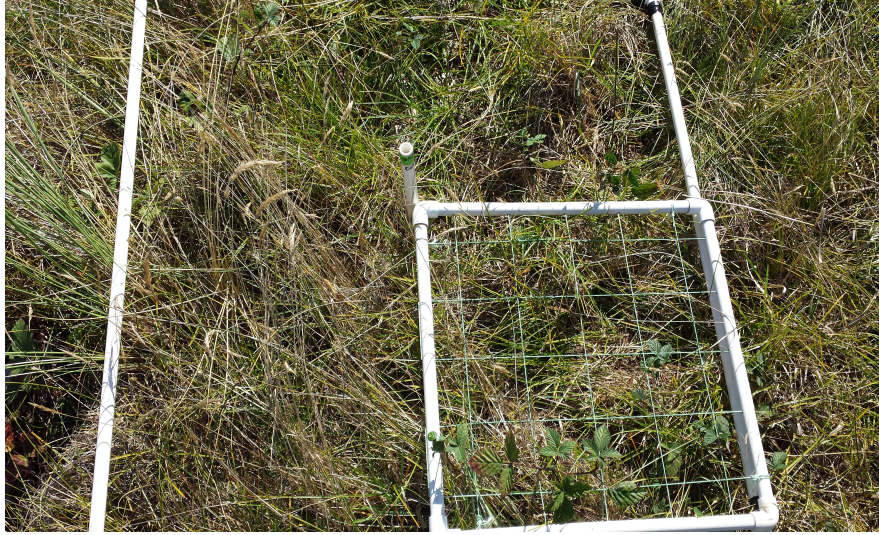
Figure 3.10: Close up of 1-m² quadrat used to determine plant presence-absence with the 0.25-m² quadrat used to determine percentage cover of vegetation. [Photo by C. Folger]

Vascular plant presence or absence (usually at the species level) was visually assessed by scanning one 0.25 -m² quadrat within each 1-m² quadrat (Figure 3.10, 3.11). Plant percent cover was assessed by visually evaluating the percentage that each plant species contributed to the overall plant community present within the 1-m² quadrat. Percent cover estimates also considered non-plant substrata such as open or bare ground and detrital material. Photographs of each quadrat were taken from several perspectives.

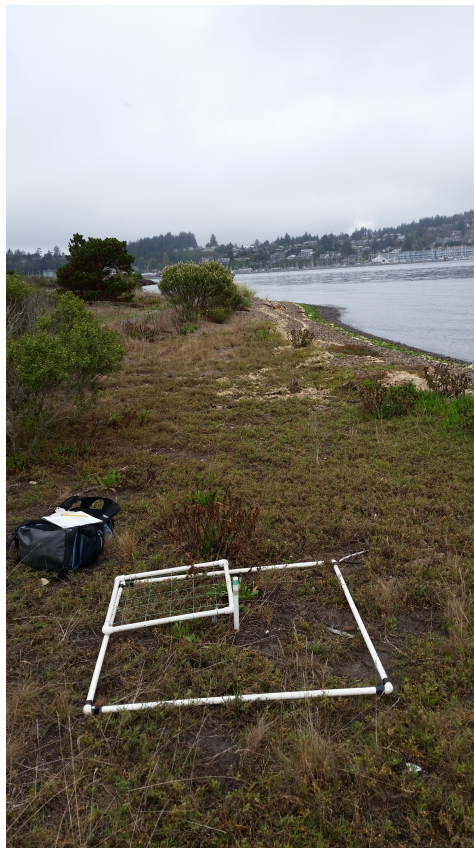
Figure 3.11: Vegetation monitoring Quadrat DRP 2, October 2015. View to northeast. . [Photo by C. Folger]

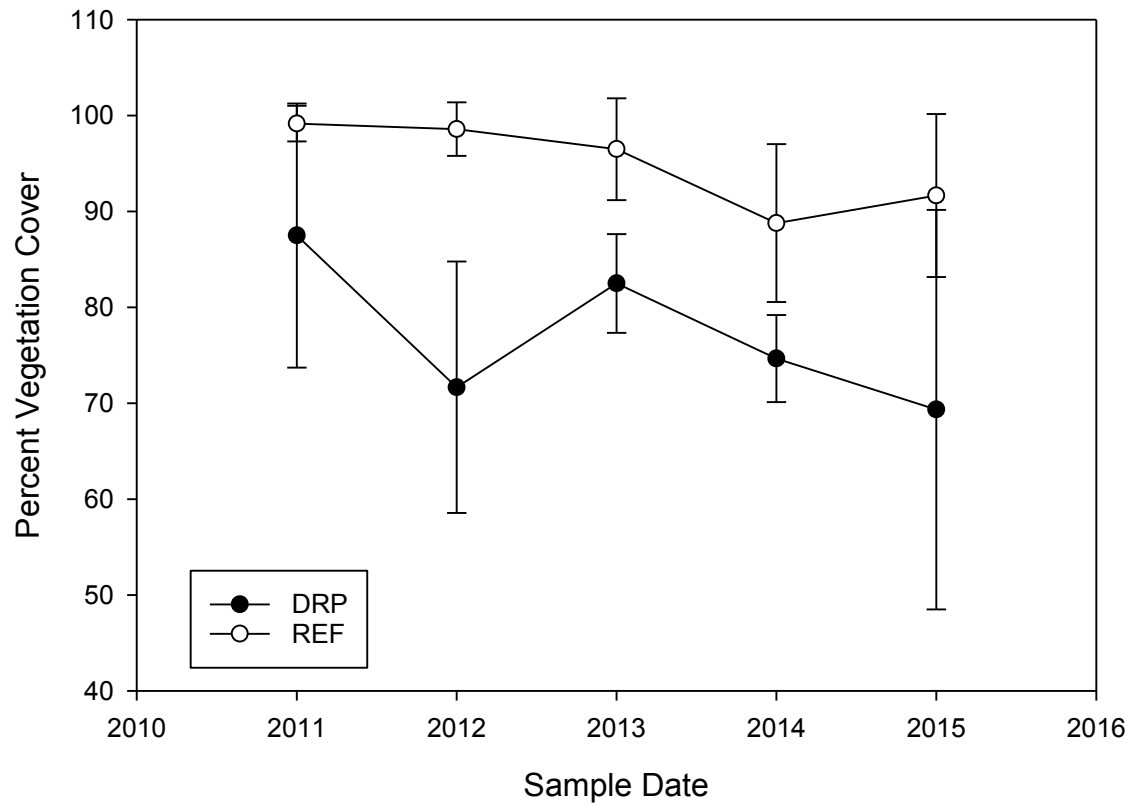
Figure 3.12. Comparison of mean (± 1 s d) percent vegetation cover over the period of the DRP monitoring study between the DRP and the Reference vegetation areas.

The lower average vegetation cover at the DRP sites has been a consistent result during the monitoring, and was present in the pre-project samples (Figure 3.12). DRP quadrats 1-3 occur at lower elevation than most other sample locations, and as described in previous reports, there is also a topographic low spot in the shoreline near beach profile 9 (Figure 3.1), which allows the back shore area to be more frequently flooded by fall and winter King tides. This increased flooding has transported gravel from the DRP back into some of the vegetation plots, and there were also heavy deposits of seaweed wrack consisting mostly of the green alga *Ulva* spp.

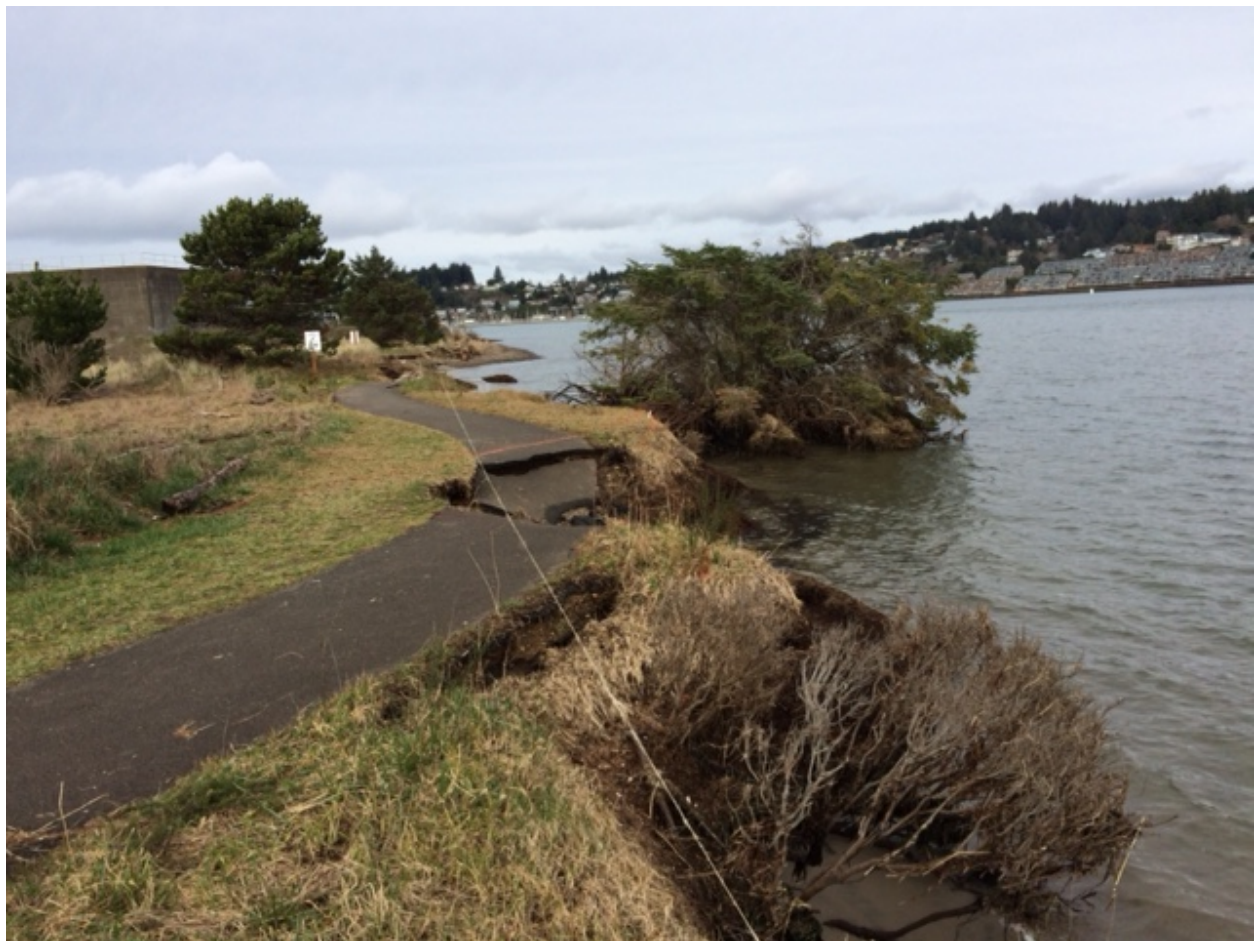
Figure 4.1: View of collapsed section of HMSC nature trail, February 3, 2015. [Photo by W. Nelson]

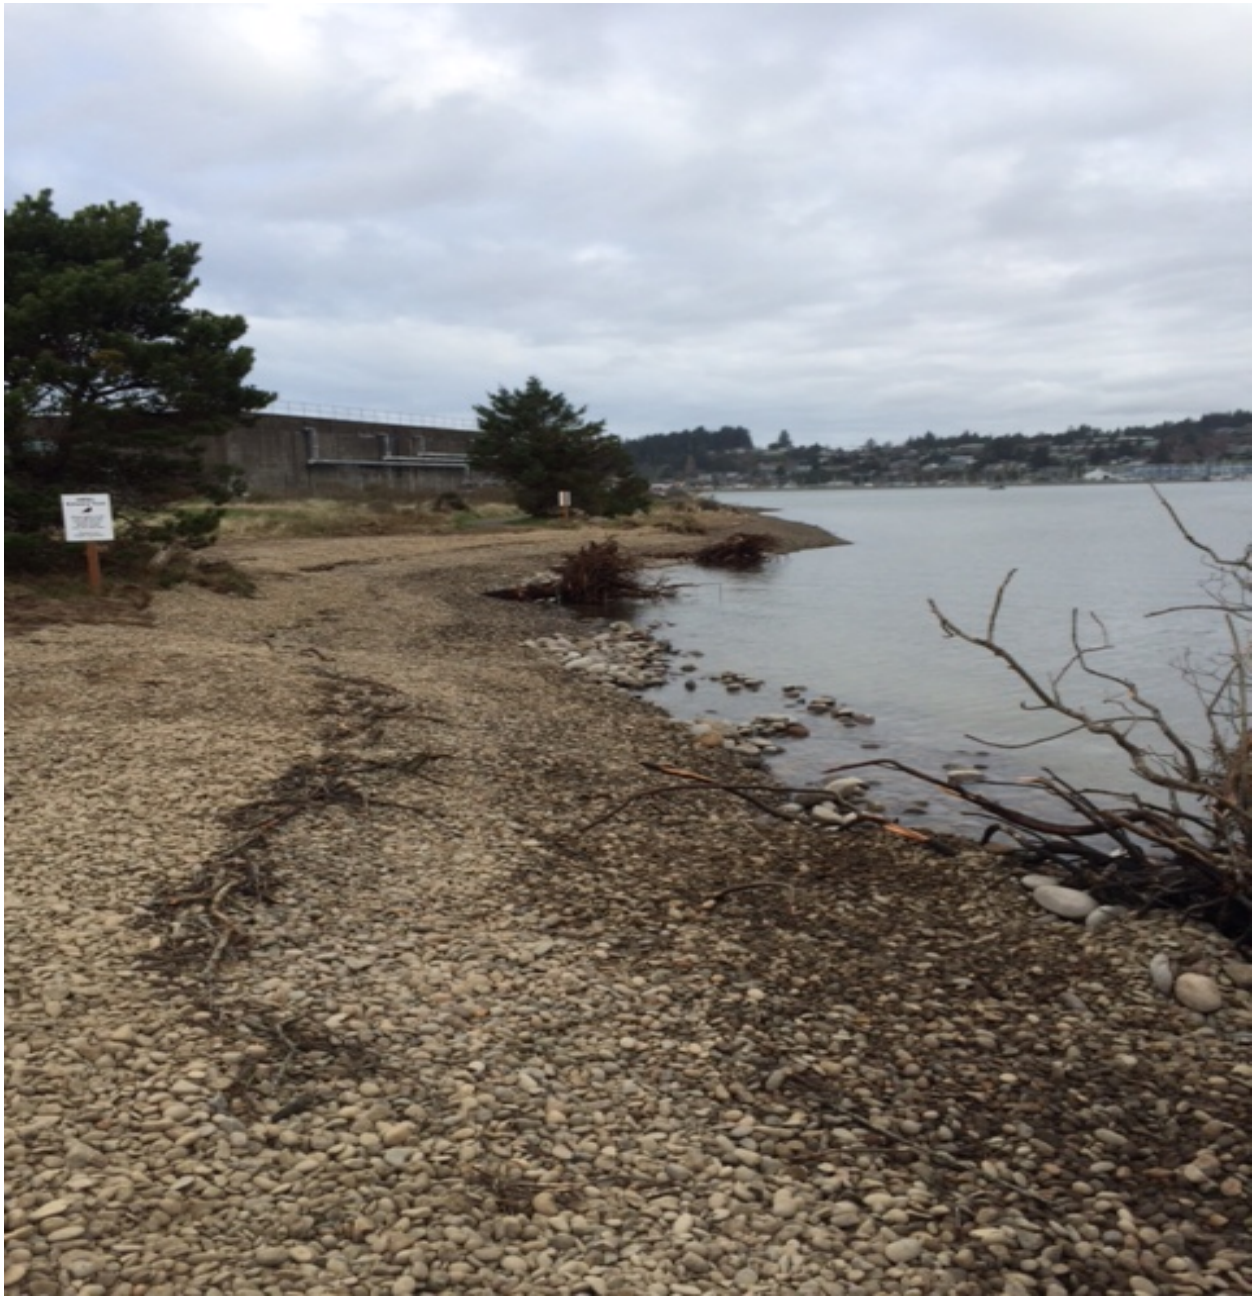
Figure 4.2: View of dynamic revetment project February 18, 2015 showing gravel grading to cobble at the toe of the beach slope. Six trees with root masses exposed were emplaced along the lower margin of the project. [Photo by W. Nelson]

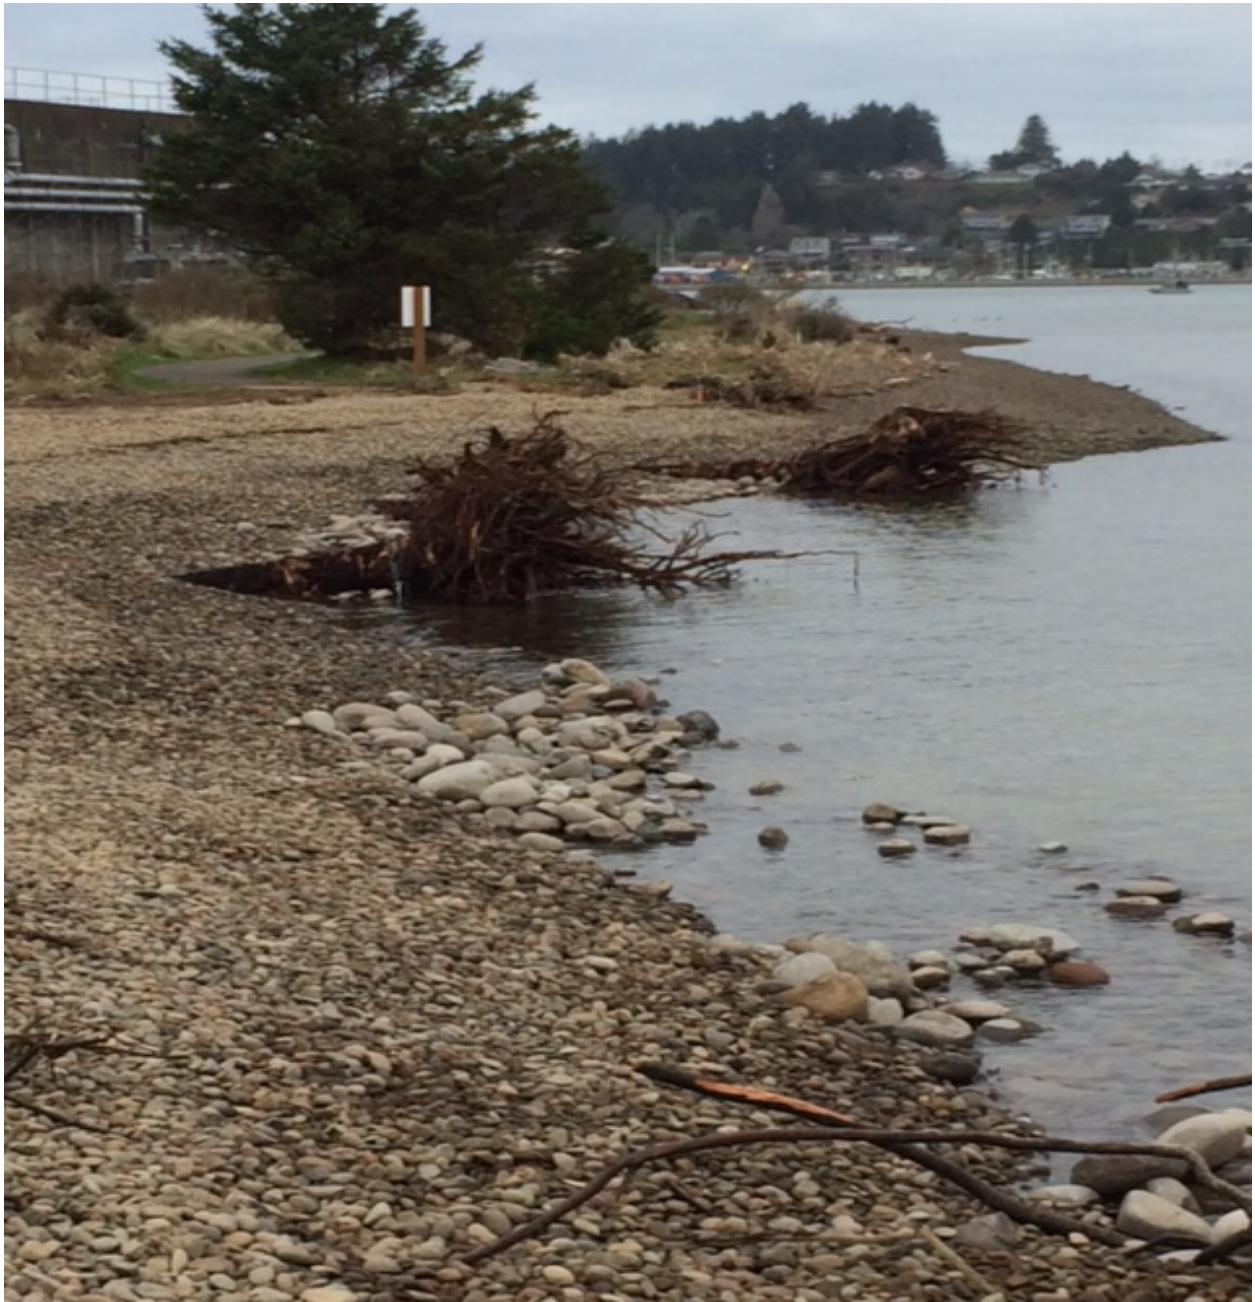
Figure 4.3: Close up view looking north along the dynamic revetment project February 18, 2015. The terminus of the 2011 dynamic revetment is seen in the upper center of the photo, located opposite the white sign. [Photo by W. Nelson]

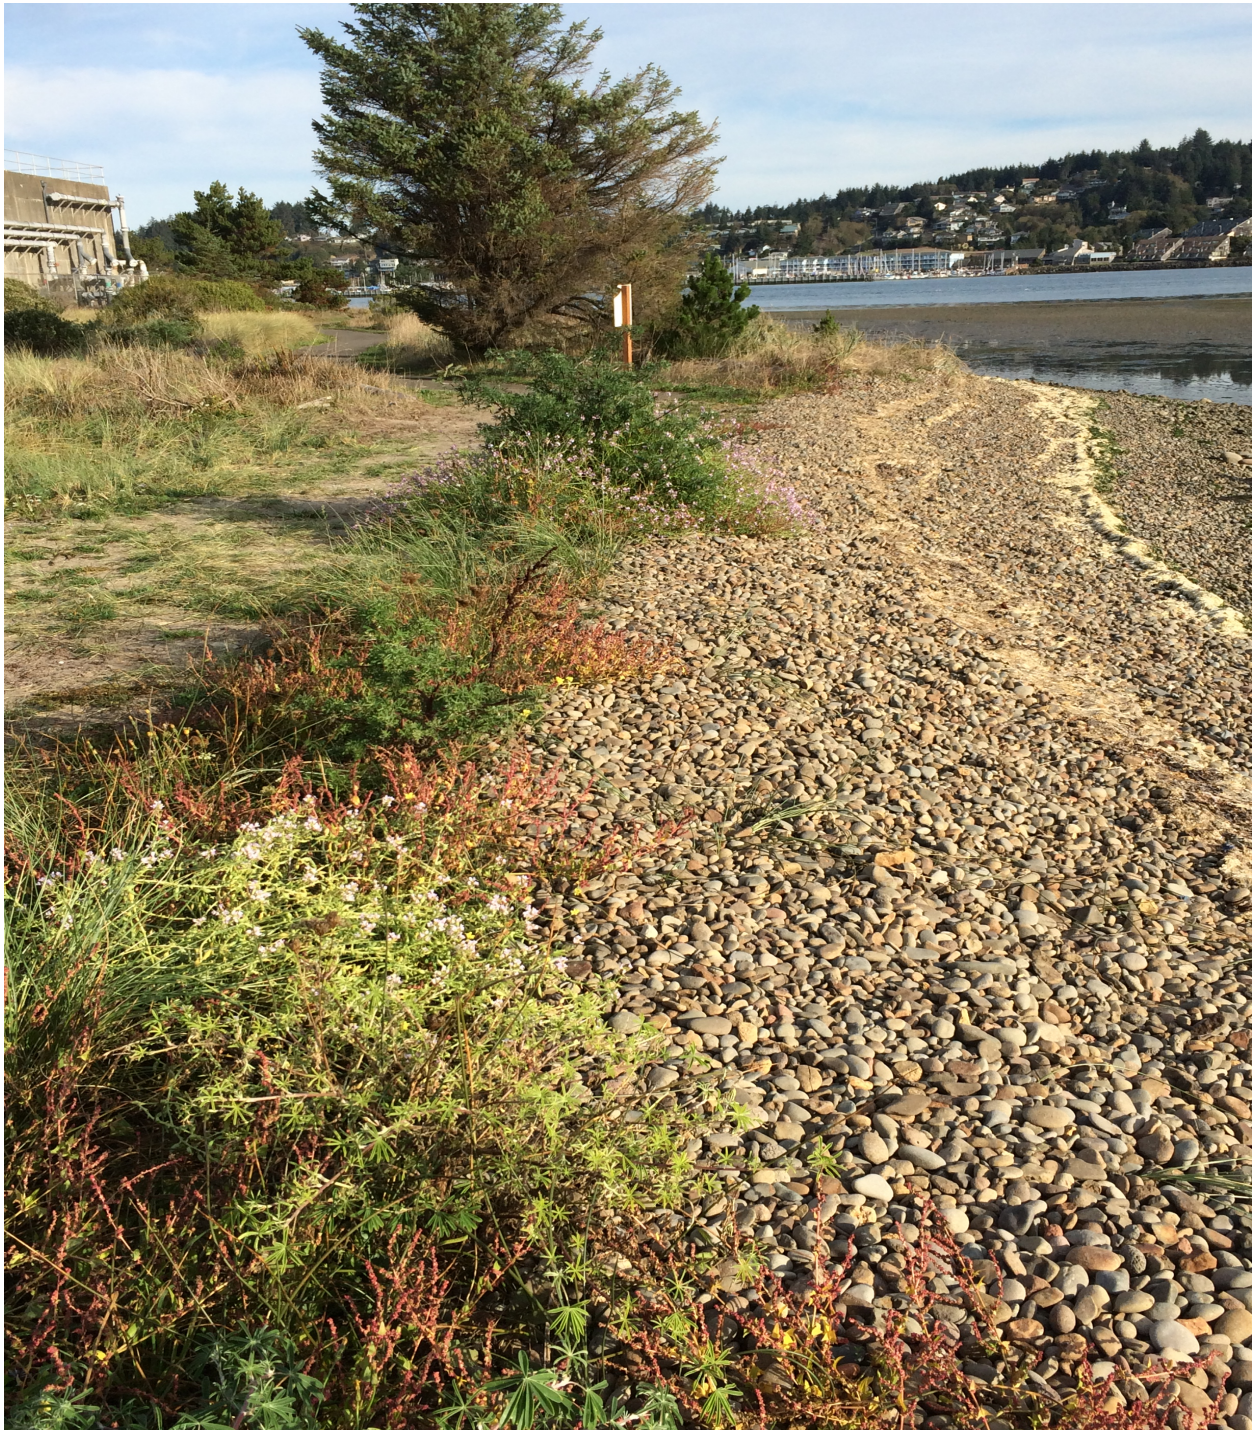
Figure 4.4: View looking north along the dynamic revetment project October 15, 2015. Vegetation has recovered along the upper edge of the project, and the beach face has accumulated a tidal wrack line of organic material. [Photo by W. Nelson]

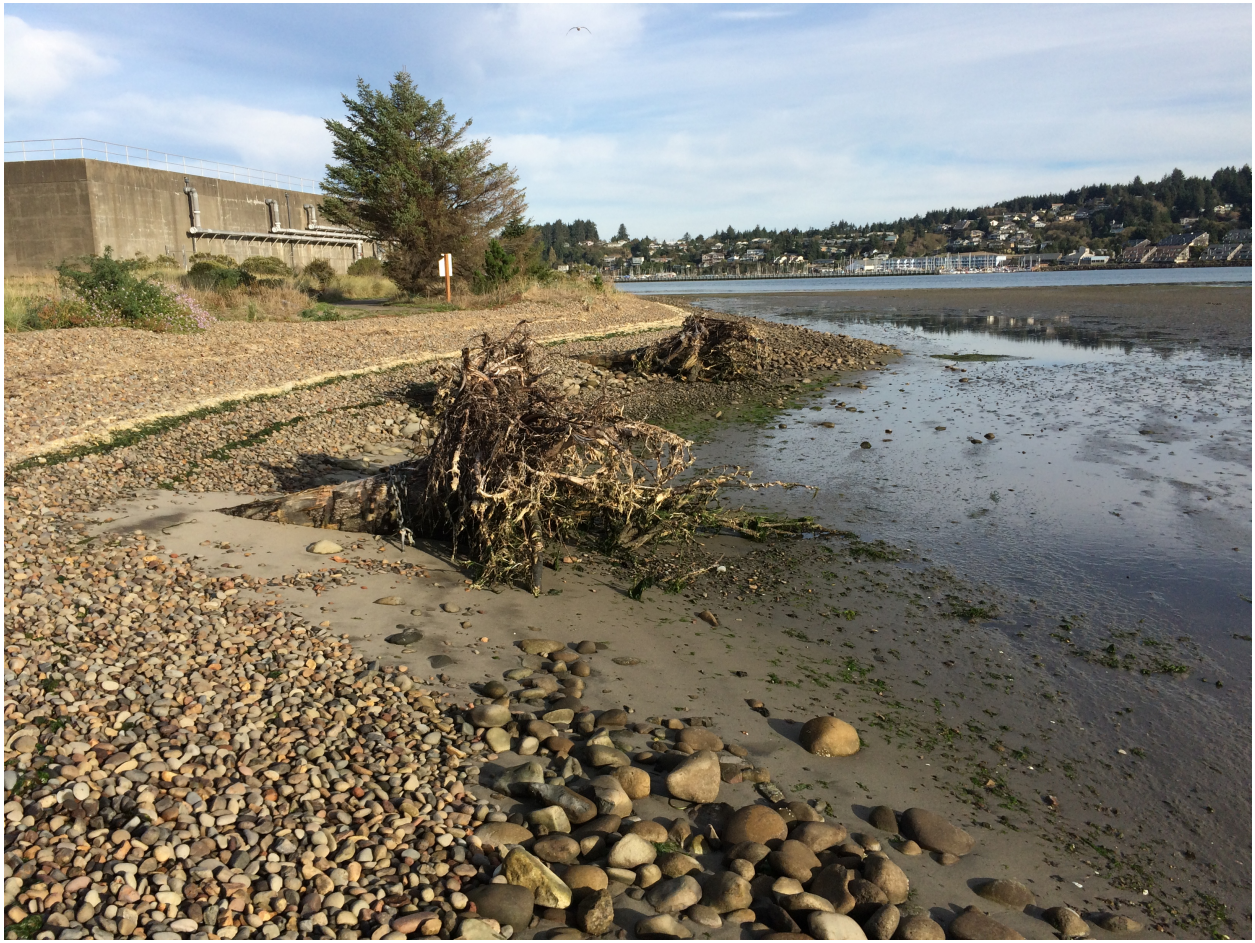
Figure 4.5: View to the north along the dynamic revetment project October 15, 2015. Sand has accumulated in the vicinity of the tree stumps sufficiently to bury the cobble toe of the project in some spots. [Photo by W. Nelson]

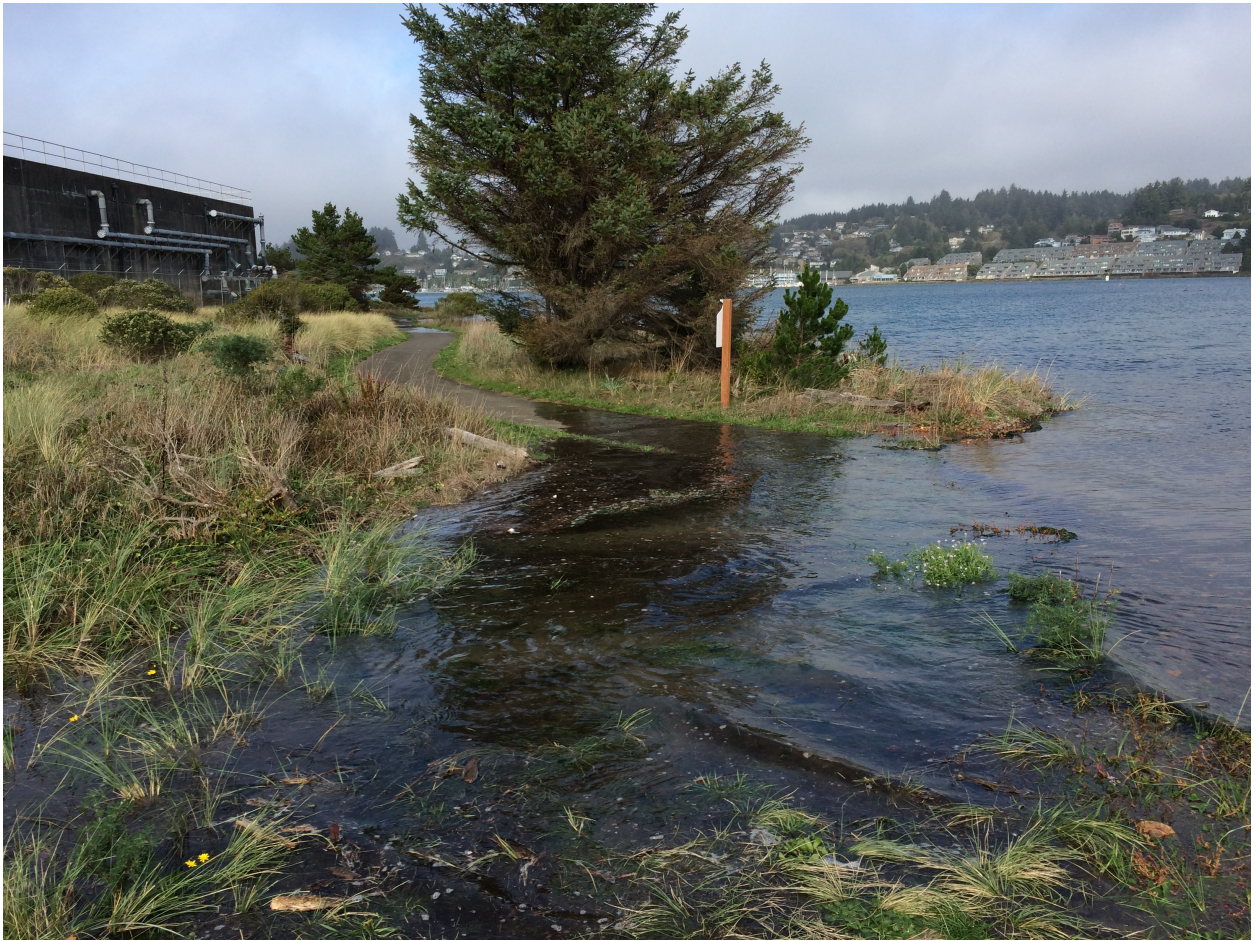
Figure 4.6: View at the northern end of the 2015 dynamic revetment project October 28, 2015 during king tides. Water levels surged over the top of the project berm and inundated the HMSC nature trail. [Photo by W. Nelson]

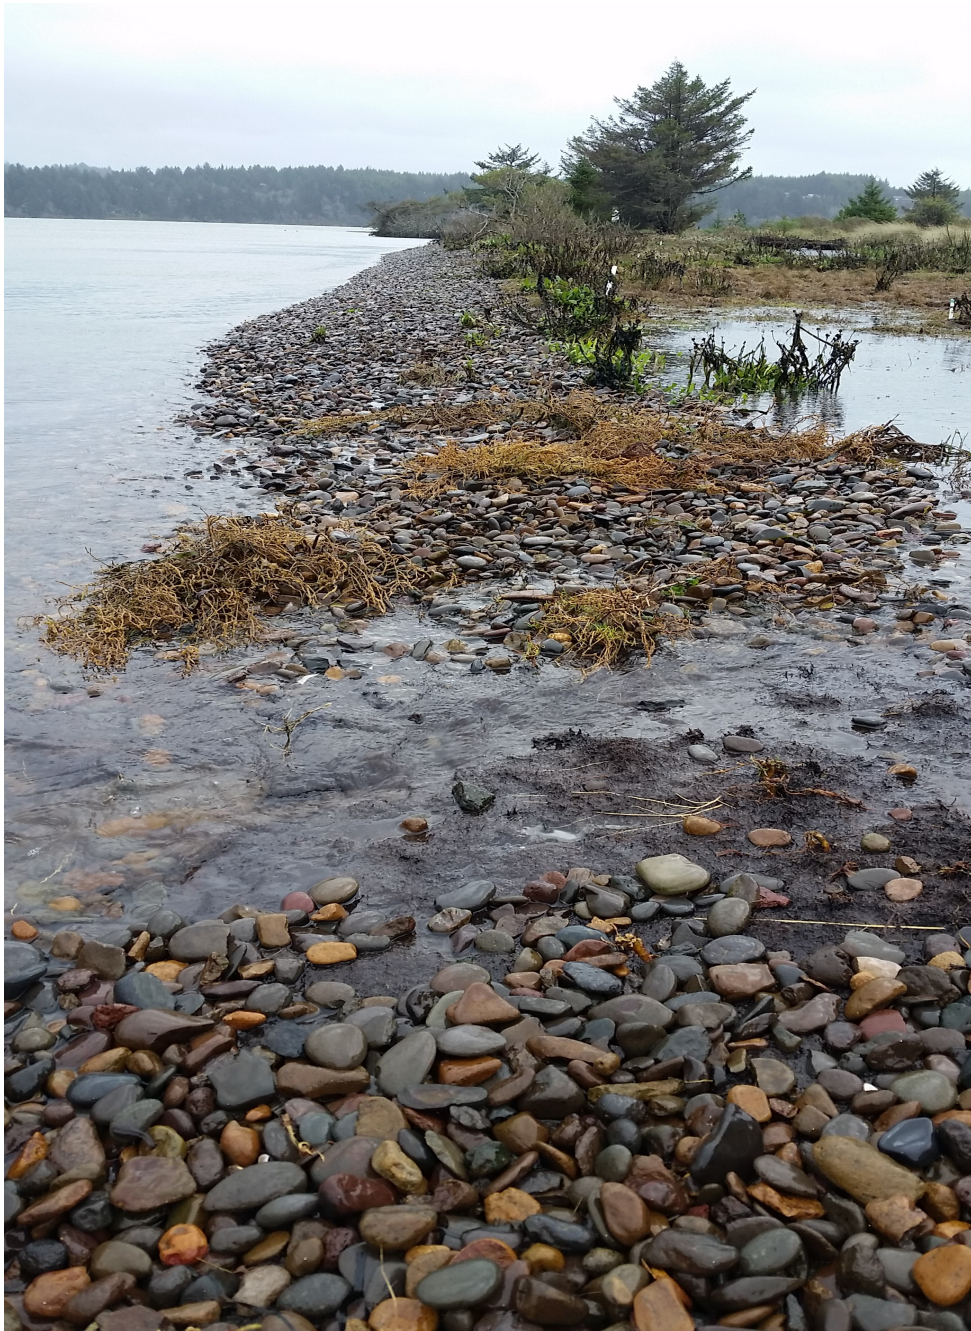
Figure 4.7: View of the 2011 dynamic revetment project on January 21, 2016 during king tides, showing over topping of the project with a drain channel for water returning to the estuary as the tide falls. [Photo by C. Folger]

As described in more technical detail in Section 2.2, as of February, 2016, the 2015 DRP project has largely stabilized shoreline erosion within the project area. Both the 2007 and 2011 DRP shoreline sections appear mostly stable. “King” tides occurring from November – February coupled with east wind driven wave action have continued to roll back the shoreline vegetation, and steep vertical scarps at the vegetation edge are the norm along this shore section. Erosion in the unprotected Reference area in the period 2009-2014 has been as great as 11 m (36 ft). The effect of erosion during 2014 can be seen in comparison of Figures 4.1 through 4.4, taken from a similar spot on the HMSC Nature Trail. Erosion in 2014 continued to create vertical banks of collapsed sod, with salt marsh vegetation collapsing and being eroded away (Compare Figures 4.5 and 4.6). Erosion has begun to accelerate for low salt marsh habitat beyond the southern edge of the currently proposed new project area, which has not been exposed to erosion before (Figure 4.7).

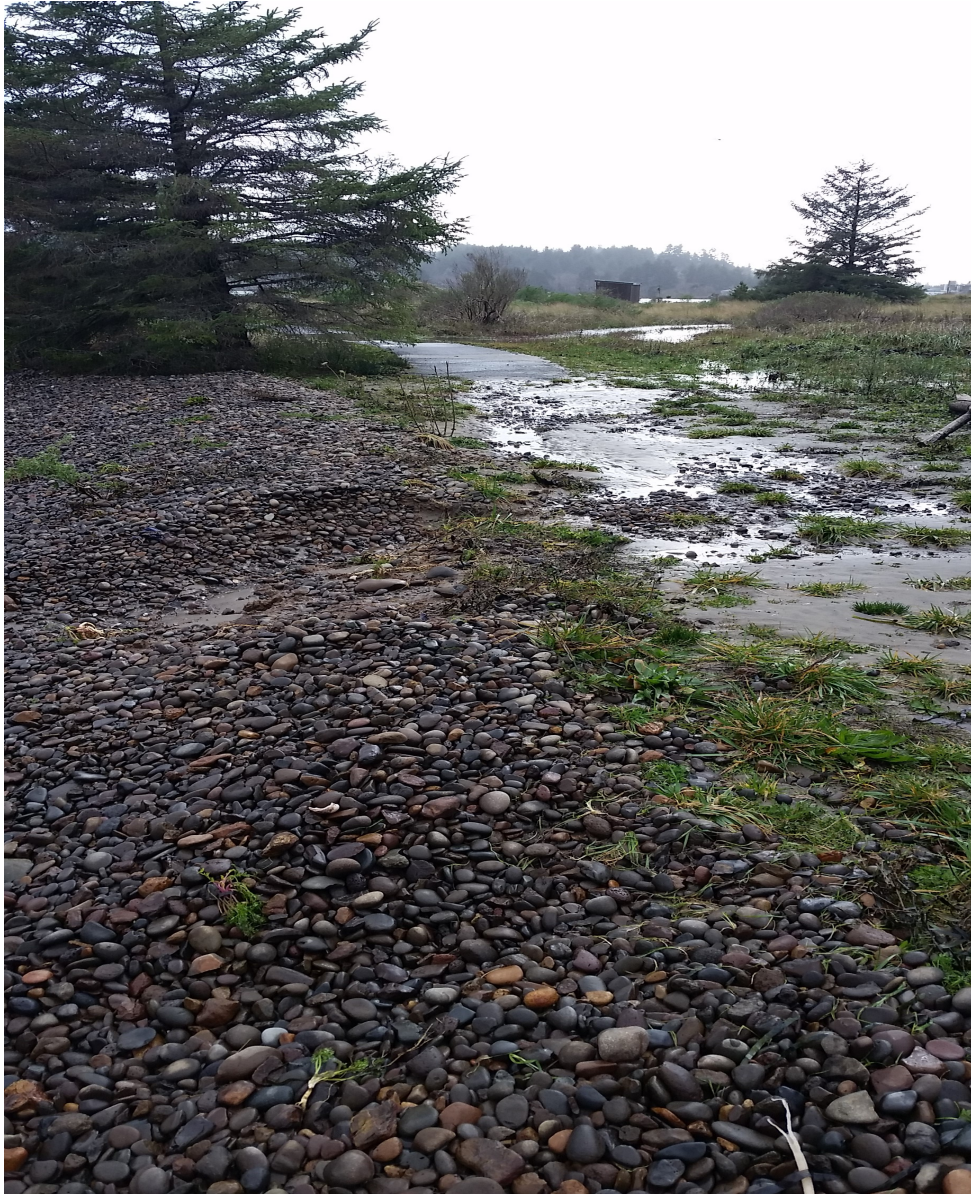
Figure 4.8. View of the 2015 dynamic revetment project on January 21, 2016 during king tides, showing scouring of gravel at the top of the project associated with a drain channel for water returning to the estuary after over topping of the project. Gravel was moved down the beach and bare earth was exposed. [Photo by C. Folger]
