**Hatfield Marine Science Center
Dynamic Revetment Project
DSL permit # 45455-FP**

**Final Monitoring Report
February, 2016**

February 15, 2016

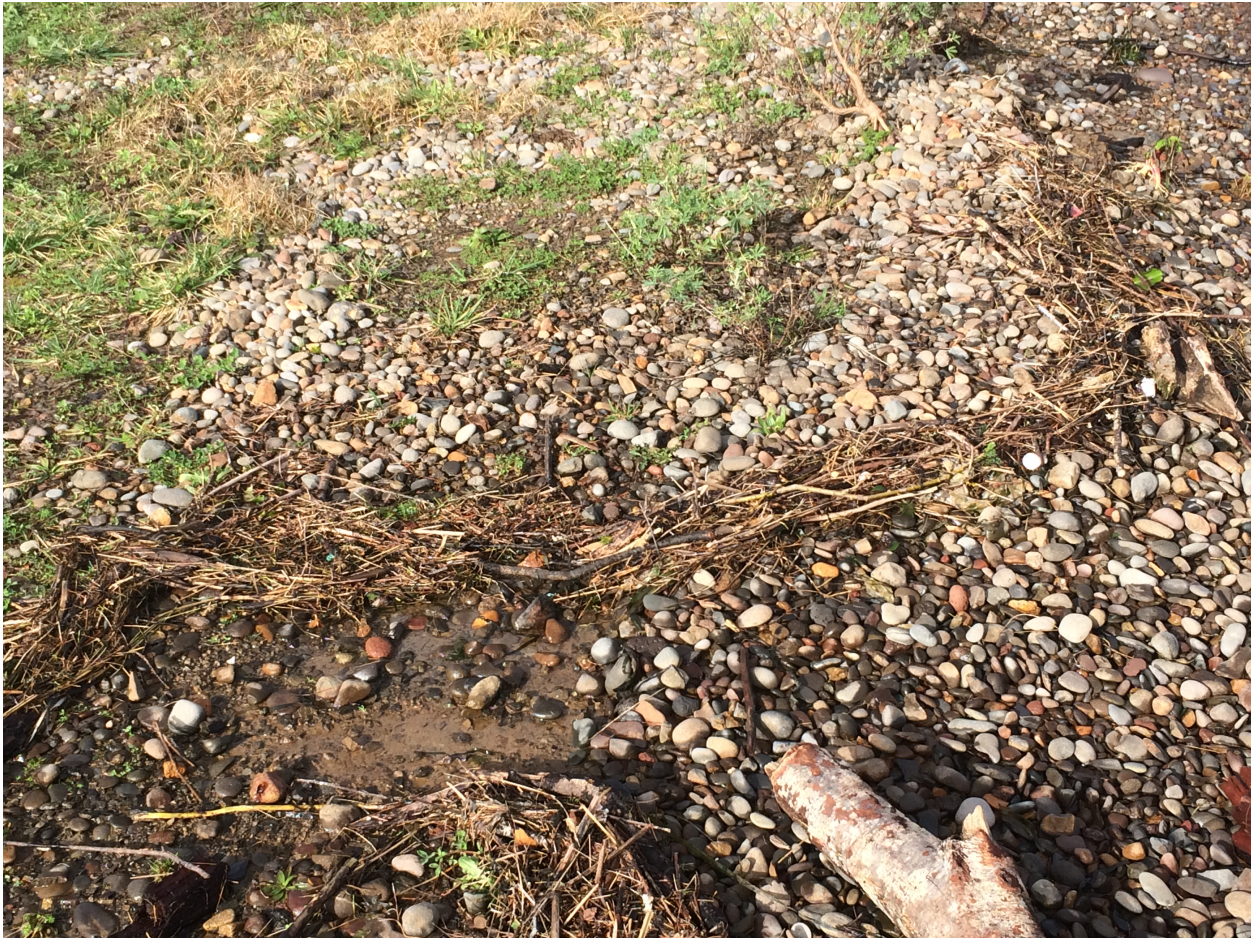
Figure 4.9. Close-up view of the 2015 dynamic revetment project on January 22, 2016 during king tides, showing scouring of gravel at the top of the project associated with a drain channel for water returning to the estuary after over topping of the project. [Photo by W. Nelson]
