Title: Design and Environmental Performance of Near-Surface Mounted Carbon Fiber
Reinforced Polymer Strips for Shear Strengthening Reinforced Concrete Bridge Girders.

A THESIS

Oregon State University

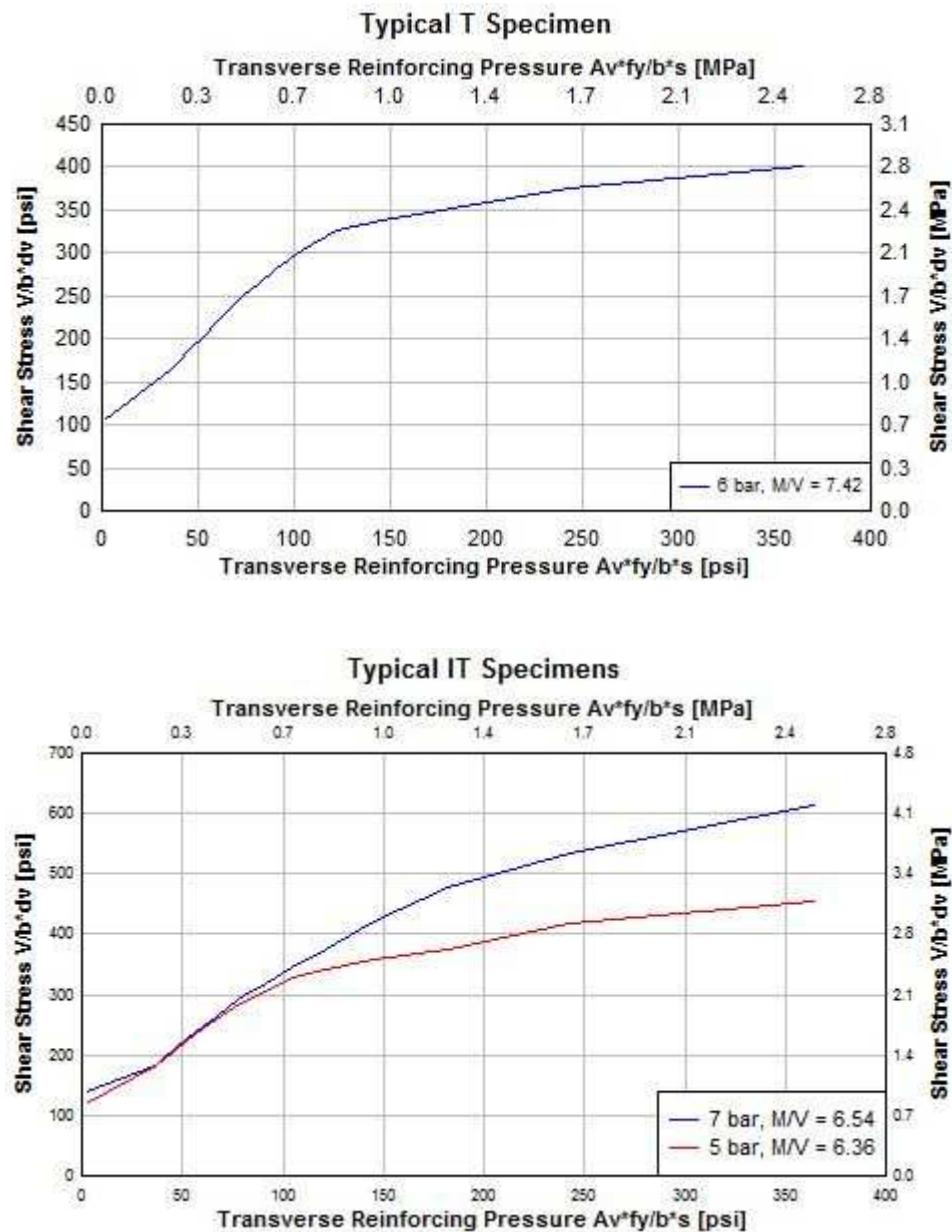
Fig. 4.6 – Shear curves created using R2K for typical cross-sections

It should be noted that the graph for the IT section has curves for specimens with five (5) 36 mm (#11) flexural reinforcing bars and for seven (7) 36 mm (# 11) flexural reinforcing bars. These curves are different because they are based on MCFT which accounts for the

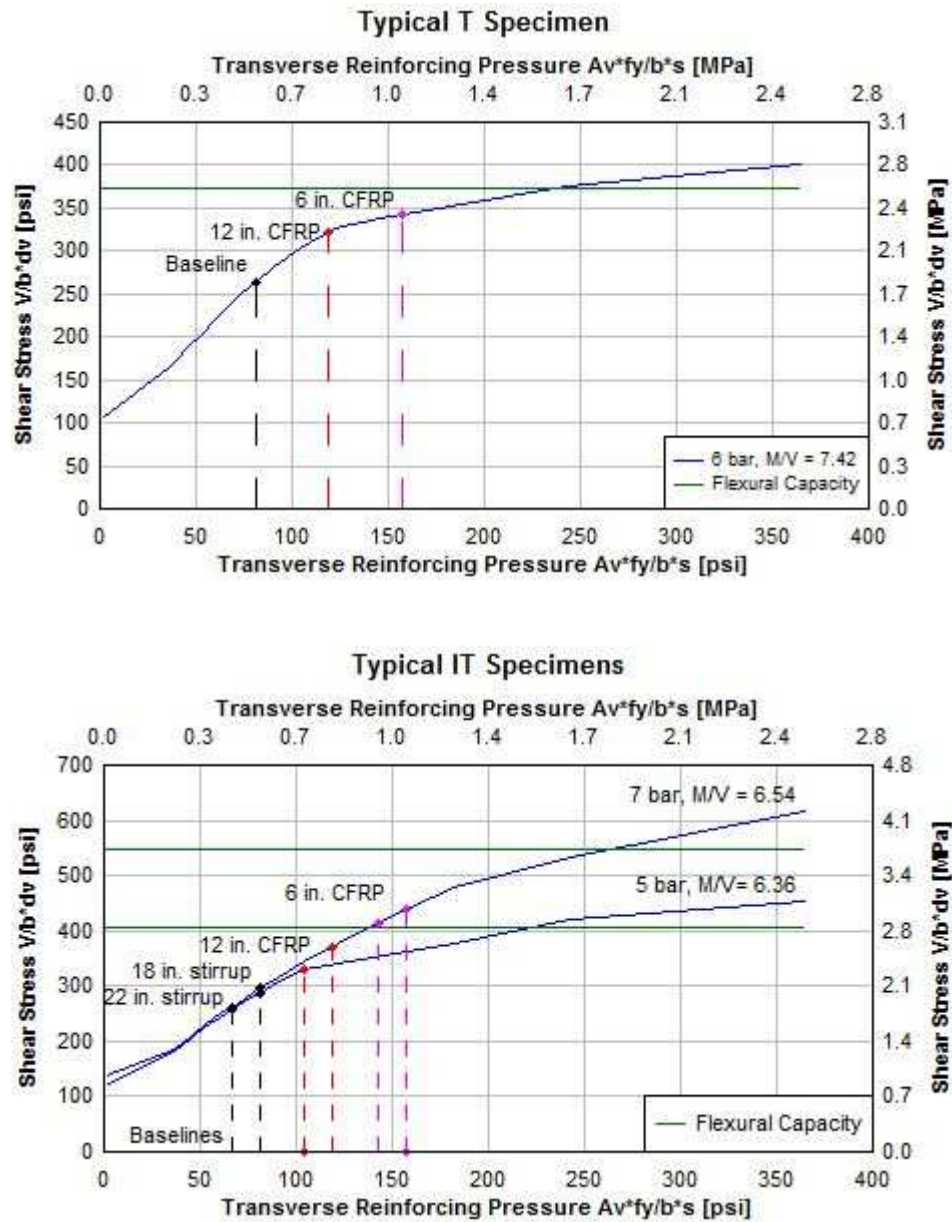
Fig. 4.7 – Typical shear stress vs. transverse reinforcing interactions for constructed specimens

All of the specimens were to be constructed with a 457 mm (18 in.) internal steel stirrup spacing to match previous tests done at Oregon State University and represent a realistic amount of internal steel stirrups above the minimum required by design specifications. The first specimen constructed and tested was an IT with seven 36 mm (#11) bars. This specimen turned out to be stronger than predicted and was at the limits of the hydraulic testing capacity in the laboratory. Therefore, one of the IT specimens with five bars was not constructed; instead an IT with seven flexural bars, 559 mm (22 in.) stirrups, and 152 mm (6 in.) NSM-CFRP spacing was constructed to use as a control in order to lower the final failure load of the remaining unconstructed specimens. The one IT specimen constructed with five bars was also constructed with 559 mm (22 in.) stirrups and strengthened with 152 mm (6 in.) CFRP strip spacing, but this specimen started to fail in flexure. To achieve a shear dominated failure, half the NSM-CFRP was removed by saw-cutting it out of the specimen. This will be discussed further in the results section, but this resulted in the specimen having 305 mm (12 in.) CFRP strip spacing. With all these factors taken into account, the specimens constructed are shown on the curves in Figure 4.7. The baseline points represent the cross-sectional strength without any NSM-CFRP retrofit. The predicted shear strengths of the specimens based on these curves are listed in Table 4.4.

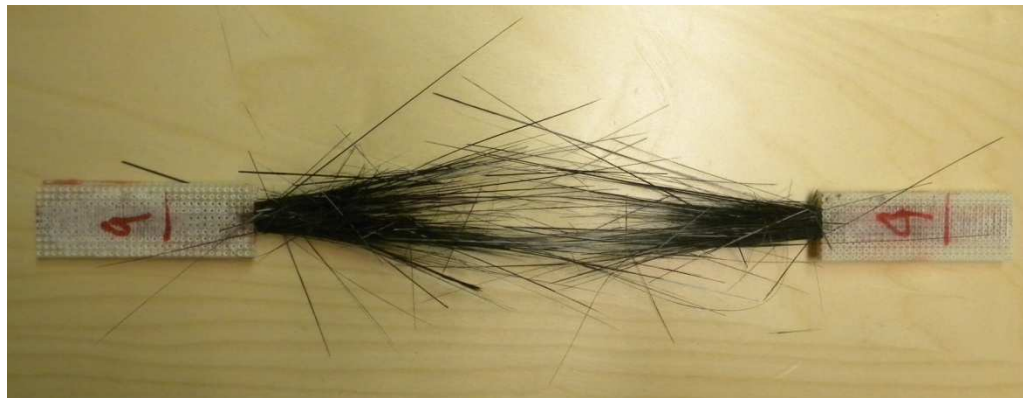
Fig. 4.9 – Example of desired CFRP coupon failure

the United States is made by Hughes Brothers, in Seward Nebraska. Hughes Brothers carbon fiber has been used in previous research for NSM applications and the carbon fiber strips have a unique roughened surface. Due to this, Hughes Brothers Aslan 500 rectangular carbon fiber tape was chosen as the CFRP material. Coupon tests were performed according to ASTM D 3039 to determine the actual material properties. One issue of testing the CFRP is that the grips of the test machine can damage the CFRP causing it to weaken and break at the grips. This was mitigated by bonding polymer computer board to the ends of the CFRP coupons so the grips would not damage the fibers. Only coupons that failed by rupture/brooming were considered as demonstrated in Figure 4.9.

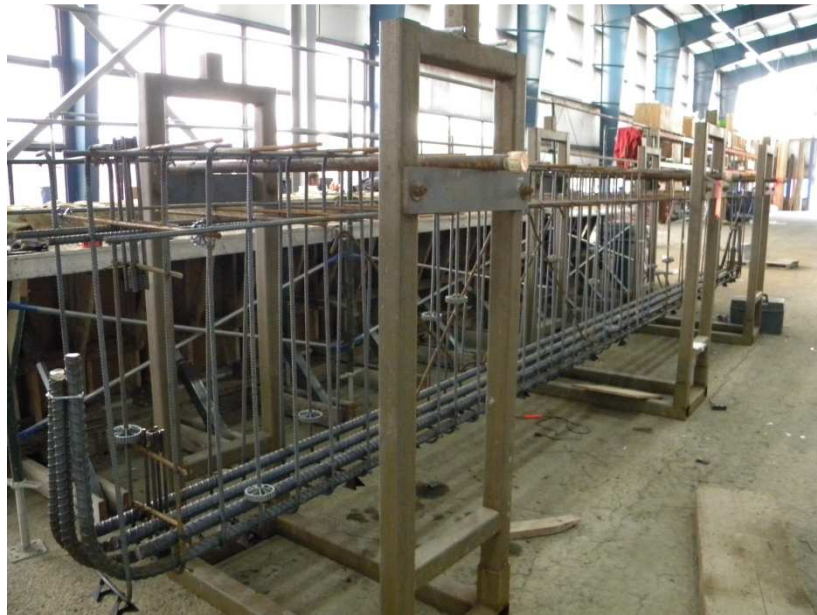
Fig. 5.1 – Example of reinforcing cage

All of the specimens for this research were constructed in the Oregon State University Structural Engineering Research Laboratory. The first step of construction was to attach strain gages to the steel. Strain gages were placed at midheight on one leg of each stirrup on the less reinforced side of the specimen. No strain gages were placed on the over strengthened side of the specimen. Strain gages were also placed at midspan of the 36 mm (#11) flexural bars. To protect the gages a water proof layer of sealant was applied, and a thin neoprene pad and piece of foil was placed over each gage. After strain gaging, the reinforcing cage was assembled while being supported by a steel frame adjacent to the formwork. Standard steel reinforcing ties were used to connect the bars to each other.

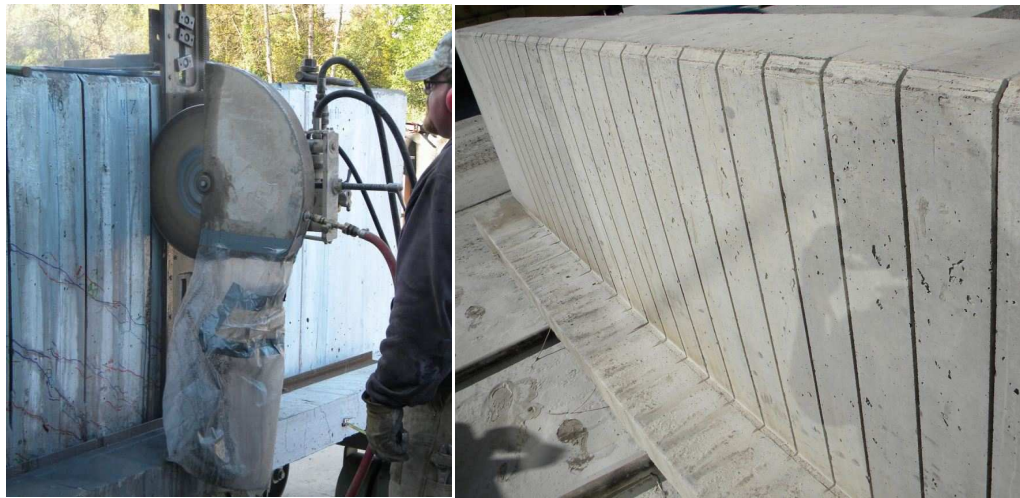
Fig. 5.4 – Sawing NSM grooves in a specimen

Following the pre-cracking, grooves were cut in the webs of the specimens. The cutting was performed by Columbia Concrete Sawing Company. The groove dimensions were determined to meet ACI 440.2R-08 section 13.3 which states the groove width must be at least three times the CFRP width and the groove depth must be at least 1.5 times the CFRP depth. Therefore, based on the Aslan 500 dimensions of 16 mm (0.63 in.) by 2 mm (0.079 in.) the following must be met.

The grooves cut in the specimens had a depth of 25 mm (1.0 in.) and a width of 8 mm (0.31 in.) to meet the requirements. The grooves were cut vertically into the web of the specimens and went as close to the flange as the saw could without cutting into the flange. The cut reached to within 25 mm (1.0 in.) of the flange by using a concrete chain saw with a small point on the end of the saw's bar. After the grooves were cut, a pressure washer was used to clean the grooves, and then they were allowed to dry. Previous research has shown NSM repairs done perpendicular to the crack angle are more effective. Nonetheless, this research chose a vertical orientation because it is more practical to

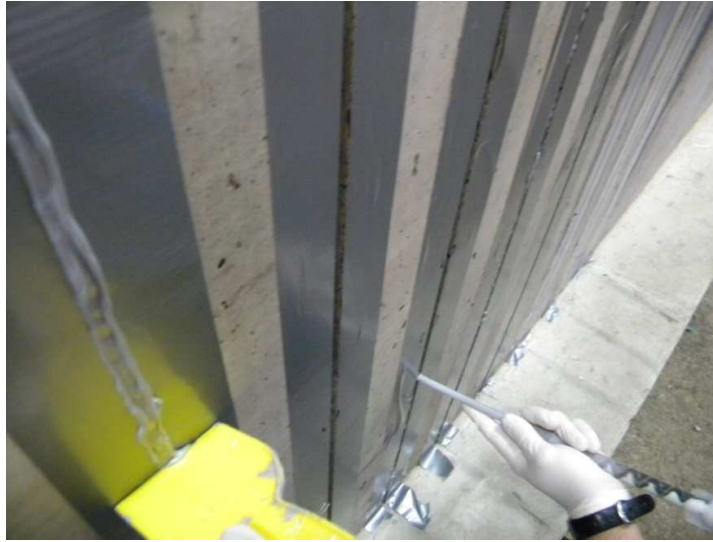
Fig.5.5 – Epoxying CFRP strips into NSM grooves

After the grooves were dry, the specimens were retrofitted with CFRP. The epoxy used on the full-scale specimens was Concretive 1420. It was applied with a pneumatic gun and the adhesive was warmed before applying to insure proper application procedures. The first step was to fill the groove about 3/4 full with epoxy. Then a CFRP strip was pushed into the center of the groove while making sure epoxy squeezed out on both sides of the CFRP strip. More epoxy was then applied to fill the groove and a putty knife was pulled across the surface to remove the excess adhesive.

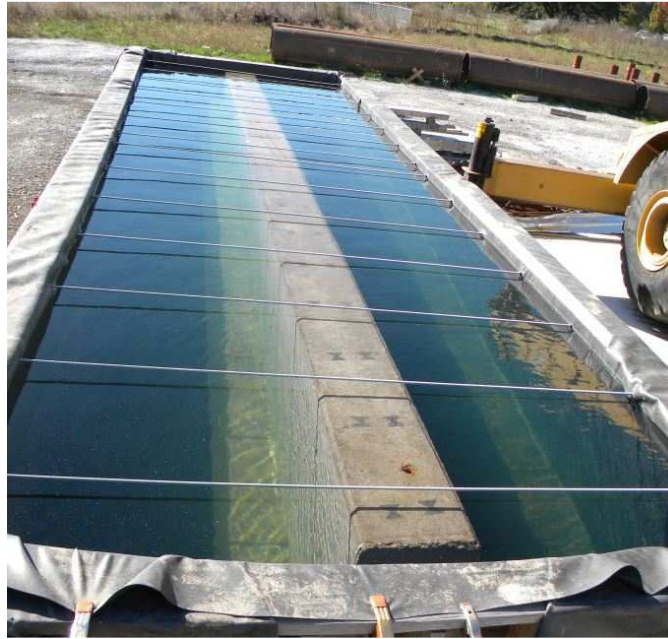
Fig. 5.6 – Specimen IT.7.18.6.M submerged in the dunk tank

After installation of the NSM-CFRP, specimen IT.7.18.6.M was subject to moisture exposure. To do this, a tank large enough to hold the full-scale specimen was constructed outside the laboratory. It was built with wooden walls and a wooden floor and had a rubber liner to make it water tight. The specimen was lifted into the tank with a crane and set on two rubber pads to allow water to flow beneath the specimen. Steel rods were placed to hold the walls together and then the tank was filled with fresh water until the specimen was completely submerged. The specimen was allowed to sit in the tank for six months before being removed to test. This time period was chosen to represent a bridge girder during a full wet season in Oregon.

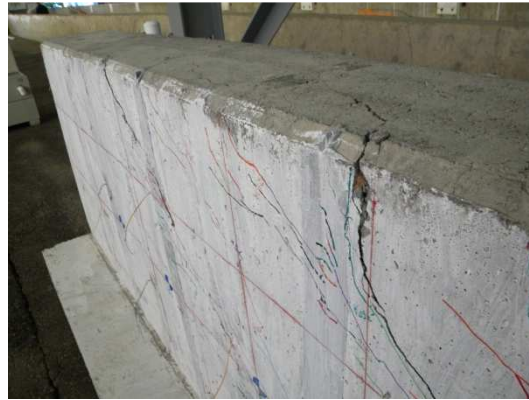
Fig. 6.1 - Specimen T.6.18.12.S was approaching a shear failure (specimen is inverted in photograph prior to loading on a truck for disposal)

This was the second T-specimen constructed and tested. It was the same as the other T-specimen except it had a 25 mm (12 in.) CFRP strip spacing. This specimen also failed in flexure. At a load of 1895 kN (426 kips) the specimen deflection increased without increasing load. This implied flexural yielding and the test was stopped before the compression zone was compromised. The support locations of the specimen were moved toward the load point to a span of 300 cm (118 in.). This allowed a higher shear force to be applied by decreasing the moment demand. The specimen still began to exhibit flexural yielding so the support was again moved to the base of the largest diagonal crack. This was the final attempt to induce a shear failure, but the specimen still failed in flexure. The compression zone crushed at a load of 2051 kN (461 kips). At failure, the diagonal cracks in this specimen were more pronounced than the other T-specimen. This implies the specimen was close to a shear failure. However, the actual shear capacity cannot be

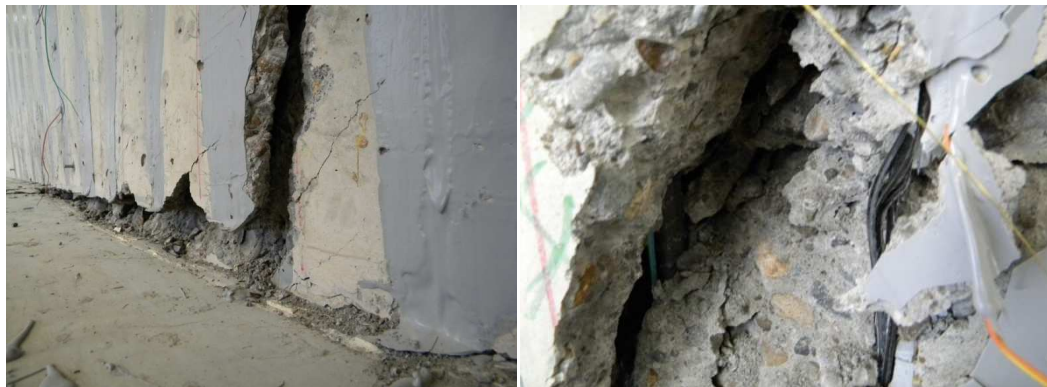
Fig. 6.2 – Specimen IT.7.18.6.S failing around the NSM retrofit and a bent CFRP strip

was noticeable. The failure plane of this specimen was not identical on both sides of the specimen, as was the case with many of the specimens. The failure crack on the east side started at the edge of the loading plate and ran diagonally at 59° to the specimen flange. The west side was different because near the loading point the failure crack ran behind the NSM retrofitting for about 81 cm (32 in.) and then it cracks at a steep diagonal slope of 60° down to the base of the stem. The crack on both sides then ran horizontally along the junction of the flange and stem for approximately 76 cm (30 in.) and then cracked diagonally through the flange near the support. In the region where the failure occurred horizontally below the CFRP strips, the concrete also cracked behind the NSM retrofit. It appeared that the CFRP strips made a reinforced shell that peeled away from the steel reinforced inner core of the specimen over this short region and at the top of the shear crack on the west side. This peeling behavior is shown in Figure 6.2.

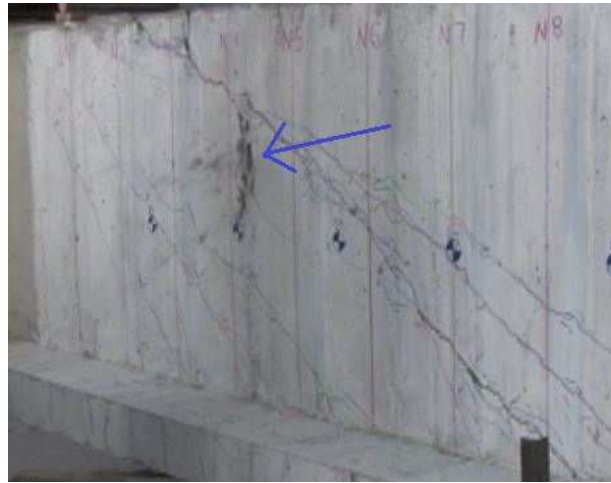
Fig. 6.3 – Concrete failing around CFRP strip just prior to shear failure

from the support to about 305 mm (12 in.) away from the load point. The failure was brittle, but it took place over a time span of about three seconds. The concrete around the top of the third CFRP strip and the bottom of the fourth CFRP strip on the whitewashed side of the beam failed. This occurred just prior to the whole failure crack opening and a still shot from a video shows the concrete exploding around a CFRP strip in Figure 6.3. This failure plane is a typical diagonal shear failure and is a different failure mode than what occurred in the specimens with a six inch CFRP strip spacing. The wider NSM spacing caused the CFRP strips to contribute individually to the strength gain. An outer reinforced shell was not formed and no peeling was observed like occurred in the specimens with a tighter NSM spacing.

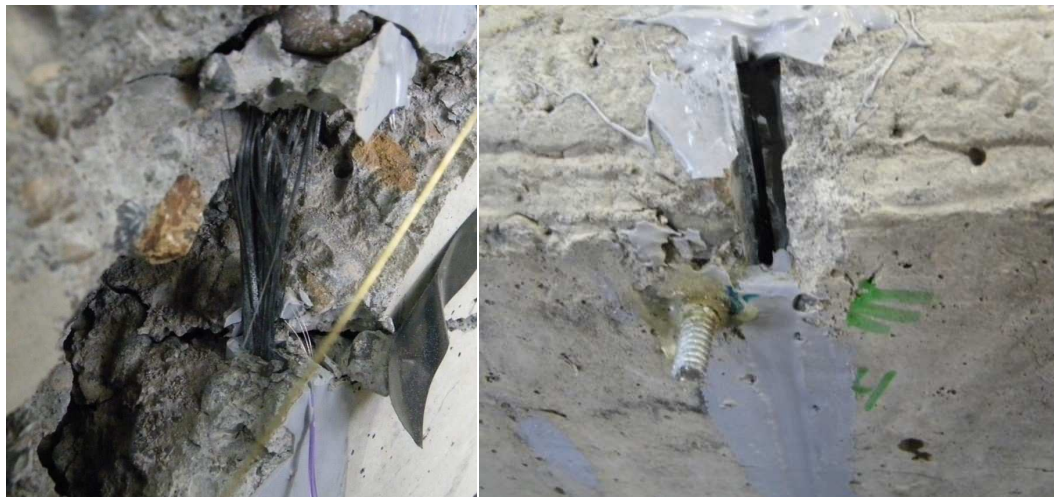
Fig. 6.4 – CFRP bending/rupture combination and slippage at the top of strip

Slippage of the CFRP strips occurred in the 3rd and 4th strips from the centerline on the east side of the specimen and on the 2nd, 4th, and 5th strips from the centerline on the west side of the specimen. The CFRP slip can be identified because the top of the strip is no longer visible. It has been pulled down through the epoxy. Additionally, some of the CFRP strips appear to have nearly ruptured in tension; however, it is likely that bending occurs during failure because the strip slips and that contributes to this rupture. An example of a CFRP strip slipping and a strip rupturing due to bending are shown in Figure 6.4.

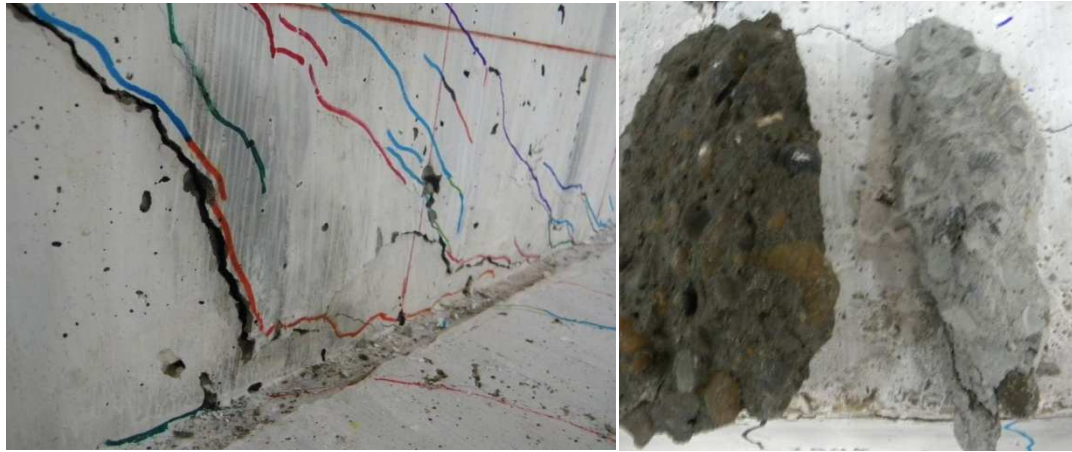
Fig. 6.5 – Specimen IT.7.18.6.M initial peeling and saturated concrete vs. dry concrete

This specimen was the same as IT.7.18.6.S except it was submerged in water for six months before it was tested for shear capacity. The only visible effect of the moisture exposure was some rust spots on the flange and on the top of the stem where the exposed steel reinforcing chairs had formed rust. As the specimen was tested, damp areas formed on the specimen's surface as water was squeezed out from the induced stress. The specimen failed in shear similar to the other specimens at a load of 2295 kN (516 kips). At the 2224 kN (500 kip) load step, just prior to the specimen's failure, two areas of debonded concrete were visible at the bottom of the stem. An example of this is shown in Figure 6.5. These debonding regions are the beginning of the peeling failure mode observed in most of these specimens. The failure crack ran from the load point behind the CFRP for about 61 cm (24 in.) on both sides of the specimen and then cracked at a steep 60° angle down to the top of the flange. The failure plane then ran along the stem and flange junction to the support. At the top and bottom of the diagonal crack it appears the outer shell of NSM reinforced concrete peeled away from the inner core of concrete. Some of the ends of the CFRP strips had also visibly debonded from the specimen during the failure. The ends of these strips had regions with epoxy still bonded and regions of bare carbon fiber; this implies debonding occurred both by CFRP strips pulling out of the epoxy and from the concrete breaking around the NSM epoxy. The broken concrete was visibly darker than other specimens due to its moisture saturation.

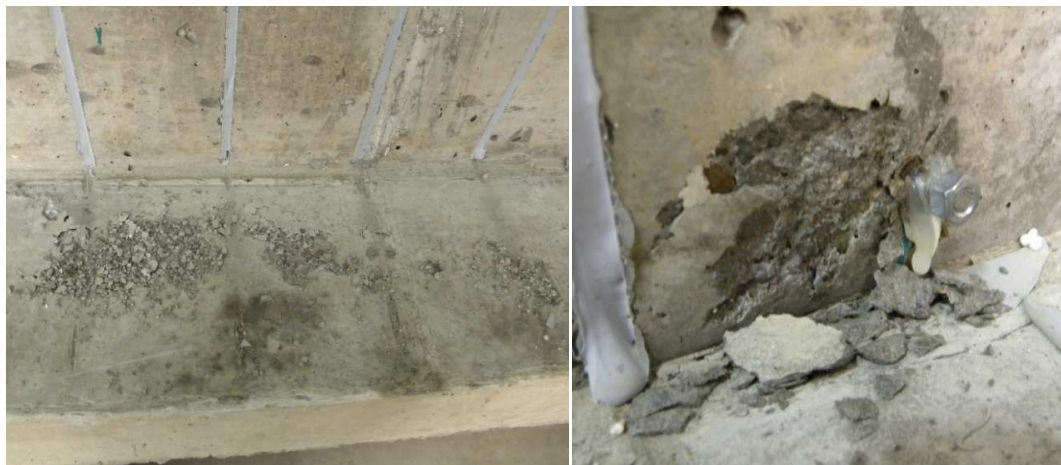
Fig. 6.6 – Specimen IT.7.22.6.FT effects from freeze-thaw exposure

The specimen was subjected to 400 freeze-thaw cycles before being tested for shear capacity. The most obvious freeze-thaw damage was raveling of concrete on the specimen flange. This was primarily where water was sitting and would not have occurred if the specimen was in the T-orientation. There were also two small areas of debonded surface concrete on the web. Some examples of the freeze-thaw effects are shown below.

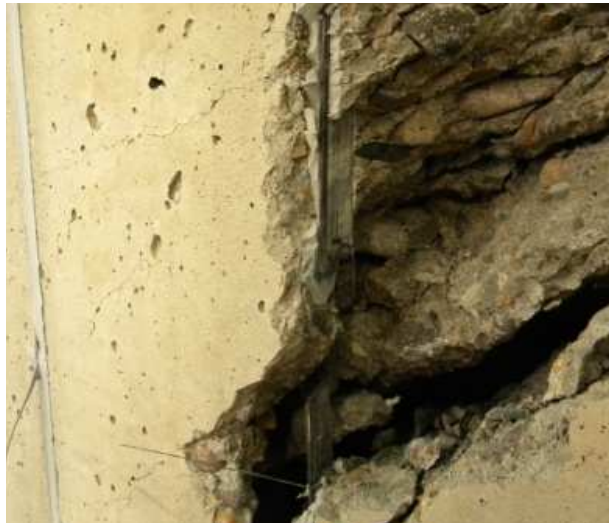
Fig. 6.7 – Rupture of CFRP strip without slippage

This specimen was constructed with the same details as IT.7.22.6.S, which was the control for this specimen. It failed in shear at 2211 kN (497 kips) of load. The east side of the specimen failed diagonally from the edge of the load plate to the top of the flange at an angle of 45° . It then cracked horizontally along the stem junction for 54 cm (25 in.) and diagonally through the flange. The west side broke behind the NSM retrofit for the 51 cm (24 in.) next to the load plate. It then cracked at a steeper 70° angle down to the flange and then horizontally along the flange and stem junction. Slippage of the top of the CFRP strips was observed in the 3rd, 4th, and 5th strips from the load point on the east side of the specimen. On the west side, only the 5th CFRP strip showed signs of slippage. The bottom of one strip on each side exhibited debonding of the concrete around the epoxy. Additionally, one strip on the west side appears to have ruptured in tension. There is a clean break with no signs of slippage on either end of the CFRP to cause bending. This is the only specimen to achieve pure rupture in a CFRP strip.

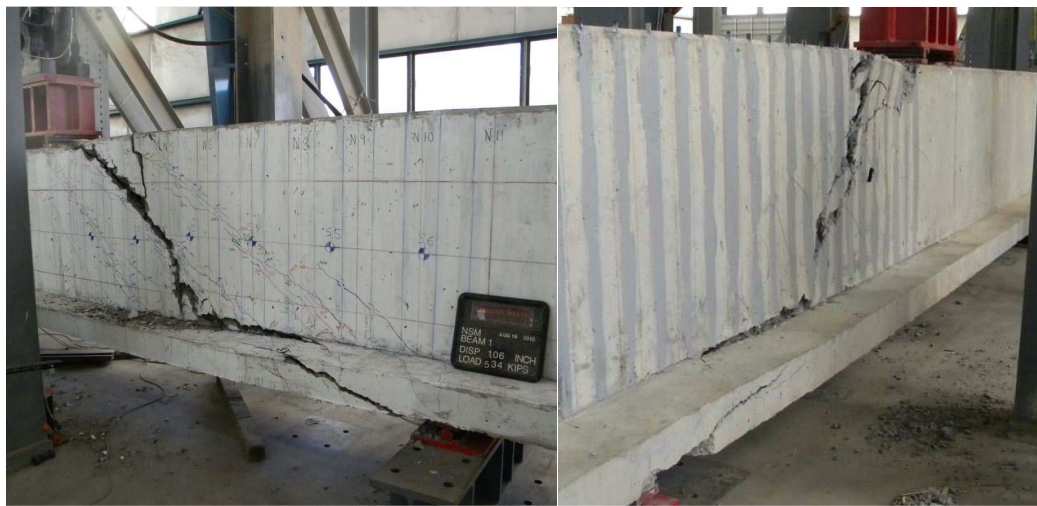
Fig. 6.9 – Specimen IT.7.18.6.S failure

Diagonal cracks propagated towards the loading point as the specimen load was increased. The failure was a sudden brittle shear failure that occurred as the concrete separated nearly instantly at a load of 2375 kN (534 kips). No slipping of the NSM repaired CFRP strips

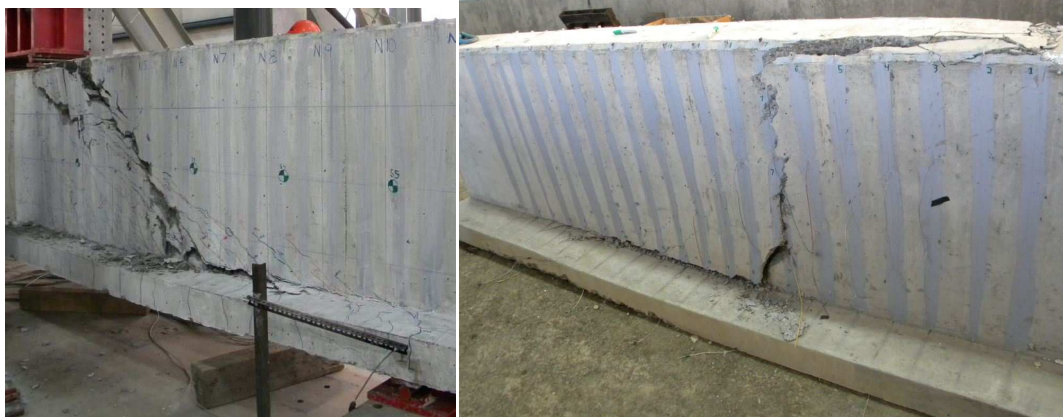
Fig. 6.11 – Specimen IT.7.22.6.S failure

This specimen was the same as IT.7.18.6.S except it had 559 mm (22 in.) steel stirrup spacing. This specimen was constructed because the shear capacity of the 457 mm (18 in.) stirrup spacing was too high. One region of concrete around the bottom of a CFRP strip approximately 152 mm (6 in.) long broke momentarily before the specimen failed. The

specimen failed in shear at a load of 2286 kN (514 kips). The east and west sides of the specimen exhibited slightly different failure paths. The east side failed similarly to other specimens; it broke diagonally from the edge of the load plate to the bottom of the stem, then cracked horizontally along the flange and stem junction, and then cracked diagonally through the flange. The horizontal break ran from approximately 213 cm (84 in.) away from the centerline to 290 cm (114 in.) from the center line. The west side failure crack followed a different path. It cracked along the top of the stem behind the CFRP strips for 86 cm (34 in.). It then cracked vertically down to the top of the flange and horizontally along the stem junction for 107 cm (42 in.). It then cracked diagonally through the flange to near the support location. At the top and bottom of this shear crack it clearly demonstrated the outer shell of NSM reinforcing peeling away from the inner core of the specimen. No CFRP strip slippage was visible in this failure.

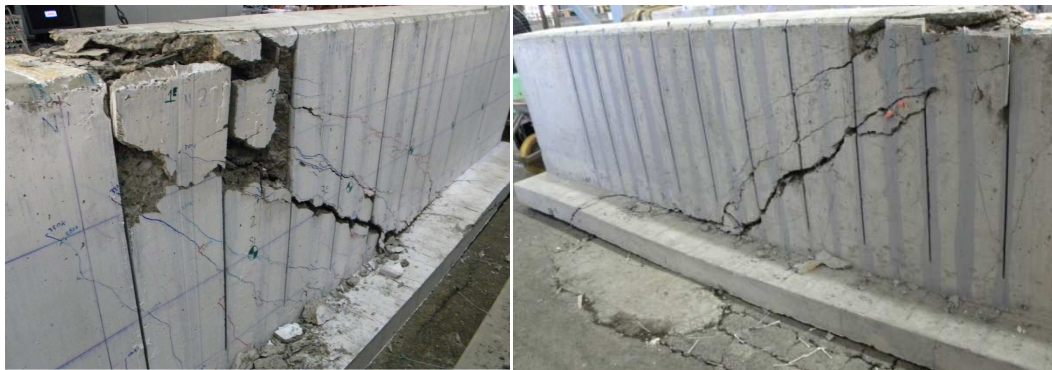
Fig. 6.12 – Specimen IT.5.22.12.S failure

This specimen was the only IT beam constructed with five flexural reinforcing bars. The result of this was the specimen had a lower flexural capacity and was difficult to force a shear dominated failure. The specimen was originally designed and constructed with a 152 mm (6 in.) CFRP strip spacing. When the specimen was tested it began to exhibit a flexural failure at a load of 2006 kN (451 kips). This was observable because the deflection began to grow without an increase in load. The testing was halted at this point to avoid a flexural failure. It was decided that making adjustments to force a shear failure would be more insightful than a flexural failure. The first adjustment to force a shear failure was to move the support locations closer to the load point. This changed the shear span and allowed the specimen to be subjected to a higher shear load with the same

moment demand. The support was moved 305 mm (12 in.) and then the specimen was tested again. When the specimen was loaded in this setup it reached a load of 2184 kN (491 kips) and then began to fail in flexure again. It was decided that moving the support any further would start to change the behavior of the specimen. The solution implemented was to saw-cut out every other NSM-CFRP strip. This essentially gave the specimen a 305 mm (12 in.) CFRP strip spacing. The supports were moved back to the original position. The weaker amount of transverse reinforcing allowed the specimen to fail in shear under an applied load of 1979 kN (447 kips).

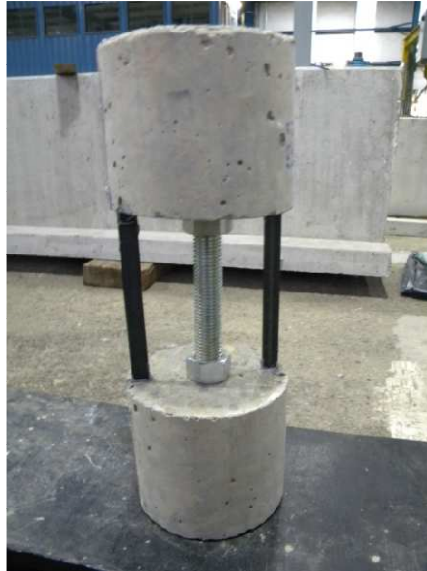
Fig. 8.1 – Example bond specimen

A conventional pull-out test could be used to examine the bond specimen variables, but it is difficult to grip the CFRP for a pull-out test without damaging the strip. For that reason it was desired to have a bond specimen made from two pieces of concrete retrofit together with NSM CFRP strips. Then the concrete could be pushed apart (creating direct tension in the NSM-CFRP strips) until failure. One objective of the bond specimens was to make the construction easy and reproducible. To incorporate this, it was decided to construct the bond specimens from standard 305 mm (12 in.) tall concrete cylinders with a 152 mm (6 in.) diameter. These cylinders are cheap, easy to cast, and create a convenient sized specimen to handle. The idea of the specimens was to cut grooves in each cylinder (assuring alignment of the grooves) then cut the cylinders in half and install two 152 mm (6 in.) pieces of NSM-CFRP to attach the halves together, but leave a space between the

two concrete ends. This space allows for a hydraulic jack, load cell, and confinement plates to be placed between the concrete. An example bond specimen can be seen below in Figure 8.1. A steel bolt is tightened in the gap between the concrete to provide stability for handling until testing.

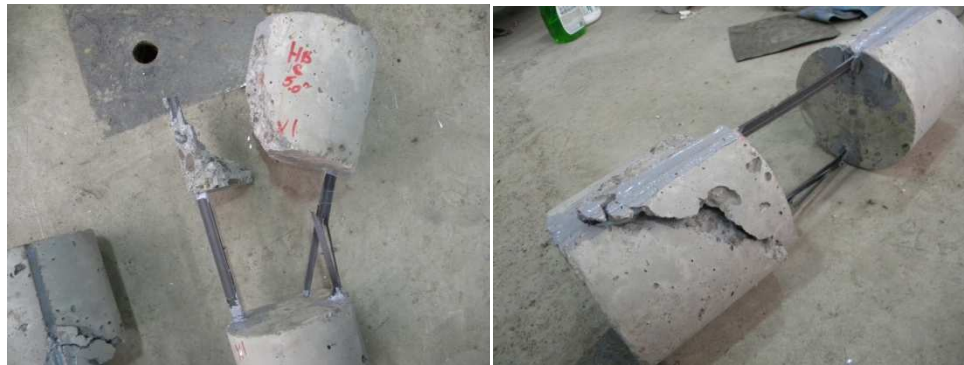
Fig. 8.2 – Failure of concrete around the NSM repair

After some testing, it was found that L was long enough that sometimes the 152 mm (6 in.) side failed. To prevent this from occurring, a bond length of L/2, 64 mm (2.5 in.) was used for all the epoxy and environmental tests. Without any modifications there are four primary failure mechanisms the bond specimens could experience. These are failure of the concrete around the NSM groove, failure of the epoxy to concrete bond, failure of the epoxy to CFRP bond, or rupture of the CFRP strip. To see if the bond specimen idea worked some initial trial specimens were constructed and tested until failure. These trial bond specimens all failed by the concrete splitting in a triangular shape around the NSM CFRP strip. An example can be seen below in Figure 8.2.

These trials showed that the bond specimen idea worked, but the failure mode was only through the concrete. Therefore, the capacity depended only on the strength of the concrete and not on the type of epoxy. It was decided to use confinement plates that were notched to fit around the NSM groove. With these confinement plates between the jack and the concrete it prevented the concrete from cracking and forced a failure to occur in the epoxy or CFRP. By doing this, the strength contribution from different epoxy types and any environmental degradation experienced by the epoxy could be compared. Care was taken to make sure smooth bearing surfaces were located between the confinement plates and concrete. The best way this research found to do this was to use a large concrete saw blade to make one smooth cut and then duct tape the surface during the retrofit process to keep it clean of epoxy. The addition of confinement plates changed the observed failure mode. The concrete around the NSM retrofit could still crack, but it was held in place by the plate and it eventually forced a failure in the epoxy or epoxy concrete interface. The observed failure modes are discussed in the results.

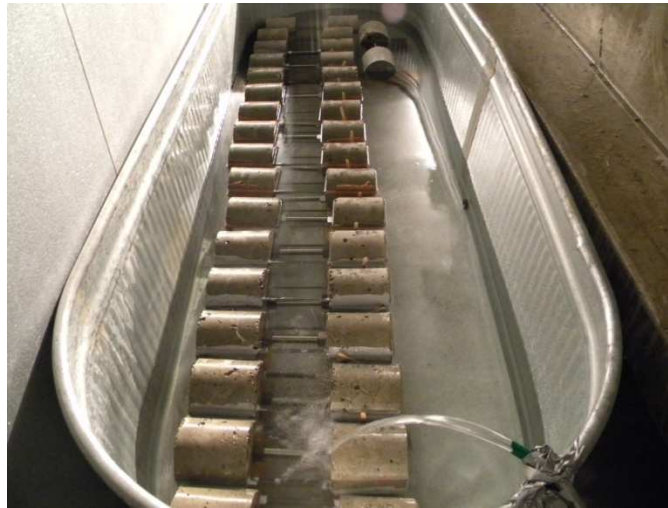
Fig. 8.4 – Bond specimens undergoing freeze-thaw effects and wet-dry conditions

Environmental exposure was also tested on bond specimens with each of the three adhesives. It was decided that the CFRP strips would not be as susceptible to environmental degradation; therefore, Hughes Brothers Aslan 500 laminate strips were used as the reinforcing for all of the specimens. Specimens were tested for degradation due to moisture exposure by being submerged in water for six months. Other specimens were exposed to 400 freeze-thaw cycles similar to the full-scale specimen. Some of these specimens were dry while they were frozen and thawed while others experienced a combination of wet and dry exposure. The wet and dry condition was created by placing the cylinder specimens in a trough inside the environmental chamber. Once a day (every eight freeze-thaw cycles) the trough was filled with tap water on a warm cycle. The water was allowed to soak the cylinders for 30 minutes and then pumped out. A similar trough outside the environmental chamber exposed specimens to the same wet and dry conditions without the freezing and thawing. A picture of one of these troughs with the specimens is shown below.

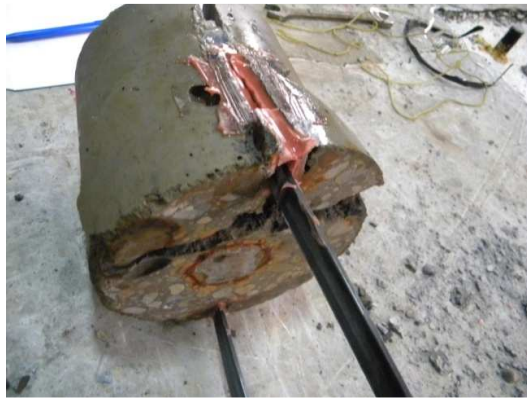
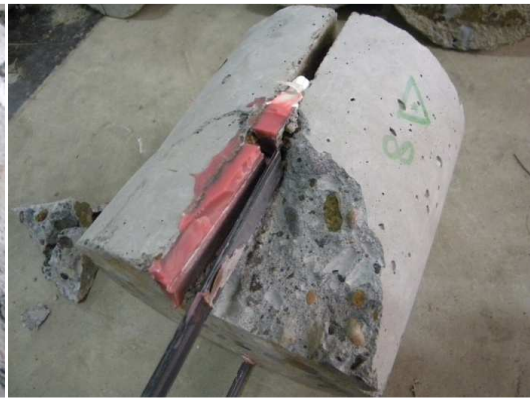
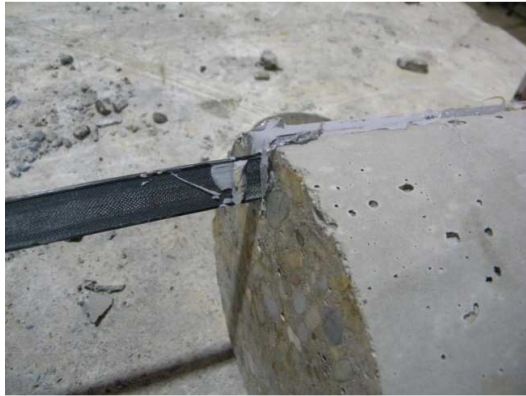
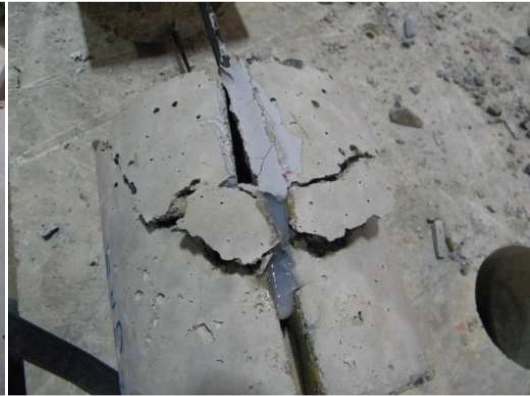
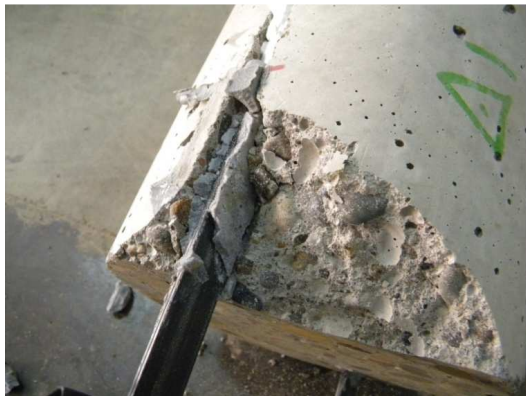
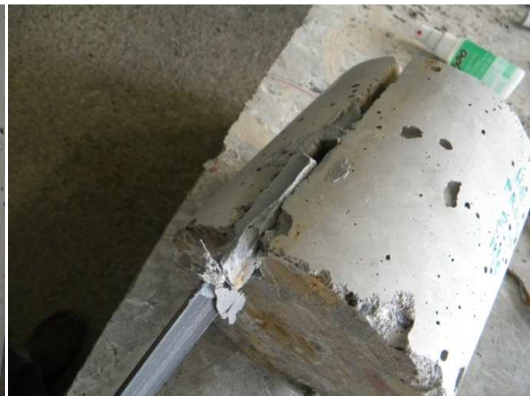
Fig. 8.7 – Example failure modes for bonds specimens

- 1) Concrete cone failure and CFRP slip
- 2) Half concrete cone failure and CFRP slip
- 3) No concrete cone failure and CFRP slip
- 4) Concrete cone failure and epoxy concrete interface failed
- 5) Half concrete cone failure and epoxy concrete interface failed
- 6) No concrete cone failure and epoxy concrete interface failed
- 7) Concrete cone failure and CFRP slip/concrete interface combined failure
- 8) Half concrete cone failure and CFRP slip/concrete interface combined failure
