WALLOWA COUNTY
OREGON

Physical Description of the Wallowa River Above and Below the Lake

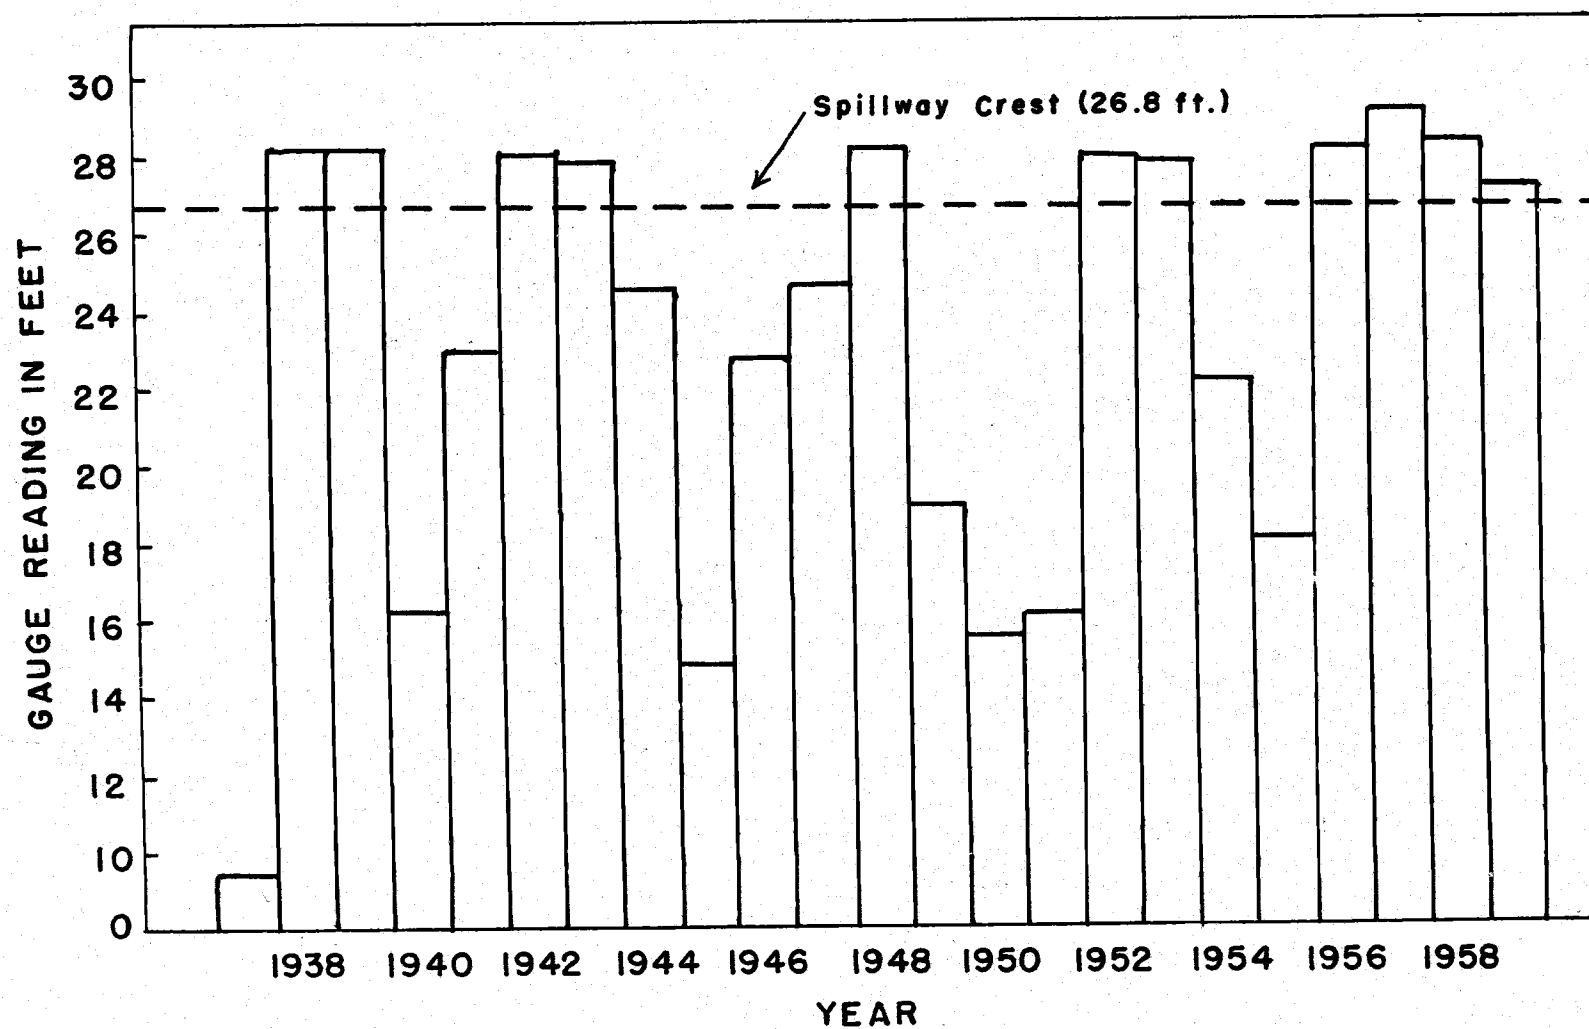
FIGURE 3. YEARLY MAXIMUM WALLOWA LAKE GAUGE READINGS, 1937-59

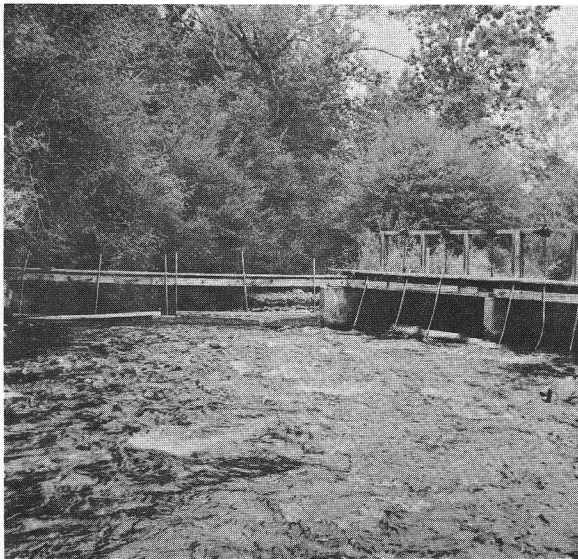
Figure 18. Wallowa River in Foreground Entering Consolidated Ditch on Right Side of Photograph. (Almost the entire stream flow was being diverted into the ditch when this picture was taken on August 17, 1959).

The Consolidated Ditch dam consists of removable 2-inch x 12-inch boards and is a barrier during low flow periods especially in August and early September. Water in the river below this dam results from leakage between the 2-inch x 12-inch boards and from seepage from the Consolidated Ditch which parallels the river for 200 yards. The low flow immediately below the dam also represents a barrier to upstream migration.
