# Some Water Problems and Hydrologic Characteristics of the UMPQUA BASIN

by G.L. HAYES and  
H.G. HERRING

JULY 1960

PACIFIC NORTHWEST  
FOREST AND RANGE EXPERIMENT STATION  
R. W. Cowlin, Director                      Portland, Oregon

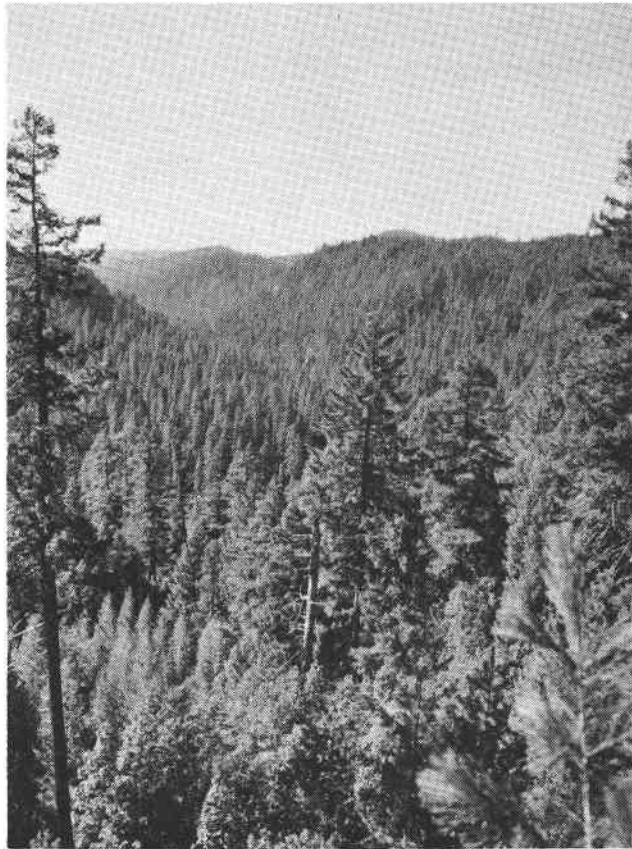
*Figure 1.--Typical forest conditions in the older Cascades of the Umpqua Basin.*

For the most part, however, the Umpqua Basin is covered with a dense timber stand (fig. 1). As is to be expected, the higher, less accessible parts of the watershed are more completely vegetated than the lower parts. Several forest types are represented, with Douglas-fir being most important. A mixed-conifer type occupies extensive

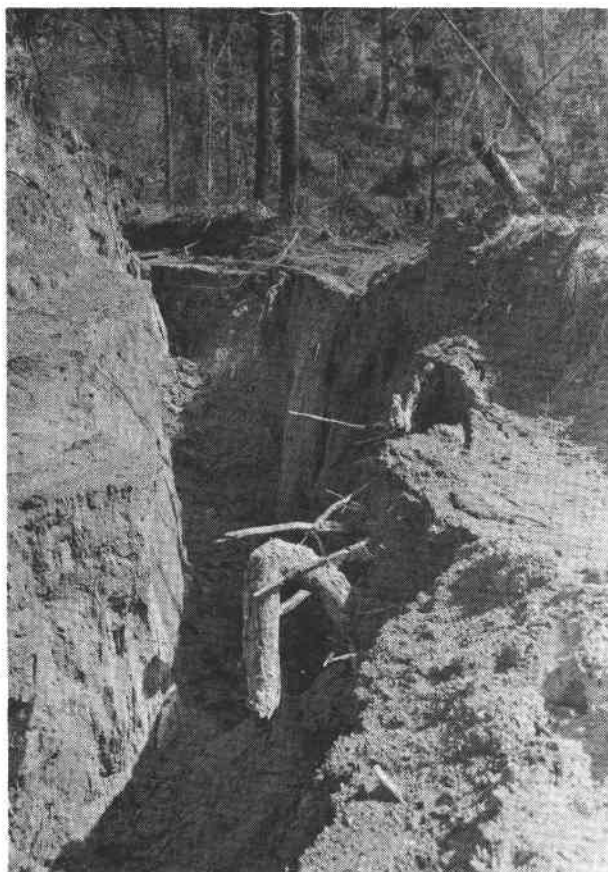
*Figure 2.--Erosion caused by concentrated runoff on an abandoned road in pumice soil.*

flood and they maintain a good summer flow. Highest flows from such streams are typically only 5 to 50 times greater than the least flows. If an unusual combination of circumstances results in surface runoff, however, pumice will erode rapidly, creating deep, vertical-sided gullies (fig. 2).

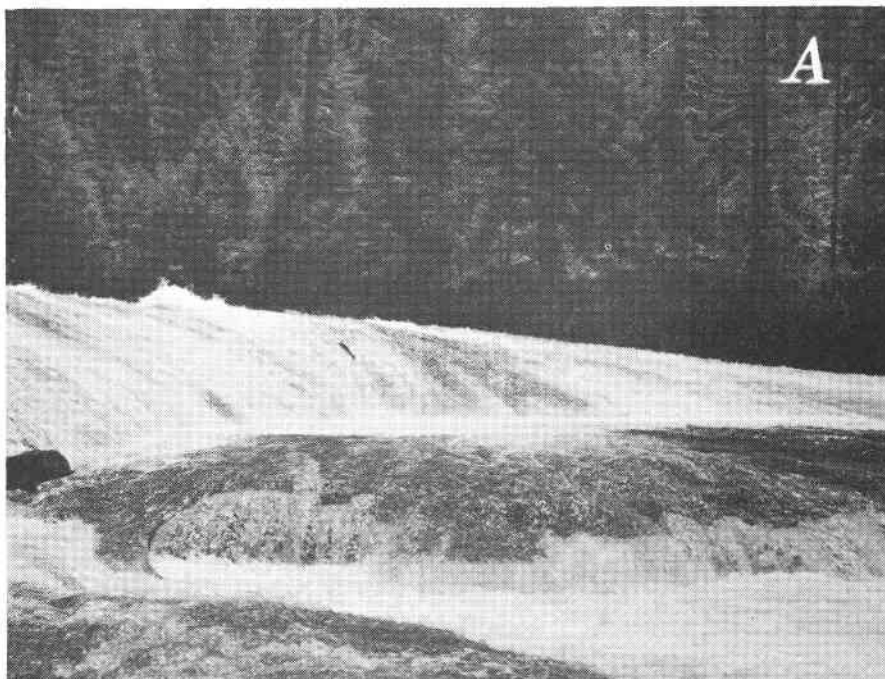
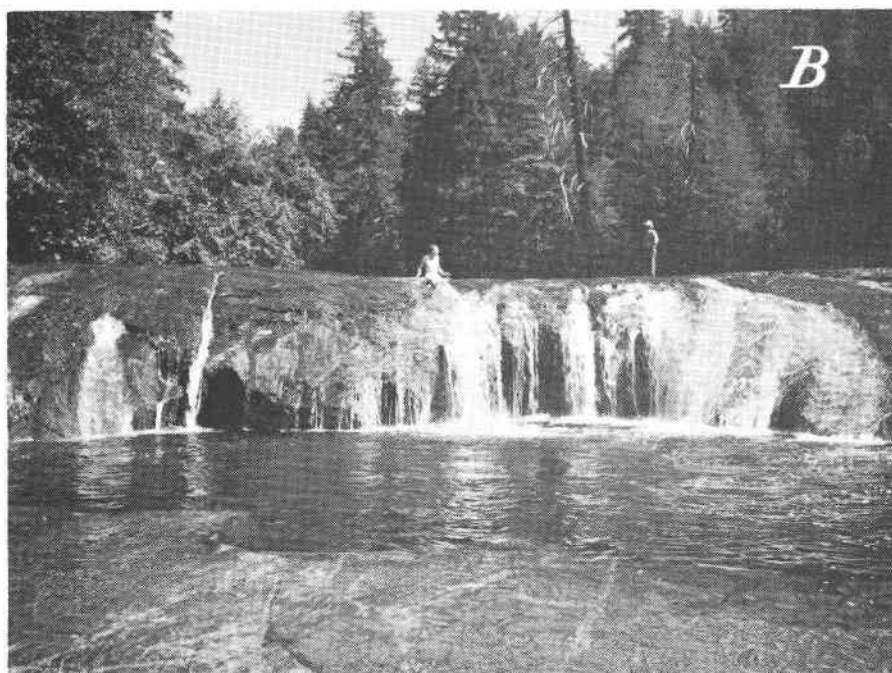
*Figure 4.--Flow at the South Umpqua Falls in June (A) declines considerably by September (B). Drainage area above the falls is about 6 percent of the drainage area above Roseburg.*

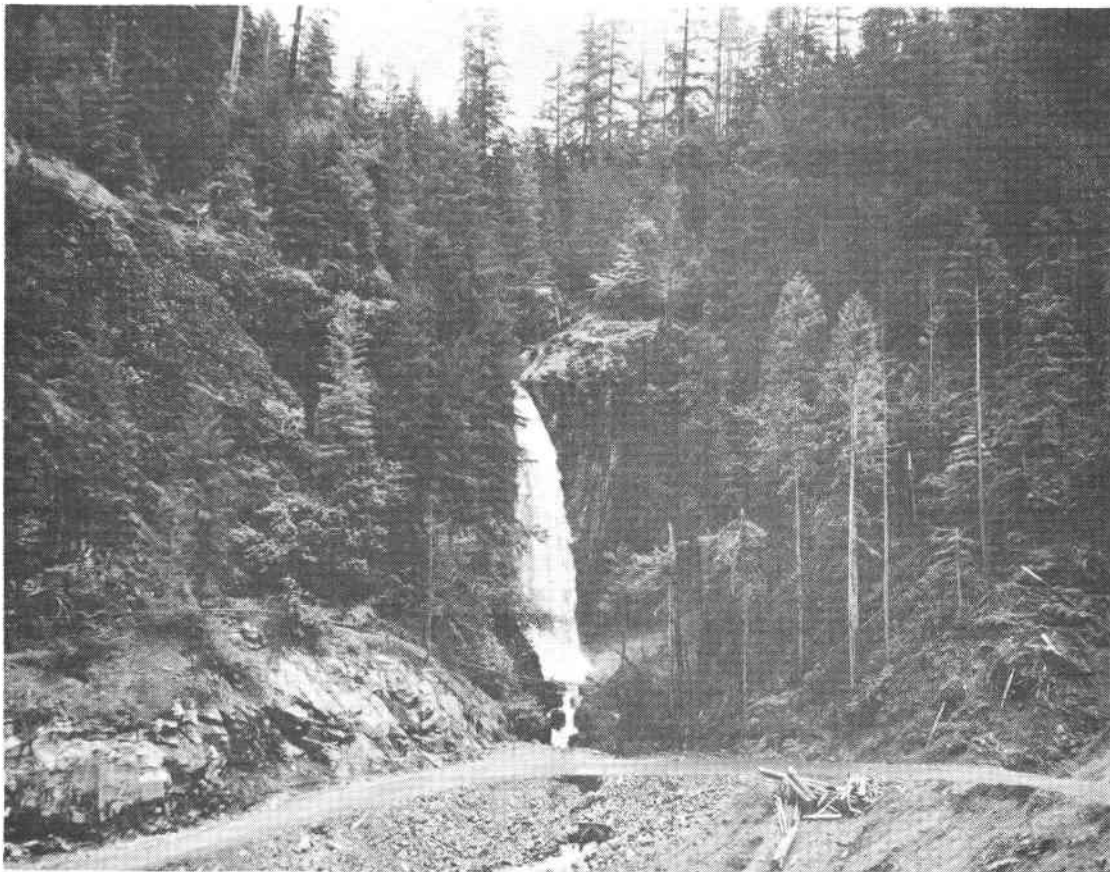
*Figure 5.--A small snow-fed tributary of the North Umpqua River during the spring runoff.*

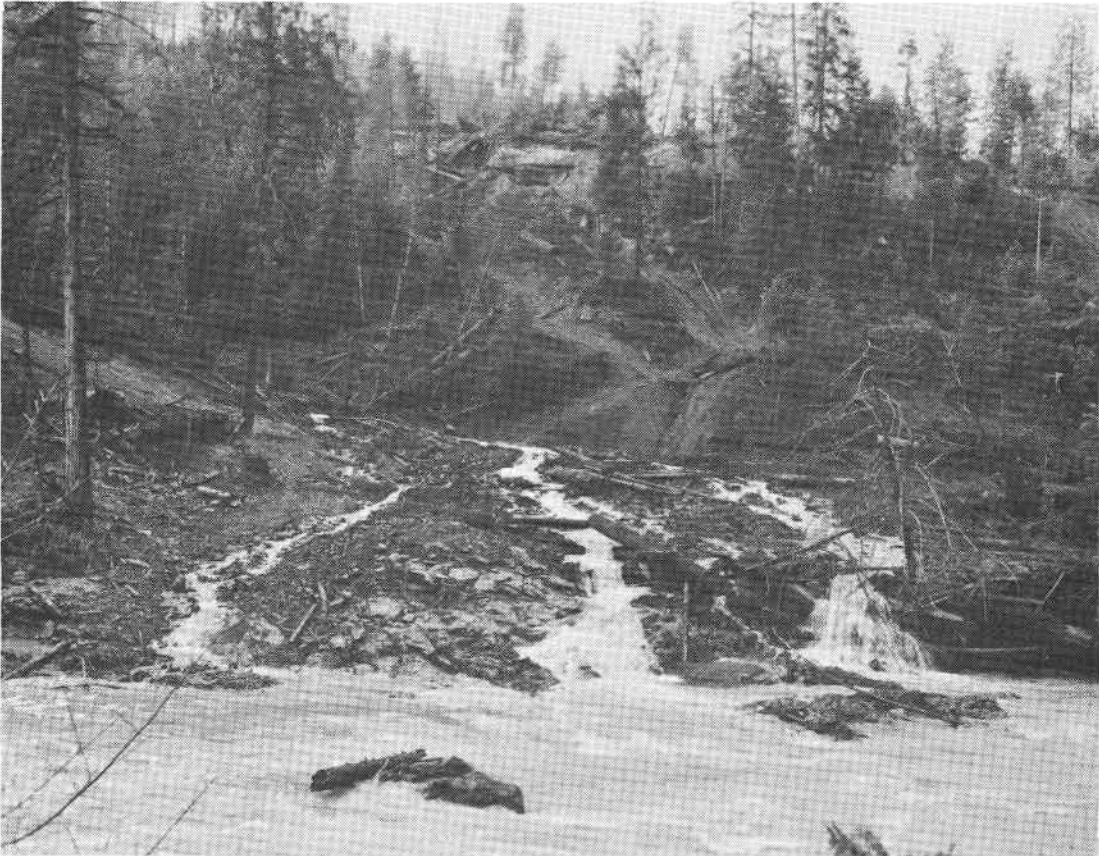
*Figure 7.--When landings are located adjacent to streams, there is no opportunity for filtration of sediment-laden water before it reaches the stream.*
