Title: <u>Shear Repair Methods for Conventionally Reinforced Concrete Girders and Deep</u> <u>Beams.</u>

Shear Repair Methods for Conventionally Reinforced Concrete Girders and Deep Beams

#### A DISERTATION

Oregon State University

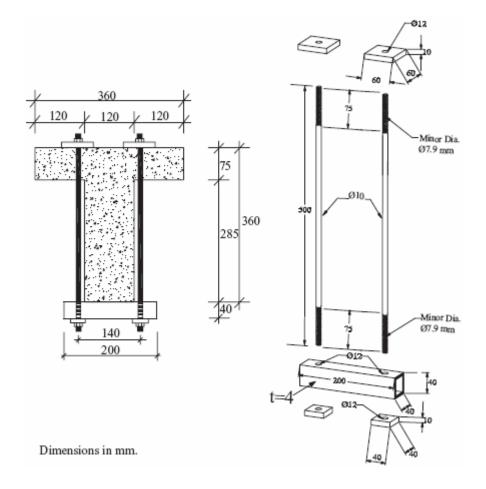
Fig. 2.8 External stirrup repair scheme from Altin, et al.

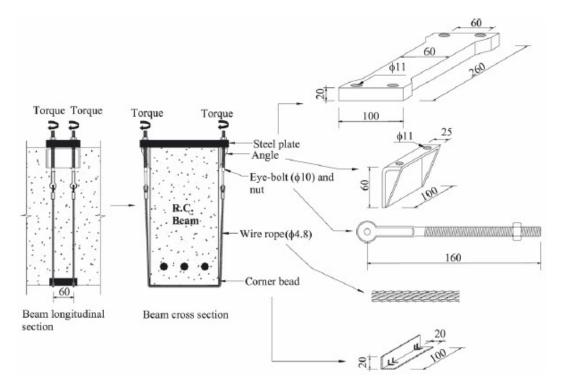
Fig. 2.9 External stirrup repair scheme from Kim, et al.

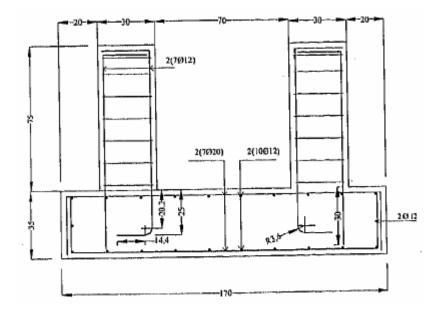
Fig. 2.12 Test setup for post installed anchors taken from Hammad et al.

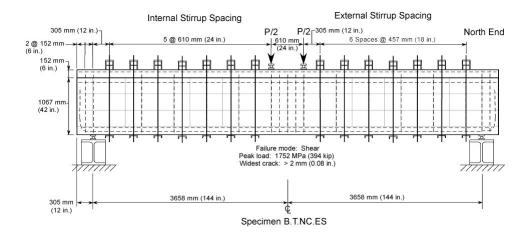
Fig. 3.13 – Specimen B.T.NC.ES repair.

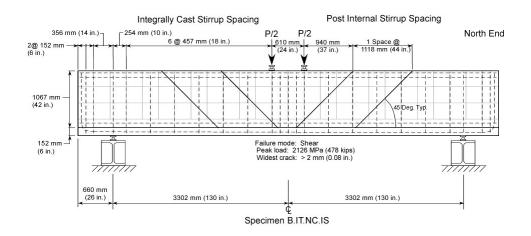
Fig. 3.15 – Specimen B.IT.NC.IS repair.

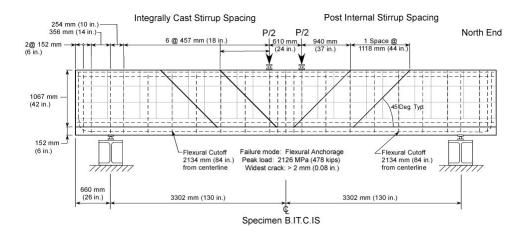
Fig. 3.16 – Specimen B.IT.C.IS repair.

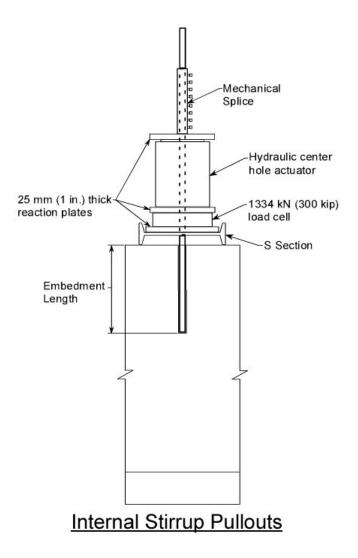
Fig. 3.18 – Internal stirrup pullout test setup.

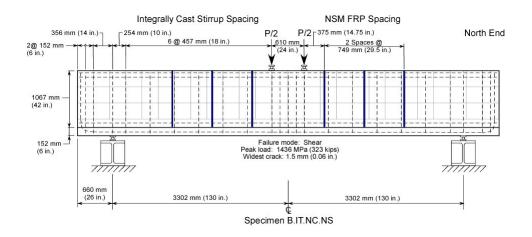
Fig. 3.26 – Specimen B.IT.NC.NS repair.

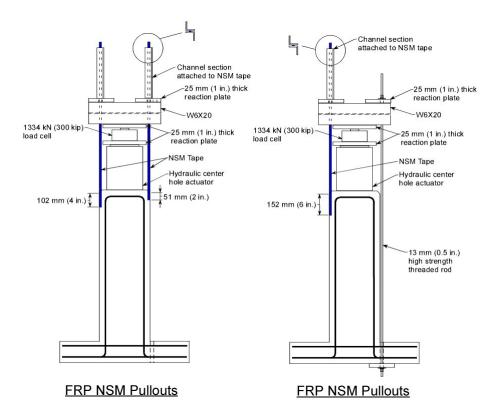
Fig. 3.28 – NSM pullout test setup.

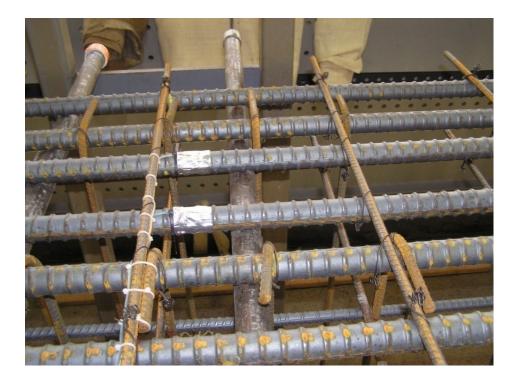
Fig. 3.31 – Typical strain gage locations along flexural steel.

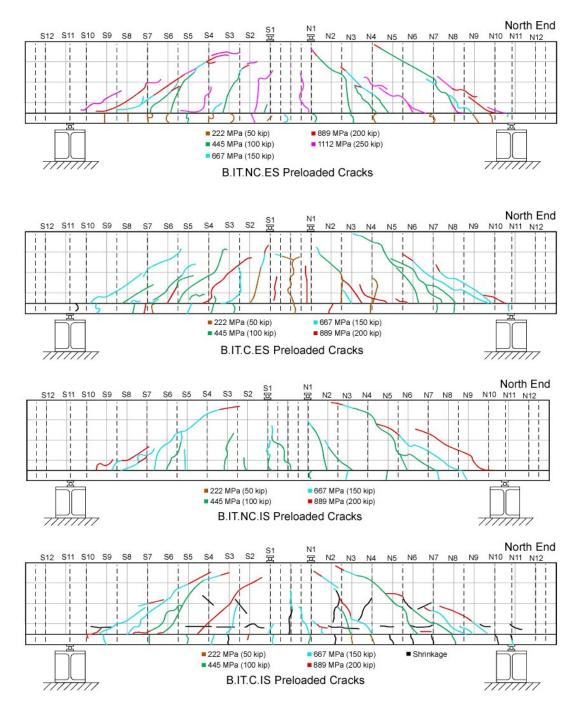
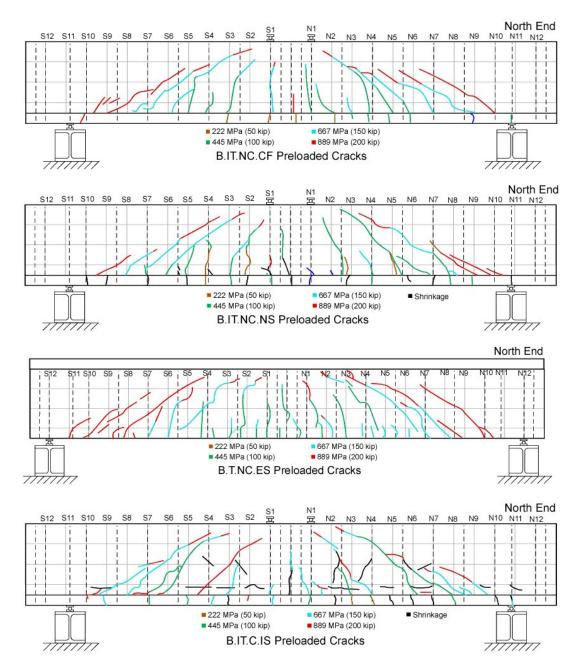
Fig. 3.39 – Beam preloaded crack maps.

Fig. 3.39 Continued – Beam preload crack maps.

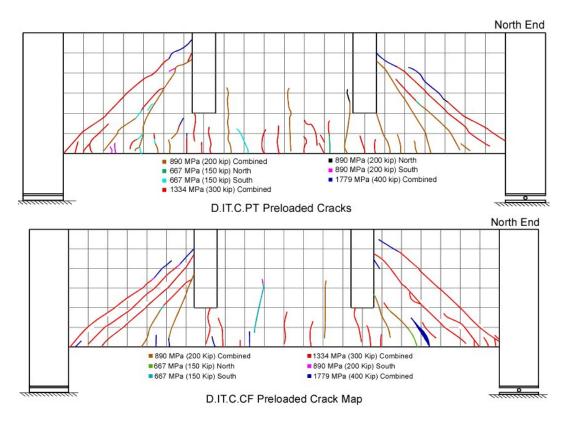
Fig. 3.40 – Bent cap preloaded crack maps.

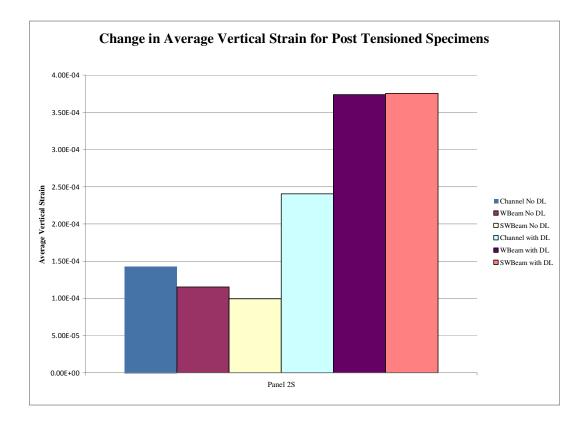
Fig. 4.5 – Average vertical strain comparison between different dead load and external stirrup support conditions at installation of external stirrups due to post tensioning

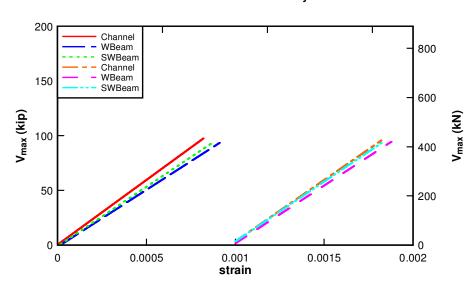
Best Curve Fit Note: PT strain shown offset by 0.001

Fig. 4.6 - Best fit curve of shear versus average vertical strain for panel 2S: beam self

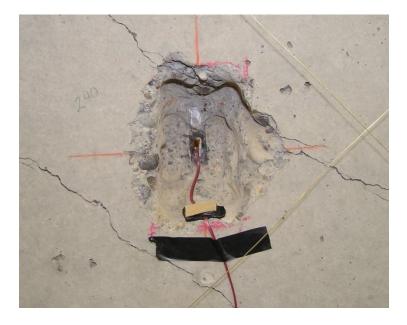
Fig. 4.8 – Exposure of integrally cast stirrup leg to replace failed strain gage

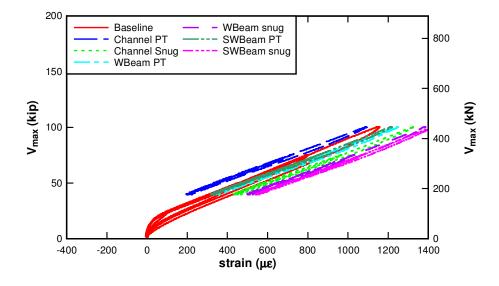
Fig. 4.9 – Shear force versus internal stirrup 3N strain range for three reaction sections:

service loading

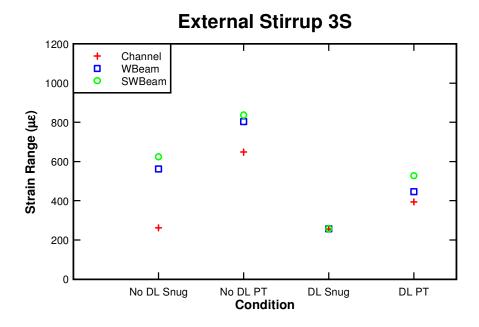
Fig. 4.10 – External stirrup 3S strain range for various loading conditions: service loading

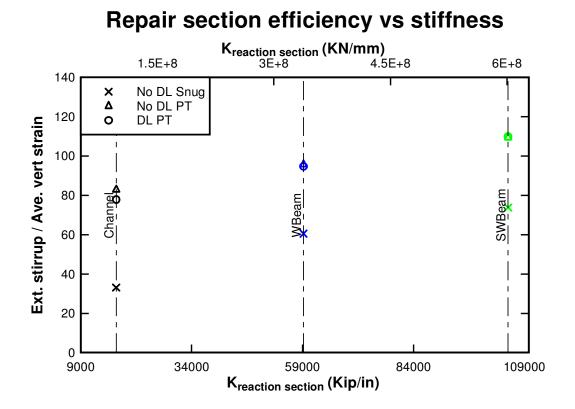
Fig. 4.13 - Repair section efficiency versus repair section stiffness

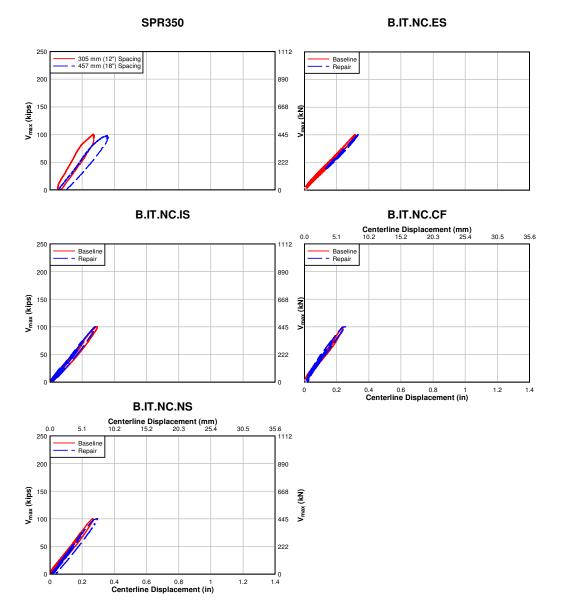
Fig. 4.15 – IT Beam shear force versus centerline displacement: service loading condition

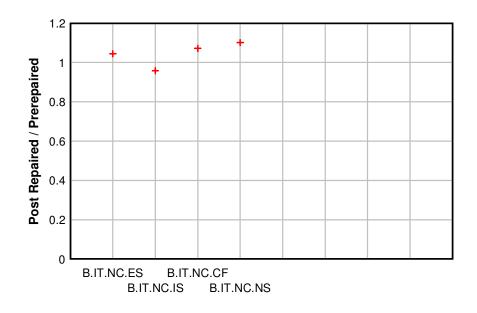
Fig. 4.16 – IT Beams without cutoffs centerline displacement: service range

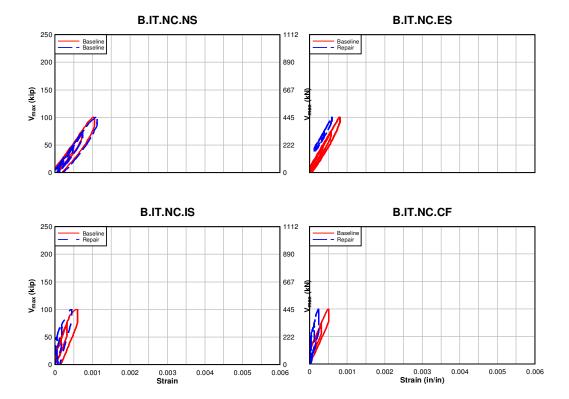
Fig. 4.18 – IT Beam shear force versus average vertical strain: service loading condition

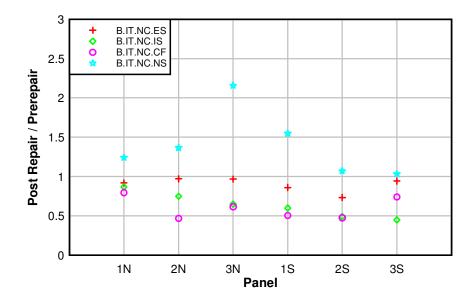
Fig. 4.19 - IT Beam shear force versus typical internal stirrup strain: service loading

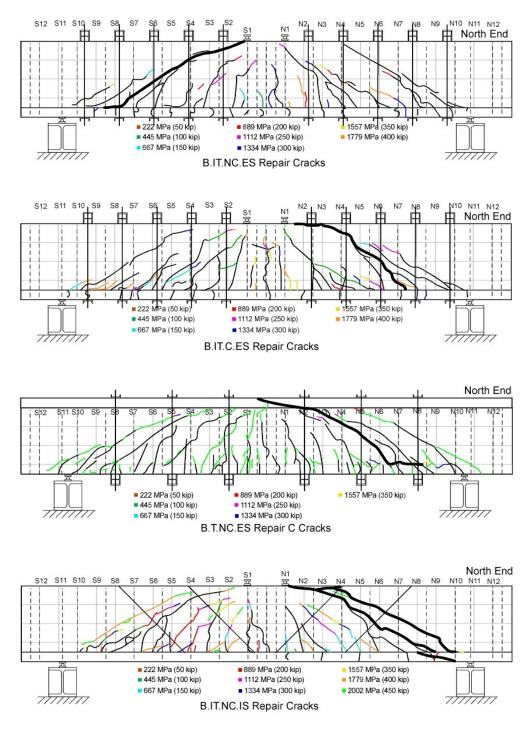
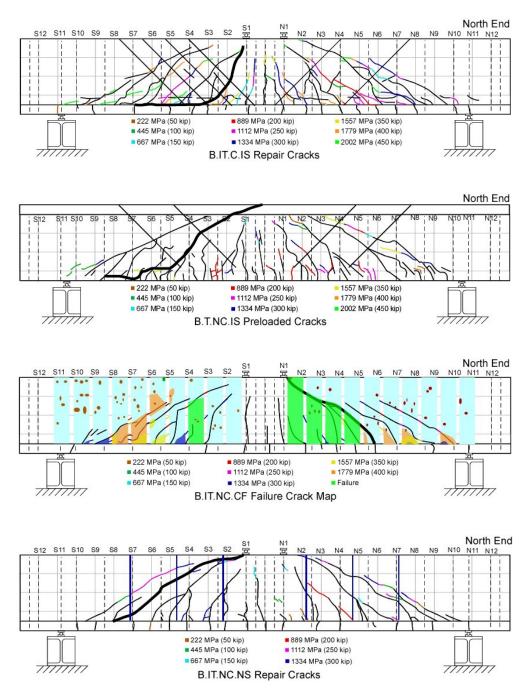
Fig. 4.32 - Beam specimen crack maps: individual load steps indicated

Fig. 4.32 - Beam specimen crack maps: individual load steps indicated continued

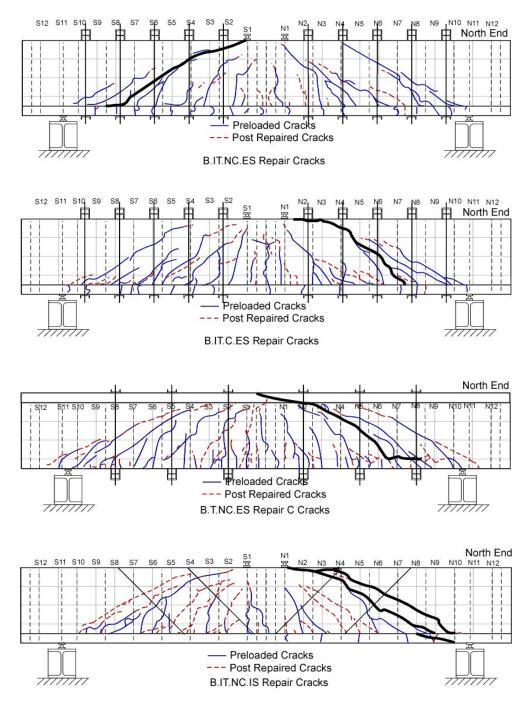
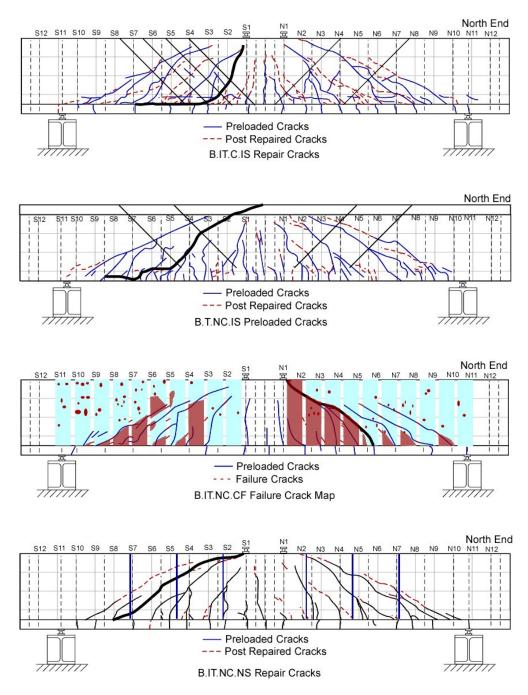
Fig. 4.33 - Beam specimen crack maps: precrack versus repair

Fig. 4.33 - Beam specimen crack maps: precrack versus repair continued

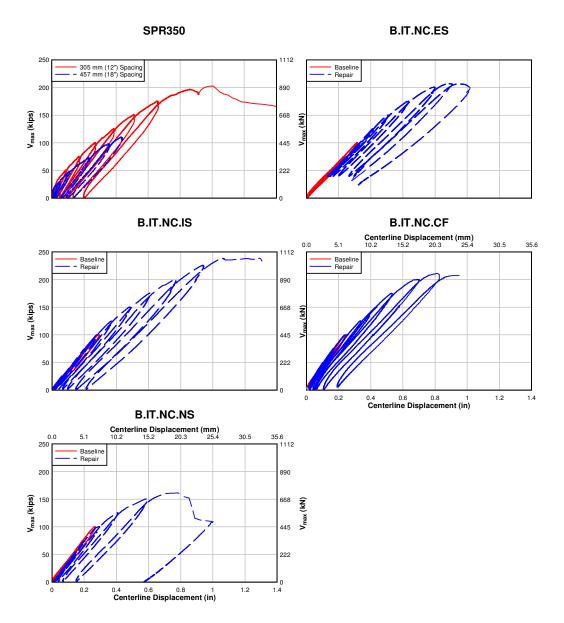
Fig. 4.34 – IT Beam shear force versus centerline displacement: strength loading condition

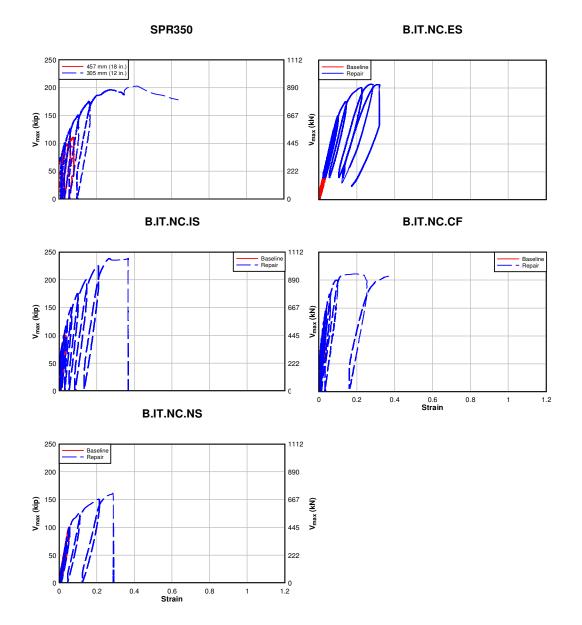
Fig. 4.35 – IT Beam shear force versus tensile diagonal displacement: strength loading

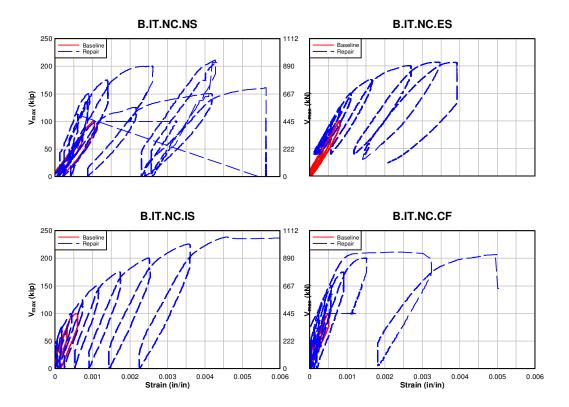
Fig. 4.36 – IT Beam shear force versus average vertical strain: strength loading condition

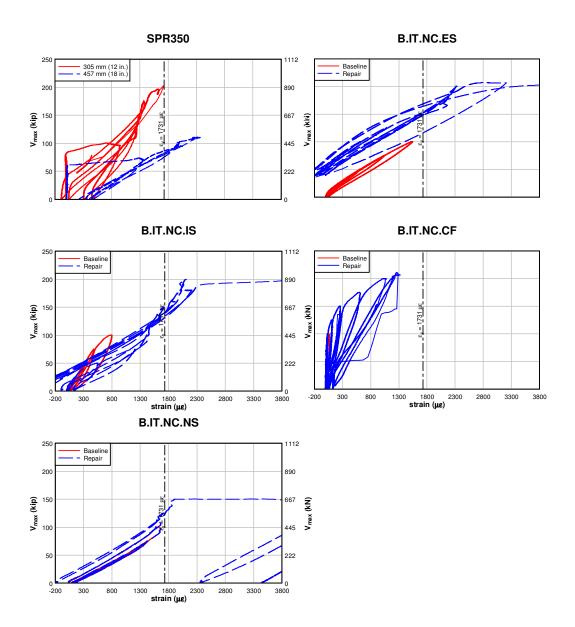
Fig. 4.37 – IT Beam shear force versus typical internal stirrup strain: strength loading

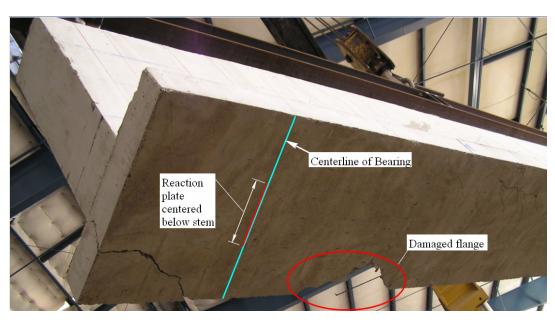
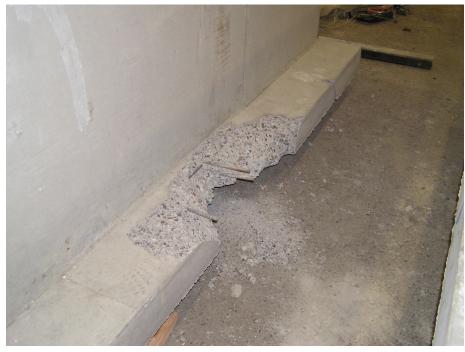
Fig. 4.47 – B.IT.C.IS flange damage: a) top of flange and b) side of flange

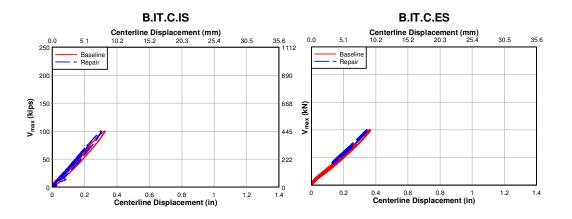
Fig. 4.49 – IT Beam with flexural cutoff details shear force versus centerline displacement:

## service loading condition

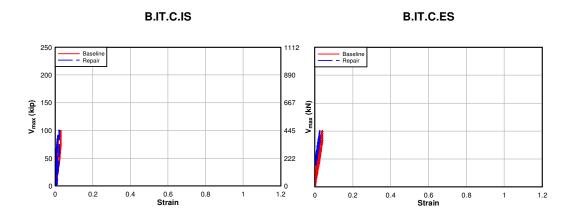
Fig. 4.50 – IT Beam with flexural cutoff details shear force versus tensile diagonal

displacement: service loading condition

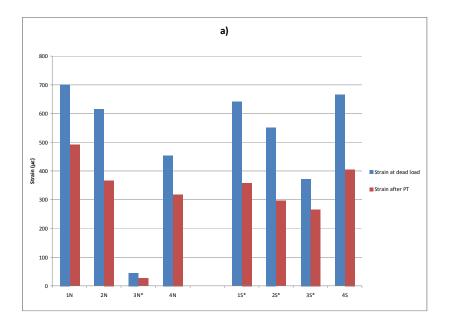
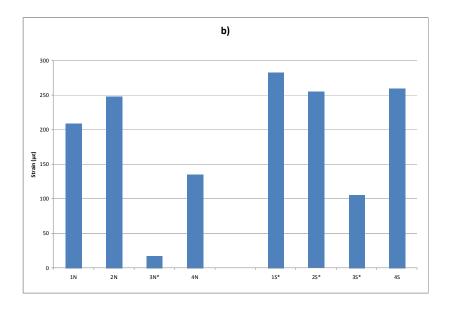
Fig. 4.53 – Specimen B.IT.C.ES integrally cast stirrup strain: a) before and after post tensioning, b) strain reduction due to post tensioning. Note: asterisk denotes chipped in stirrups.

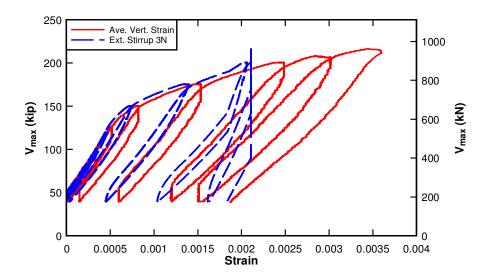
Fig. 4.62 – Specimen B.IT.C.ES shear force versus external stirrup and average vertical

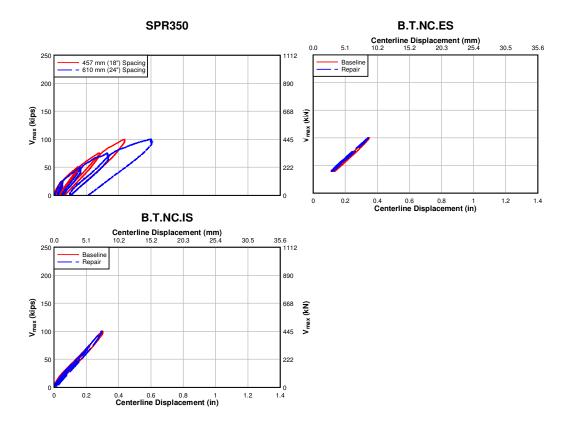
Fig. 4.67 – T Beam shear force versus centerline displacement: service loading condition

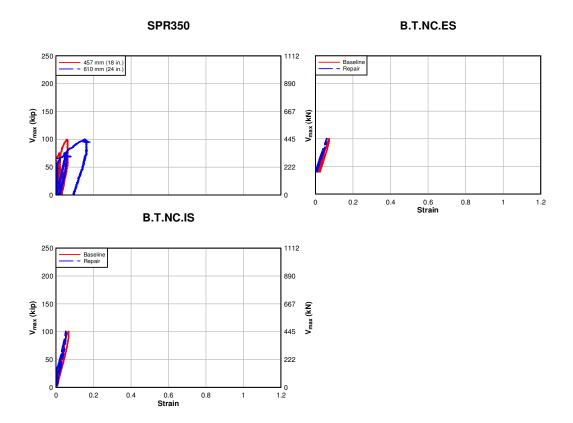
Fig. 4.68 – T Beam shear force versus tension diagonal strain: service loading condition

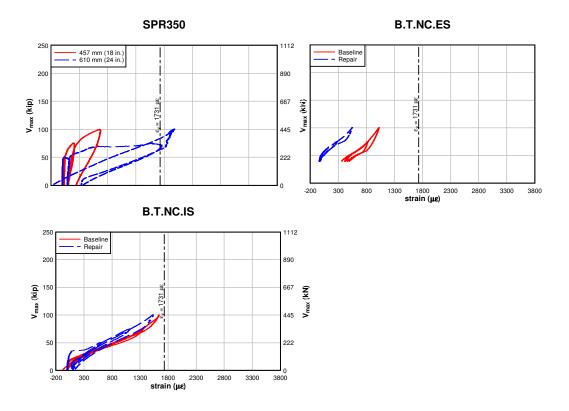
Fig. 4.70 – T Beam shear force versus typical internal stirrup strain: service loading condition

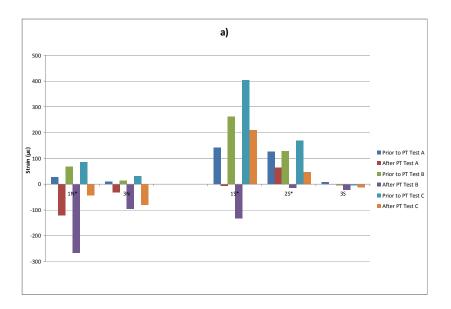
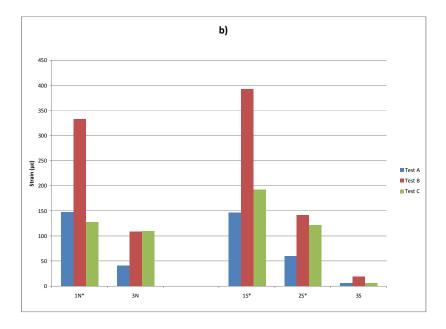
Fig. 4.72 – Specimen B.T.NC.ES integrally cast stirrup strain: a) before and after post tensioning, b) strain reduction due to post tensioning. Note: asterisk denotes chipped in stirrups.

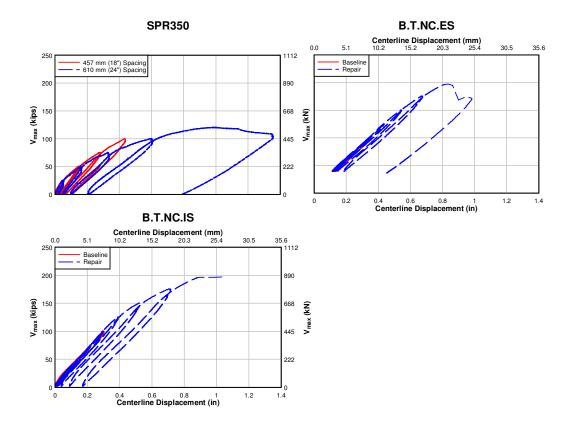
Fig. 4.80 – T Beam shear force versus centerline displacement: strength loading condition

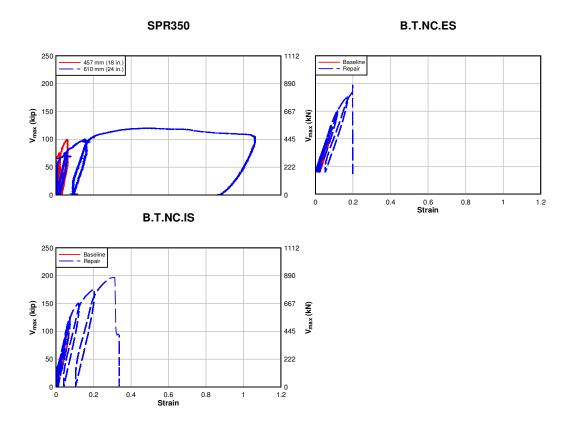
Fig. 4.81 – T Beam shear force versus tension diagonal strain: strength loading condition

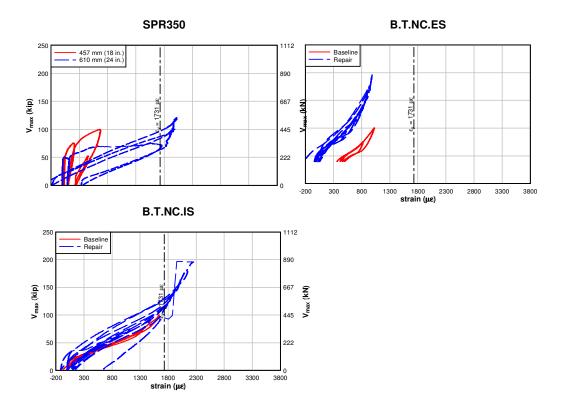
Fig. 4.83 – T Beam shear force versus typical internal stirrup strain: strength loading

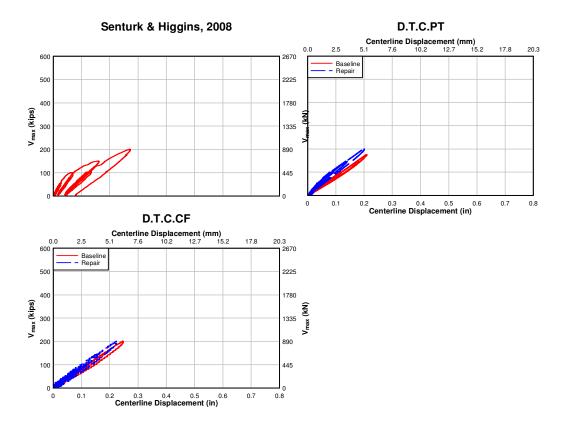
Fig. 4.87 – Bent cap shear force versus centerline displacement: service loading condition

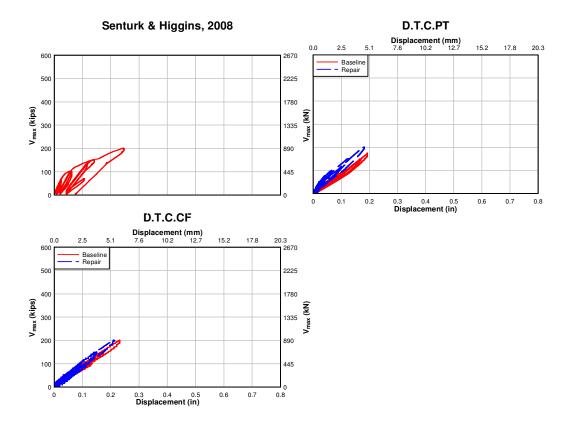
Fig. 4.88 – Bent cap shear force versus south stub girder displacement: service loading

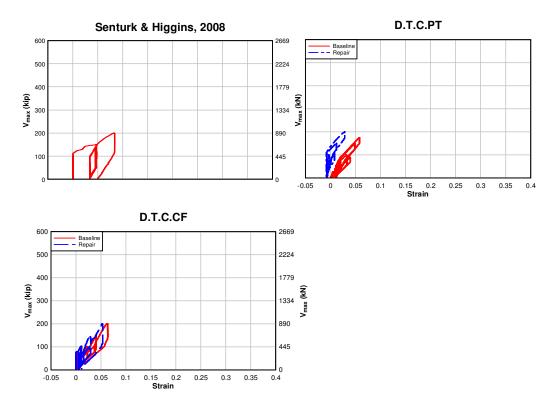
Fig. 4.92 – Bent cap shear force versus north tension diagonal: service loading condition

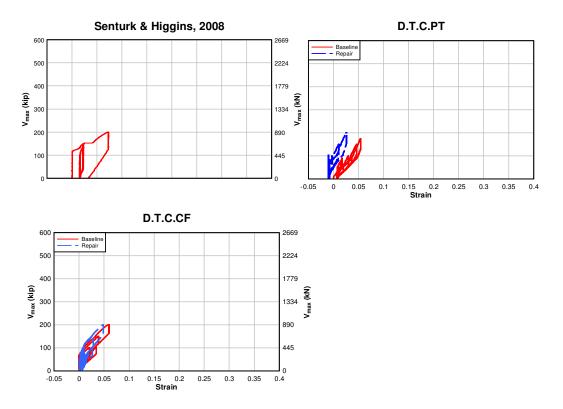
Fig. 4.93 – Bent cap shear force versus south tension diagonal: service loading condition

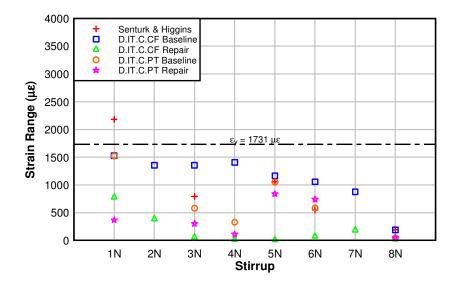
Fig. 4.97 – Bent cap north integrally cast stirrup strain: service loading condition

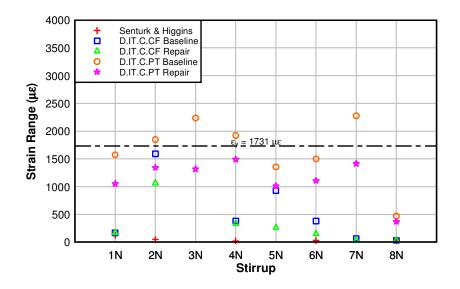
Fig. 4.98 – Bent cap south integrally cast stirrup strain: service loading condition

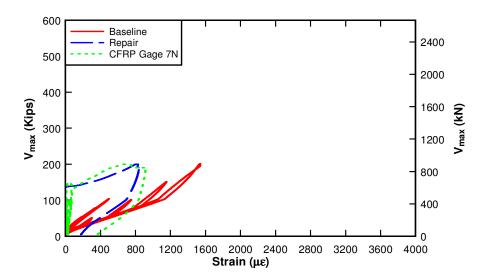
Fig. 4.101 – Bent cap D.T.C.CF shear force versus CFRP and average vertical strain:

service loading condition

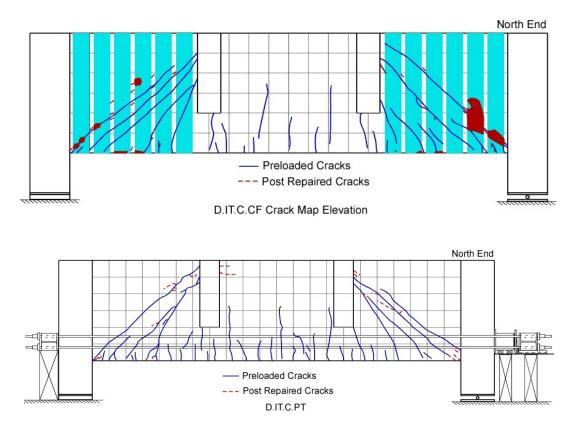
Fig. 4.103 – Baseline and strength loading crack maps for bent cap specimens

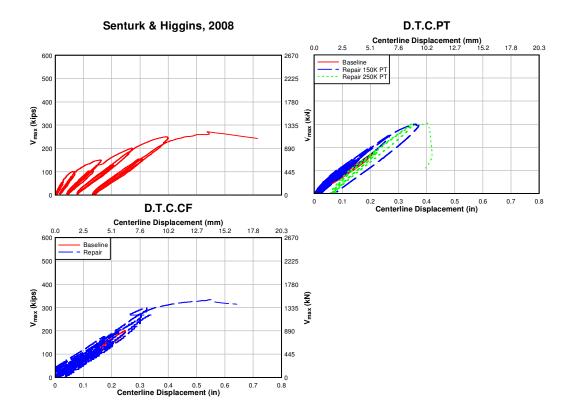
Fig. 4.104 – Bent cap shear force versus centerline displacement: ultimate loading

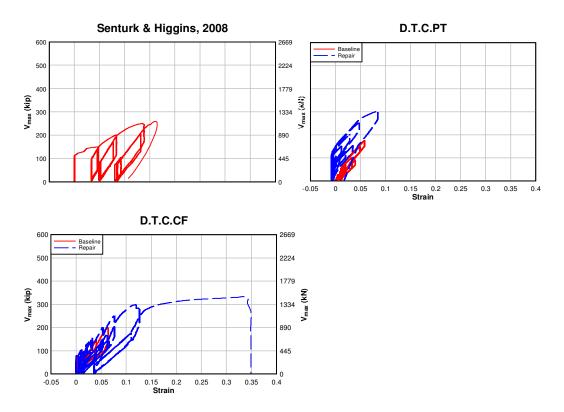
Fig. 4.109 – Bent cap shear force versus north tension diagonal: ultimate loading condition

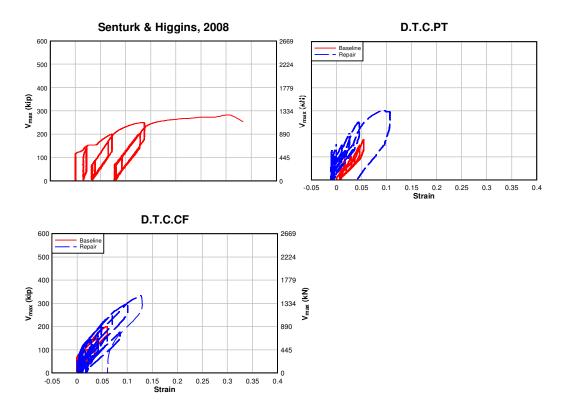
Fig. 4.111 – Bent cap shear force versus south tension diagonal: ultimate loading condition

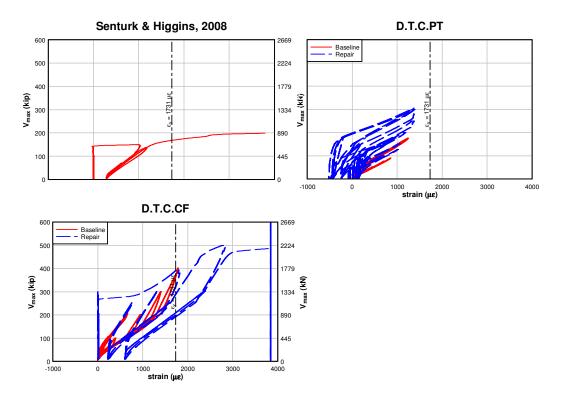
Fig. 4.112 – Bent cap shear force versus typical north internal stirrup: ultimate loading

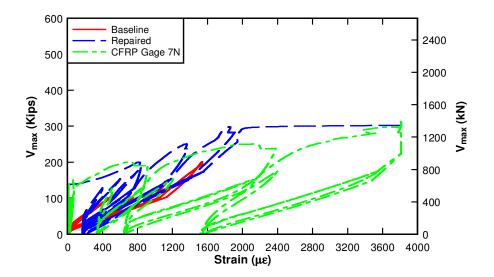
Fig. 4.114 – Bent cap D.T.C.CF shear force versus CFRP and average vertical strain:

strength loading condition

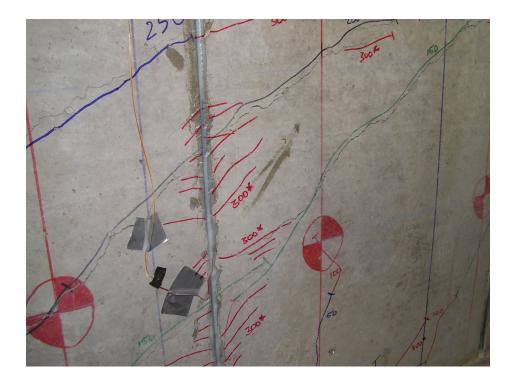
Fig. 5.27 – B.IT.NC.NS restraint of cracks under load

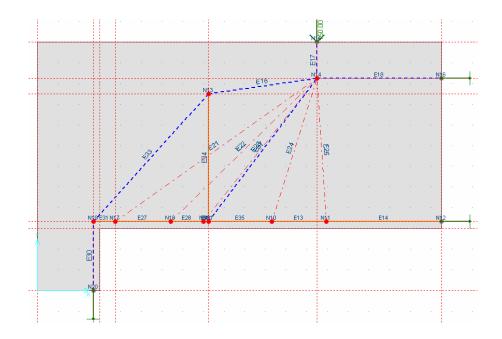
Fig. 5.28 - CAST STM Model Base Specimen: Member and Node Assignments

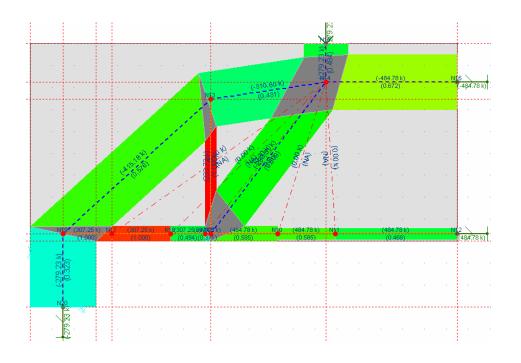
Fig. 5.30 – D.T.C.CF Failure Load-CAST STM Model

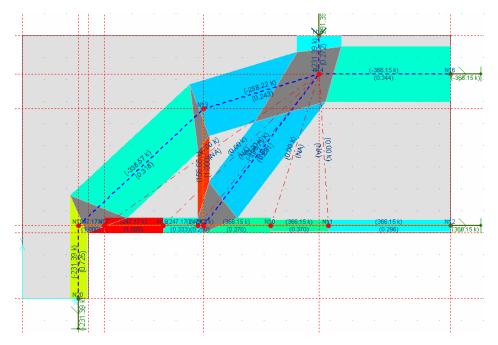
Fig. 5.31 – D.T.C.PT Failure Load-CAST STM Model

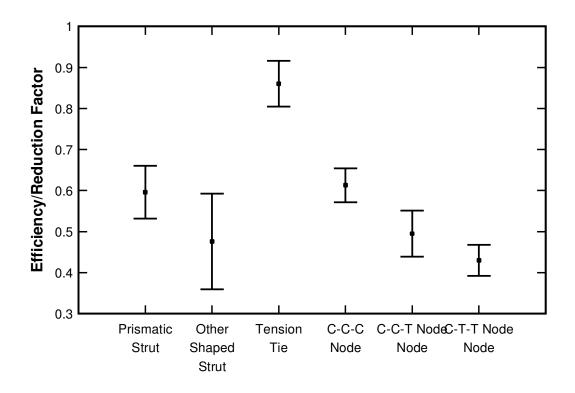
Fig. 5.32 – STM efficiency factors from international codes
