Title: Shear Capacity Assessment of Corrosion-Damaged Reinforced Concrete
Beams

Shear Capacity Assessment of Corrosion-Damaged Reinforced Concrete Beams

A THESIS

Oregon State University

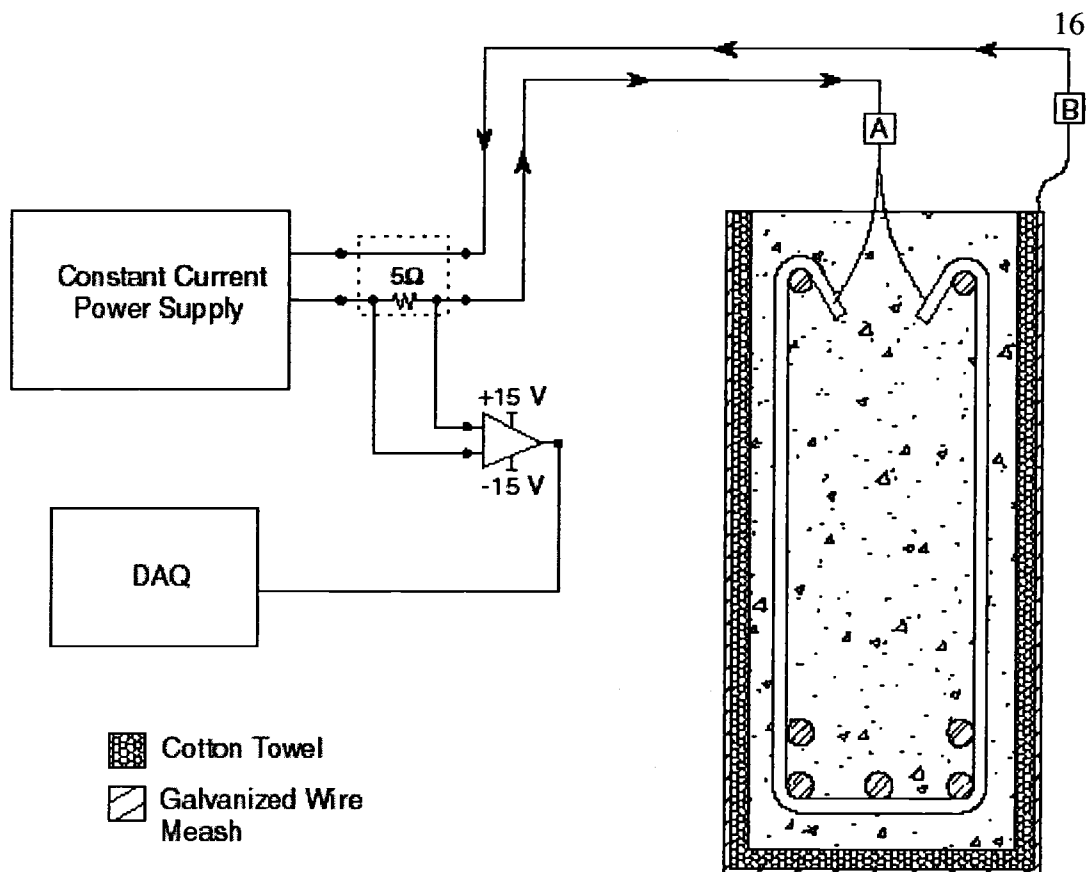
Figure 6: Schematic of corrosion cell (A-anode (+), B-cathode (-)).

The accelerated corrosion process was conducted using a corrosion cell to pass current through the stirrups within the test span. The corrosion cell consisted of a 14 gauge galvanized wire mesh with 1/4-inch spacing in both directions acting as the cathode, and placed on the sides and bottom of the beams. The stirrups, #4 rebar, acted as the anode and were connected in series to a current supply. A wetted cotton towel was placed between the galvanized wire mesh and the concrete surface to provide electrical contact and to maintain low resistivity of the concrete. The cotton towel also allowed oxygen to diffuse to the concrete. Automated pumps circulated water over the specimen to maintain wetting and drying cycles. A schematic of the corrosion cell is shown in Figure 6. Current was impressed through the stirrups at a constant current density of 9.83-mA/in^3 . The current passing through the stirrups was updated daily to maintain the current density even as the bar area was reduced due to corrosion, the prediction of the corrosion rate is shown in Figure 7. The current density was sufficiently high so as to provide a reasonably fast corrosion time.

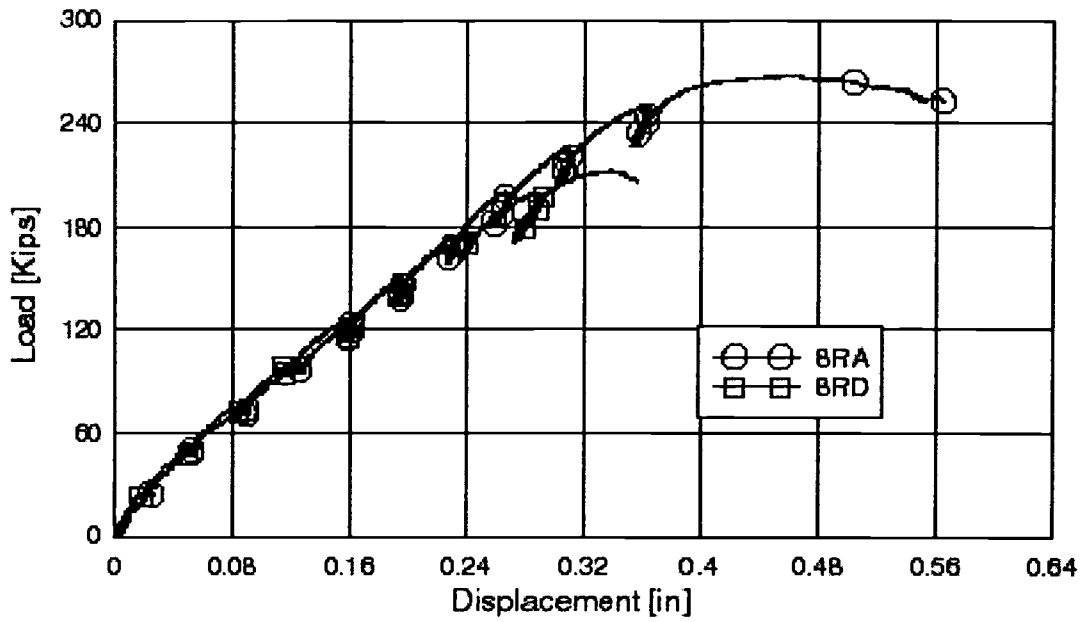
Figure 10: 8R Series load-displacement plots.

Load-displacement responses for the rectangular beams with 8-in stirrup spacing are shown in Figure 10. Specimen 8RD was subject to severe corrosion damage and showed a capacity loss of 20% and a loss of ductility of 37% compared to the uncorroded specimen. The maximum load was obtained just prior to fracture of stirrup S2. Stirrup fracture occurred at the bottom bend location due to severe section loss. The largest shear crack width measured on the beam web prior to failure was 0.02 inches. The cracking patterns for the two beams at failure are shown in Figure 11, with the heavier line weight representing the failure crack. After failure, the stirrups crossing the failure crack (3 stirrups) were removed to determine the average and maximum local section loss. The average section loss was 29%, and is defined as average section loss of all stirrups that cross the failure crack. The maximum section loss was 64% and is defined as the maximum section loss of all stirrups in the failure region regardless of where it occurs on the stirrup leg. Section loss measurements for all removed stirrups (S1, S2, S3) are shown in Table 11. The concrete was also examined to assess the damage. Corrosion damage could be discerned from load induced damage based on rust staining. The close spacing of the stirrups caused

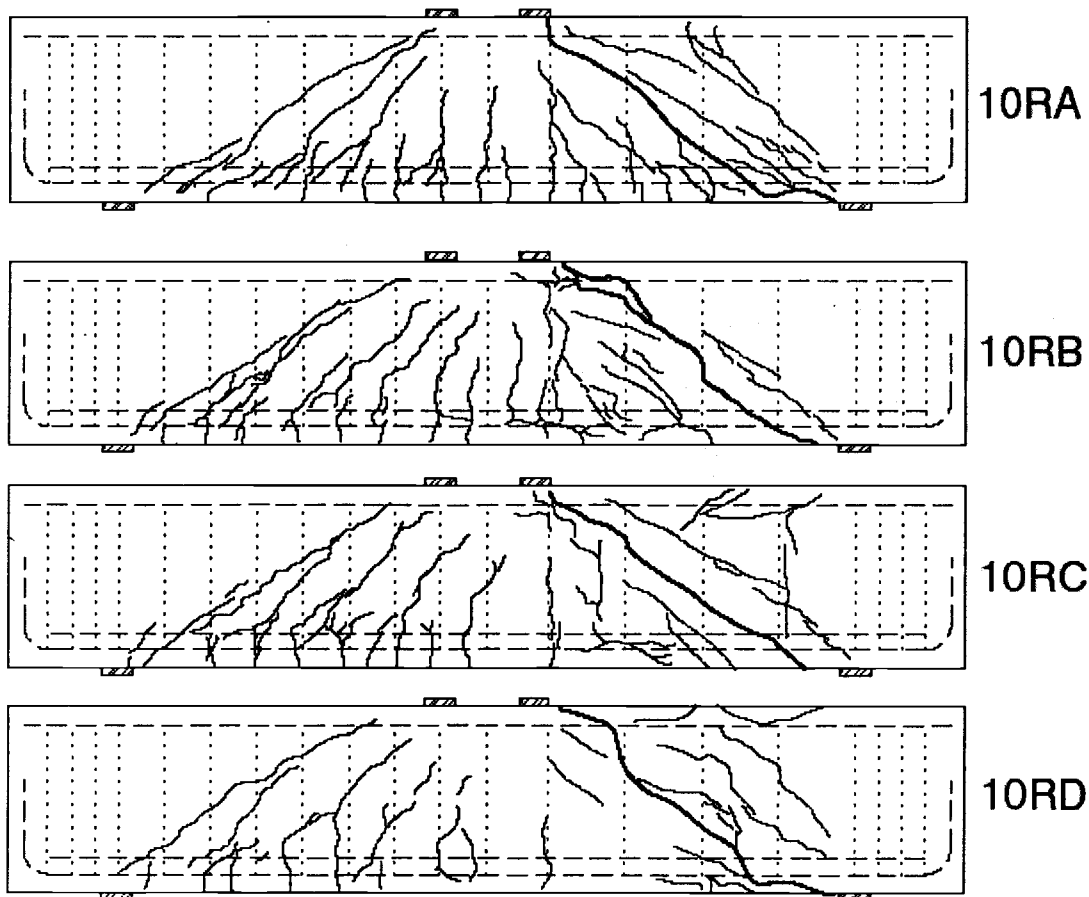
Figure 15: 10R Series crack maps.

maximum crack width measured prior to failure was 0.025 inches and occurred at the location of the bar fracture. Stirrup S3 in 10RD fractured at point of severe section loss at a point below the compression steel. Crack maps for the 10R Series are presented in Figure 15, with the heavier line representing the failure crack. After failure, the stirrups that crossed the critical crack (2 stirrups) were removed to determine the average and local maximum section loss. The average of the 2 stirrups in the critical region for specimen 10RB is 13%, while the local maximum was 34%. For specimen 10RC the average section loss was 23% and the local maximum was 61%. For the severely corrosion-damaged specimen, 10RD, the average section loss was 32% while the local maximum section loss was 100%. The section loss measurements for all stirrups for the 10R series are shown in Table 11. The concrete was examined after failure to assess damage from corrosion. The spacing of the stirrups was sufficient so that the corrosion cover cracking just overlapped and that wedge shaped pieces of side cover were delaminated. Measured crack widths did not vary significantly between different specimens in this series except for 10RC, where the maximum crack width occurred at a fractured stirrup location. The total deformation along the diagonals that cross the shear cracks is shown in Figures 16 and 17.

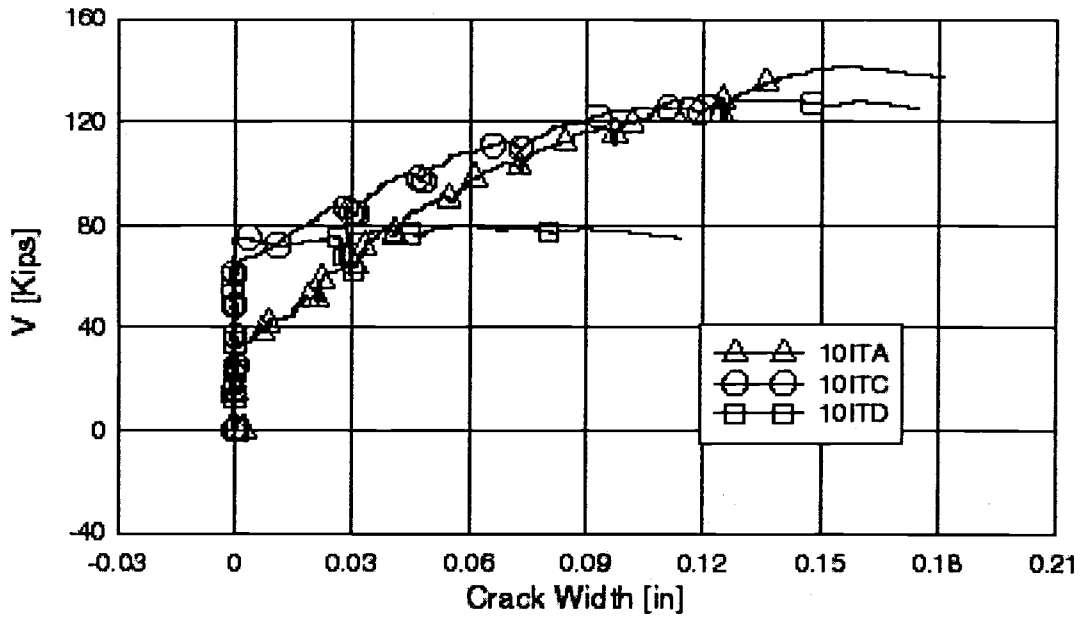
The load-displacement behaviors for the inverted T-beams with 10 inch stirrup spacing are shown in Figure 26. Specimen 10ITC was subject to moderate corrosion damage and showed a capacity loss of 5% and a loss of ductility of 9%. Specimen 10ITC failed due to shear-compression failure of the concrete. The maximum crack width measured prior to failure was 0.025 inches. Specimen 10TD showed a capacity loss of 42% and a ductility loss of 24%. The beam failed upon fracture of stirrup S3. The stirrup fractured approximately 3 inches below the deck soffit. Cracking patterns for the three beams in the series are shown in Figure 27. Average and maximum section loss of the stirrups was measured for 10ITC at 17% and 20%, respectively. The severely corrosion-damaged specimen, 10ITD, had an average section loss of 36% and a local maximum section loss of 72%. The section losses measured for all removed stirrups are shown in Table 11. The corrosion damage that occurred from the concrete was again similar to that of the 10R series. The deck developed large cracks from corrosion but no delaminations or spalling was observed. Cracks formed on 10ITC and 10ITD along the flange web interface. The total deformations along the diagonals that cross the shear cracks for the 10IT Series are shown in Figures 28 and 29. The total deformation for the

inverted T-beams changed due to corrosion damage. The maximum crack width for the heavily corroded beam was less than that for the moderately damaged beam. Specimen 10ITD first showed signs of shear cracking that propagated quickly to failure.

Figure 28: Deformations measured across cracks within Panel 1 for 10IT Series.

Figure 29: Deformations measured across cracks within Panel 2 for 10IT Series.
