PINE CREEK SYSTEM

MAIN PINE CREEK

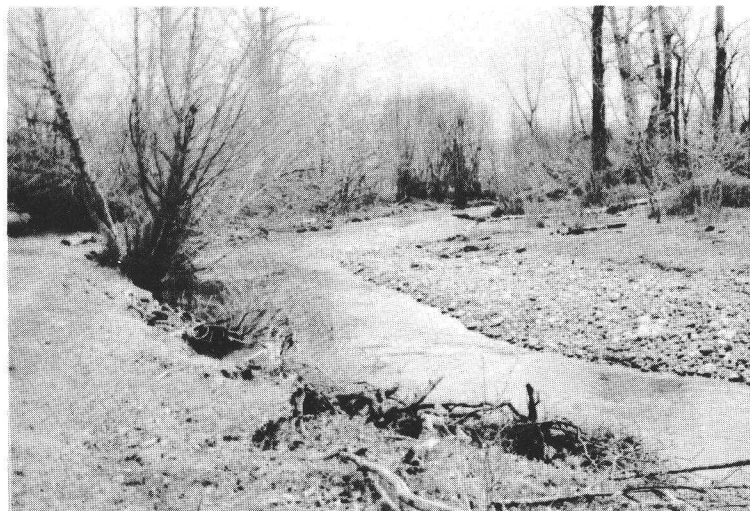
Figure 119. Bank Cover Types on Pine Creek Near Halfway, Oregon. Photo Taken April 2, 1959.

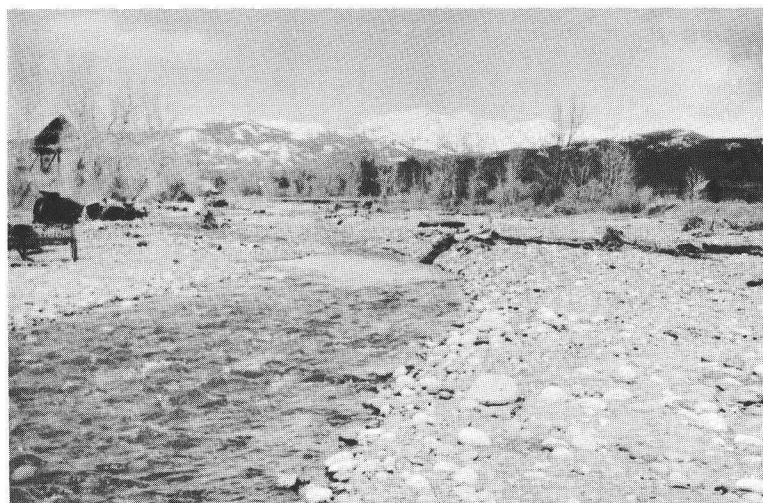
Figure 120. An Unshaded Section of Pine Creek a Short Distance Above Halfway, Oregon. Photo Taken April 2, 1959.

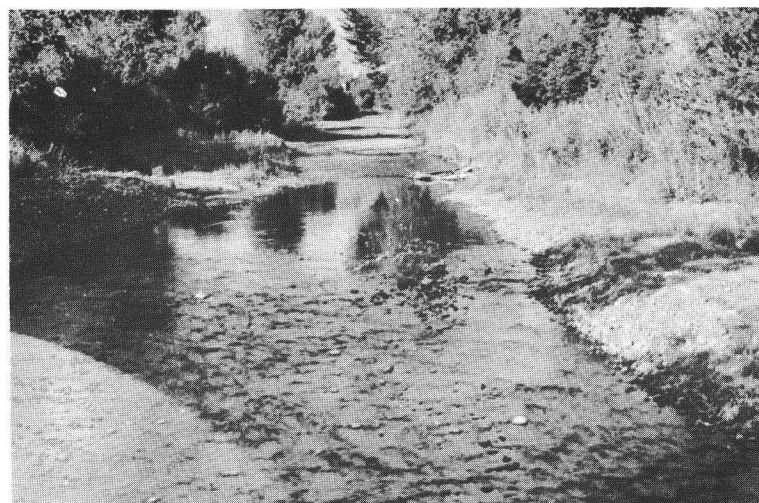
Figure 121. Pine Creek at Lower End of Pine Valley on August 18, 1959. Returning Water Recharged Stream.

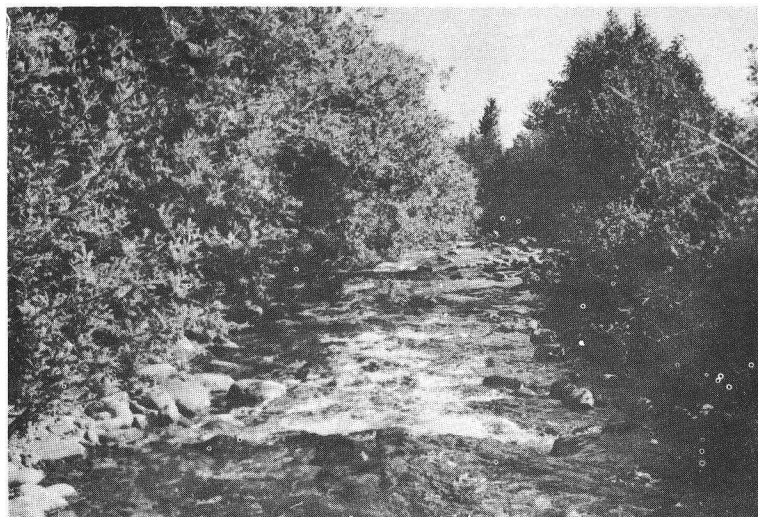
Figure 122. A section of Clear Creek 8 Miles Above the Mouth. This Area Has a Rather Steep Gradient and Very Little Spawnable Gravel. Photo Taken August 17, 1959.

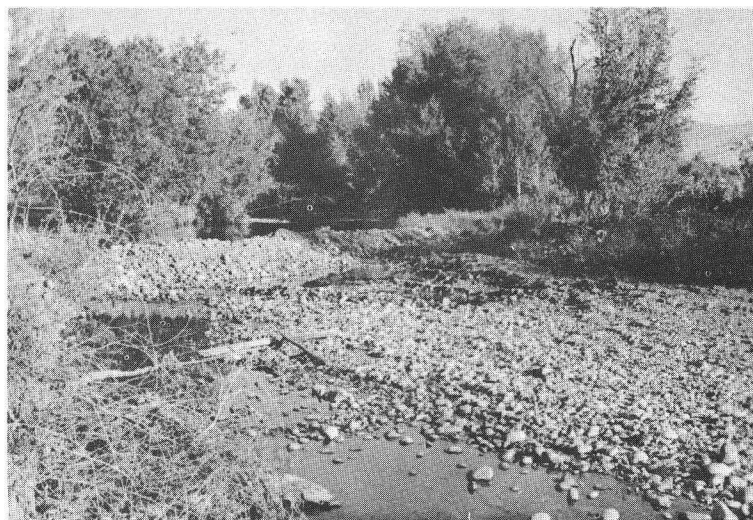
Figure 123. An Area of Low Flow on Clear Creek 1.5 Miles Above the Mouth. A Diversion Has Reduced the Flow to Under One-Half c.f.s. (8-18-59).

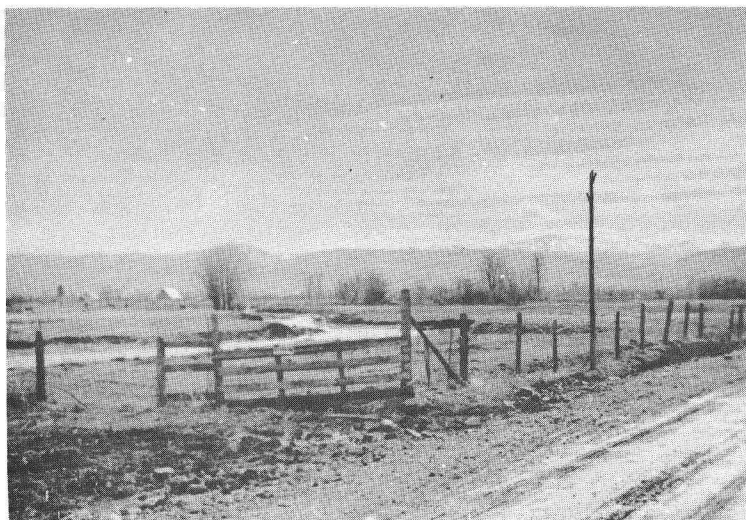
Figure 124. An Unshaded Section of East Pine Creek in Lower Pine Valley. Photo Taken April 1, 1959.

Shade: Shade conditions on East Pine Creek varied considerably within the surveyed section. Shading was generally good with partly shaded and partly to densely shaded sections predominating. Open, or open to partly shaded, sections occurred from 0.75 to 1.5 miles and from 1.75 to 2.25 miles above the mouth (Figure 124).

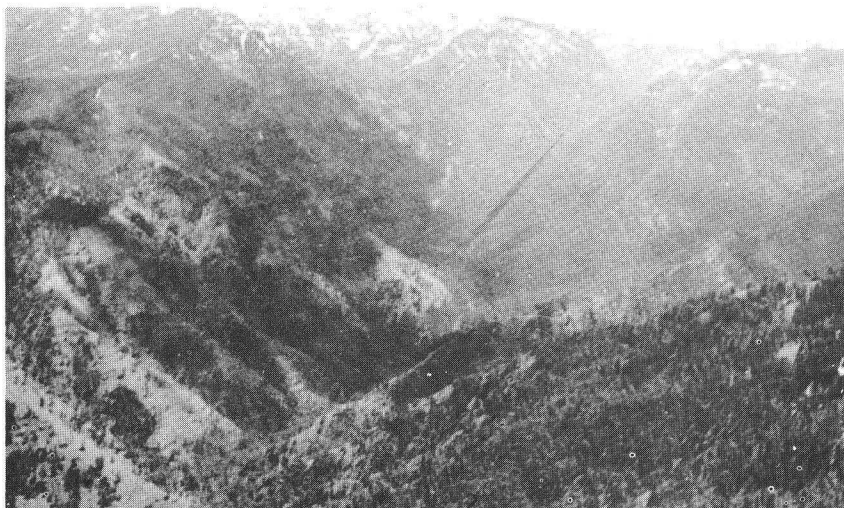
Terrain and Gradient: North Pine Creek flows through mountainous terrain throughout its course. The stream canyon is relatively deep (Figure 125) and becomes narrower above Lake Fork in the 13-mile observed section from Duck Creek to the mouth. The gradient in this section was considered steep except for some moderate-to-steep areas in the lower 6 miles.

Figure 125. North Pine Creek Canyon a Few Miles Above the Mouth.

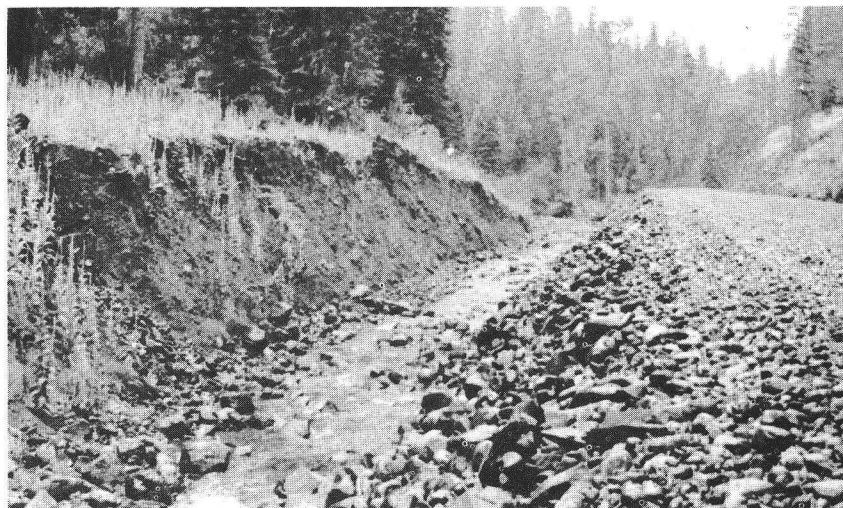
Slope and Bank Cover: Slope cover from Duck Creek to the mouth is composed of conifers and grass with some rock outcroppings. Conifers become less numerous with downstream progression. Bank vegetation above Lake Fork is a mixture of conifers, brush, and grass. Below Lake Fork, deciduous trees gradually replace the conifers. A road is adjacent to the stream over part of the lower 13 miles and certain areas have exposed soil and rubble rock banks (Figure 126).

Figure 126. A Section of North Pine Creek 11 Miles Above the Mouth. A Road is Adjacent to the Stream.

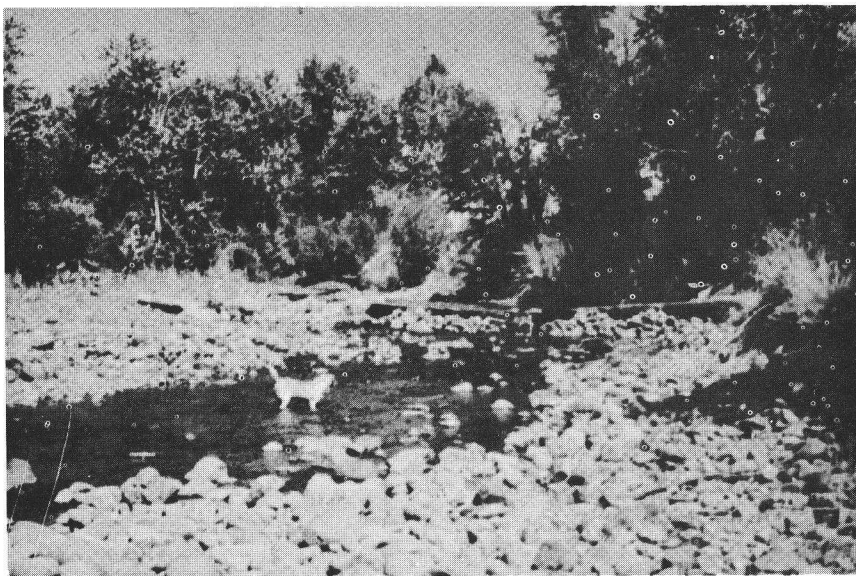
Figure 127. A Diversion Dam on North Pine Creek Located One-Half Mile Above the Mouth. This Dam Was Blocking Upstream Migration on September 11, 1959.

Obstructions and Diversions: No obstructions were noted on the aerial survey of June 1, 1959, but in late summer a diversion dam (P-NP-1) (Figure 127) located 0.5 mile above the mouth blocked the stream. No other obstructions were noted on North Pine Creek.

Surveys during the irrigation season in August 1959 revealed a total of 19 temporary and permanent diversion dams in Pine Valley which were considered impassable. Impassable areas also existed due to low flows. On North Pine Creek, flow conditions were somewhat better because of less irrigation. Only one diversion dam (P-NP-1) was observed on North Pine Creek. This was located approximately 0.5 mile above the mouth and was blocking upstream migration in the late summer.

No recommendations are made concerning fish passage at diversion dams at this time, but it is recommended that the 3 debris obstructions (P-EP-1) located on East Pine Creek be removed.

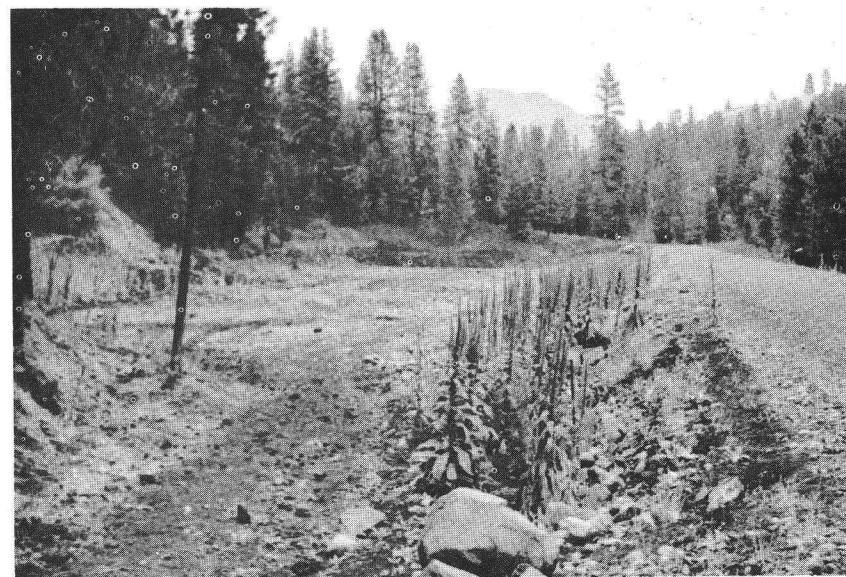
Figure 128. One of Several Possible Impoundment Areas of Small Acreage Located Between the Canyon Wall and a Roadbed on North Pine Creek.

Impoundment and Hatchery Sites: Possible impoundment areas exist on North Pine Creek. The most promising areas are small depressions created by the canyon wall and the roadbed which runs along the stream (Figure 128). Nine such locations were noted in the section from 3.5 miles above the mouth upstream for 7.5 miles to Trap Creek. These sites were small and ranged in size from approximately 1 to 6 acres. It is estimated that possibly 25 acres of pond area could be developed from these small depressions. No hatchery sites were noted on North Pine Creek.

A considerable amount of level area for the excavation of off-channel impoundments exists in Pine Valley, and a limited area is present in the canyons above the valley. The only impoundment sites which would require relatively little excavation were observed on North Pine Creek. These were formed from the enclosing of small areas by a road bed and the canyon wall. Up to 25 acres of impoundment area could be obtained by developing these 1- to 6-acre sites.
