Delayed Survey of the 2011 Tohoku Tsunami in the Former Exclusion Zone in Minami-Soma, Fukushima Prefecture

Delayed survey of the 2011 Tohoku Tsunami in the former exclusion zone in Minami-Soma, Fukushima Prefecture

Abbreviated title: Tohoku Tsunami survey in Minami-Soma, Fukushima

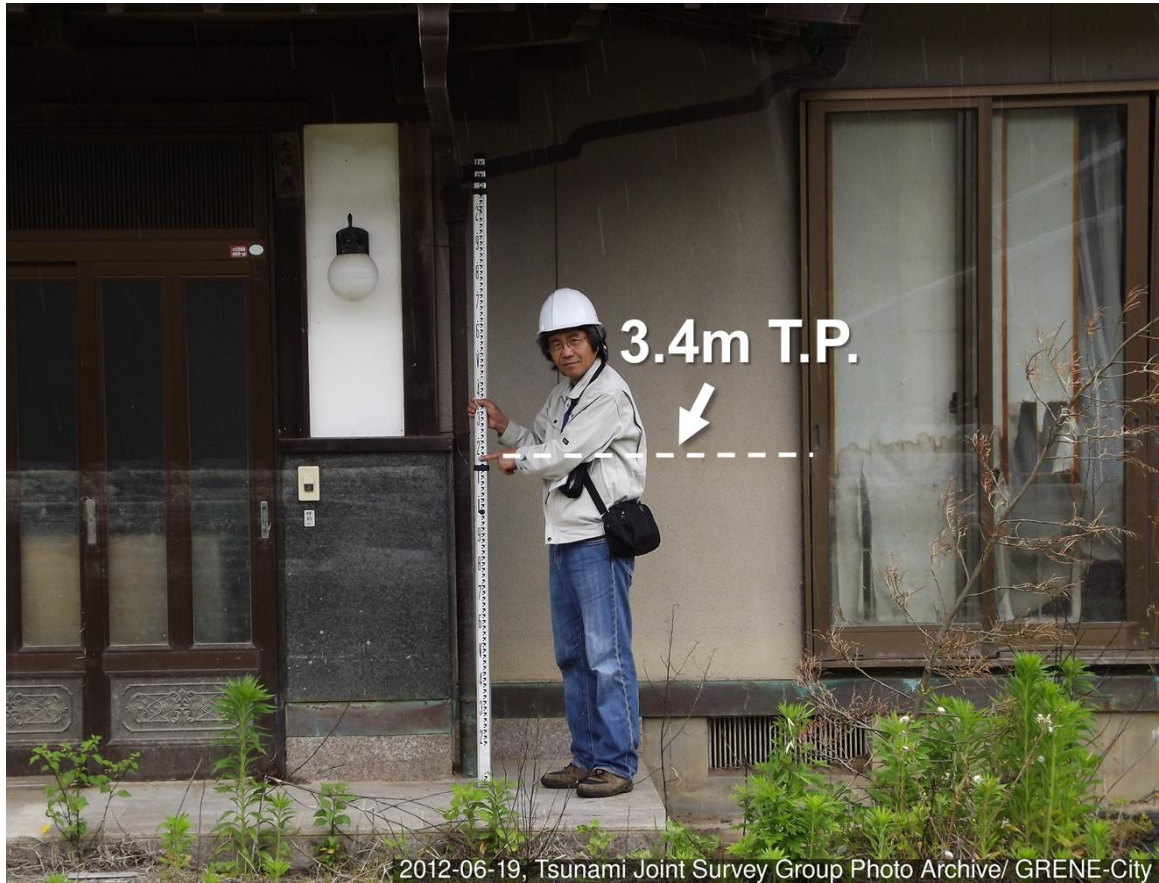
Figure 3 A clear mudline watermark around the exterior of a residential house located 1.2 km from the shoreline at Idagawa, Minami-Soma (tagged with RPDJ-0017 in TTSG database, June 19, 2012. Note that all watermark photographs are archived and available on the Internet with URL listed in the references).

As shown in Figure 3, many clear tsunami watermarks, such as mudlines representing the inundation levels on buildings, were found intact even more than one

year after the tsunami inundation. We could easily identify and record tsunami borne debris stranded in sheltered locations such as inside houses, tsunami-induced damage marks on communication towers, and breakage of tree limbs. (Note that all watermark photographs are archived and available on the Internet in Tsunami Joint Survey Group Photo Archive, 2013). This highlights that some tsunami watermarks can remain preserved for an extended time under the absence of human activities such as clean-up, recovery and reconstruction.

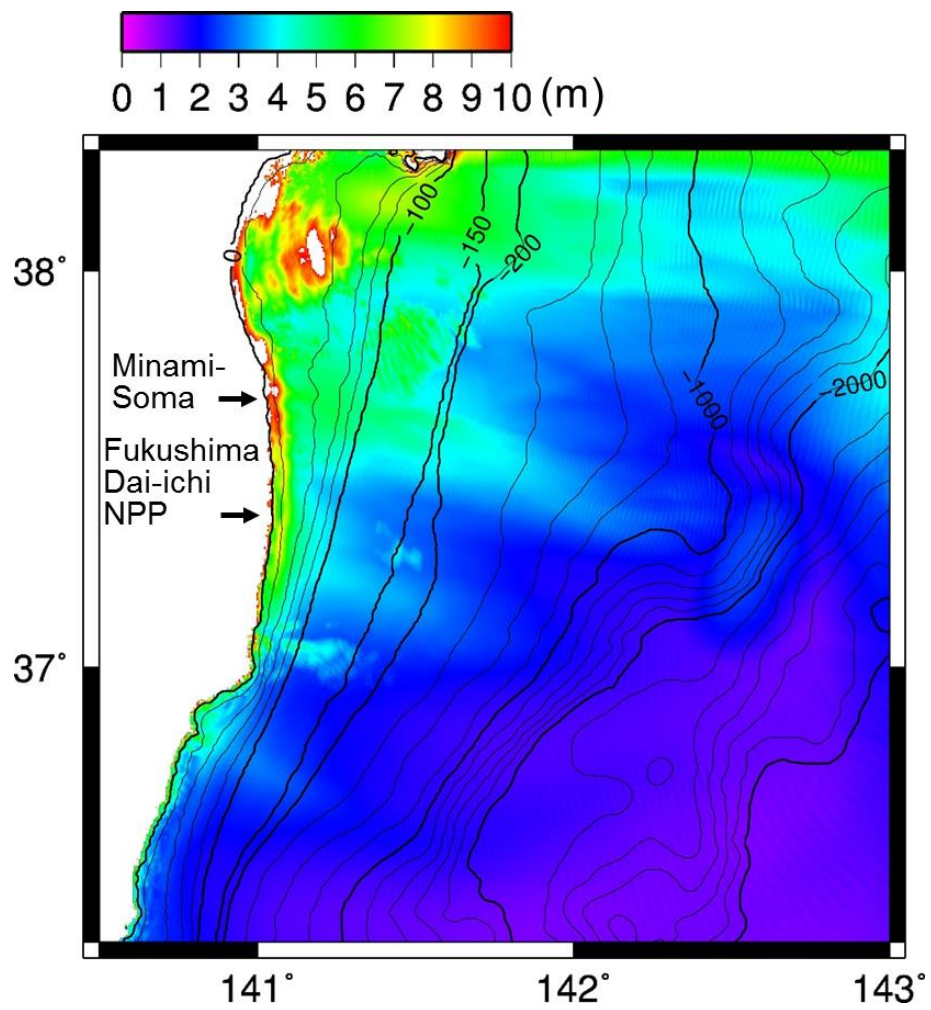
Figure 4 Maximum water level due to computed tsunami (Sato et al., 2013).

Hydrodynamic tsunami modeling suggests focusing of tsunami wave energy towards Minami-Soma (Sato et al., 2013). The computation was based on the linear long-wave theory with the use of the tsunami source estimated by Fujii et al. (2011). Figure 4 illustrates distribution of maximum water level due to tsunami. The numerical simulation suggests that the refraction of tsunami due to bathymetry played an important role in the propagation direction and the local tsunami amplification. Note that one of the local peaks appears to be headed towards Minami-Soma.

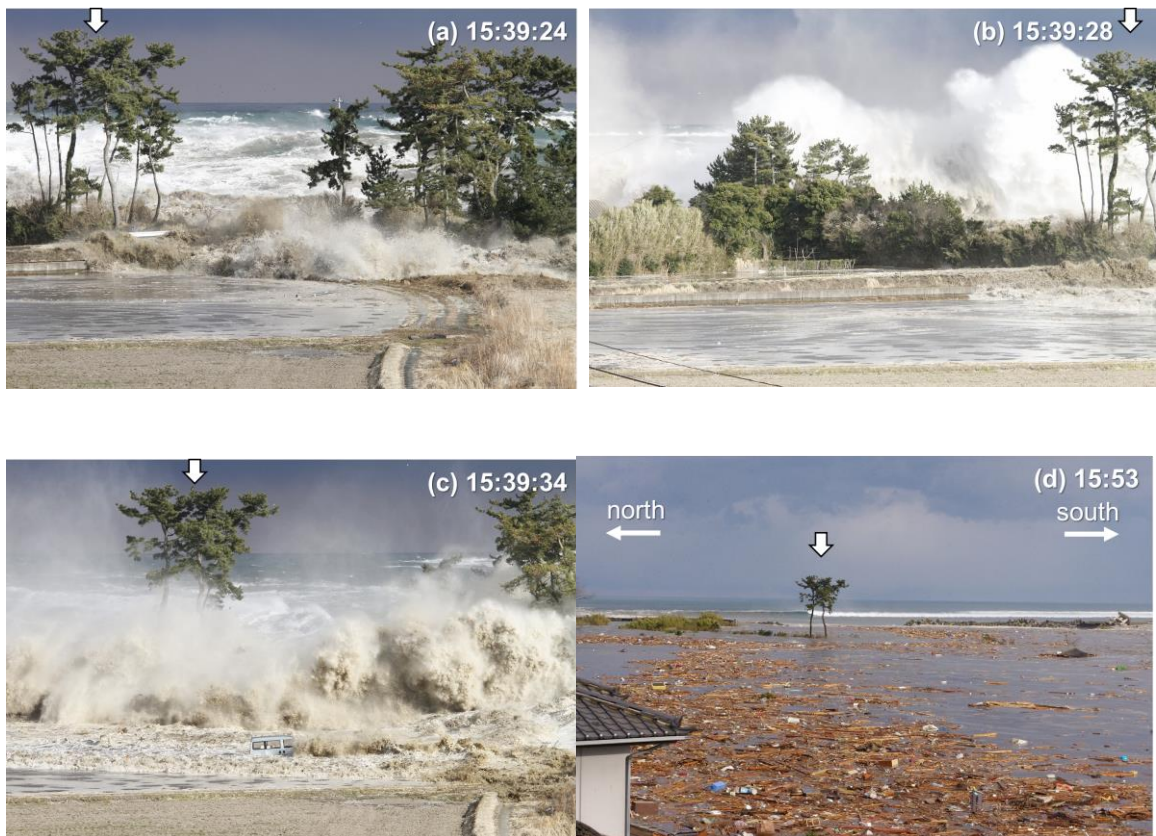
Figure 5 (a)-(d) Tsunami observed at Tsukabara, Minami-Soma (Photographs courtesy Mr. Sadatsugu Tomisawa).

Based on videos and photos recorded by local residents, the tsunami reached the shore in the form of a breaking bore with a height of about 10 m (Sato et al., 2013, Sanuki et al., 2013). When the bore impacted coastal cliffs or seawalls, the deflected water splashed up to heights of 20 to 30 m. The formation of such high splash-up near the shoreline is confirmed in a series of photographs recorded at Tsukabara (Figure 5). Examining the successive series of photographs with the time interval of 0.5 s (only three snapshots are shown in Figure 5a, b and c), the incident tsunami direction is inferred from the location of the two surviving pine trees (about 20 m high above sea level based on laser field measurements) marked by arrows in subsequent images in Figure 5. The tsunami initially attacked the area from the southeast (15:39:24, according

to the camera time stamp) and seconds later also from the northeast (15:39:28 and 15:39:34).

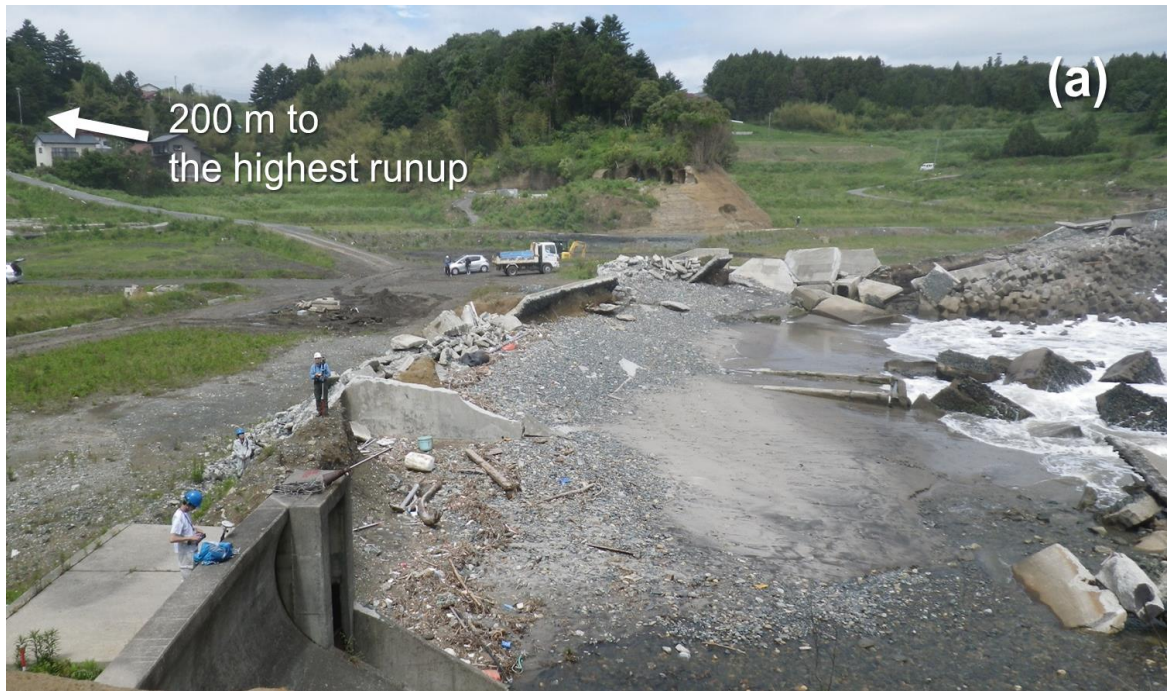
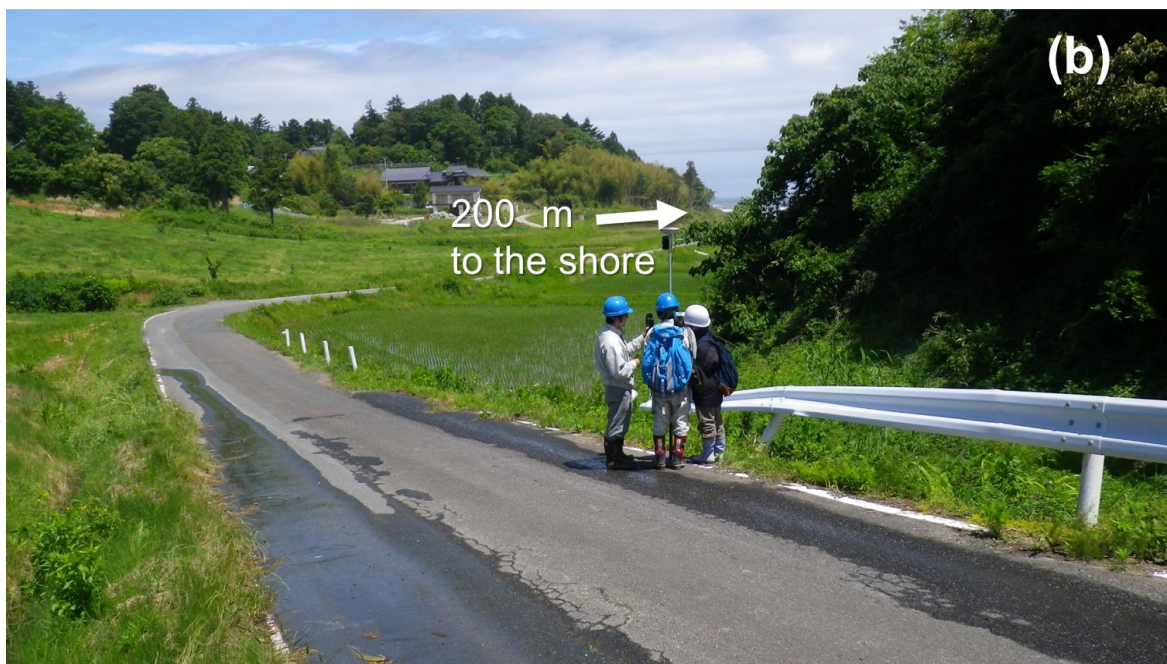
Figure 7 Photos of Kabaniwa, Soma, displaying (a) completely broken seawall and (b) location near the maximum runup (June 20, 2012).

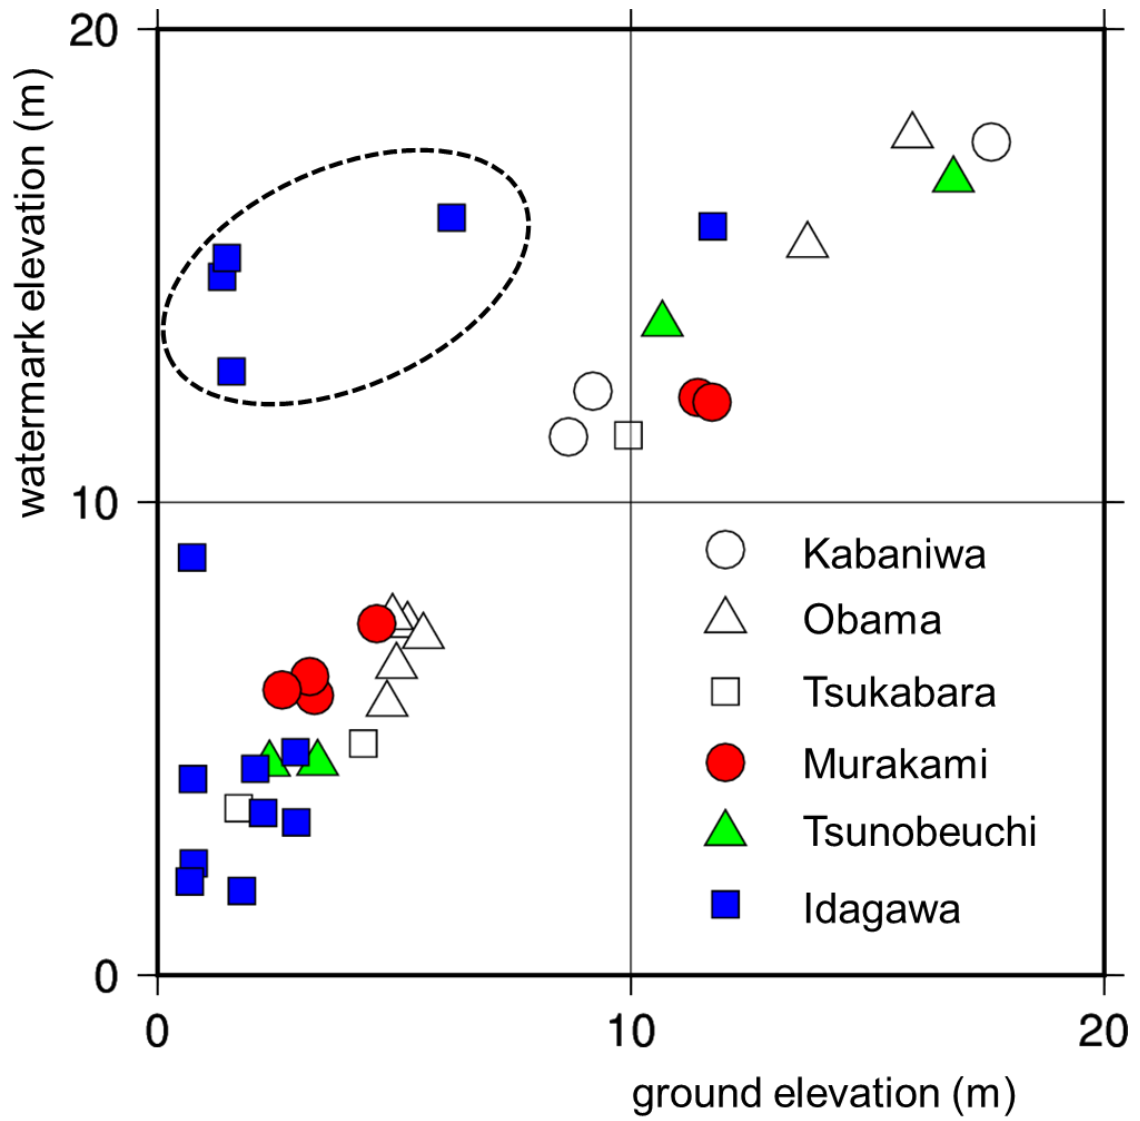
Figure 9 Relationship between tsunami heights and ground elevations.

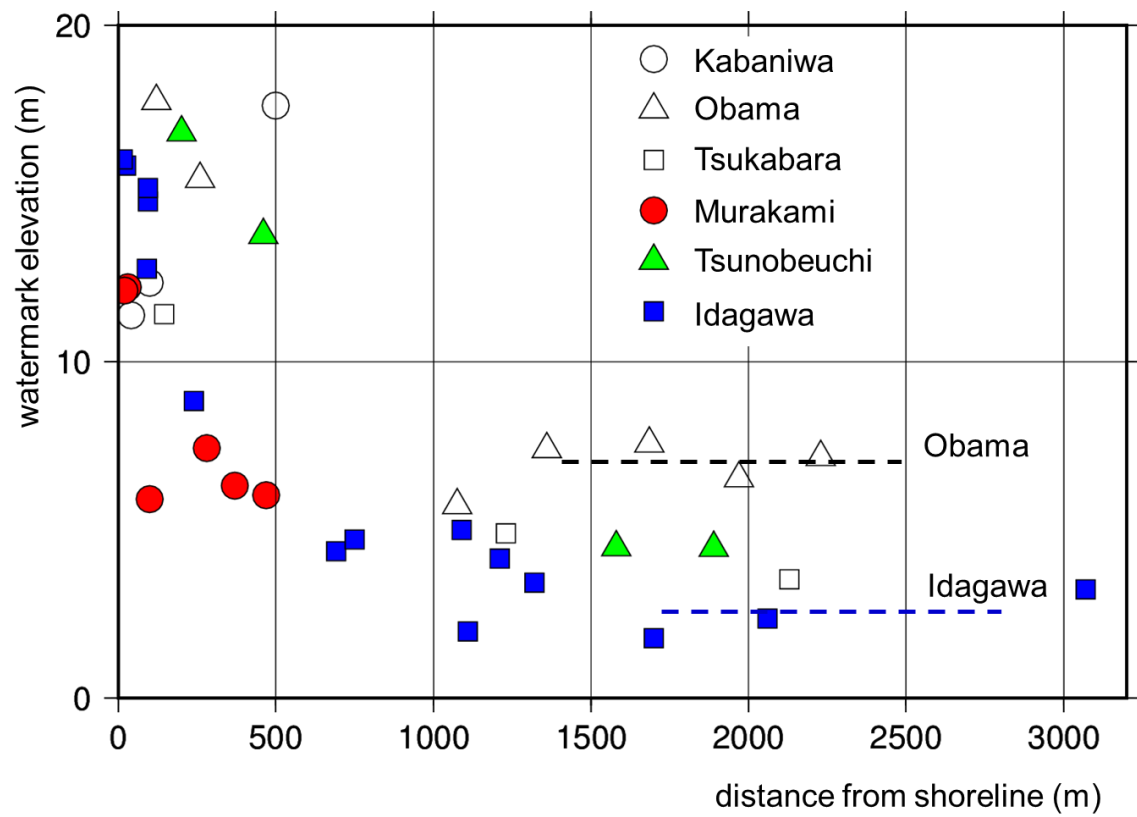
Figure 10 Relationship between tsunami heights and distance from the shoreline.

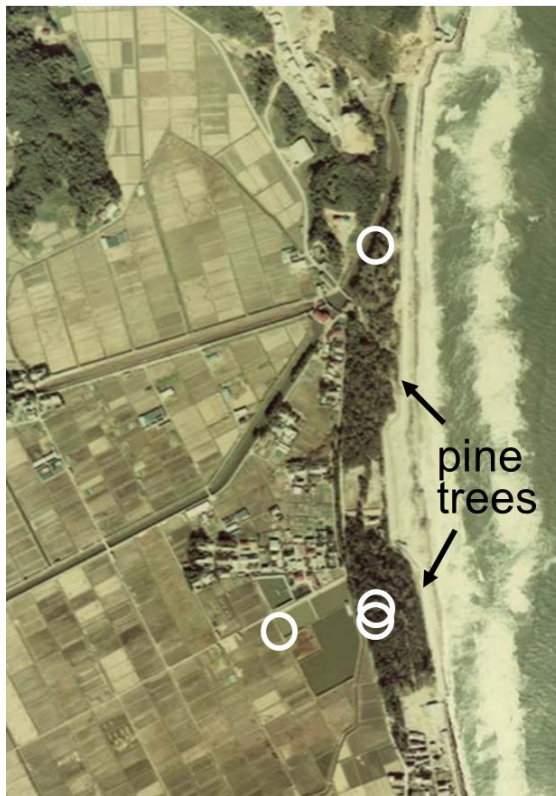
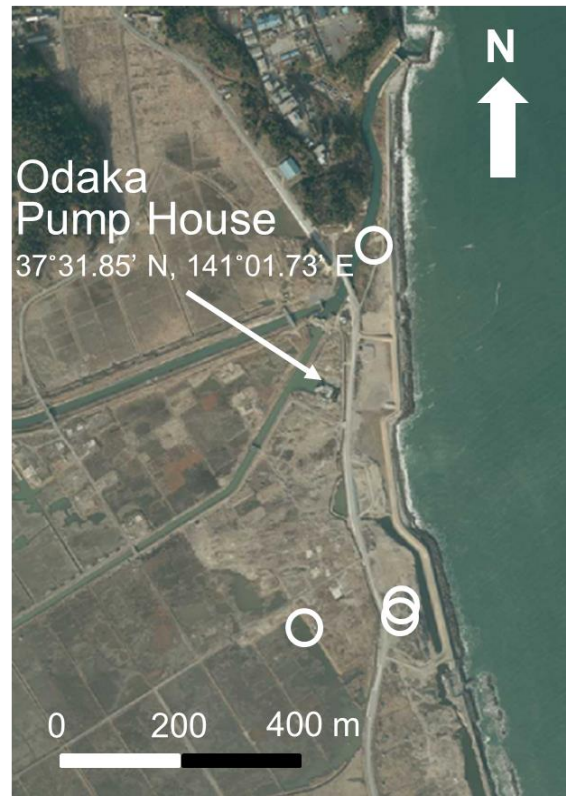
(a) before tsunami, November 1975

(b) after tsunami, December 2012

Figure 11 (a), (b) Aerial photos before and after tsunami showing a band of coastal pine trees (Photos are taken by Geospatial Information Authority Japan). Note that the forest remained unchanged in a satellite image taken in November 2009.

Figure 11 shows aerial photos of Idagawa indicating the locations of the four measurements marked in Figure 9. The photo taken before the tsunami (Figure 11a) shows that the measurement points are located near or inside the coastal pine tree forest, which was approximately 100 m wide and used to exist behind the seawall. Most of the

trees were completely washed away by the tsunami. Only 6 trees survived, which provided tsunami watermarks such as broken branches along with scratch marks on the bark of tree trunks. It is noted that devastating destruction of so called “tsunami control forests” by the tsunami was also observed at Rikuzentakata, Iwate Prefecture (Liu et al, 2013).

Broken tree branches, as well as the damage marks on the two nearby communication towers, at Idagawa indicate that the tsunami reached 11 to 13 m above ground at terrain elevation of about 1.5 m above sea level. Such large tsunami heights are attributed to the flow deflection by seawalls and the initially increased flow resistance induced by the dense coastal pine forest. Similarly at Futaba Beach, located 6 km south of Idagawa and 4 km north of the Fukushima Dai-ichi NPP, a 16.9 m high watermark was measured in the forest while nearby watermarks adjacent to the forest were 12.2 m and 13.6 m (Sato et al., 2013).

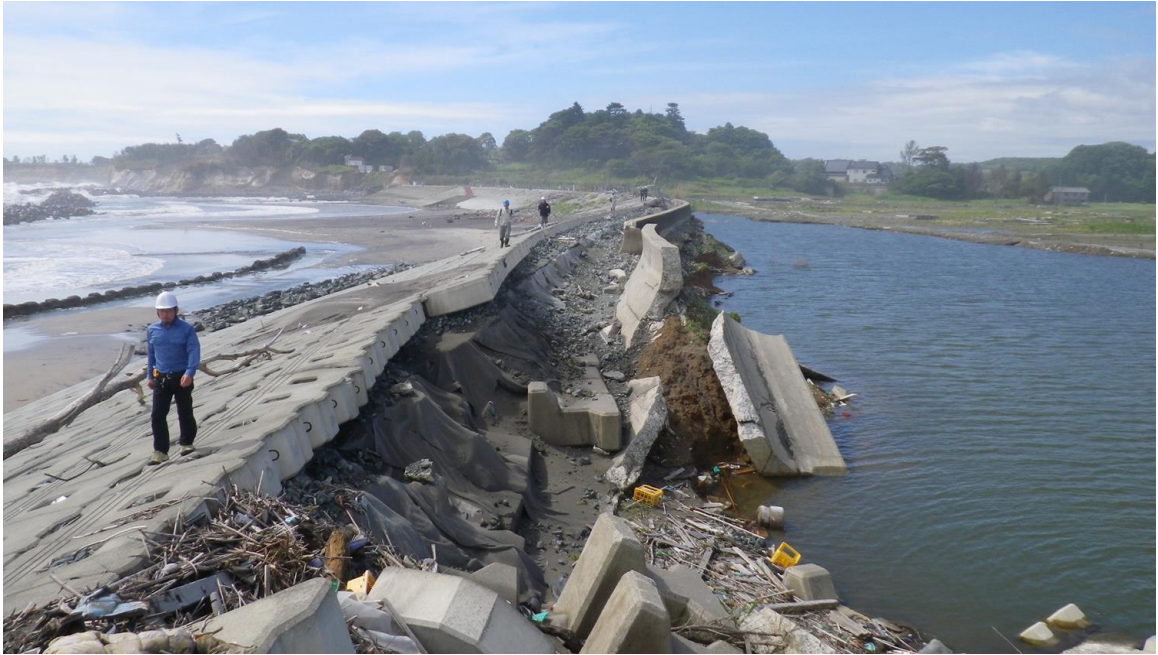
Figure 12 shows a partially damaged seawall at Isobe in Soma City (see Figure 1 for location). The gently sloped front face is intact but significant damage was found on the crown and along the landward slope. A large amount of water impounded on the lee side of the seawall filled a scour hole excavated by the extensive tsunami overtopping flow. The detached rubble mound breakwaters located about 100 m offshore of the seawall appeared to be intact.

Figure 12 Seawall damage observed in Isobe, Soma (June 20, 2012).

The foregoing observations on seawall failures suggest that design improvements for the crown portion and the lee side of the seawalls are important to enhance “nebari” under overtopping flow. For example, a heavier crown cap combined with milder side

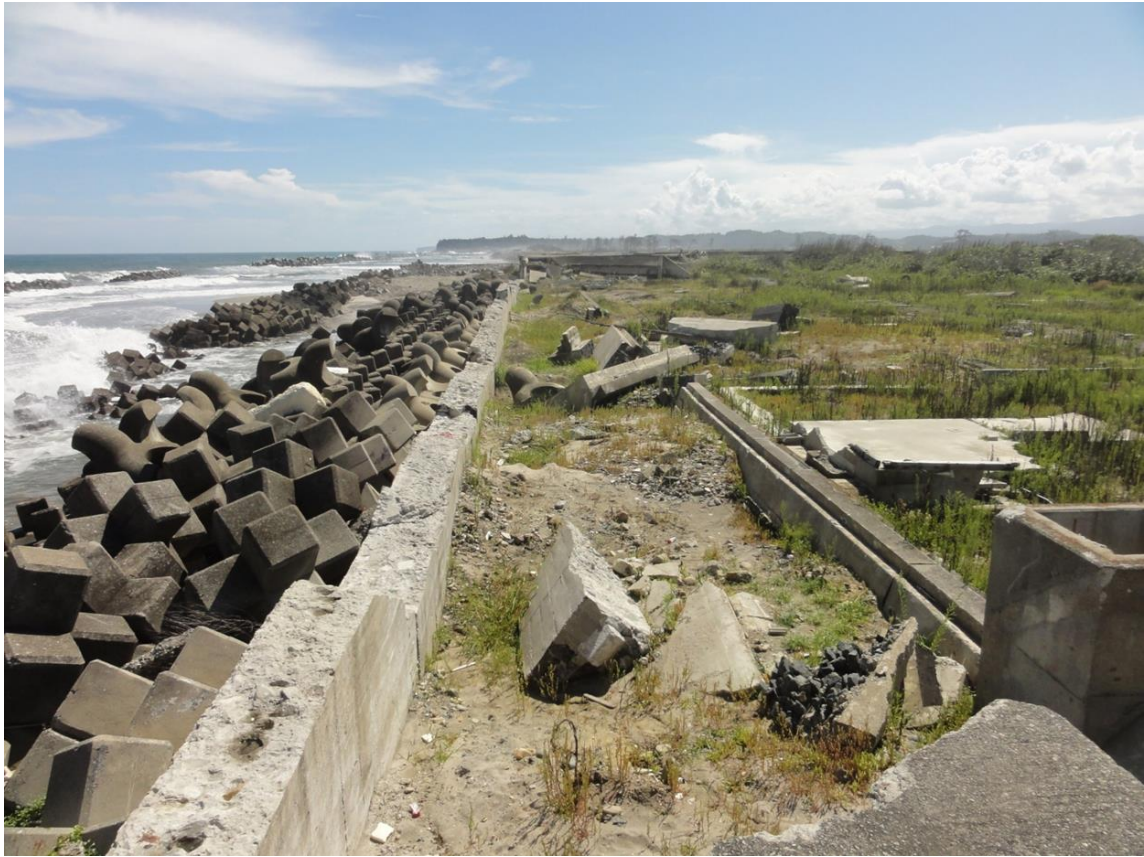
The Tsukabara coast was also protected by seawalls with a crest height of 6 m T.P. Figure 13 shows upright concrete seawalls completely broken off at the ground level. The 3 m wide capping concrete plate and the landside concrete plate were displaced and transported inland by the overflowing tsunami. The sand filled core inside the seawall was completely washed away. The progressive collapse and scour removed the backside support leading to the fracture at ground level of the seaside concrete wall. Some of the concrete armor blocks, originally placed in front of the seawall, were found more than 300 m inland.

Figure 13 Seawall damage observed in Tsukabara, Minami-Soma (September 3, 2012).

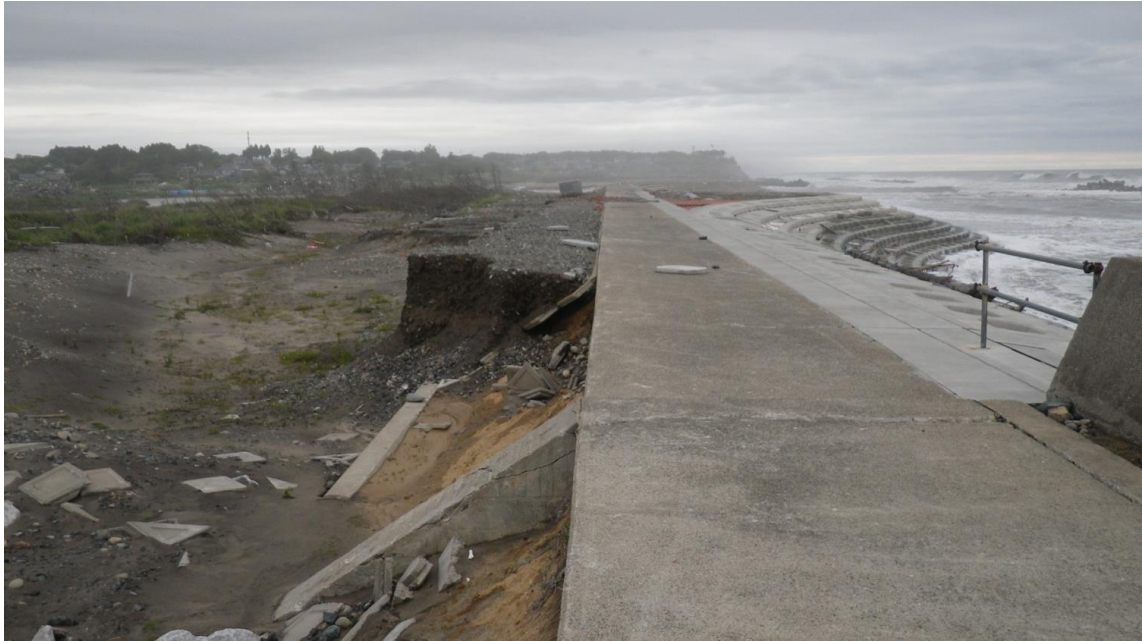
Figure 14 shows a surviving seawall on the south side of the Odaka River in Tsukabara. The gentle slope of the front face and the crown of the seawall are intact. The landward side is partly collapsed, but the gravel land fill which had been placed to cover the landward slope of the seawall appeared to minimize the scour there.

Figure 14 A surviving seawall observed in Tsukabara, Minami-Soma (June 20, 2012).

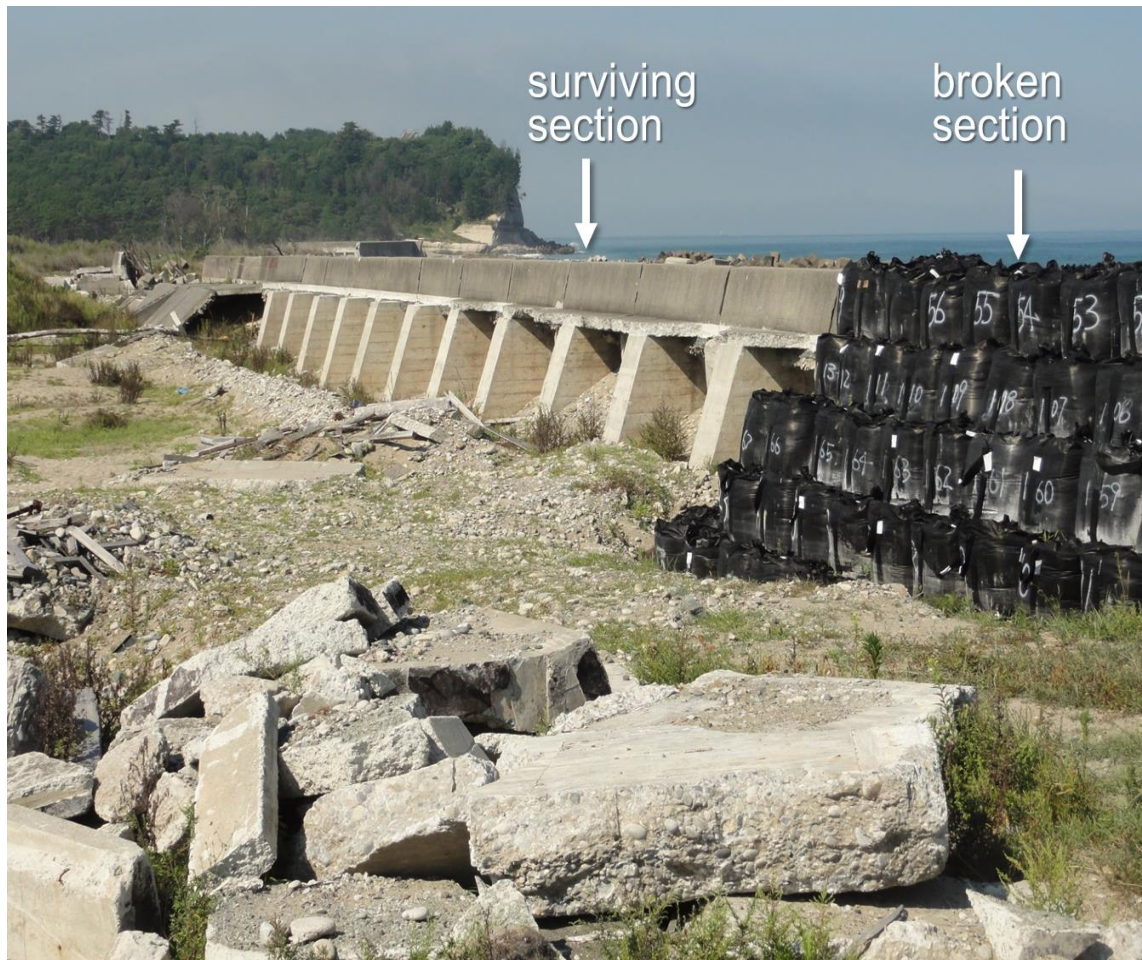
slopes could help reduce damage to the seawall. Furthermore, a concrete apron extended landward from the lee-side toe of the sea wall could reduce scour actions. Another example of a remnant seawall is shown in Figure 15, indicating that the presence of partitioning walls was effective in supporting the seawall even where a substantial amount of the fill material was scoured away. Black sand bags were placed in the section of total failure, where partitioning walls were not installed (Figure 15). The foregoing and many other observations should be analyzed carefully to develop the designs of future protective coastal structures based on “nebari.”

Figure 15 A surviving seawall connected with a completely broken section observed in Naraha (August 24, 2012) approximately 20 km south of the Fukushima Dai-ichi Power Plant.

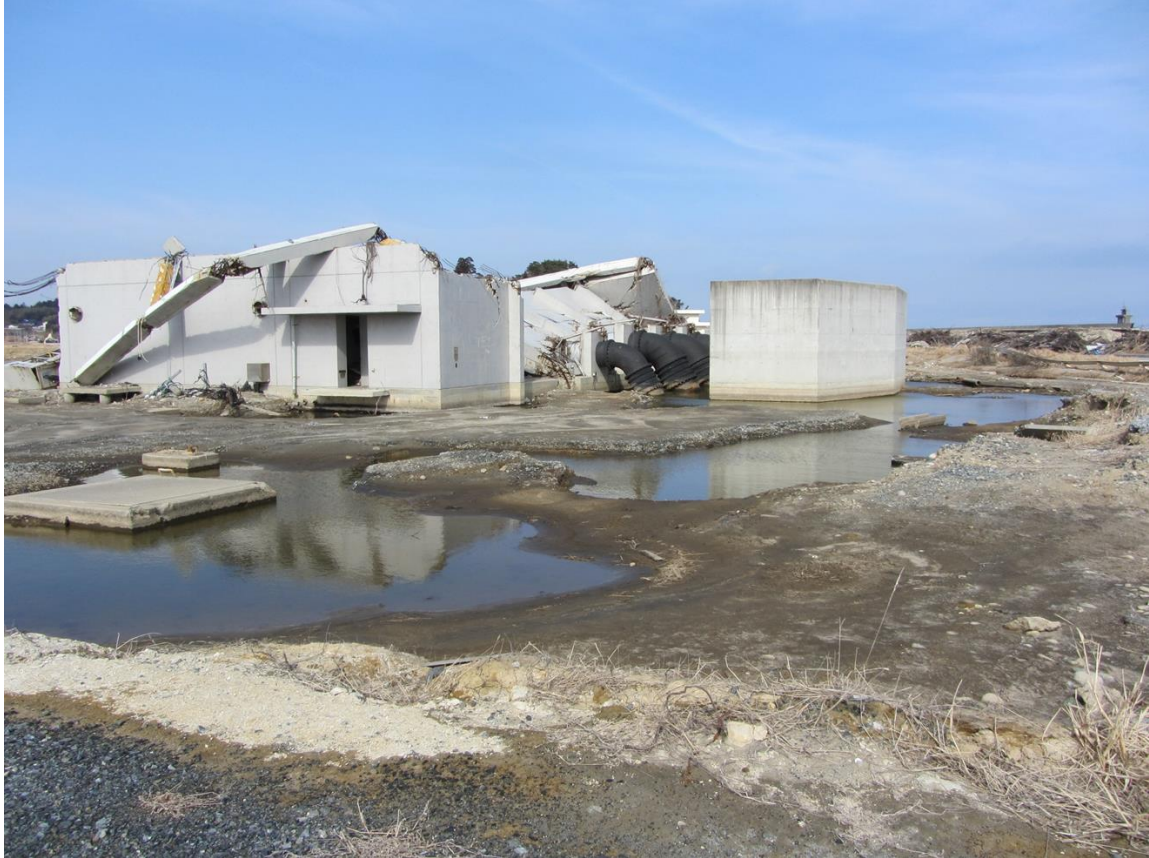
Figure 16 shows the destruction of the Odaka Pump House located close to the shoreline along the Idagawa Coast (see Figure 11 for the location). The pump house is a reinforced-concrete structure which failed completely as indicated by fractured walls and columns snapped off at their base. Observed scour holes around the foundation of the pump house did not appear to contribute to the structural failure. The seawalls initially blocked the incident tsunami flow allowing energy storage and accumulation until overtopping commenced. This stored energy – *at least* to the crown elevation (6.1 m) of the seawall – must have been released to the lee side. The overtopping flow released from the high elevation of the seawall crown created a high-velocity (more than 11 m/s based on the Bernoulli theorem) onto the initially dry soil surface behind the seawall. The upper limit of the flow speed is estimated to 17 m/s for a tsunami height of 15 m near the seawall at Idagawa (Figure 9). Therefore, the flow speed behind the seawall in Idagawa is constrained within a range of 11 ~ 17 m/s, which is comparable to velocity measurements at Kesenuma (Fritz et al., 2012). The corresponding stagnant pressure range is 61 ~ 145 kPa, which could explain the massive fluid forces applied to any trees and structures behind the seawall. The generation of

such massive hydrodynamic forces by overtopping flows immediately behind the seawall can be considered as one of the disadvantages of seawalls. Protective coastal structures limit the ocean view and the noise from an approaching tsunami, which in combination with psychological overconfidence in engineered defense structures, could mislead people to delay their evacuation. In Japan, signs on coastal structures remind residents to heed evacuations regardless of the engineered defenses.

Figure 16 Devastating damage of the Odaka Pump House located close to the Idagawa Coast (February 6, 2012).
