Title: Seismic Performance of Aging Prestressed Transmission Poles with Simulated Soil Foundation.

A THESIS
submitted to
Oregon State University

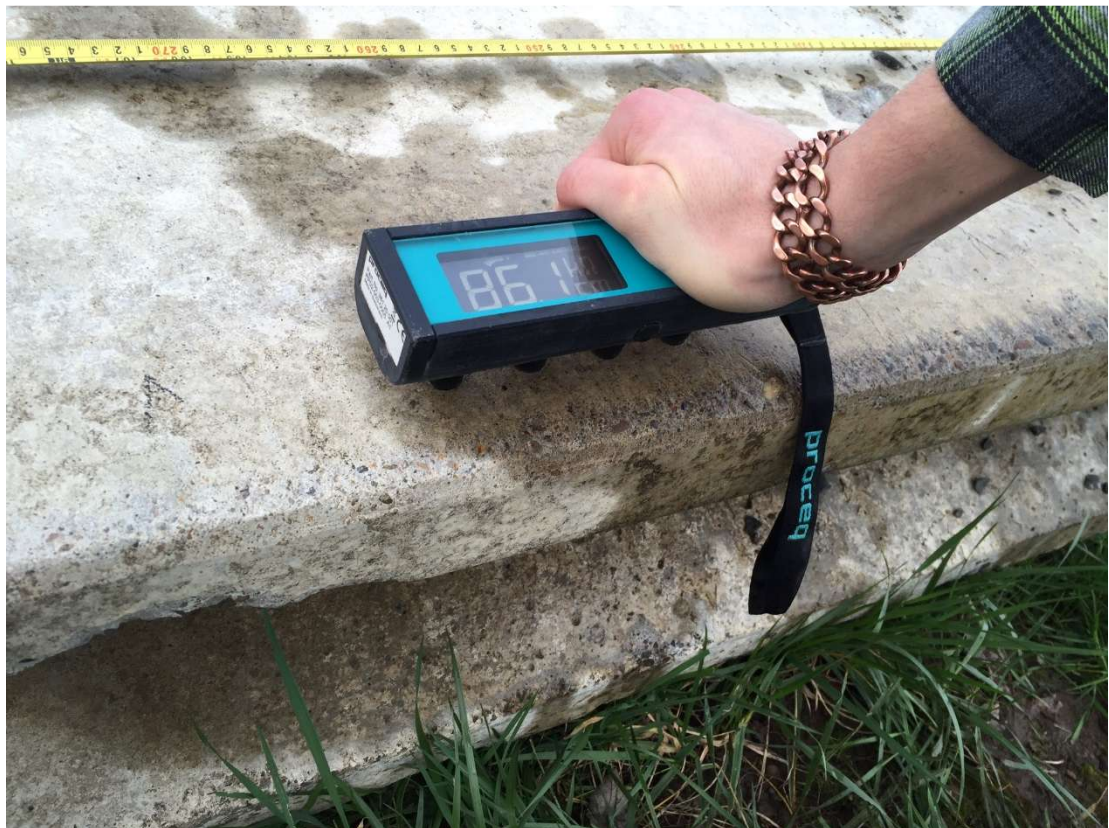
Fig. 3-9 Electrical surface resistivity measurements.

measurements are taken directly on the surface of the concrete, and a reading is recorded within seconds. One durability indicator is the ability to determine a relationship between electrical resistivity and corrosion rate of reinforcing steel, as well as transport properties throughout the bulk concrete (Polder *et al.* 2000). It was found that the electrical resistivity and corrosion rate are inversely proportional (Lopez and Gonzalez 1993, Gowers and Millard 1999). However, the state of the concrete can affect the electrical resistivity measurements. These include the degree of saturation in the pore network, chloride concentrations (Morris *et al.* 2004, Song *et al.* 2007), and the presence of reinforcing steel (Millard 1991). In this research, a four-point Wenner probe was used as seen in Fig. 3-9.

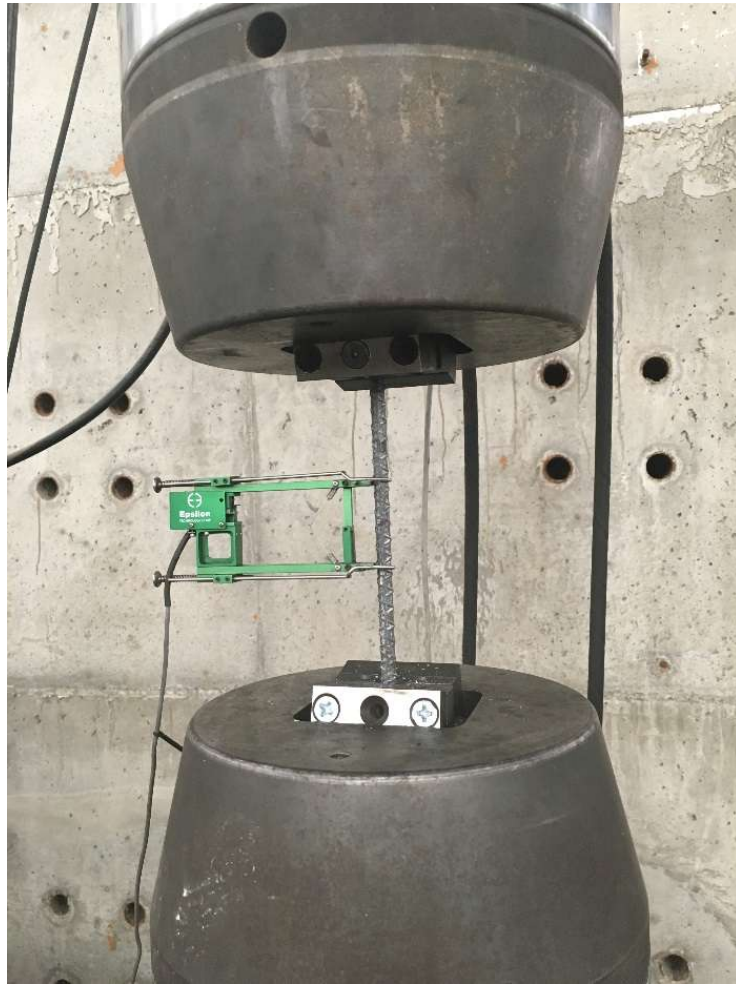
Fig. 3-13 Mild reinforcing steel samples within UTM.

steel used during construction to assemble the cages. A schematic of the transverse steel with weld locations and strand is seen in Fig. 3-12. The straight bars without welds located on the samples were tested in accordance with ASTM E8 for *Tension Testing of Metallic Materials* on a hydraulic MTS ASTM (Standards 2015) as seen in Fig. 3-13.

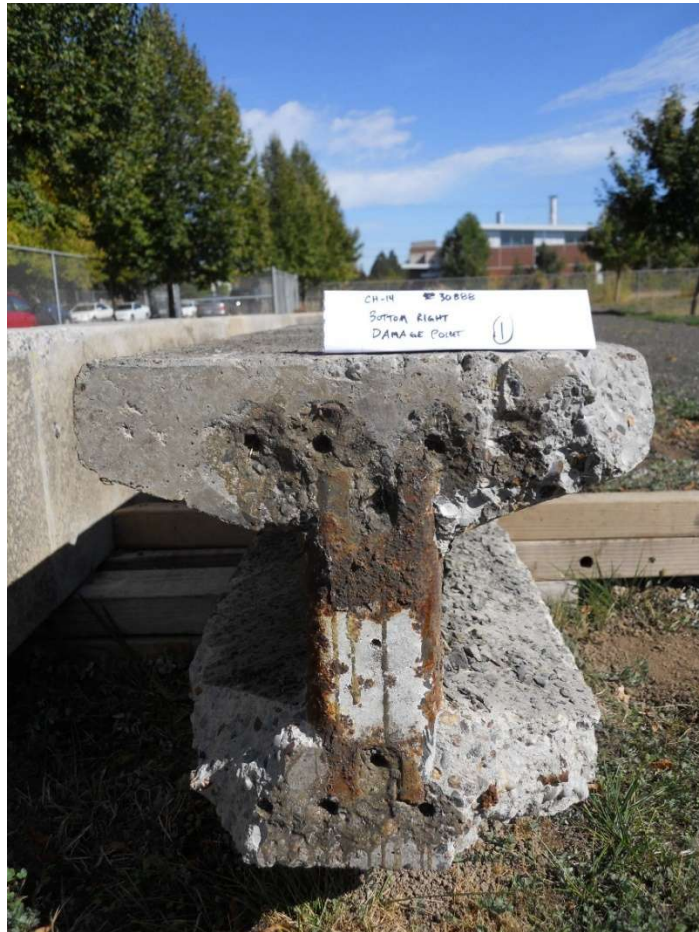
Fig. 3-16 Condition of reinforcing steel at pole ends.

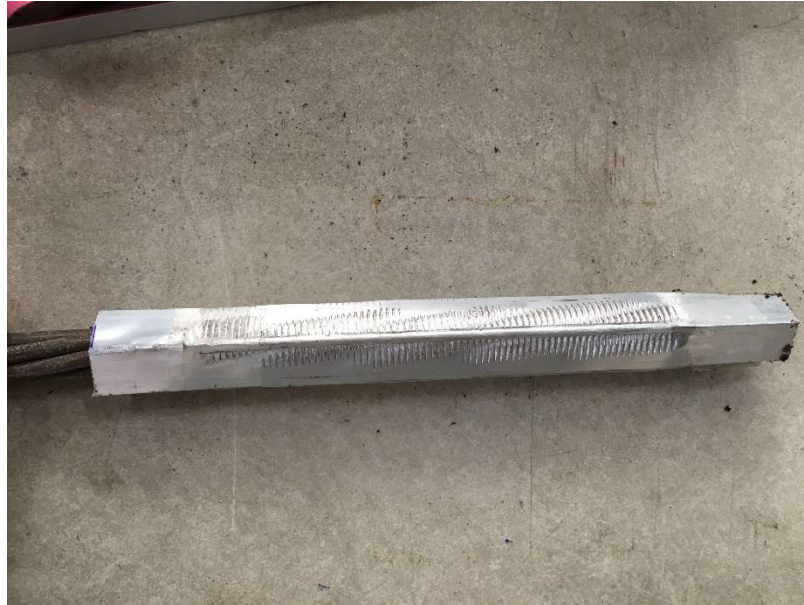
Fig. 3-21 Aluminum angle after gripping prestressing strand during a test.

The prestressing strand was gripped in the UTM using aluminum angles to prevent damage of the cross section of the strand and cause failure in the grips. *Fig. 3-21* provides an image of the aluminum angle after testing and the underlying strand twisting pattern can be seen through the angle.

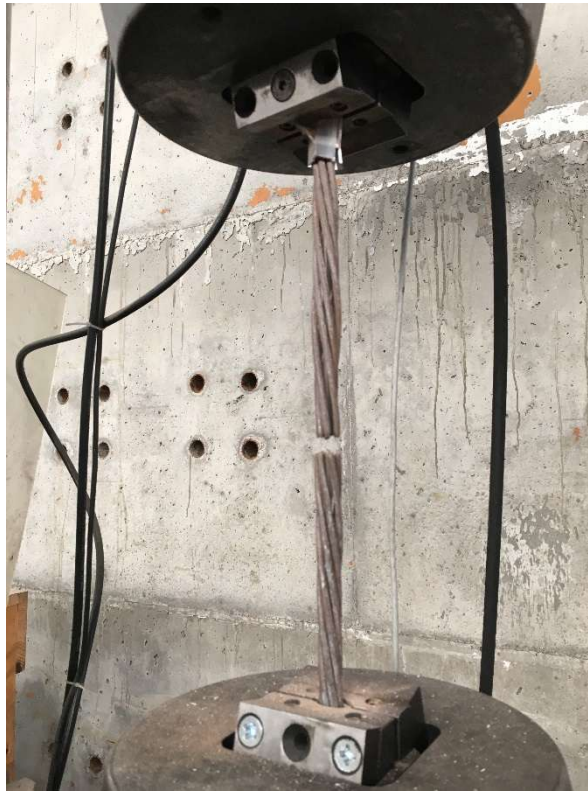
Fig. 3-22 Tensile failure of prestressing strand.

The rupture of the prestressing strands occurred outside the grips and provided examples of cup and cone fracture surfaces typical of ductile metallics. *Fig. 3-22* depicts the strand after failure at mid-length of the 2 ft long specimen. At the top of the figure, the aluminum angle can be seen protruding out of the grips.

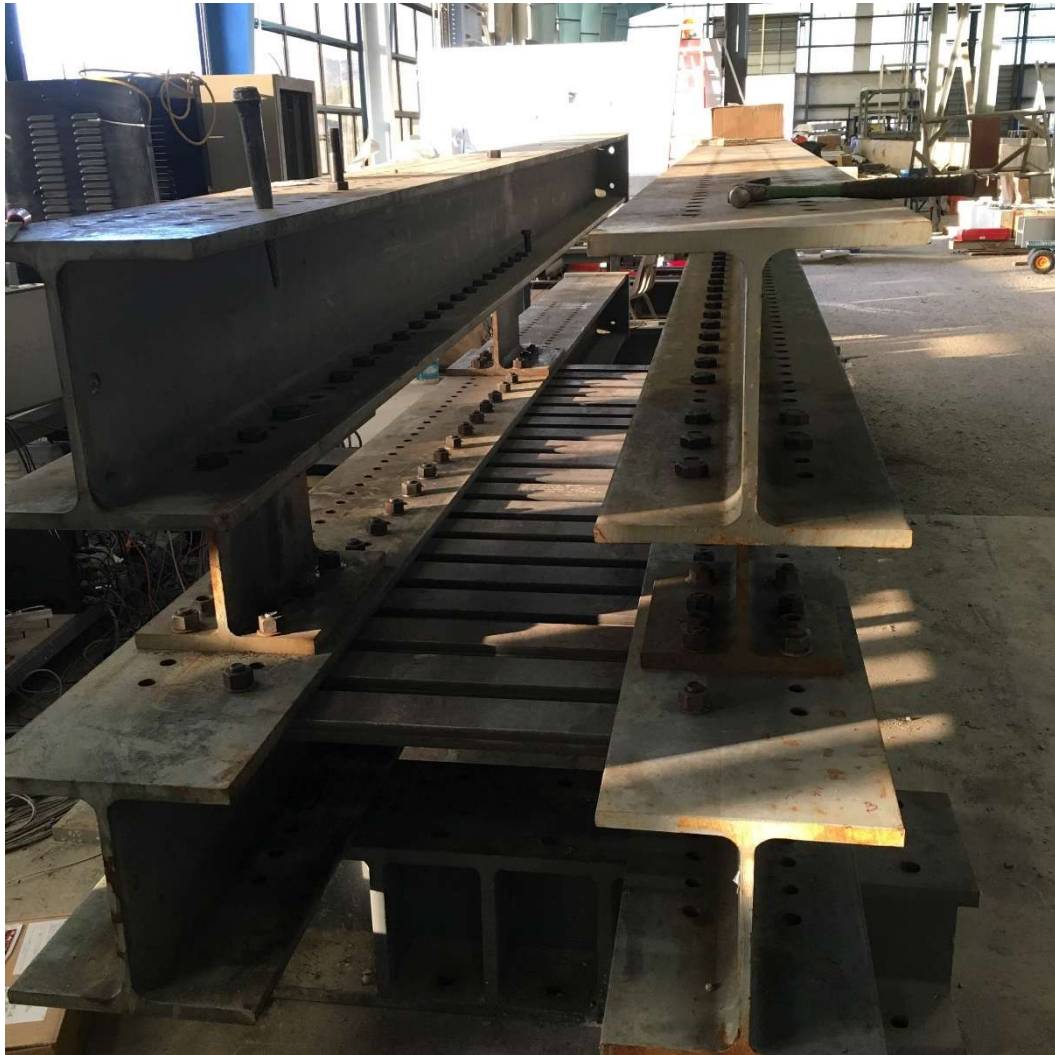
Fig. 3-29 Construction of foundation setup prior to placement of specimen (springs shown across the bottom only).

The spring constant for one $\frac{3}{4}$ in. thick and 4 in. wide plate was computed as 8.9 kip/in. This value was nearly three and a half times the desired amount for a soil spring. Due to high demands in the plate when the strength of the pole is achieved, a second plate was required to prevent yielding of the plate during testing. The plates were fastened only at the ends where they join to the flanges of the W14x159 sections. This allows slip along the interface and results in the plates acting as springs in series. The two plates placed in series produce a spring constant of 17.8 kip/in. The final spring design consisted of two plates stacked on top of one another, 1.5 in. thick, 4 in. wide, by 31 in. long. The plates had two $\frac{1}{16}$ in. diameter drilled holes that were spaced 28 in. apart. The holes were drilled to match the holes along the flanges of the W14x159. The spring plates were bolted to the underside of the flanges of the W14x159, and thus did not interact with the steel flanges during deflection. The steel grade for the springs was chosen to be 50 ksi to prevent yielding the plates. The springs were placed every 6 in. on-center over a length of 9'-6". The test setup with the springs added is illustrated in Fig. 3-28. Fig. 3-29 gives perspective of the setup in the laboratory.

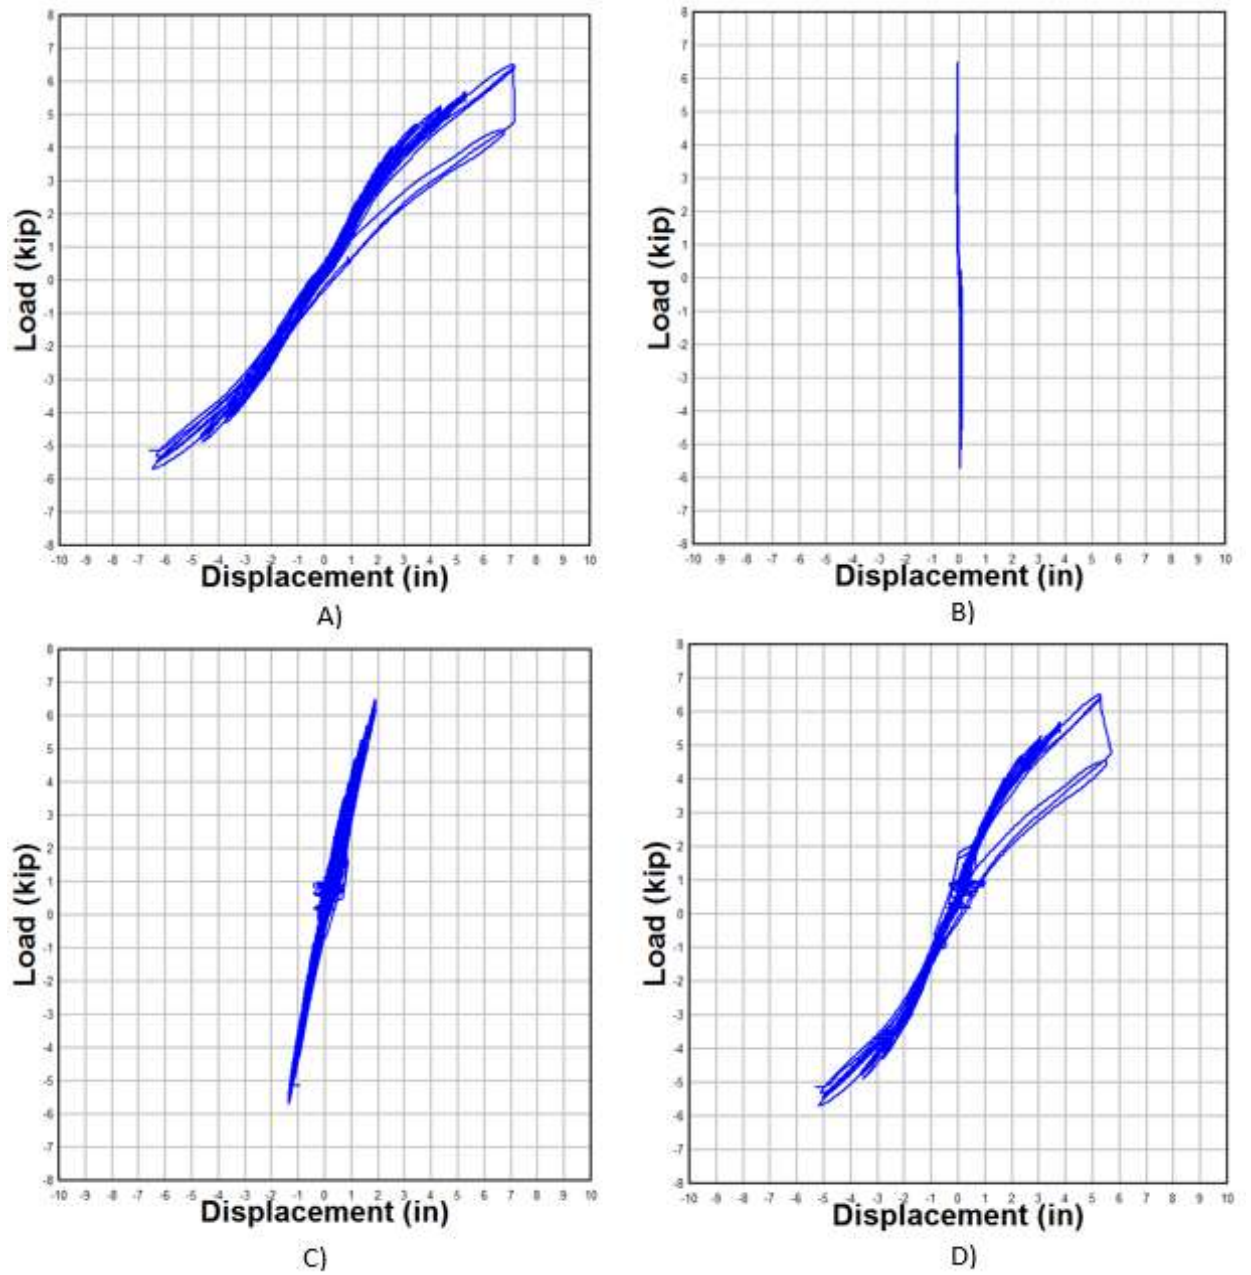
Fig. 4-1 A) Tip displacement, B) translational displacement of the steel plates, C) tip displacement due to rotation within the springs, and D) bending displacement at the tip for Pole 1 during cyclic testing.

The displacement of the pole was broken into the components produced by bending within the pole, rigid body rotation, and translation due to the simulated soil springs shown in Fig. 4-1. The translation was very small in comparison as it accounted for the springs settling due to the load of the beam being fully engaged to the springs after removal of supports. Rotation of the pole within the foundation has little effect until higher load cycles when the springs are fully engaged. The displacement due to bending of the pole contributes the most to the total tip displacement and can be seen in Fig. 4-1. Upon Pole 1 failing, the load drops significantly while allowing further bending displacement as seen in Fig. 4-1 D).

Due to continued cycles in both the positive and negative direction as seen in Fig. 4-1, the failure of both compression faces in the extreme fibers of the flanges spalled exposing the prestressing strand and transverse reinforcement. The remains of the cross section just above the ground line after both failures can be seen in Fig. 4-2.

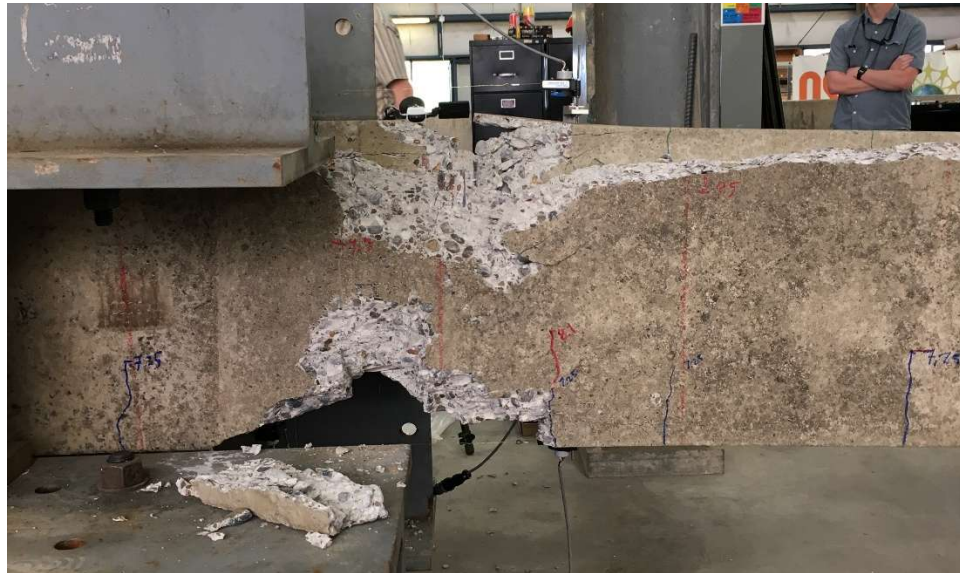
Fig. 4-2 Pole 1 after both positive and negative failure.

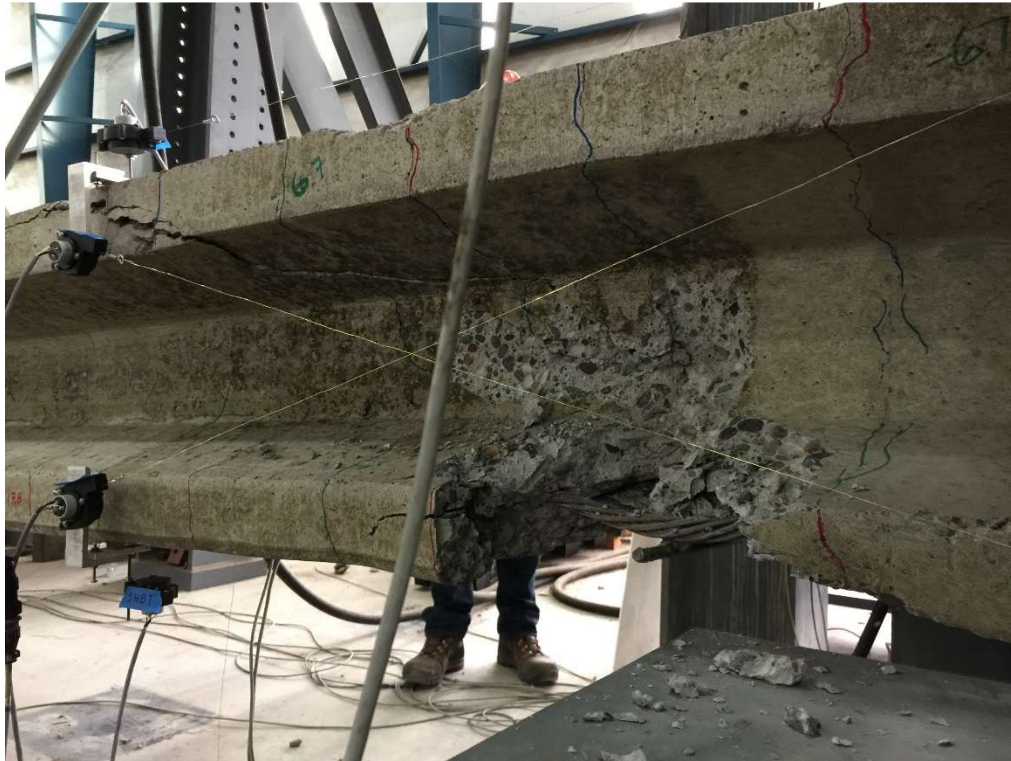
Fig. 4-10 Pole 2 cyclic failure to bottom flange.

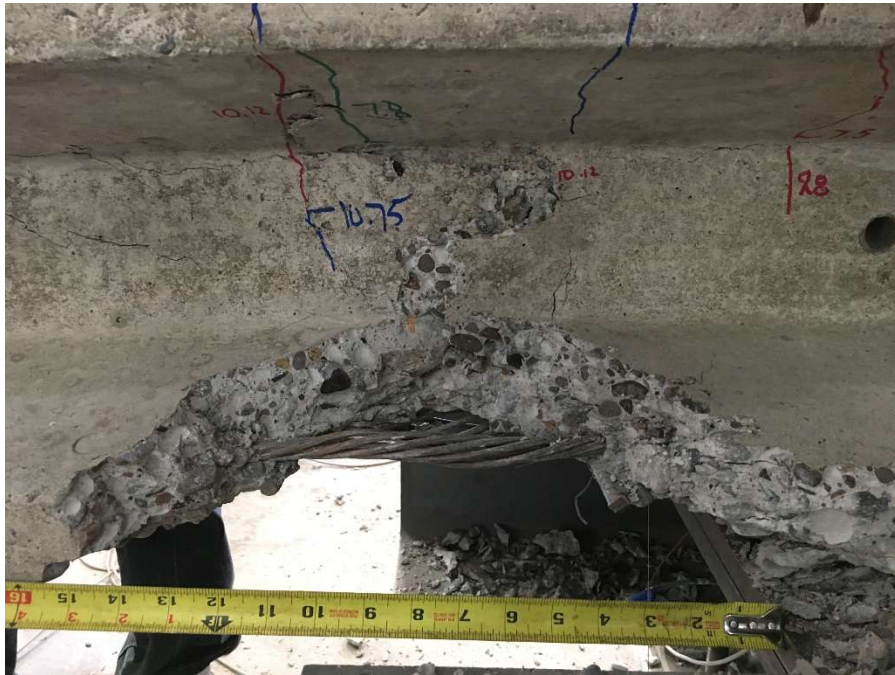
Fig. 4-17 Flange failure for Pole 2 in monotonic loading.
