BUECHE GROUP

Current Conditions

MORNING STAR

Roads and Trails

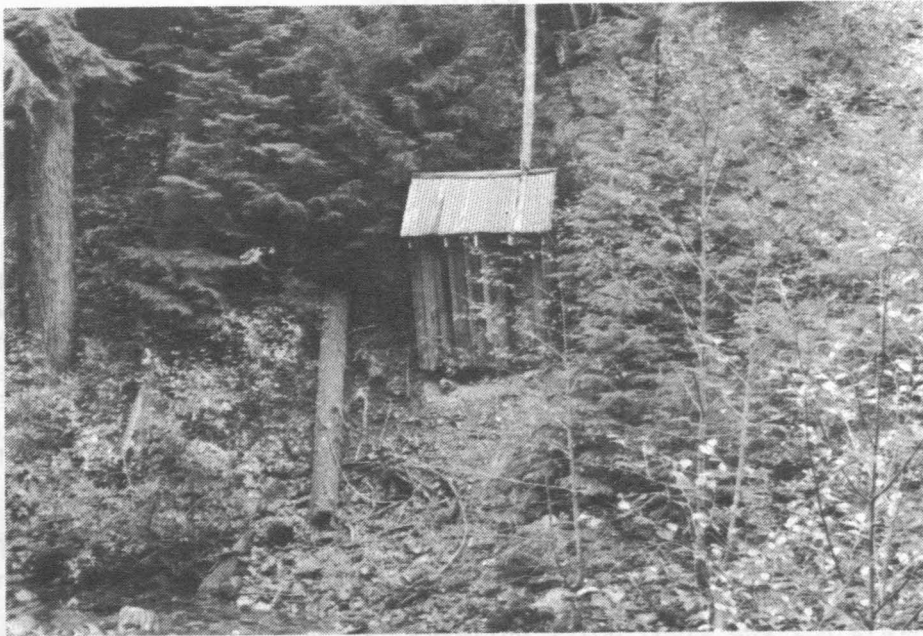
A board and bat shack stands 60 feet west of the adit on the north side of Battle Axe Creek. This is 6 feet square, with a corrugated metal roof. Further west, another 120 feet, is a pile of boards and a few sheets of metal roofing. These appear to be the remains of a structure similar to the extant shack.

Shack on north bank of Battle Axe Creek at Bueche Group.

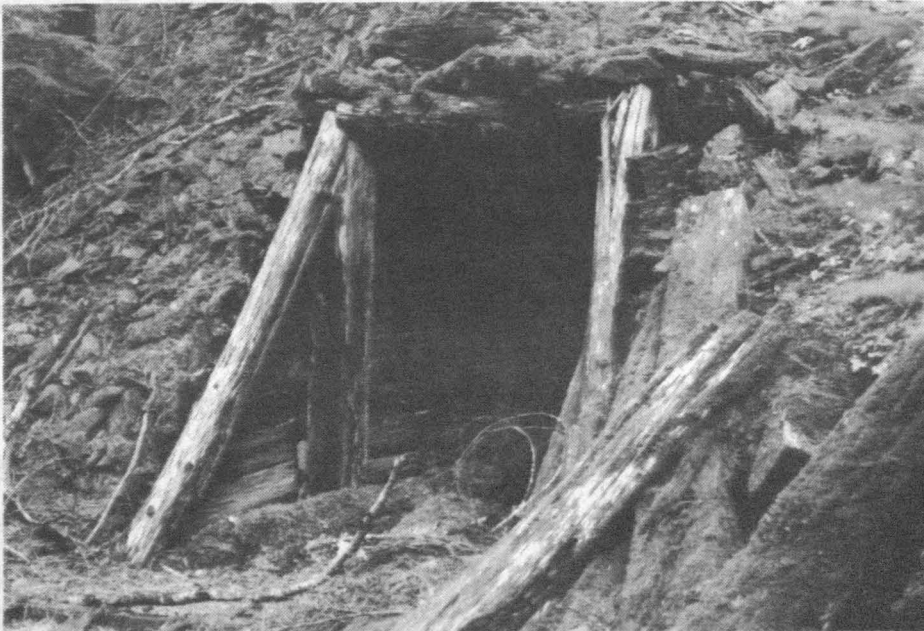
Two adits were located on the south side of the creek, roughly across from the one on the north bank. The eastern-most adit was collapsed, although timbering around the portal was still standing. Ore cart tracks also ran from this mine to the edge of the creek bank. The western adit lies 10 feet higher than the eastern one. It was open and had no track associated with it.

Portal of eastern adit on south bank of Battle Axe Creek in Bueche Group.

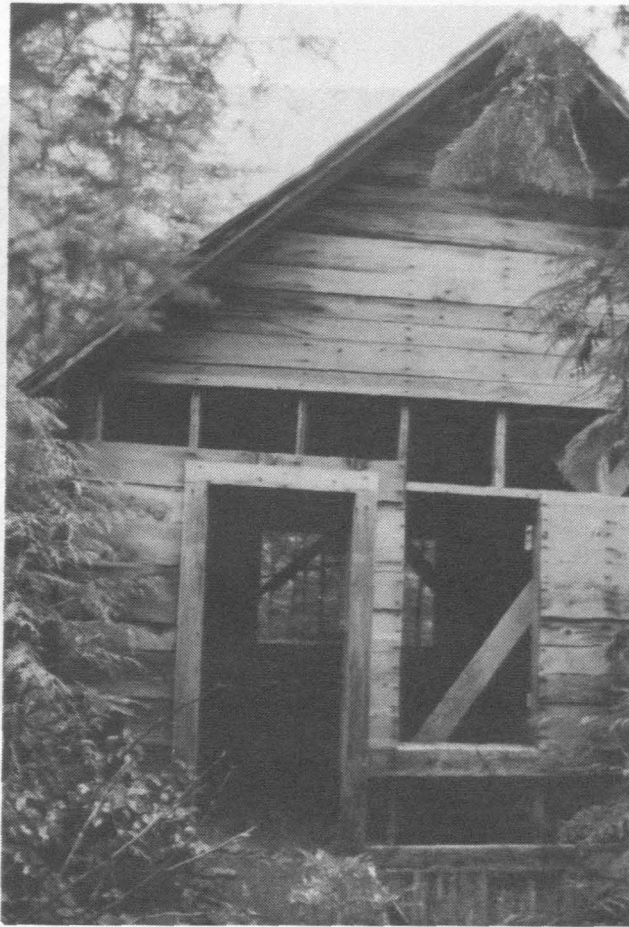
Unstable, vandalized structure in upper Amalgamated camp.

The third standing structure in this area is located on the north side of the spur road between the cabin previously discussed and the junction with the main road. This building is 15 x 20 feet square. It is built on the steep hillside using poles to support the downhill side. Construction is rough sawn board over 2 x 4 framing. The floor is tongue and groove over 2 x 6 subflooring. The gabled roof, originally shake, is now covered with rolled tin.

This structure is unstable and appears to have been vandalized. A thick wire rope, wrapped around a stump and the ends attached to large bolts imbedded in the corners, keeps the building from falling down the ridge. Boards have been removed from the exterior walls and the ceiling. The windows and doors are gone.

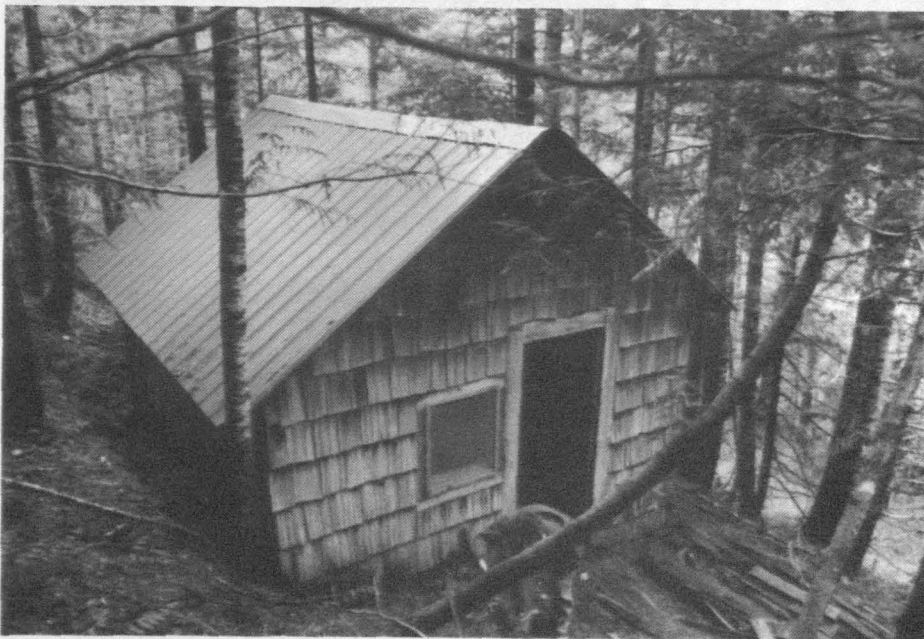
Shake cabin in upper Amalgamated camp.

A small, one room cabin is located on the north side of the spur road leading from the main road to the Ruth level 4. This cabin is 14 x 18 feet square. The gabled roof, originally shake, is now covered with rolled tin. Three of the exterior walls are shake with the south wall vertical board. The floor is tongue and groove boards. Three interior walls are panelled with rough sawn lumber. Nail holes in studs and rafters indicate that the ceiling and fourth wall were originally covered.

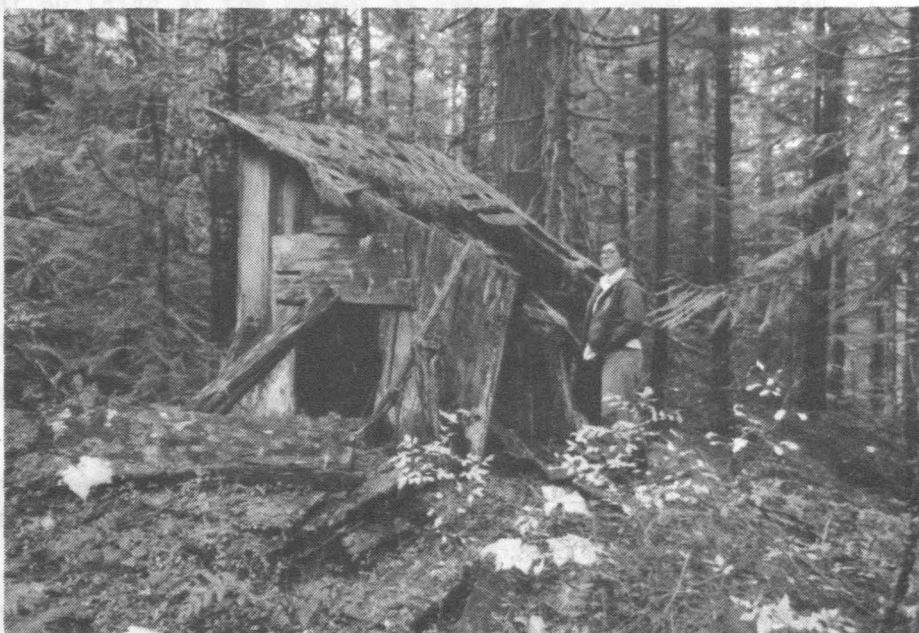
Power generation shed in upper Amalgamated camp and Dotty Lamolinara.

A small shed is located below the main road. This is identified locally as a power generation shed. This is 6 x 10 feet and has a shake covered shed roof. The walls are board. It is in poor condition with half of the roof and one wall gone.

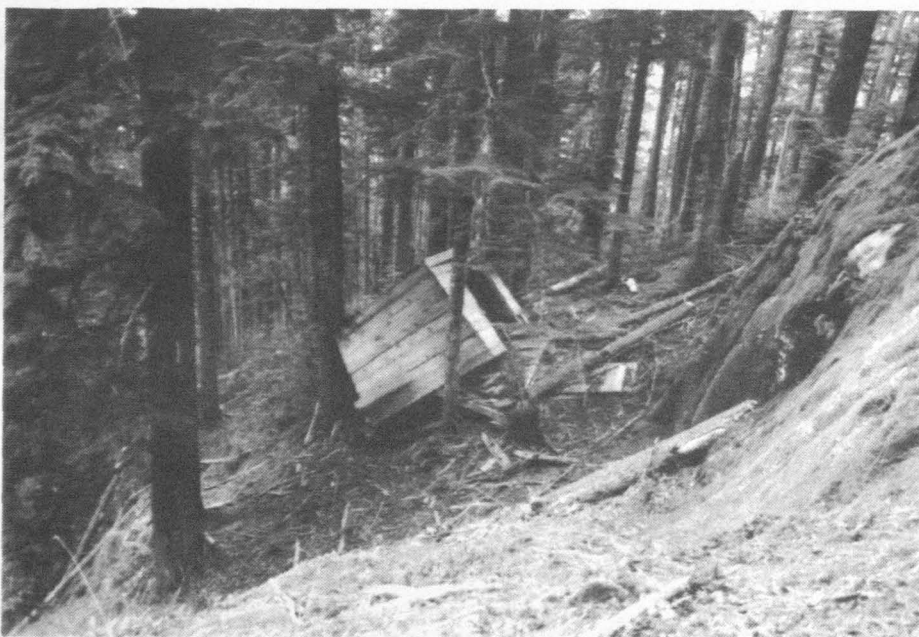
Remains of building at Morning Star Mine.

The remains of a small building are located 150 feet northeast of the mine. It is in poor condition. The roof has caved in, and the building leans precariously. It is built entirely of rough sawn lumber. The walls and roof were framed with 2 x 4's, and the floor with 2 x 8's supported by 8- x 8-inch beams. The floor, exterior walls, and roof were covered with 1 inch thick boards and nailed in place with round nails.

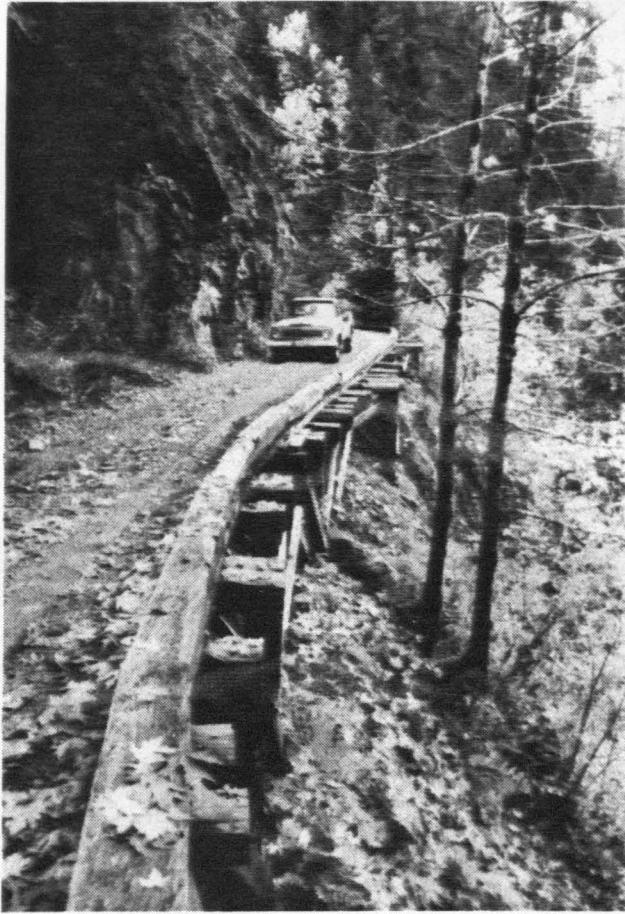
All of the current bridges date to no earlier than the 1960's. This includes the half-bridges on the unimproved portion of the road east of Gold Creek. These were completely reconstructed in the early 1970's. This was done based on plans drawn from the original bridges, using similar materials, in an attempt to duplicate the original structures.

Eastern half-bridge on road east of Gold Creek.

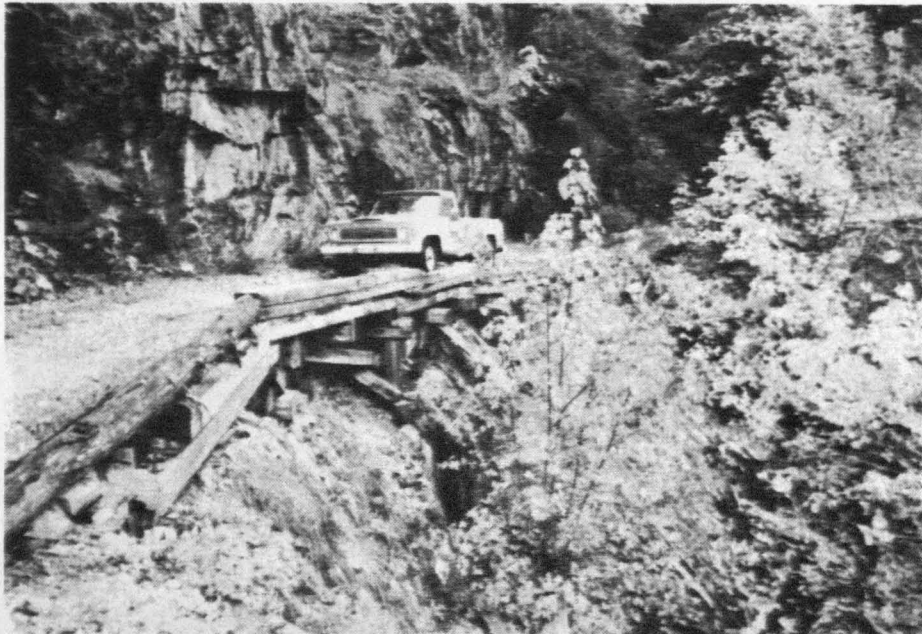
Western half-bridge on road east of Gold Creek.

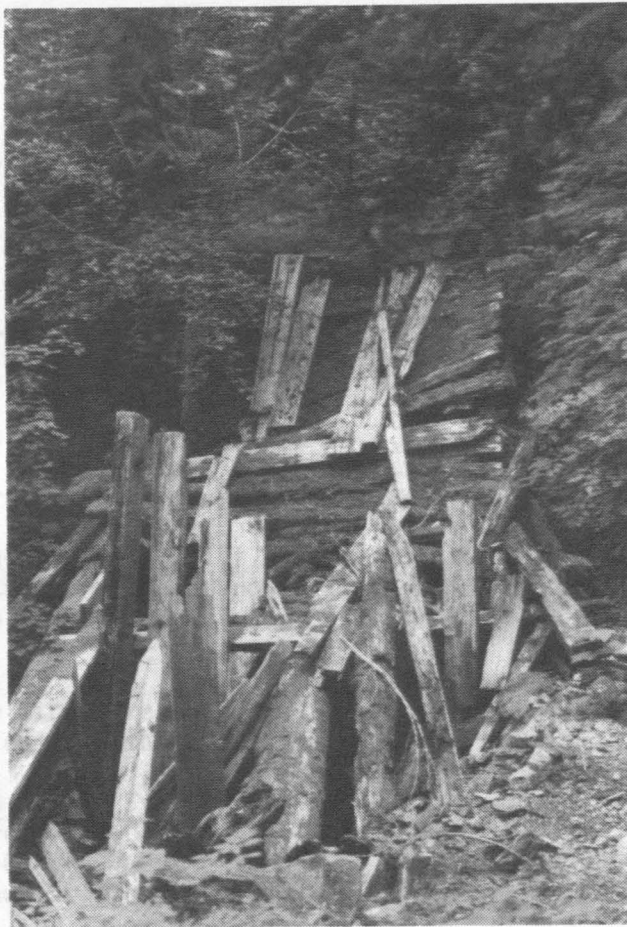
A tram road was constructed in the early 1930's that ran along the south side of Battle Axe Creek from level 5 of the Ruth Mine to a junction with the miner's road some 1,000 feet east of the Amalgamated ore mill. This road was used by trucks to haul ore to the mill (George Atiyeh, personal communication).

Collapsed bridge on tram road.
