R e s e a r c h C o n t r i b u t i o n 3 8

**RIPARIAN FOREST BUFFERS ON
AGRICULTURAL LANDS IN THE
OREGON COAST RANGE:
BEAVER CREEK RIPARIAN
PROJECT AS A CASE STUDY**

J u l y 2 0 0 2

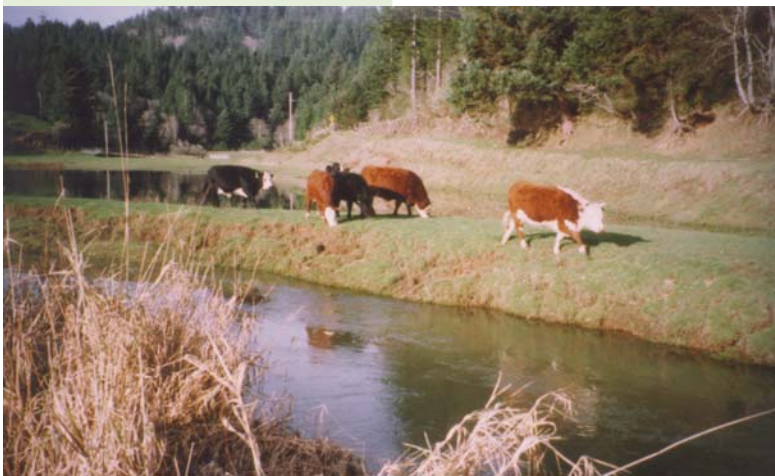
Figure 2. Cattle grazing along coastal streams (far bank) can lead to bank erosion. Lack of tree cover means that streams heat up during summer low flows. Note the heavy grass cover on the near bank (foreground) that developed in only 2 yr after the fencing to exclude the cattle.

Other factors that affect stream temperature are stream channel morphology, flow rates, and stream surface area. These are important because the capacity of a stream to buffer against temperature increase is directly influenced by water volume and the size of the surface area that is exposed to the energy source. Beaver Creek is characterized as a narrow, meandering stream with a width of 2.4–3.7 m (8–12 ft) during the summer season. Like many coastal streams, the lower reaches of Beaver Creek are unconstrained. Beaver Creek is a flood-prone, moderately entrenched, medium fish-bearing stream with low (<3%) gradient. It meanders through a flat valley floor composed of post-glacial deposits capped by fine sediments. Sand and silt are predominant in the streambed, and the banks are kept bare of vegetation by grazing livestock (Figure 2, 3).

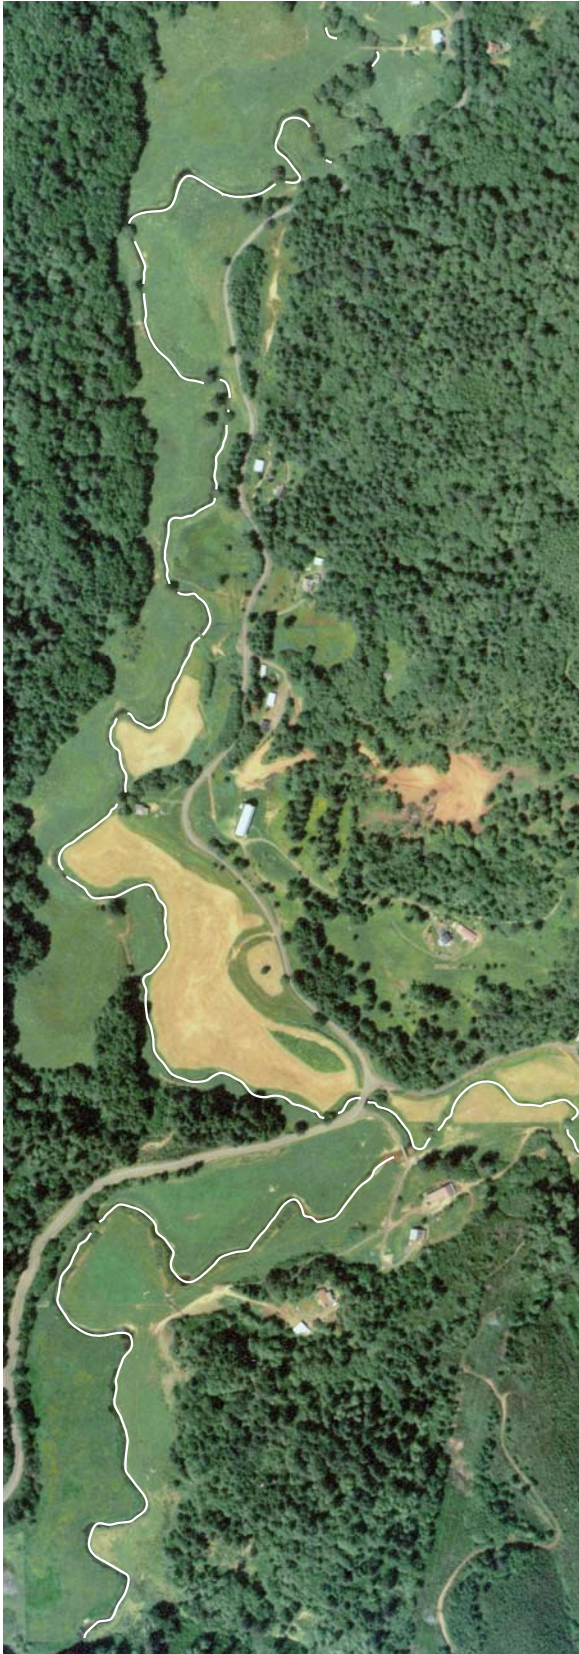
Figure 3. Aerial view of North Beaver Creek, Oregon (1997), showing a typical small stream meandering through pastures, with little forest vegetation on much of the streambank. The riparian planting project is barely visible toward the bottom of the picture.

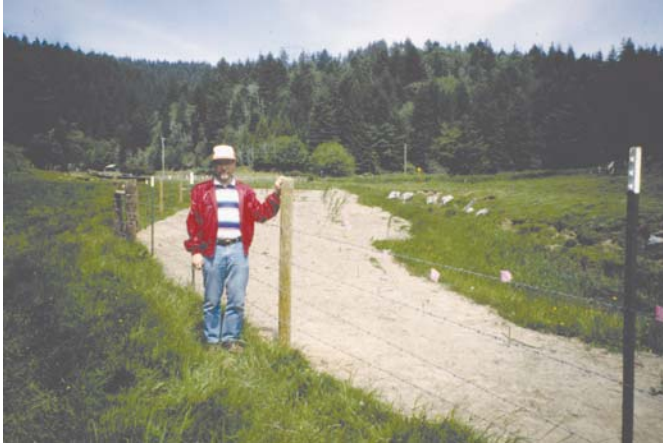
Figure 6. A four-strand barbed wire fence effectively excluded cattle from the filter belt.

A stream reach of 335.3 m (1100 ft) along the south bank was fenced by four-strand barbed wire to keep livestock out and protect the study trees from animal browsing (Figure 6). Within the fenced area, a 3.1-m (10-ft)-wide grass strip along the entire bank of the stream was left untreated to minimize soil erosion. Treatment areas 30.5 m (100 ft) in length were identified and marked, and then were prepared for planting. Site preparation included herbicide treatment with a backpack sprayer. Accord (glyphosate, Monsanto, St. Louis MO), then Oust (sulfometuron, Dupont, Wilmington DE), herbicides were used to eliminate existing pasture grasses in all areas to be planted (Figure 7). Sites were then planted with tree seedlings (Figure 8). Follow-up treatments with Roundup Ultra (glyphosate, Monsanto, St. Louis MO) around individual seedlings occurred during the next 2 yr. The control area consisted of a 30.5-m (100-ft) strip of pasture that was neither sprayed nor planted with trees (Figure 5).

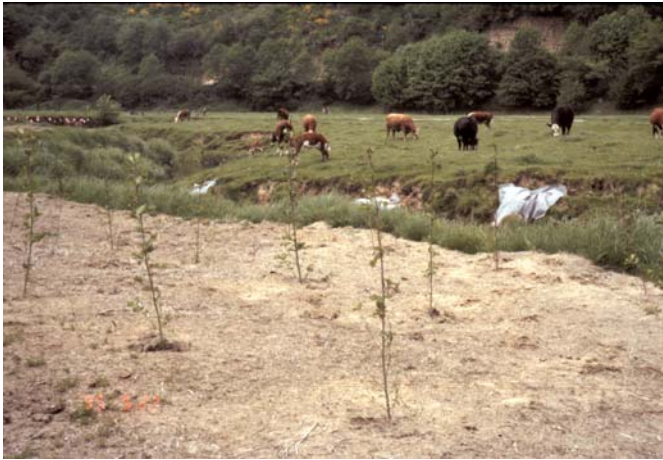
Figure 7. During project initiation (spring 1995), the area was given a herbicide site-preparation treatment to eliminate pasture grass competition, and bare root red alder seedlings were planted. In May, as shown here, individual seedlings were not protected.

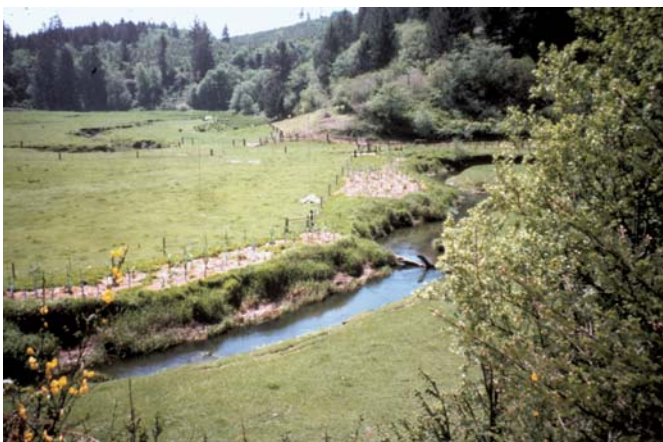
Figure 8. A view of one of three replications just after planting, showing site preparation vegetation control and the 3-row treatment (foreground), unsprayed control, and 6-row treatment. Note the contrast between the vegetation on the fenced south bank and the unfenced and grazed north bank just 3 mo after fencing.

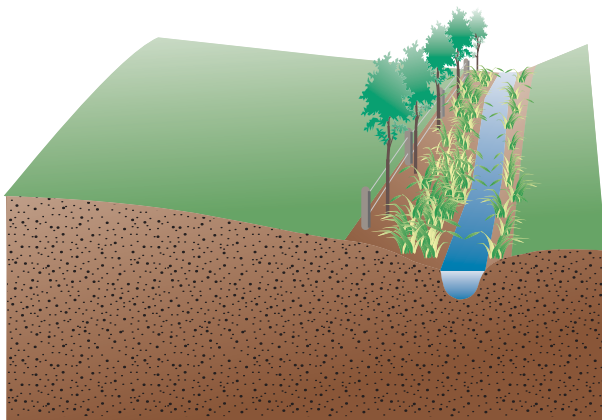
Figure 9. Diagram showing filter belts of differing numbers of rows of trees.

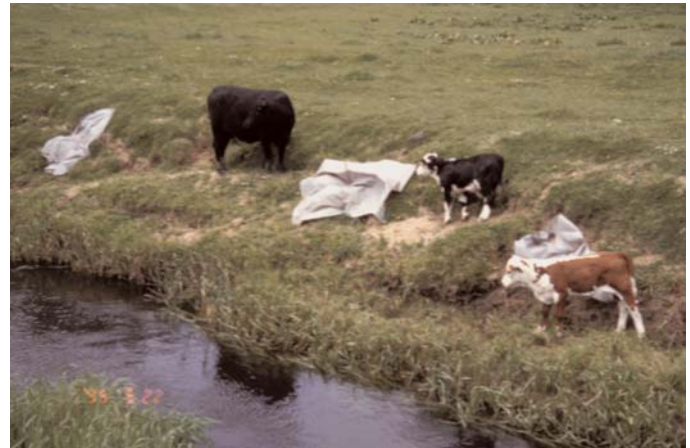
Figure 10. Weed control fabric (Polyspun 350) was used in some areas to test its efficacy in controlling competition. Here, unprotected alder seedlings were planted on the unfenced north bank to demonstrate how cattle eat seedlings and the necessity of a cattle-excluding fence.

Observations of tree performance and animal damage were made immediately after planting in spring of 1995. Within 2 mo of planting, cattle had eaten all trees planted in the unfenced areas on the north side of Beaver Creek (Figure 10). By early June 1995, 31 trees on the fenced south bank had been eaten by beaver. Half of the cottonwoods and a few red alder trees died from other causes. At that time, we began to implement the first of three different measures to protect trees from beavers (Figure 13). We initially installed 45.7 cm (18-in.) tall Vexar tubes (Terra Tech, Eugene OR) on 100 red alder trees (Figure 14). Later that month, 50 additional trees had been eaten by beaver. Magic Circle repellent was then applied to most trees to protect them from further animal browsing. In July 1995, all surviving trees were Vexar-tubed and double-staked by a FS Job Corps forestry crew, although there had been no additional losses in the month since Magic Circle was applied. Magic Circle was then applied to the stems and leaves of trees immediately above the Vexar tubes.

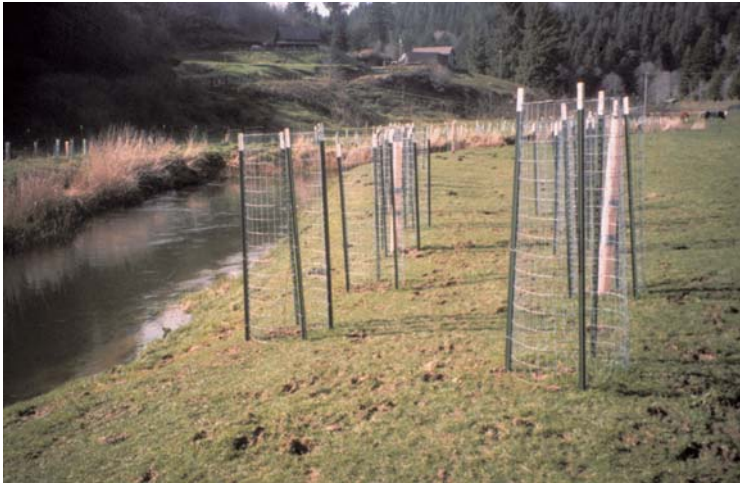
Figure 11. Individual tree protectors were designed to protect seedlings from cattle grazing in unfenced pasture. Although the cost of each device is high (\$12.50), use of this strategy would eliminate the necessity of constructing an expensive cattle fence and minimize the amount of pasture lost in creating a tree cover. Note that mice and voles will girdle trees within these cages if vegetation management is not continued. Mouse-vole protection of individual trees within these shelters can be provided by wrapping the base of the tree in aluminum foil.

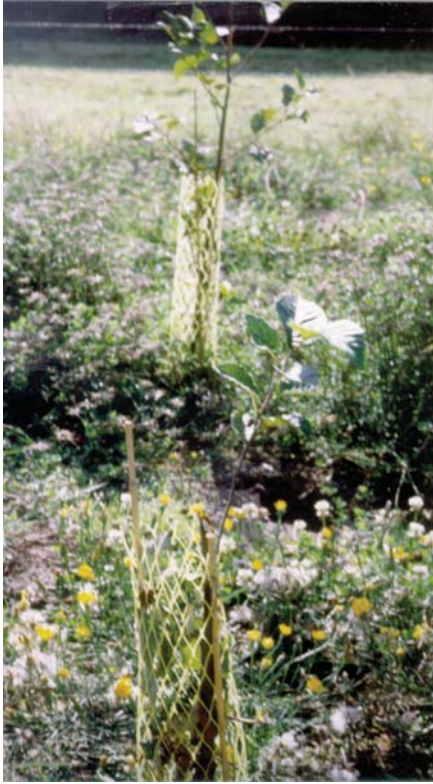
Figure 14. Alder trees were protected with 45.7-cm (18-in.)-tall Vexar plastic tubes when beavers began to eat the unprotected seedlings. These tubes were not effective protection because beavers either climbed the tubes to eat the tree tops or pushed the tubes up and clipped off the tree at the base.

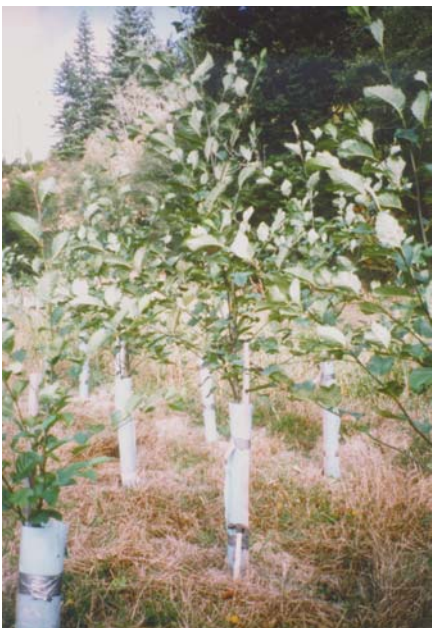
Figure 15. Tree shelters (Protex growth tubes) were installed on half of the surviving alder trees after the first growing season, when beavers ate unprotected or Vexar-protected trees. Here, the alder protected with 0.9-m (3-ft)-tall tree shelters are growing vigorously in their second growing season. Tubes require maintenance. Duct tape was used to secure tubes that had been opened by beavers, flooding, or wind. With proper maintenance, only 2% of the seedlings protected in this manner were killed by beavers after 5 yr.

In December 1995 and January 1996, 3- or 5-ft (0.9- or 1.5-m)-tall Protex smooth-sided growth tubes (Terra Tech, Eugene, OR) were placed on half of the surviving trees (Figures 13, 15). Most of the 5-ft-tall (1.5-m-tall) tubes were later bent over or were removed by severe winter winds and floods. Very few of the shorter tubes were lost. Between January and March 1996, about 125 additional alder were planted to replace those that had died. At this time, additional hybrid cottonwood, along with western redcedar, western hemlock, and grand fir seedlings were also planted in small blocks and protected with Protex growth tubes. All of the western hemlock died within 2 mo during a period of heavy flooding in February 1996.

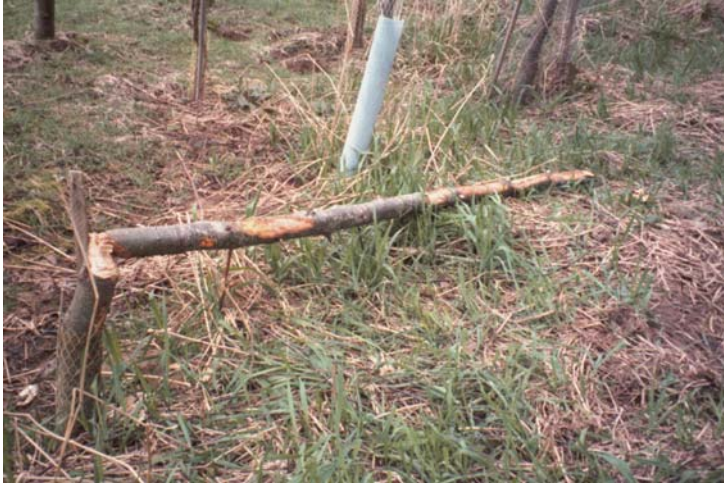
Figure 16. Beavers fell alder that are not adequately protected and remove twigs and bark for food. The 45.7-cm (18-in.) Vexar tube was not effective in protecting this tree. Excess trees may provide a food source for beavers as protective devices are removed. Beavers can cut down trees up to 2 ft in diameter, so long-term tree protection is required.

In April 1998, 3 yr after the initial planting and 2 yr after the follow-up planting, the overall survival rate was 73% (264 trees) for the 6-row treatments, 75% (135 trees) for the 3-row treatments, and 67% (40 trees) for the 1-row treatments, for a total of 439 healthy young red alder trees growing along the stream. Beavers continued to cut down trees protected only by Vexar tubes (Figure 16).

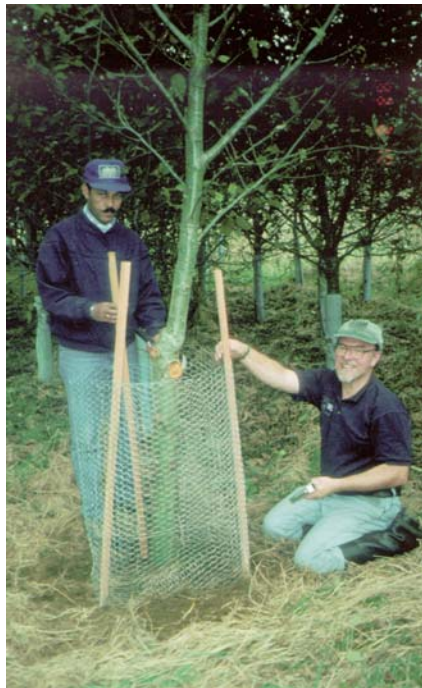
Figure 17. When trees outgrew the tree shelter tubes, protective cages were constructed with chicken-wire fencing and wooden stakes. Cages were made 0.9 m (3 ft) in diameter to provide long-term tree protection.

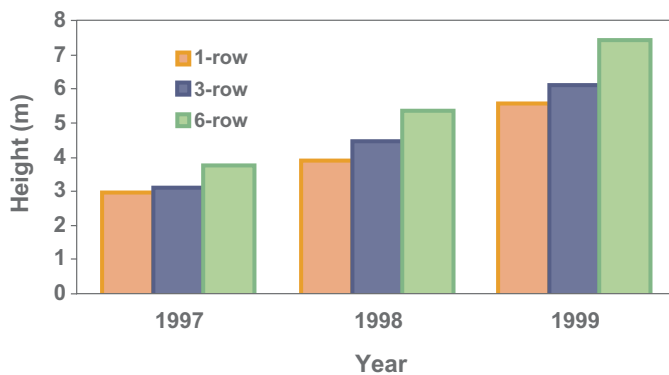
Figure 18. Mean height of red alder trees planted in 1-row, 3-row, and 6-row plots in the Beaver Creek riparian area after the third, fourth, and fifth years (1997, 1998, and 1999, respectively) of growth.

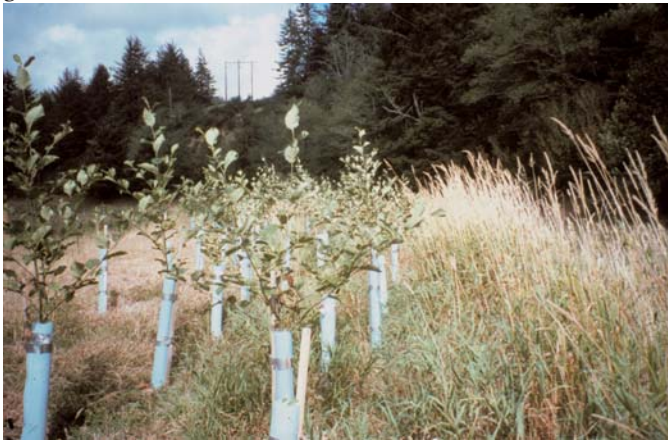
Figure 19. These red alder were growing well at mid-summer during their second growing season (1996). Note that most had grown well above the 0.9-m (3-ft)-tall tree shelters, and vegetation had re-established over most of the ground surface.

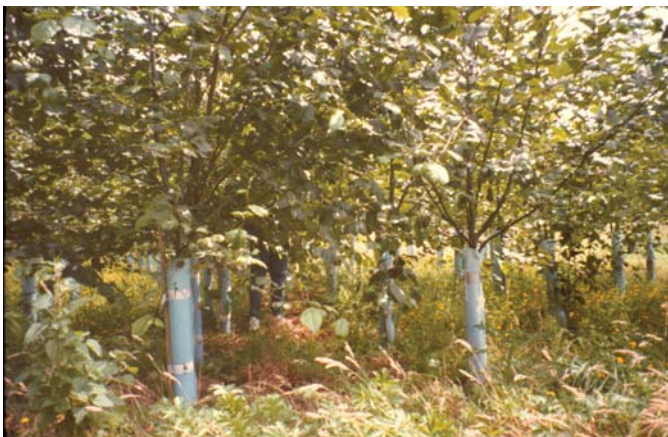
Figure 20. During the third growing season (1997), the red alder in the 3- and 6-row treatments formed a closed canopy and were nearly 3.1 m (10 ft) tall.

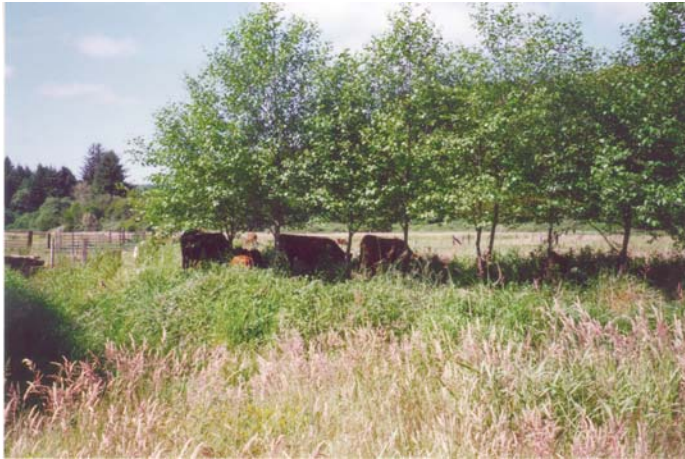
Figure 23. Cattle grazing beneath established trees in filter belt.

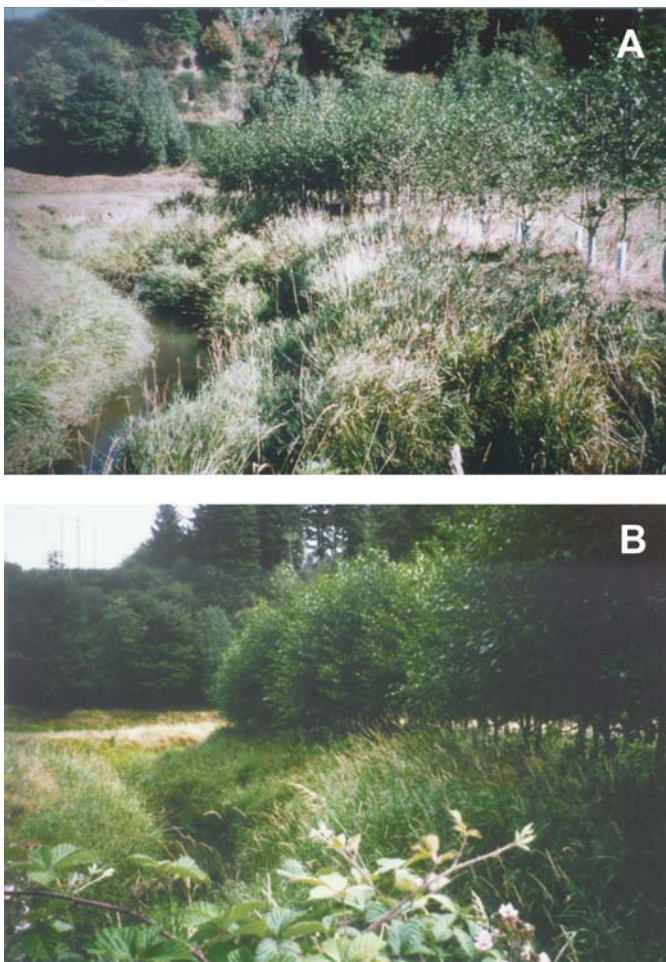
Figure 25. A) During the third growing season, reed canary grass had formed a protective cover on the fenced south bank of the stream (foreground). Grazing on the unfenced north bank continued to remove grass cover (left foreground). At mid-right, 1-row, then 3-row alder, had begun to provide shade. B) Two years later (fifth year of study), both 1-row and 6-row alder plantings on the same bank are providing considerable shade during part of the day. Note that the unfenced north bank was not grazed during this growing season, and considerable grass cover was evident.
